Appendix A.
2017 Main Stem Erosion Repair Project
Feasibility Report, May 2016

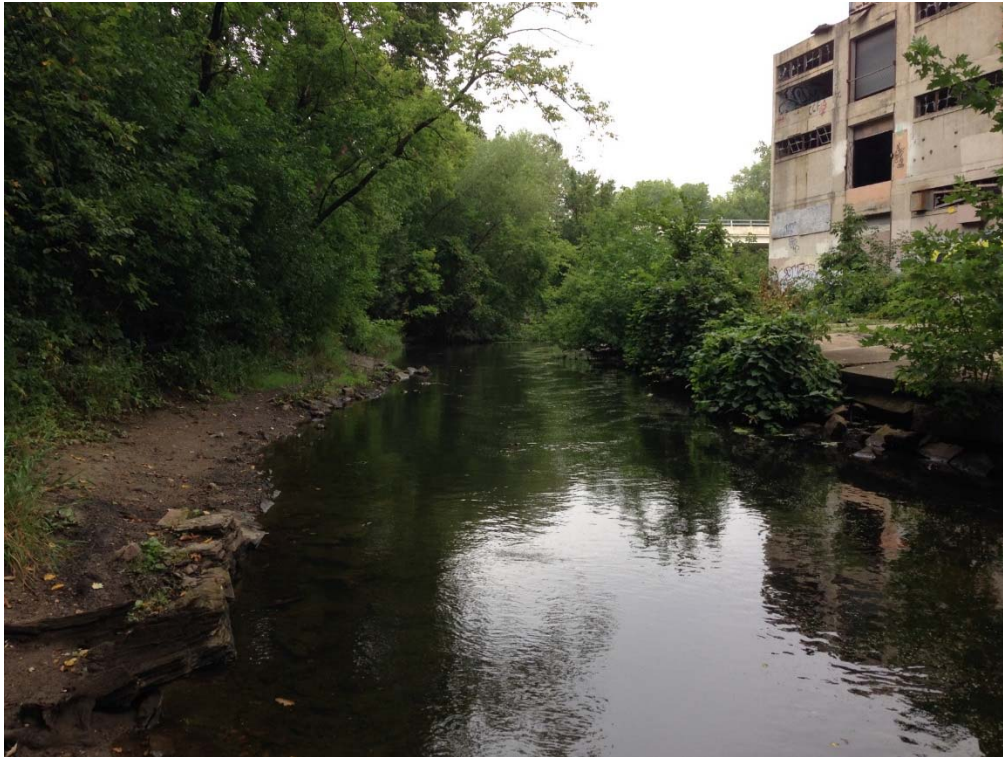
Photo 1. *Site 1.* Existing trail along stream (photo looking upstream)

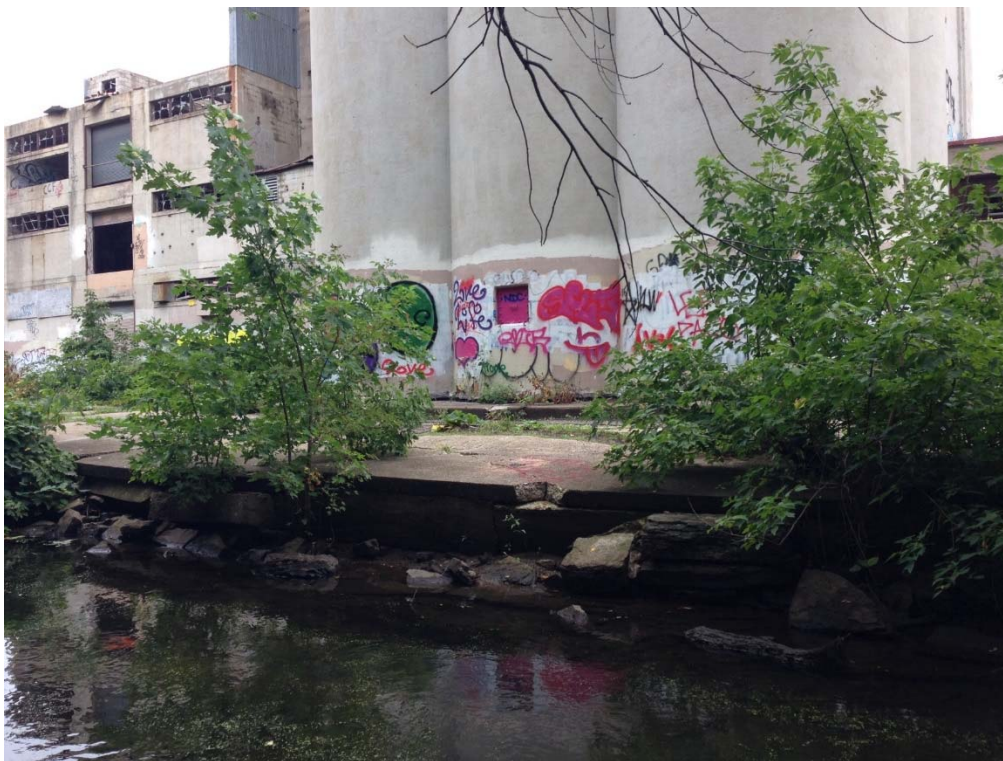
Photo 2. *Site 2.* Concrete and block on stream bank

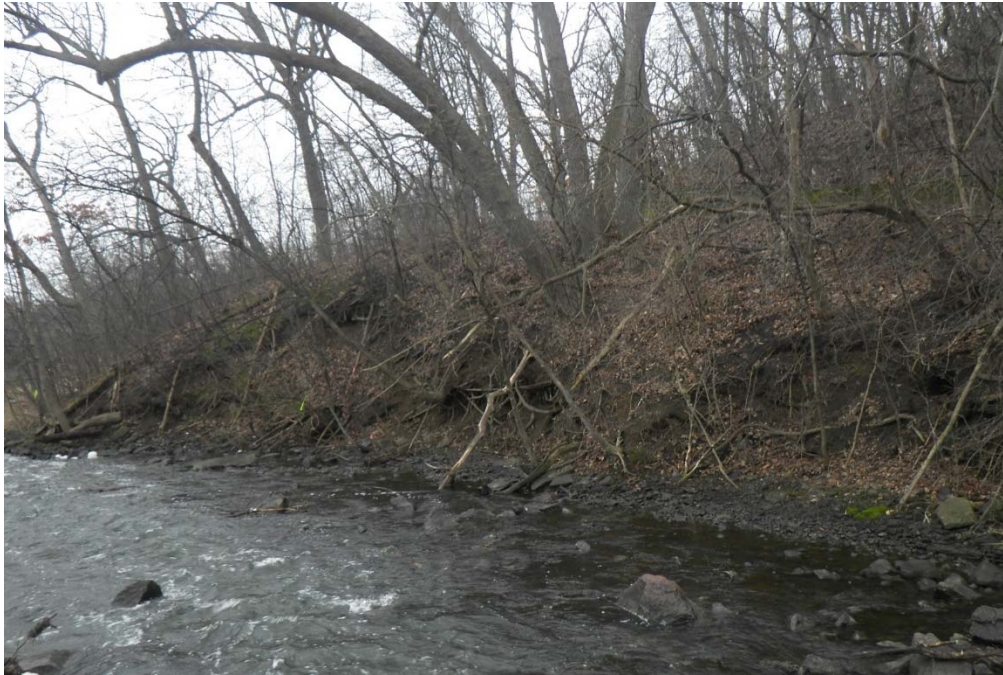
Photo 5. *Site 5.* Moderate erosion on steep bank

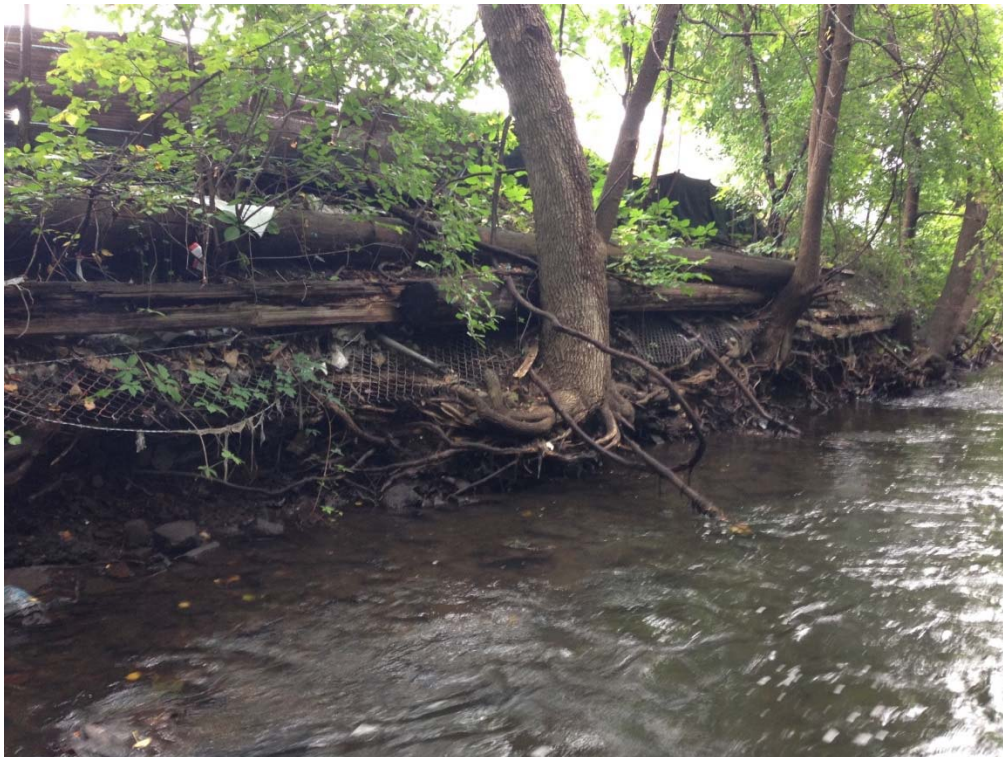
Photo 6. *Site 6.* Steep eroding bank

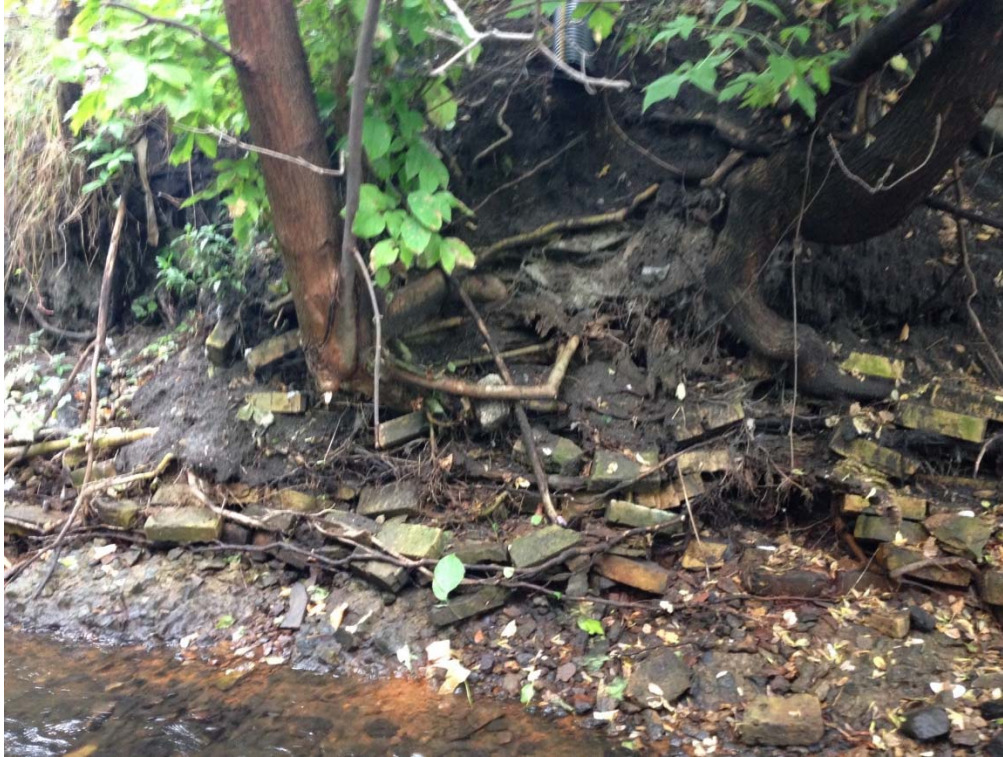
Photo 7. *Site 7.* Stream bed debris & non-native materials

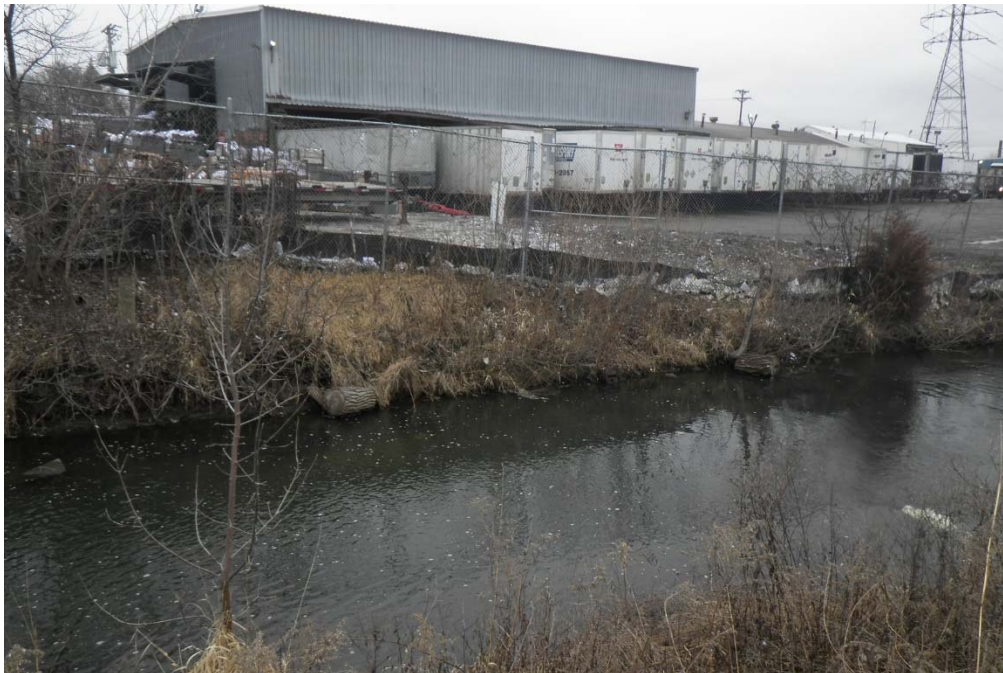
Photo 8. *Site 8.* Top of stream bank

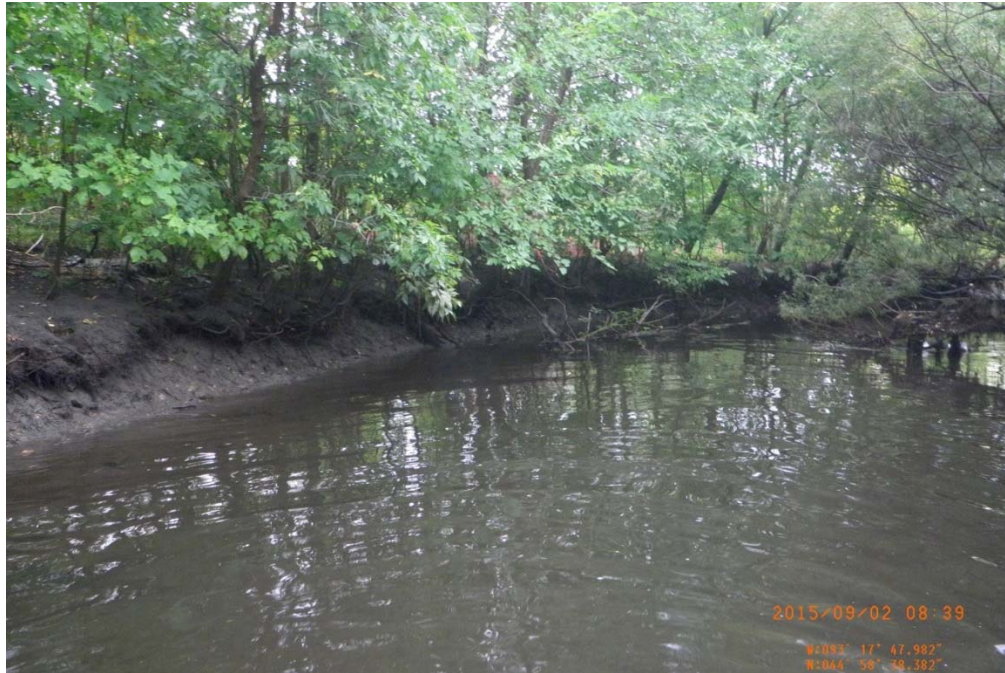
Photo 13. *Site 13.* Undercut bank

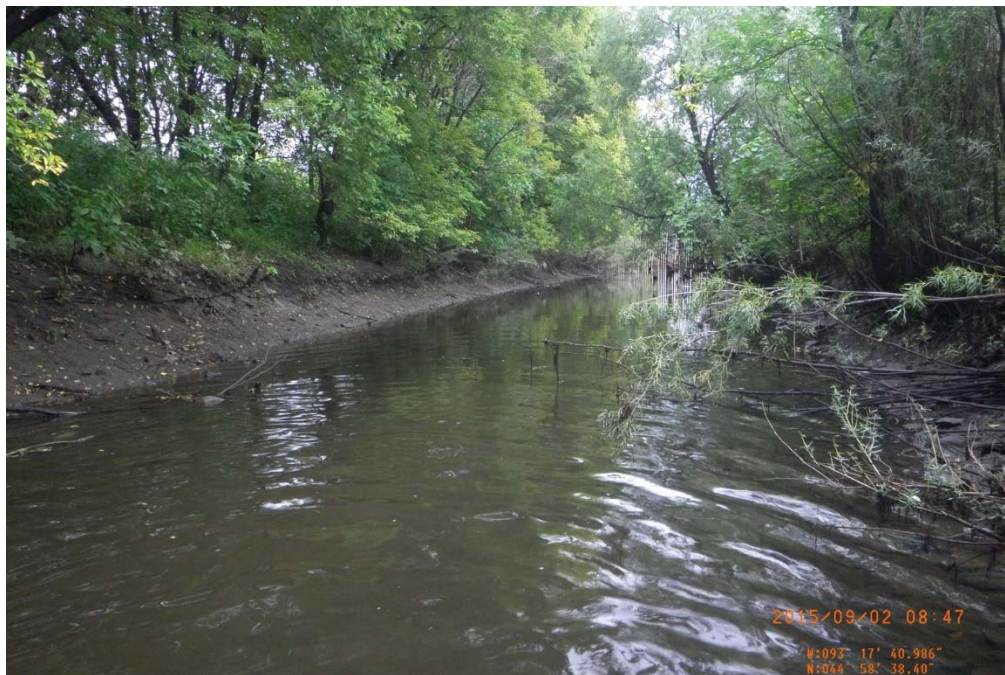
Photo 14. *Site 14.* Bare lower banks

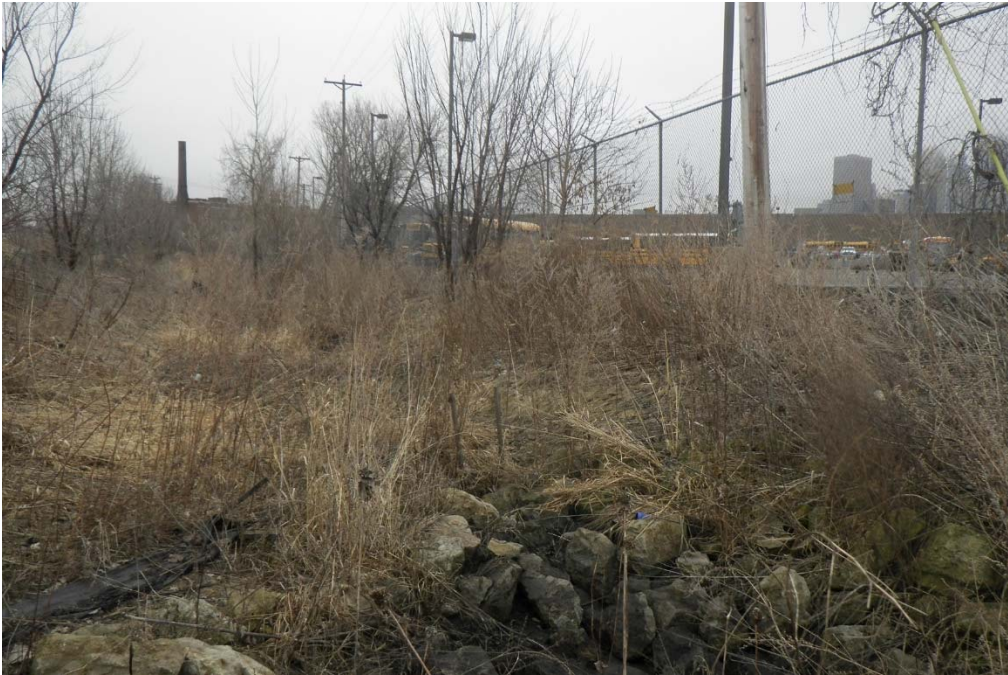
Photo 15. *Site 15.* Brush in overflow channel
