# Feasibility Report for Bassett Creek Restoration Project - Reach 1

***Golden Valley, Minnesota***

***Prepared for  
Bassett Creek Watershed Management Commission***

***September 2010***

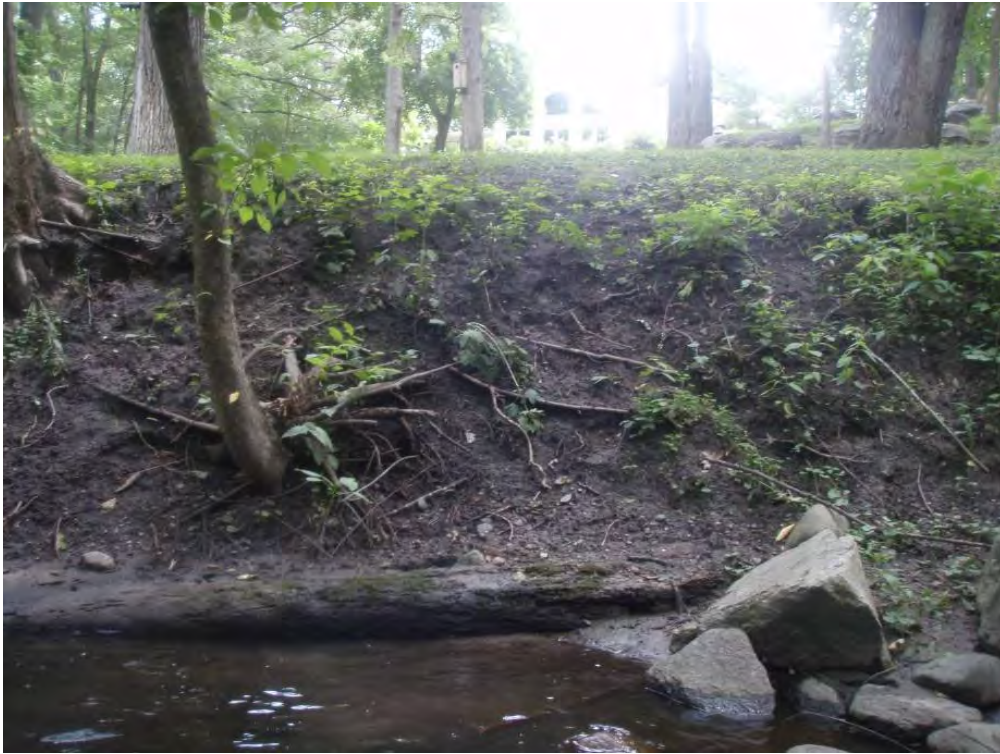
**Photo 2.** *Site 1.* Minor to moderate erosion near the Golden Valley-Crystal border.

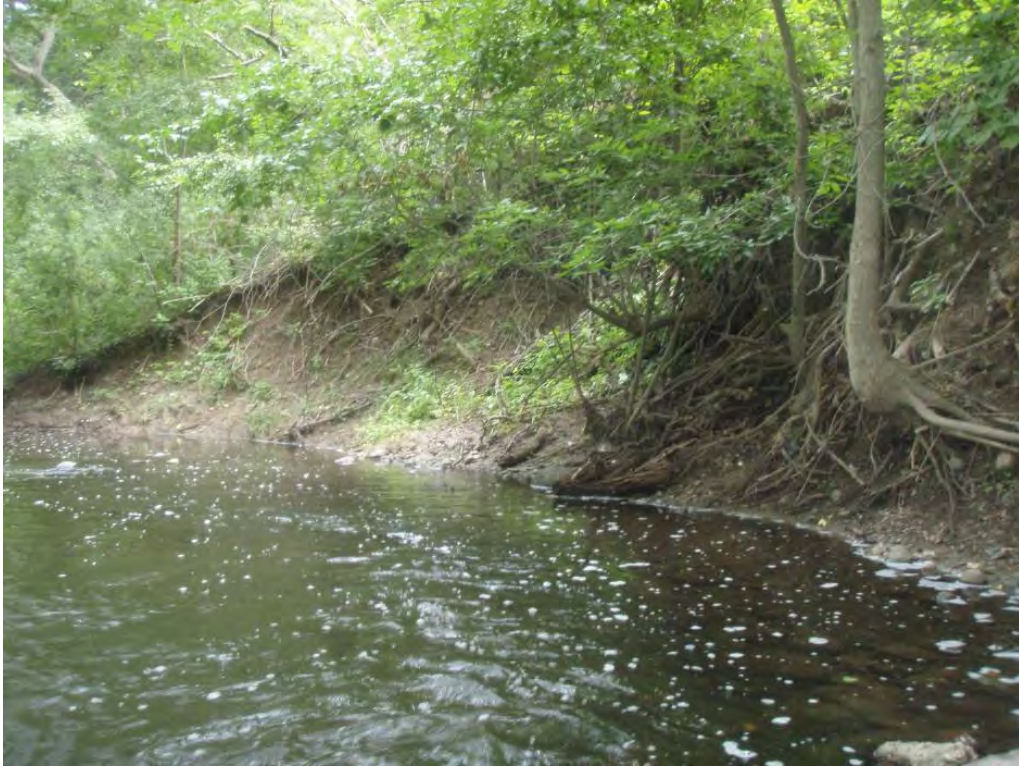
**Photo 4.** *Site 2.* Severely eroding bank

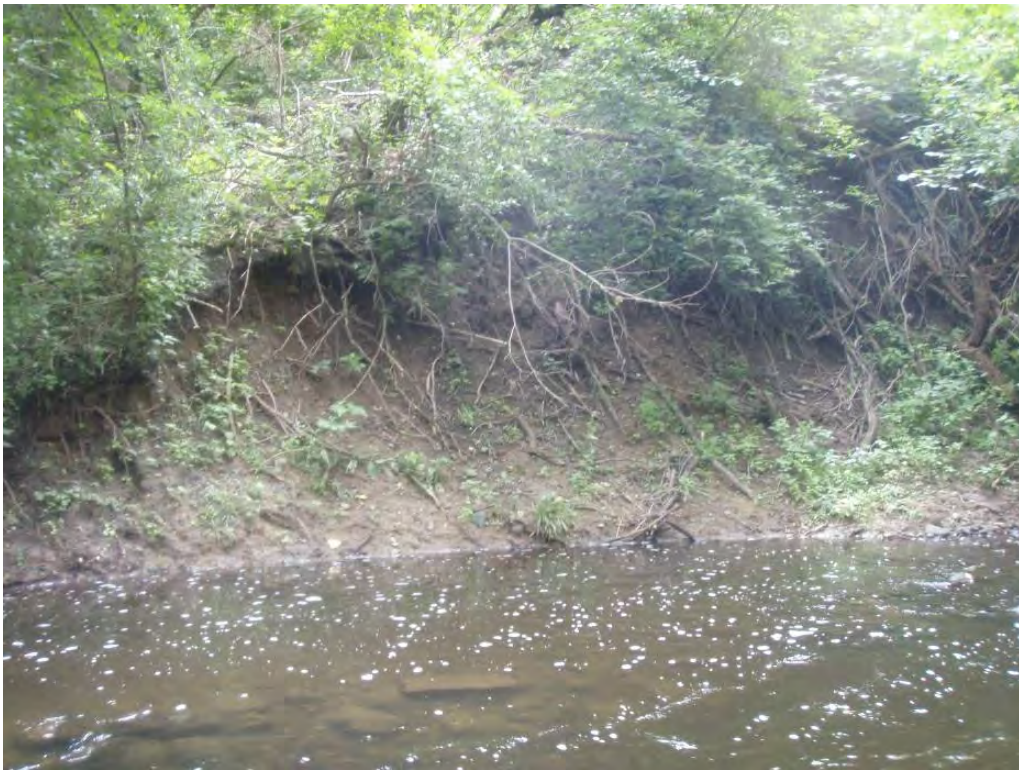
**Photo 5.** *Site 3.* Minor bank erosion on an outside bank of a meander.

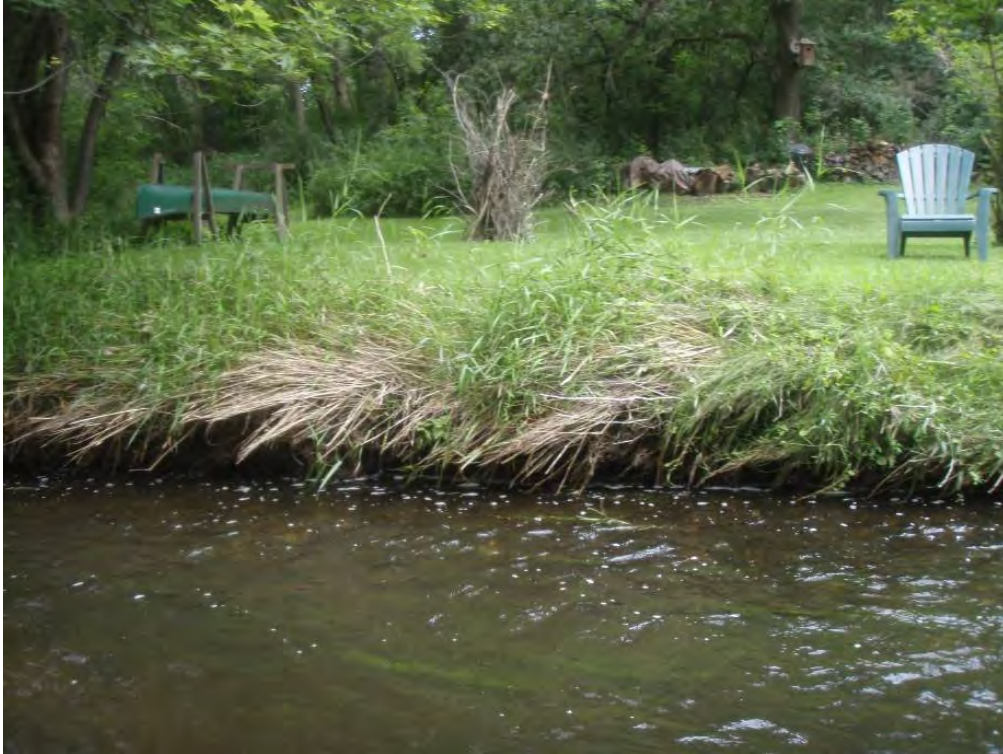
**Photo 6.** *Site 4.* Moderate to severe erosion.

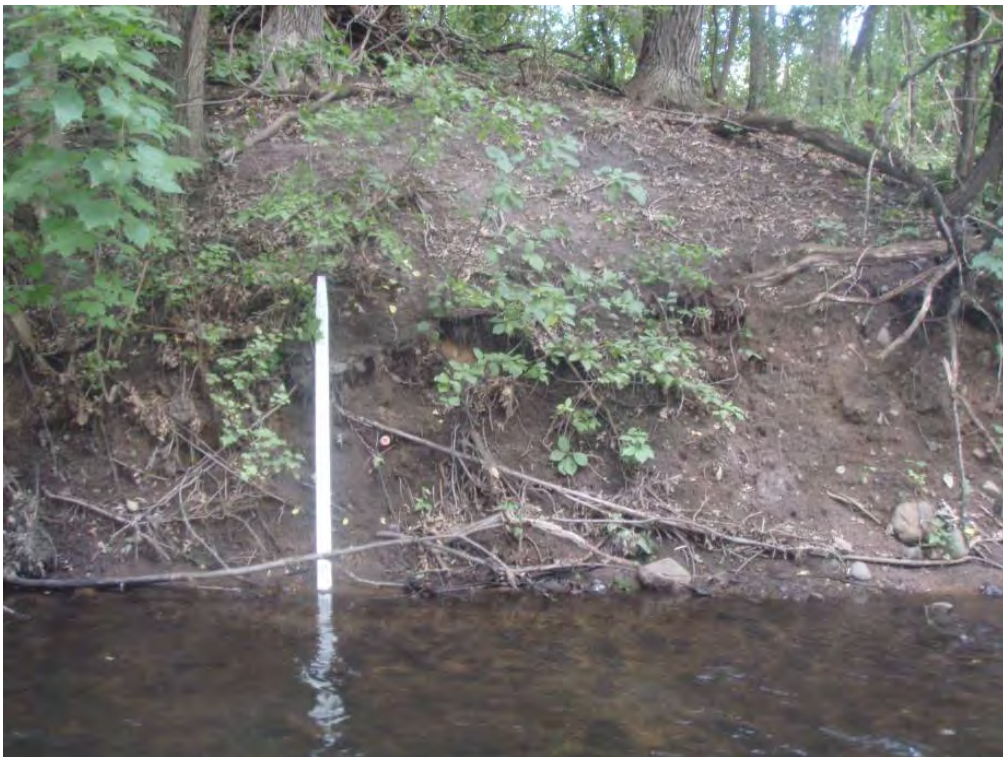
**Photo 7.** *Site 4.* Moderate erosion.

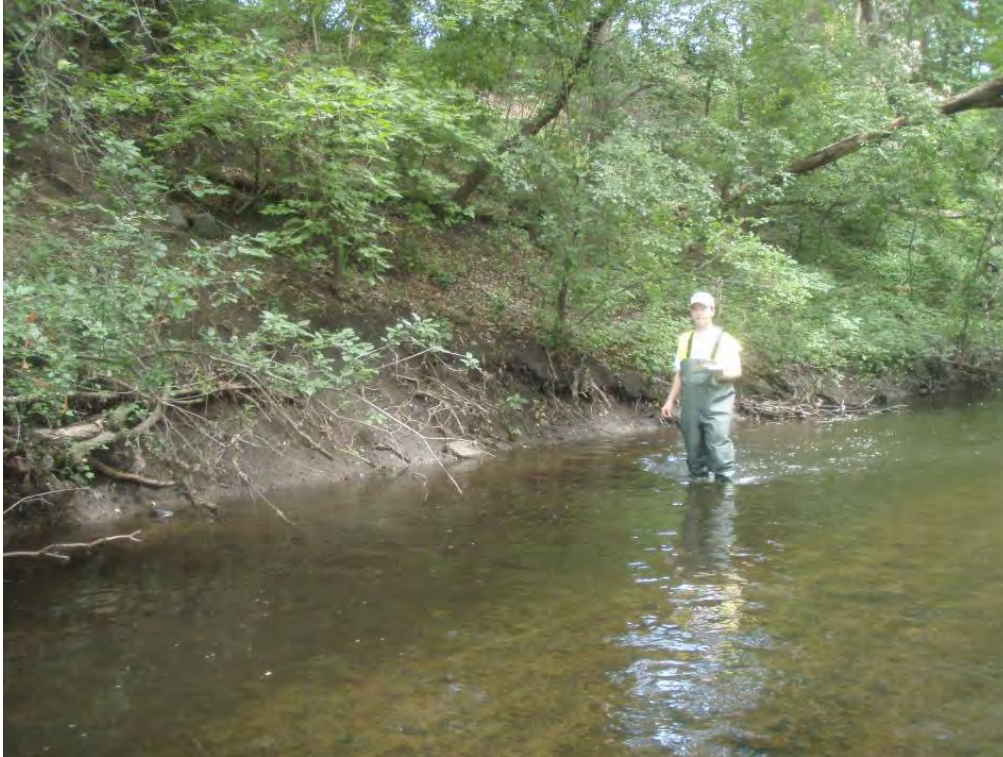
**Photo 8.** *Site 5.* Moderate erosion.

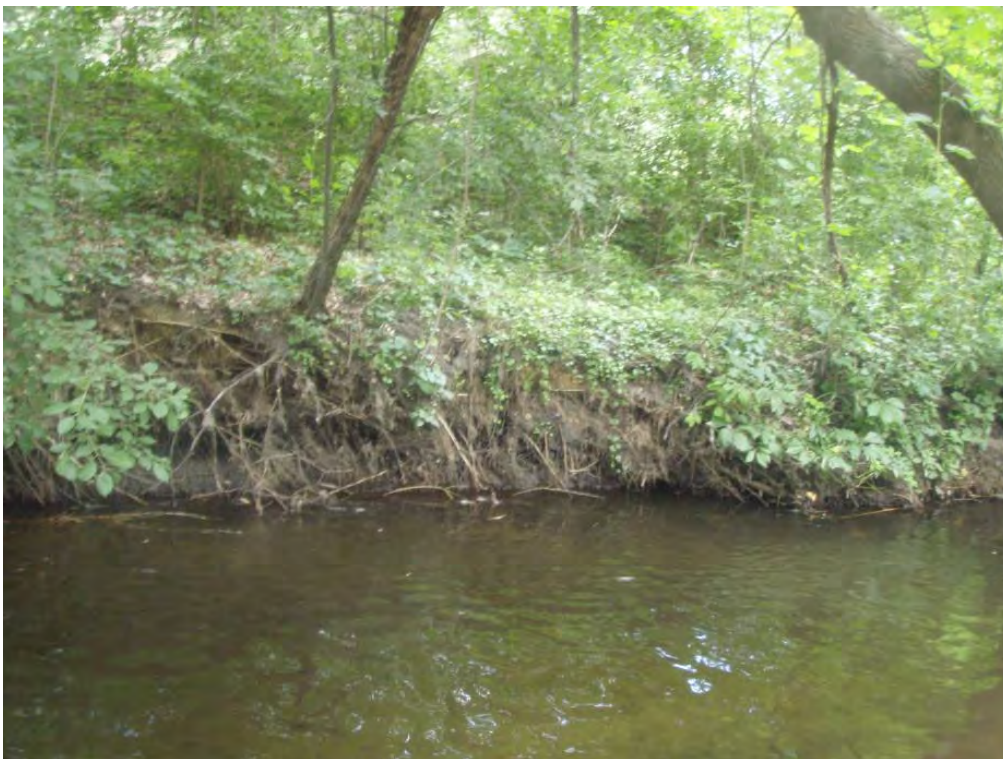
**Photo 9.** *Site 5.* Moderate erosion.

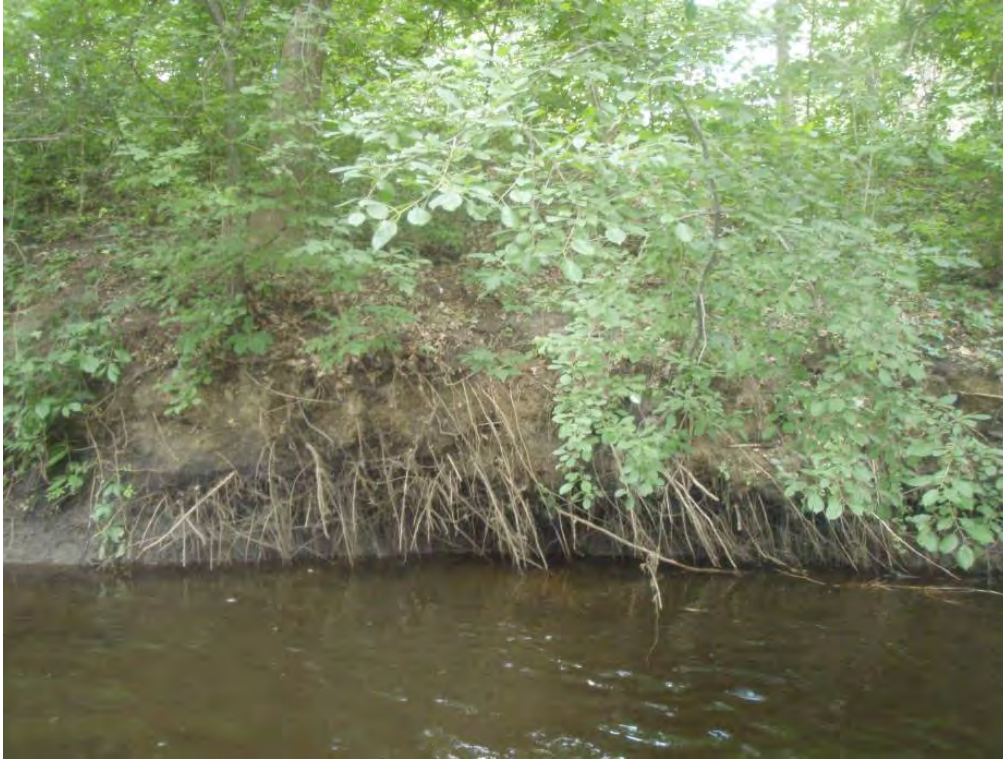
**Photo 10.** *Site 6.* Minor bank erosion.

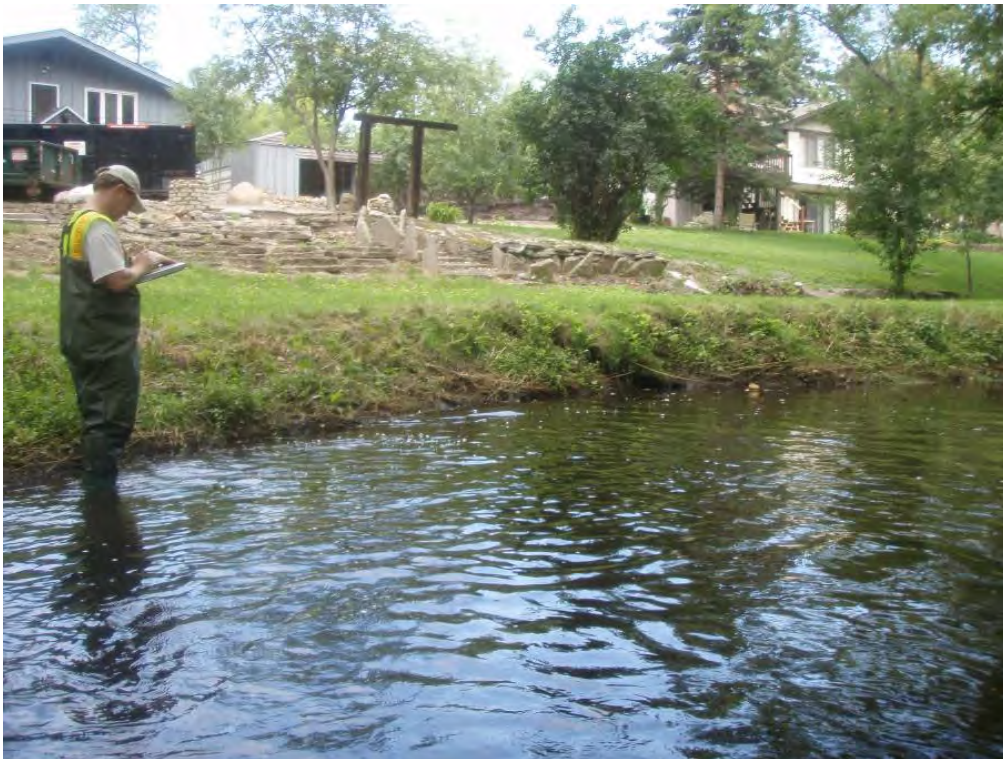
**Photo 11.** *Site 7.* Severe bank erosion with a new channel being cut through floodplain.

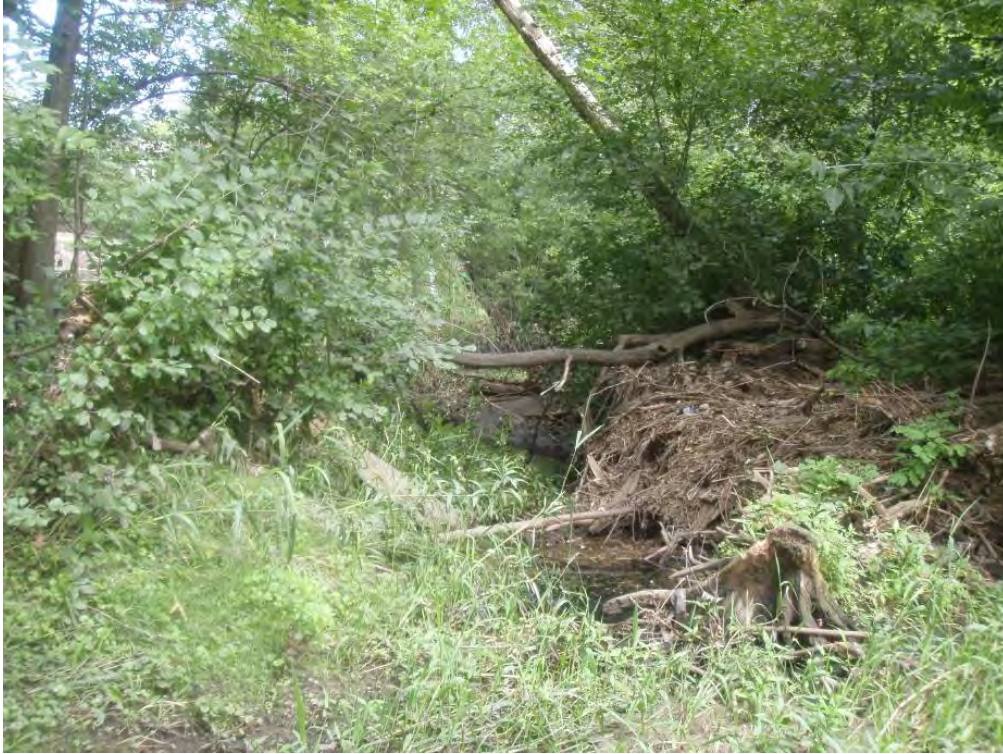
**Photo 12.** *Site 7.* Downstream end of new channel being cut.

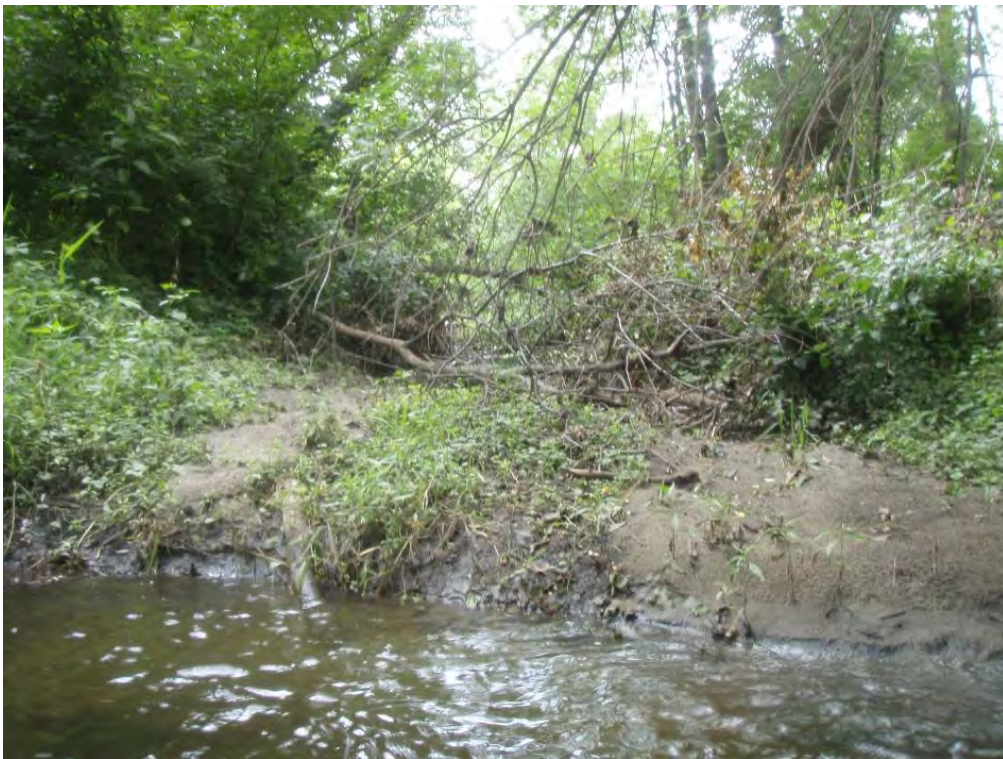
**Photo 13.** *Site 8.* Minor bank erosion on an outside bank of a meander.

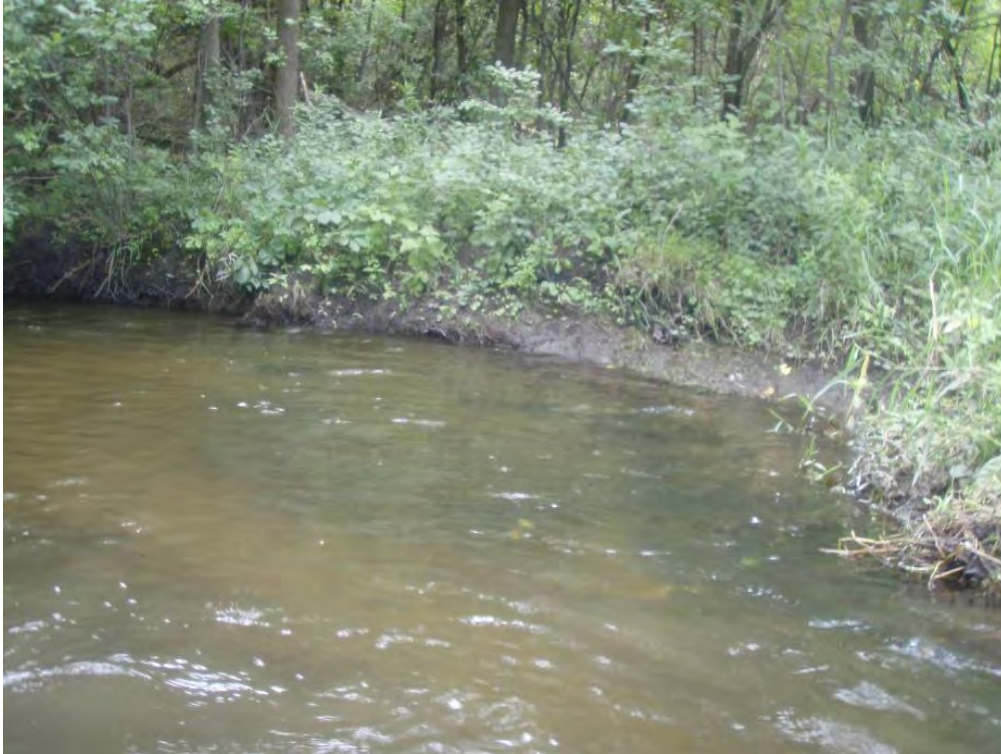
**Photo 14.** *Site 9.* Erosion around flared end section.

8	49+75	Install riprap for toe protection. Install two j vanes. Install biologs and live stakes. Remove 12 trees.	13
9 <sup>3</sup>	149+00	Replace flared end section. Install riprap around flared end section. Remove four trees.	14
10 <sup>3</sup>	151+50	Install two cross-vanes. Install biolog. Install live stakes in the bank. Remove three trees.	15, 16
11	156+50	Remove fallen tree. Install live stakes in eroding bank	17, 18
12 <sup>3</sup>	160+00	Remove buckthorn. Install biolog and live stakes. Remove three trees.	19

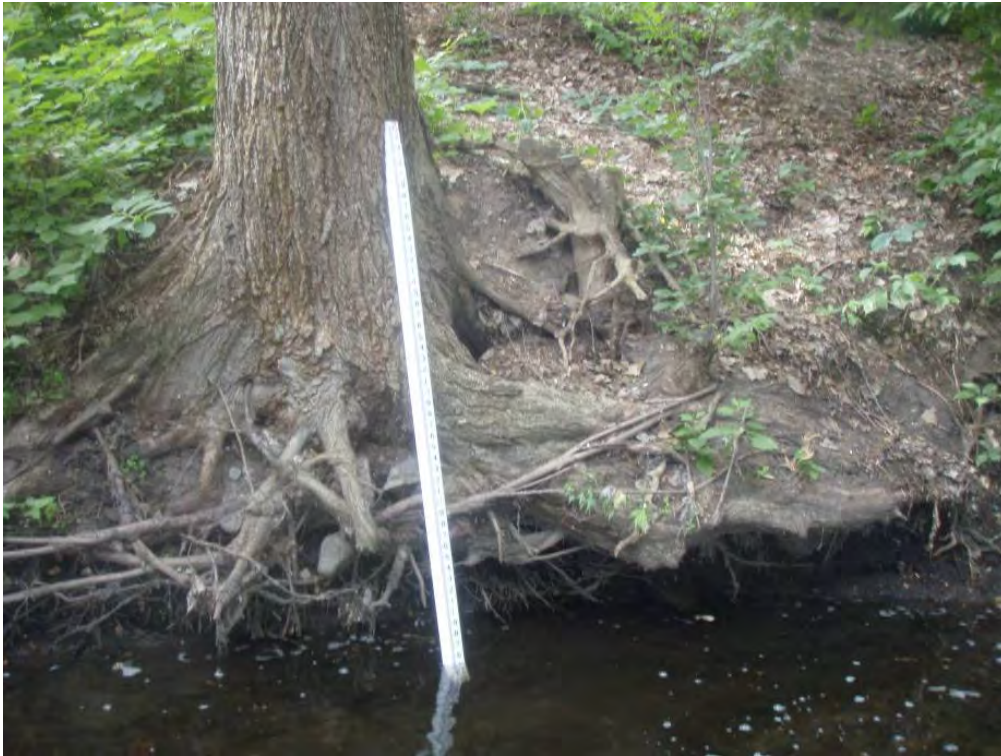
**Photo 16.** *Site 10.* Minor bank erosion with undercut trees.

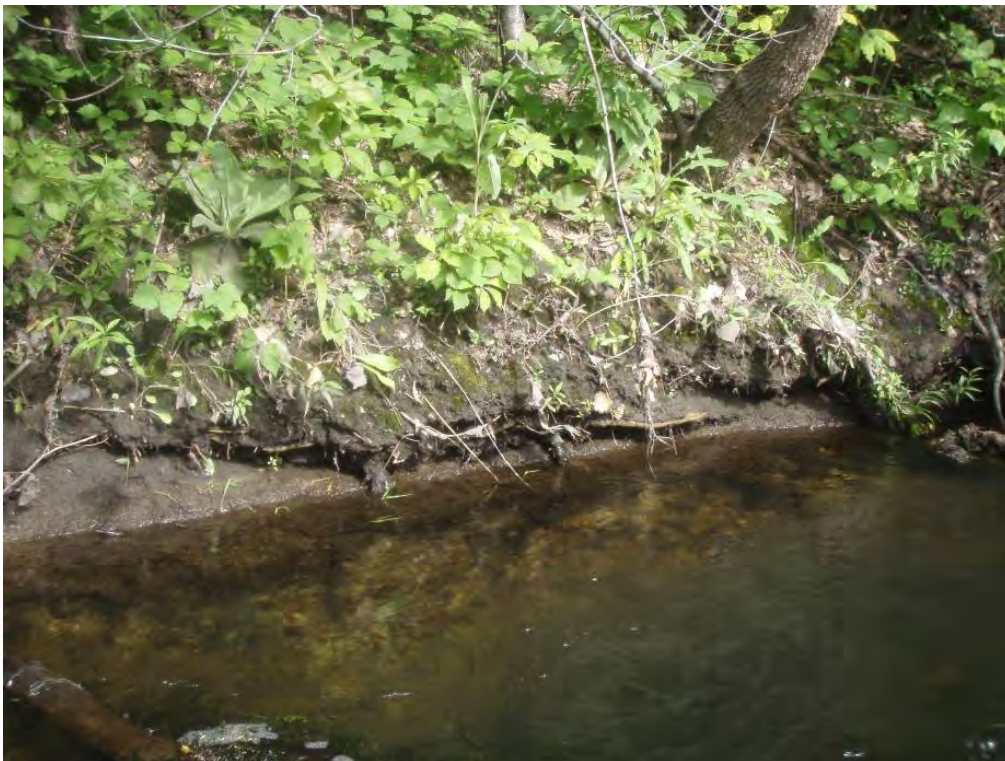
**Photo 19.** *Site 12.* Minor bank erosion with severe buckthorn problem.

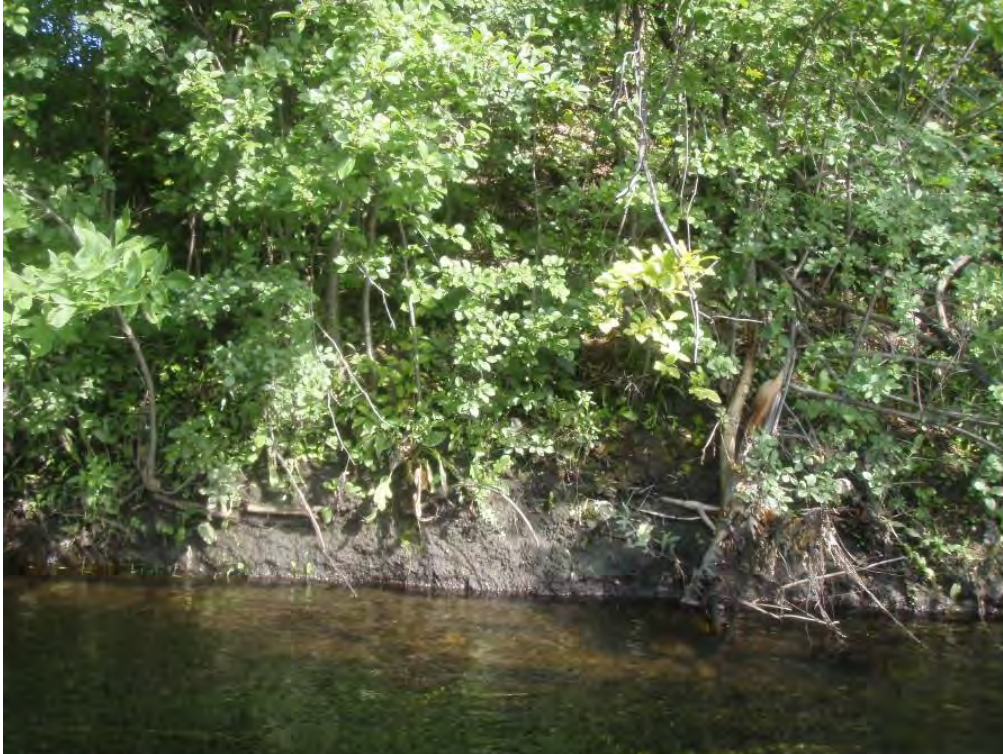
**Photo 20.** *Site 13.* Moderate bank erosion.
