Plymouth Creek Restoration Project

Bassett Creek Watershed Management Commission

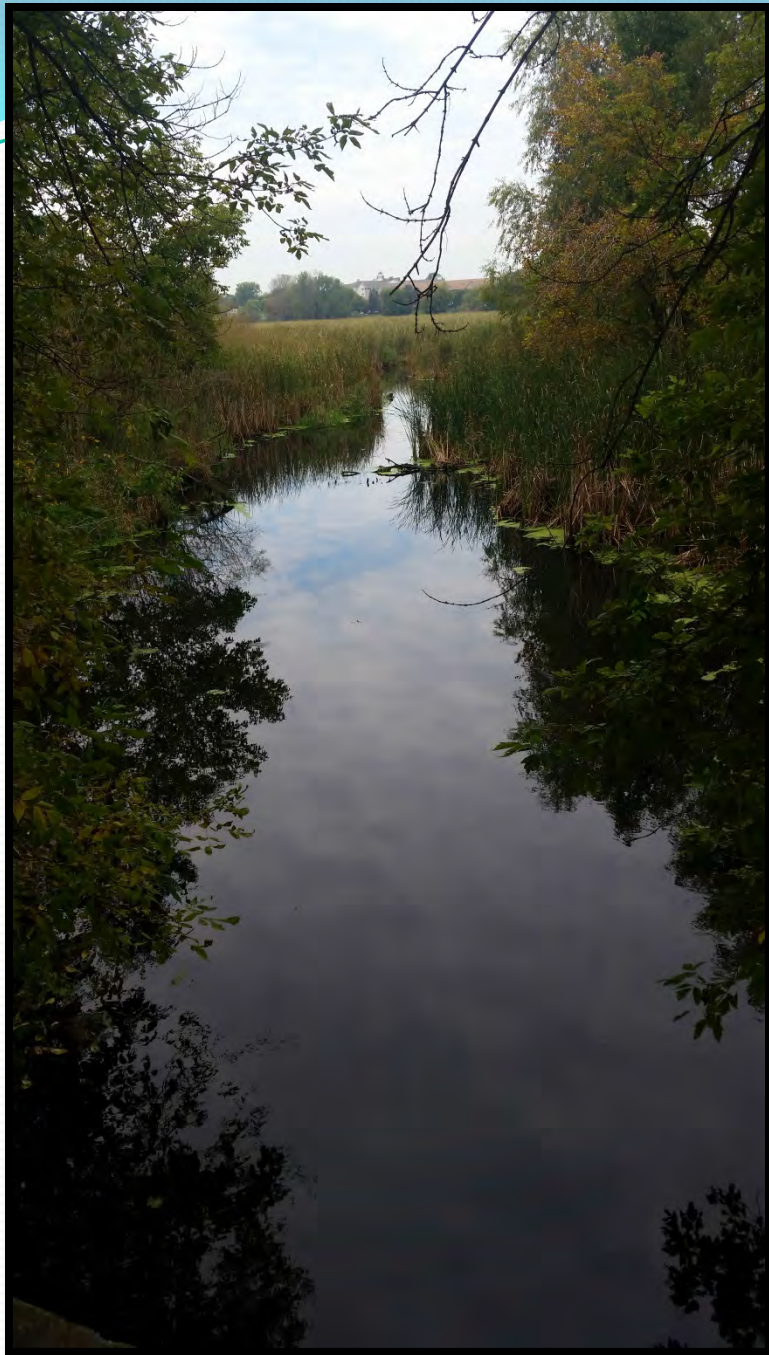
Looking upstream
of flood control
structure in park;
not in Project Area

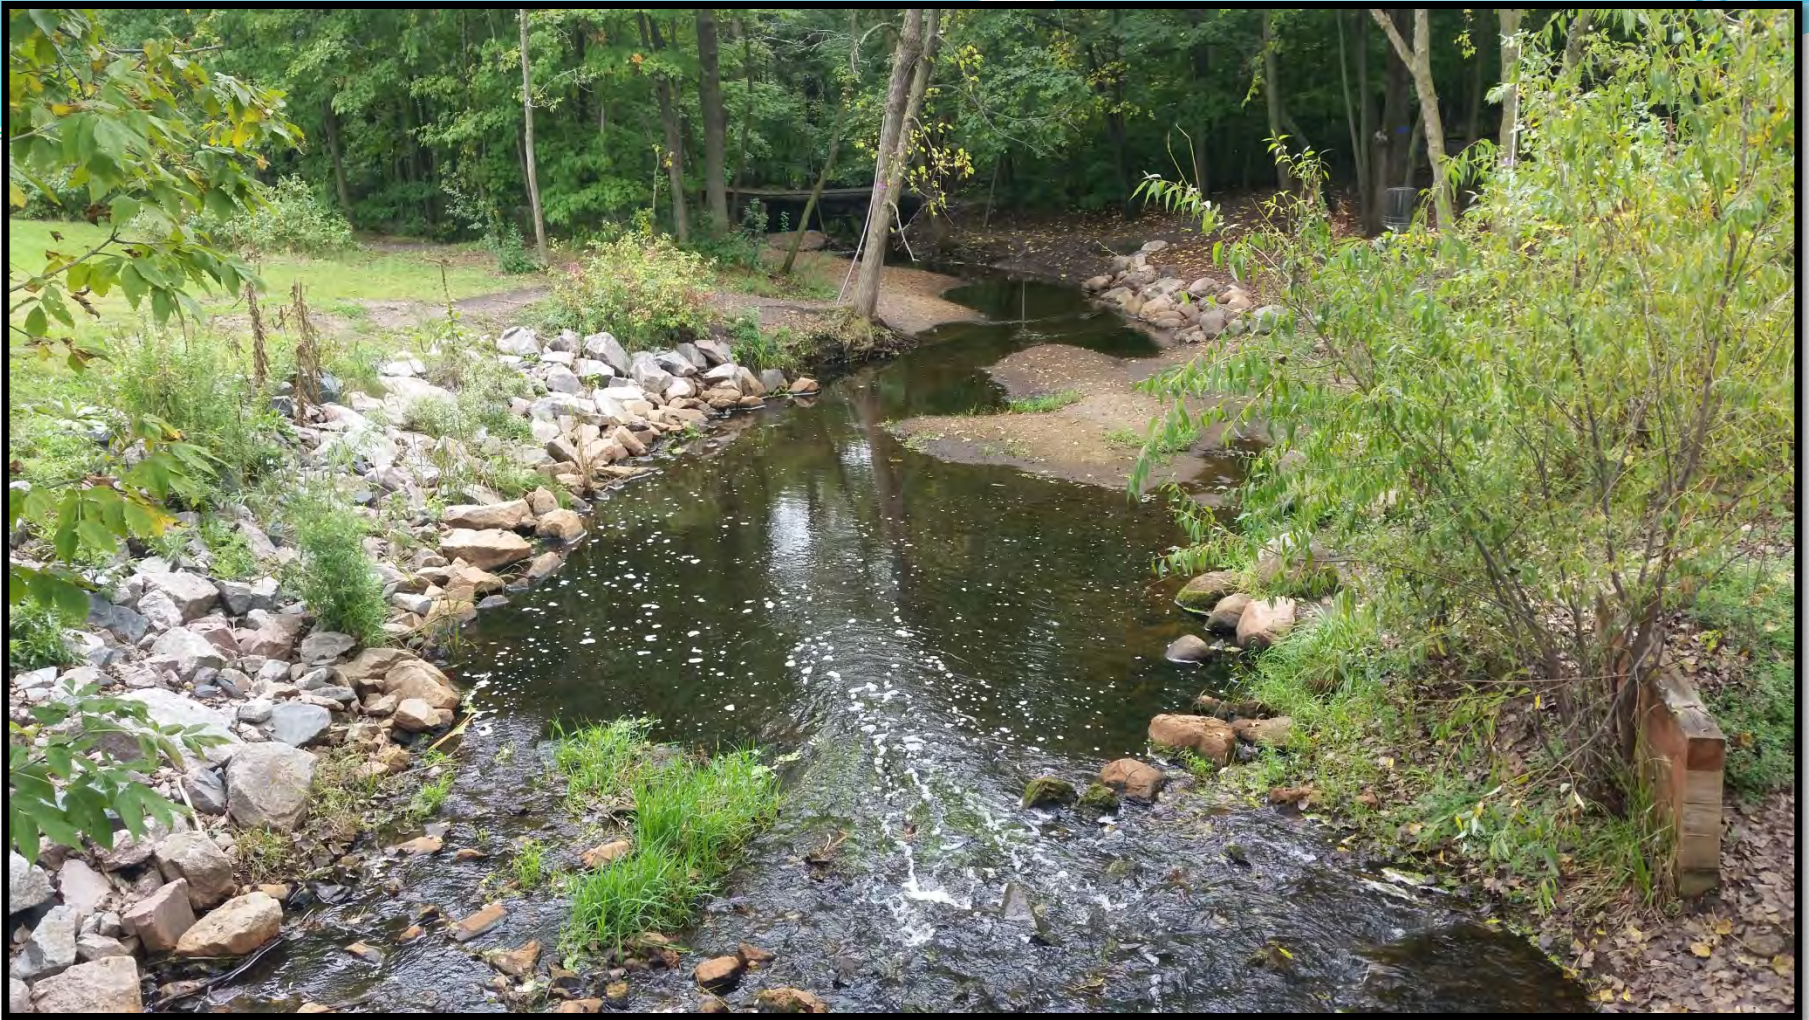
Looking downstream from flood control structure in park. Upper limit of Project Area (Reach 1); within disc golf course.

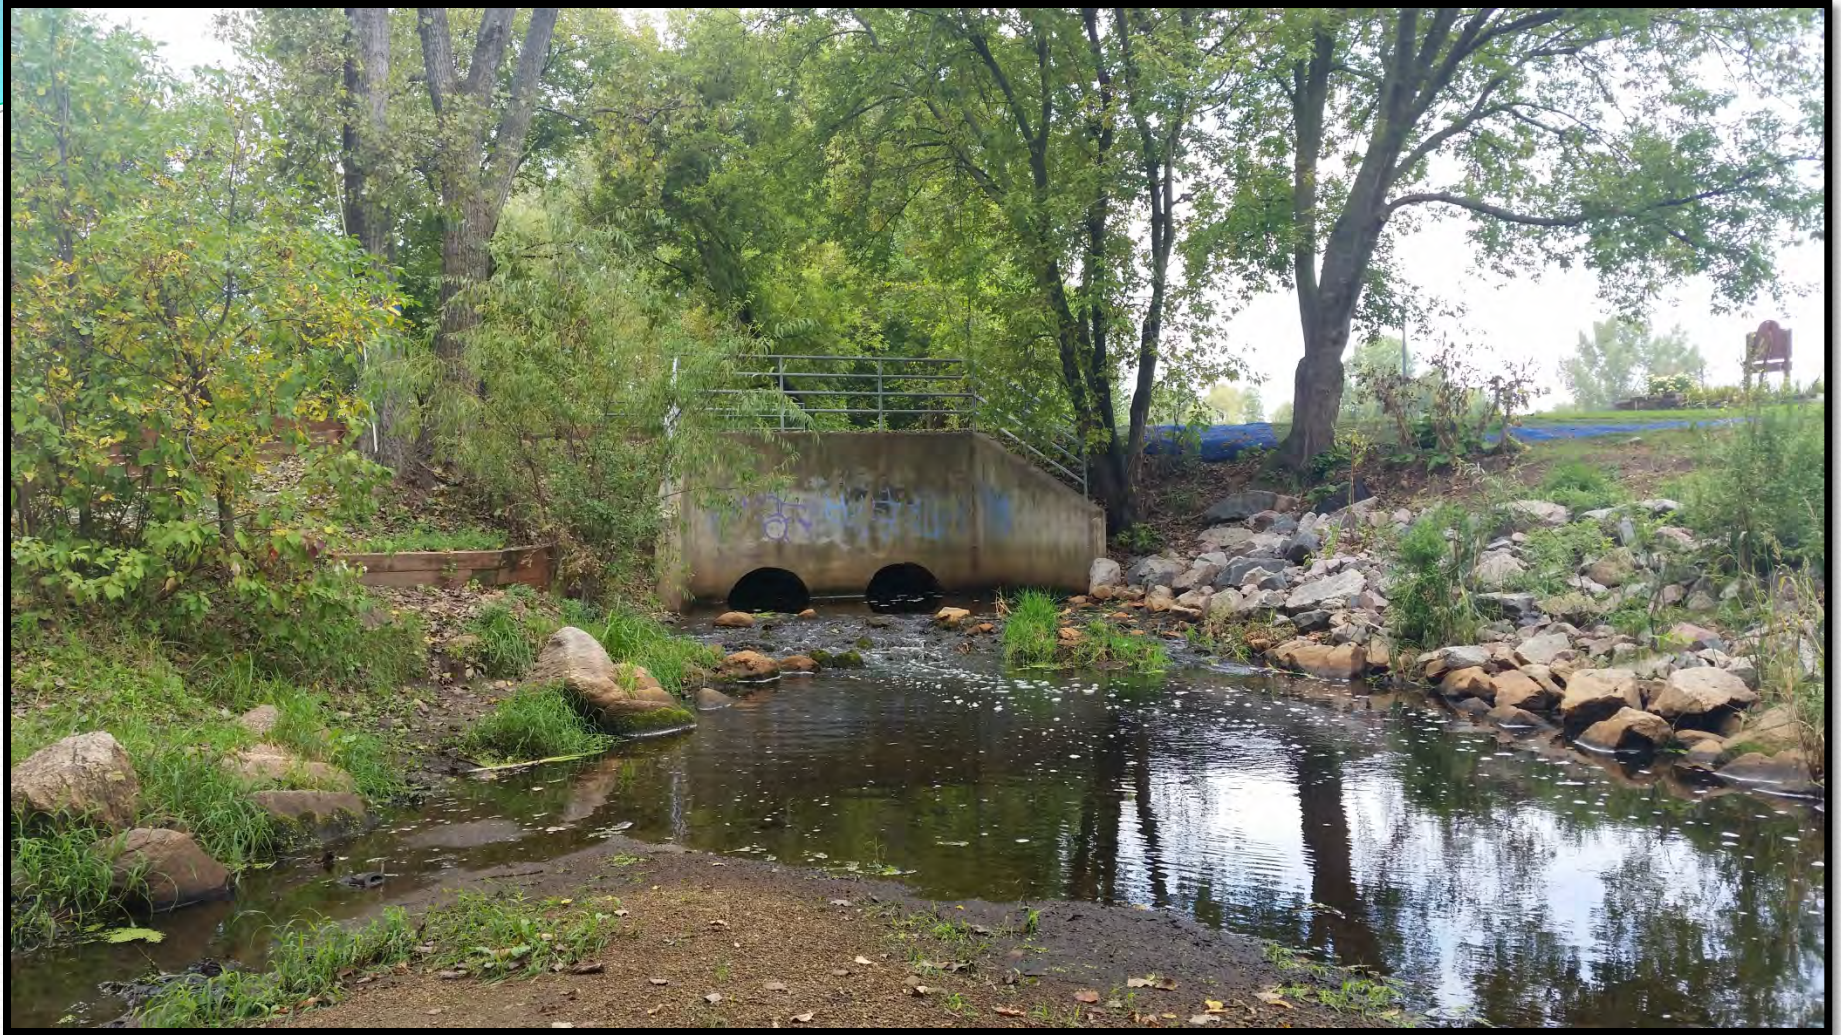
Looking at flood control structure in park.
Upper limit of Project Area (Reach 1); within
disc golf course.

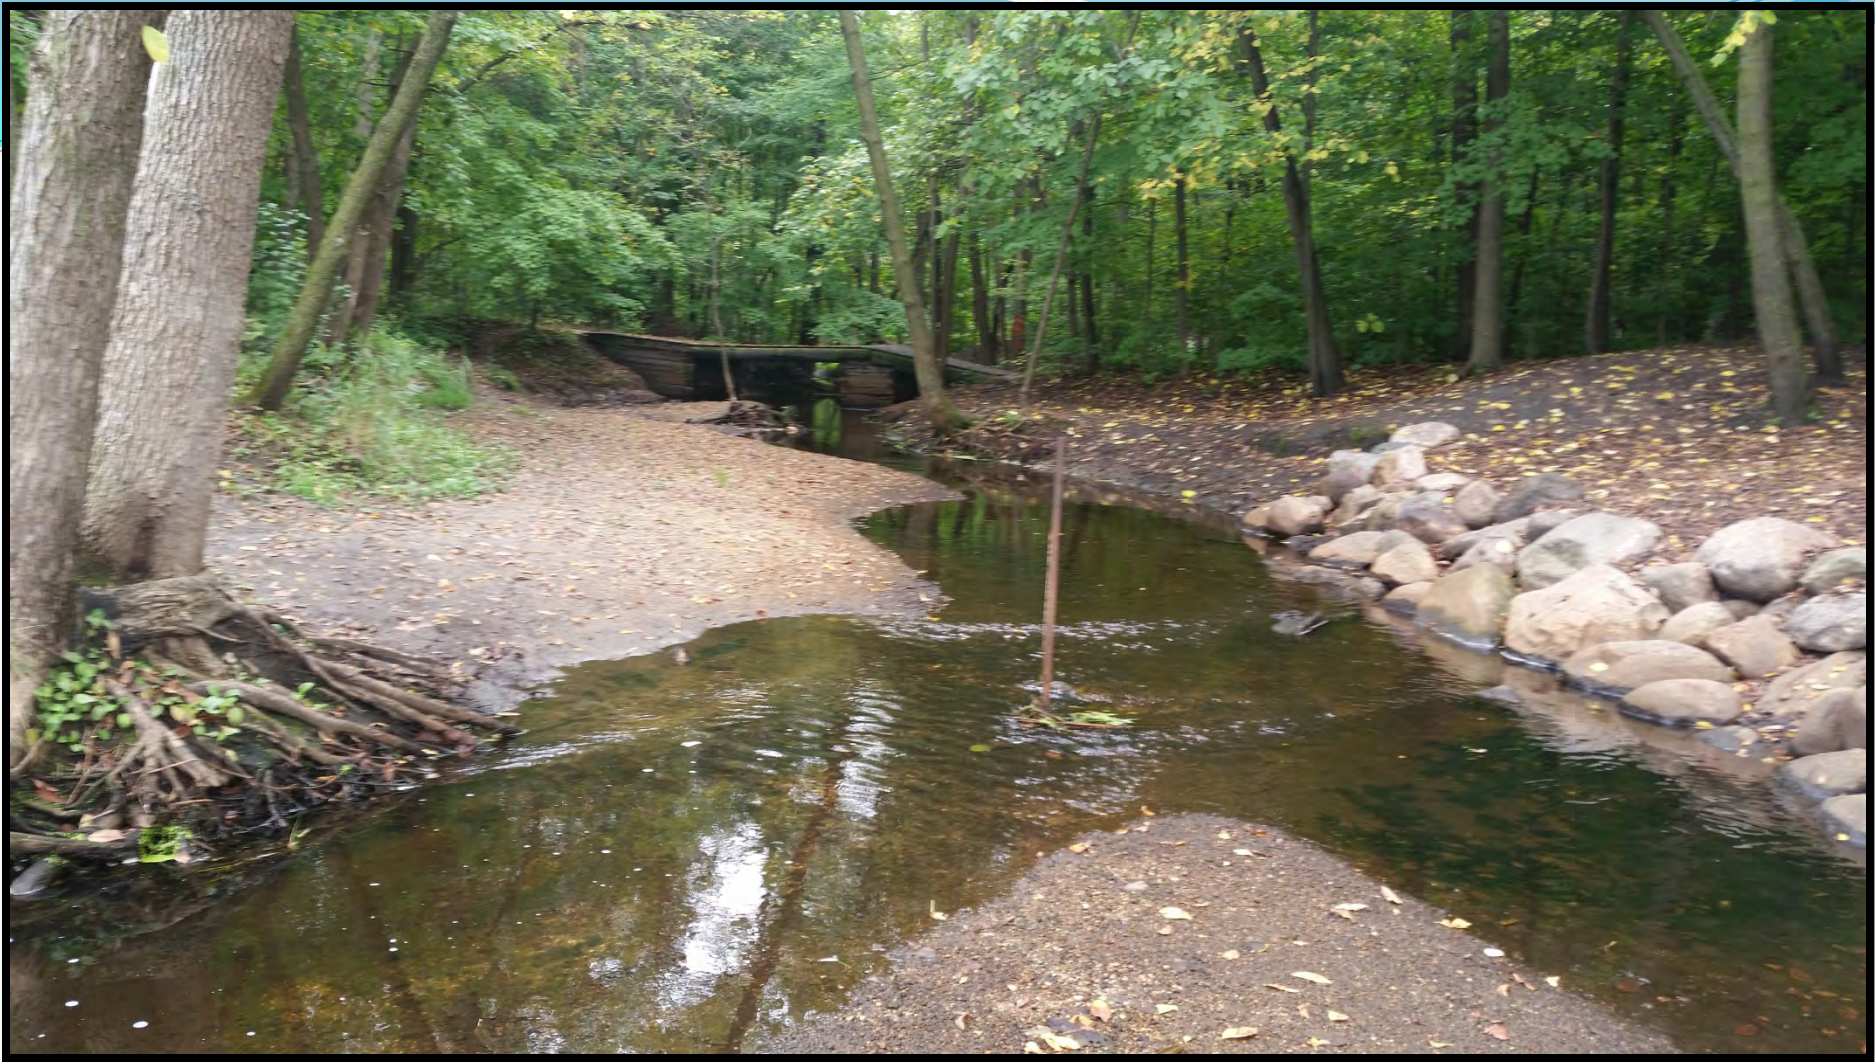
Just downstream of flood control structure in park. Reach 1 of Project Area; within disc golf course.

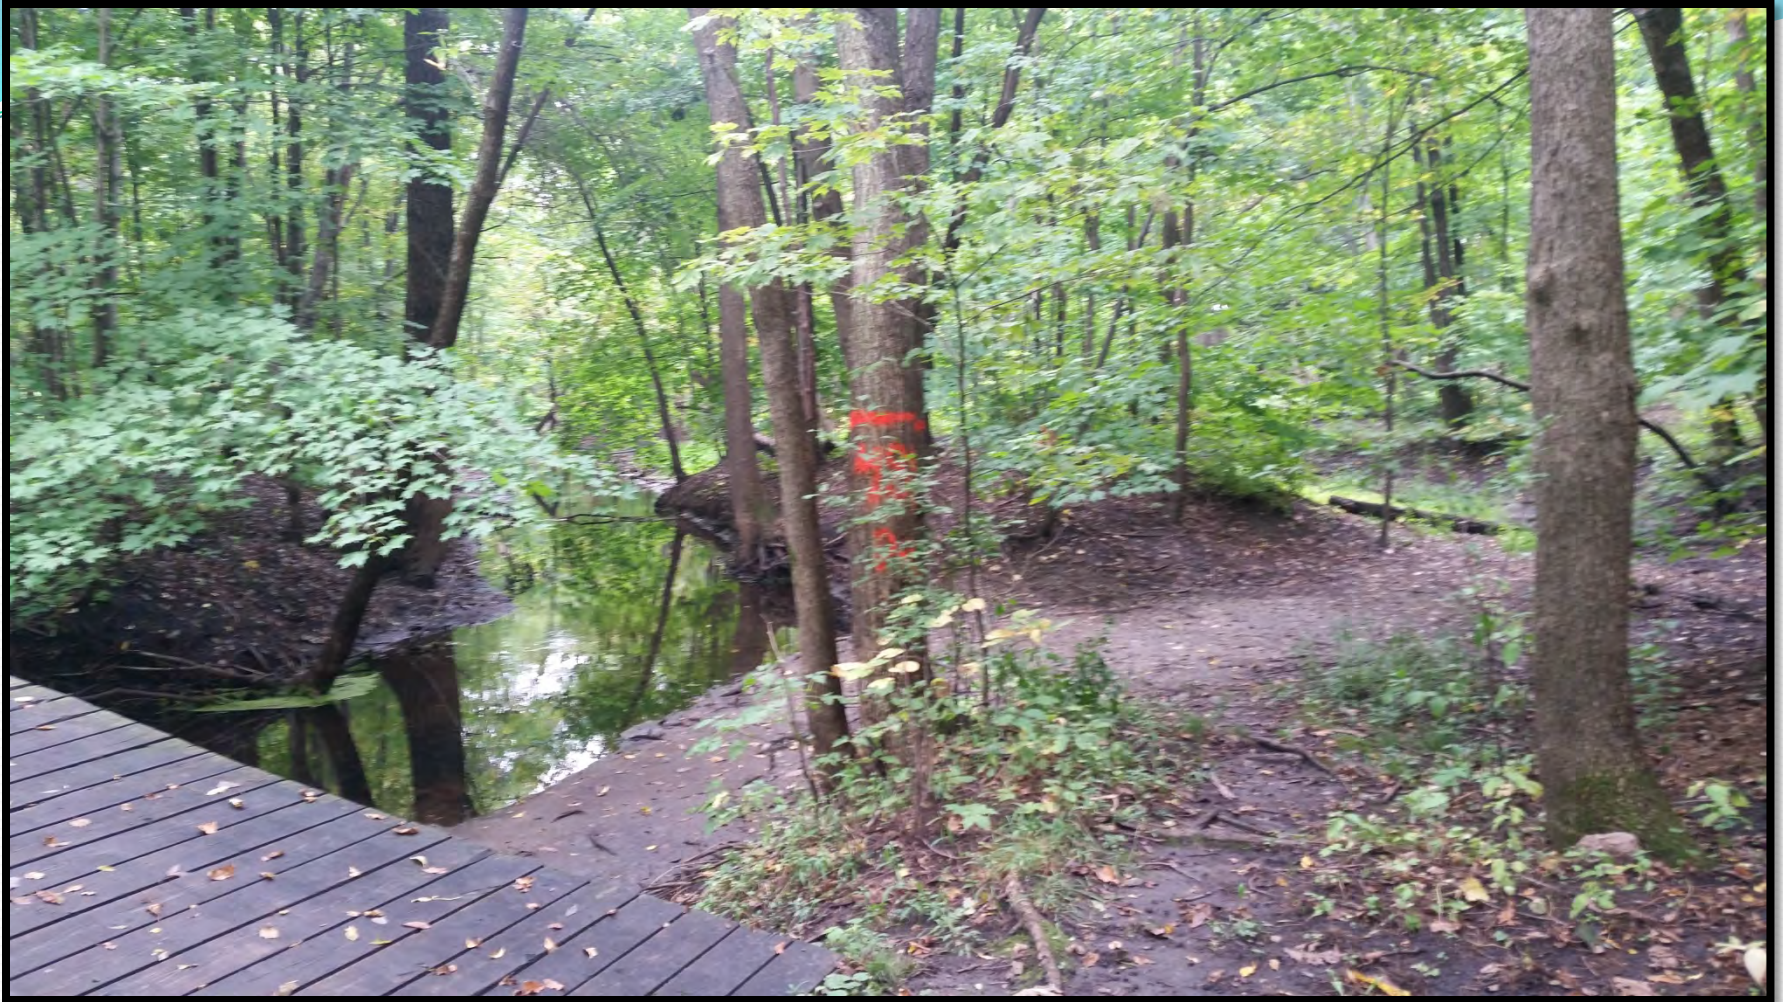
Reach 1 of Project Area; within disc golf course in park at one of several footbridges.

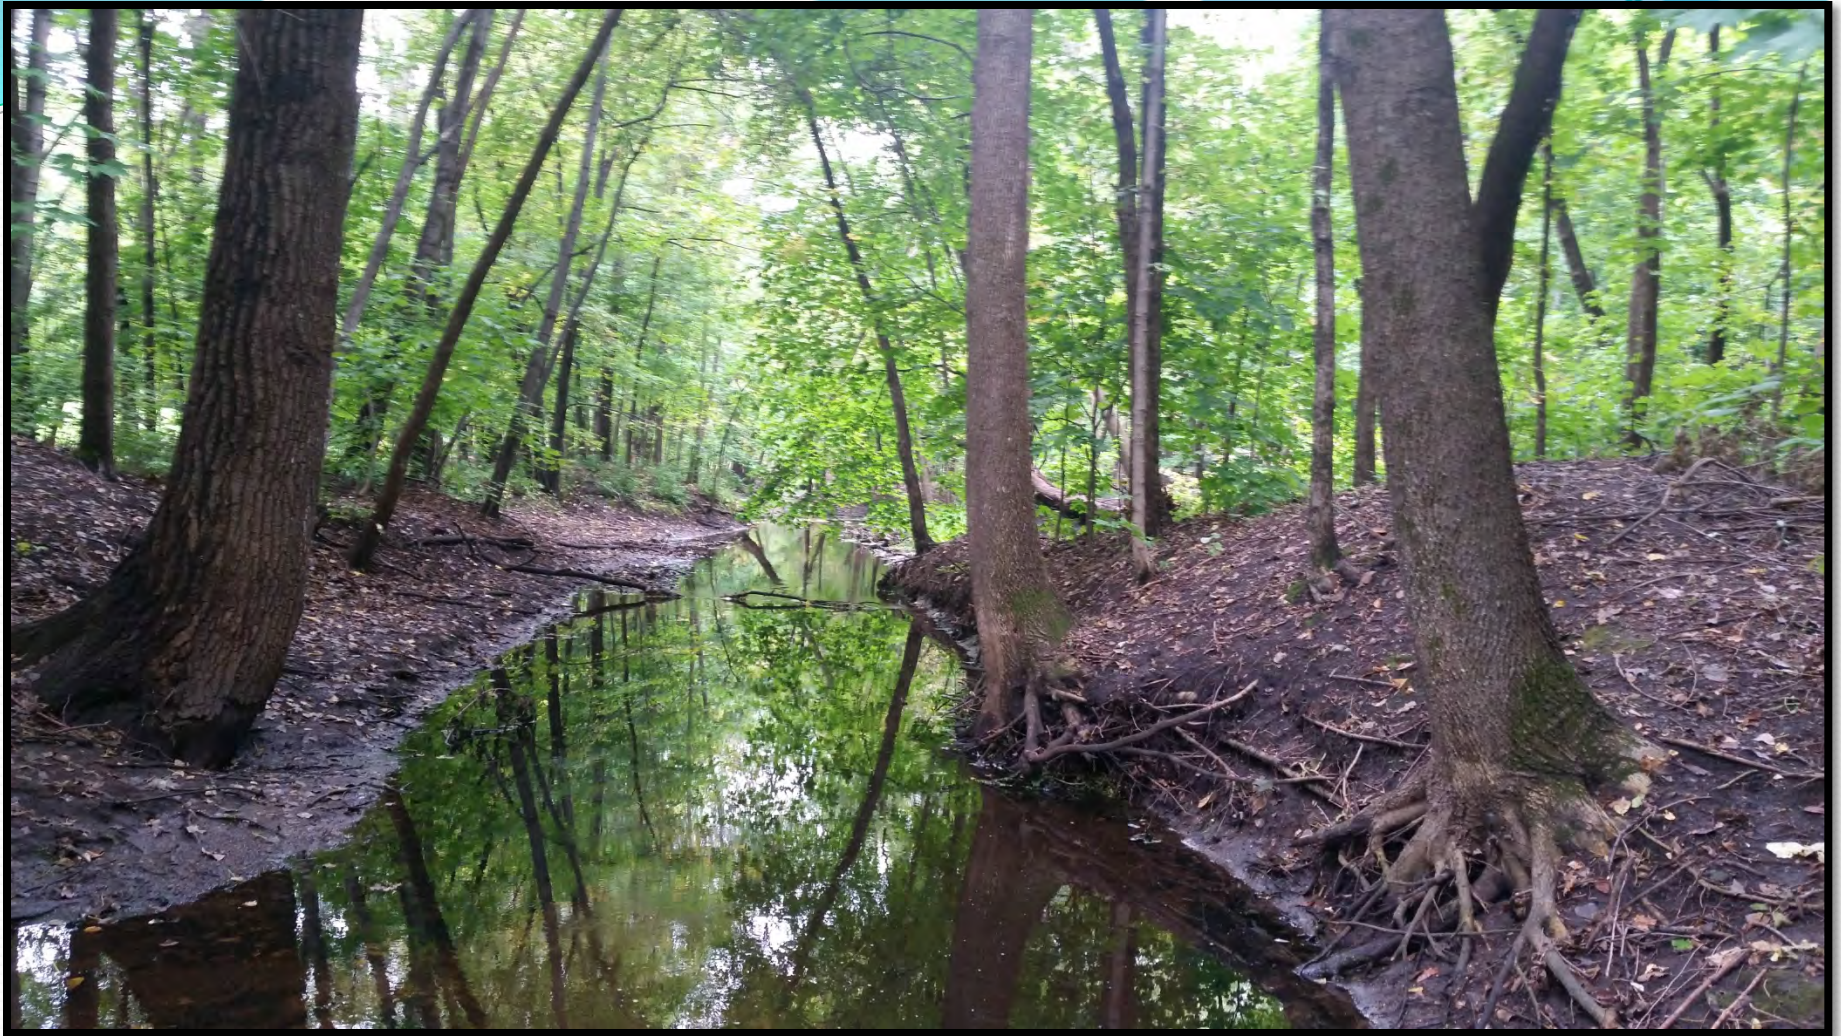
Reach 1 of Project Area; within disc golf course in park; eroding banks; heavily wooded; heavy foot traffic

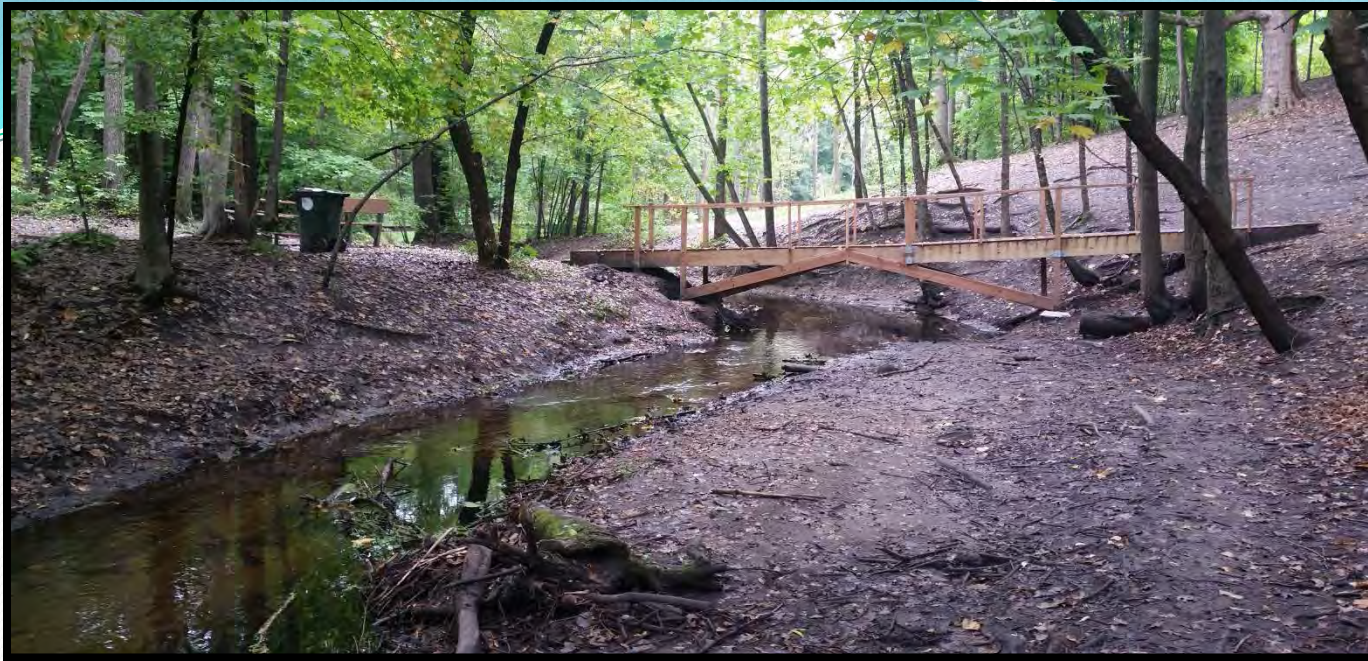
Reach 1 of
Project
Area;
within disc
golf course
in park;
heavily
wooded;
heavy foot
traffic

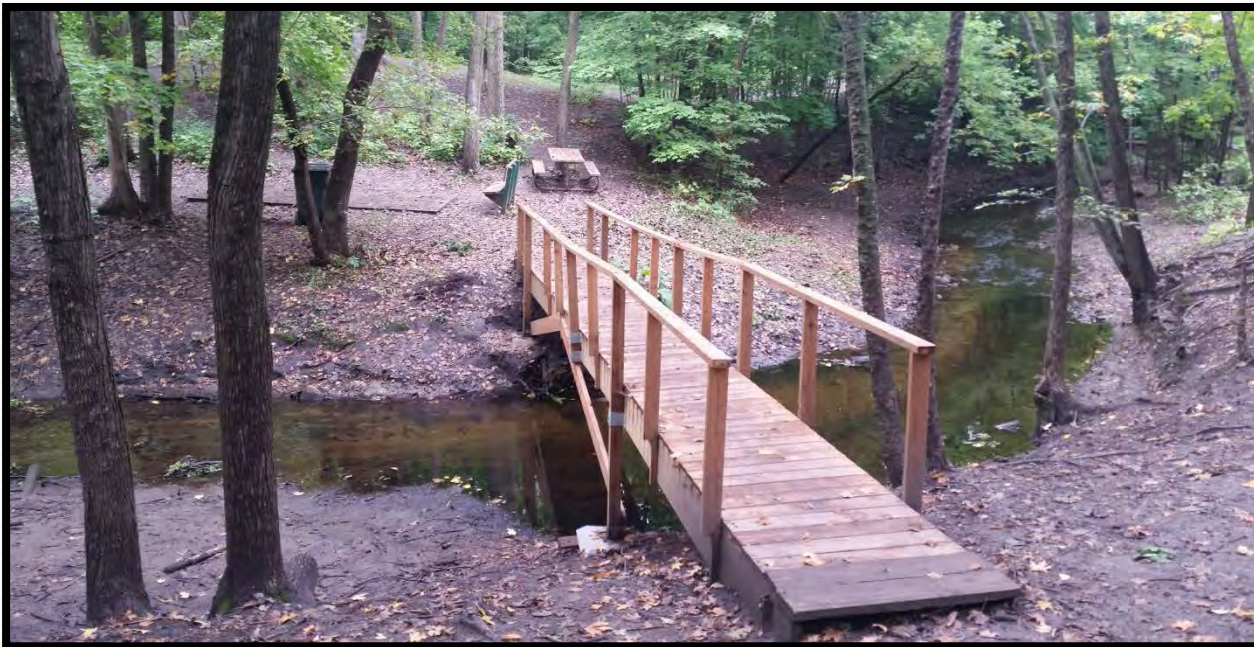
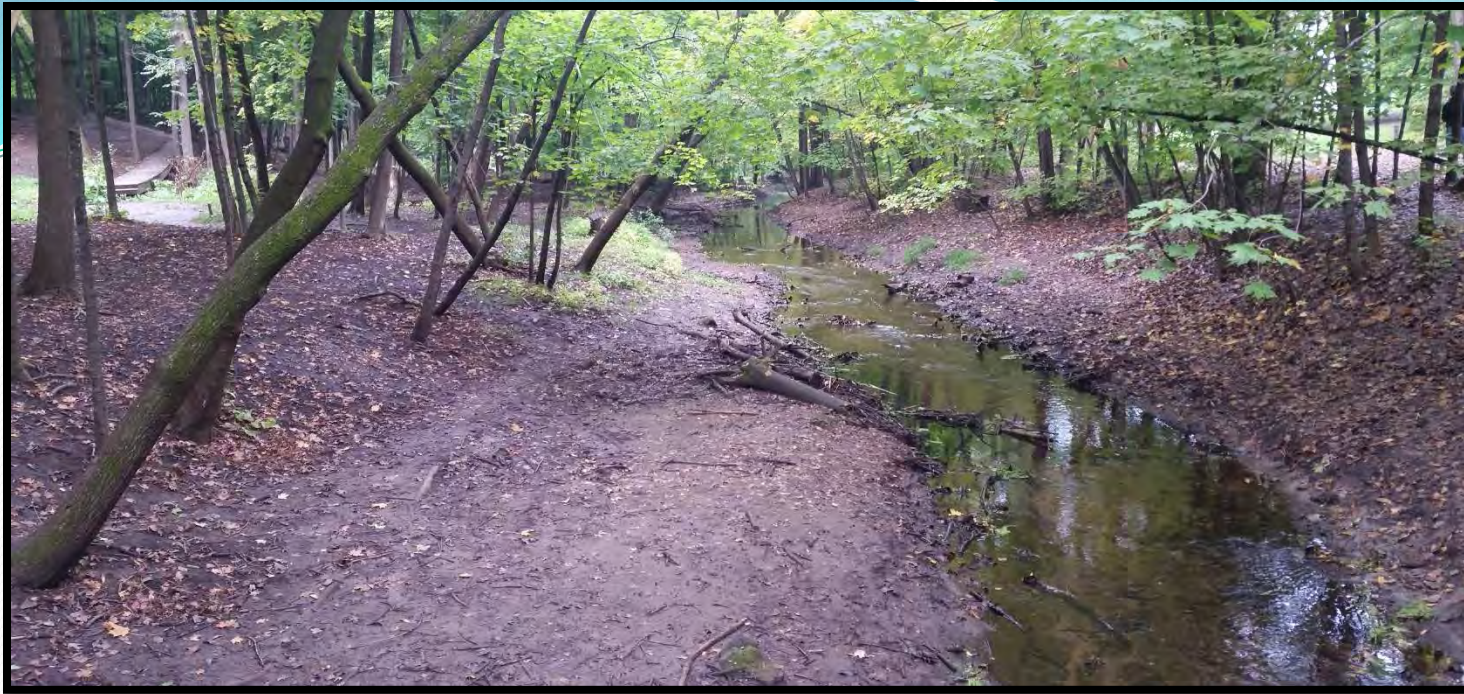
Reach 1 of
Project
Area;
within disc
golf course
in park;
heavily
wooded;
heavy foot
traffic

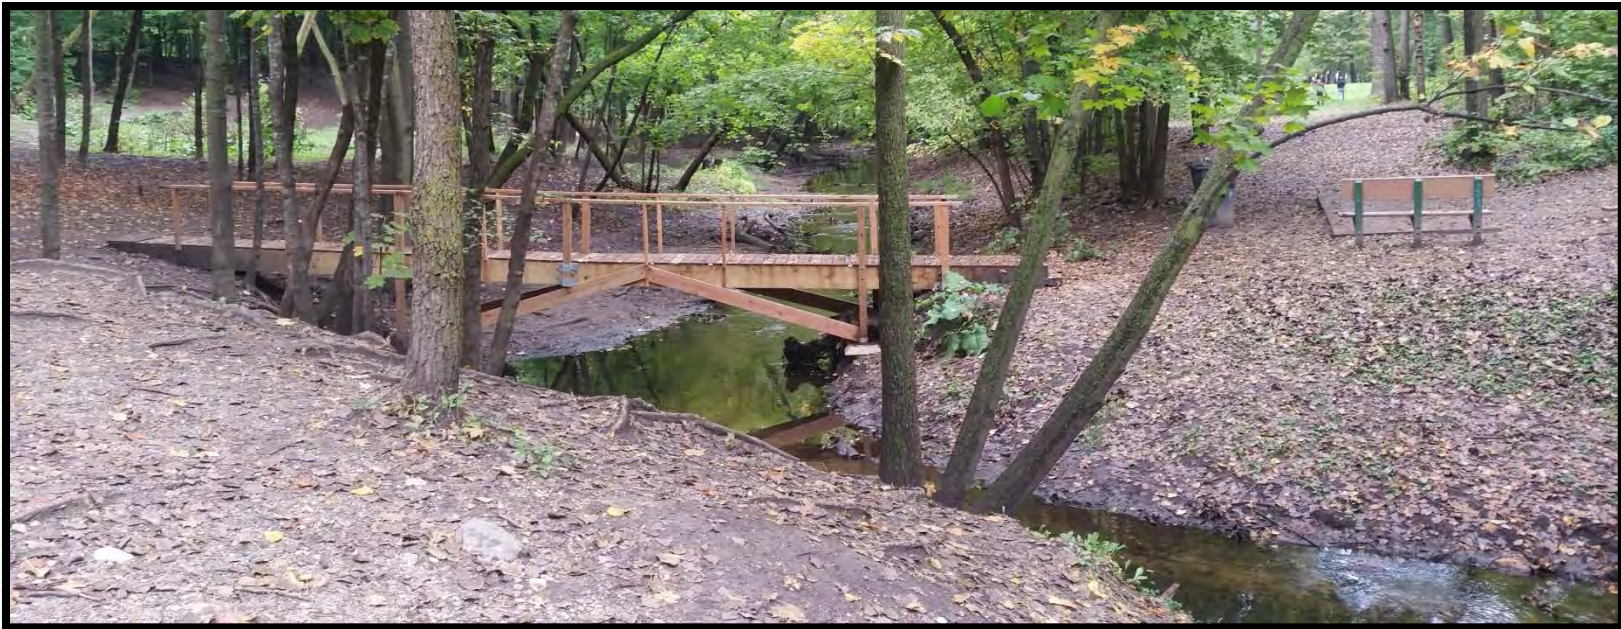
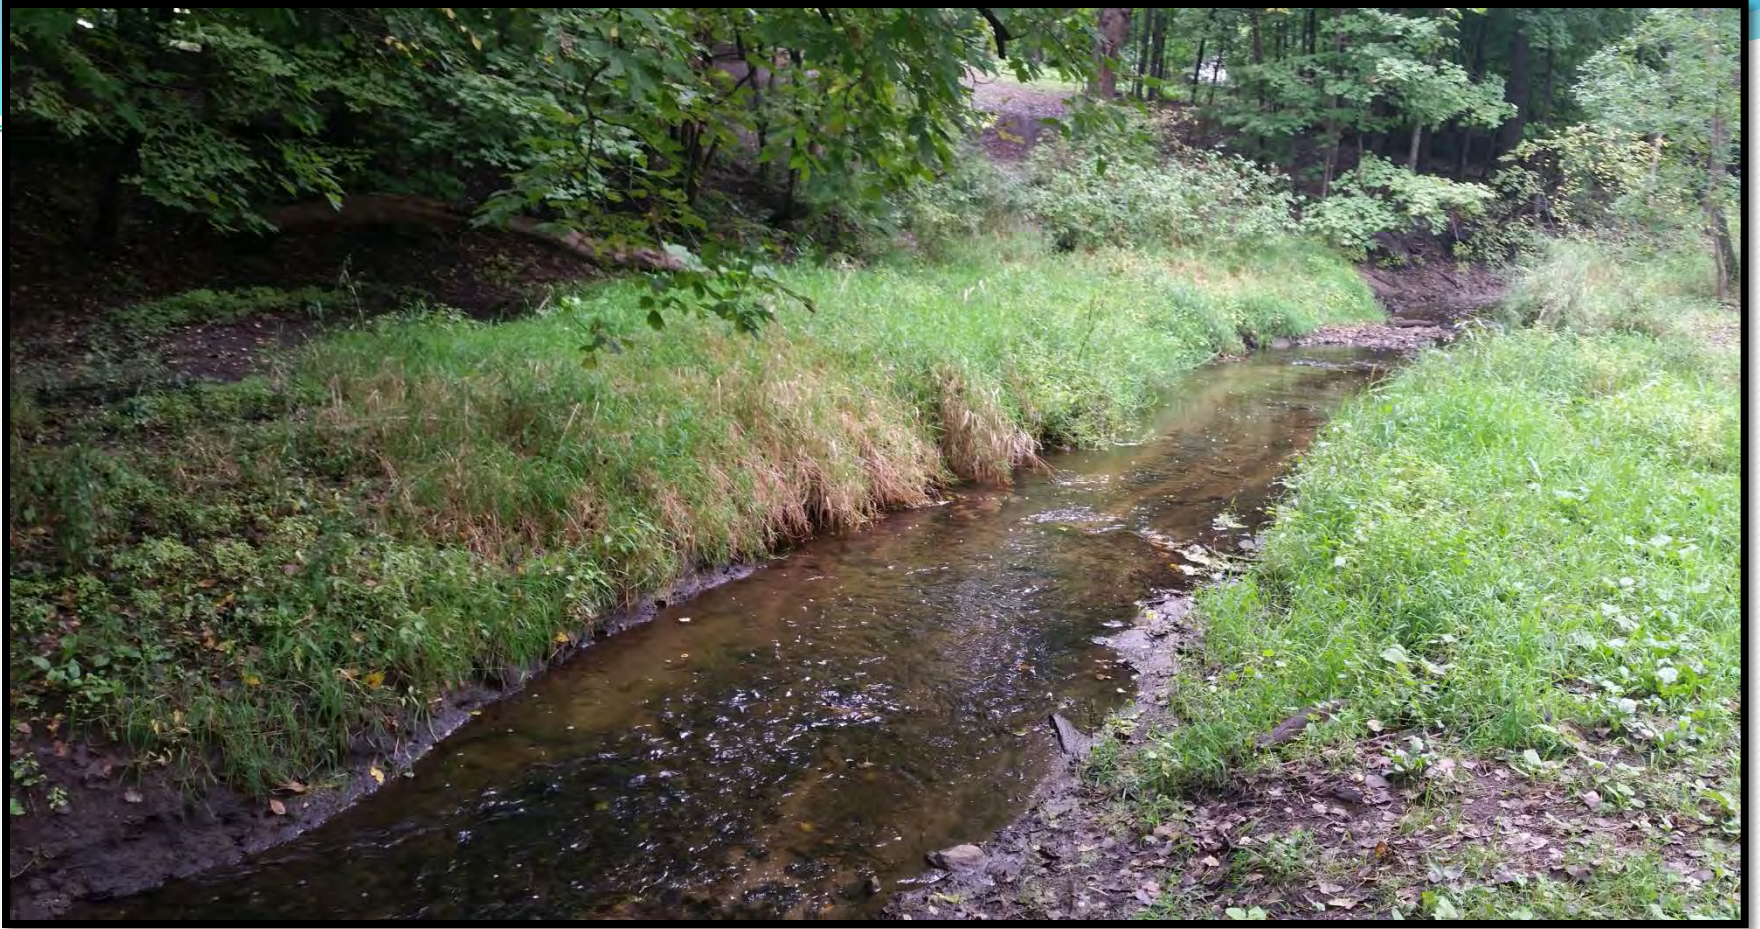
Reach 2 of Project Area; within disc golf course in park; some bank vegetation

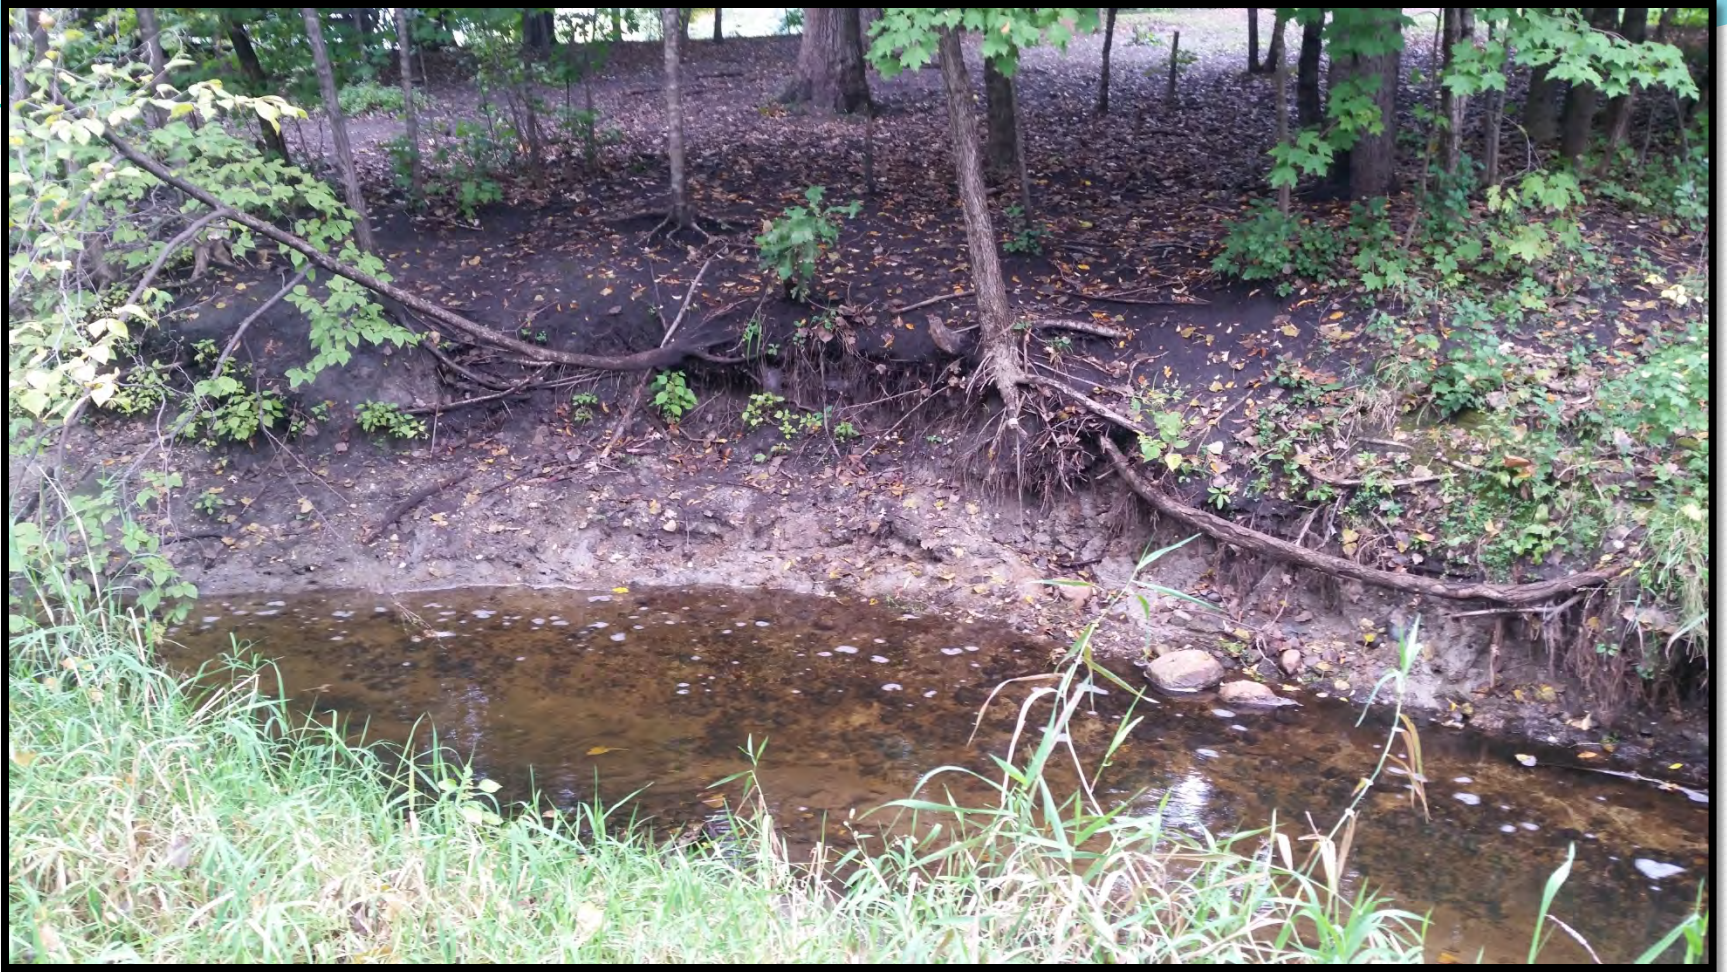
Reach 2 of Project Area; within disc golf course in park; at bend in creek; bank erosion

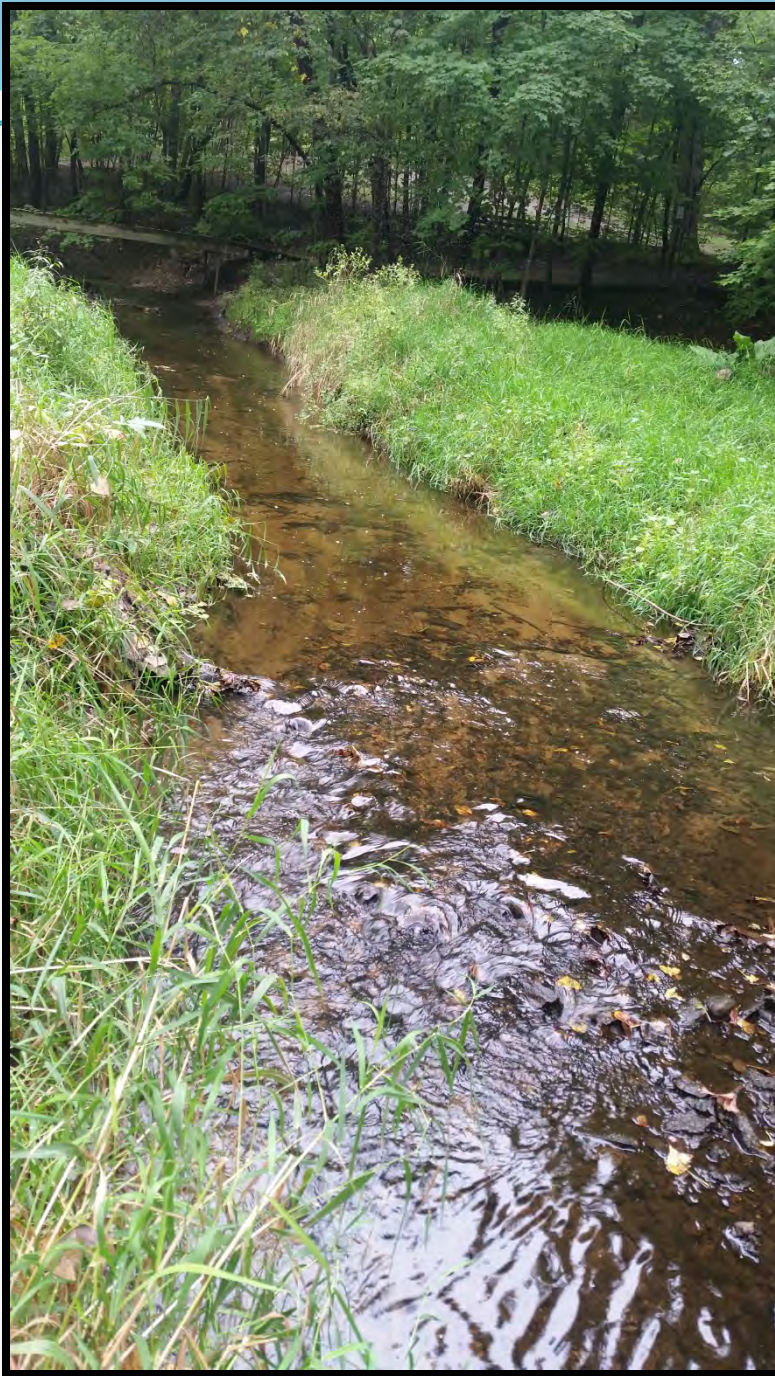
Reach 2 of Project
Area; within disc golf
course in park; reed
canary grass; more
light here

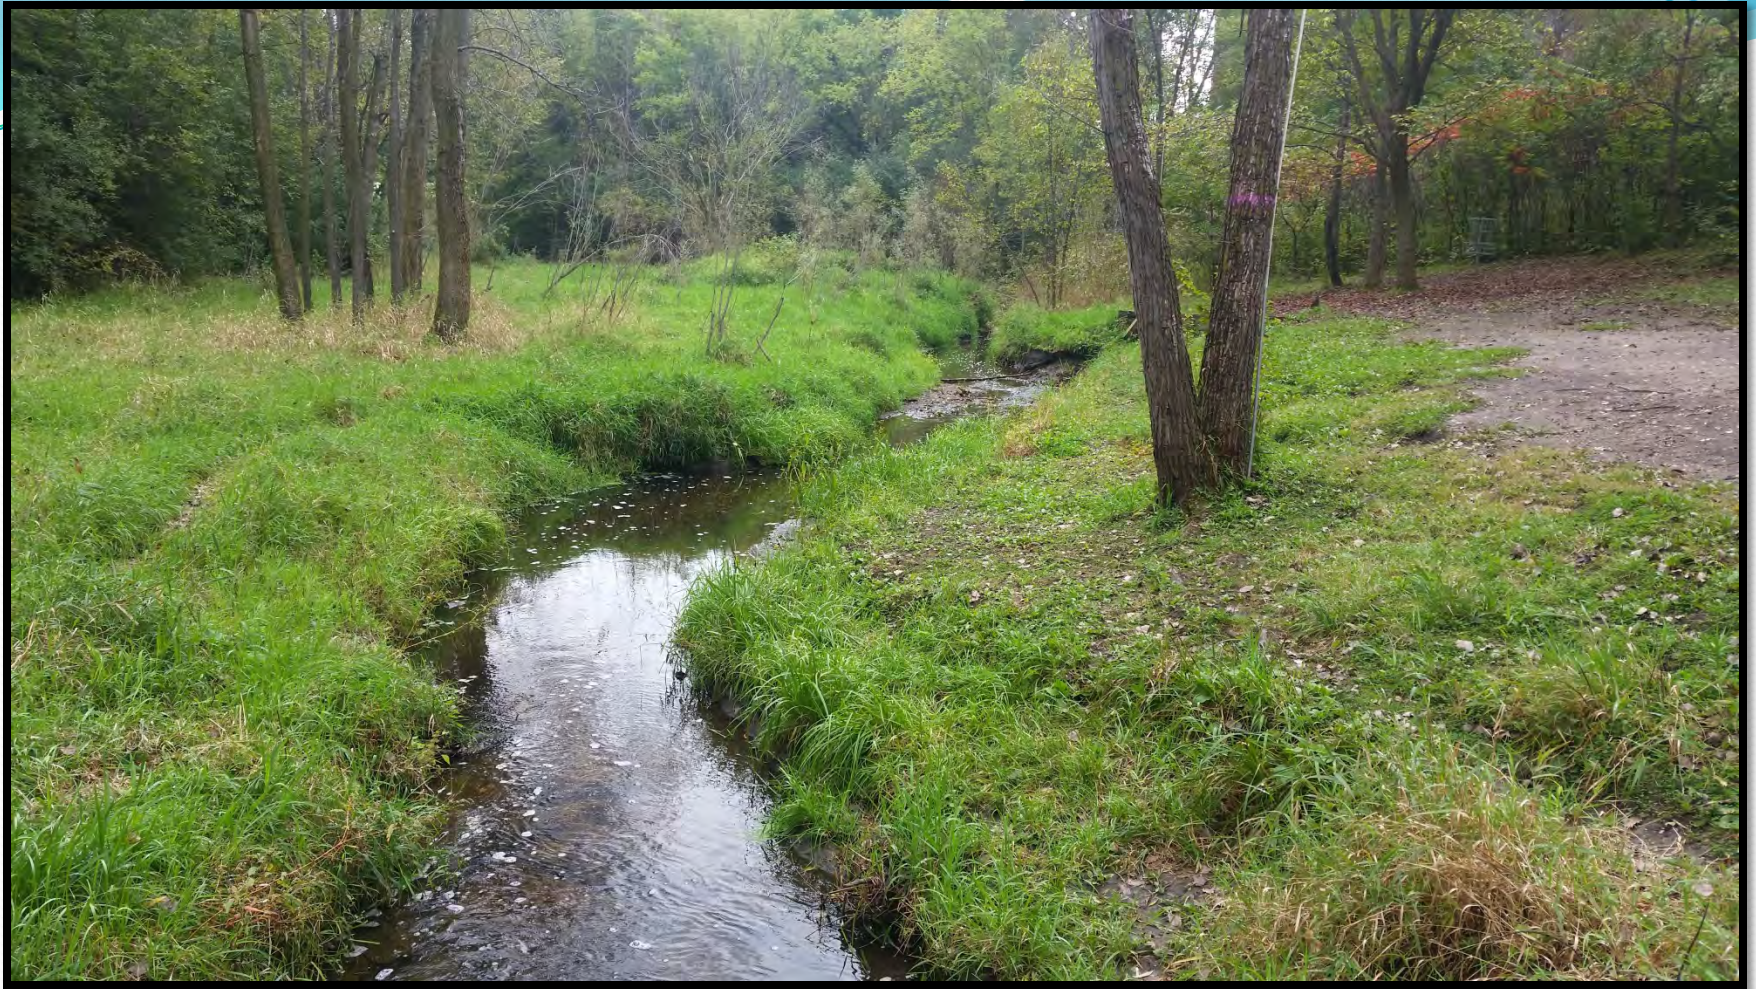
Reach 2 of Project Area; within disc golf course in park; reed canary grass and wetland area on left (north side of creek); more light here

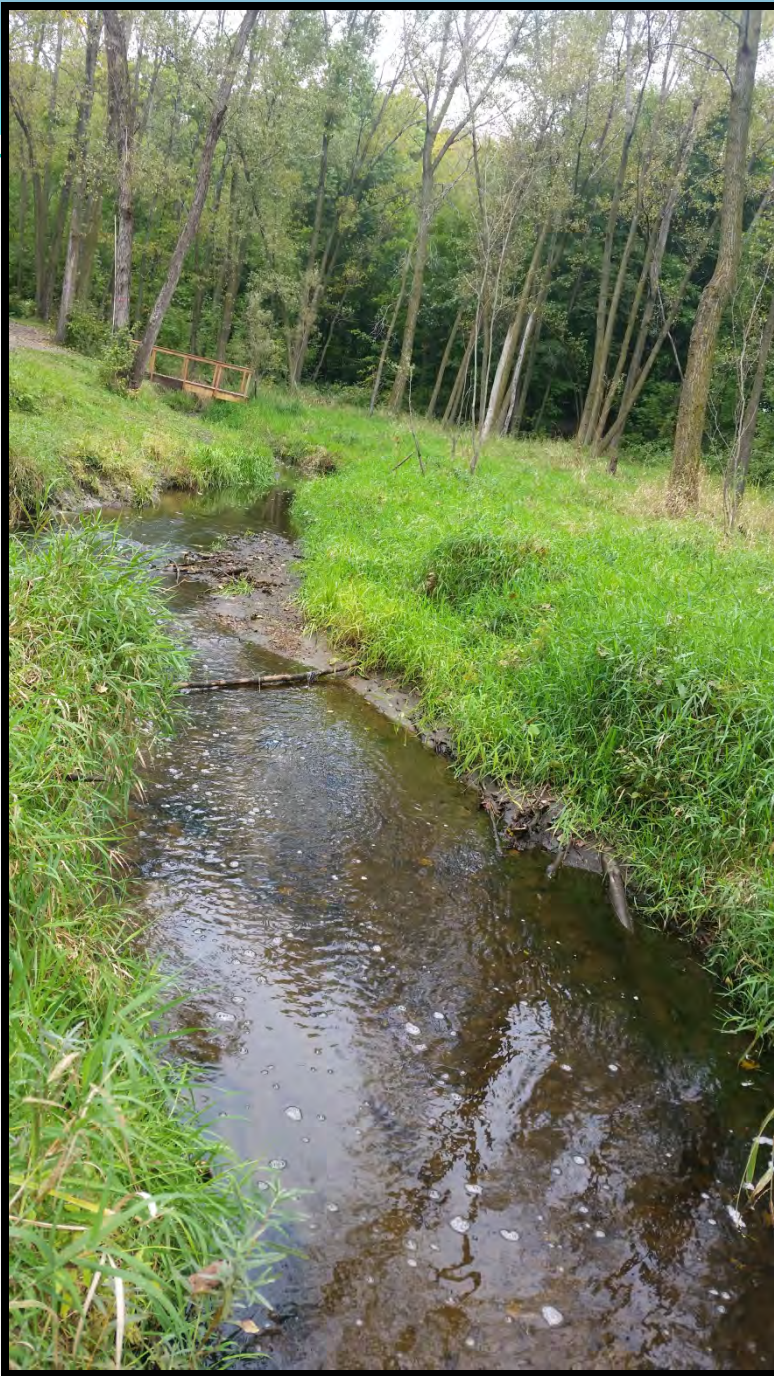
Reach 2 of Project Area;
within disc golf course
in park; reed canary
grass and wetland area
on north side of creek;
more light here
