Plymouth Creek Restoration Project

Bassett Creek Watershed Management Commission

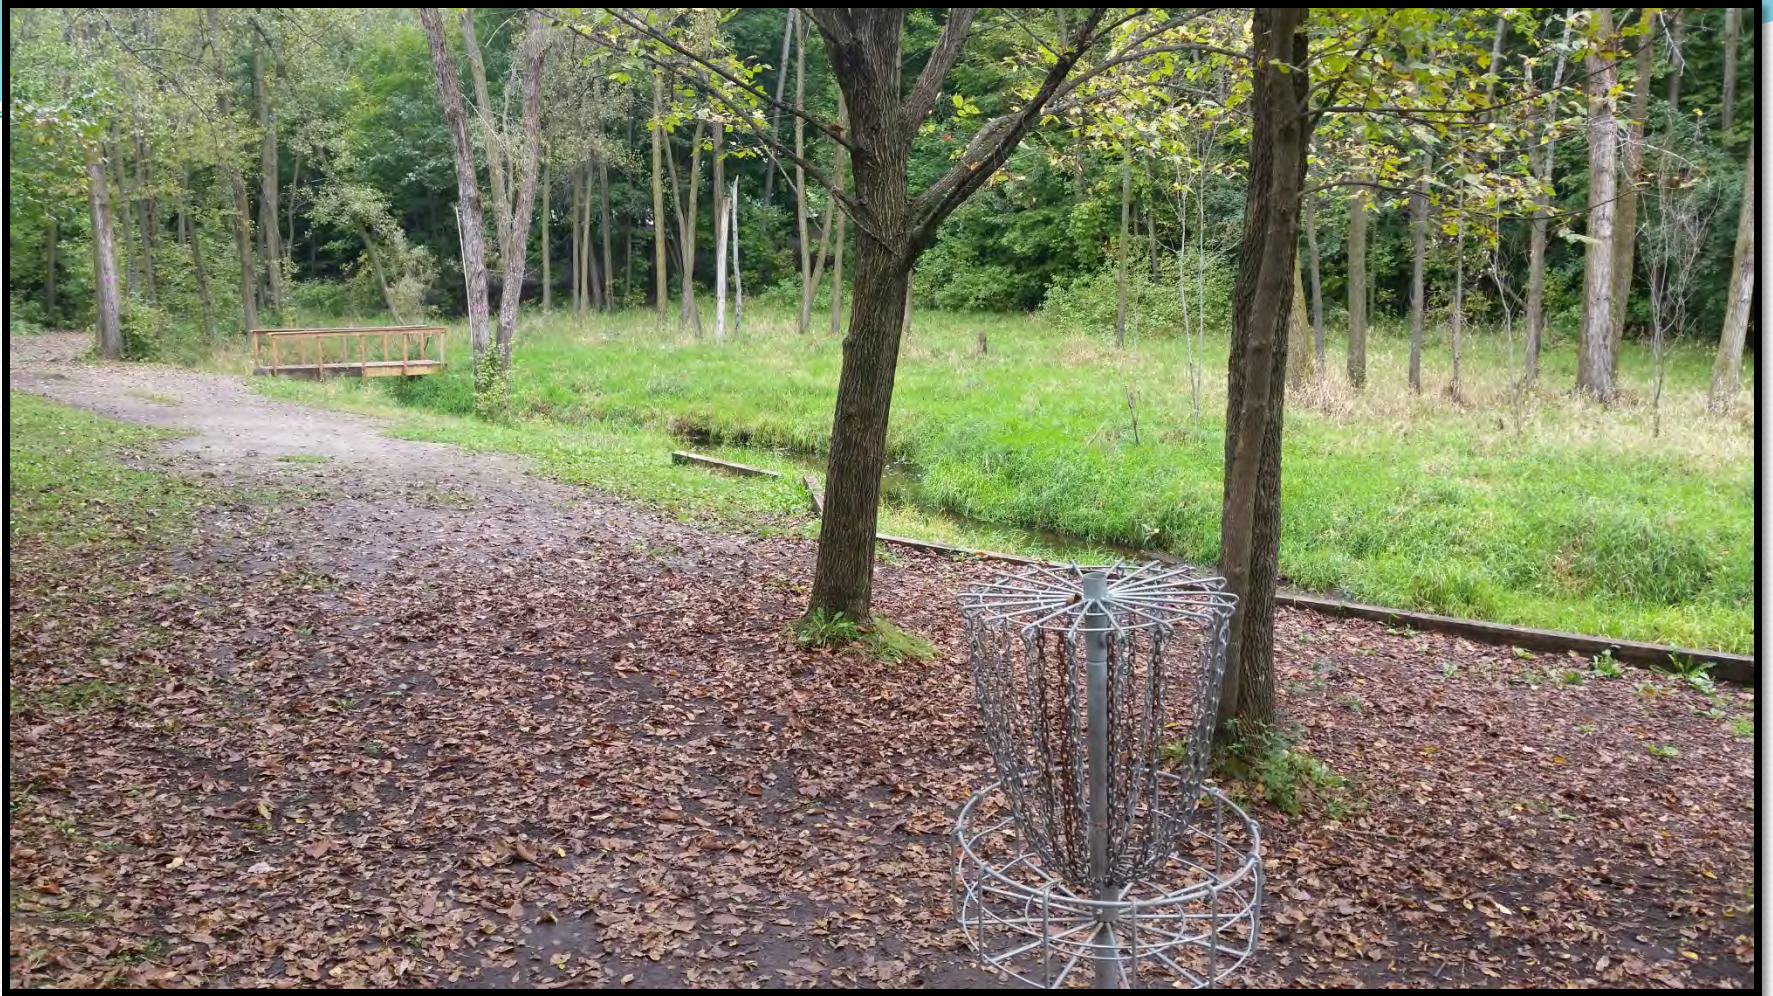
Reach 2 of Project Area; within disc golf course in park; reed canary grass and wetland area across creek; more light here

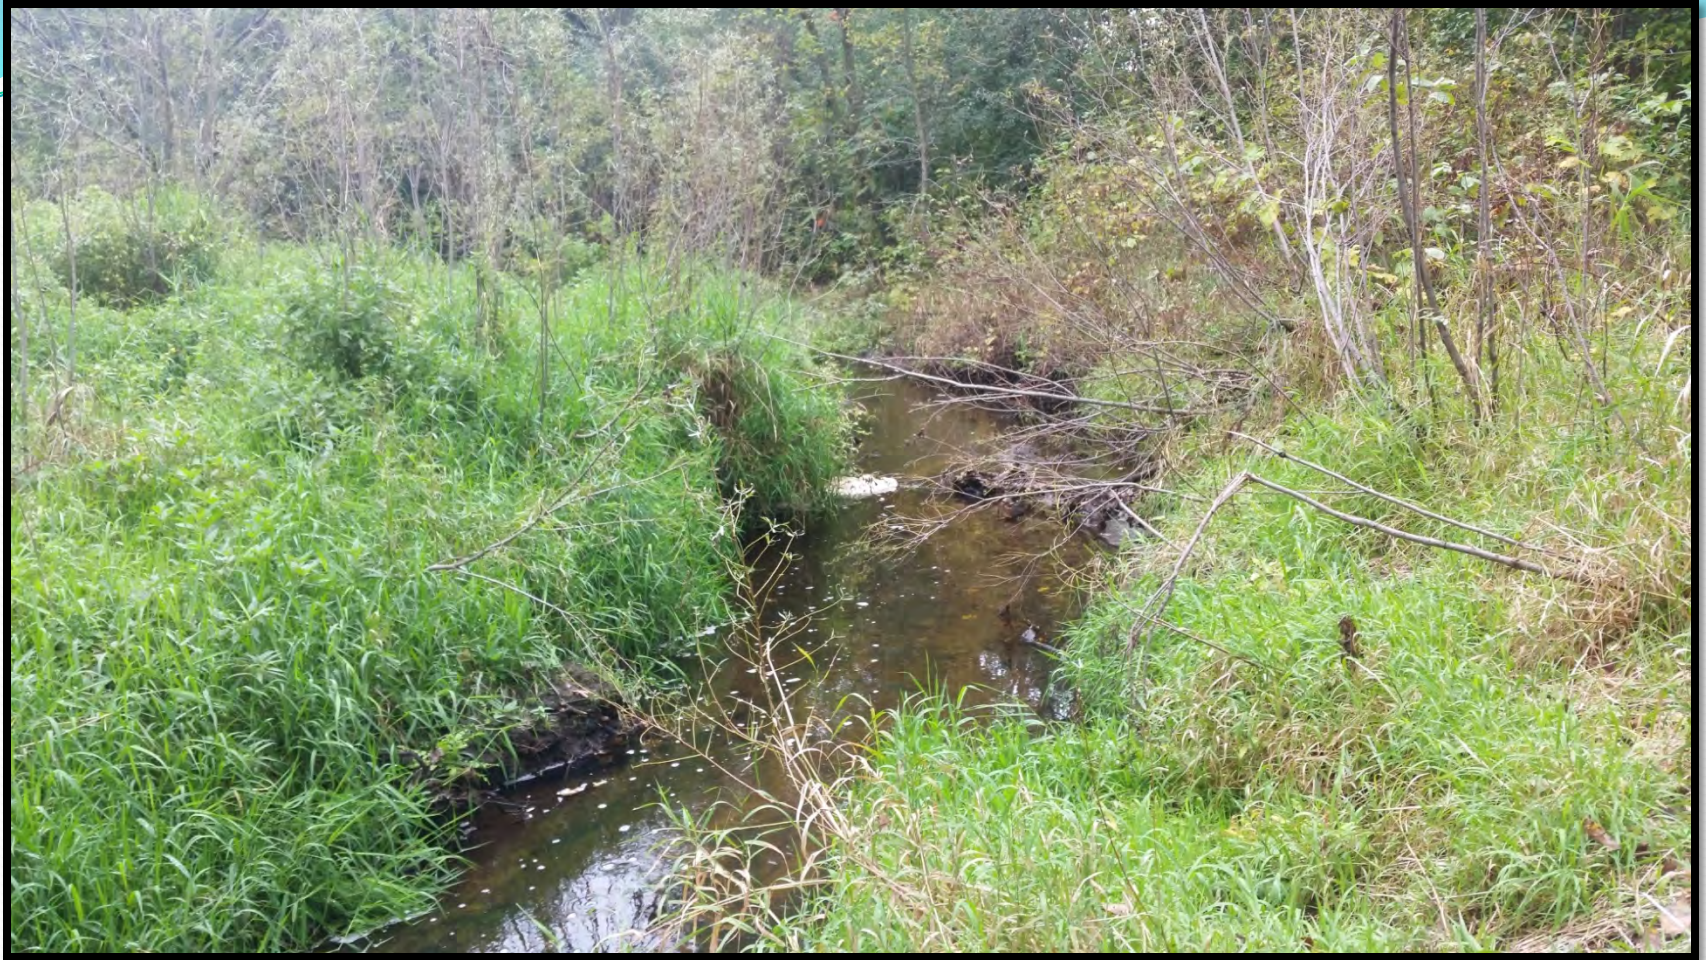
Reach 2 of Project Area; downstream of disc golf course in park; just upstream of Fernbrook Lane; reed canary grass, brush, wetland on left; incised channel; more light here

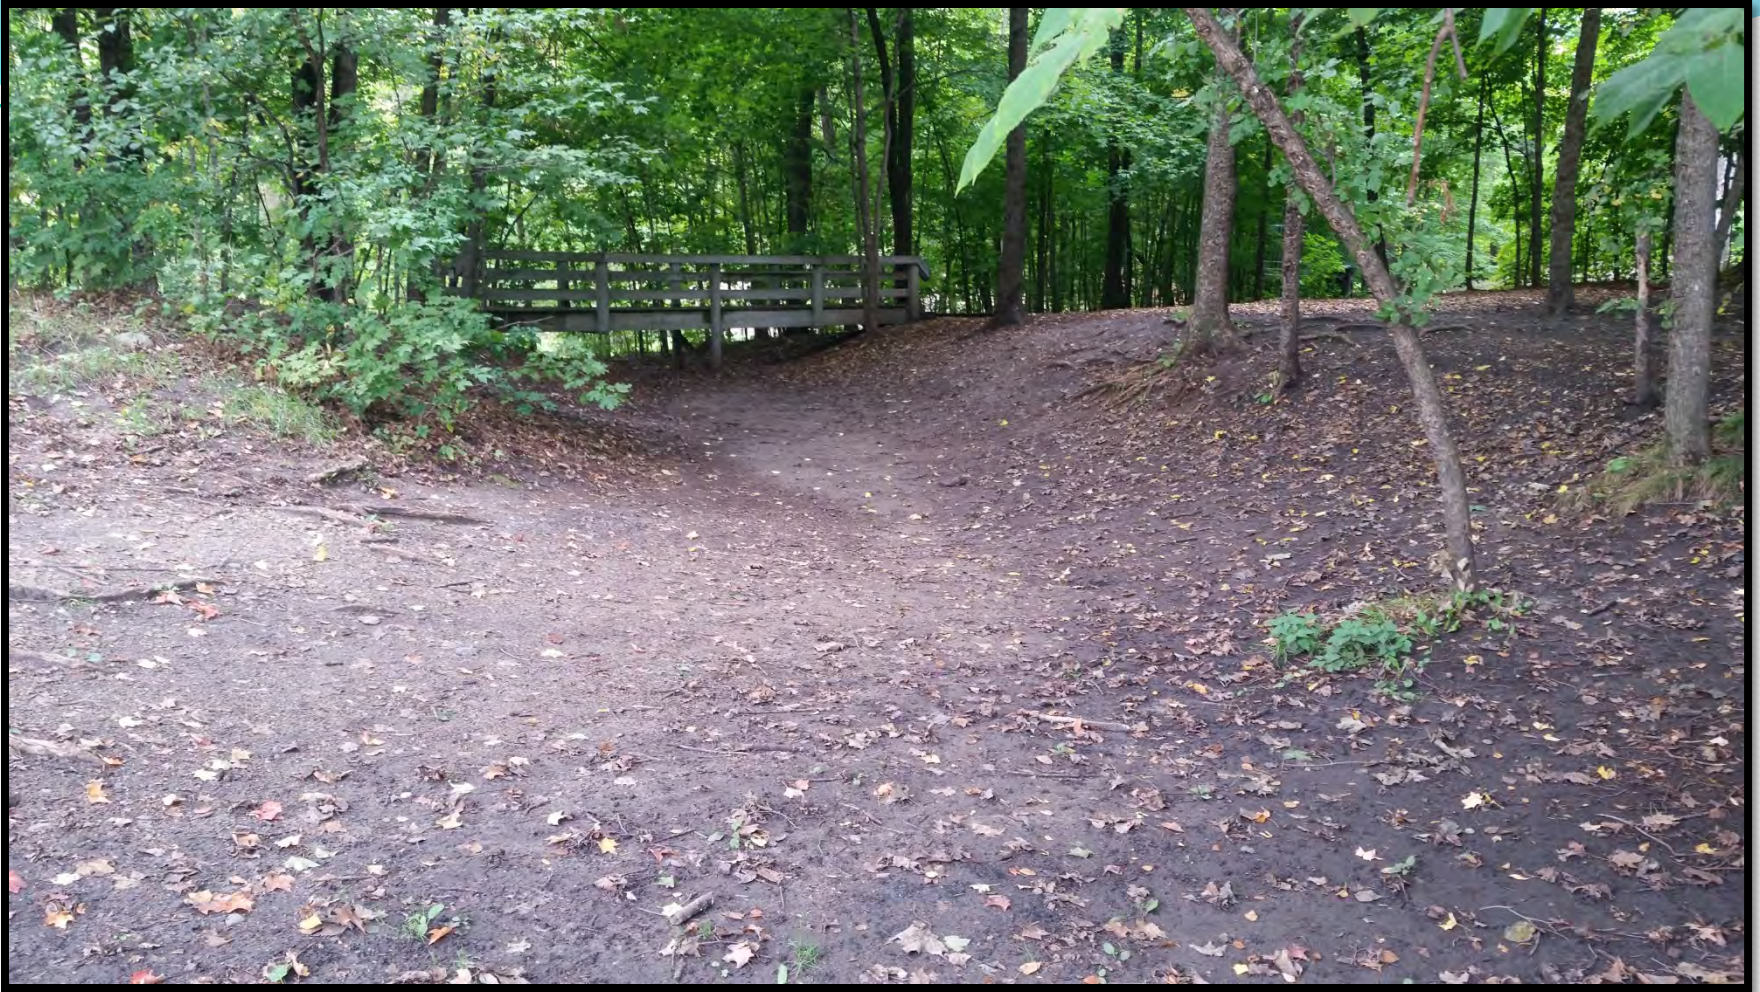
Adjacent to Reach 2; swale from parking lot to stream; heavy foot traffic and erosion

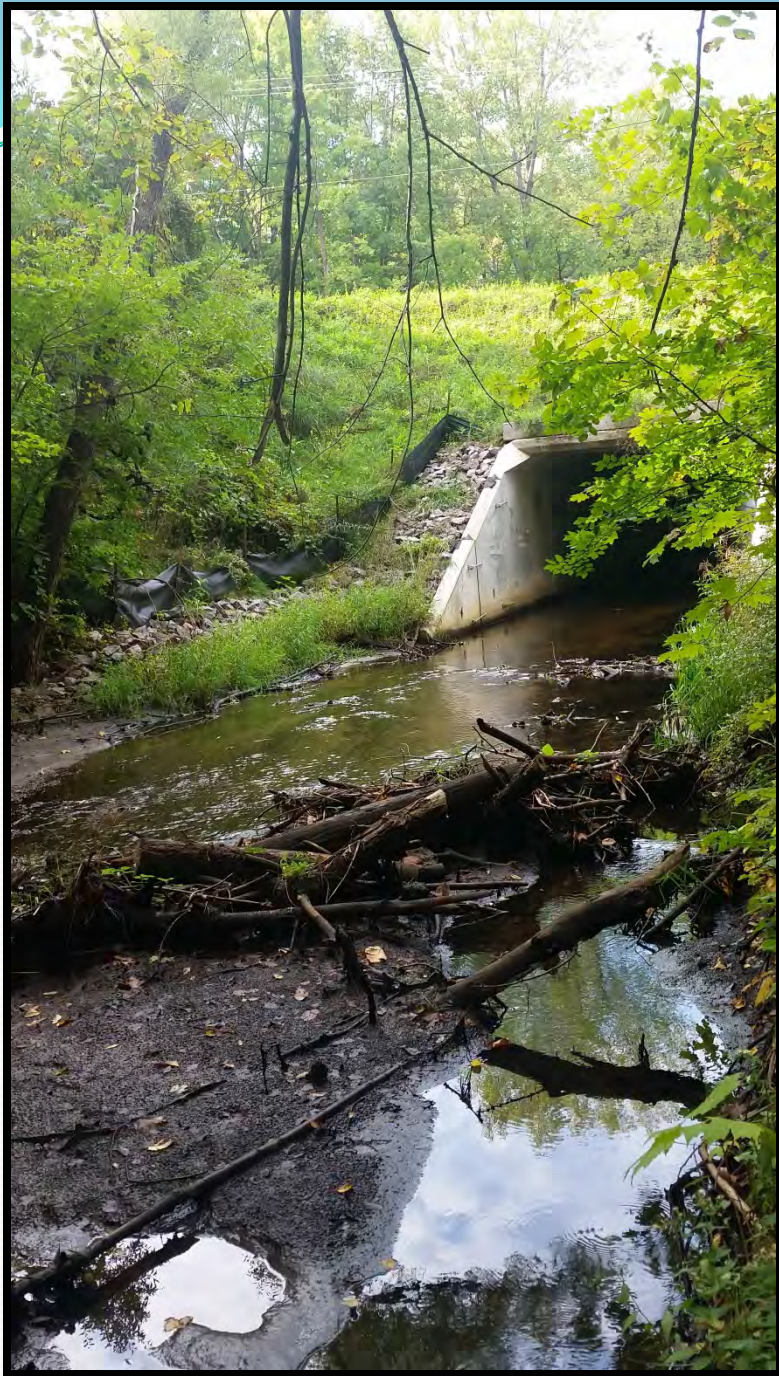
Beginning of Reach 3;
downstream side of
culvert under
Fernbrook Lane

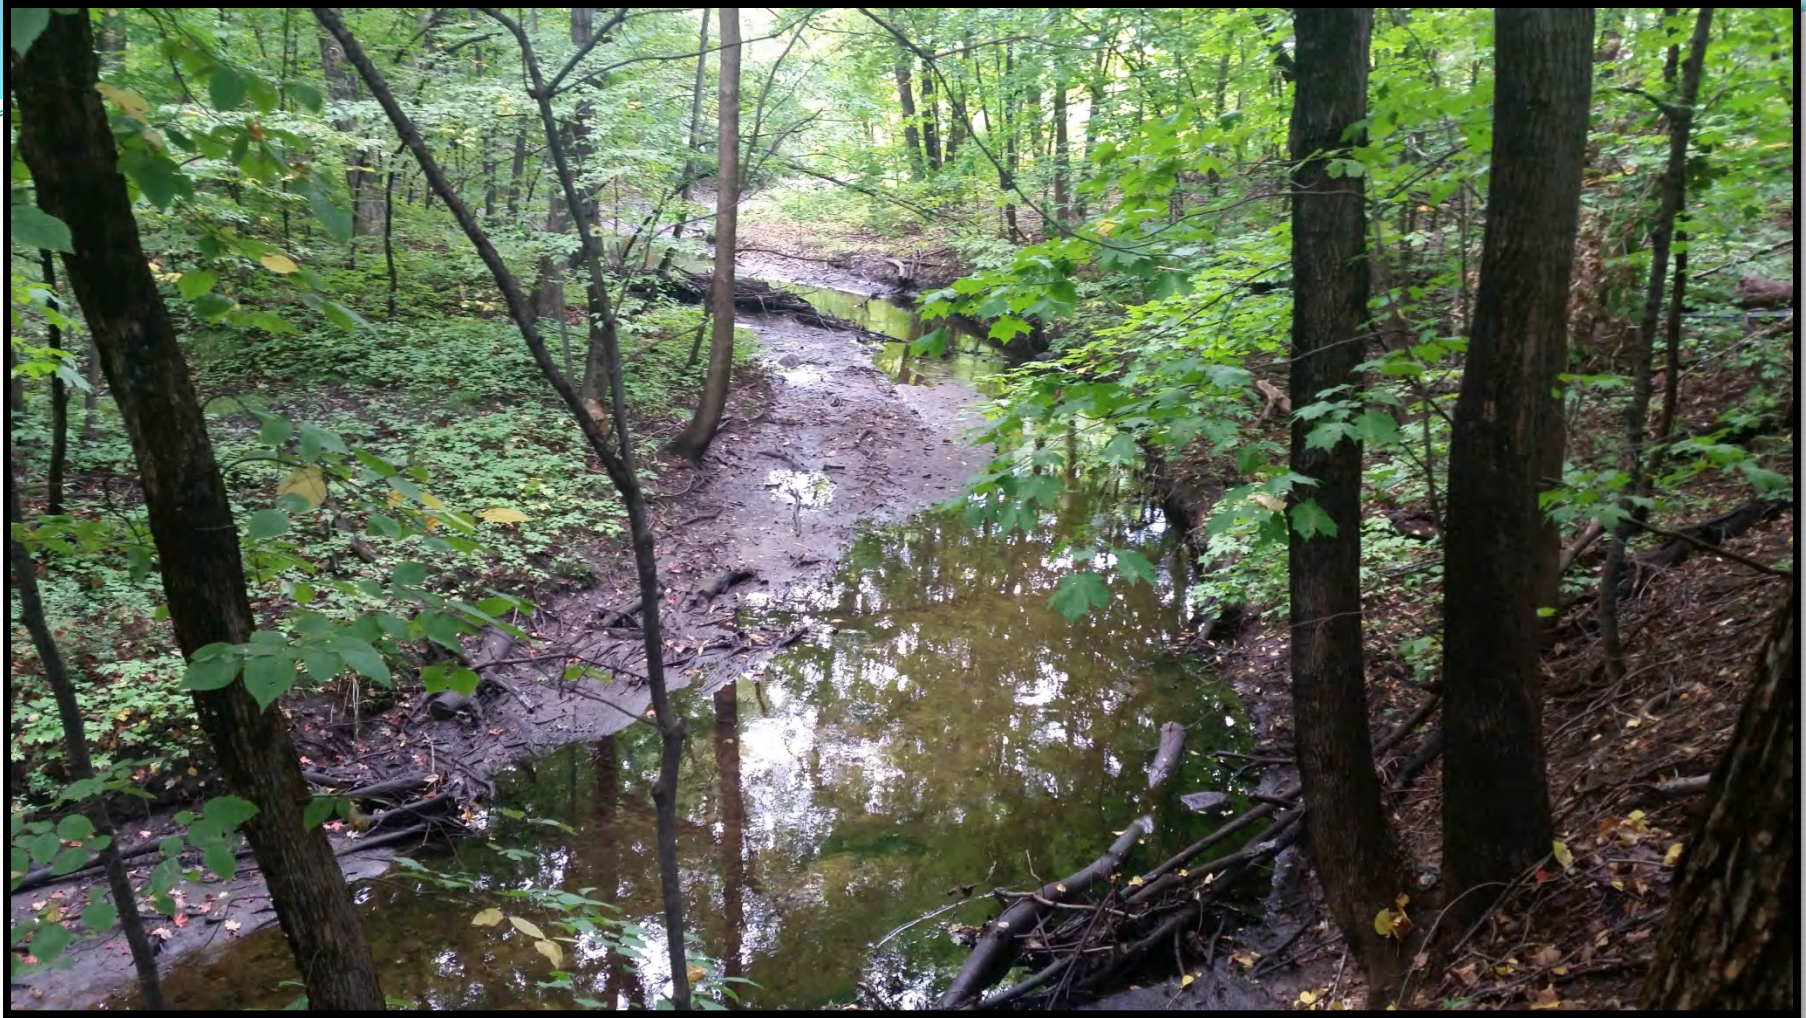
Reach 3 just downstream of Fernbrook Lane;
erosion, shady area

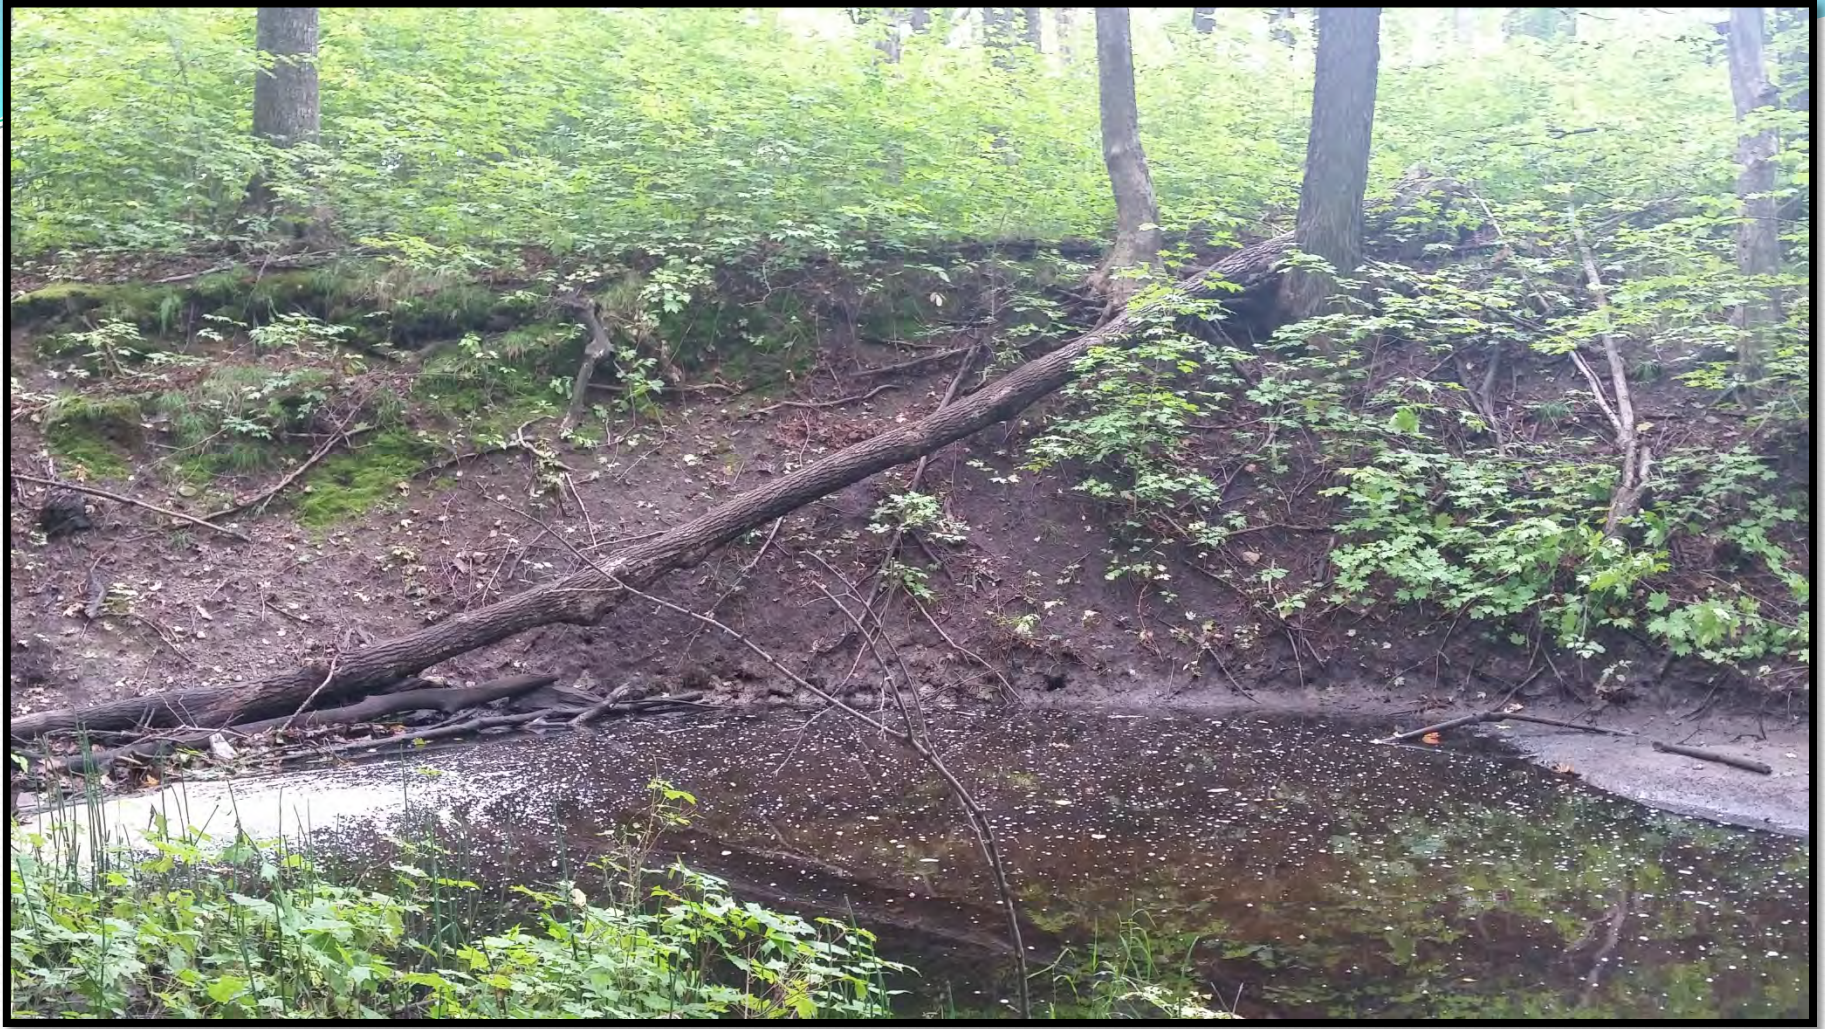
Reach 3; bend in stream with significant erosion on steep bank; shady area

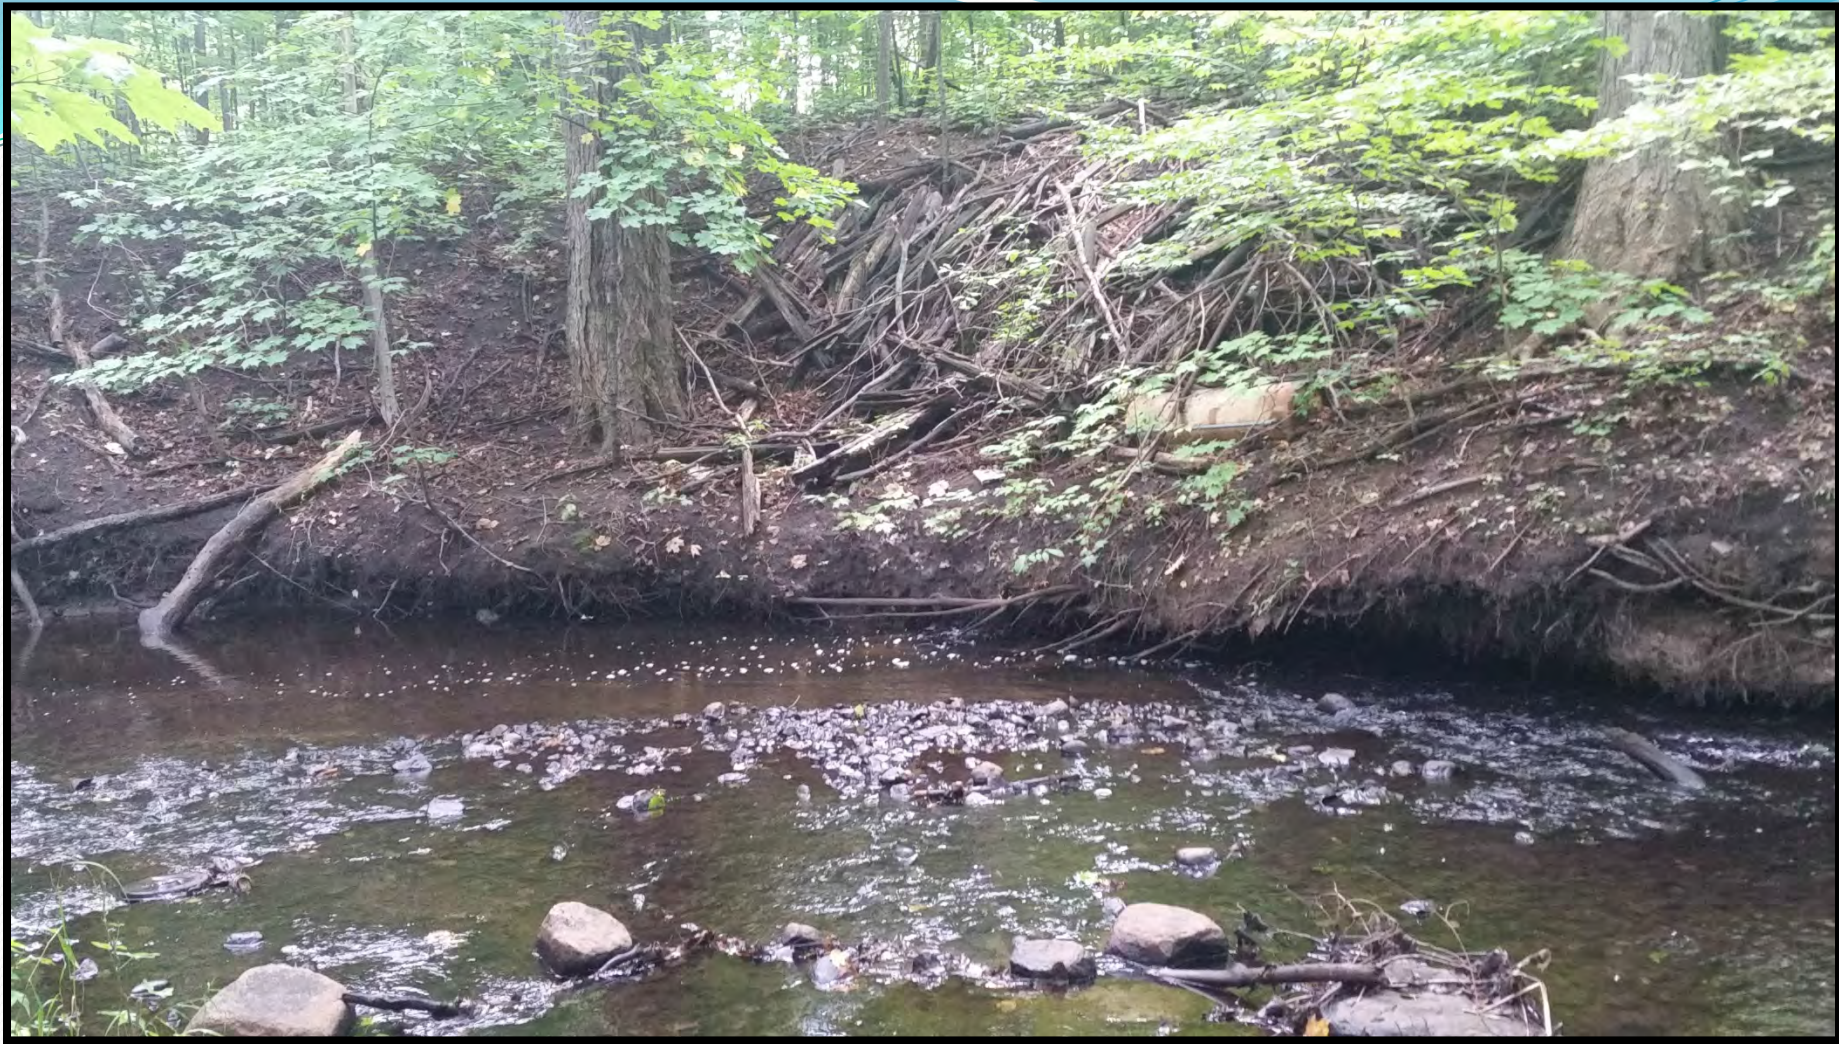
Reach 3; significant erosion; shady area; no understory vegetation to hold soils in place

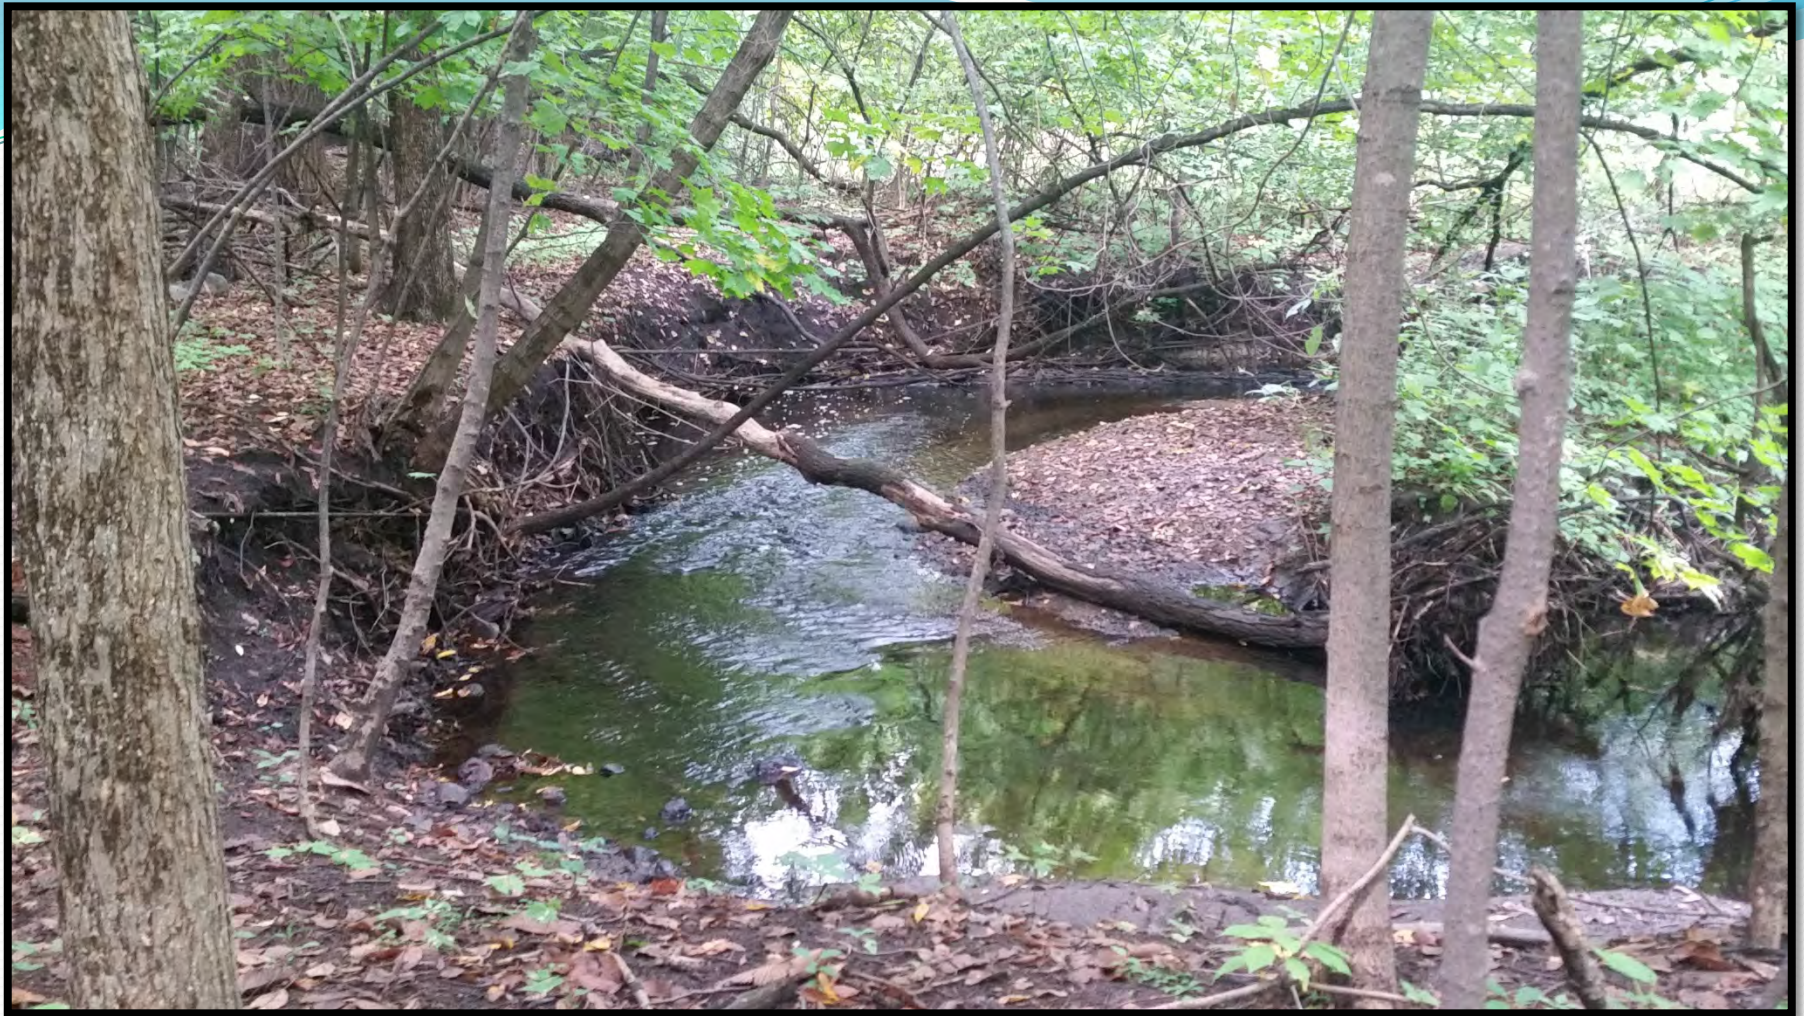
Reach 3; significant erosion on bend in creek; shady area; no understory vegetation to hold soils in place

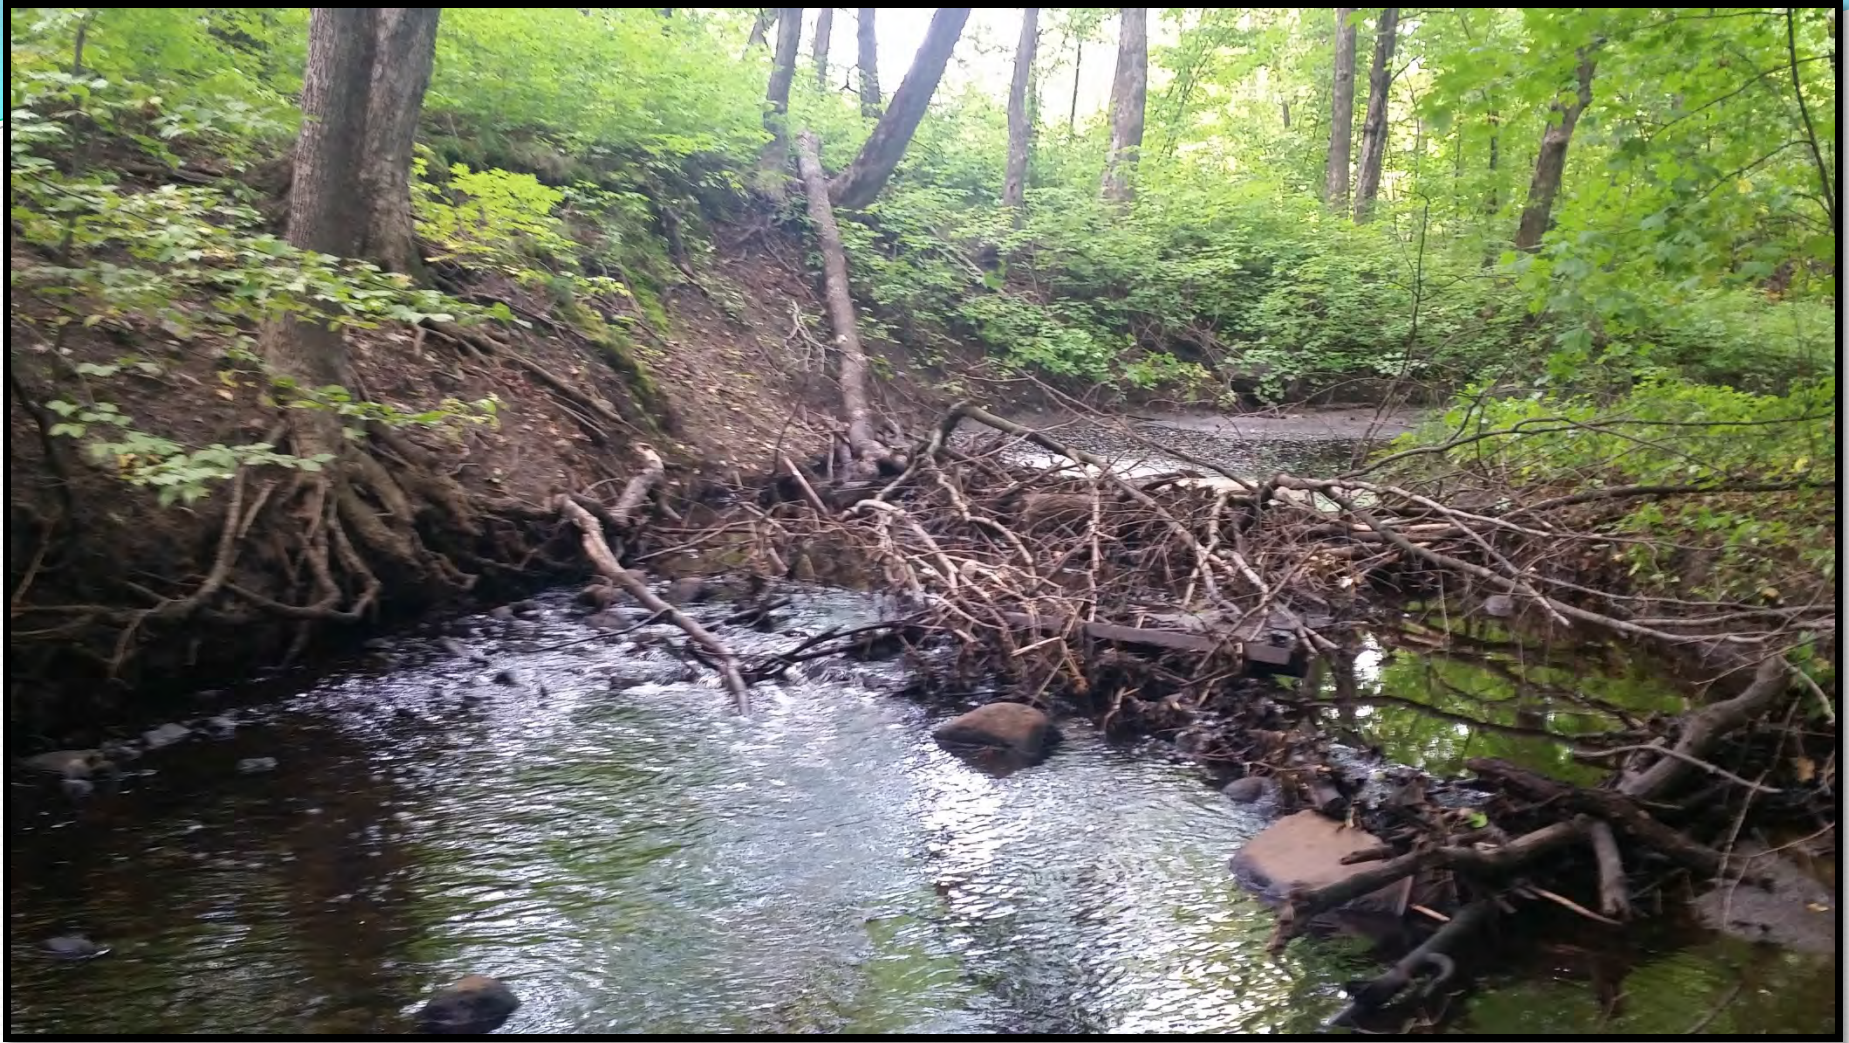
Reach 3; woody debris in channel altering stream flow
