Phase I Environmental Site Assessment

Bassett Creek Main Stem Erosion Repair Project

Bassett Creek from Cedar Lake Road to Dupont Avenue

December 2015

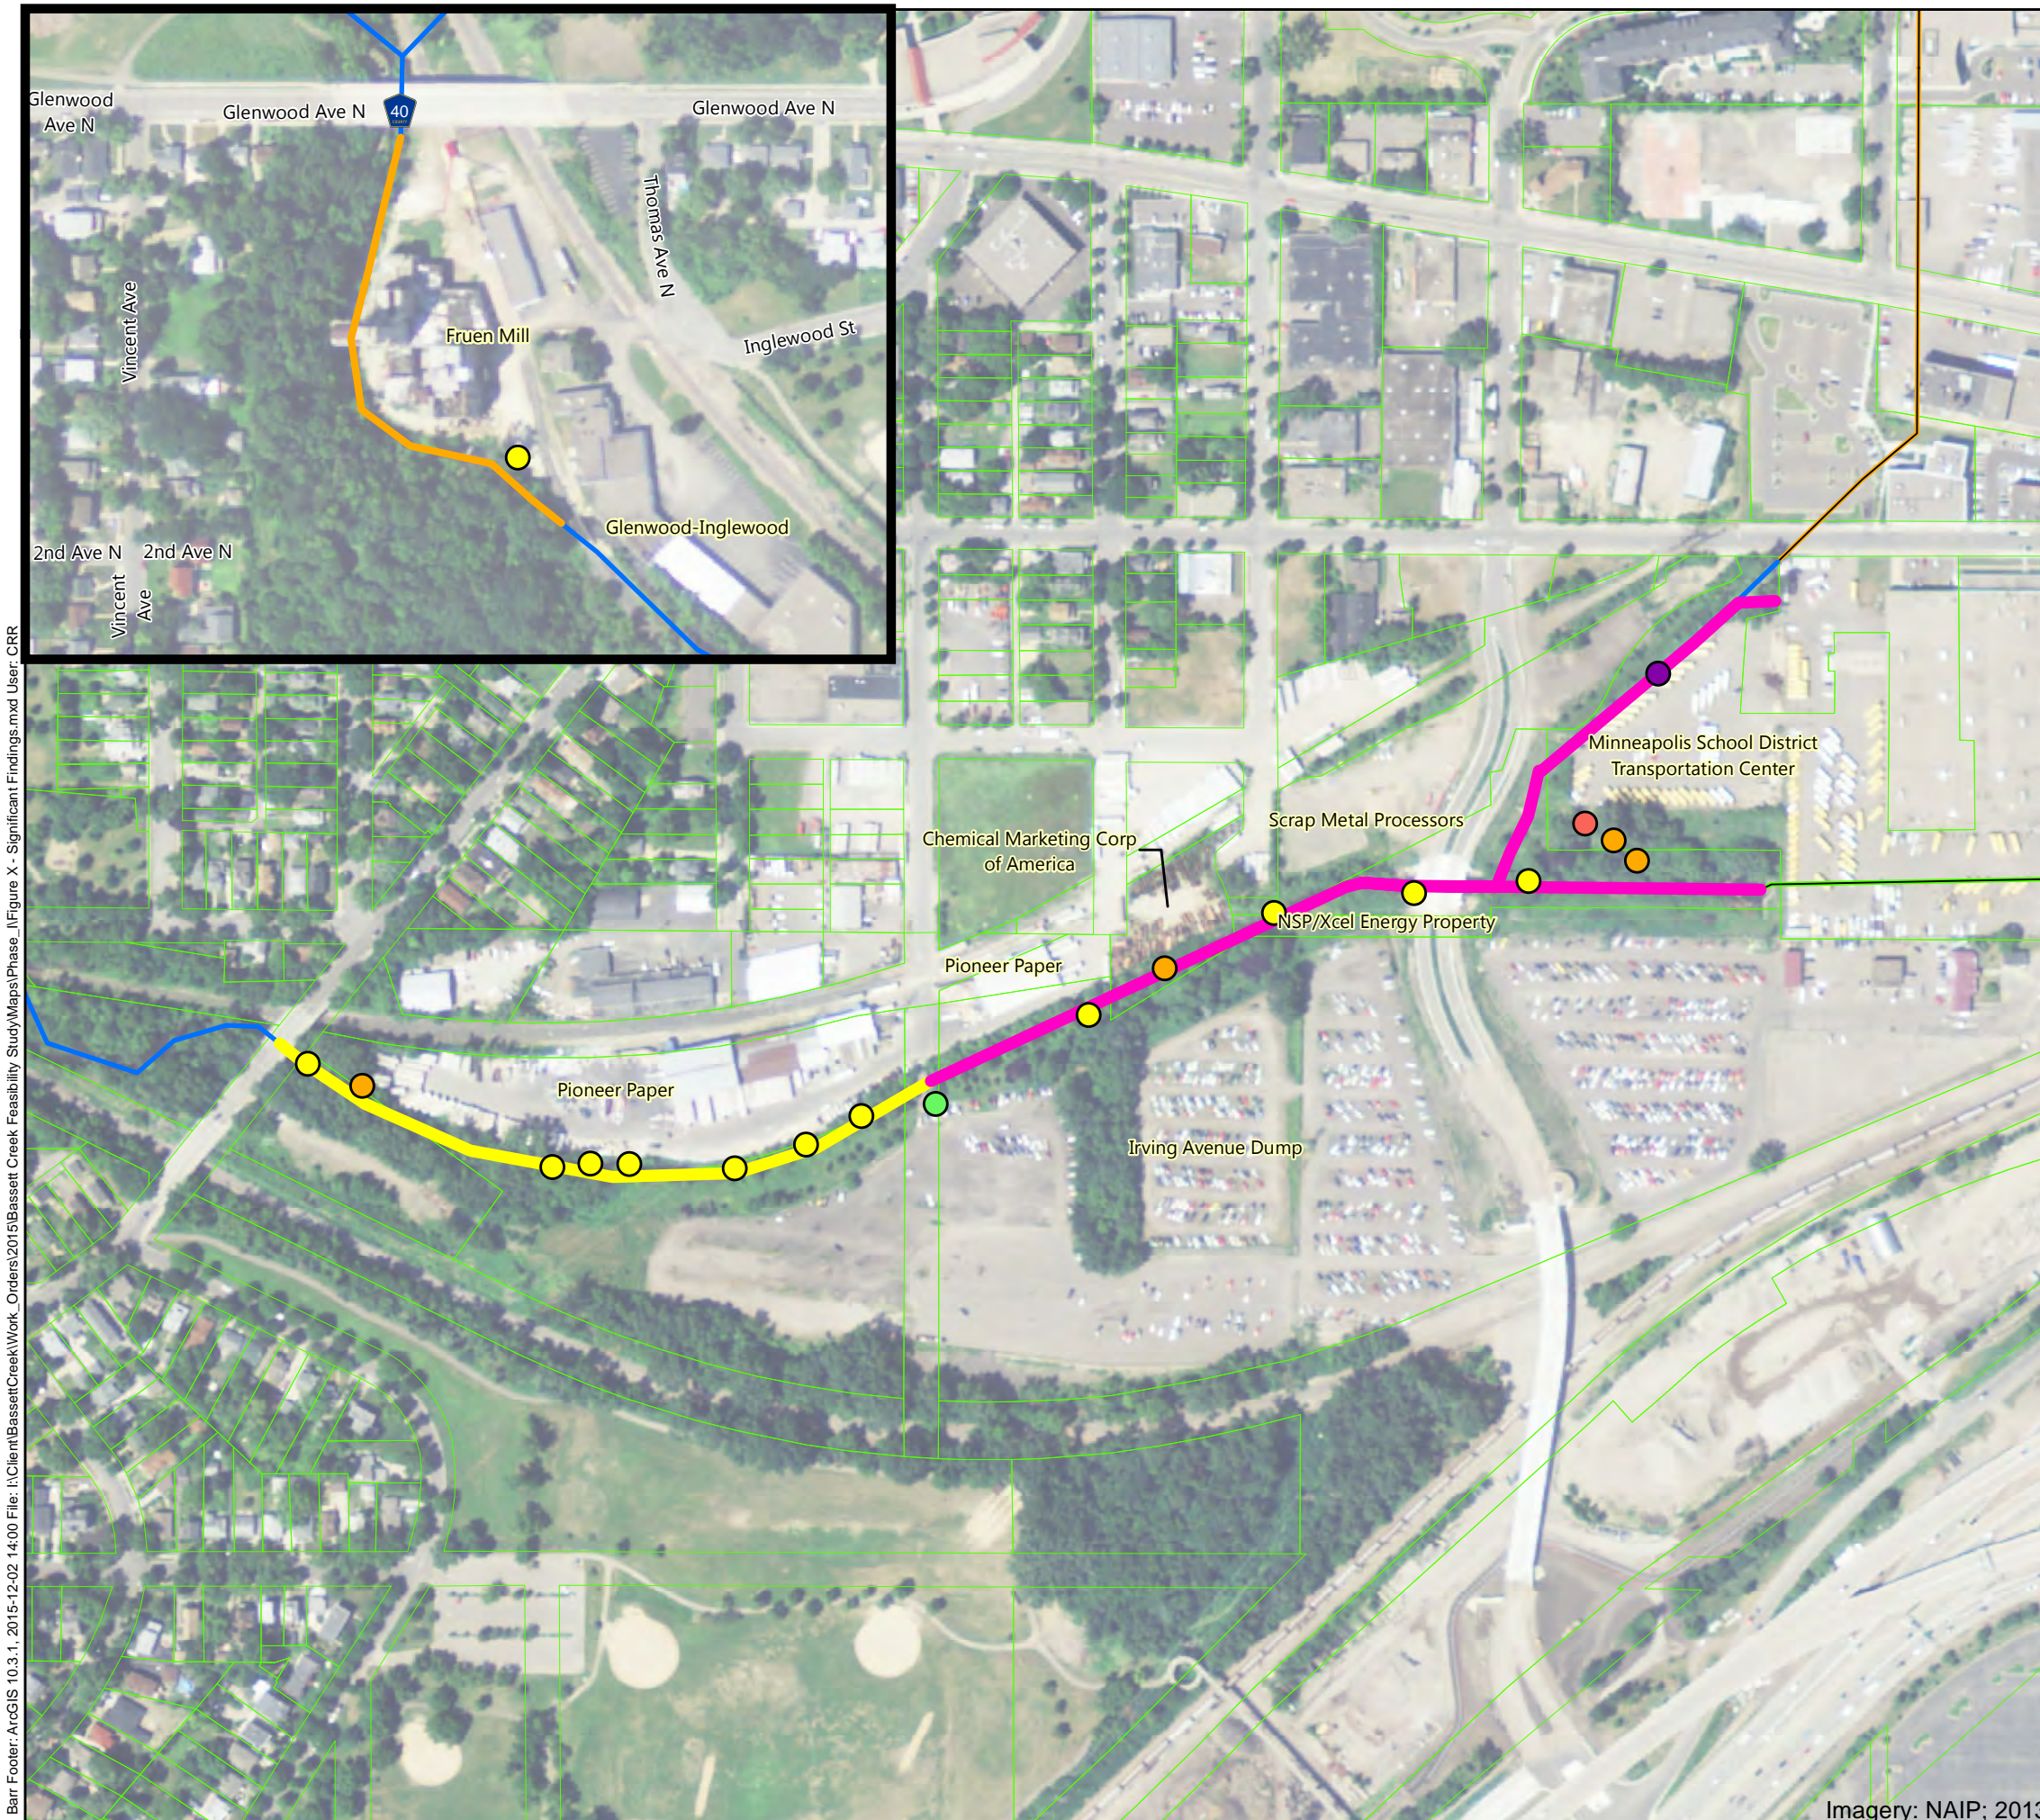
Figure 4

Visible sheen on water	Iridescent sheens were observed in water at the creek along the shores as well as near some culverts.	The nature of the sheen indicates the presence of petroleum product in the water. This finding is considered a REC.	REC #3
Abandoned equipment and material storage near edge of Property	Several large pieces of apparently abandoned machinery and surplus materials were observed in the southwest corner of the Minneapolis School District Transportation Center parcel. The machinery appeared to be rusted and in poor condition and was covered in a black liquid that	No release to the ground surface was identified and the machinery was not on the Property. This finding is not considered a REC for the purposes of the erosion repair and creek stabilization project.	NA

Wastewater, stormwater, and other visible liquid discharge points into a pipe, pond, ditch, stream adjoining property or the Property: Numerous stormwater pipes and runoff trenches were observed with discharge into Bassett Creek. Additionally, several unidentified pipes, both open and capped, were observed exiting the bank in Reaches 1 and 2. .

Transformers: Pole-mounted transformers were incidentally observed on the Property in Reach 2. Documenting the location of all pole-mounted transformers within the vicinity of the creek was not performed.
