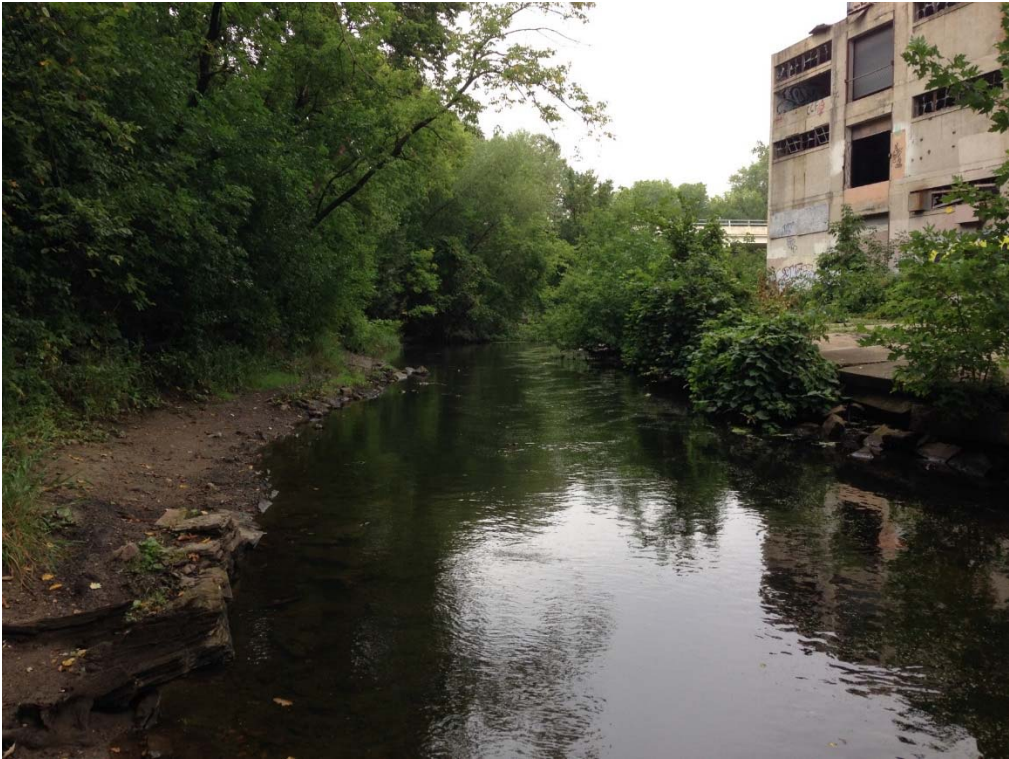
Photo 1. Site 1. Existing trail along stream (photo looking upstream)

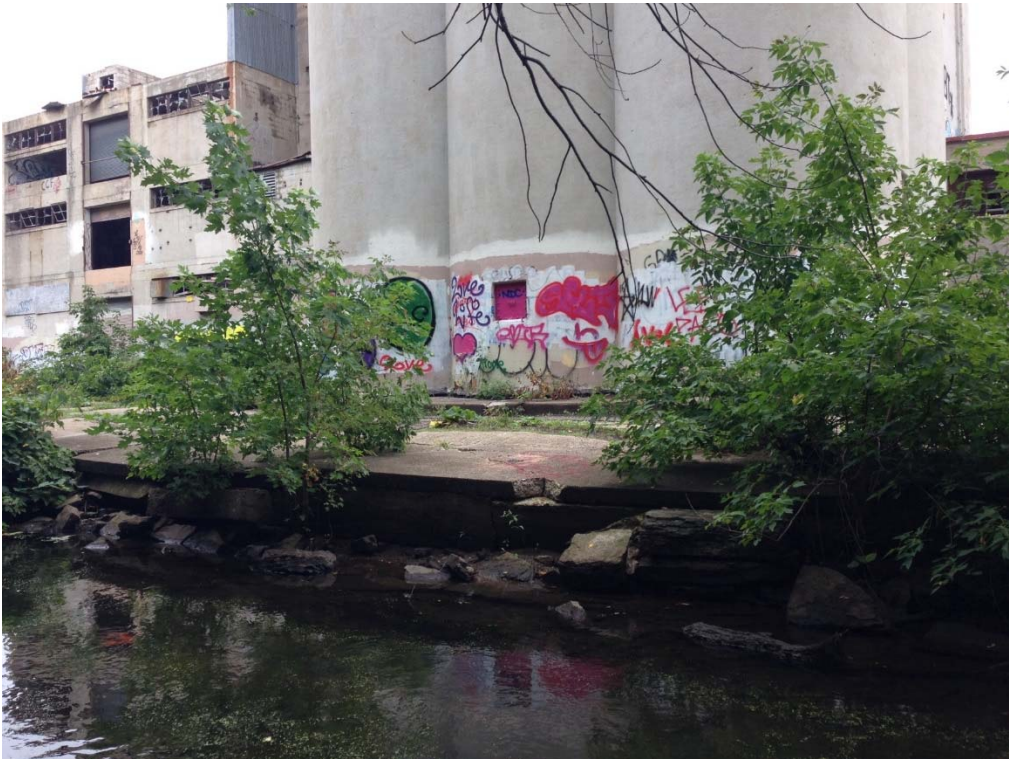
Photo 2. Site 2. Concrete and block on stream bank

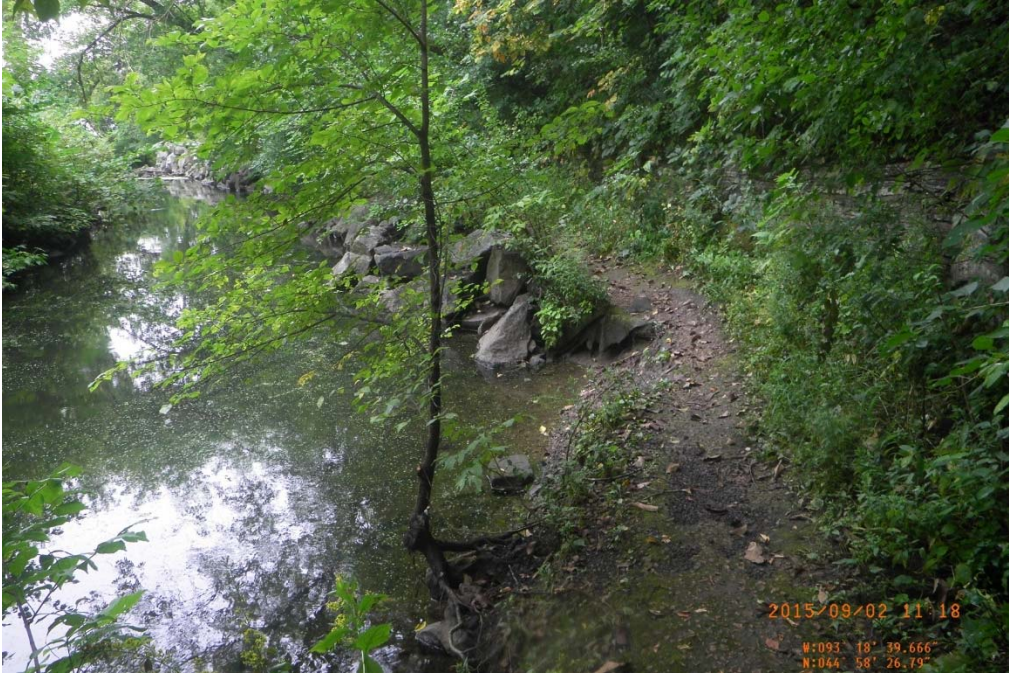
Photo 3. Site 3. Eroding outer bank upstream of riprap (photo looking downstream)

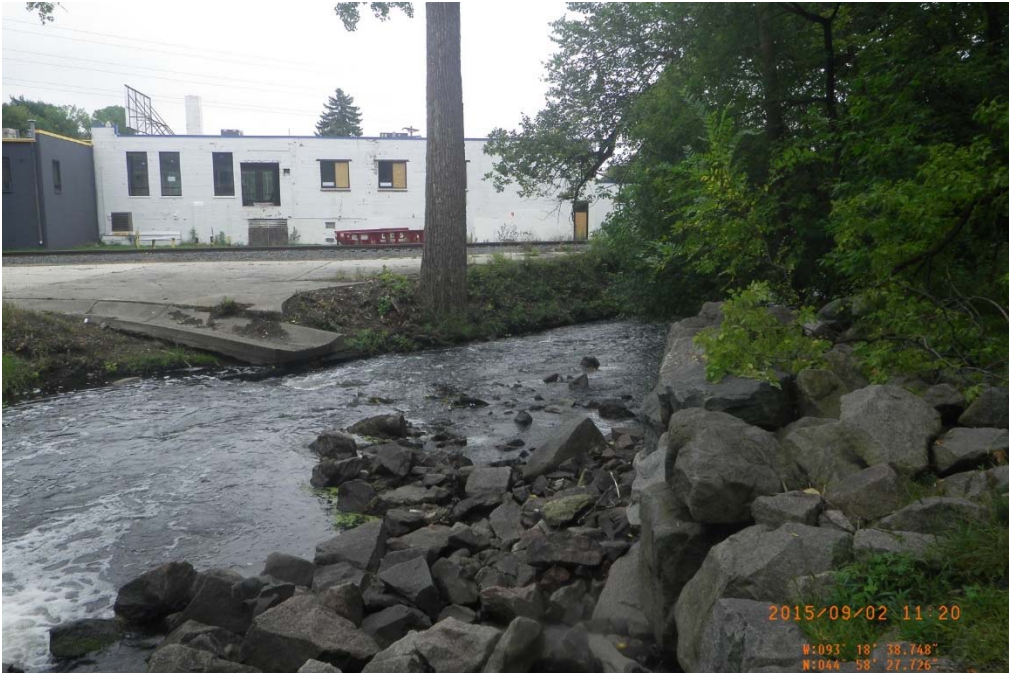
Photo 4. Site 4. Undercut swale and downstream bank

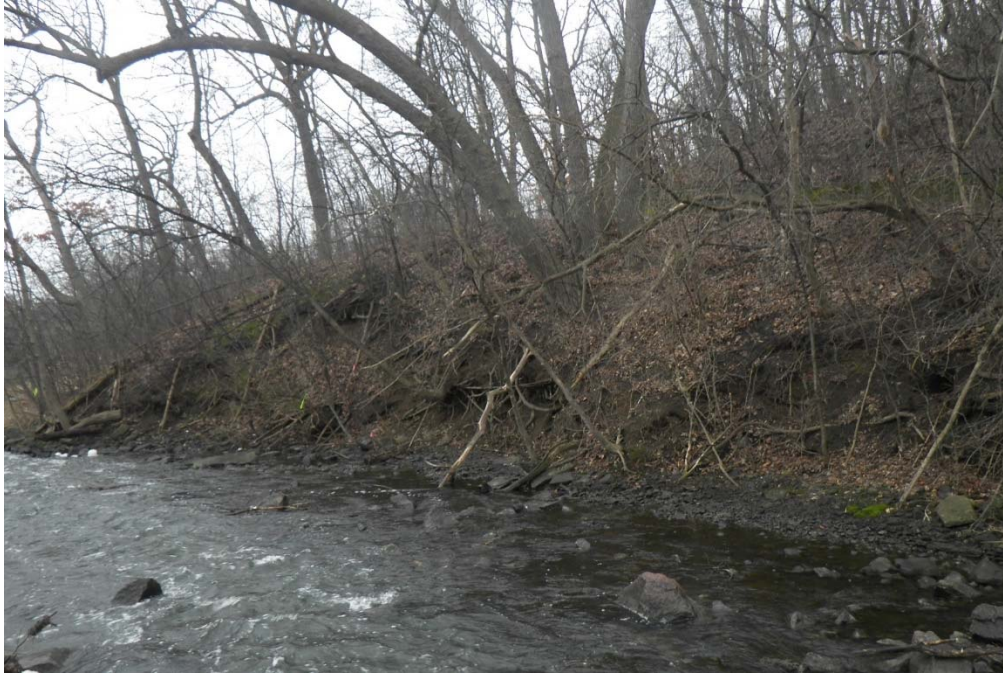
Photo 5. *Site 5.* Moderate erosion on steep bank

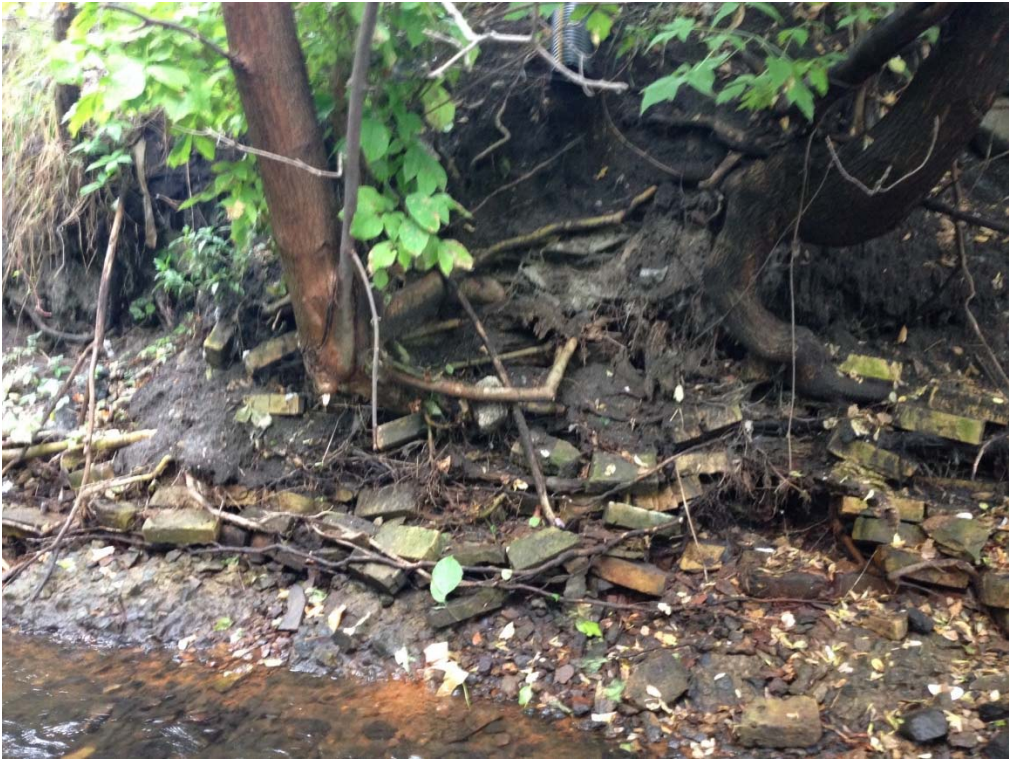
Photo 7. Site 7. Stream bed debris & non-native materials

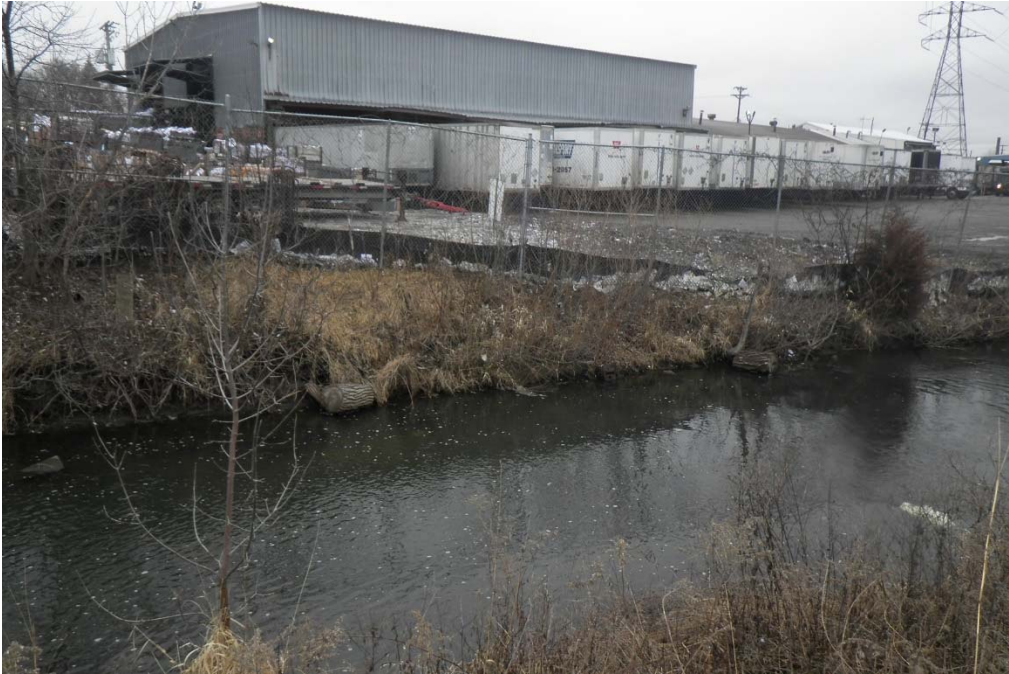
Photo 8. Site 8. Top of stream bank

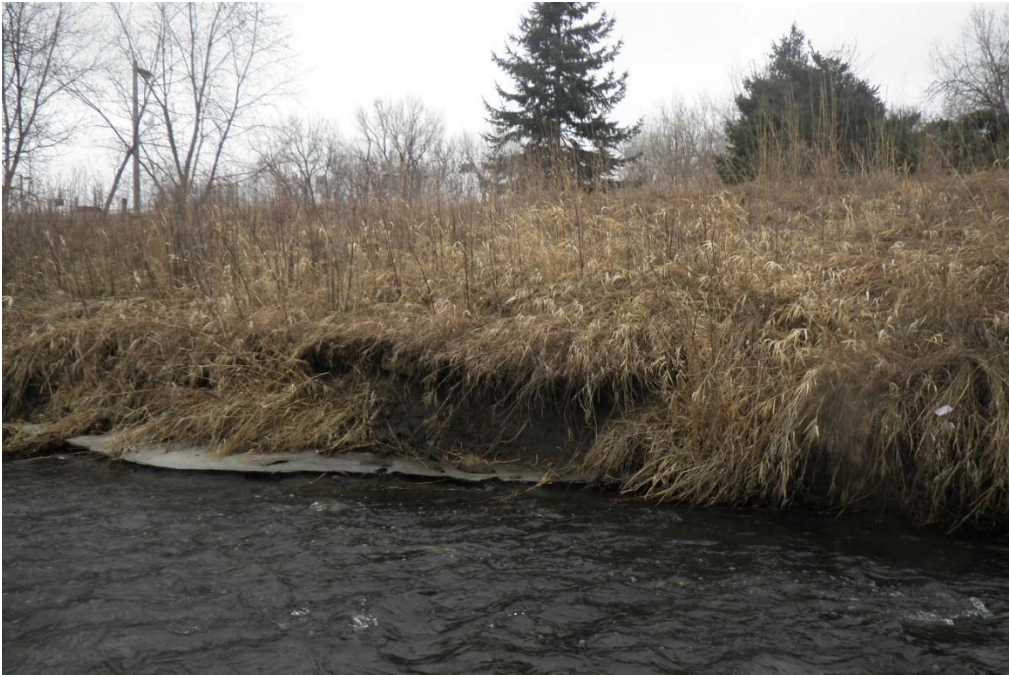
Photo 9. *Site 9.* Undercut bank

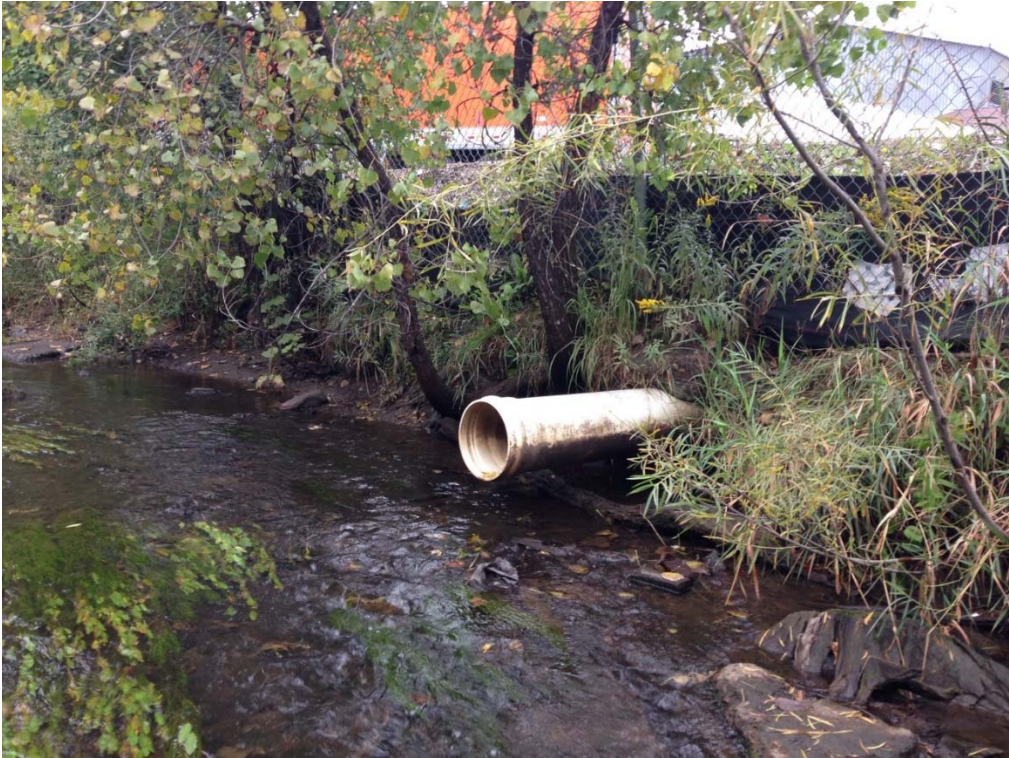
Photo 10. *Site 10.* Protruding Culvert

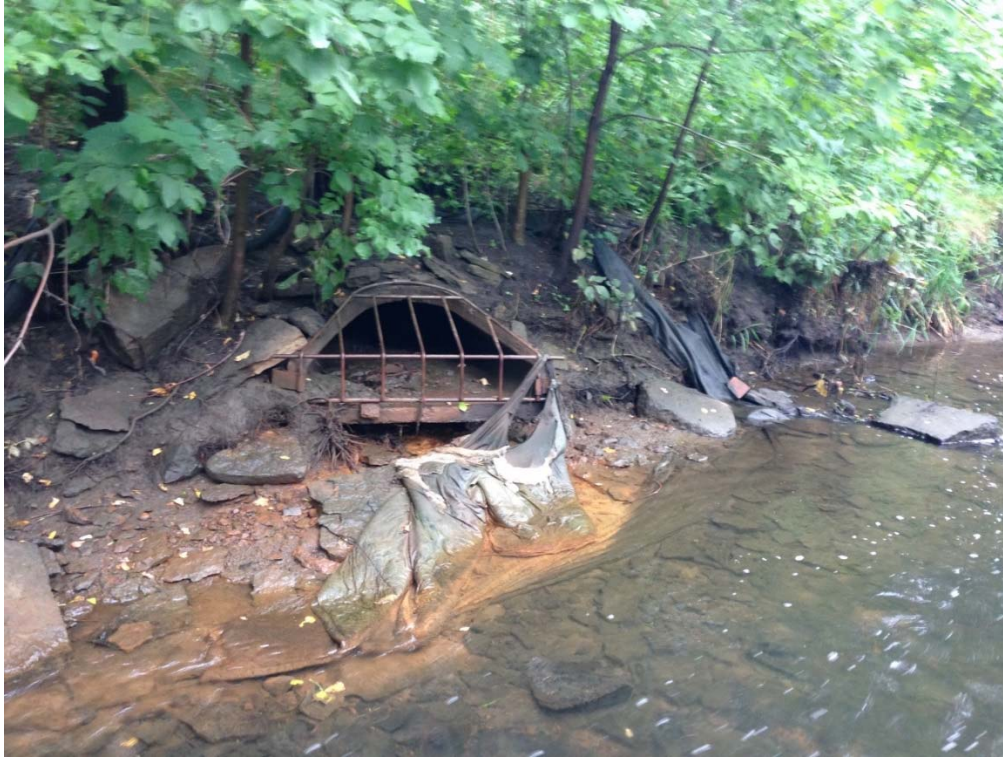
Photo 11. *Site 11.* Protruding culvert

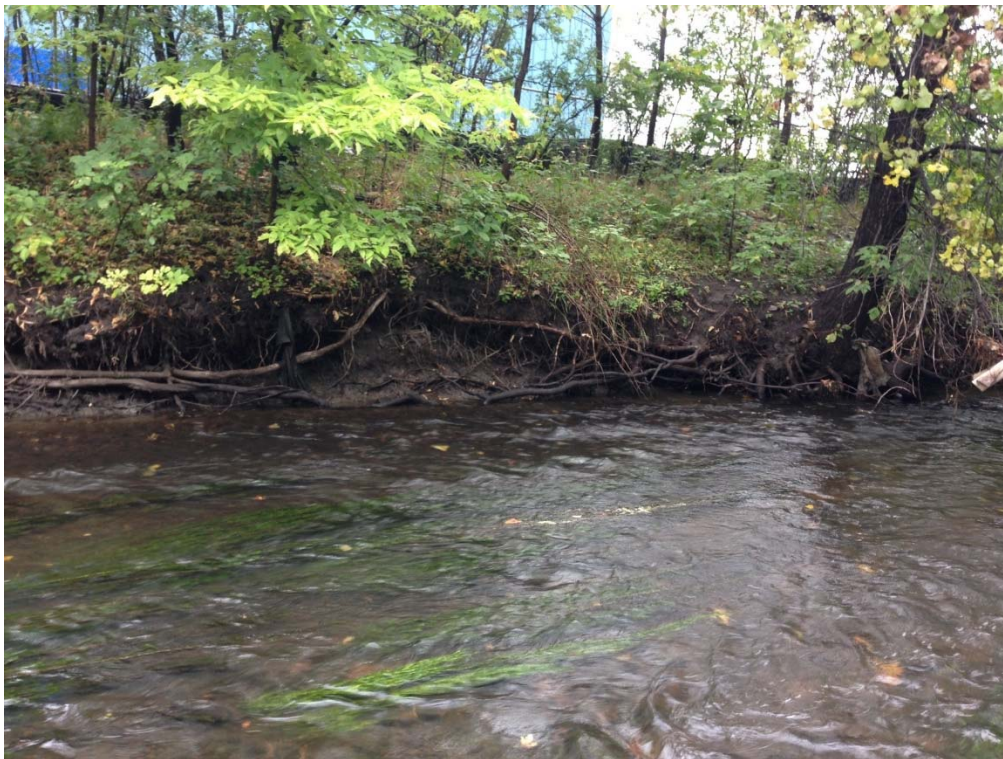
Photo 12. *Site 12.* Minor to moderate erosion on stream bank downstream of riprap

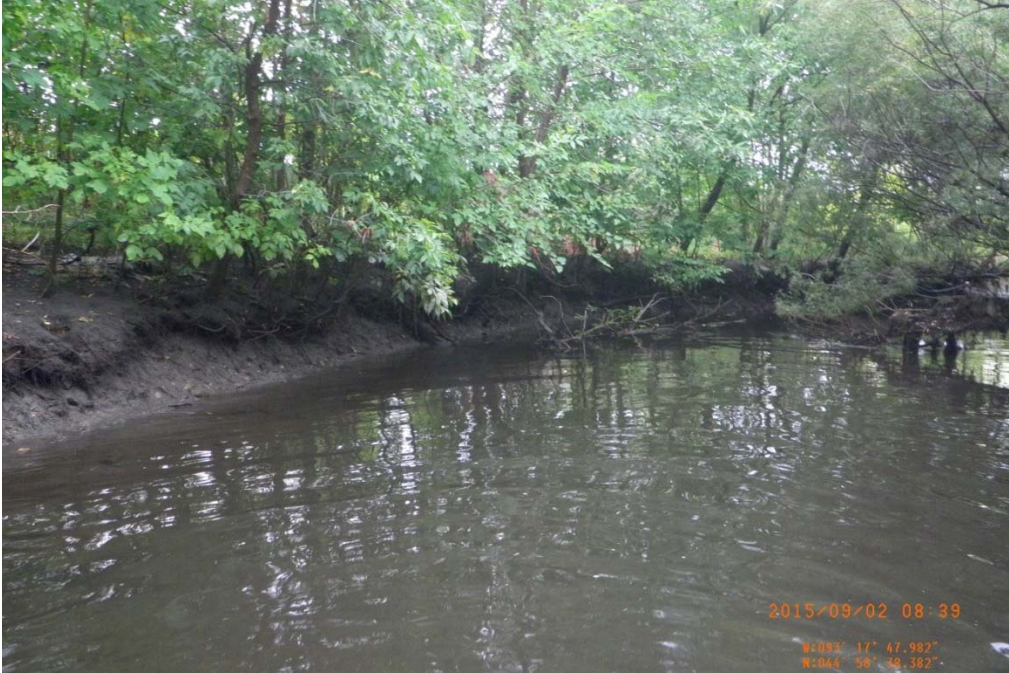
Photo 13. Site 13. Undercut bank

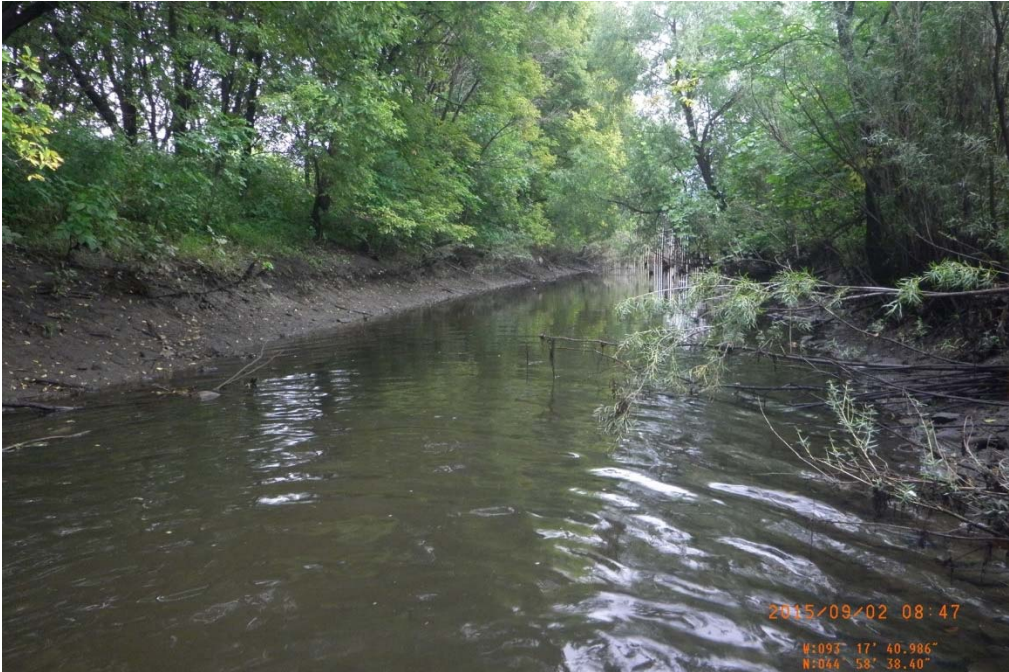
Photo 14. Site 14. Bare lower banks

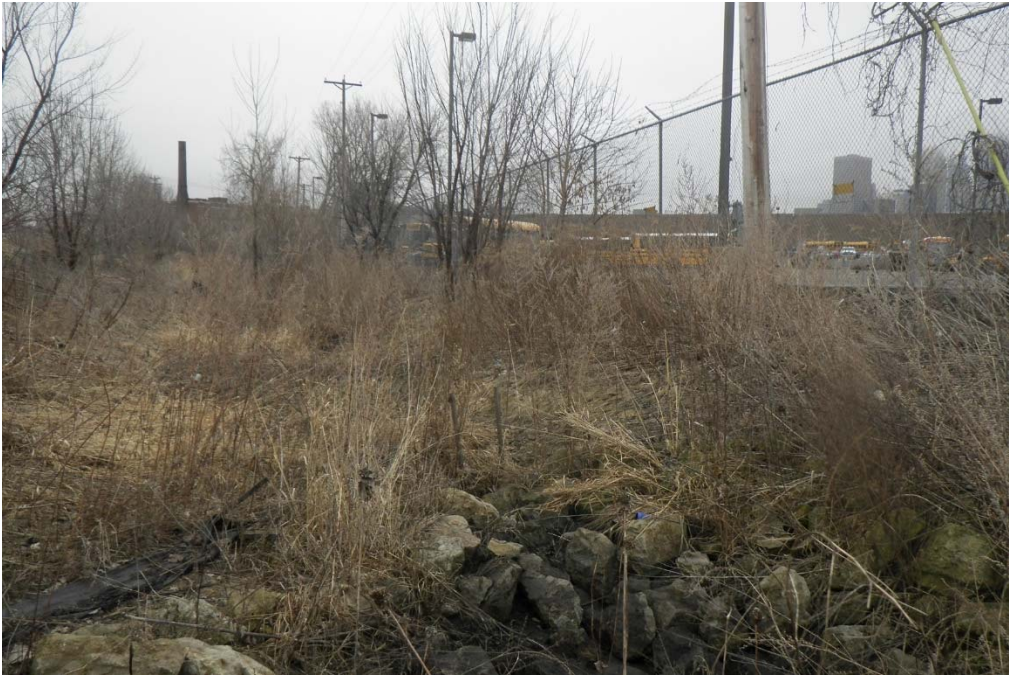
Photo 15. *Site 15.* Brush in overflow channel
