Memorandum

To: Bassett Creek Watershed Management Commission
From: Barr Engineering Co.
Subject: Bassett Creek 2017 Flood Control Project Inspection
Date: December 13, 2017
Project: 23270051.38 2017 4065

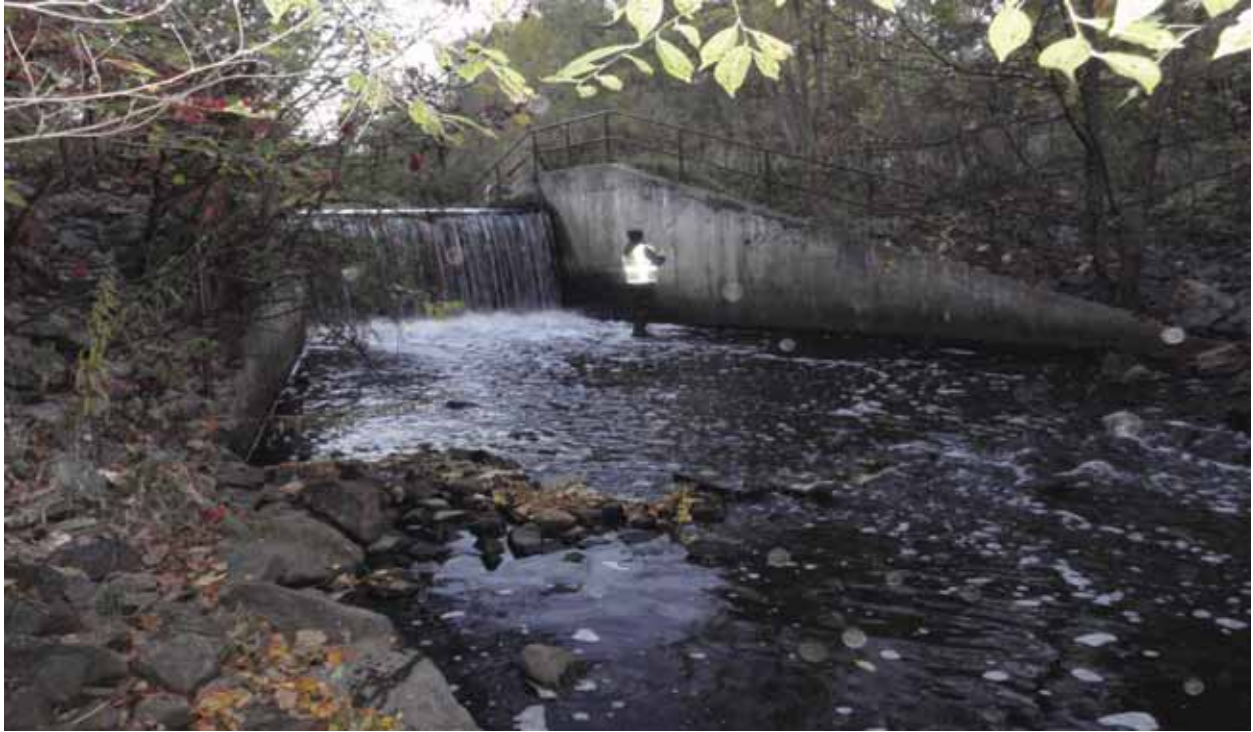
Plymouth Creek Fish Barrier (Plymouth)

- a. The water flow over the weir structure was 0.23 feet. The staff gage was at 1.35 feet.
- b. The overall condition of the structure was satisfactory and the concrete appeared to be in good condition. There are three vertical fractures in the downstream portion of the east (left) wing wall, one crack on the downstream portion of the west (right) wing wall, and some surface aggregate visible on both downstream wing walls. There is a gap in the expansion joint in the middle of the west (right) abutment wall measuring approximately $\frac{3}{4}$ inch. These observations are consistent with previous inspections.

- c. Sediment has accumulated in the pool upstream of the structure and has formed a delta/island with vegetation growing on it. The deposited sediment is generally forcing the creek to the east (left) bank, although it appears high flows may also flow along the west (right) bank.

- d. The upstream end of the railing on both sides of the structure has deteriorated due to rust below the water line and not connected to the concrete. The railing is functional but should be repaired.

- e. Some riprap on the west (right) slope downstream of the structure has slid, exposing the filter fabric underlayment. This observation is consistent with previous inspections. The downstream slopes appear generally stable and vegetation has established on both sides.

- Remove accumulation of sediment from upstream pool (coordination with MPCA and DNR will be necessary). We understand the MPCA did not support or permit sediment removal during the 2010 channel restoration project.
- Repair metal railings on both sides of the structure.
- Monitor west downstream slope and replace riprap, as necessary.
- Monitor concrete cracks, fractures, and width of joint opening during future inspections.

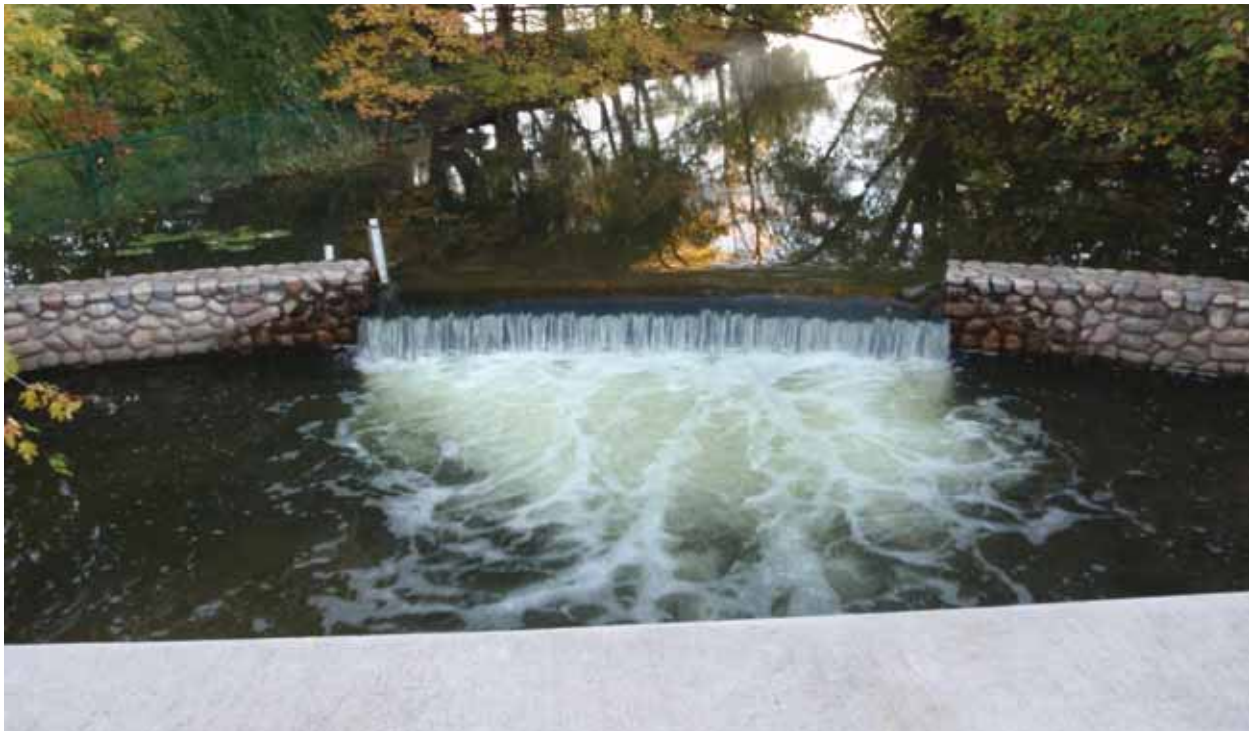
Medicine Lake Outlet (Plymouth)

- a. The overall condition of the structure was satisfactory and the concrete appeared to be in good condition.

- b. The channel between the lake and the dam was full and water was flowing 0.67 feet over the weir. The staff gage was at 1.20 feet.
- c. Upstream of the outlet structure, the east (left) bank contains a large tree, partially under an existing chain link fence, that is leaning away from the channel and exposing soil and roots. If the tree falls, it will leave a void in the bank. This observation is consistent with previous inspections.
- d. Runoff from the road has caused some minor erosion around the east (left) end of the dam where the dam ties into the east (left) bank of the creek. This observation is consistent with previous inspections.
- e. Private green chain link fence on west end of structure is damaged and missing top rail. This observation is consistent with previous inspections.

- Remove large tree upstream of the outlet structure the tree that is falling over on the east bank along with the root ball, stabilize the bank, and replace the chain link fence.
- Monitor erosion around the east (left) end of the weir.

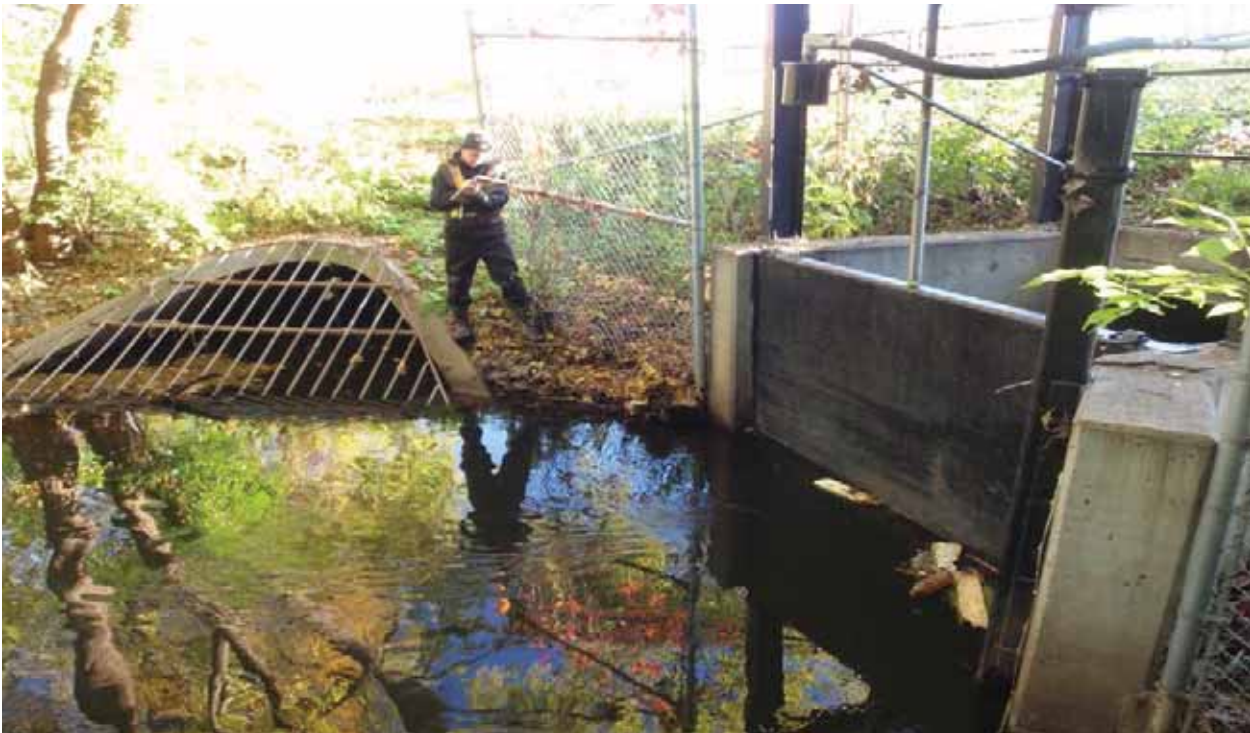
Wisconsin Ave. Control Structure (Golden Valley)

- a. The overall condition of the structure was satisfactory.
- b. The staff gage was at 881.7 feet both upstream and downstream of the culvert.
- c. The flood gate was in the down-position at the time of the inspection. Minor rust and some peeling paint on the bottom of the flood gate was observed in previous inspections, however the bottom of the flood gate was under water during this year's inspection and could not be evaluated.
- d. The culvert appears to have settled approximately 3-4 inches directly under Wisconsin Avenue. Some minor longitudinal and circumferential cracks were observed in the culvert during the inspection. These observations are consistent with previous inspections.
- e. Some of the gabion baskets upstream and downstream of the culverts have deteriorated or broken and riprap has fallen out of the baskets at some locations. Although the gabion baskets

are no longer functioning as installed, no significant erosion was observed. This observation is consistent with previous inspections.

- f. The railings at the upstream and downstream ends of the culvert are in good condition.
- g. Small trees and brush are growing around the downstream end of the culvert.

- Cut and remove trees and brush near culvert ends. Chemically treat stumps with Garlon 3A herbicide (or other specialty herbicide for use in wetland sites and waterways) to prevent regrowth.
- Sand, prime and paint lower portion of gate and other steel members, as necessary.
- Monitor gabion baskets and potential erosion during future inspections.

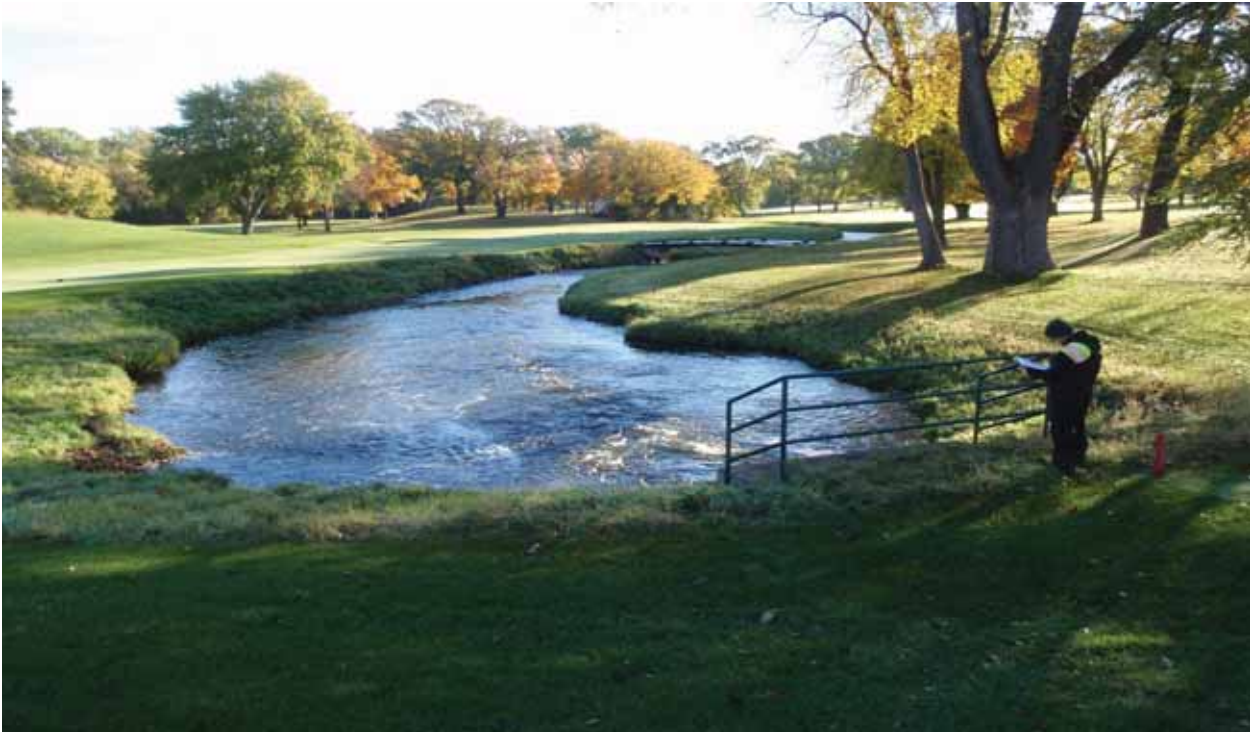
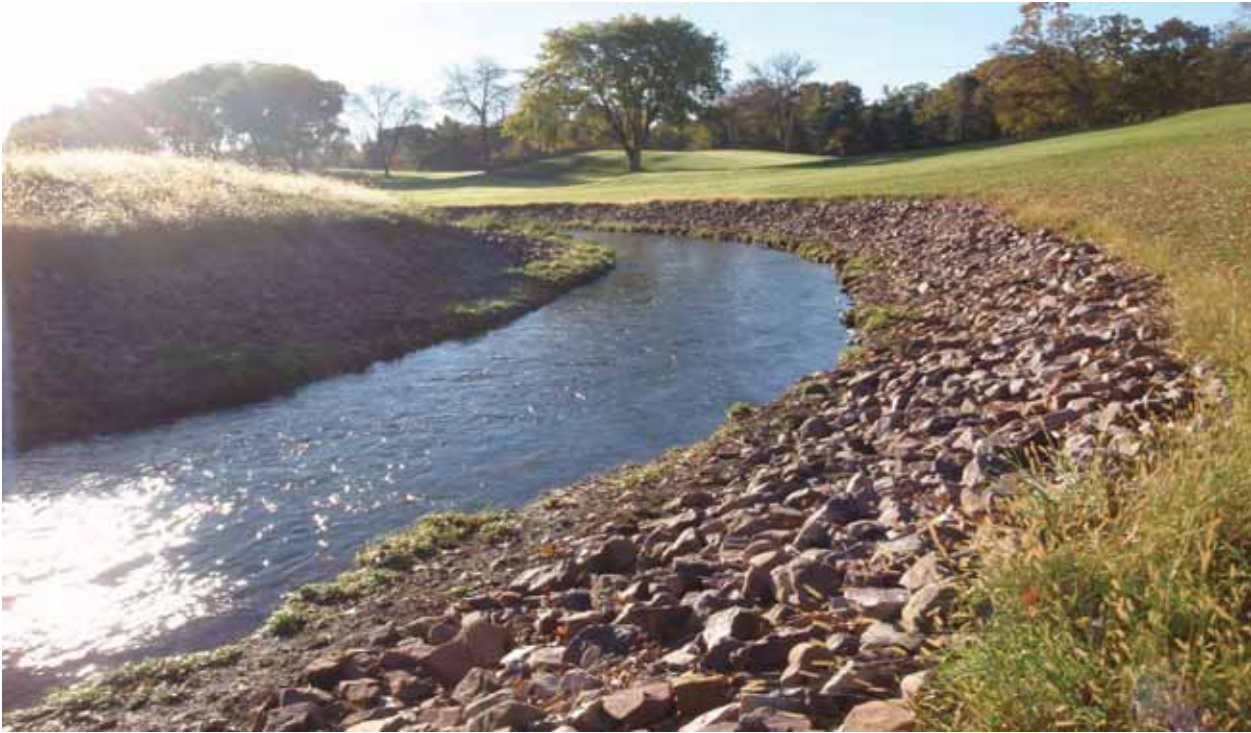
- a. The channel from Pennsylvania Avenue to downstream of the box culvert was satisfactory. Some erosion was noted on the left bank just downstream of the culvert under Pennsylvania Ave. Riprap is generally in place along the channel, although some riprap has collected in the channel bottom. Weeds and grass that have grown in the riprap in the lower part of the channel have been mowed by golf course maintenance staff. No debris, trees or brush have accumulated in the channel.
- b. The box culvert structure was satisfactory. No debris was found around the structure to obstruct the flow. The box culvert was not inspected this year due to high water flow.
- c. The handrails at each end of the box culvert appeared to be in good condition.
- d. The overflow weir (earth berm) was in good condition and has been maintained by the country club staff as manicured fairway turf.

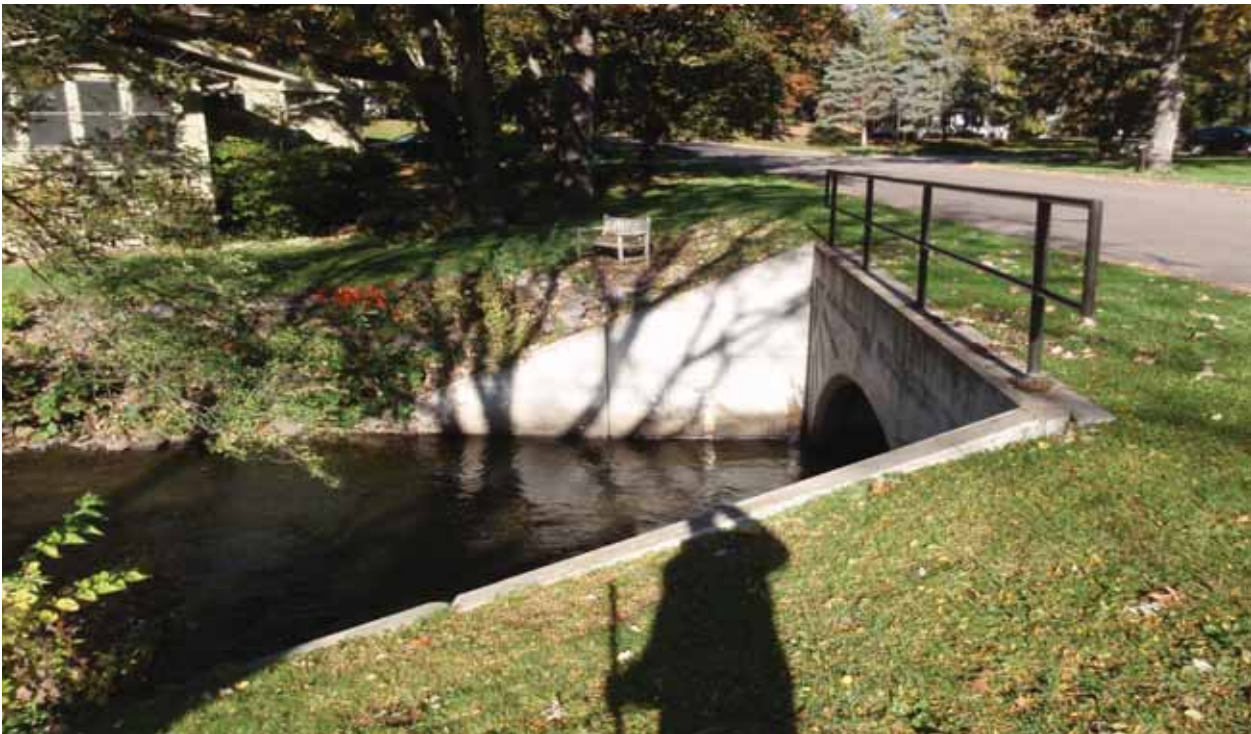
Westbrook Road Crossing (Golden Valley)

- a. The overall condition of the structure was satisfactory.
- b. There is some exposed rebar around the storm sewer pipe entering the Bebo culvert on the west (left) side. This observation is consistent with previous inspections.
- c. The last Bebo culvert section on the downstream end has separated at the top of the section. The joint gap appears to be wider between the last two sections and there are signs of pressure points

where the last section has pushed against the top of the two wing walls. Some concrete has fractured and fallen from the structure. These observations are consistent with previous inspections.

- d. There is some spalled concrete at multiple locations at the top of the wing wall sections upstream and downstream of the Bebo culvert and in one location near a railing connection on the downstream side. These observations are consistent with previous inspections.
- e. There are some minor cracks in the top of the Bebo culvert throughout the culvert. This observation is consistent with previous inspections.

- Repair/patch exposed rebar at storm sewer connection entering Bebo section on west (left) side of culvert. Place grout or mortar over exposed rebar to form better seal.
- Monitor cracks in the Bebo arch sections and the road surface during future inspections.
- Monitor spalling on top of the concrete headwall near wing walls and railing connections.

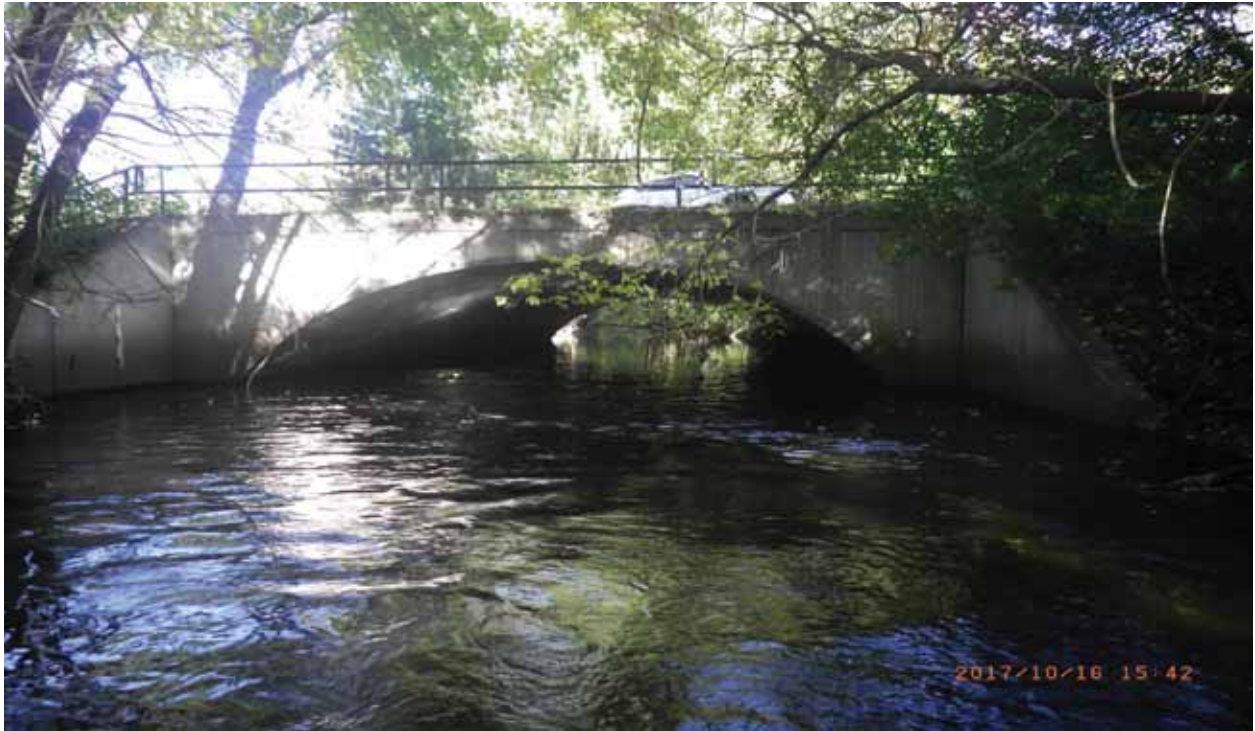
Regent Ave. Crossing (Golden Valley)

- a. The overall condition of the structure was satisfactory.
- b. The interior of the Bebo culvert was not fully inspected due to high water levels.
- c. Cracks were observed throughout the crown of the Bebo culvert. This is consistent with previous inspections.

- d. Some scour/erosion was observed around the end of the north (left) downstream bank and at the upstream south (right) wing wall. The riprap is missing and the filter fabric is exposed on the upstream south (right) end of the culvert.

- e. The top of the upstream north (left) wing wall has minor spalling along end section joint. This is consistent with previous inspections.
- f. There is a diagonal crack near the top of the upstream north (left) wing wall. This is consistent with previous inspections.

- g. There is a diagonal crack near the top of the downstream south (right) wing wall. This is consistent with previous inspections.
- h. Some small trees are growing around the upstream and downstream side of the structure, along the concrete wing walls.

- Repair erosion at upstream south (right) wing wall by adding new fabric/filter and riprap on creek bank.
- Cut and remove trees and brush near culvert ends. Chemically treat stumps with Garlon 3A herbicide (or other specialty herbicide for use in wetland sites and waterways) to prevent regrowth.
- Monitor bank erosion at downstream north (left) wing wall and consider repair of bank with riprap.
- Monitor bed elevation at upstream end of culvert for possible scouring.

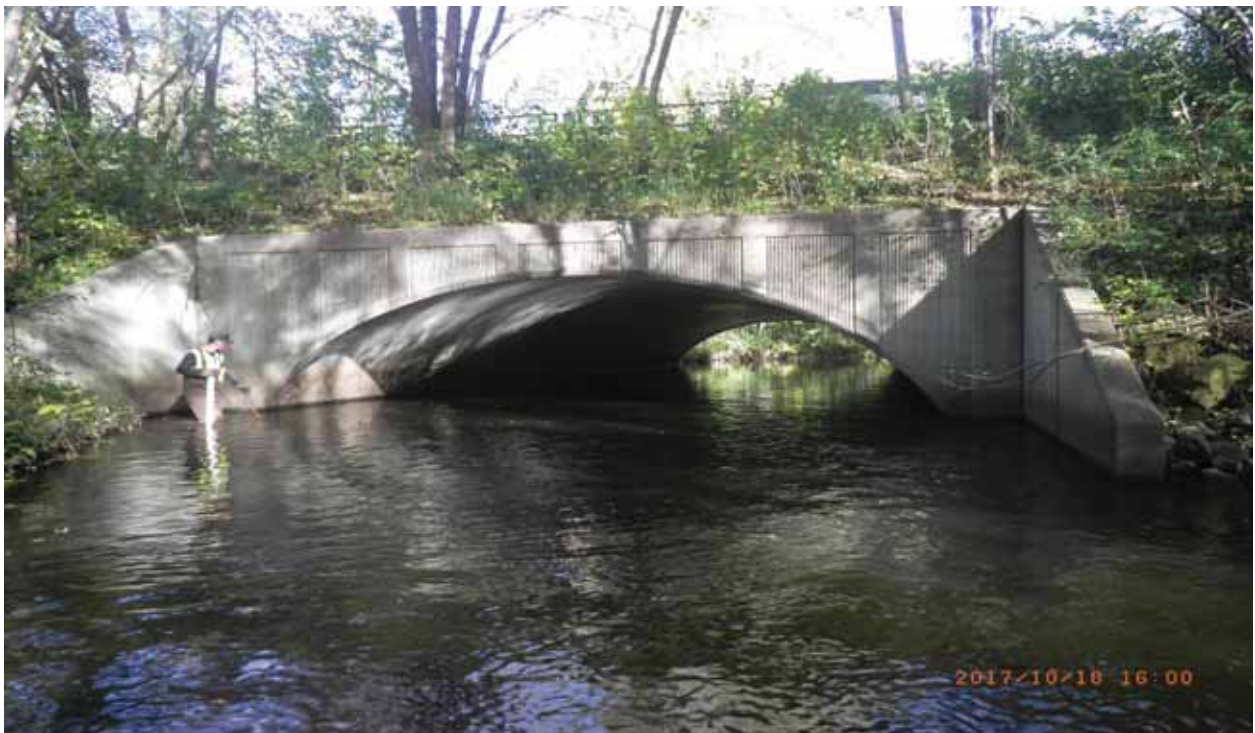
Noble Ave. Crossing (Golden Valley)

- a. The overall condition of the structure was satisfactory.
- b. Cracks were observed throughout the crown of the Bebo culvert. This is consistent with previous inspections.

- c. Previously observed spalling has exposed some plastic joint material in some of the culvert sections near the downstream end and along the cracks approximately two feet either side of center. The cement paste covering the plastic joint material is separating and exposing the plastic. This is consistent with previous inspections.

- d. The downstream south (right) wing wall is tilted toward creek. This is consistent with previous inspections.
- e. Spalled concrete and cracking was observed at the top of the north (left) downstream wing wall. This is consistent with previous inspections.

- f. Erosion has occurred along the outside edge of the upstream south (right) wing wall and the filter fabric is exposed. This may, in part, because the creek is entering the Bebo arch culvert at an angle. This observation is consistent with previous inspections.

- g. Bank erosion has occurred on both sides of the downstream wing walls. This is consistent with previous inspections.
- h. Storm sewer pipe on the north (left) side entering the Bebo arch under the road has spalled concrete and exposed rebar. This is consistent with previous inspections.

- i. The paint on the hand rails is chipping and coming off in a number of locations.

- Repair/patch storm sewer connection entering Bebo section on north side of culvert.
- Repair erosion at upstream wing wall by adding riprap.
- Monitor cracks, spalling and scour during future inspections, especially at the downstream left wing wall.
- Monitor erosion at downstream wing walls.
- Monitor cracks in crown exposing plastic expansion material to determine if spalling is from weathering or movement of the Bebo sections.
- Monitor bed elevation at upstream end of culvert for possible scouring.

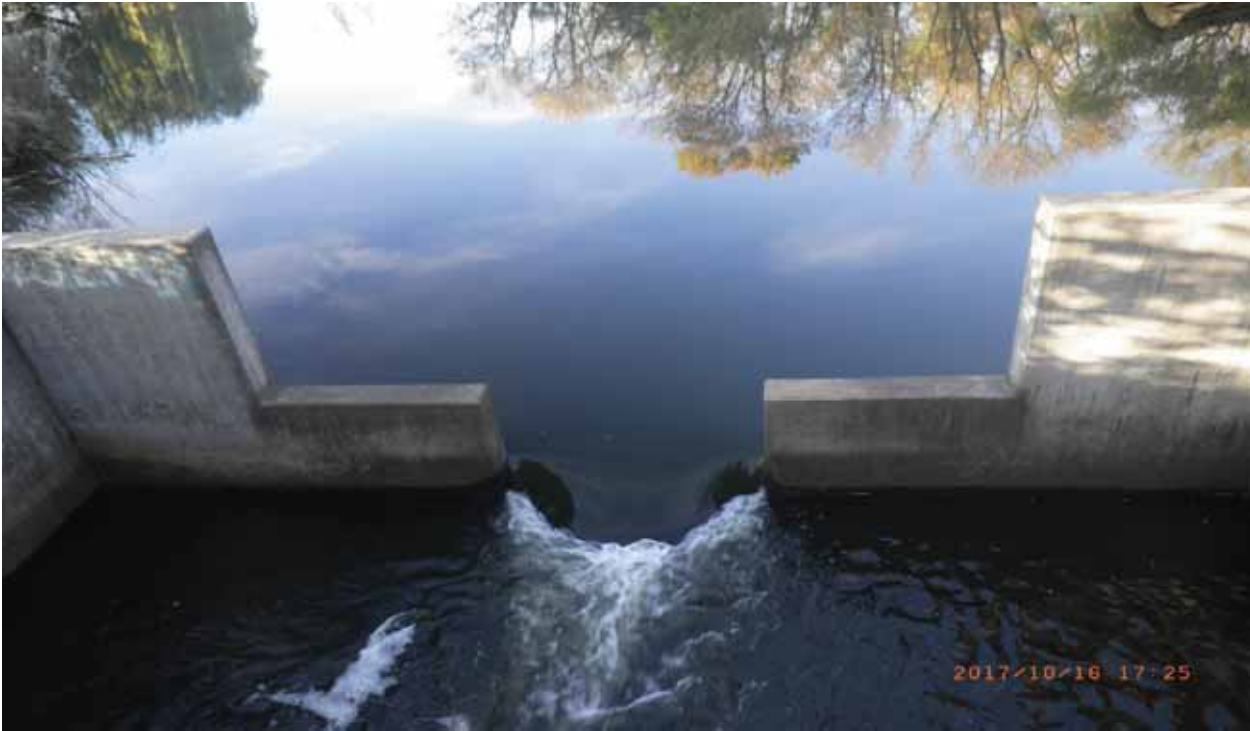
Highway 55 Control Structure (Golden Valley/Minneapolis)

- a. The overall condition of the structure was satisfactory.
- b. Erosion was observed around both the east and west sides of the structure from water flowing along the sides of the structure that runs off the bituminous path from above the structure. The erosion on the east side is more significant and appears to be worsening. Some gravel was dumped off the trail down the east side along the structure wall in previous years, but the gravel has not stopped the erosion.
- c. There is a small crack in the left wall of the inlet structure. The crack is positioned in the middle of the wall extending full height. This is consistent with previous inspections.

- Add riprap and filter to each side of the structure.
- Monitor cracks and erosion during future inspections.

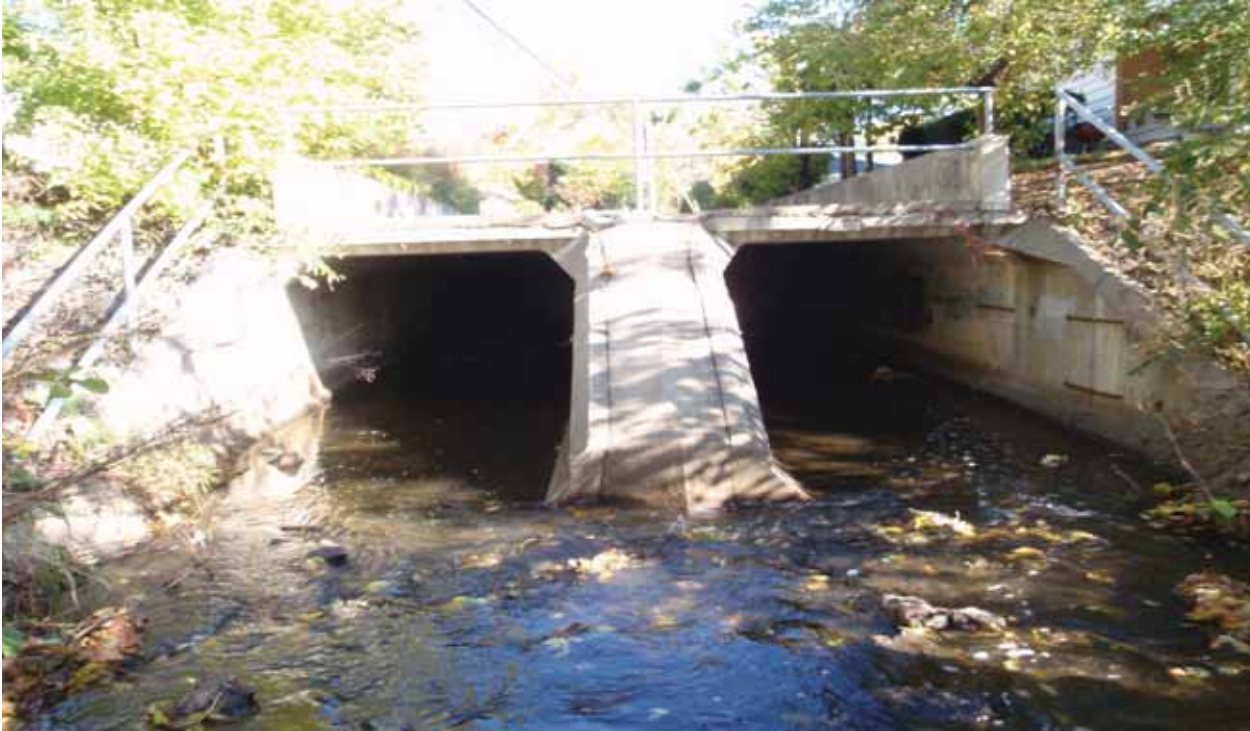
Markwood Box Culverts and Channel Improvements (36th Ave. and Hampshire Ave. Crossing - Crystal)

- a. The overall condition of the structure was satisfactory.
- b. Some riprap was observed in the box culverts. Riprap was most prevalent before the first bend of the culverts, but present throughout the culvert. Both culverts have some sediment buildup mostly in the downstream half of the culvert. The south (right) culvert has more sediment than the north (left) culvert.
- c. There is a crack in the top right of the south (right) culvert. This is consistent with previous inspections.
- d. On both culverts, the fifth joint from the downstream end had a 2 ½ inch gap, which is a larger gap than the rest of the joints. This is consistent with previous inspections and does not appear to be worsening.
- e. Natural boulder riprap in the channel downstream of the culverts appears undersized and has been redistributed somewhat by high flows. This is consistent with previous inspections.

- Monitor cracks and joint gaps during future inspections.
- Monitor sediment and riprap buildup in the culverts.

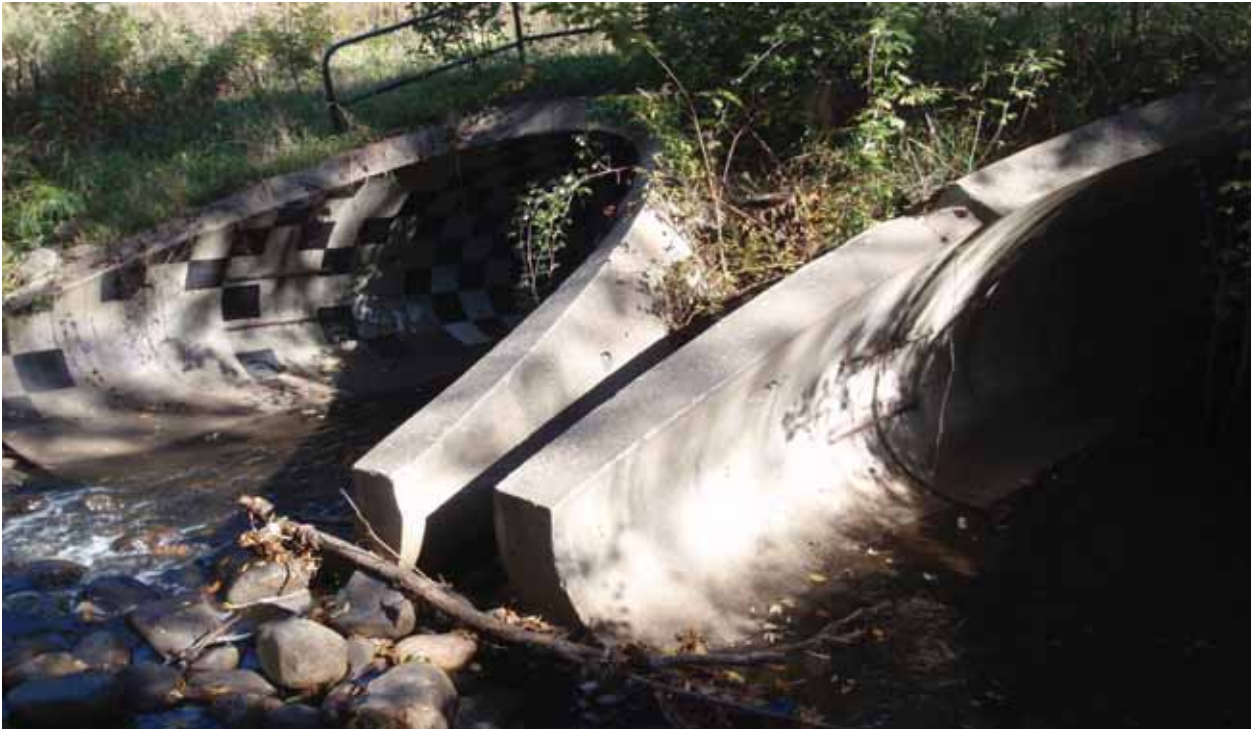
Georgia Ave. Crossing (Crystal)

- a. The overall condition of the two culverts was satisfactory.
- b. The riprap on the downstream end appears undersized and has been redistributed somewhat by high flows. This is consistent with previous inspections.
- c. Some small trees are growing around upstream and downstream ends of the culverts.

- Remove trees near culvert ends, as necessary. Chemically treat stumps with Garlon 3A herbicide (or other specialty herbicide for use in wetland sites and waterways) to prevent regrowth.

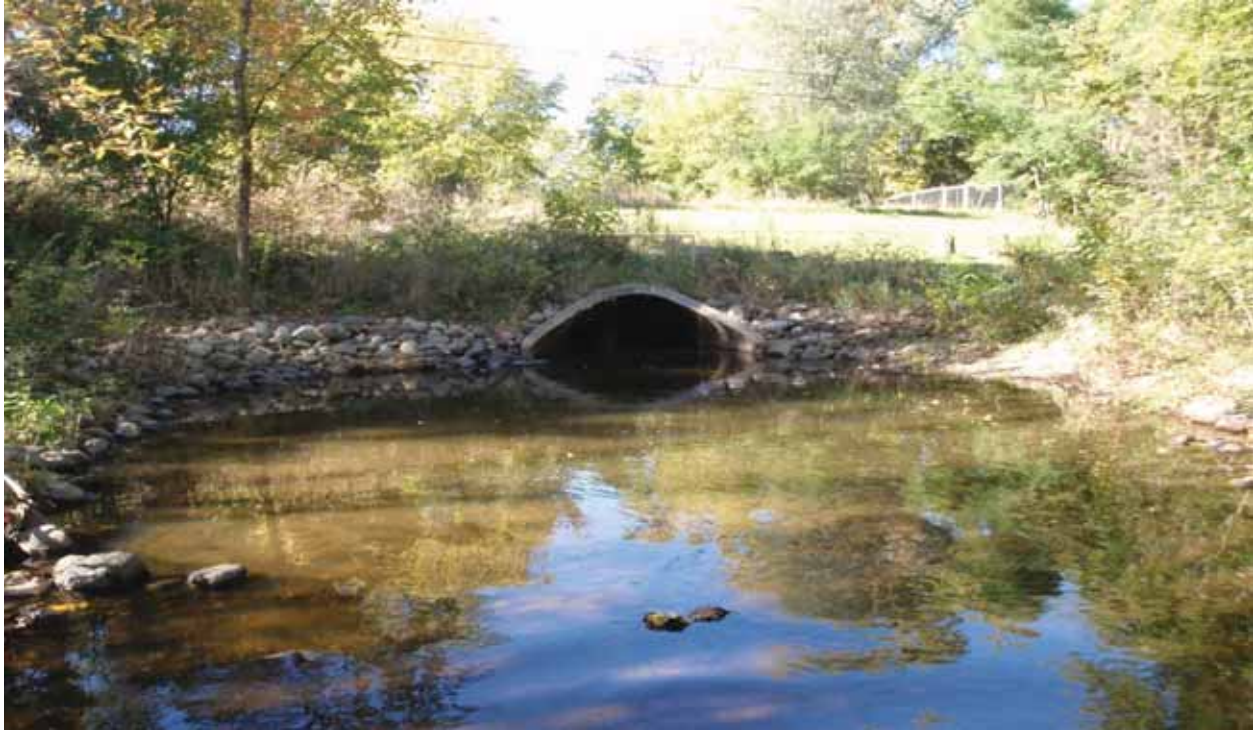
Edgewood Embankment and Ponding Area (Crystal)

- a. The overall condition of the culvert and embankment was satisfactory.
- b. There is a small amount of erosion on the upstream north (left) side of the culvert at the embankment. This is consistent with previous inspections.
- c. There is no visible settlement along the embankment.
- d. The pool on the downstream side of the culvert and the downstream creek banks were repaired and new natural boulder riprap was installed in 2014. These areas appear to be in good condition.

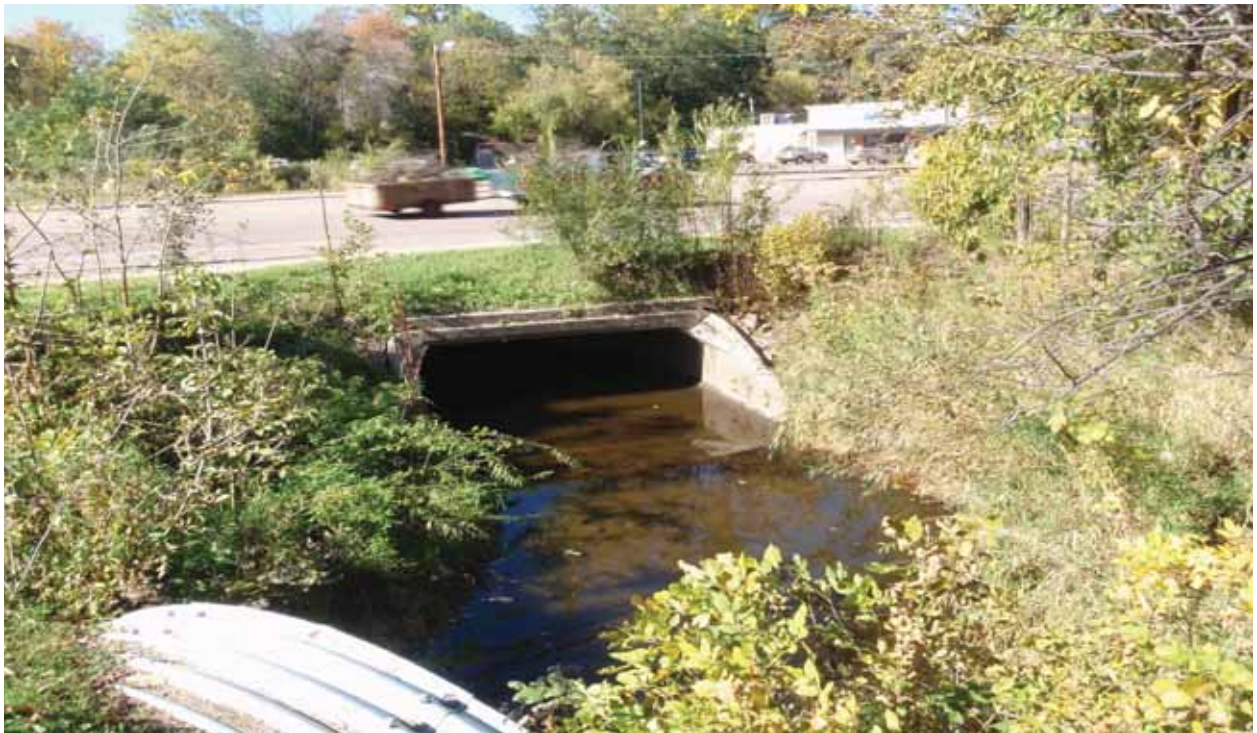
Douglas Drive Crossing (Crystal)

- a. The overall condition of the structure was satisfactory.
- b. Grouted riprap installed on either side of the box culvert outlet has started to deteriorate, and a gap has opened between the grout and the wall of the box culvert.

- Monitor grouted riprap at the downstream end of the box culvert.

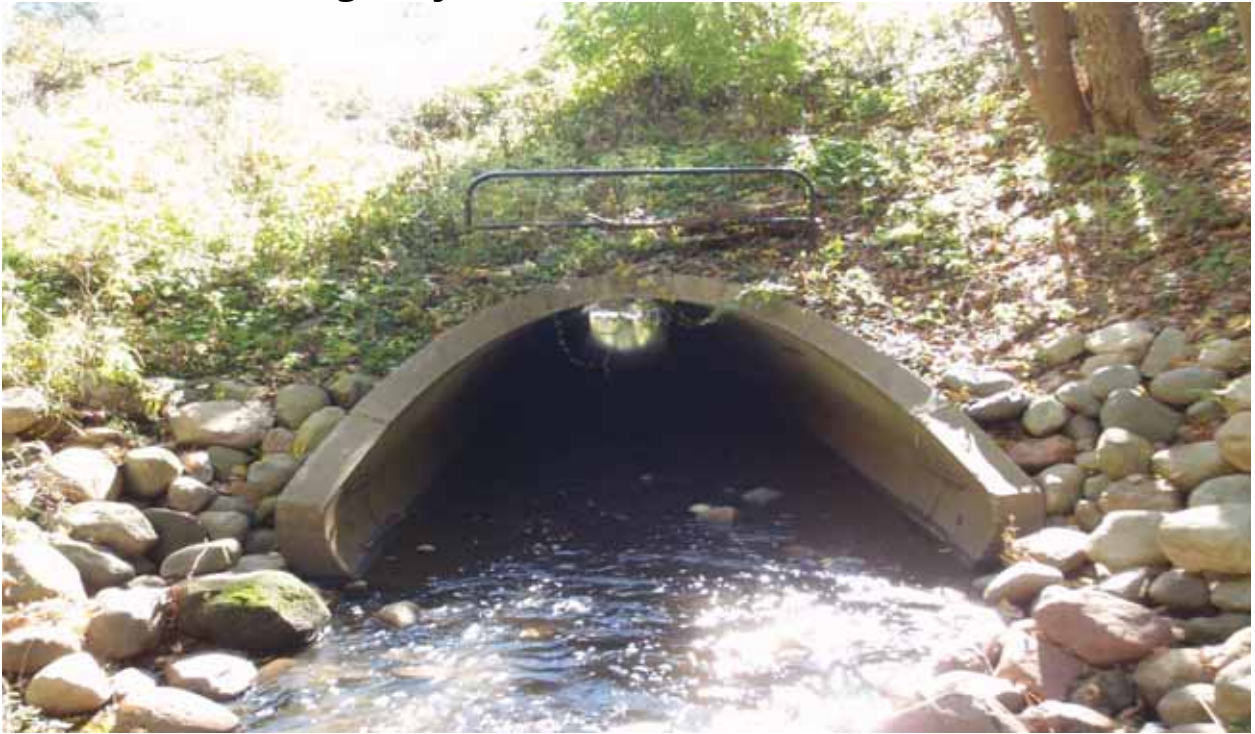
34th Ave. Crossing (Crystal)

- a. The overall condition of the structure was satisfactory.
- b. The natural boulder riprap upstream and downstream of the culvert was generally in good condition. Some riprap from the upstream end has washed into the culvert.
- c. The invert of the culvert generally has 2-6 inches of accumulated sediment with some areas as deep as 12 inches.
- d. The tie rods are rusty and flaking near the center section of the culvert. This is consistent with previous inspections.

- Monitor sediment accumulation in culvert.

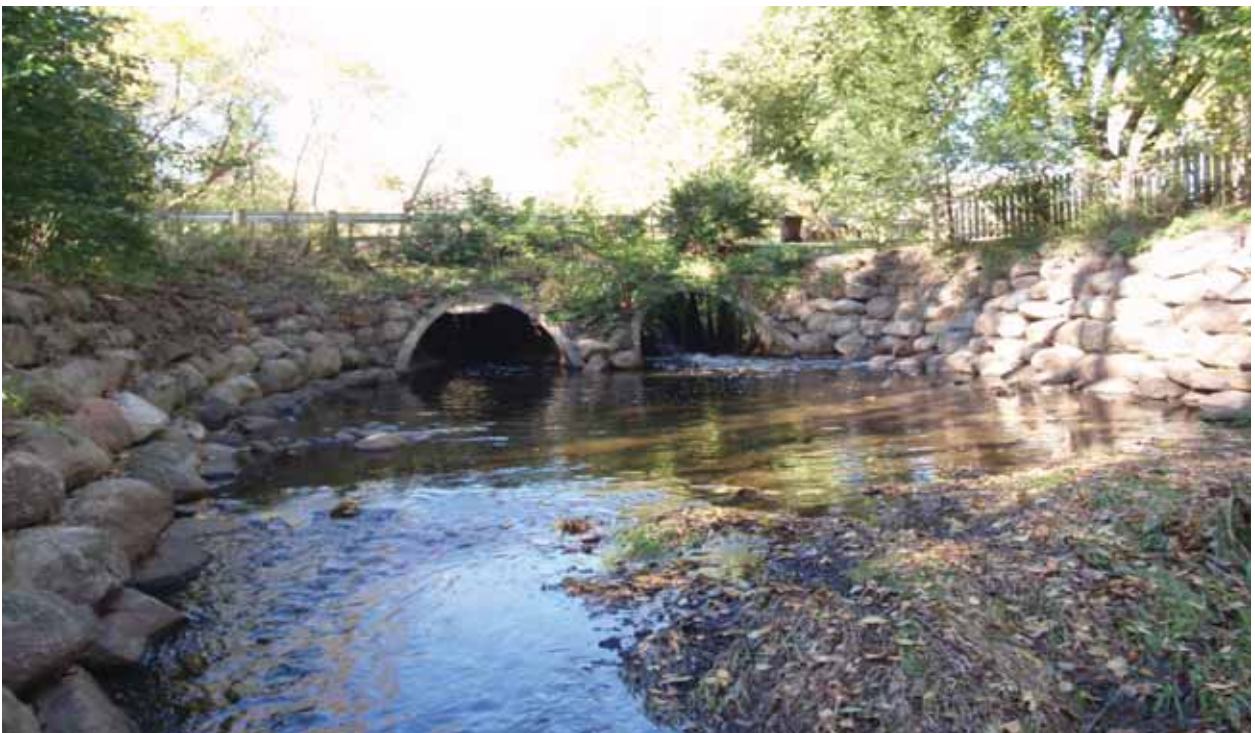
Brunswick Ave. Crossing (Crystal)

- a. The overall condition of the structure appeared satisfactory.
- b. There is spalled concrete on both sides of the downstream end of the south (right) culvert with exposed rebar.

- c. On the south culvert, the fourth pipe joint from the downstream side, and the location of the slope transition, has two broken ties and was previously re-grouted by the City. There is now a gap between the pipe joint and the new grout.

- d. There are a number of joints that were cracking or spalling. Some of the grout that was placed to fill the separating joints has started to detach due to joint movement and is falling out. On the south culvert, the third joint from the downstream side, there is a crack on the bell end of the pipe, which extends across the top of the pipe.

- e. There are cracks in the pavement over the culverts. There appeared to be an additional crack observed during the inspection, which was not present in previous inspections.

- f. There are small and medium-sized trees growing near the upstream and downstream ends of the culvert. There is also a willow tree growing in a sediment delta just downstream.

- Repair or replace pipe ties, weld new rods on pipe ties.
- Remove small and medium sized trees growing near upstream and downstream ends of the culvert, and in the channel downstream. Chemically treat stumps with Garlon 3A herbicide (or other specialty herbicide for use in wetland sites and waterways) to prevent regrowth.

- Monitor concrete pipe joints condition during future inspections.
- Monitor cracks in the pavement.

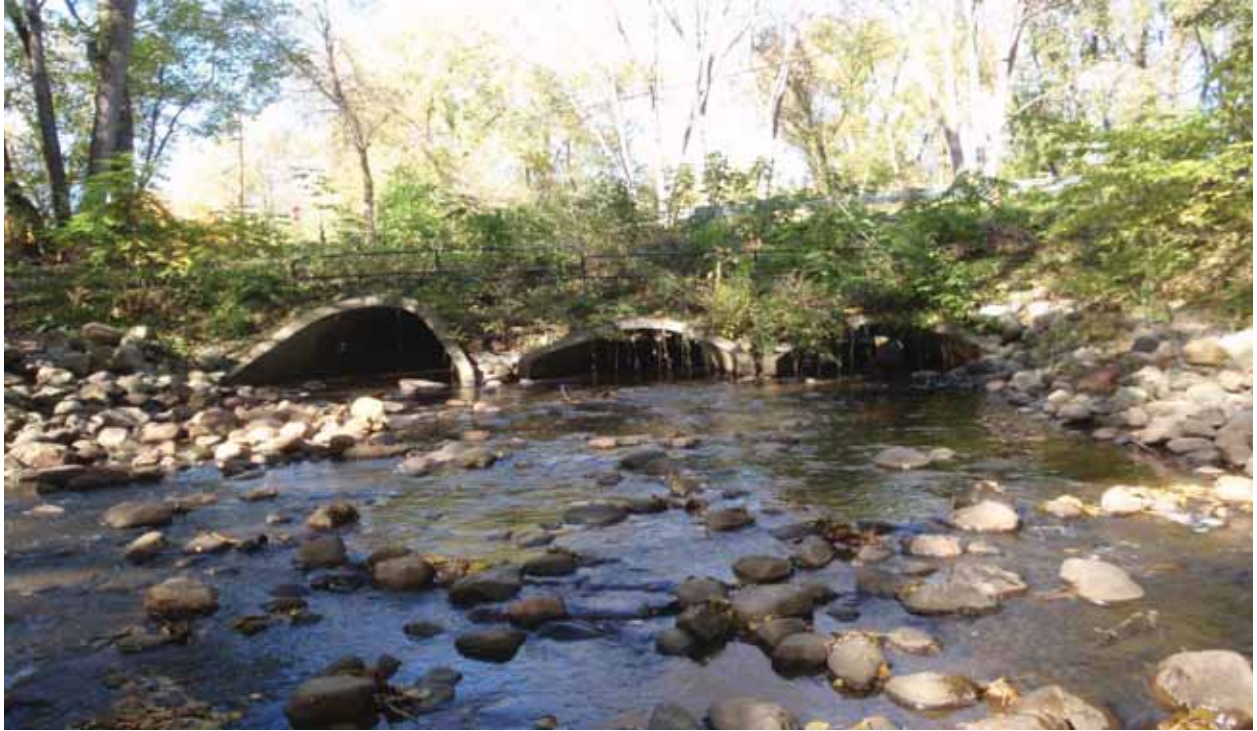
32nd Ave. Crossing (Crystal)

- a. The overall condition of the structure was satisfactory.
- b. The natural boulder riprap upstream and downstream of the culvert was generally in good condition. Some riprap on the downstream end has been displaced by high flows.
- c. Brush was cleared on the upstream and downstream sides of the culvert in 2015. Some brush has started growing back in both locations.

- Remove brush growing near the upstream and downstream ends of the culvert as part of continued maintenance. Chemically treat with Garlon 3A herbicide (or other specialty herbicide for use in wetland sites and waterways) to prevent regrowth.

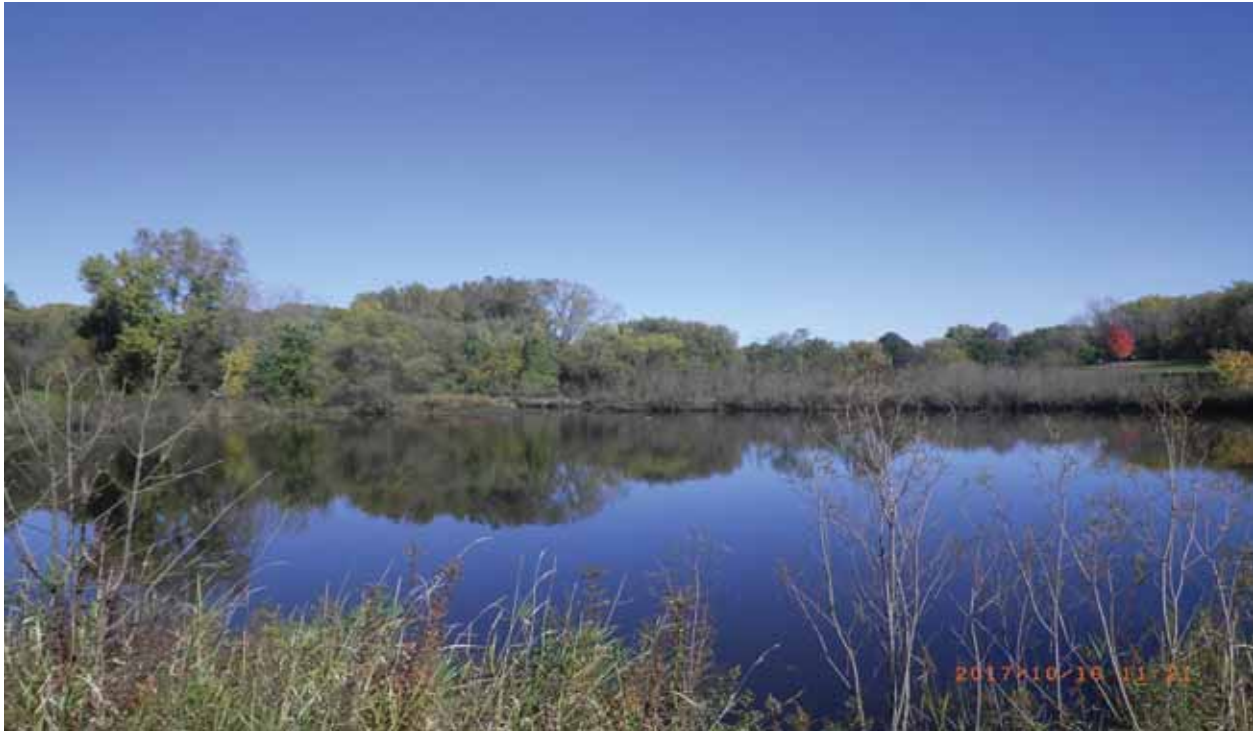
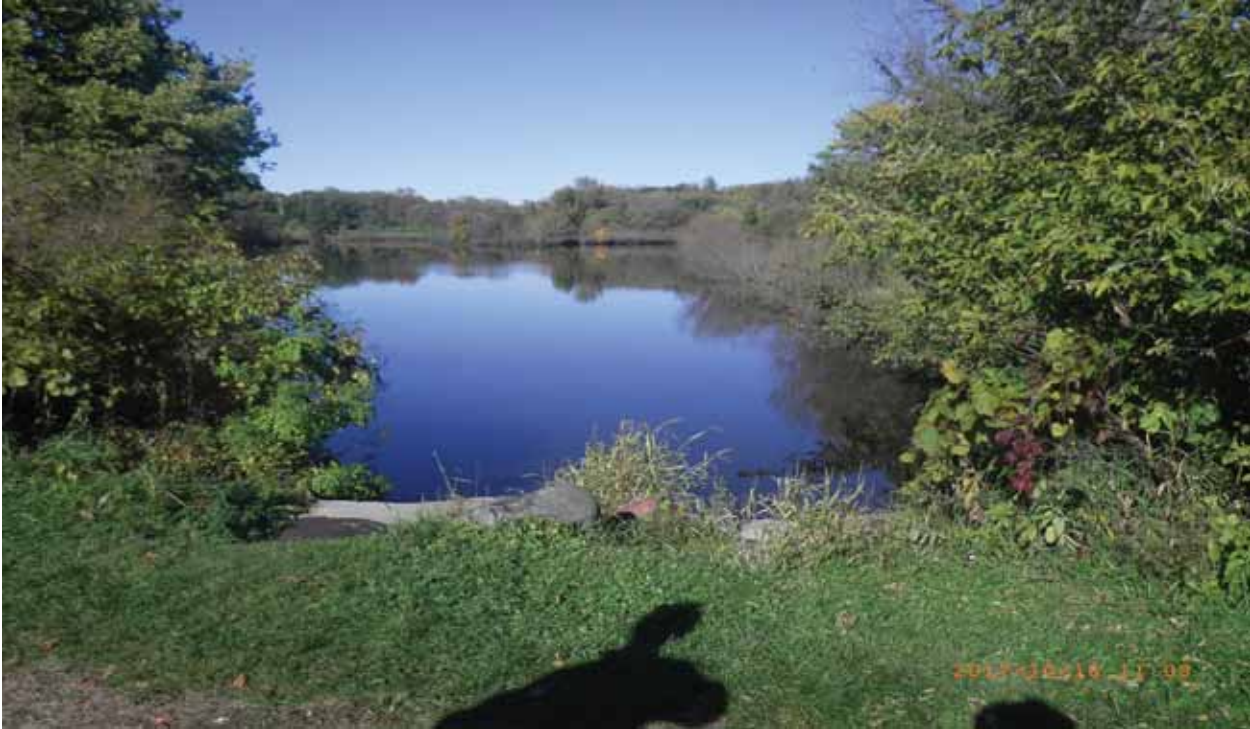
- a. The overall condition of the outlet pipes was satisfactory.
- b. The creek stabilization along the reach where the pond outlet culvert discharges to Bassett Creek is in good condition.
- c. There is a large amount of sediment that has accumulated in the northwest corner of the pond where the creek enters the pond; small and large trees, brush and vegetation is growing in these areas on the sediment deltas. This is consistent with previous inspections.
- d. Most of the shoreline of the pond was in good condition. Previously noted locations on the south side of the pond, near the outlet pipes, where some bank erosion was observed were well vegetated during this year's inspection.

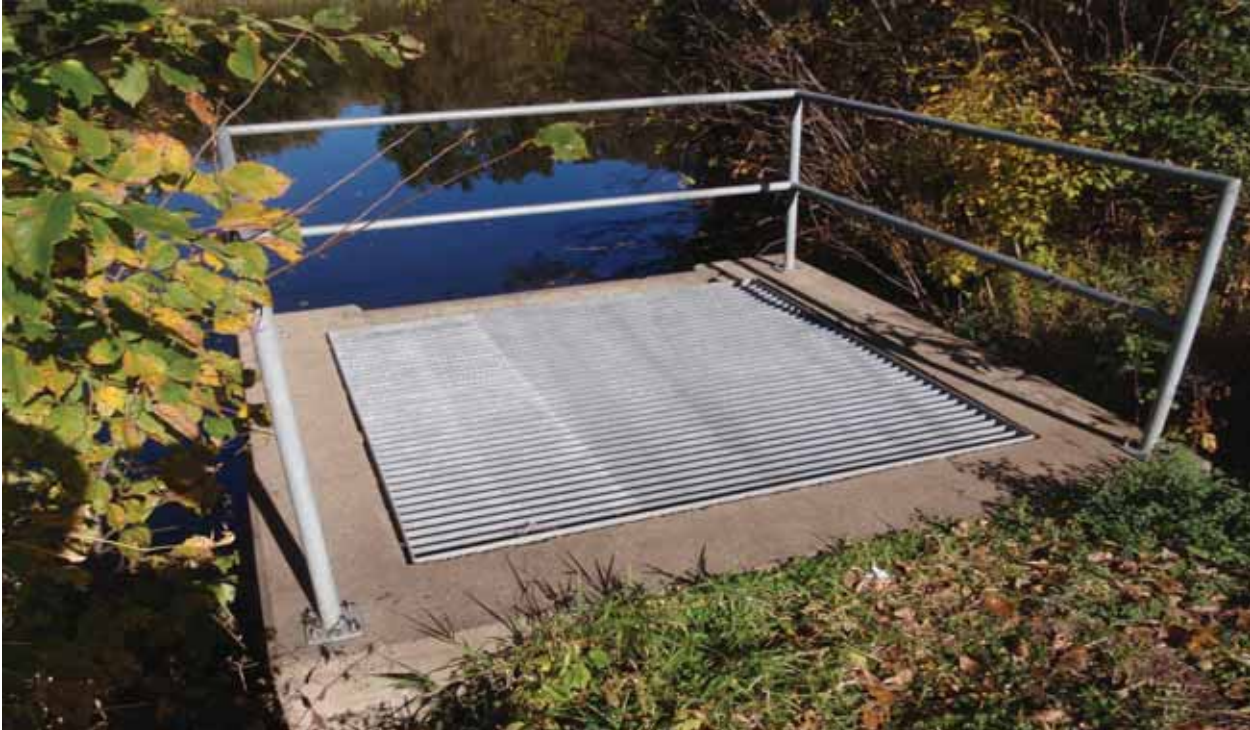
Detention Pond Outlet Structure (Crystal)

- a. The overall condition of the outlet structure was satisfactory.
- b. Although the pond appears in good condition from the surface, a survey is needed to assess accumulated sediment.
