Memorandum

To: Bassett Creek Watershed Management Commission
From: Barr Engineering Co.
Subject: Bassett Creek 2017 Flood Control Project Inspection
Date: December 13, 2017
Project: 23270051.38 2017 4065

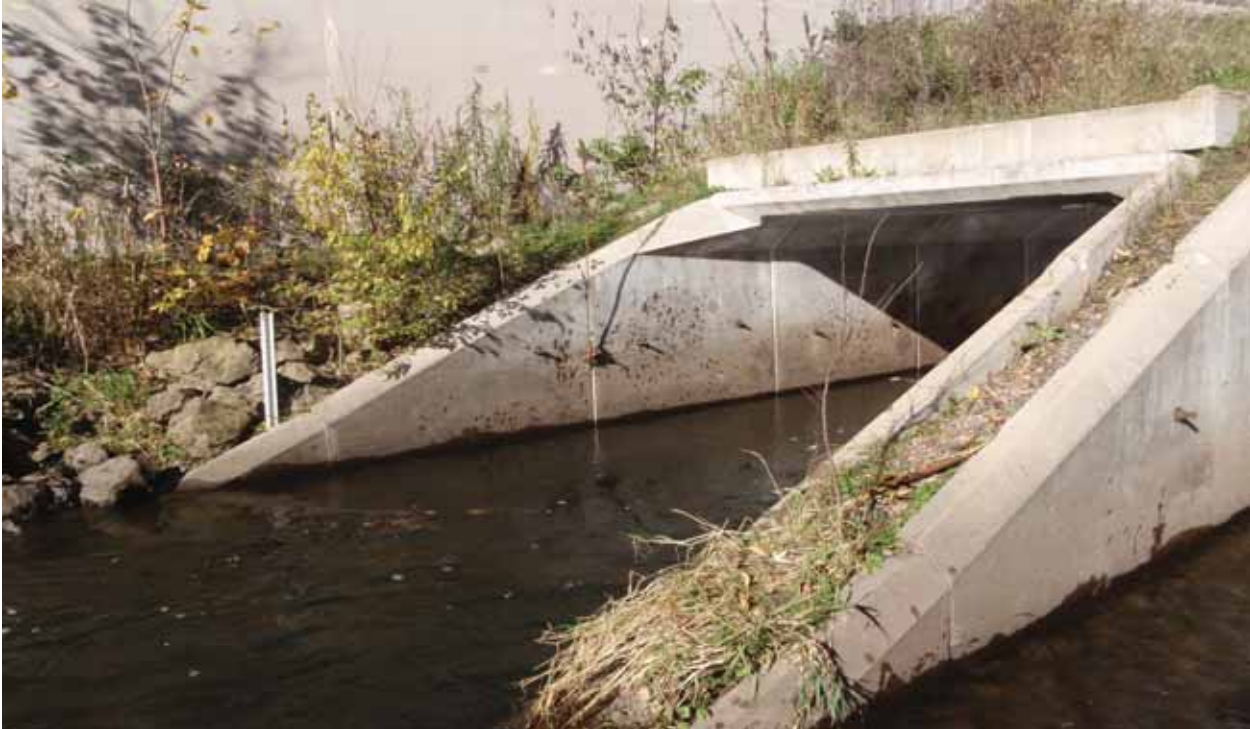
Highway 100 Double Box Culvert (Crystal/Golden Valley)

- a. The overall condition of the control inlet structure was satisfactory. Some minor debris at the inlet was removed during the inspection.
- b. The improvements to the creek channel upstream of the structure are in good condition.

- c. The large cracks and transition joint damage as noted in previous inspections were repaired by Mn/DOT in 2007. The repairs are mostly in good shape, but numerous cracks are visible around the patching and some of the concrete patching has become dislodged at the top of the culvert.

- e. The overall condition of the outlet portion of the structure was satisfactory.

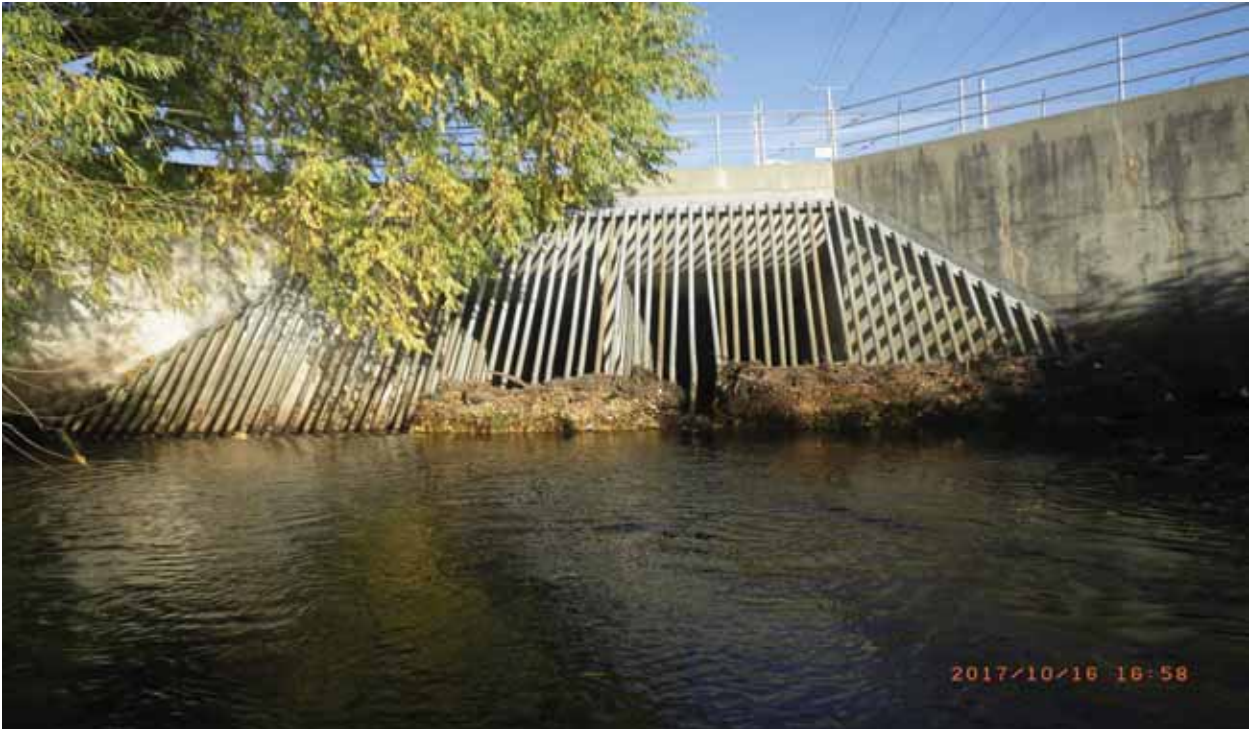
Inlet Structure (Minneapolis)

- a. The overall condition of the inlet structure was satisfactory.
- b. The overall condition of the fence and railing was satisfactory.
- c. Minor cracks were noted in the concrete, especially where handrail posts were embedded. Some spalling was noted on the back of the south wing wall. This is consistent with previous inspections.

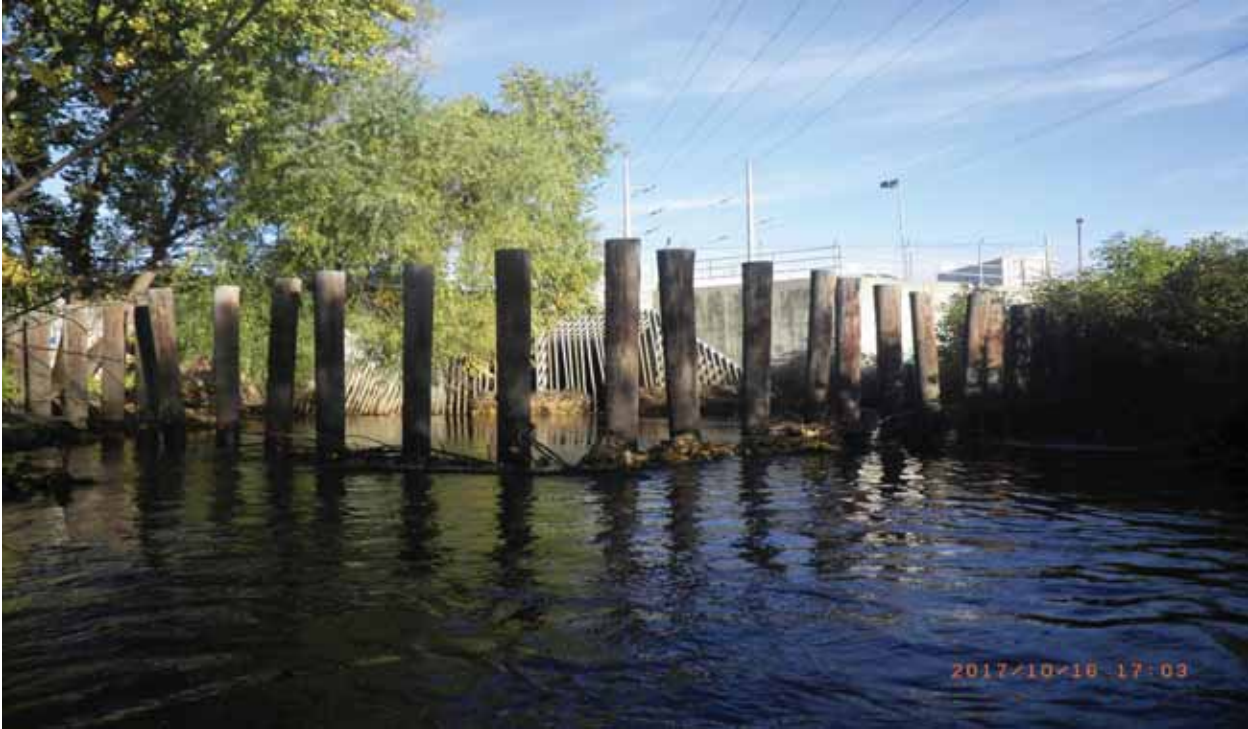
Debris Barrier (Minneapolis)

- a. The debris barrier cable is missing in the center portion of the channel. The cable is supposed to be continuous from end to end, attached at each post, but has come detached and/or broken off of the wood poles and needs to be reinstalled or replaced.
- b. Barrier is partially full of debris. Trees, logs and other debris was recently removed from the channel and placed at the top of the slope for future removal from the site.

- Repair/replace steel cable on debris barrier.

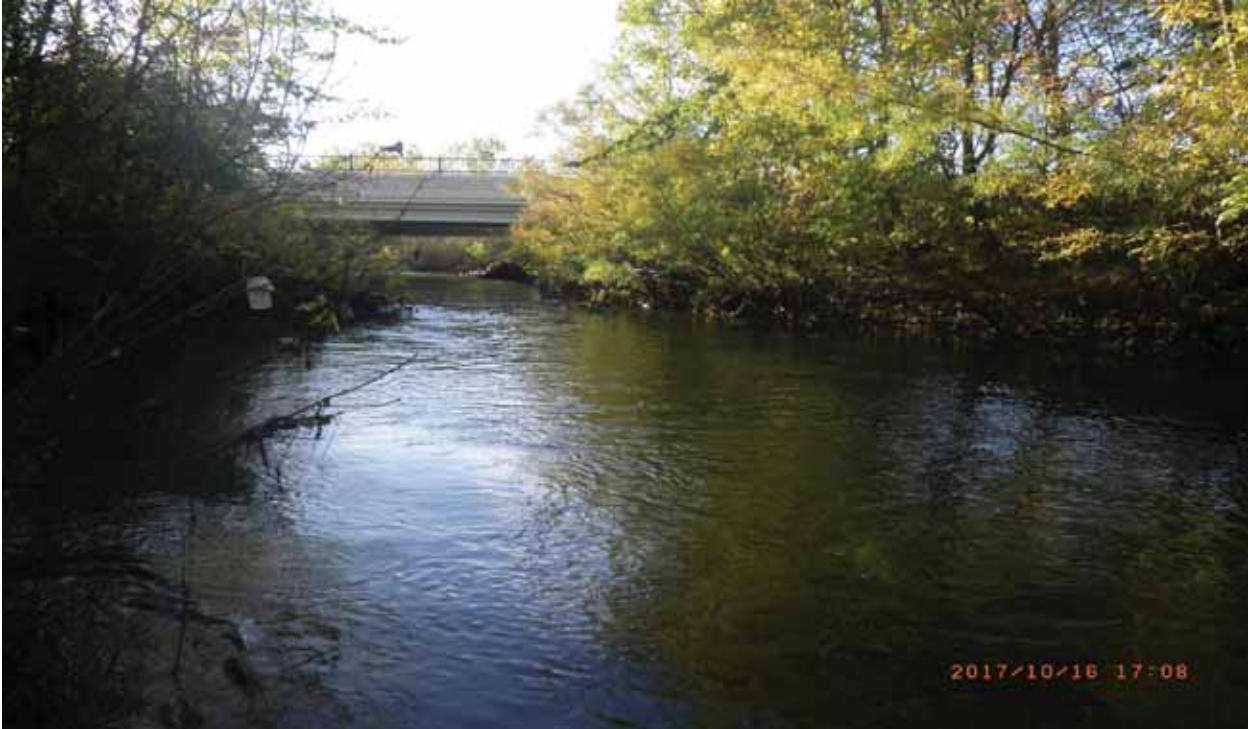
Open Channel (Minneapolis)

- e. The creek channel was partially inspected this year. The banks are generally covered with brush and trees about 3-4 feet above the channel bottom. Below the level of the trees and brush, the banks are bare soil on both sides for most of the length of the channel. No obvious signs of bank erosion were noted.

- Monitor for debris and as needed.
- The BCWMC completed a feasibility study for the 2017 Bassett Creek Main Stem Erosion Repair Project (CIP 2017 CR-M) in May 2016, and ordered construction of the project at their September, 2016 meeting. The resultant construction project should address the noted erosion issues.
