Memorandum

To: Bassett Creek Watershed Management Commission (BCWMC)
From: Barr Engineering Co.
Subject: Bassett Creek 2019 Flood Control Project Inspection
Date: December 11, 2019
Project: 23/27-0051.45 2019 4065

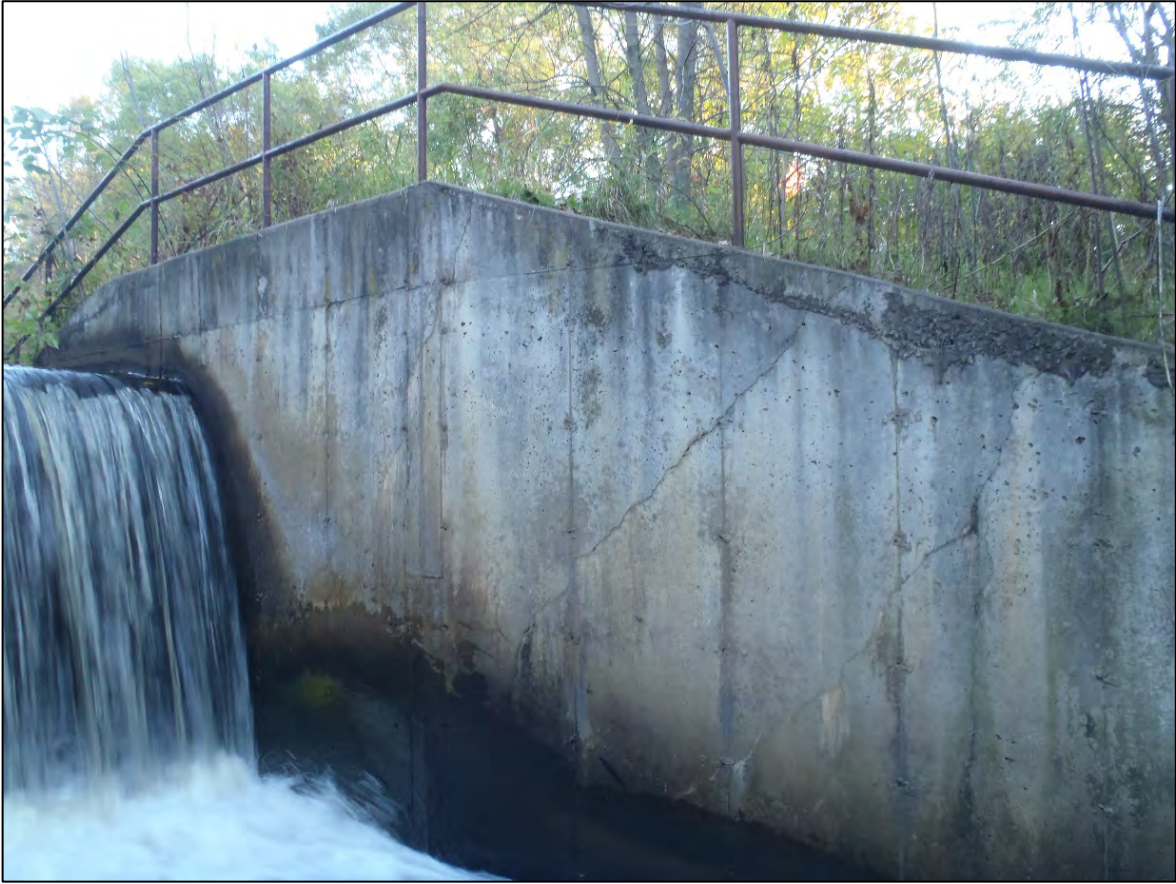
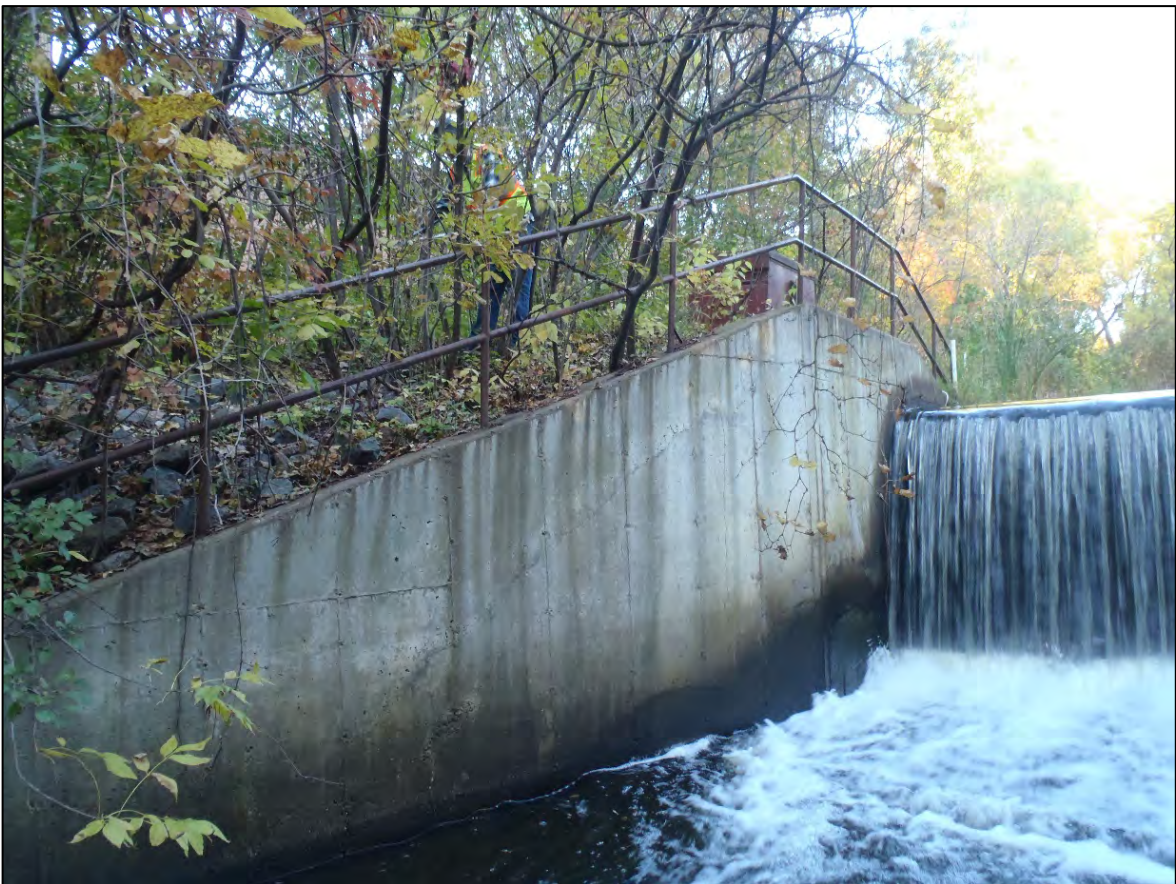
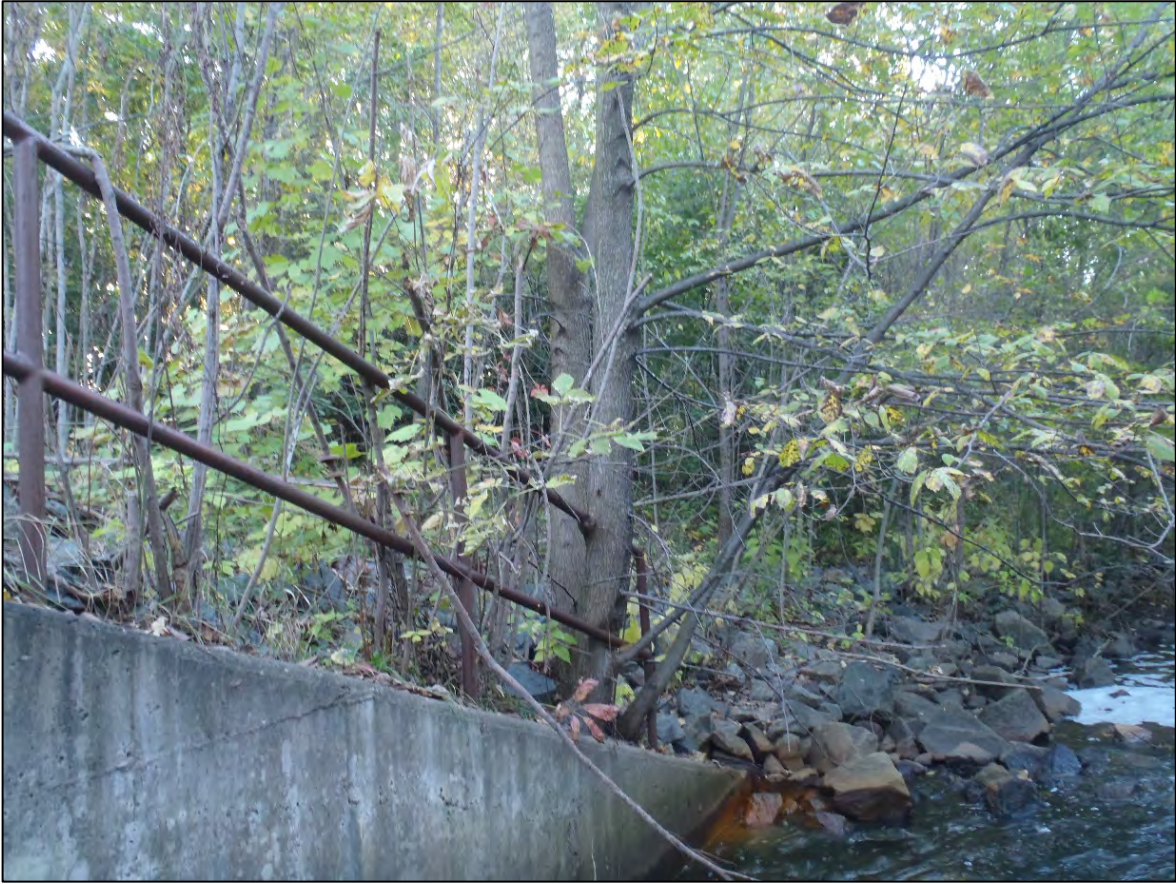
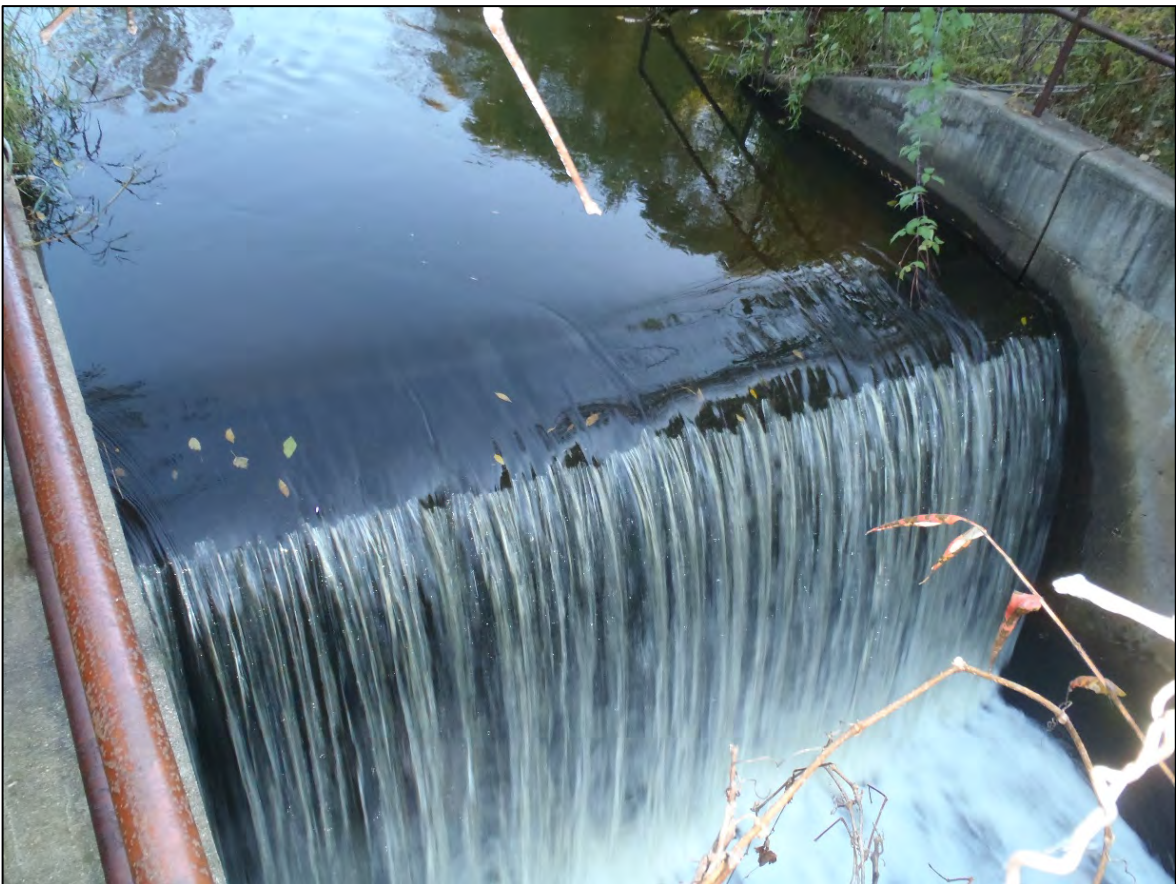
Plymouth Creek Fish Barrier (Plymouth), continued

- c. Sediment has accumulated in the pool upstream of the structure and formed a delta, which was overgrown with vegetation. The deposited sediment was generally creating meander in the creek toward the east (left) bank. Deposited sediment has been noted since 2005 and appears to be increasing.

- d. The railings at the upstream end of the structure, on the east (left) and west (right) sides, have rusted off below the water level. This is consistent with previous inspections and has been noted since 2015.

- f. Three cracks were observed on the downstream west (right) wing wall. This is consistent with previous inspections and has been noted since 2004.
- g. Seven diagonal cracks were observed on the downstream east (left) wing wall. Three of the cracks are very prominent. Observation of the three prominent cracks is consistent with previous inspections and has been noted since 2002. The other four cracks are minor and less noticeable.

- h. A 12-inch diameter tree was observed growing adjacent to the downstream east (left) wing wall and through the railing.
- i. Small trees and shrubs were observed growing on the embankment and downstream channel banks, including some near the wing walls and railings.

- Repair railings on the upstream side of the structure.
- Remove trees and vegetation on embankment and channel banks. Chemically treat stumps with Garlon 3A herbicide (or other specialty herbicide for use in wetland sites and waterways) to prevent regrowth.
- Monitor concrete cracks and the width of the expansion joints.

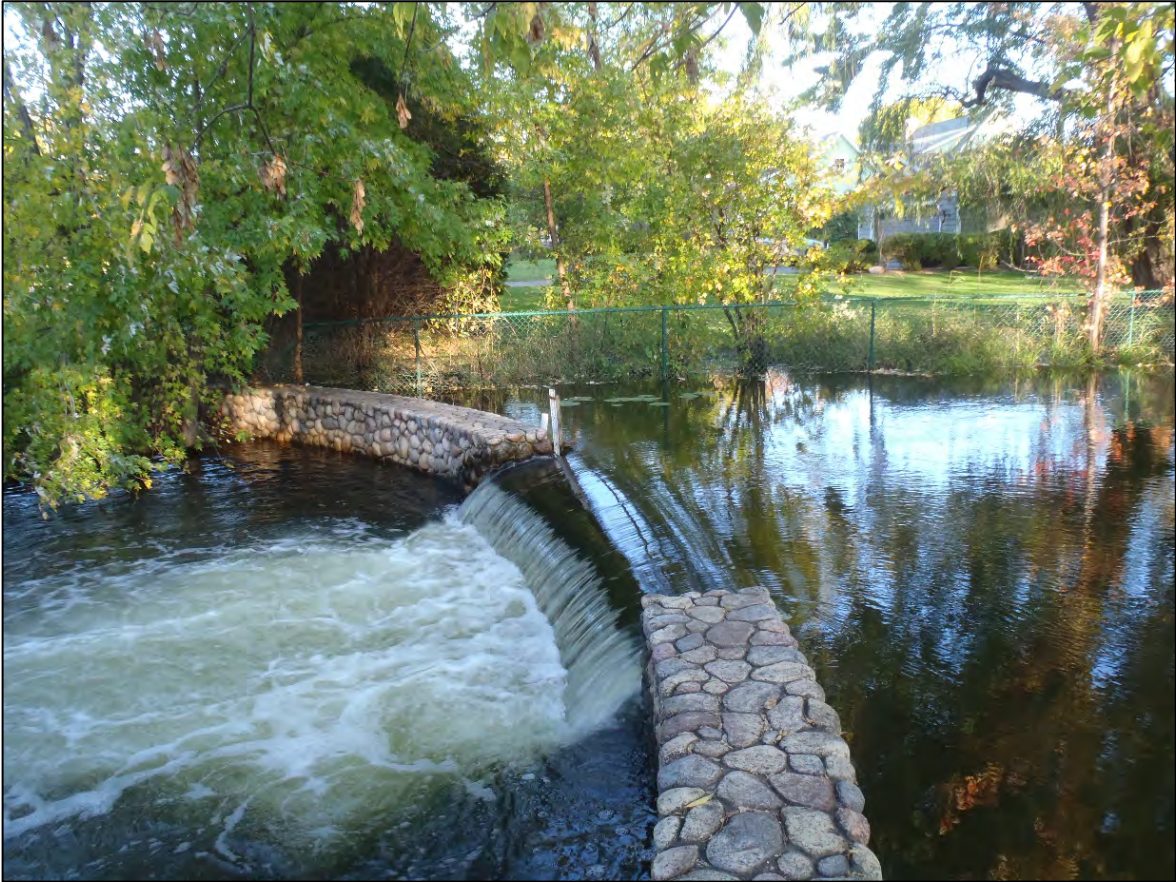
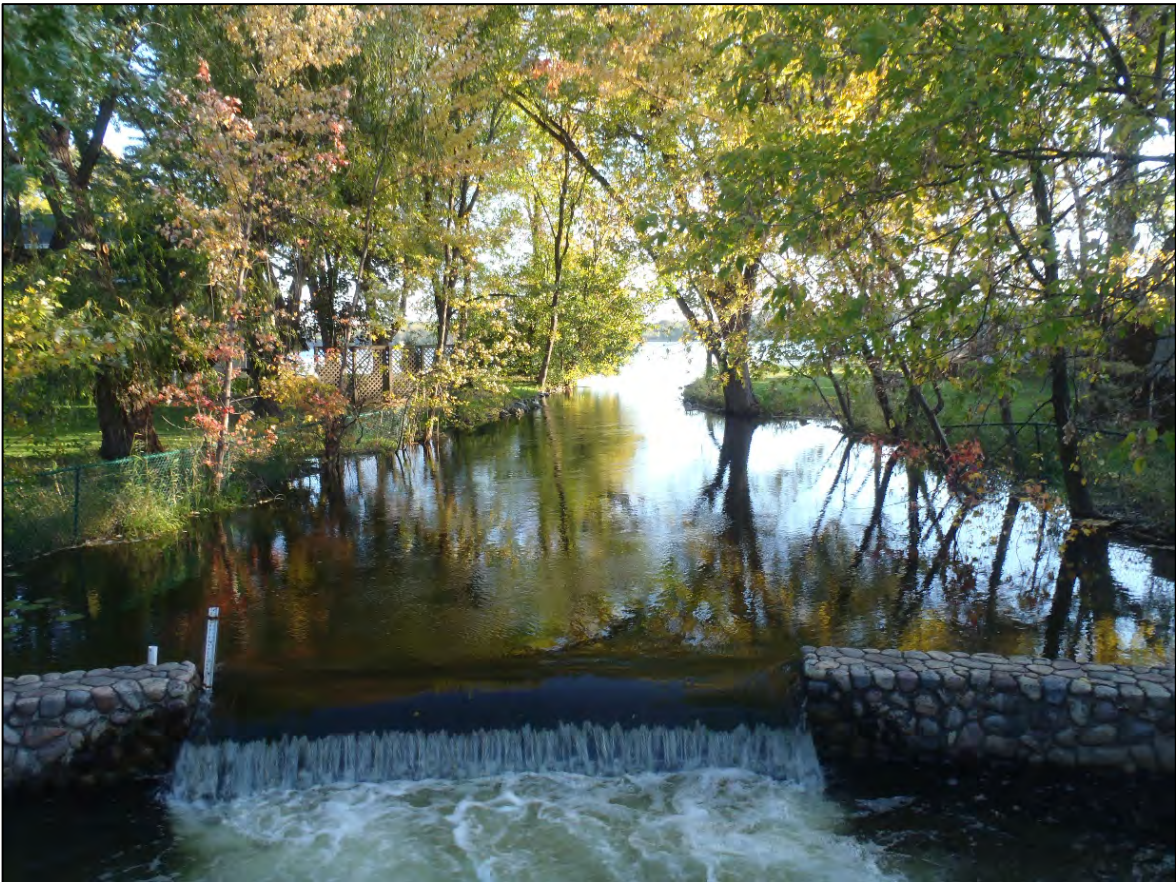
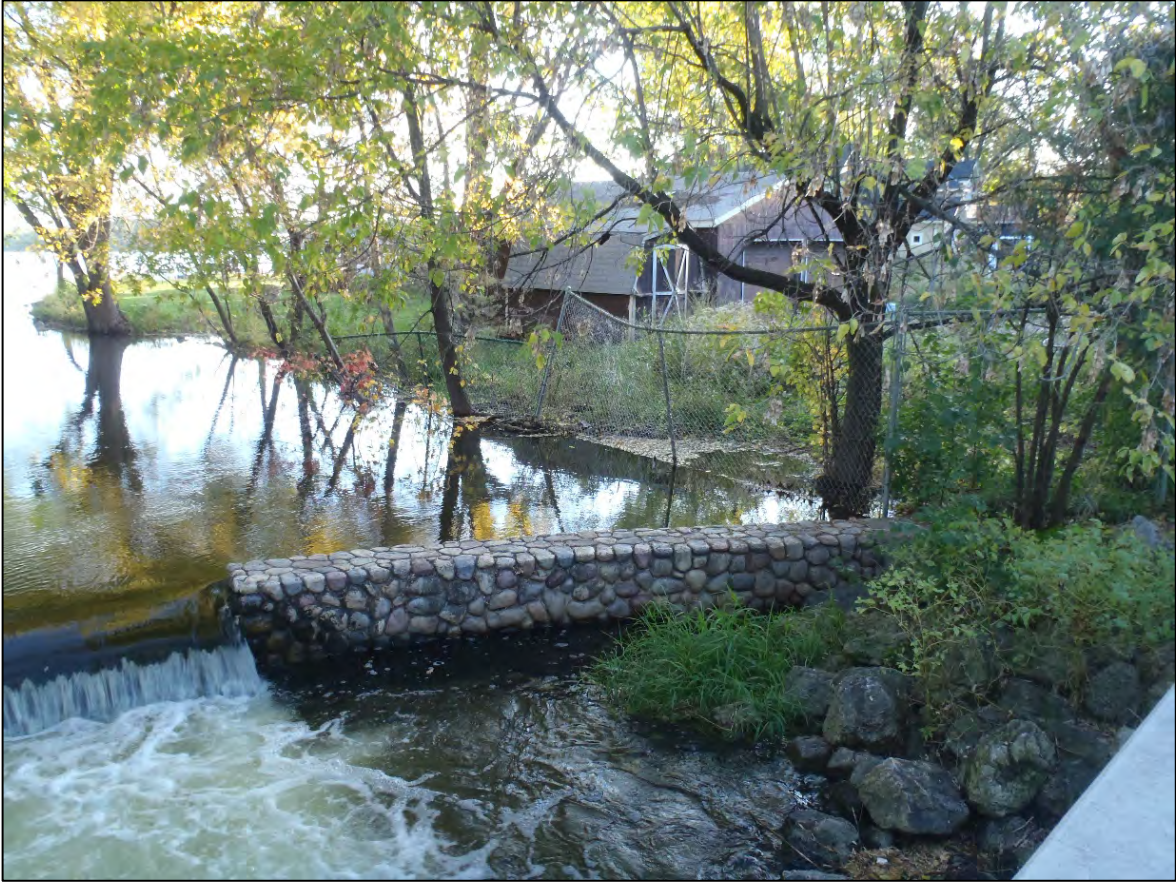
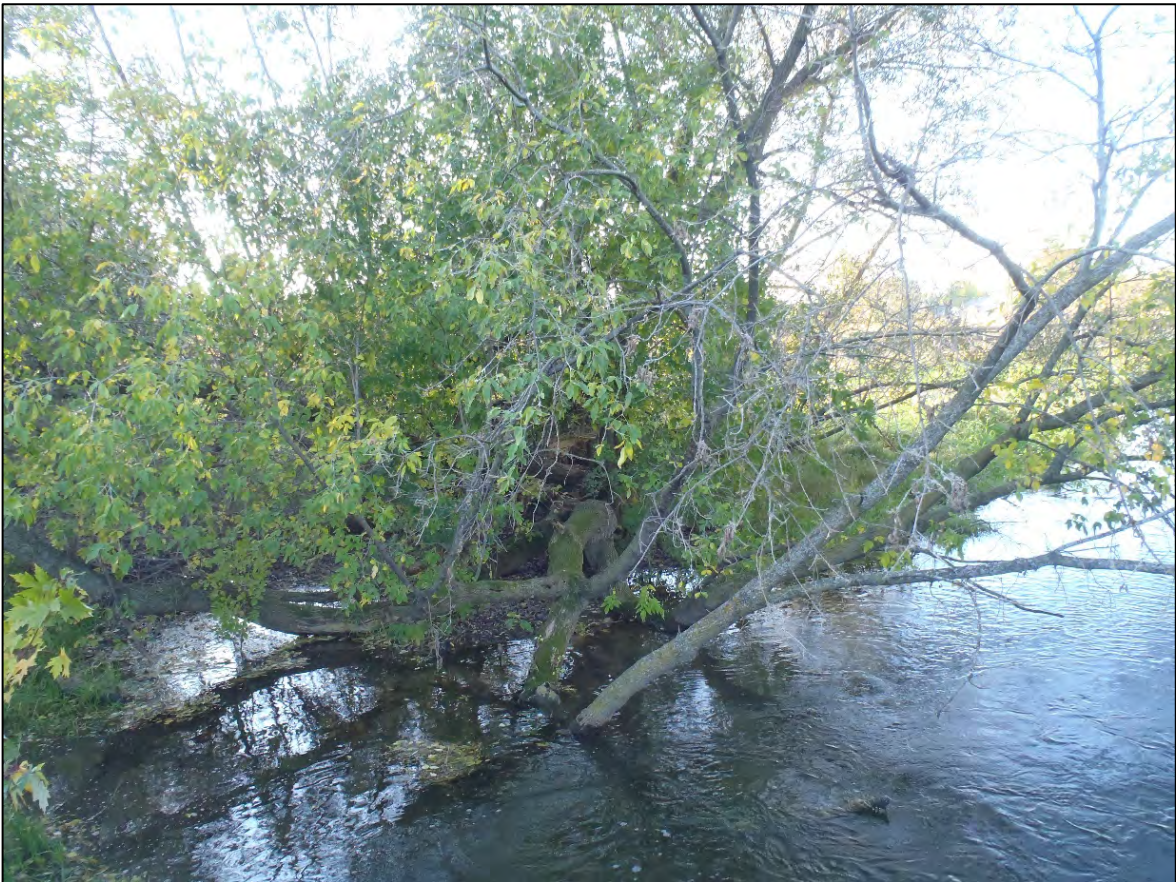
Medicine Lake Outlet (Plymouth)

- a. The channel between the Medicine Lake and the outlet structure was clear of debris and flowing full.
- b. The outlet structure appeared to be in satisfactory condition.
- c. The water level at the staff gage was at 1.56 feet and the depth of water flowing over the structure was 0.86 feet.
- d. While not part of the Bassett Creek FCP, there is a large willow tree directly downstream of the South Shore Drive bridge that has begun to fall into the creek and could block or divert flows toward the right bank if it falls completely.

In late May 2019, City of Plymouth staff observed water flowing over the east side, but not the west side, of the Medicine Lake Outlet Structure. The city surveyed the dam in the summer of 2019 and found that the east side of the dam was 0.15 feet lower than the west side.

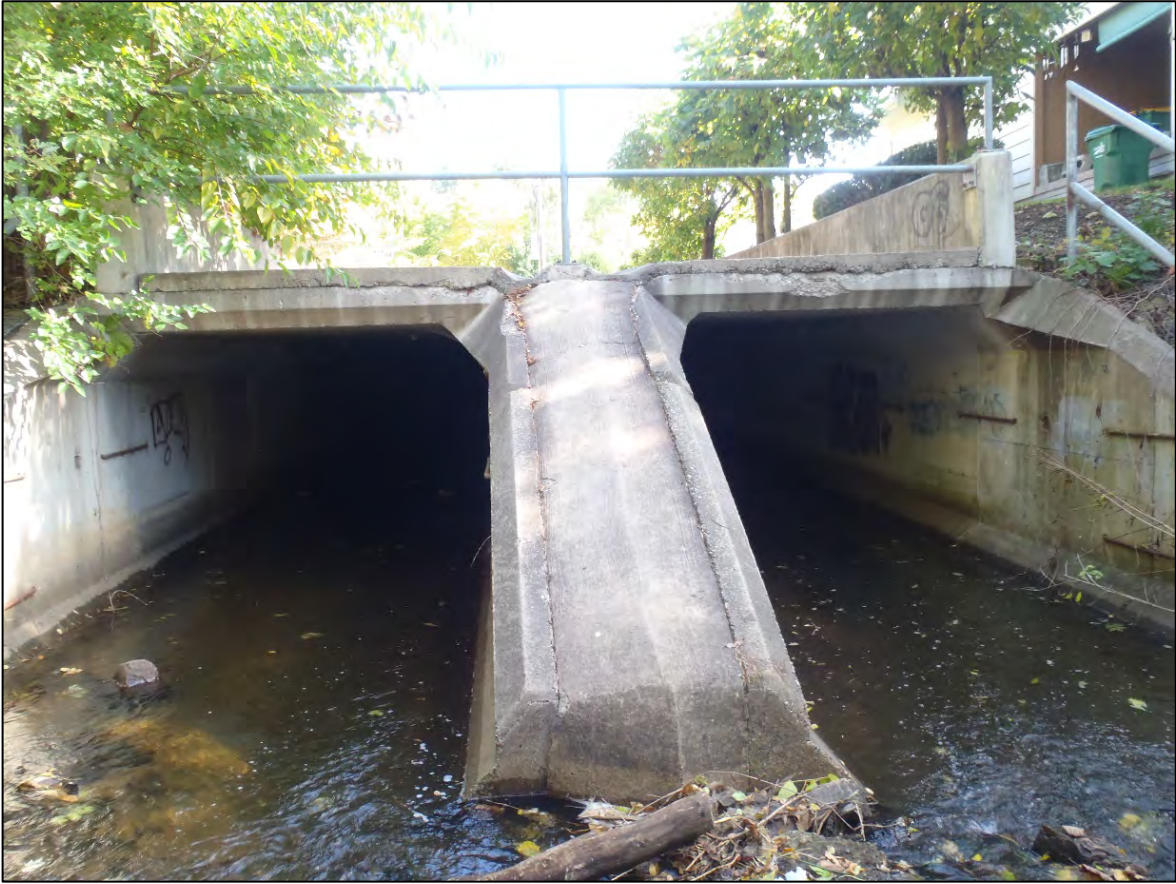
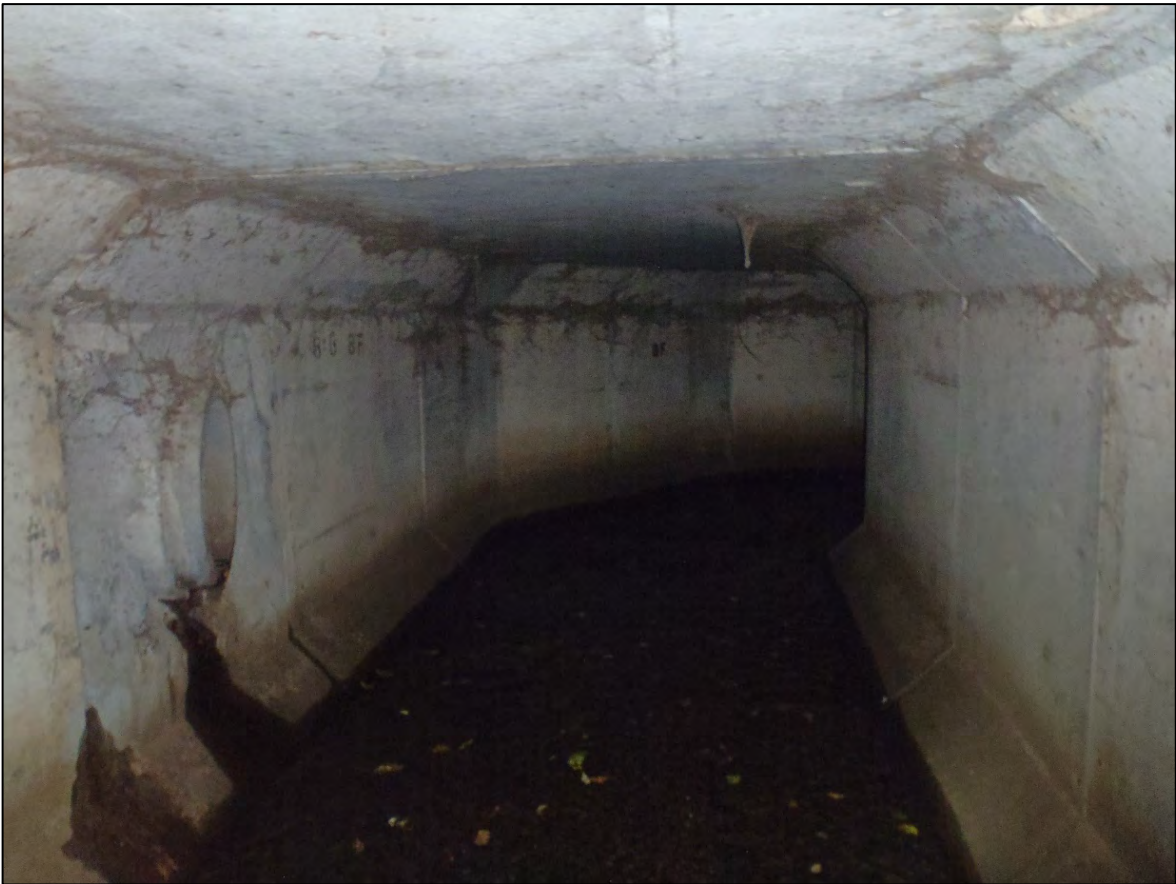
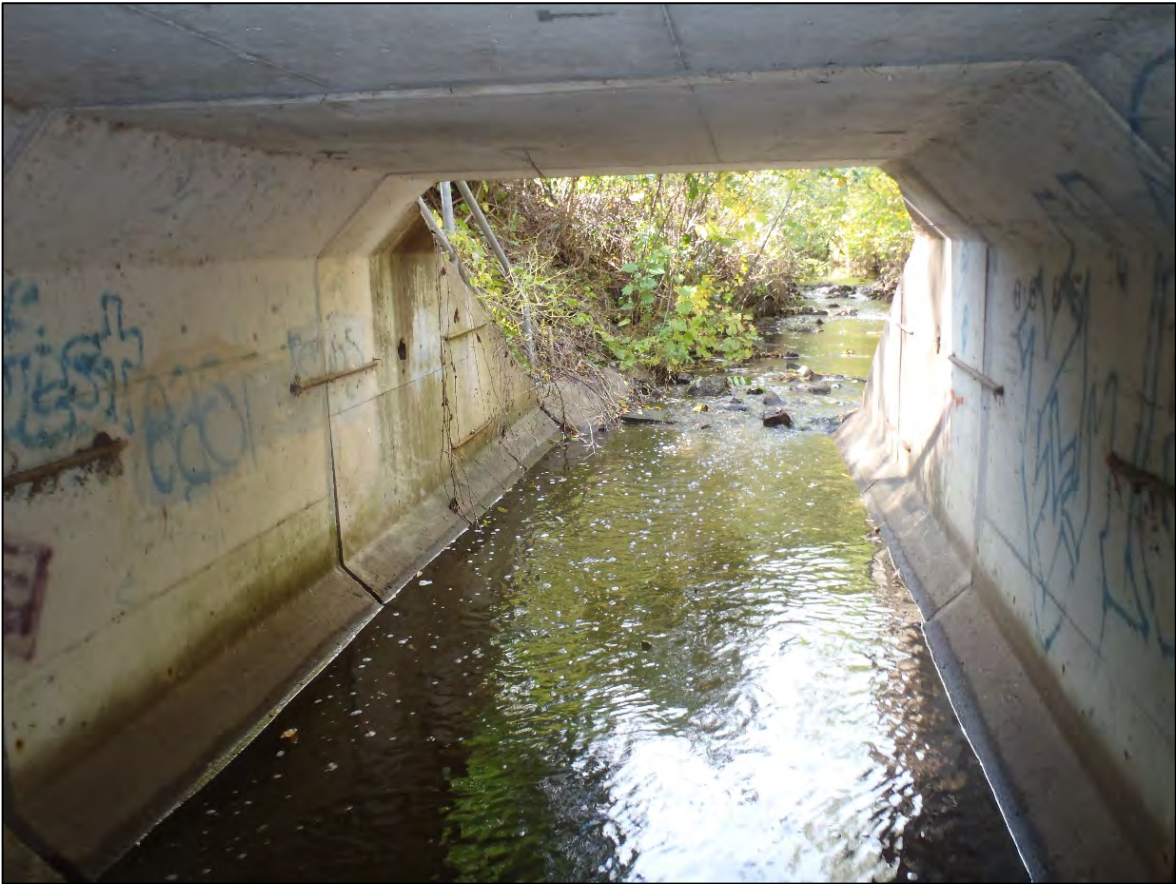
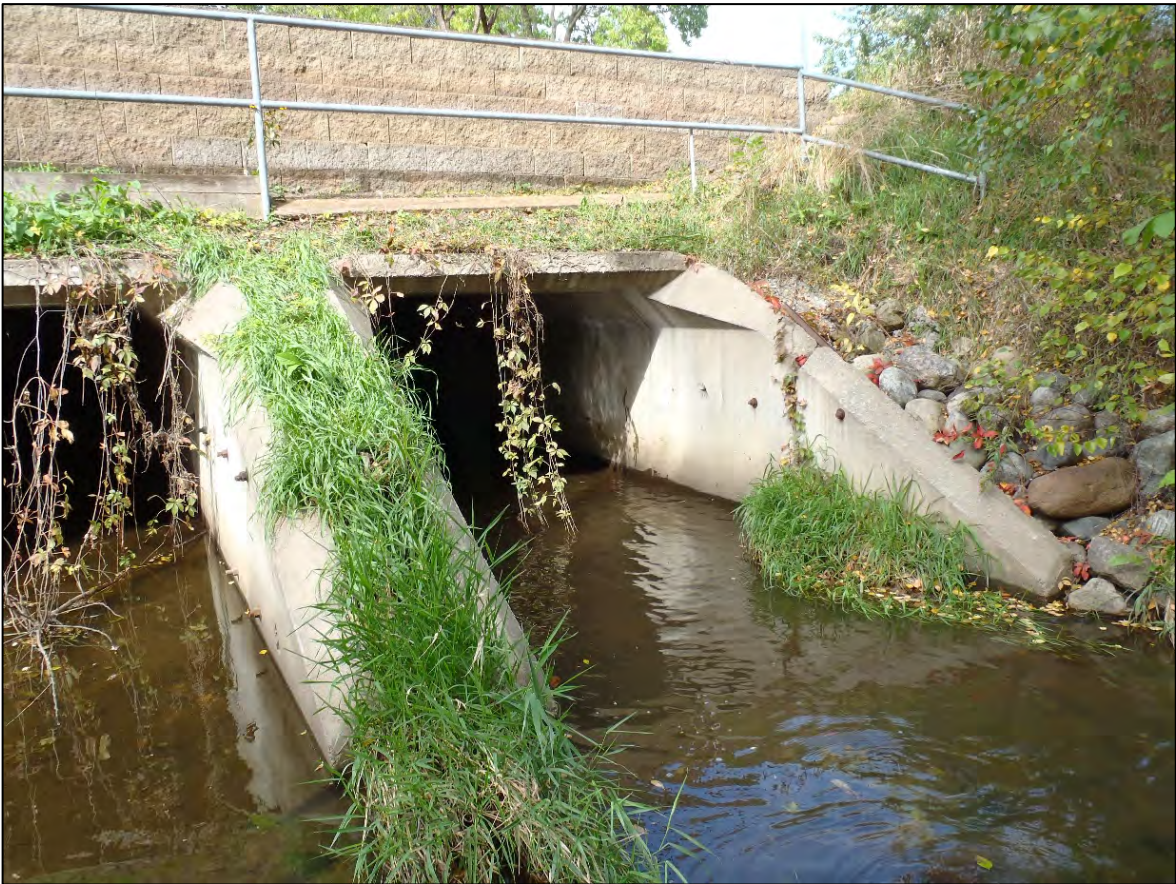
36th Avenue and Hampshire Avenue Crossing (Crystal)

- a. The concrete box culverts, joints and tie bars appeared to be in satisfactory condition.
- b. Some riprap has deposited in the box culverts.
- c. Sediment has deposited in the box culverts, mostly in the downstream half of the box culverts. This is consistent with previous inspections and has been noted since 2016.

- d. On both culverts, the fifth joint from the downstream end had a 2 ½ inch gap, which is a larger gap than the rest of the joints. This is consistent with previous inspections and has been noted since 2010.

- e. Inspection staff performed a more detailed inspection of the culverts in 2019. While additional structural, and operation and maintenance defects are noted for the first time in this section, these defects did not appear to be new in 2019. In the north (left) culvert, inspection staff observed the following:

- i. An Infiltration weeper, or slow ingress of water (with no visible drips) through a defective or faulty joint or culvert wall at the culvert inlet upstream of the first culvert bend.

- ii. Spalled concrete at two joints at the first culvert bend on the left side (outside of bend).
 - iii. Exposed reinforcing at the first culvert bend on the right side (inside of bend).

- iv. Spalled concrete at three joints between the first culvert bend and the second culvert bend. The spalled concrete appeared to have resulted from random defects or damage from debris rather than a pattern of stress on the culvert or joints.

- v. Spalled concrete at one joint downstream of the second culvert bend on the left side near the culvert bottom.
- f. Inspection staff performed a more detailed inspection of the culverts in 2019. While additional structural defects are noted for the first time in this section, these defects did not appear to be new in 2019. In the south (right) culvert, inspection staff observed:

- i. Spalled concrete at one joint downstream of the second culvert bend on the right side, halfway up the culvert.
- ii. Spalled concrete at two joints between the first culvert bend and the second culvert bend, on the right side, halfway up the culvert. The spalled concrete appeared to have resulted from random defects or damage from debris rather than a pattern of stress on the culvert or joints.
- iii. A crack at the top of the culvert across a joint at approximately the fifth section downstream of the inlet. This is consistent with previous inspections and has been noted since 2002. The crack may have formed during construction.

- Remove deposited riprap in the box culverts.
- Monitor sediment in the box culverts.
- Monitor the joint gaps in the box culverts.
- Monitor infiltration weeper, spalled concrete, and exposed reinforcing in the north (left) box culvert.
- Monitor spalled concrete and crack in the south (right) box culvert.

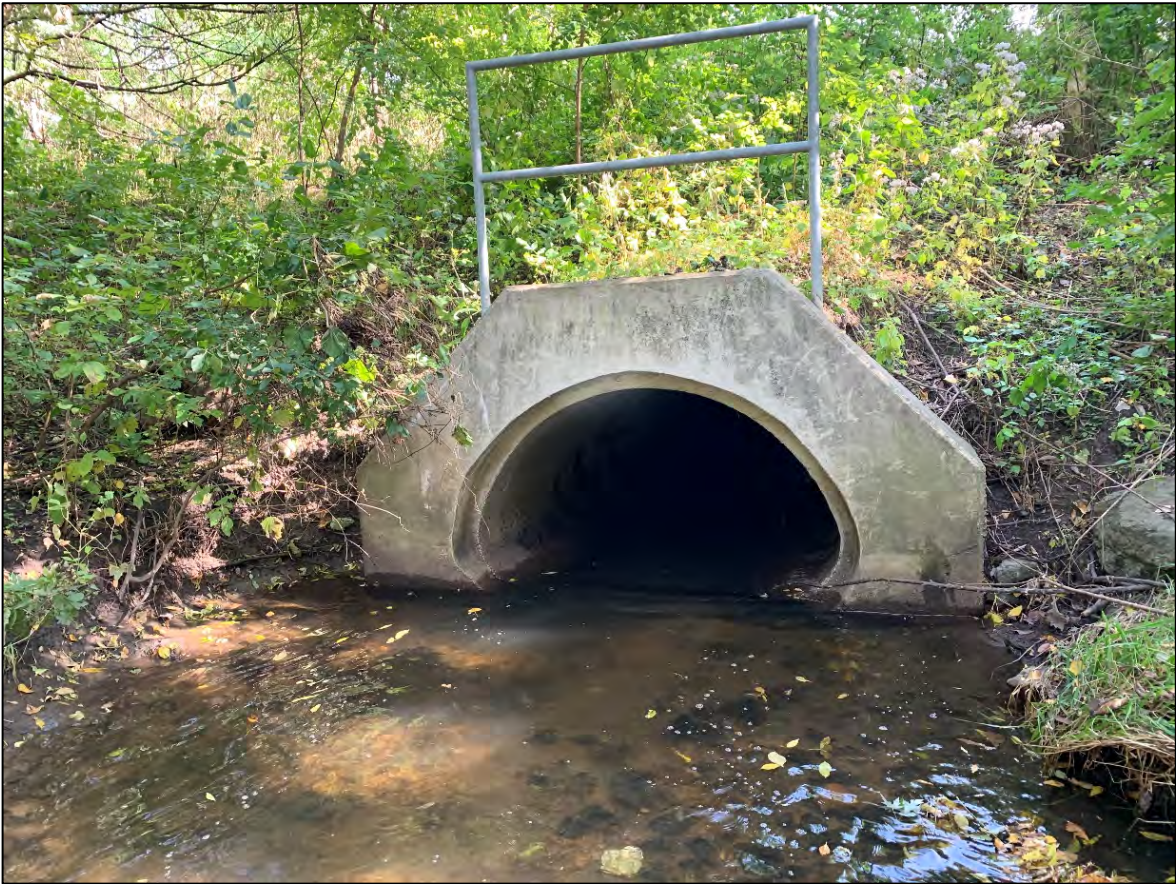
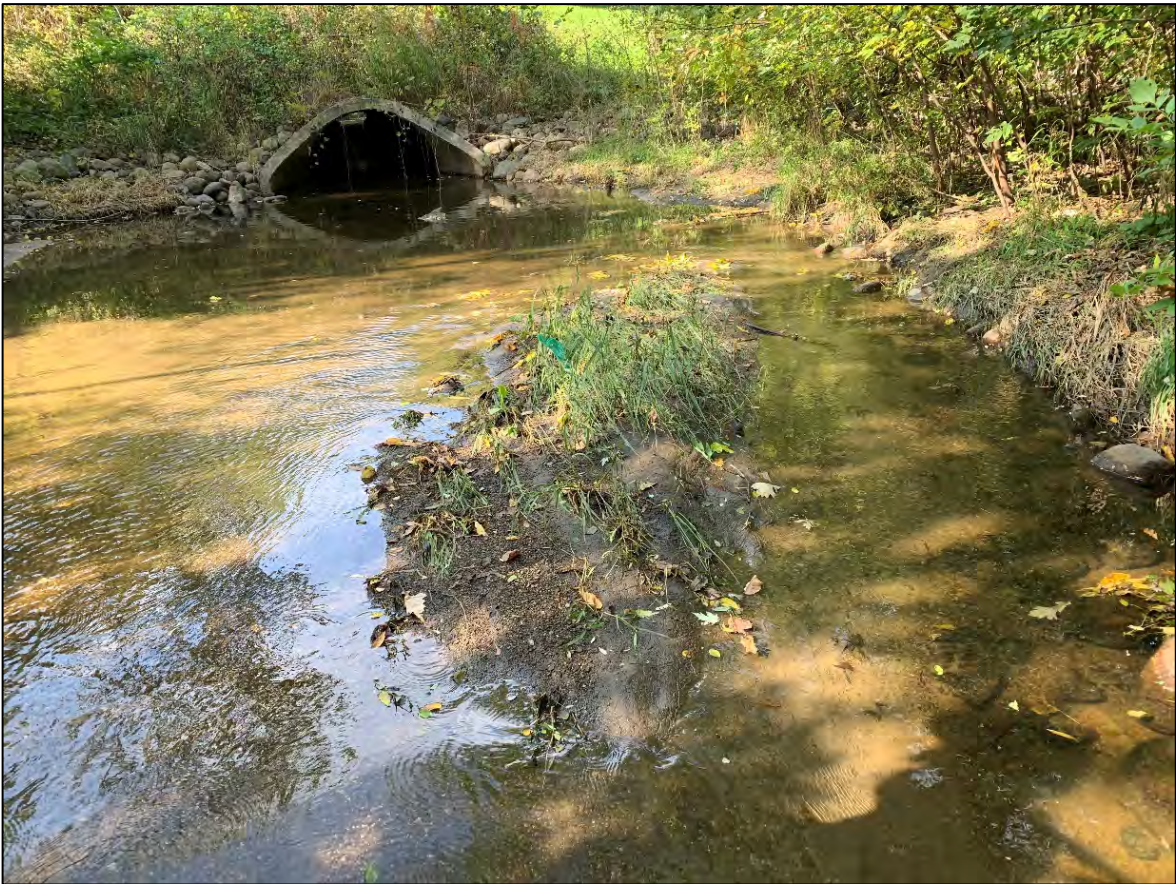
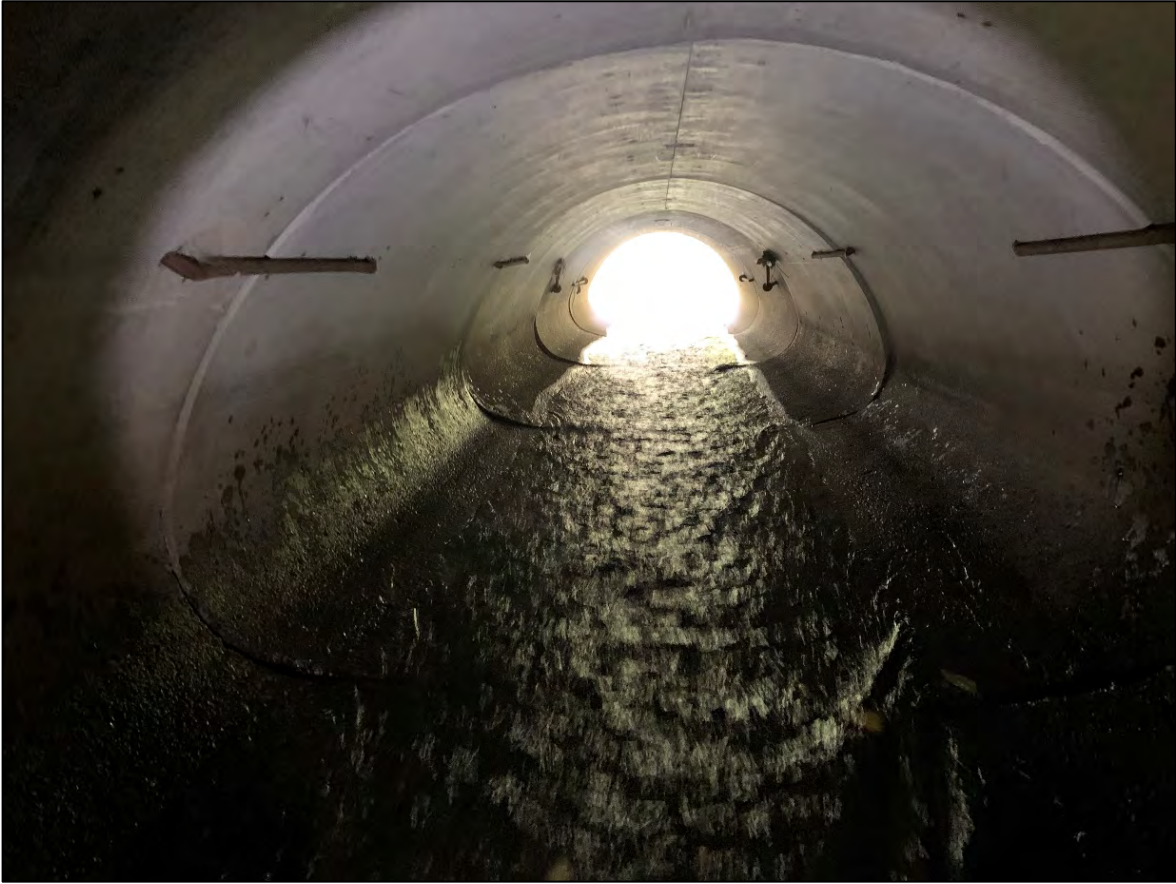
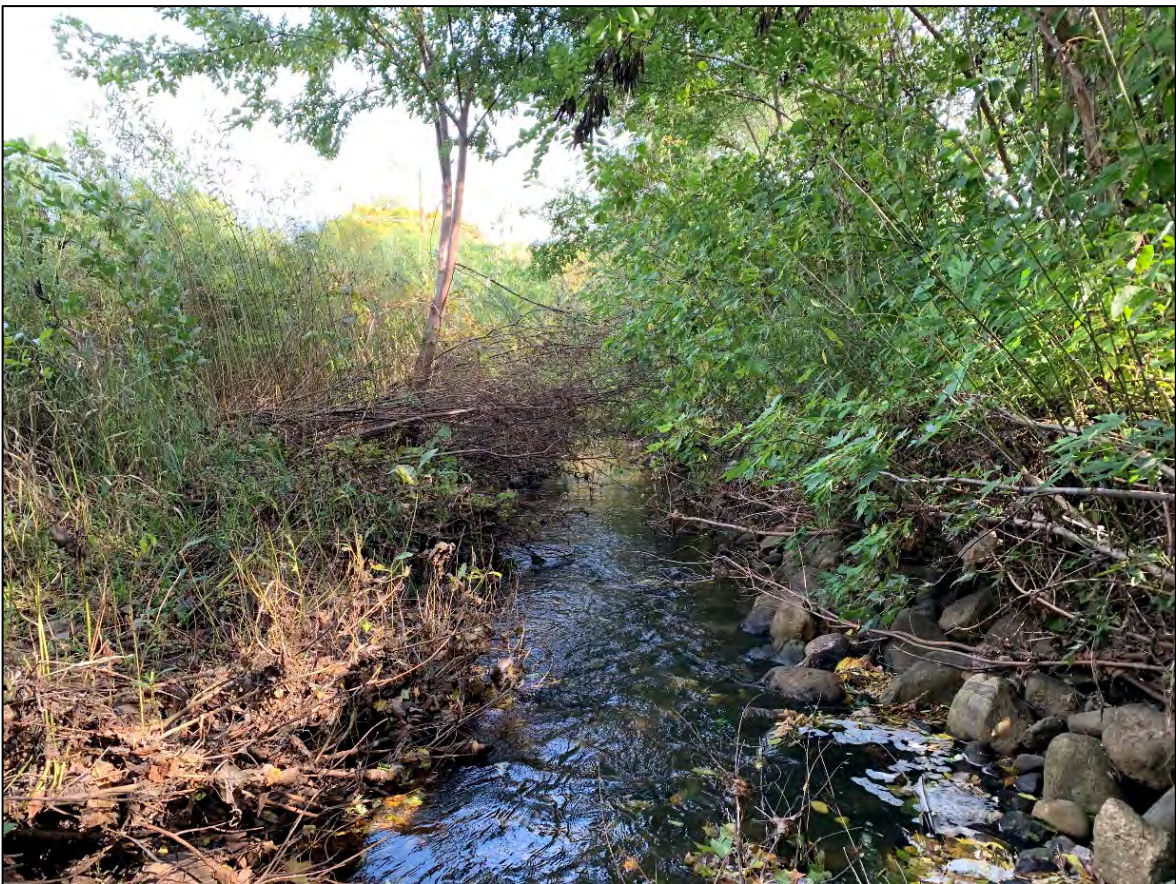
Edgewood Embankment (Crystal)

- a. The concrete culvert appeared to be in satisfactory condition.
- b. The embankment appeared to be in satisfactory condition.
- c. No visible settlement or erosion was observed along the embankment.
- d. Small trees and shrubs were observed growing on the embankment.
- e. The natural boulder riprap between the Edgewood embankment and Douglas Drive crossing is significantly overgrown with vegetation.
- f. Spalled concrete was observed at the fifth joint from the upstream end at approximately the 7 o'clock position.

- Remove small trees and shrubs growing on the embankment.
- Clear woody vegetation in the channel between the Edgewood Embankment and Douglas Drive crossing as needed to maintain a clear flow path through the channel.
- Monitor spalled concrete at the fifth joint from the upstream end in the culvert.

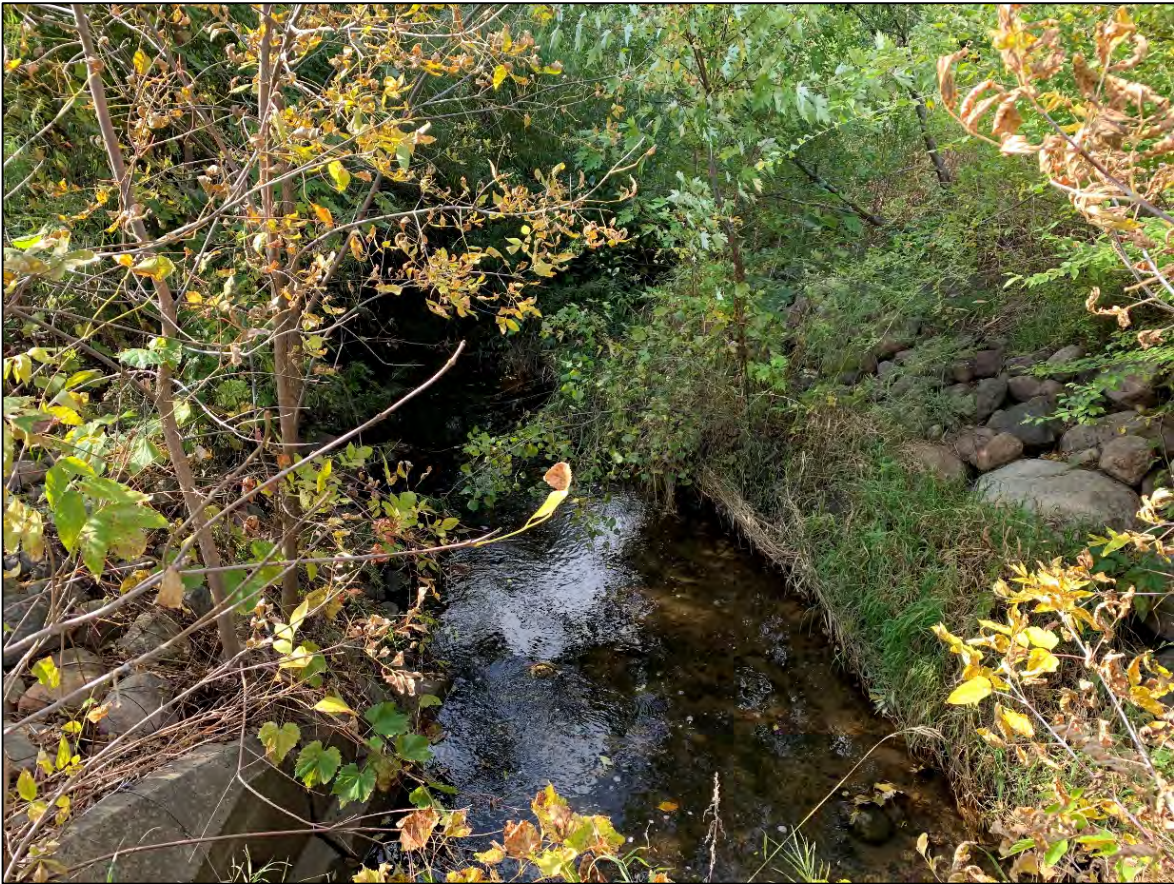
Douglas Drive Crossing (Crystal)

- a. The concrete box culvert appeared to be in satisfactory condition.
- b. The grouted riprap installed on either side of the box culvert outlet has started to deteriorate, and a gap has opened between the grout and the wall of the box culvert. This is consistent with previous inspections and has been noted since 2016.

- c. Spalled concrete was observed at the downstream north (left) wing wall.
- d. On the downstream end of the culvert, settling was observed in the sidewalk on either side of the culvert.

- e. Small trees were observed growing adjacent to the structure at the downstream end.
- f. Although not part of the flood control project, the privately-owned CMP culvert downstream of the Douglas Drive crossing is in poor condition. Sagging of this culvert has been observed during inspections since 2009 and appears to be worsening. The culvert is significantly bowing and settling has occurred on either side of the culvert, which is evident in the road pavement above the structure.

- Monitor spalled concrete at the downstream north (left) wing wall.
- Monitor settling in the sidewalk at the downstream end of the culvert.
- Although not part of the flood control project, it is recommended that the City coordinate with the property owner to repair or replace the culvert downstream of Douglas Drive.
