Memorandum

To: Bassett Creek Watershed Management Commission (BCWMC)
From: Barr Engineering Co.
Subject: Bassett Creek 2019 Flood Control Project Inspection
Date: December 11, 2019
Project: 23/27-0051.45 2019 4065

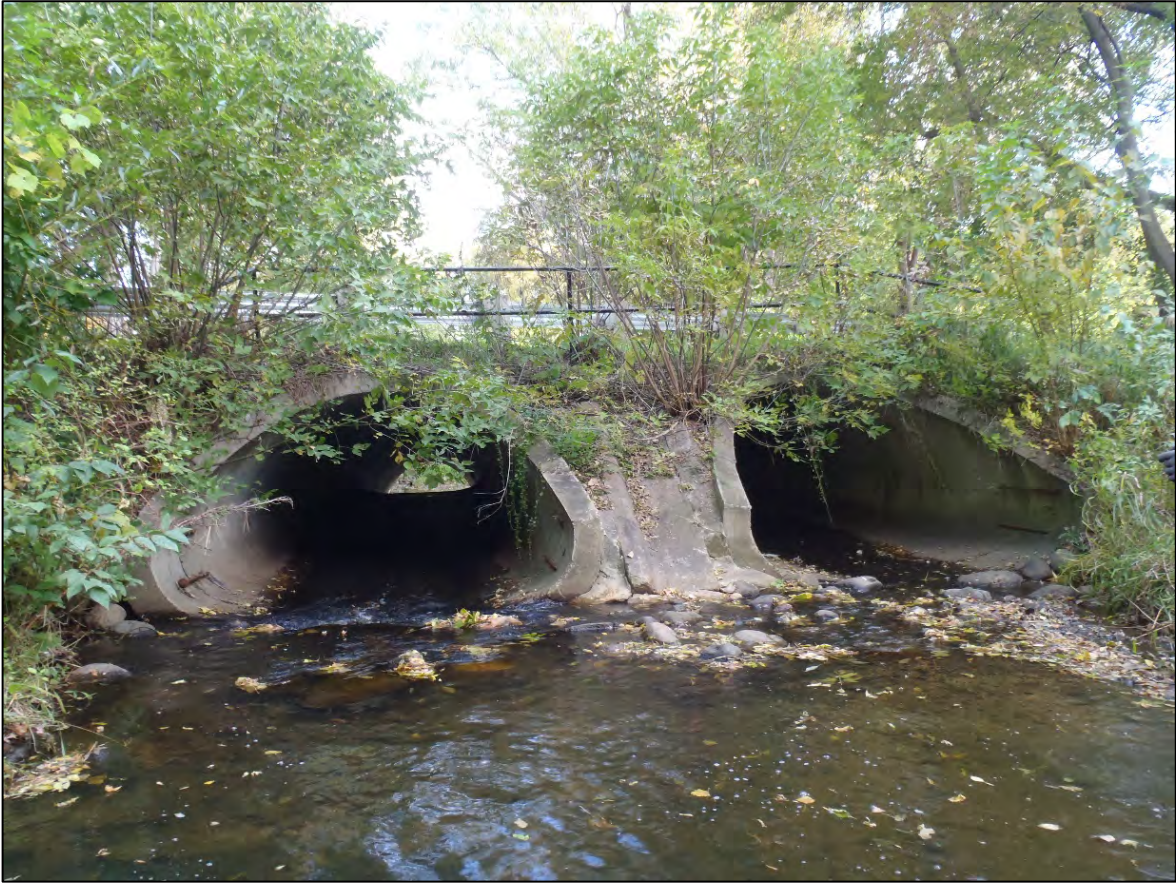
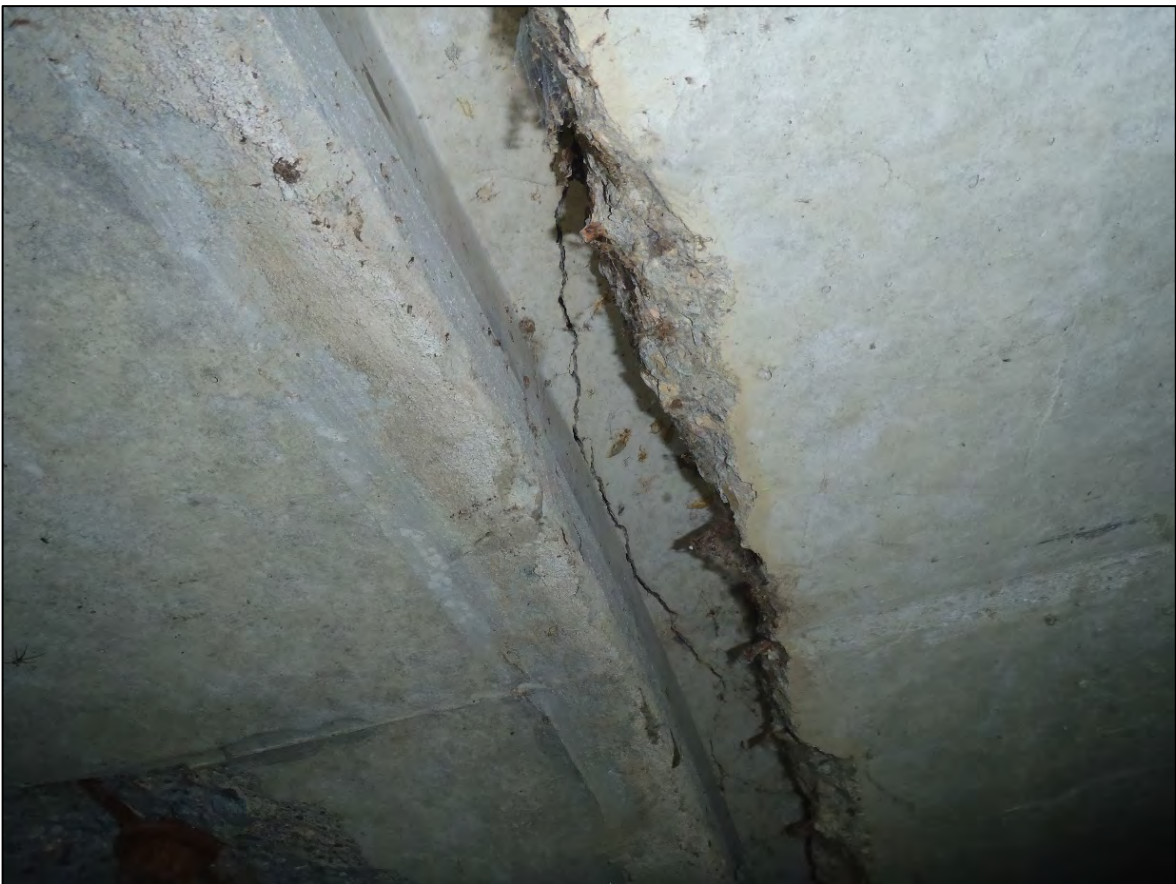
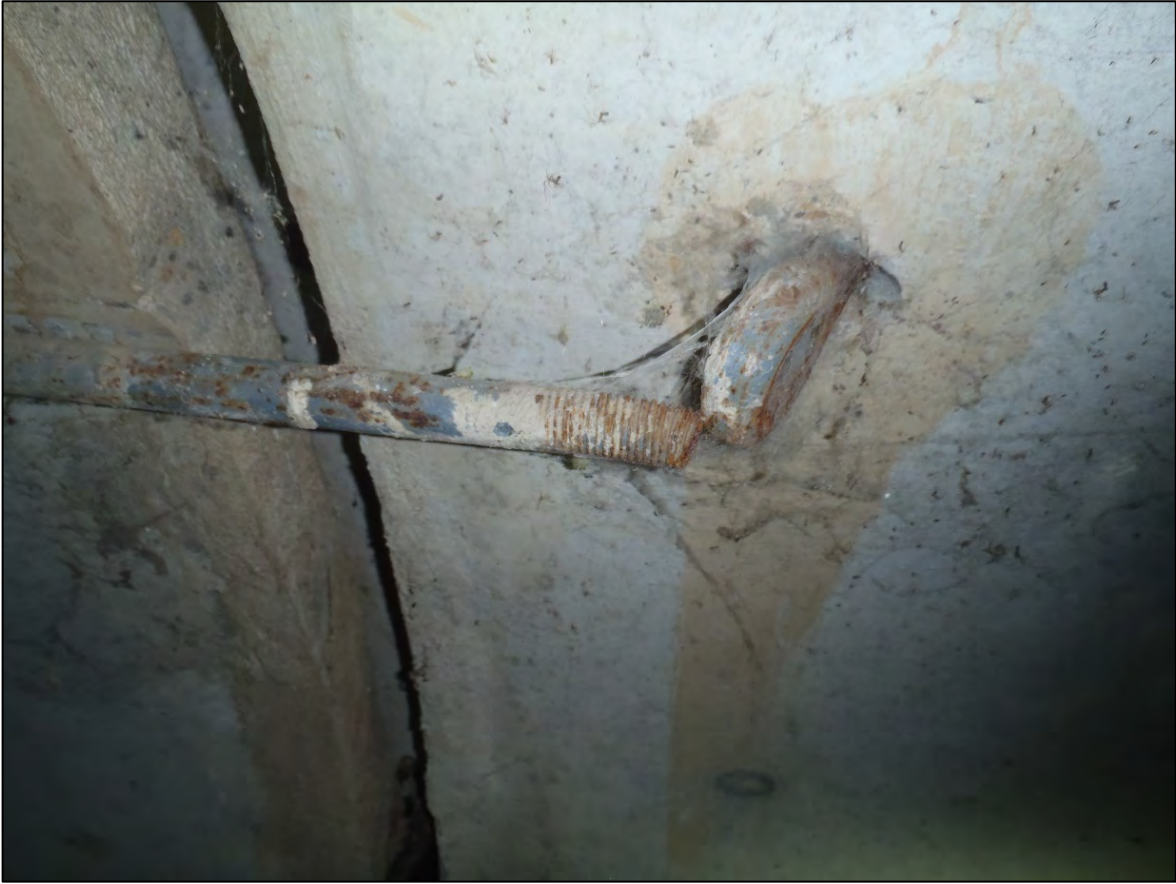
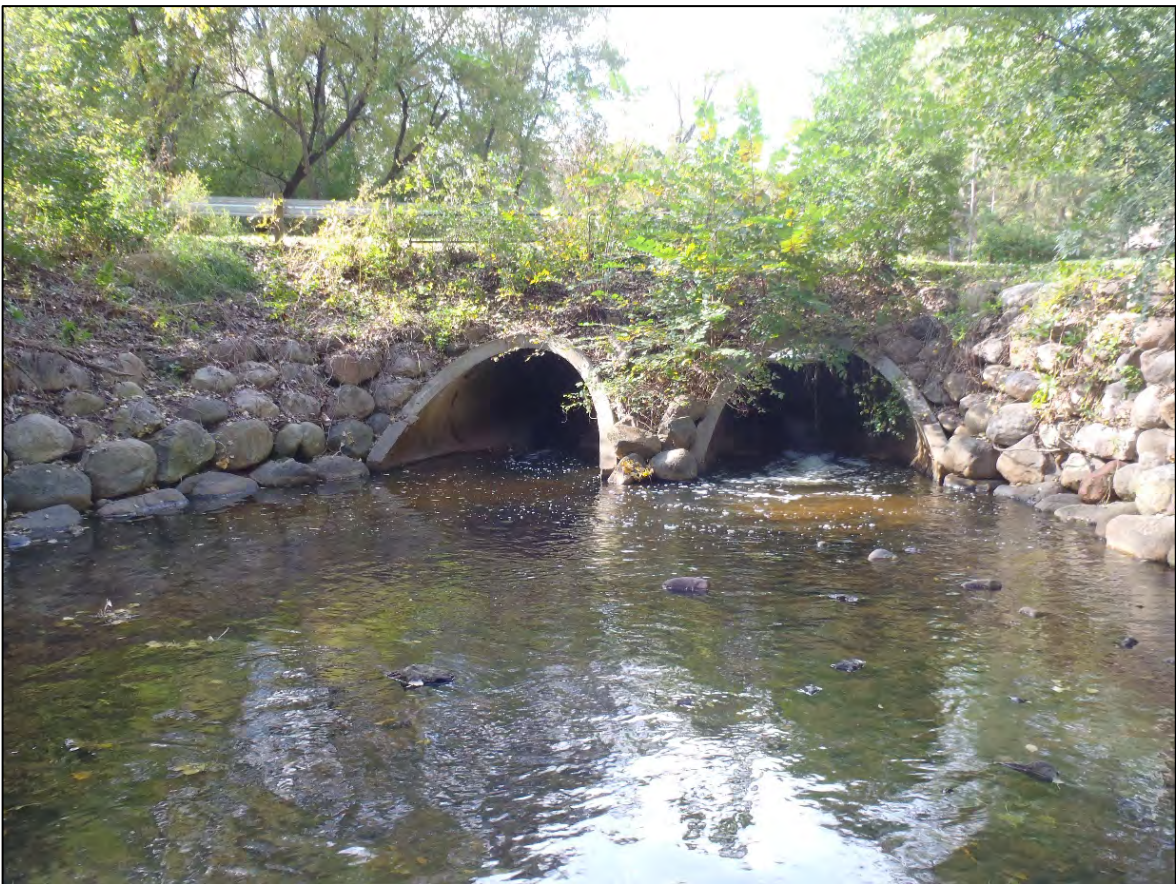
Brunswick Avenue Crossing (Crystal)

- b. Strained and detached tie bars were observed in the north (left) culvert. One joint with broken tie bars was previously re-grouted by the City of Crystal, but the joint reopened and a 1-1/2 inch gap in the joint was observed during the 2008 inspection. A 3 inch gap in the joint has been noted since 2009.

- c. Spalled concrete and exposed reinforcing was observed in various locations in the south (right) culvert.
- d. Fractured pieces of concrete and grout were observed at various joints in both culverts.

- e. Longitudinal and circumferential cracks were observed in both culverts.
- f. Cracks were observed in the road pavement above the structure.
- g. Sediment has deposited in the channel between Brunswick Avenue crossing and 32nd Avenue crossing and created two deltas in the channel. The channel was armored with boulder riprap in 2014. The sediment delta has been observed since 2017.

- Repair detached tie bars.
- Repair fractured concrete and grout at joints in the culverts.
- Replace boulders into the natural boulder wall between Brunswick Avenue crossing and 32nd Avenue crossing.
- Remove deposited sediment and vegetation in the channel between Brunswick Avenue crossing and 32nd Avenue crossing.
- Monitor spalled concrete and exposed reinforcing in the culverts.
- Monitor minor cracks in the culverts and road.

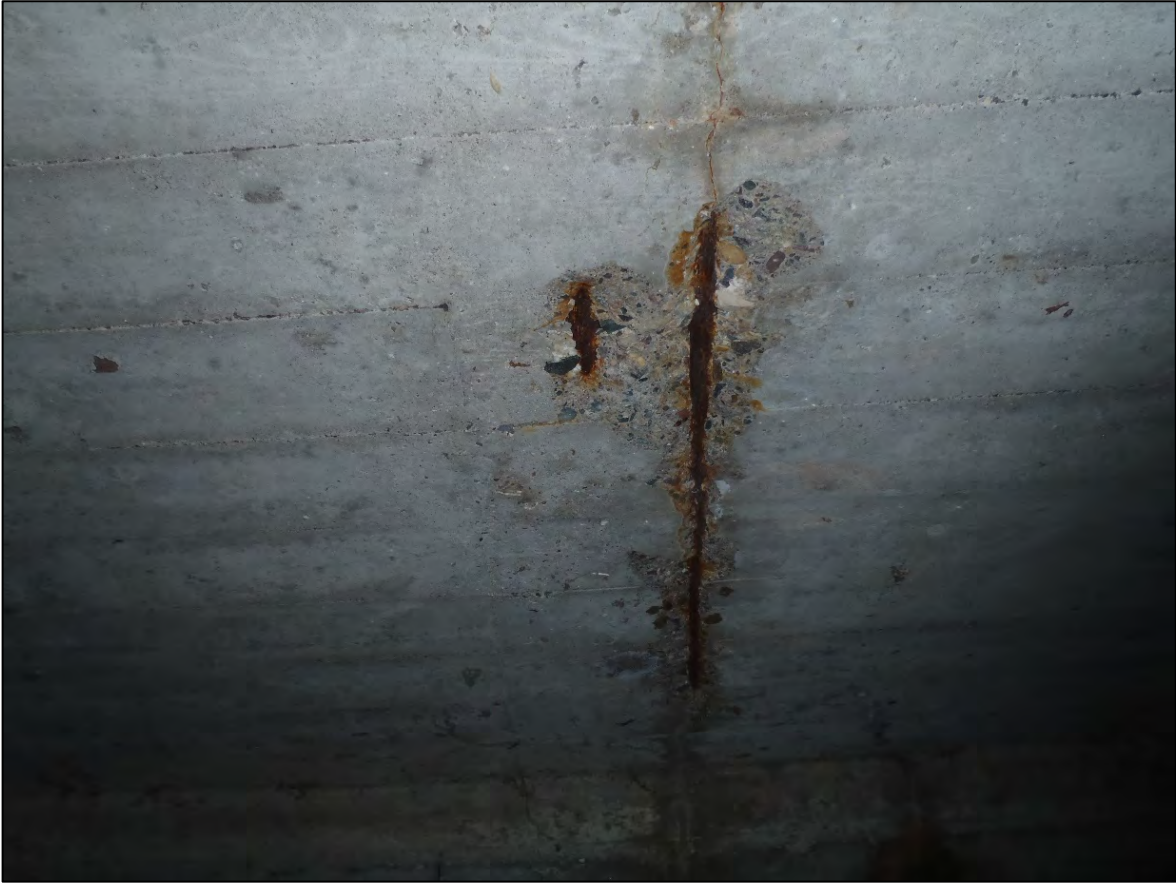
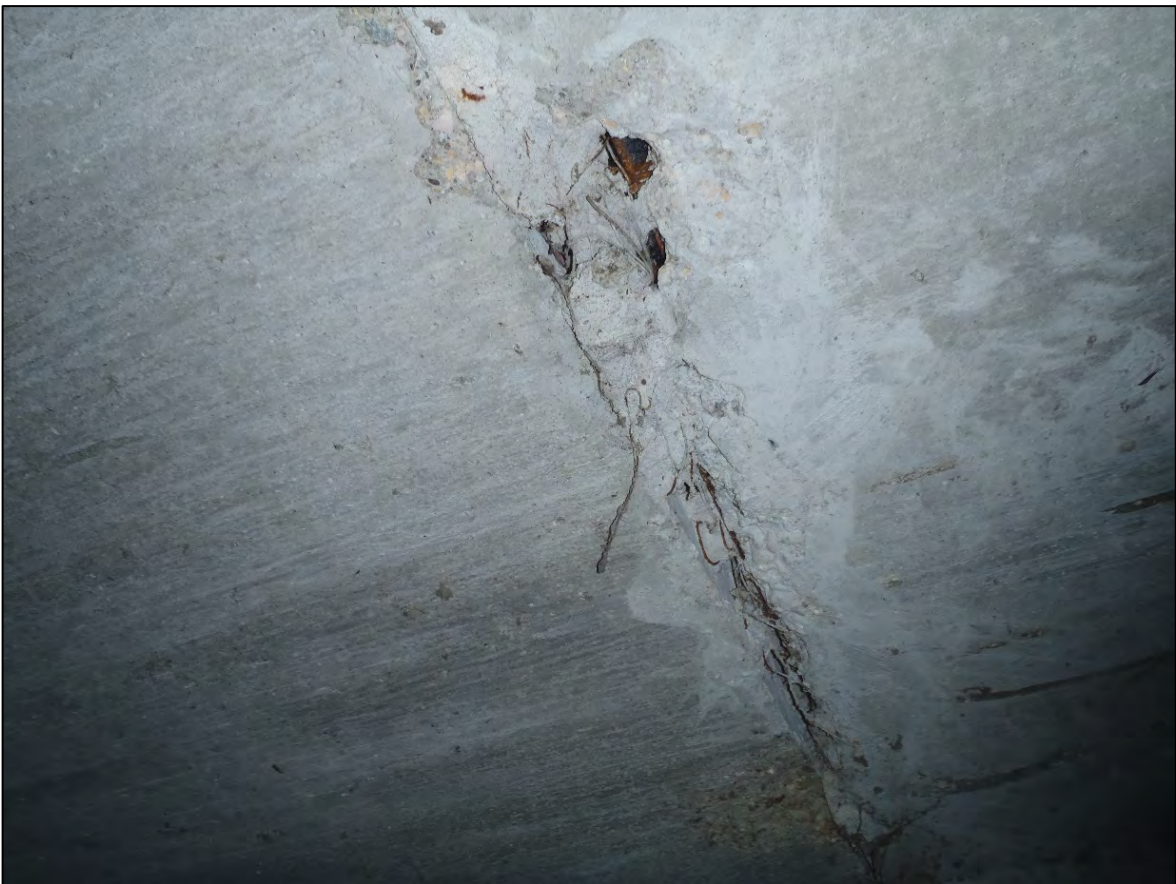
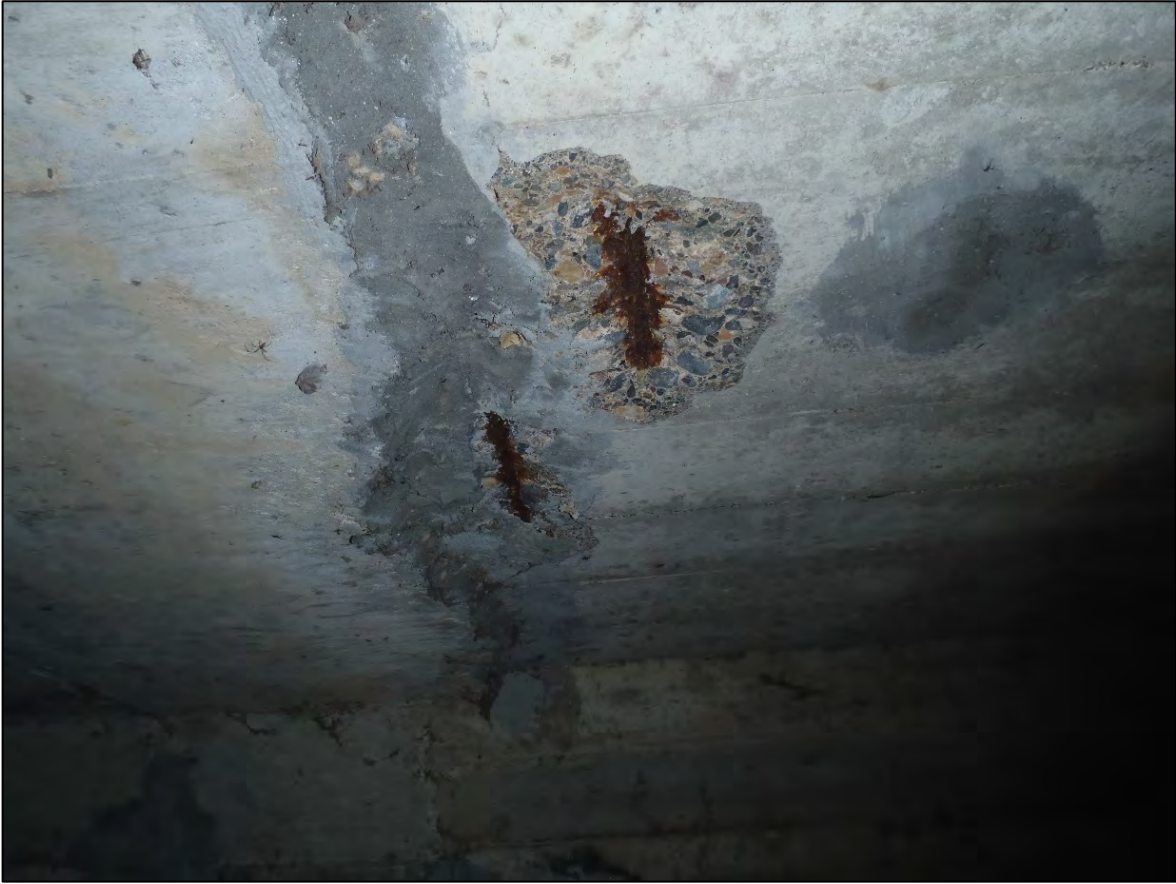
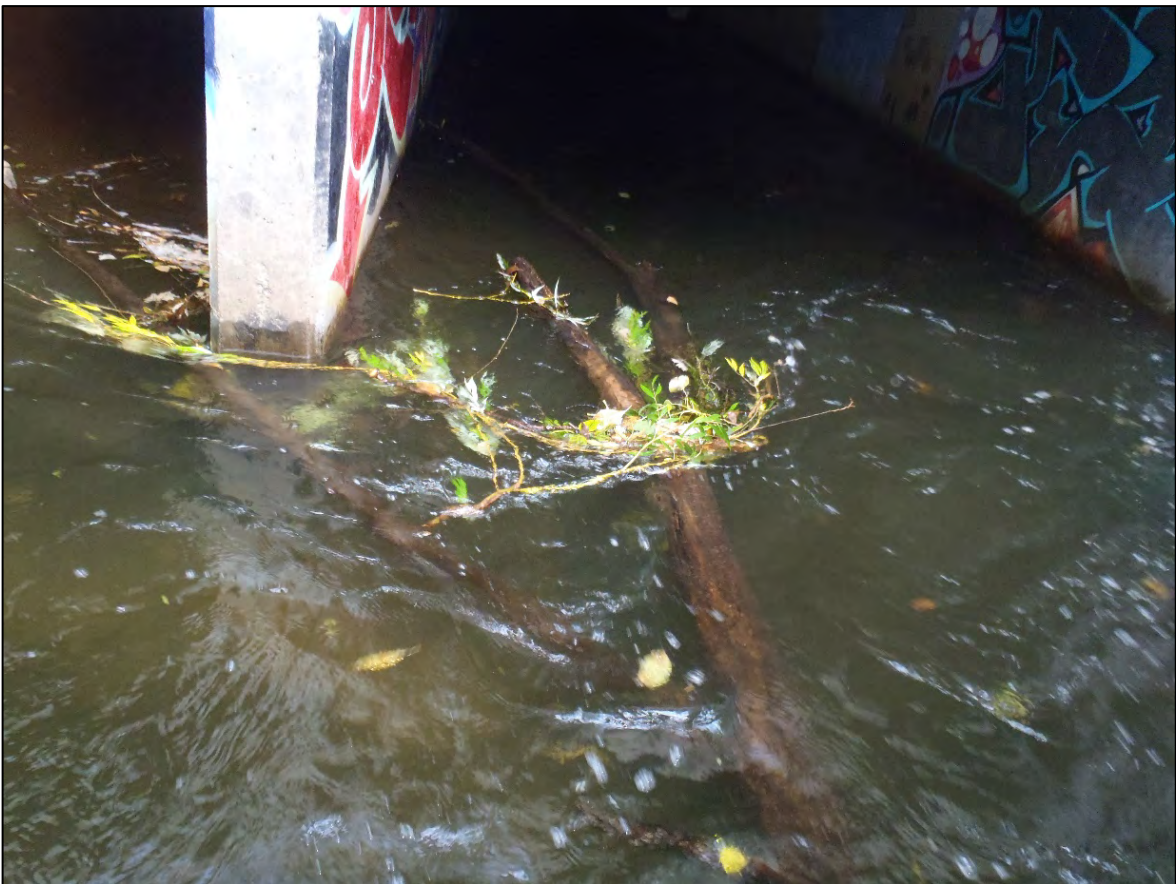
Highway 100 Double Box Culverts (Crystal/Golden Valley), continued

- a. The concrete box culverts and concrete inlet structure appeared to be in satisfactory condition.
- b. Longitudinal cracks, circumferential cracks, and areas of spalled concrete were observed along the top of the south (right) box culvert. MnDOT performed repairs to the culverts in 2007, but cracks have been noted since 2008 and areas of concrete spalling have been noted since 2014.

- c. Deposited sediment was observed in the north (left) box culvert, generally ranging from 8 to 12 inches deep. High flows in 2019 appeared to have more evenly redistributed sediment throughout the north (left) box culvert. This is consistent with previous inspections and 6-24 inches of deposited sediment has been observed in the north (left) box culvert since 2002.

- d. A large branch was stuck on the wall between the double box culverts in the inlet structure.
- e. The outlet portion of the structure appeared to be in satisfactory condition.

- Remove the large branch between the double box culverts in the inlet structure (Recommended by Crystal due to location of debris).
- Monitor accumulated sediment in north (left) box culvert and consider future removal.
- Monitor cracking and spalling concrete in the south (right) box culvert.
