## Bassett Creek Double Box Culvert Inspection Report

Prepared for  
Bassett Creek Watershed Management Commission

Inspection Date: October 2019

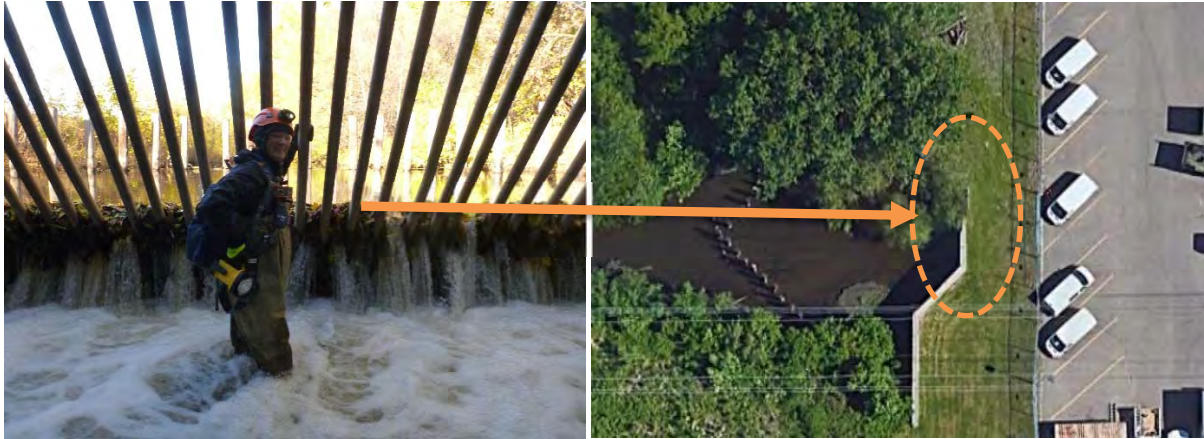
Figure 3-1 Trash Rack Debris

Significant debris buildup was observed on the trash rack at the inlet of the Double Box Culvert, as shown in Figure 3-1. It is recommended that the inspection team coordinate with the City of Minneapolis ahead of the inspection to remove accumulated debris in the trash rack to lower the upstream pool level.

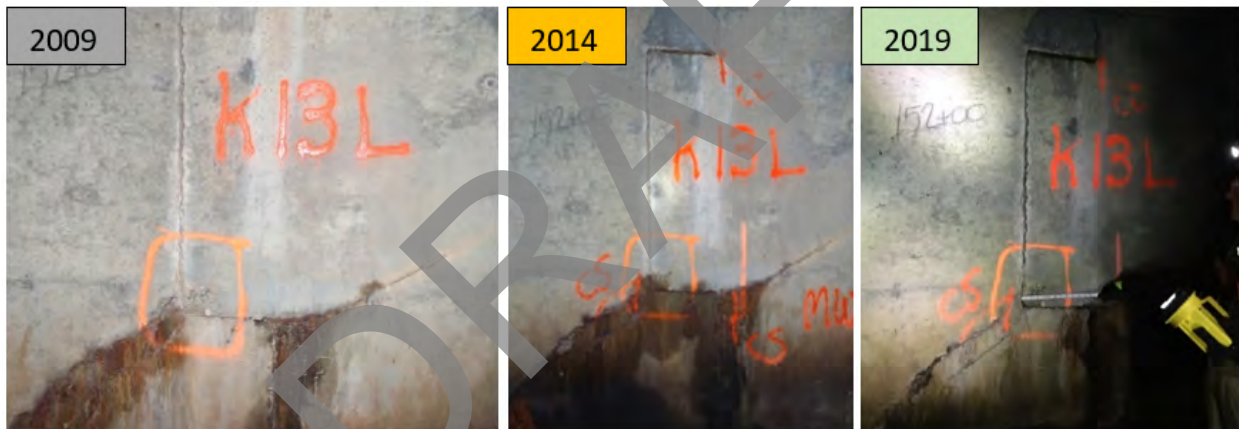
Figure 5-1 Shear Key 13 Comparison Photos

Qualitative evaluation of change in tunnel condition between the 2009, 2014, and 2019 inspections was performed by comparing representative photos of the same area of concern. Because the majority of significant defects was observed at the shear keys, special emphasis was made in comparing them. Noticeable changes were observed over the 10-year duration in some areas. For example, at shear key 13, varying degrees of infiltration were observed between the inspections, with minor infiltration observed in 2009, more significant infiltration in 2014, and less infiltration in 2019 as shown in Figure 5-1.
