Bassett Creek Double Box Culvert Inspection Report

Prepared for
Bassett Creek Watershed Management Commission

Inspection Date: October 2019

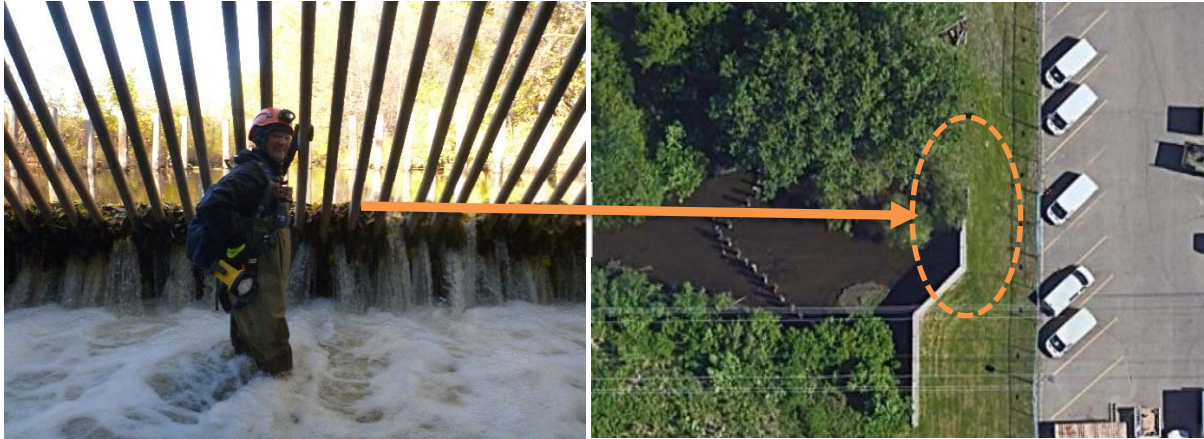
Figure 3-1 Trash Rack Debris

Significant debris buildup was observed on the trash rack at the inlet of the Double Box Culvert, as shown in Figure 3-1. It is recommended that the inspection team coordinate with the City of Minneapolis ahead of the inspection to remove accumulated debris in the trash rack to lower the upstream pool level.

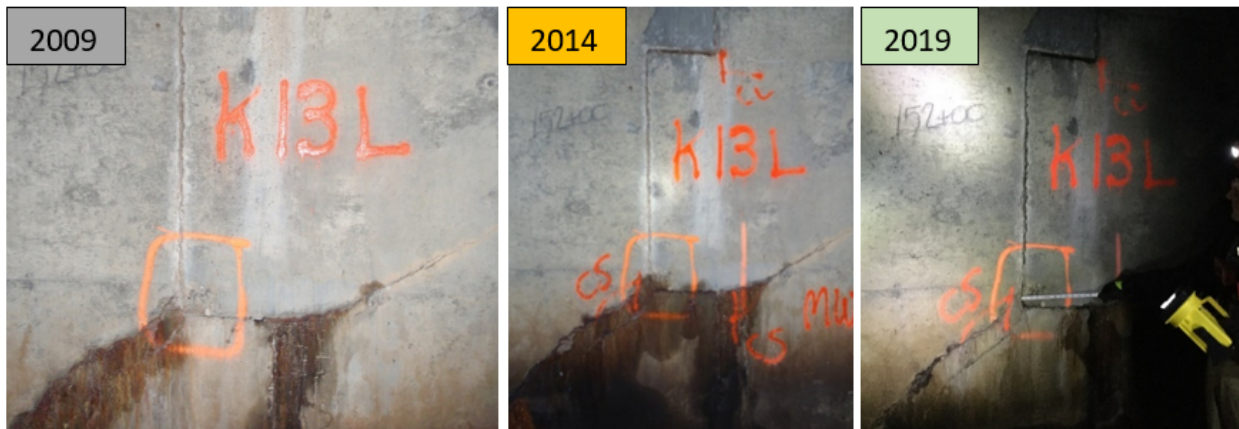
Figure 5-1 Shear Key 13 Comparison Photos

Qualitative evaluation of change in tunnel condition between the 2009, 2014, and 2019 inspections was performed by comparing representative photos of the same area of concern. Because the majority of significant defects was observed at the shear keys, special emphasis was made in comparing them. Noticeable changes were observed over the 10-year duration in some areas. For example, at shear key 13, varying degrees of infiltration were observed between the inspections, with minor infiltration observed in 2009, more significant infiltration in 2014, and less infiltration in 2019 as shown in Figure 5-1.
