Bassett Creek 3rd Avenue and 2nd Street Tunnel Inspection Report

Prepared for
Bassett Creek Watershed Management Commission

3rd Avenue and 2nd Street Tunnel Inspection Report

Inspection Date: October 2020

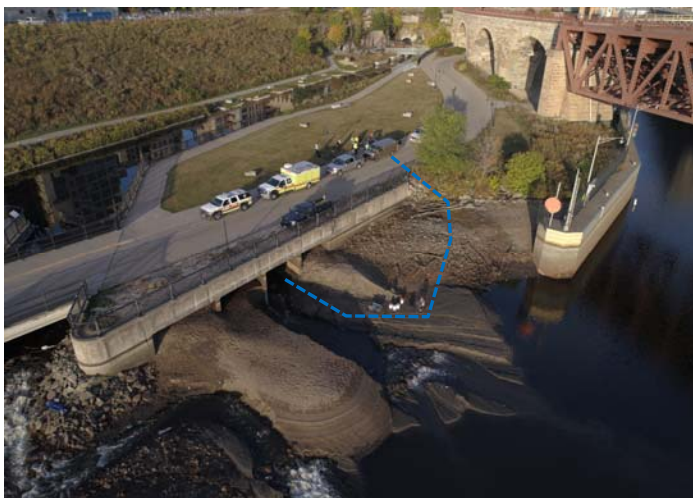
Figure 3-1 Tunnel Outlet

The tunnel outlet was the primary access and egress point for the first day of inspection. Access was achieved by walking around the fence (along Mill Ruins Park access road), down the riprap slope, and directly into the tunnel as shown in Figure 3-1. The water depth within the tunnel was approximately 2 feet for approximately the first 1,500 feet of tunnel.

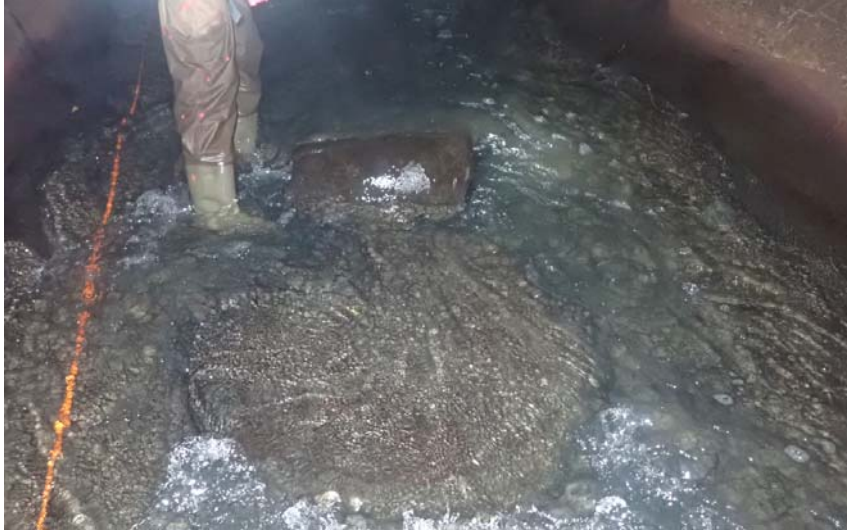
Figure 6-1 Concrete Debris

Debris Removal: Concrete debris was observed within the invert of the tunnel near the junction with the I-94 tunnel as shown in Figure 6-1. It is recommended that this debris be removed to improve tunnel conveyance and to minimize trip hazards.

Debris Removal: Concrete debris was observed within the invert of the tunnel near the junction with the I-94 tunnel. It is recommended that this debris be removed to improve tunnel conveyance and to minimize trip hazards.

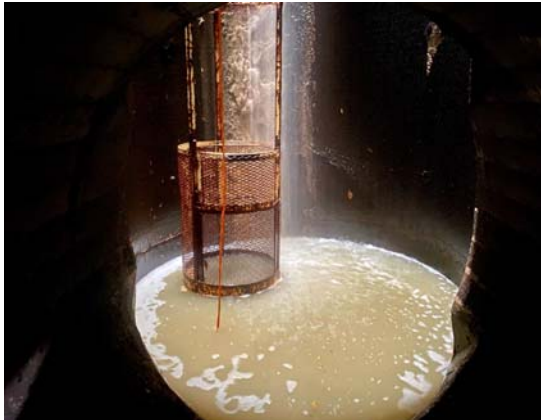
Figure 6-2 Washington Avenue Shaft

Washington Avenue Shaft Modification: The Washington Avenue Shaft is one of the primary access points to enter the Bassett Creek and the I-94/2nd Street tunnel system. The 8-foot-diameter shaft is approximately 70 feet deep and has an approximately 4-foot-deep sump at the bottom that is typically filled with water. This configuration adds challenges for access as well as safety hazards (i.e. submergence of inspectors). Barr recommends that a grated landing be installed to improve this access point for future inspections and maintenance. A photo showing the bottom of the existing shaft is included in Figure 6-2.

Washington Avenue Shaft Modification: The Washington Avenue Shaft is one of the primary access points to enter the Bassett Creek and the I-94/2nd Street tunnel system. The 8-foot-diameter shaft is approximately 70 feet deep and has an approximately 4-foot-deep sump at the bottom that is typically filled with water. This configuration adds challenges for access as well as safety hazards (i.e. submergence of inspectors). Barr recommends that a grated landing be installed to improve this access point for future inspections and maintenance..

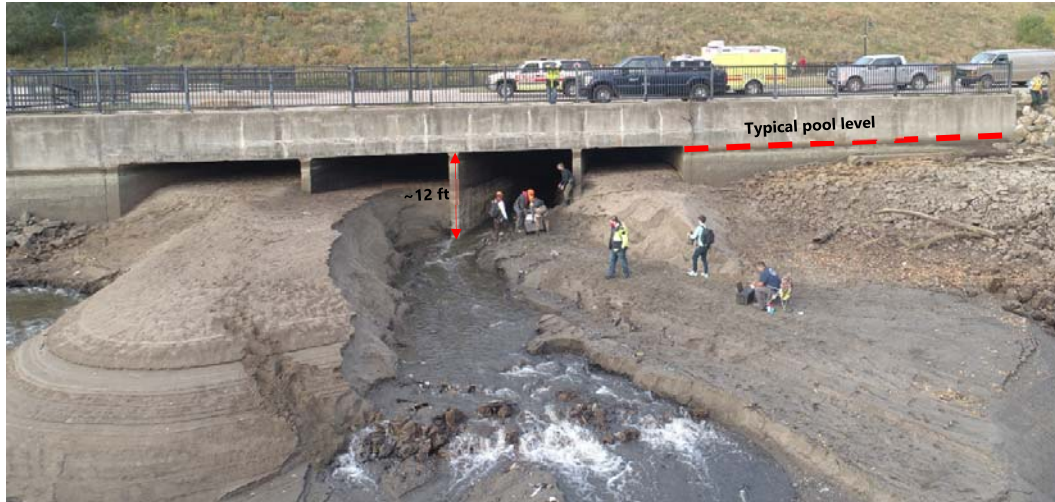
Figure 6-3 Sediment Accumulation at Tunnel Outlet

- O&M Rating – Poor: This rating is the result of the continuous sediment buildup in three of the four outlet bays. The sediment buildup results in a significant reduction in stormwater conveyance capacity.
- Structural Rating – Good: Due to the buildup of sediment, detailed structural inspection could not be performed in three of the four bays. Inspection of the one open bay indicated the concrete to be in good structural condition.

Outlet Sediment Removal: Sediment was observed blocking three of the four outlet bays in both the 2008 inspection, as well as the 2020 inspection, as shown in Figure 6-3. It is recommended that this sediment be removed within the tunnel outlet structure and immediately downstream of the outlet to improve tunnel conveyance.

Outlet Sediment Removal: Sediment was observed blocking three of the four outlet bays in both the 2008 inspection, as well as the 2020 inspection, as shown in Figure 6-3. It is recommended that this sediment be removed within the tunnel outlet structure and immediately downstream of the outlet to improve tunnel conveyance.

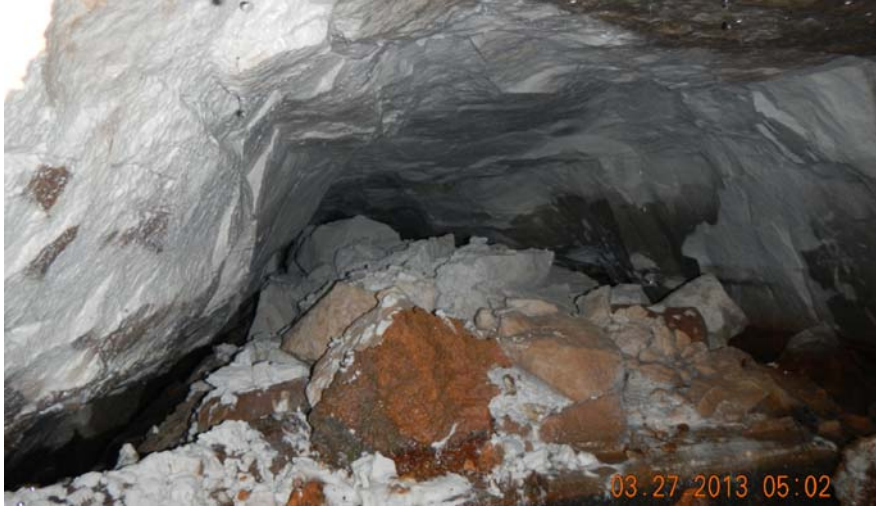
Figure 6-4 Typical Void

Void Filling: The 2020 inspection did not include an assessment of void thicknesses behind the existing concrete tunnel liner. However, voids ranging from 0 feet to 0.9 feet were measured in 2008 by others (Ref. (1)). The presence of these voids likely does not present an immediate risk to the structural integrity of the tunnel; however, if left untreated, the voids may increase due to the friable nature of the sandstone which can be transported into the tunnel through points of infiltration which could lead to larger more significant problems including:

- **Tunnel Lining Failure:** The tunnel lining is unreinforced concrete and relies upon a solid contact with the surrounding sandstone to transfer surcharge loading. If this contact is lost, the tunnel lining can crack and ultimately fail. This is particularly important for the Cathedral Arch tunnel between station 23+70 to 64+94 which is unreinforced concrete.
- **Ground Loss and Sinkholes:** The St. Peter Sandstone formation is friable, and the development of large voids is a common occurrence outside of the deep stormwater tunnels in the Twin Cities region. If left untreated, these voids can increase and extend up to ground surface and cause ground loss or damage to infrastructure.

It is recommended that these voids be filled with grout to restore the outside tunnel lining contact, as well as close flow paths that lead to erosion and development of these voids. A photo of a typical void above a similar stormwater tunnel in Minneapolis is provided in Figure 6-4 for reference.
