Memorandum

To: Bassett Creek Watershed Management Commission (BCWMC)
From: Barr Engineering Co.
Subject: Bassett Creek 2021 Flood Control Project Inspection
Date: October 14, 2021
Project: 23270051.52 2021 4065

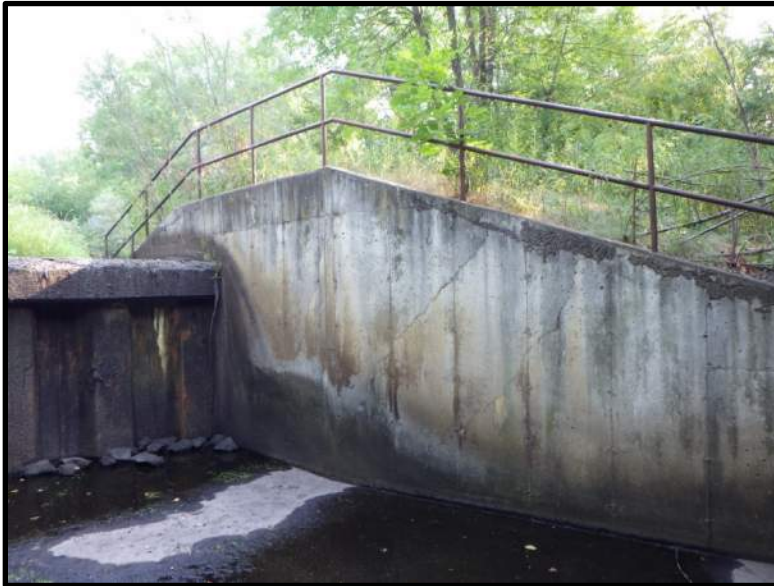
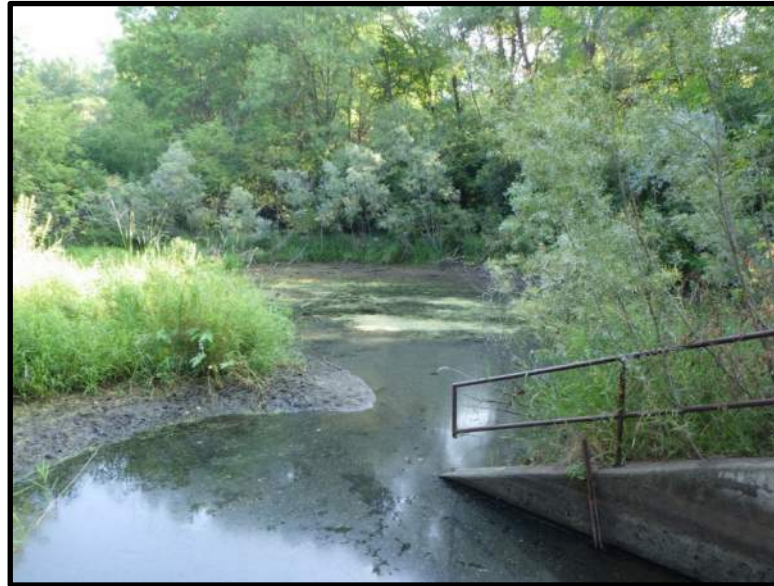
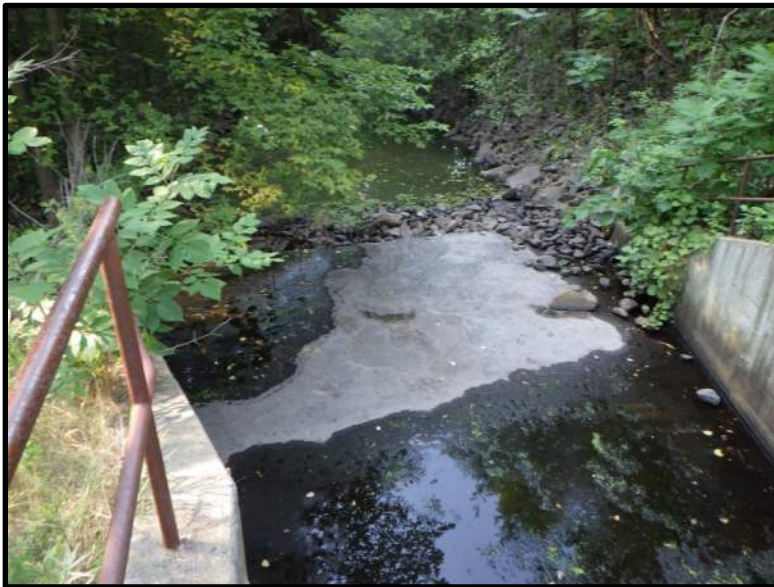
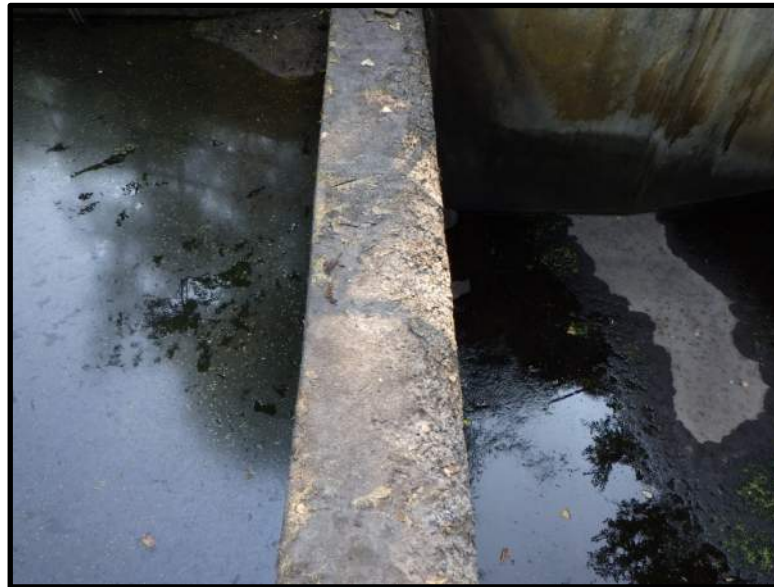
Plymouth Creek Fish Barrier (Plymouth)

- a. The structure appeared to be in satisfactory condition.
- b. The water level was below the staff gauge but was calculated as -0.90 feet by measuring down. Water was 1.04 feet below the weir at the time of the inspection.

- c. Sediment has accumulated in the pool upstream of the structure and formed a delta, which was overgrown with vegetation. The deposited sediment was generally creating a meander in the creek toward the east (left) bank. Deposited sediment has been noted since 2005 and appears to be increasing over time.

- d. The railings at the upstream end of the structure, on the east (left) and west (right) sides, have rusted off below the water level. This is consistent with previous inspections and has been noted since 2015.

- f. The top downstream edge of the concrete pile cap forming the weir has deteriorated along its entire length. Deterioration includes loss of cement paste and fines resulting in exposed aggregate. The weir appears to be functioning properly and controlling water to the design elevation.

- g. Three cracks were observed on the downstream west (right) wing wall. This is consistent with previous inspections and has been noted since 2004.
- h. Seven diagonal cracks were observed on the downstream east (left) wing wall. Three of the cracks are more prominently defined, closed cracks. Observation of the three prominent cracks is consistent with previous inspections and has been noted since 2002. The other four cracks are generally closed hairline cracks and less noticeable.

- i. A 14-inch diameter tree was observed growing adjacent to the downstream east (left) wing wall and through the railing.
- j. Small trees and shrubs were observed growing on the embankment and downstream channel banks, including some near the wing walls and railings.

therefore dredging of the sediment upstream of the fish barrier, in order to continue to utilize the area upstream of the fish barrier as a sedimentation pond, was prohibited by the MPCA and not permitted. It is recommended that the City of Plymouth coordinate with the MPCA to revisit this issue or discuss viable alternatives to remove the sediment since the project intent was not as a sediment basin but as a fish barrier.)

- Repair railings on the upstream side of the structure.
- Remove trees and vegetation on embankment and channel banks. Chemically treat stumps with Garlon 3A herbicide (or other specialty herbicide for use in wetland sites and waterways) to prevent regrowth.
- Monitor concrete cracks and the width of the expansion joints.

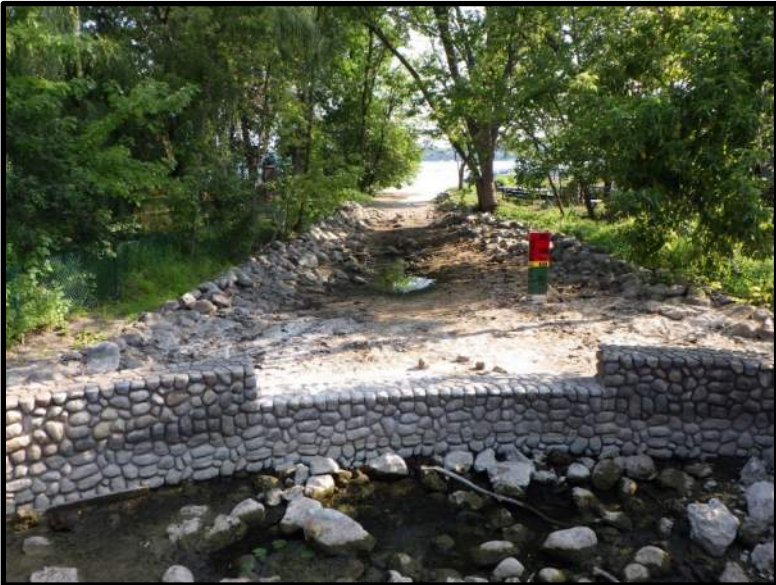
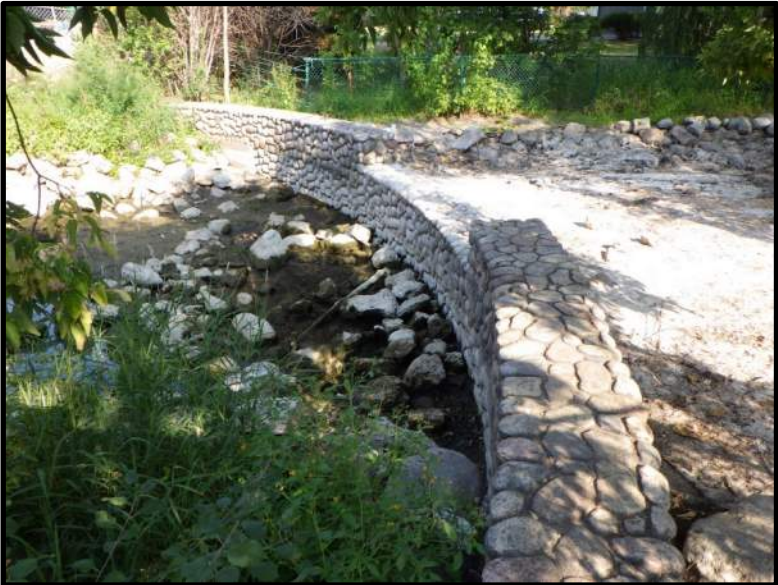
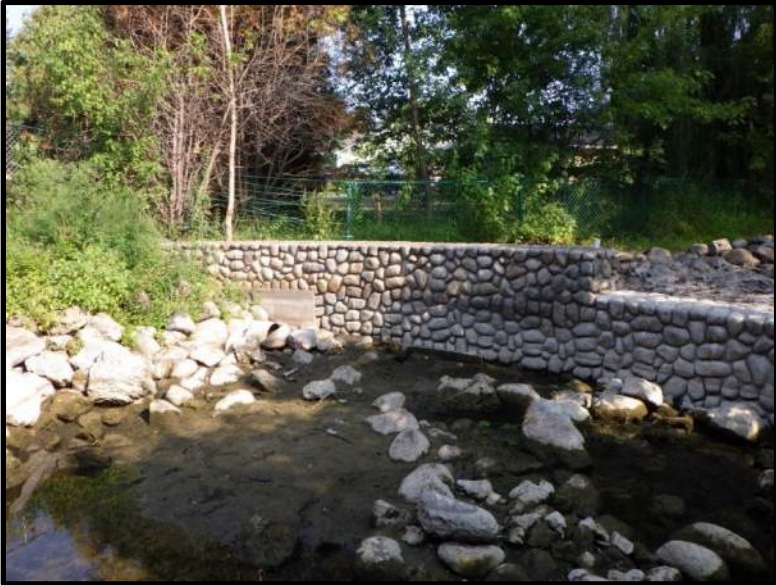
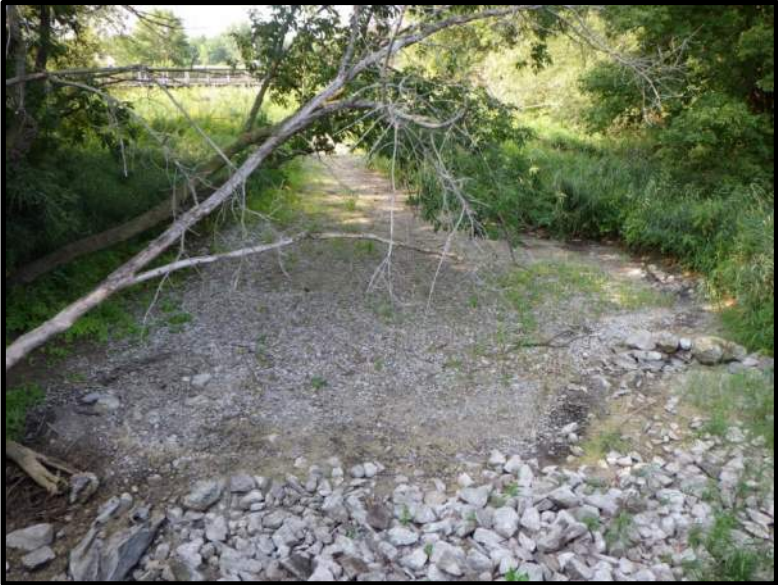
Medicine Lake Outlet (Plymouth)

- a. The channel between Medicine Lake and the outlet structure was dry and clear of debris.
- b. The outlet structure appeared to be in satisfactory condition.
- c. A new staff gauge was cooperatively manufactured and installed by the BCWMC and City of Plymouth on March 17, 2021. The gauge was "in the dry" due to drought conditions during the inspection.
- d. Although not part of the Bassett Creek FCP, there is a large willow tree directly downstream of the South Shore Drive bridge that has begun to fall into the creek and could block or divert flows toward the right bank if it falls completely.

In late May 2019, City of Plymouth staff observed water flowing over the east side, but not the west side, of the Medicine Lake Outlet Structure. The city performed a baseline survey of the dam in the summer of 2019 and found that the east side of the dam was 0.15 feet lower than the west side. Future surveys can be performed to compare against the baseline.

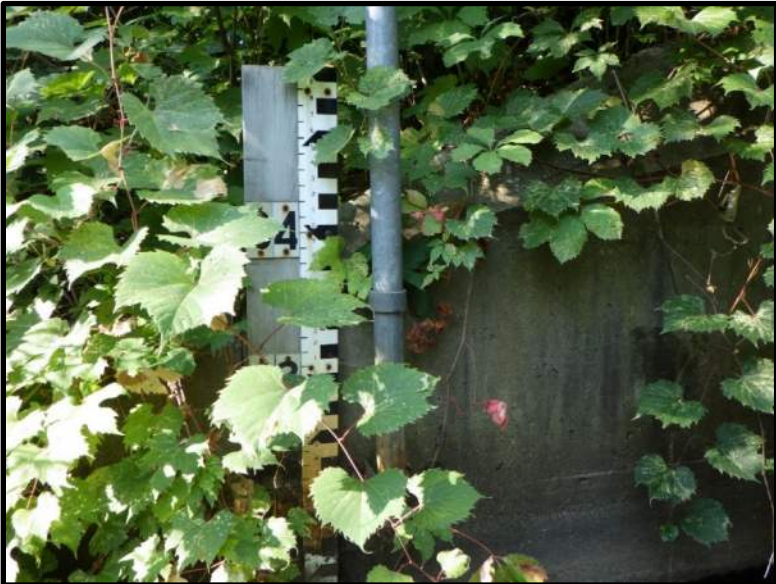
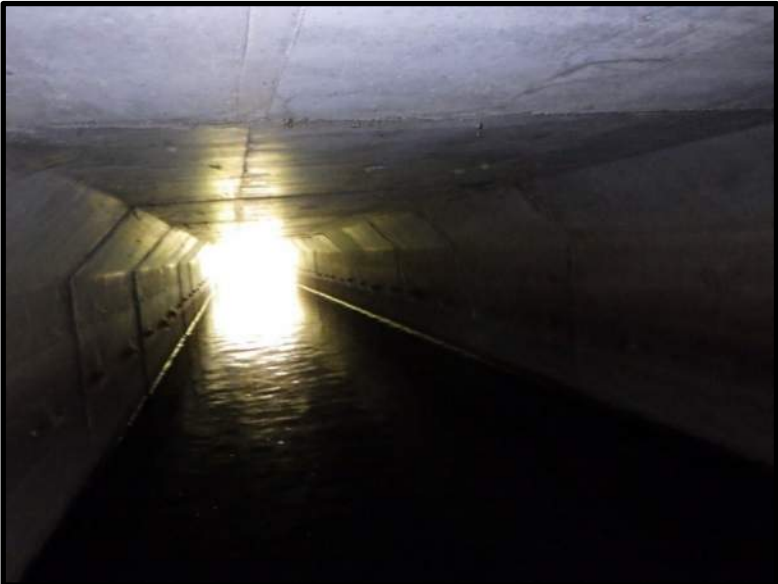
Wisconsin Avenue Control Structure (Golden Valley)

- a. The water level was below the lowest staff gauge reading upstream and downstream of the culvert.
- b. The flood gate was closed (down) at the time of the inspection and appeared to be in satisfactory condition.

- c. Deposited sediment was observed in the bottom of the culvert, ranging from 0-2 inches deep. The deposited sediment is consistent with previous inspections and has been noted since 2006.
- d. Some of the gabion baskets upstream and downstream of the culvert have deteriorated or broken and riprap had fallen out of the baskets at some locations. Although the gabion baskets are no longer functioning as installed, no significant erosion was observed.
- e. The railings at the upstream and downstream ends of the culvert were in satisfactory condition.
- f. Brush is growing around the downstream end of the culvert.

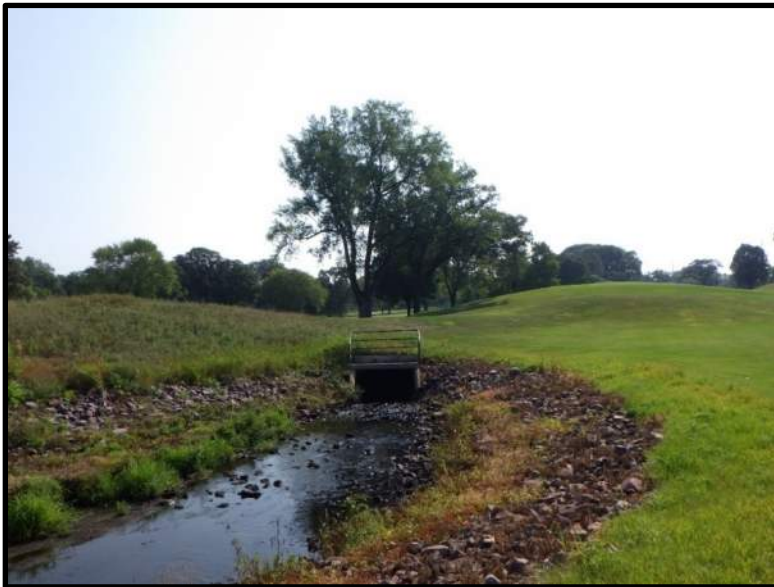
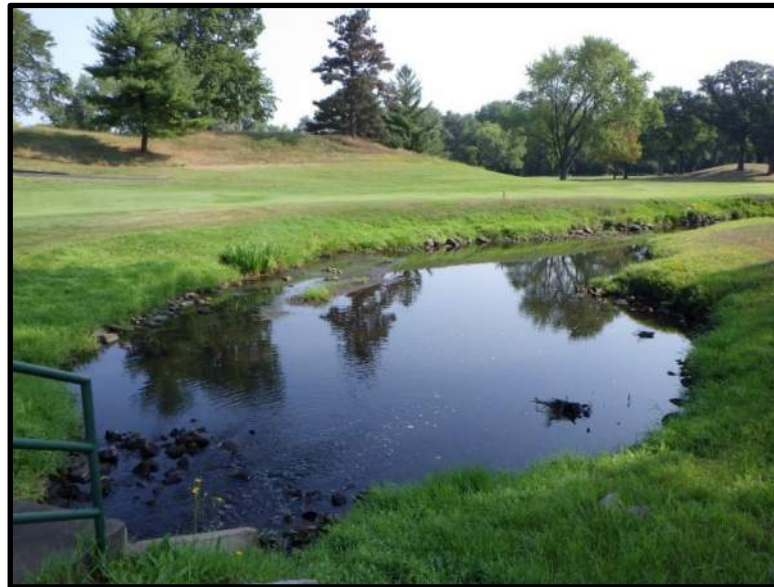
Golden Valley Country Club (Golden Valley)

- a. The channel and riprap armoring from Pennsylvania Avenue to the box culvert appeared to be in satisfactory condition.
- b. The box culvert, joints, and railings appeared to be in satisfactory condition.
- c. The overflow weir (earth berm) appeared to be in satisfactory condition and has been maintained by the Golden Valley Country Club staff as manicured fairway turf.
- d. Some sediment deposition was observed on the north (left) bank just upstream of the box culvert on top of the riprap, consistent with previous years.
- e. Some sediment deposition in other upstream areas was observed. This may have been due to low water levels.

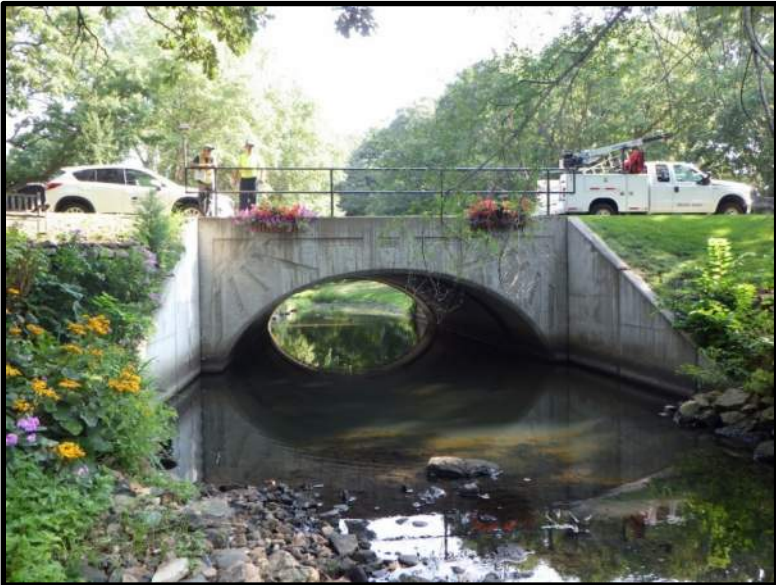
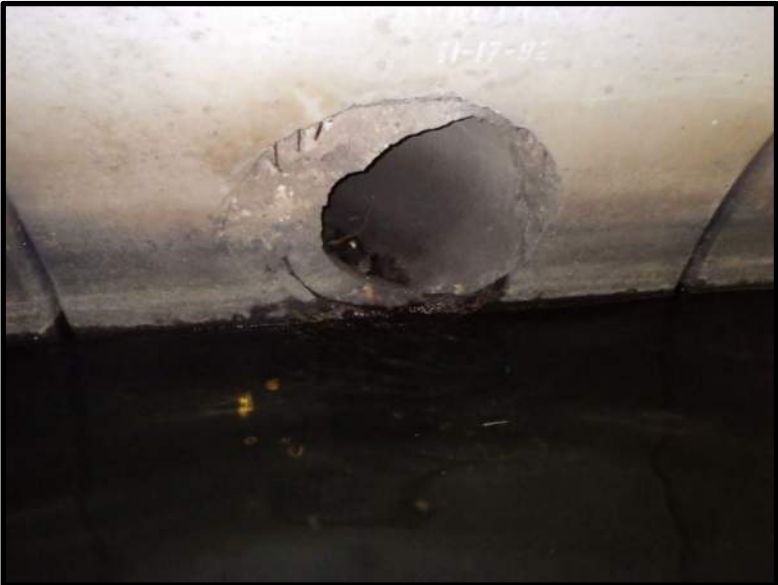
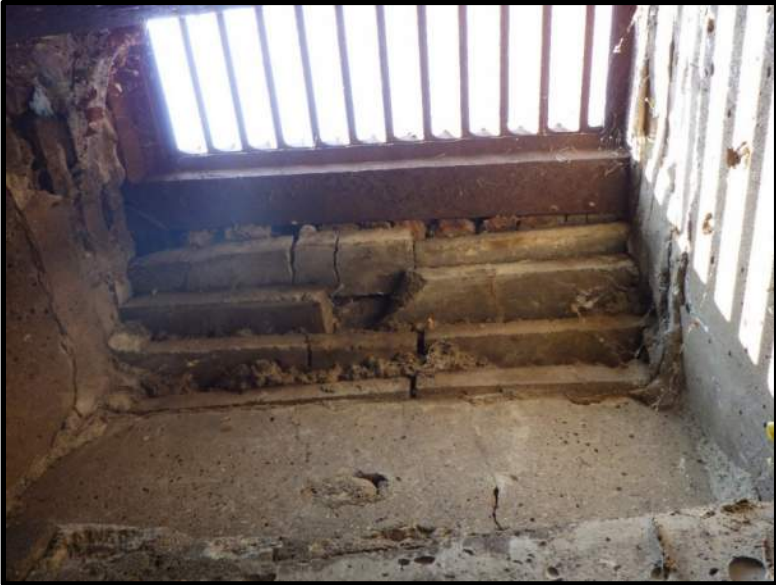
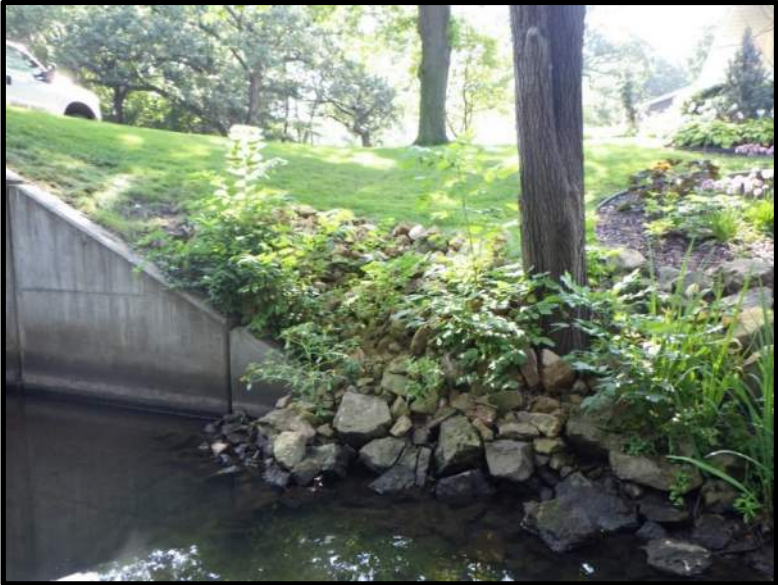
Westbrook Road Crossing (Golden Valley)

- a. The concrete Bebo culvert appeared to be in satisfactory condition.
- b. Spalled concrete and exposed rebar were observed around the storm sewer pipe entering the culvert on the west (left) side, this was noted in the previous years' inspections.
- c. Longitudinal hairline cracks were observed on the top of sections of the Bebo culvert, extending across the entire section (pre-cast section) width. The cracks are approximately 2 feet off-center of the structure. These cracks are consistent with previous inspections and have been noted since 2002.

- d. A joint gap and separation were observed between the two furthest downstream sections of the culvert and there are signs of pressure points where the last section has pushed against the top of the two wing walls. Fractured concrete was observed on the east (right) side of the culvert, potentially due to the movement. This is consistent with previous inspections and has been noted since 2015.
- e. Spalled concrete was observed at multiple locations upstream and downstream of the culvert at the top of the wing walls and head wall. This is consistent with previous inspections and has been noted since 2007.
- f. Cracks were observed in the road pavement above the structure. This is consistent with previous inspections and has been noted since 2010. Crack sealant was applied to the road surface in 2019.
- g. The railings appeared to be in satisfactory condition.

- Repair spalled concrete and exposed rebar at storm sewer connection on west (left) side of culvert.
- Provide grout at the downstream east (right) catch basin to prevent further deterioration of the concrete adjusting rings resulting in potential damage to the road or culvert.
- Monitor cracks in the culvert.
- Monitor joint gap and fractured concrete at pressure points.
- Monitor spalled concrete at wing walls and head walls.
- Monitor cracks in the road.

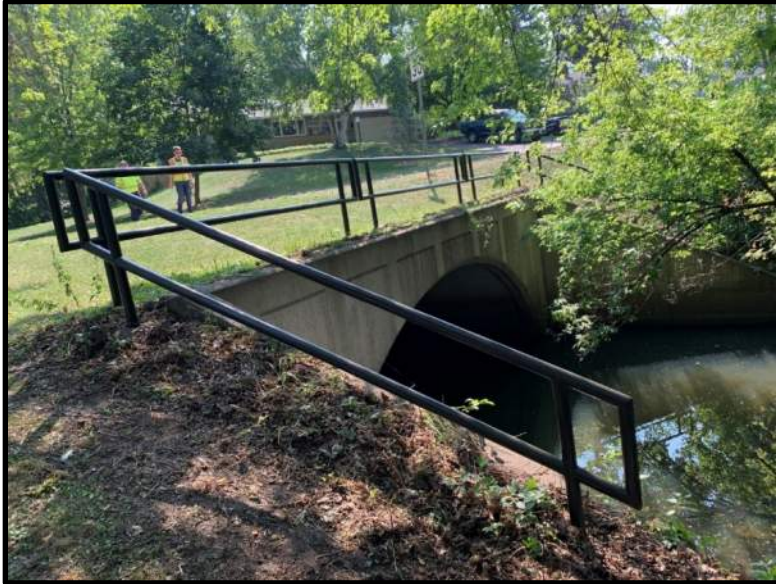
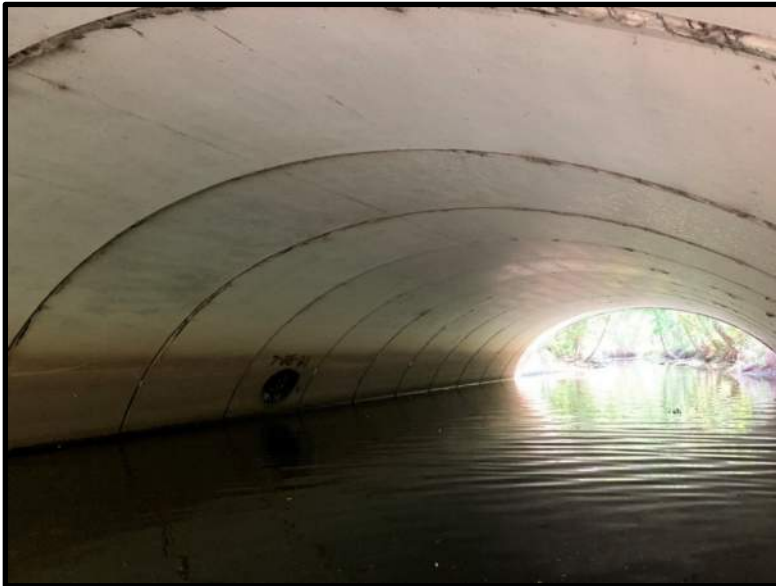
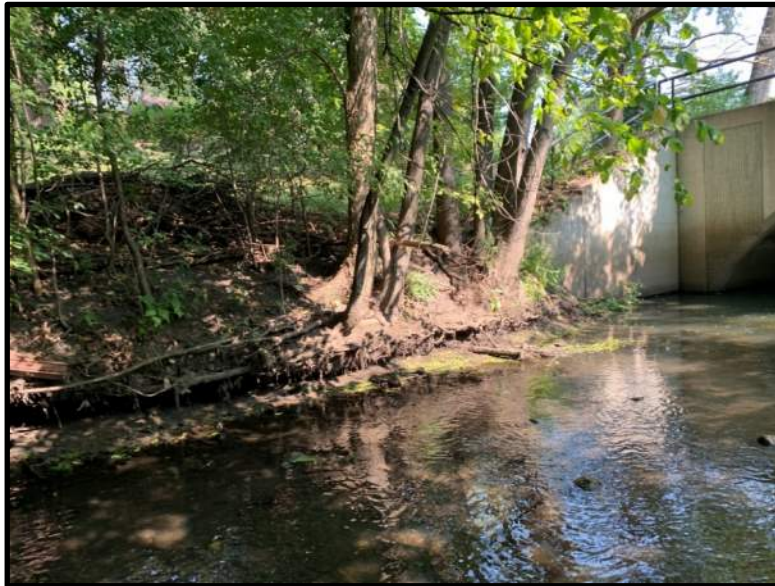
Regent Avenue Crossing (Golden Valley)

- a. The concrete Bebo culvert appeared to be in satisfactory condition.
- b. The channel bottom was soft and mucky and the water level was below the bottom of the staff gauge and not measured.

- c. Spalled concrete was observed at the middle joint of the upstream north (left) wing wall. This is consistent with previous inspections and has been noted since 2002.

- d. A crack was observed at the upstream north (left) wing wall. The crack was near the top of the wing wall and travels at a 45-degree angle down to the headwall. This is consistent with previous inspections and has been noted since 2002.

- e. Multiple cracks were observed at the upstream south (right) wing wall. This is consistent with previous inspections and has been noted since 2008.

- f. City staff repaired the spalled concrete and exposed rebar that were previously observed around the storm sewer pipe entering the culvert on the north (left) side.

- g. A crack was observed at the downstream south (right) wing wall. The crack was near the top of the wing wall and travels at a 45-degree angle down to the headwall. This is consistent with previous inspections and has been noted since 2002.

- h. Flows appeared to have scoured the north (left) side of the creek bottom and deposited sediment on the south (right) side of the creek bottom.
- i. The railings appeared to be in satisfactory condition.

- Monitor spalled concrete at the upstream north (left) wing wall.
- Monitor crack at the upstream north (left) wing wall.
- Monitor cracks at the upstream south (right) wing wall.
- Monitor crack at the downstream south (right) wing wall.
- Monitor creek bottom for scouring and deposition and, as needed, armor creek bottom along culvert foundation.

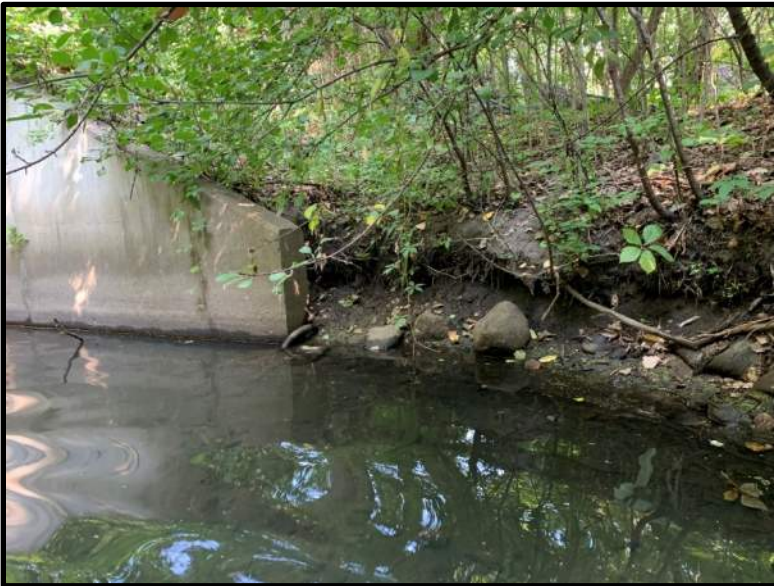
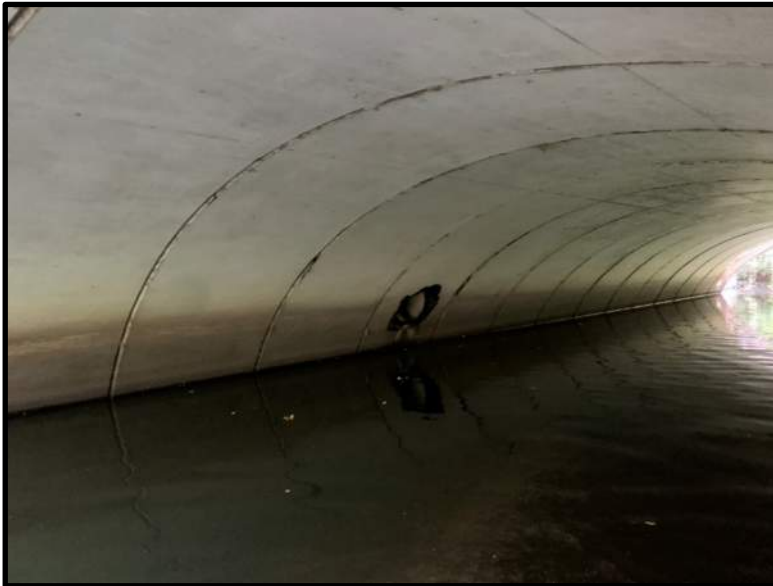
Noble Avenue Crossing (Golden Valley)

- a. The concrete Bebo culvert appeared to be in satisfactory condition.
- b. Longitudinal hairline cracks were observed throughout the length of the top of the culvert, extending across the entire (pre-cast) section width. The cracks were either in the center of the structure or approximately 2 feet off-center of the structure. This is consistent with previous inspections and has been noted since 2002.

- c. Spalled concrete and exposed plastic joint material were observed approximately two feet either side of center throughout the length of the top of the culvert. The cement paste covering the plastic joint material has separated and exposed the plastic. This is consistent with previous inspections and has been noted since 2002.

- d. In July 2021, city staff repaired the spalled concrete and exposed rebar that were previously observed around the storm sewer pipe entering the culvert on the north (left) side.

- e. Spalled concrete was observed at the downstream north (left) wing wall. This is consistent with previous inspections and has been noted since 2002.

- f. Multiple cracks and spalling were observed at the top of downstream north (left) wing wall. The cracking is consistent with previous inspections and has been noted since 2007.

- h. Minor bank erosion and scour was observed on both sides of the downstream wing walls. This is consistent with previous inspections and has been noted since 2002.
- i. Flows appeared to be scouring the north (left) side of the creek bottom.
- j. The railings appeared to be in satisfactory condition.
- k. The City of Golden Valley installed riprap in 2018 to reinforce the bank and minimize continued erosion at the outside edge of the upstream south (right) wing wall, however some erosion has perpetuated upstream.

- Monitor cracks and spalled concrete in the culvert and wing walls.
- Monitor bank erosion at downstream wing walls and upstream of installed riprap at upstream south (right) wing wall.
- Monitor creek bottom for scouring and, as needed, armor creek bottom along culvert foundation.

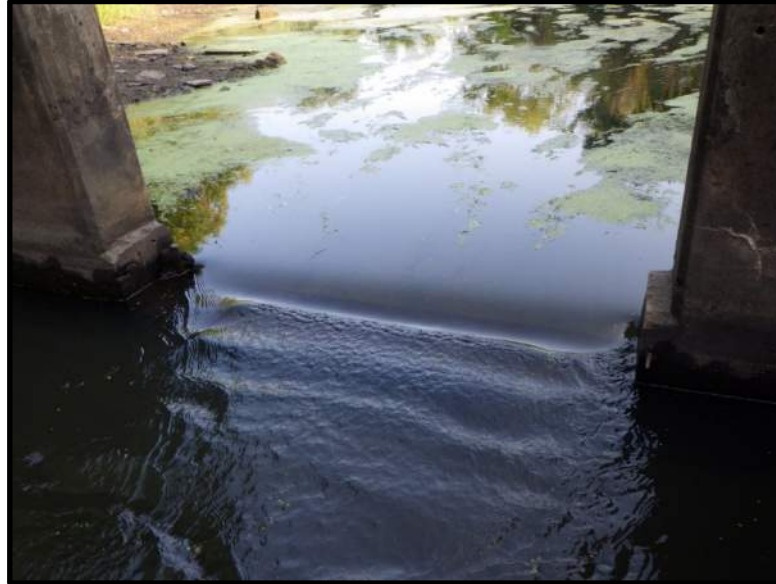
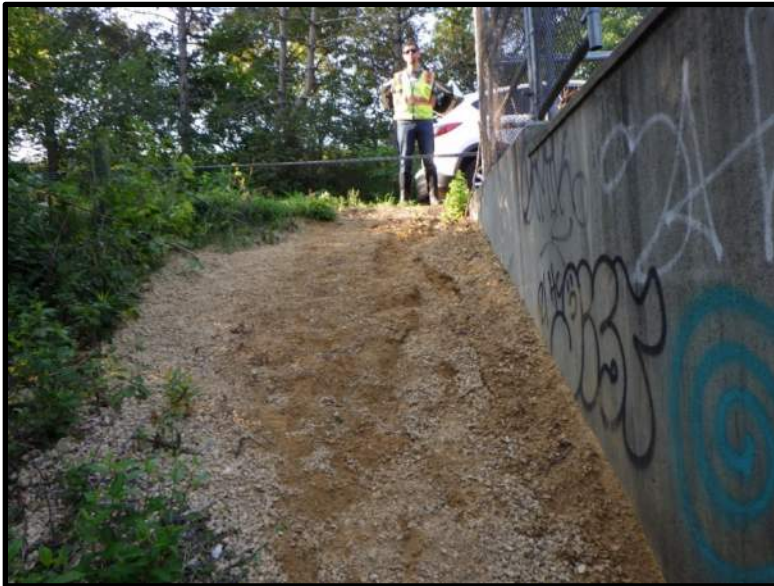
Highway 55 Control Structure (Golden Valley/Minneapolis)

- a. The concrete control structure appeared to be in satisfactory condition.
- b. A hairline crack was observed in the east (left) wall of the inlet structure, although it appears that the crack may have been previously sealed with caulk. The crack is positioned in the middle of the wall extending full height. This is consistent with previous inspections and has been noted since 2002.

- c. Erosion was observed around the east (left) side of the structure, likely from road runoff. In the summer of 2021, Minnesota Department of Transportation (MnDOT) crews placed class 5 aggregate on the east (left) side of the structure to access the upstream end of the structure to preform repairs of the double box culvert below Highway 55. The new class 5 aggregate is actively eroding.

- d. MnDOT crews also drilled holes into the structure to install brackets and a temporary plate to block flows through the structure so they could perform repairs. MnDOT removed the plate, brackets, and bolts, but did not fill or repair the bolt holes.

- e. A piece of rebar and relatively small mass of concrete extended into the lower west (right) side of the opening of the low flow weir. A steel threaded rod extended approximately 2 inches from the south face of concrete on the east (left) side of low flow weir. These observations have not been noted in previous years' inspections, but water levels were lower in 2021 than previous years, exposing this part of the structure for the first time or since 2015.

- Protect the sides of the structure with armoring (rock or riprap) or reinforced vegetation to limit additional erosion. Alternatively, divert road runoff away from the structure.
- Request that MnDOT repair bolt holes with concrete gout.
- Sawcut and remove rebar and concrete chunk on east (left) side of low flow weir.
- Sawcut steel rod to be flush to concrete along south face of concrete on the east (left) side of the low flow weir.
- Monitor hairline crack in the control structure.

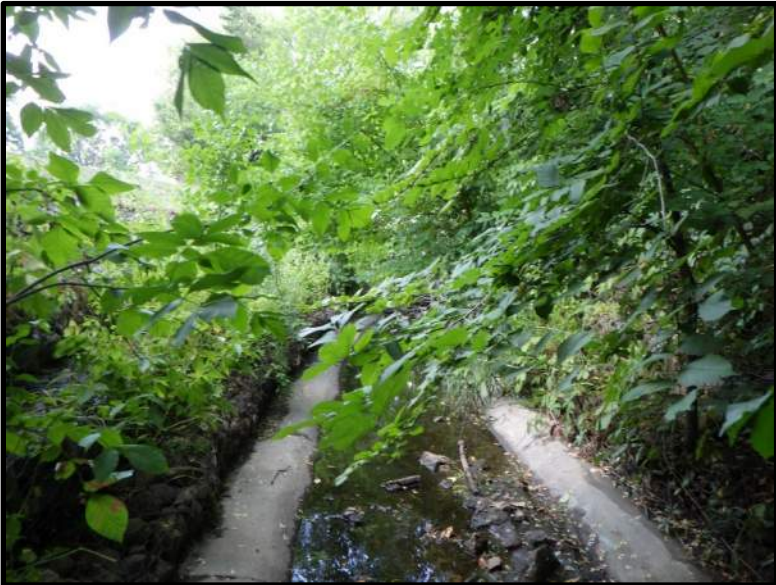
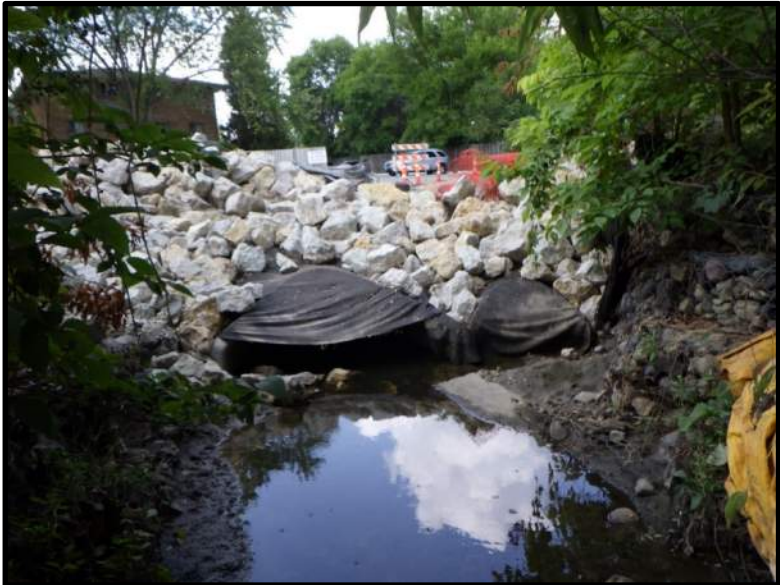
Markwood Open Channel – Gabion Section (Crystal)

- a. The channel appeared to be in satisfactory condition.
- b. Significant vegetation growth was observed along the gabion section of the channel.
- c. In 2021, the City of Crystal replaced the creek culvert across Louisiana Avenue and added riprap. Some construction features are still in place as the site was actively under construction at the time of the inspection.

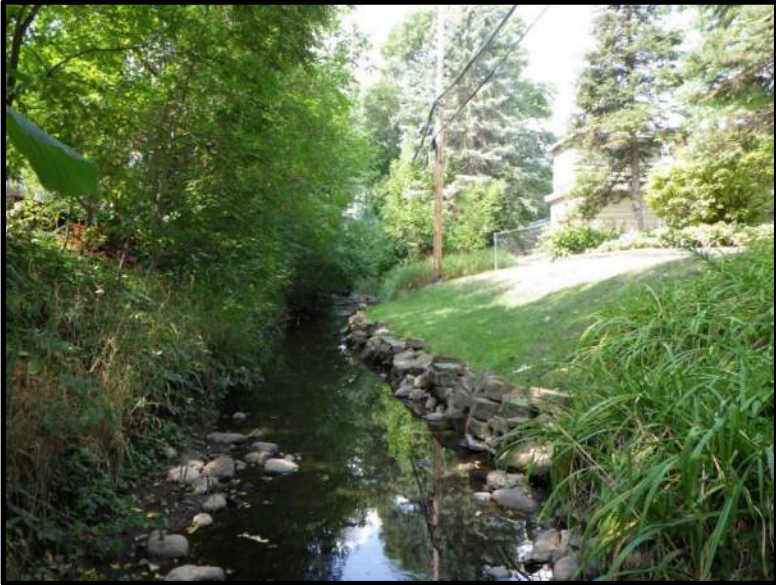
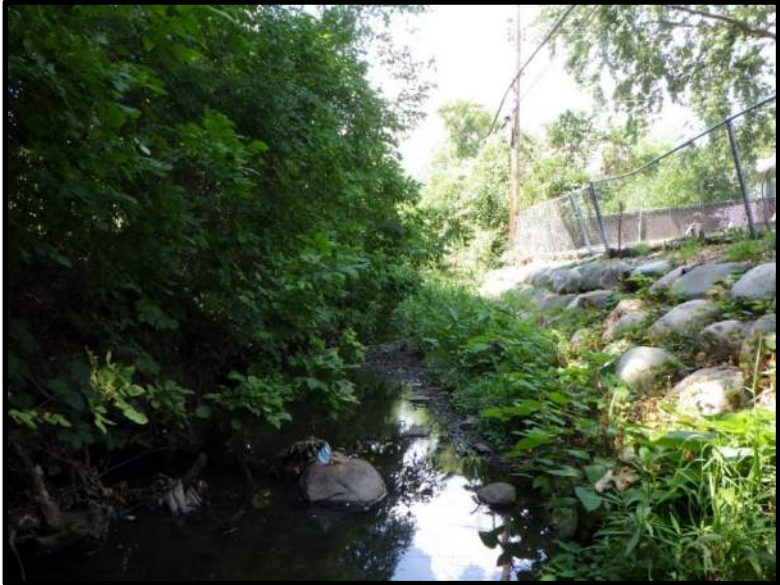
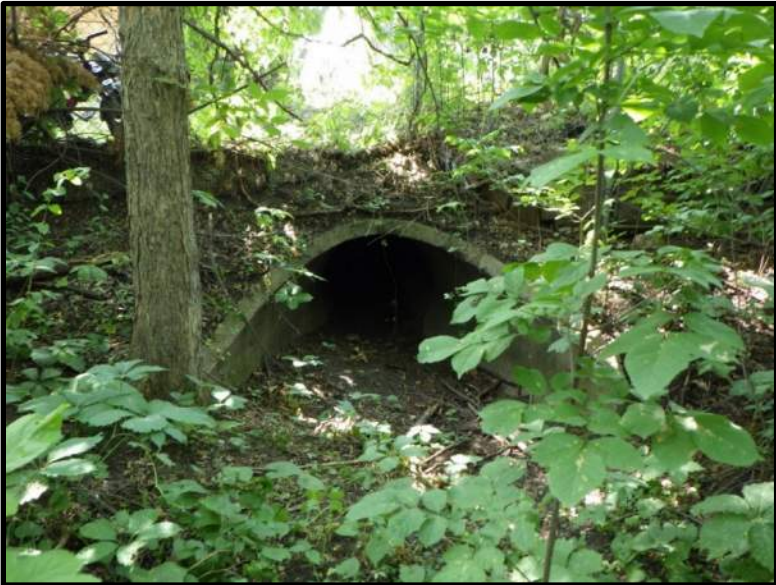
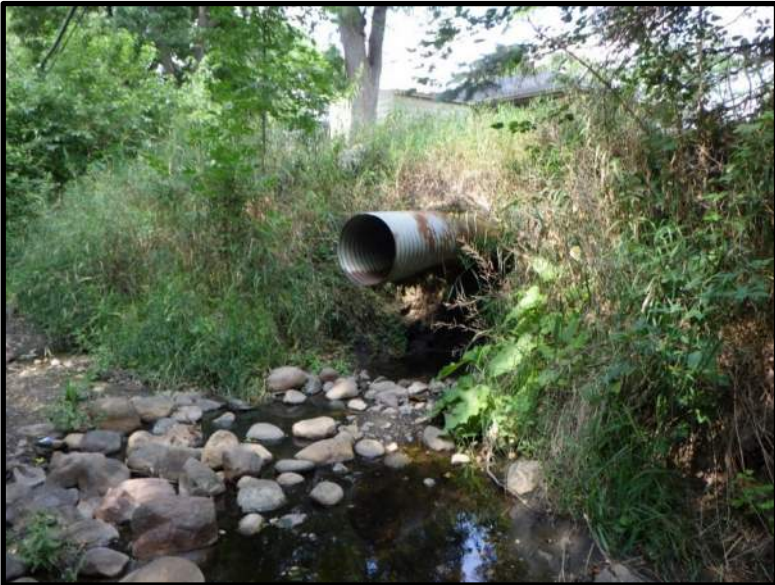
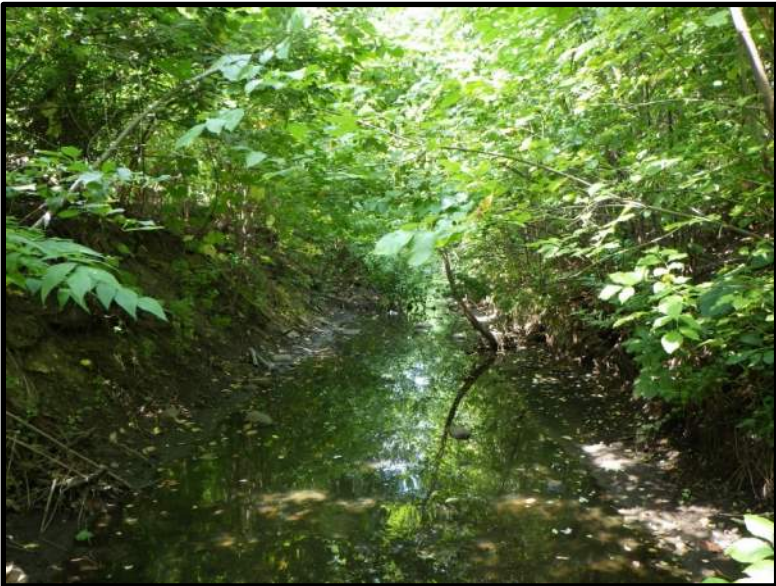
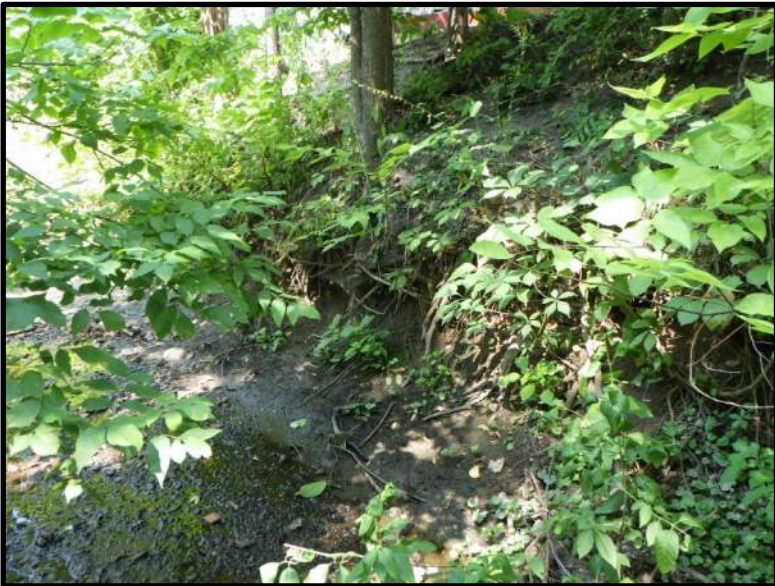
Markwood Open Channel (Crystal)

- a. The channel appeared to be in satisfactory condition.
- b. Significant vegetation growth was observed along the side slopes of the channel.
- c. Erosion was observed along the toe of the north (left) and south (right) banks. This is consistent with previous inspections and has been noted since 2006.
- d. Some homeowner retaining walls and fences along the channel were leaning toward the channel and, in some cases, appeared to be failing. This is consistent with previous inspections and has been noted since 2009.
- e. The city's corrugated metal pipe (CMP) storm sewer, discharging into the channel between 6833 and 6825 Markwood Drive, was in poor condition. The pipe bottom was corroded and there was erosion and undercutting around the pipe end.

- Although not part of the flood control project, monitor retaining walls and fences for potential failure and obstruction of flow through the channel.
- Although not part of the flood control project, City may want to consider repairing or replacing the CMP storm sewer.

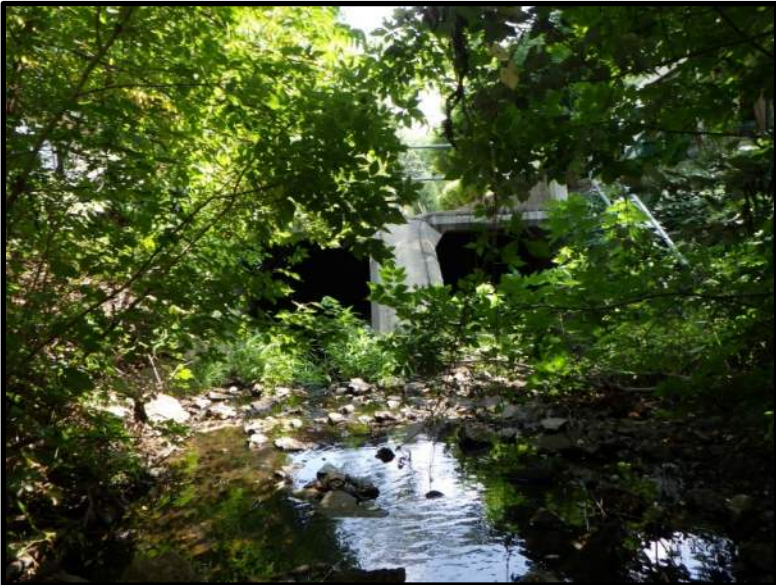
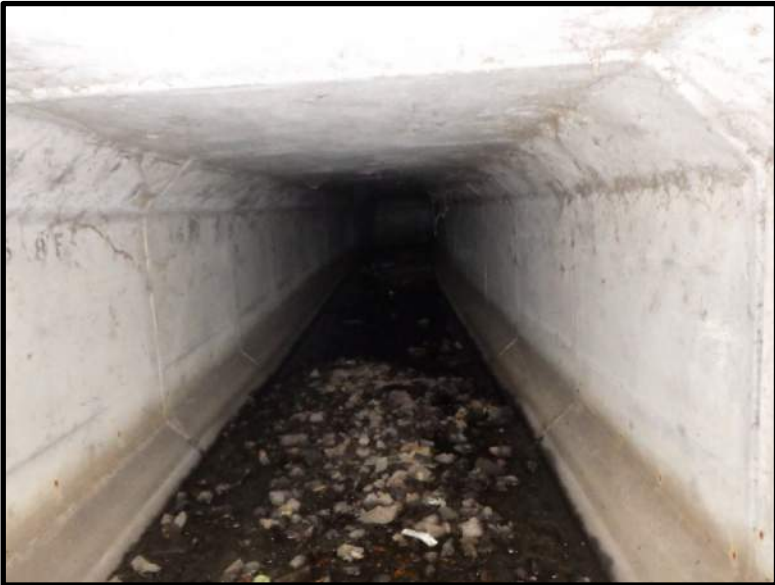
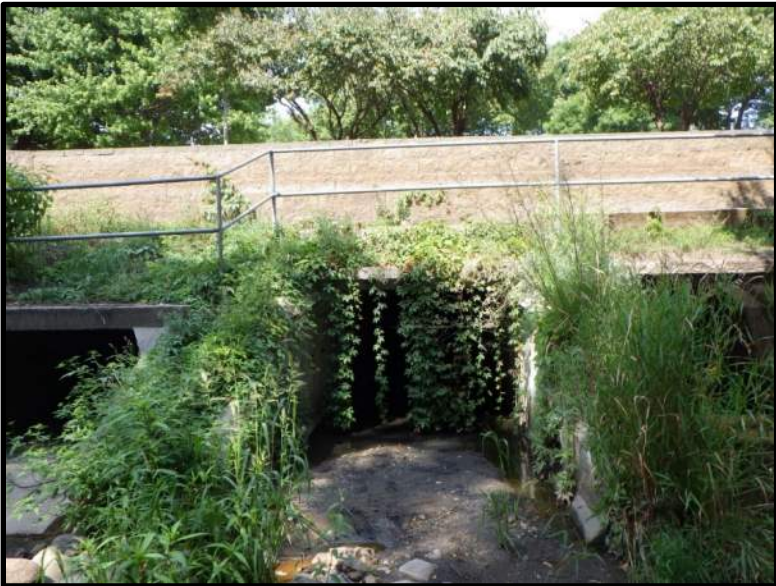
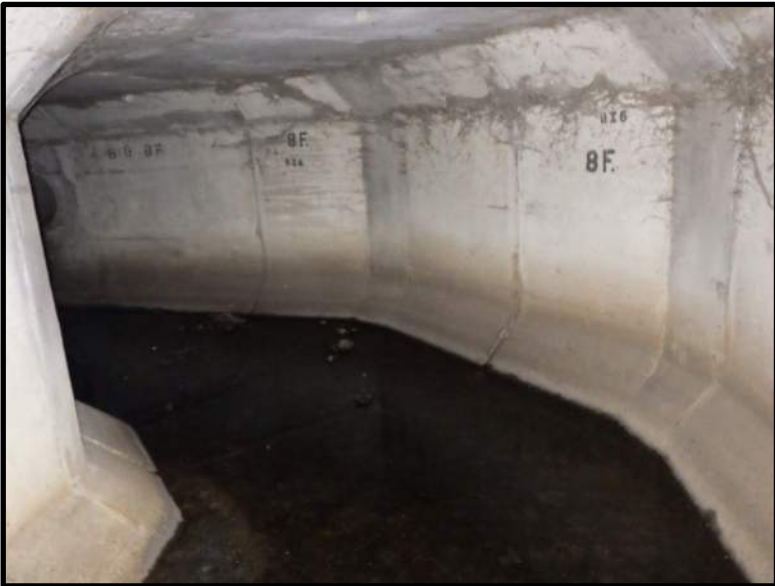
36th Avenue and Hampshire Avenue Crossing (Crystal)

- a. The concrete box culverts, joints and tie bars appeared to be in satisfactory condition.
- b. Some riprap has deposited in the box culverts.
- c. Sediment has deposited in the box culverts, mostly in the downstream half of the box culverts. This is consistent with previous inspections and has been noted since 2016.
- d. On both culverts, the fifth joint from the downstream end had a 2 ½ inch gap, which is a larger gap than the rest of the joints. This is consistent with previous inspections and has been noted since 2010.
- e. Various locations of spalled concrete and exposed reinforcing was observed through both culverts.
- f. No infiltration into the culvert was observed in 2021.

- Remove deposited riprap in the box culverts.
- Monitor sediment in the box culverts.
- Monitor the joint gaps in the box culverts.
- Monitor spalled concrete, and exposed reinforcing in the culverts.

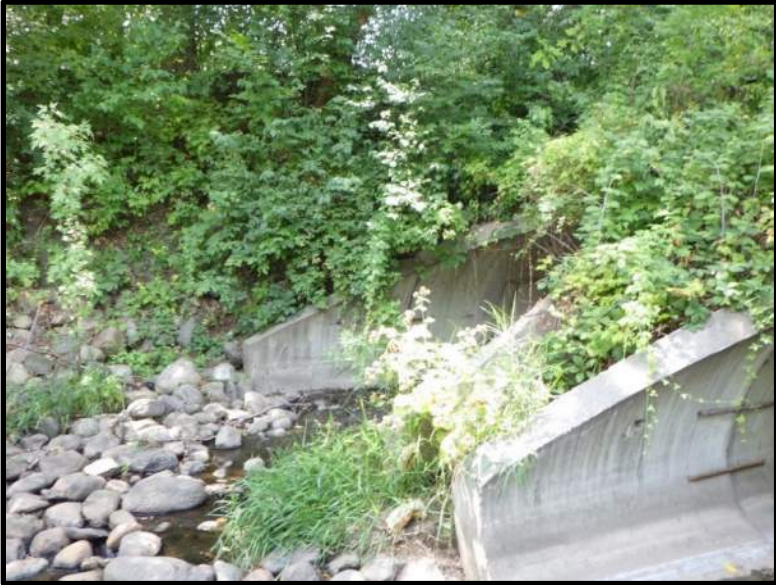
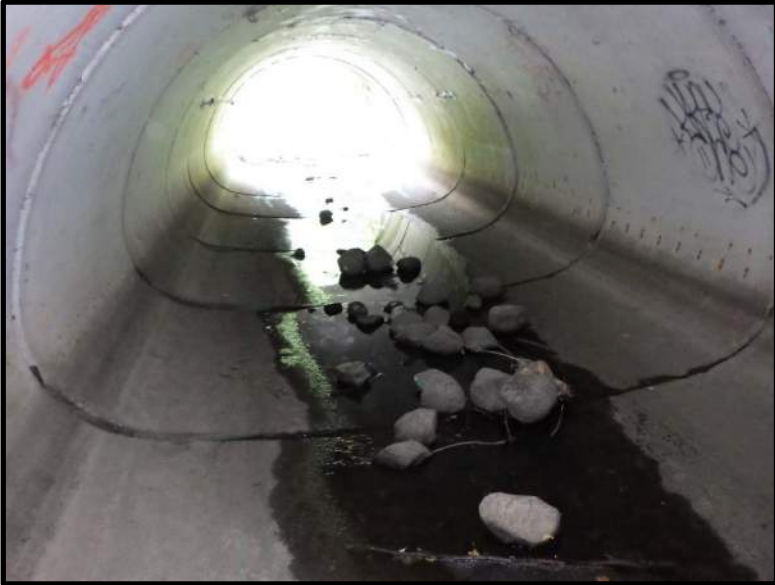
Georgia Avenue Crossing (Crystal)

- b. Cracking and potential spalling was observed in the south (right) culvert at the second and fourth joints at approximately the five o'clock position.
- c. Minor erosion was observed between the concrete culverts at the upstream end.
- d. The riprap on the downstream end has been slightly redistributed to create a channelized flow path.
- e. Both culverts appeared to begin to drop around mid-channel.
- f. There is a downed tree upstream of the culvert that is partially in the creek.
- g. Some riprap has deposited in the north (left) culvert.

- Remove the upstream downed tree.
- Remove the riprap in the north (left) culvert.
- Monitor cracking and potential spalling in the south (right) culvert.
- Monitor minor erosion between the concrete culverts on the upstream end.
- Monitor riprap on the downstream end to ensure it continues to provide adequate energy dissipation.
