Memorandum

To: Bassett Creek Watershed Management Commission (BCWMC)
From: Barr Engineering Co.
Subject: Bassett Creek 2021 Flood Control Project Inspection
Date: October 14, 2021
Project: 23270051.52 2021 4065

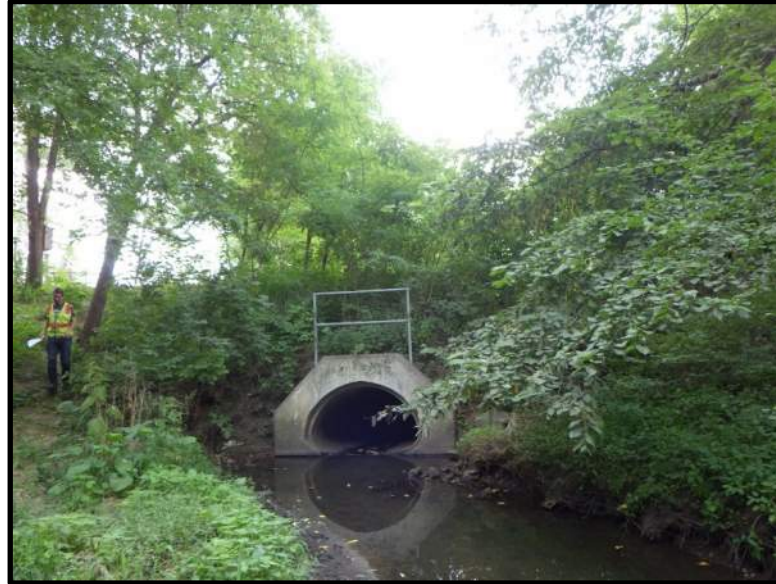
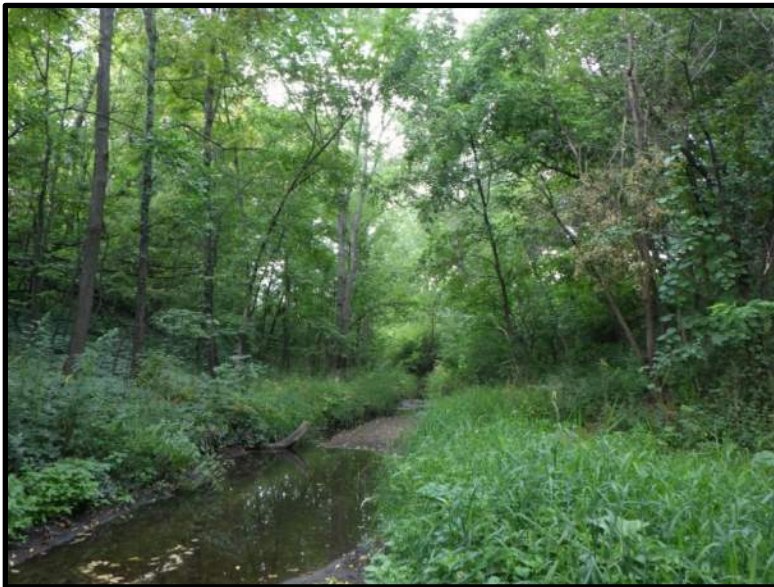
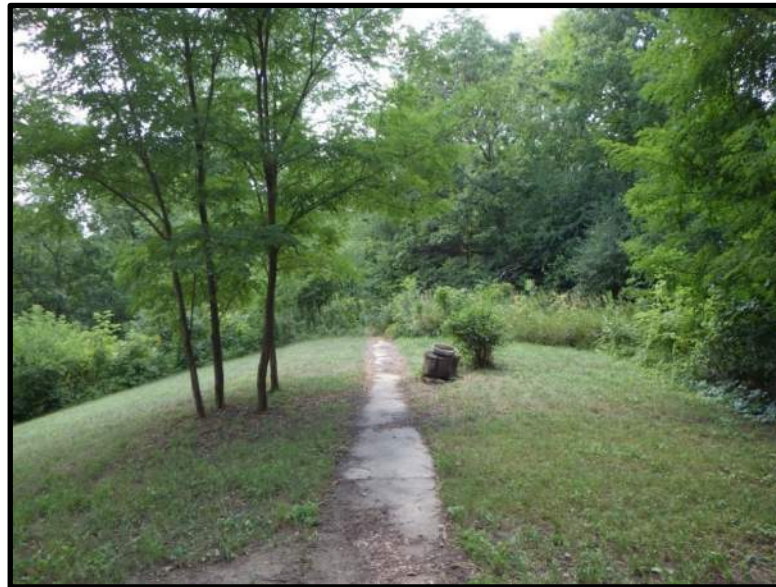
Edgewood Embankment (Crystal)

- a. The concrete culvert appeared to be in satisfactory condition.
- b. The embankment appeared to be in satisfactory condition.
- c. No visible settlement or erosion was observed along the embankment.
- d. Small trees and shrubs were observed growing on the embankment.
- e. The natural boulder riprap between the Edgewood embankment and Douglas Drive crossing is significantly overgrown with vegetation.
- f. Spalled concrete was observed at the fifth joint from the upstream end at approximately the 7 o'clock position.
- g. Spalling observed on north (right) side of outlet.
- h. Sediment has accumulated in the pool downstream of the culvert and formed a delta, which had some vegetation growing on it. The deposited sediment was generally creating a meander in the creek toward the south (right) bank.

- Remove small trees and shrubs growing on the embankment.
- Clear woody vegetation in the channel between the Edgewood Embankment and Douglas Drive crossing as needed to maintain a clear flow path through the channel.
- Monitor spalled concrete at the fifth joint from the upstream end in the culvert.
- Monitor spalling on outlet structure.
- Monitor sediment accumulation in the pool downstream of the culvert.

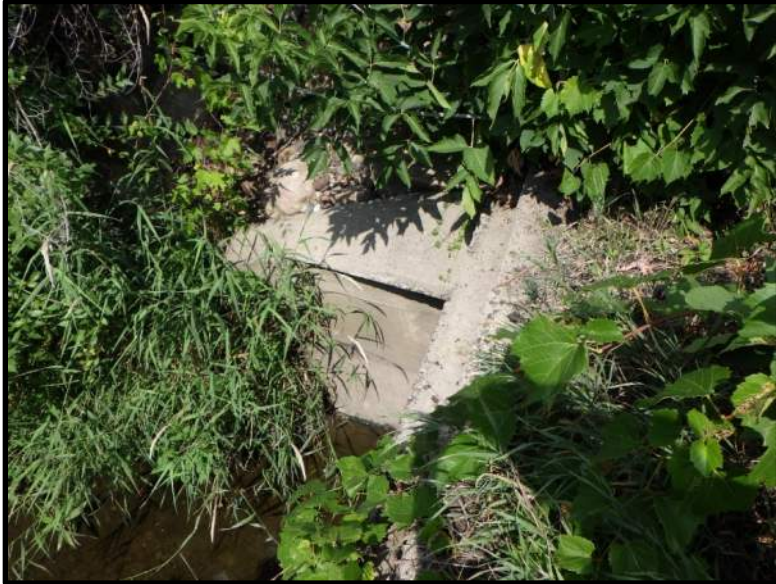
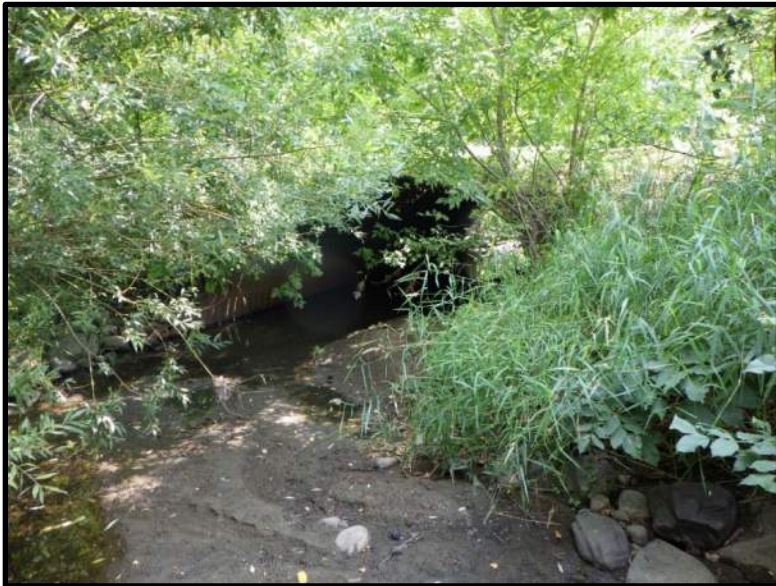
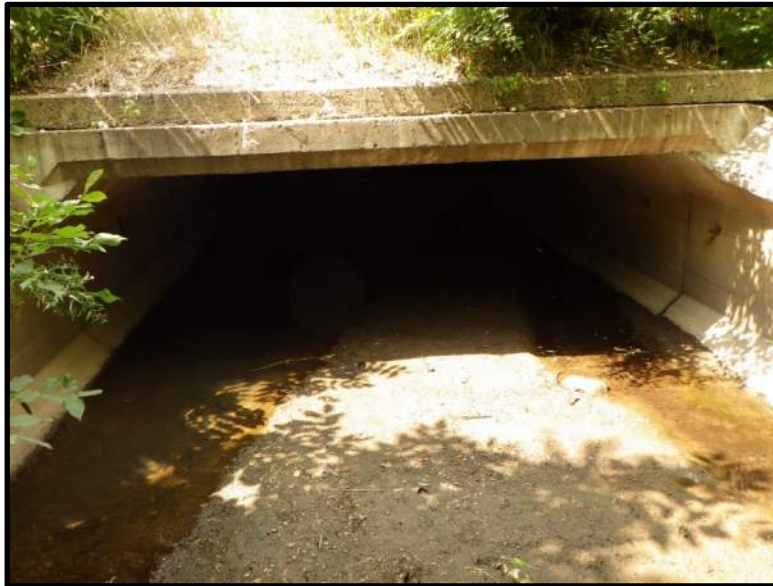
Douglas Drive Crossing (Crystal)

- b. The grouted riprap installed on either side of the box culvert outlet has started to deteriorate, and a gap has opened between the grout and the wall of the box culvert. This is consistent with previous inspections and has been noted since 2016.

- c. Spalled concrete was observed at the downstream north (left) wing wall.
- d. Sediment has deposited in the bottom of the culvert, ranging from 0-2 inches deep.

- e. Riprap was observed in the culvert.
- f. On the downstream end of the culvert, settling was observed in the sidewalk on either side of the culvert.

- g. Small trees were observed growing adjacent to the structure at the downstream end.
- h. Although not part of the flood control project, the privately-owned CMP culvert downstream of the Douglas Drive crossing is in poor condition. Sagging of this culvert has been observed during inspections since 2009. The culvert is significantly bowing and settling has occurred on either side of the culvert, which is evident in the road pavement above the structure.

- Consider adding a safety railing along the sidewalk at the upstream and downstream end of the culvert.
- Remove riprap from the culvert.
- Monitor deposited sediment in the culvert.
- Monitor grouted riprap at the downstream end of the box culvert.
- Monitor spalled concrete at the downstream north (left) wing wall.
- Monitor settling in the sidewalk at the downstream end of the culvert.
- Although not part of the flood control project, it is recommended that the City coordinate with the property owner to repair or replace the culvert downstream of Douglas Drive.

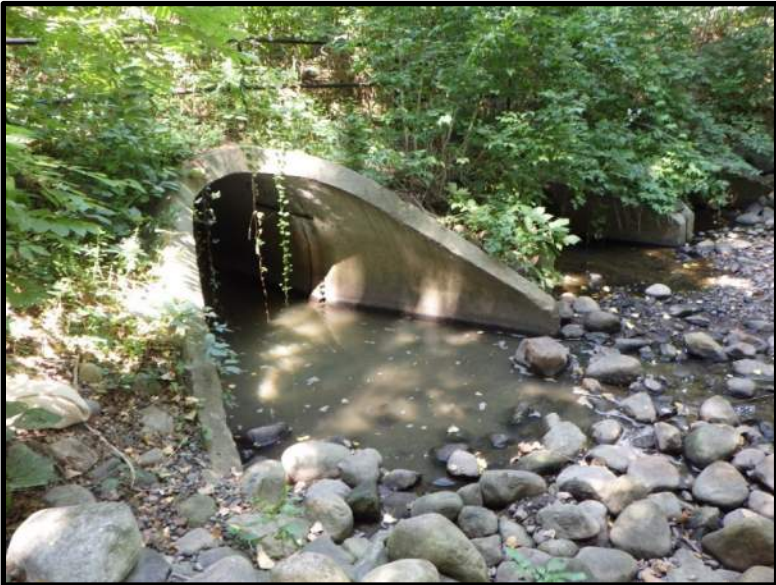
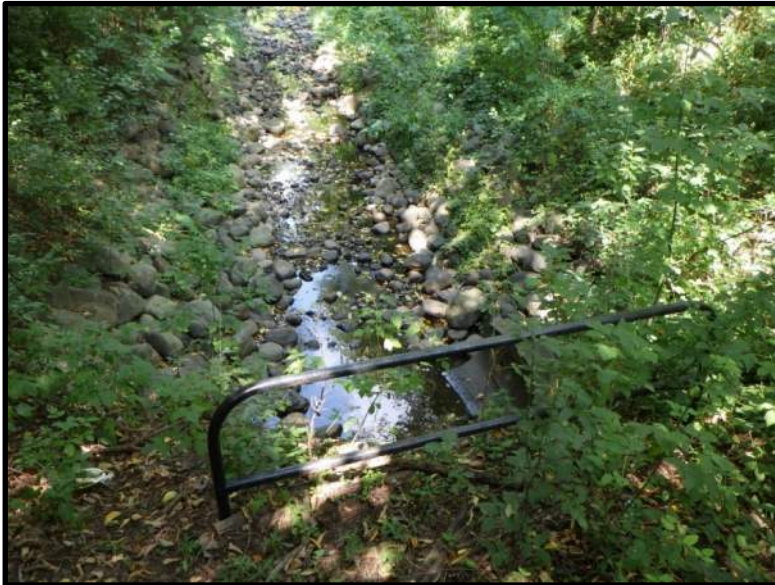
34th Avenue Crossing (Crystal)

- a. The concrete culvert appeared to be in satisfactory condition.
- b. Some riprap has deposited in the culvert.
- c. Sediment has deposited in the bottom of the culvert, ranging from 0-4 inches deep. This is consistent with previous inspections and 0-12 inches of sediment has been noted in the culvert since 2002.
- d. The tie bars directly upstream and downstream of the manhole connection to the culvert were rusty and flaking. This is consistent with previous inspections and has been noted since 2008.

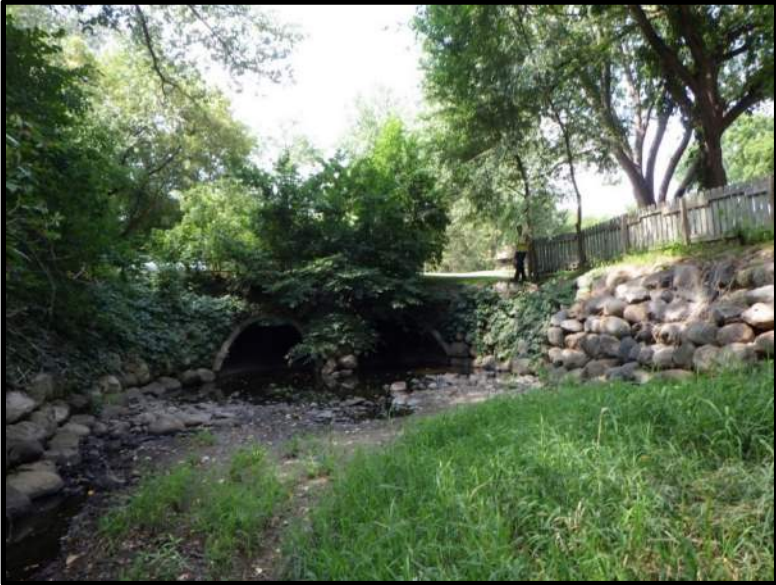
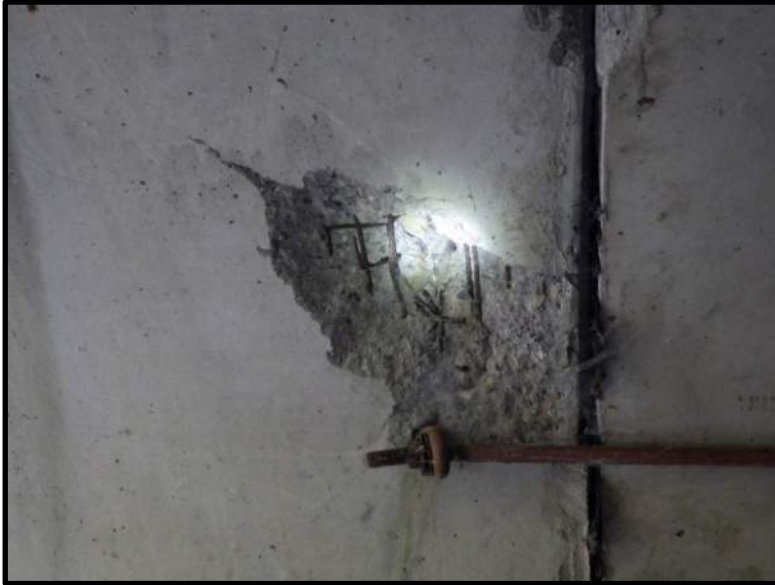
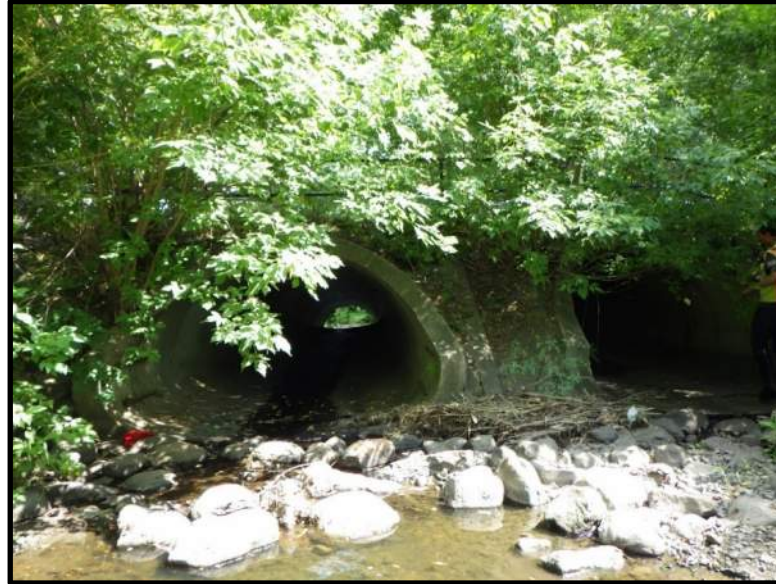
Brunswick Avenue Crossing (Crystal)

- b. The north (left) culvert had some joint separation near the downstream end. Rocks have accumulated causing a small flow obstruction.
- c. Strained and detached tie bars were observed in the north (left) culvert. One joint with broken tie bars was previously re-grouted by the City of Crystal, but the joint reopened and a 1-1/2 inch gap in the joint was observed during the 2008 inspection. A 3-inch gap in the joint has been noted since 2009.

- d. Spalled concrete and exposed reinforcing were observed in various locations in the south (right) culvert.
- e. Fractured pieces of concrete and grout were observed at various joints in both culverts.

- f. Longitudinal and circumferential cracks were observed in both culverts.
- g. Cracks were observed in the road pavement above the structure.
- h. Sediment has deposited in the channel between the Brunswick Avenue crossing and the 32nd Avenue crossing and created two deltas in the channel. The channel was armored with boulder riprap in 2014. The sediment delta has been observed since 2017.

- Repair detached tie bars.
- Repair fractured concrete and grout at joints in the culverts.
- Replace boulders into the natural boulder wall between the Brunswick Avenue crossing and the 32nd Avenue crossing.
- Remove deposited sediment and vegetation in the channel between the Brunswick Avenue crossing and the 32nd Avenue crossing.
- Monitor spalled concrete and exposed reinforcing in the culverts.
- Monitor minor cracks in the culverts and road.
- Monitor joint separation in north (left) side culvert.

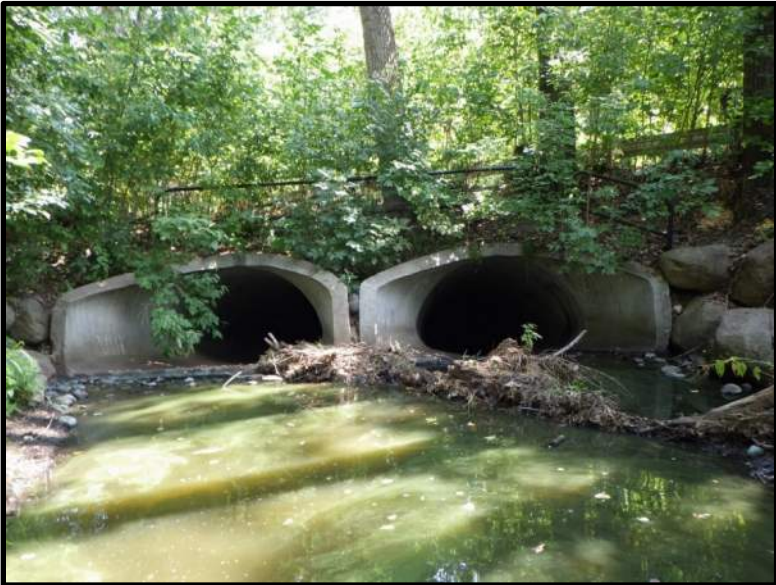
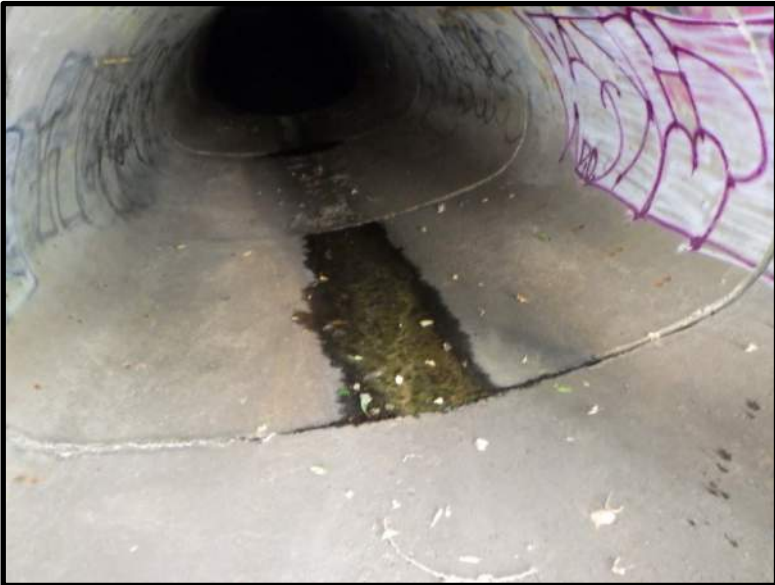
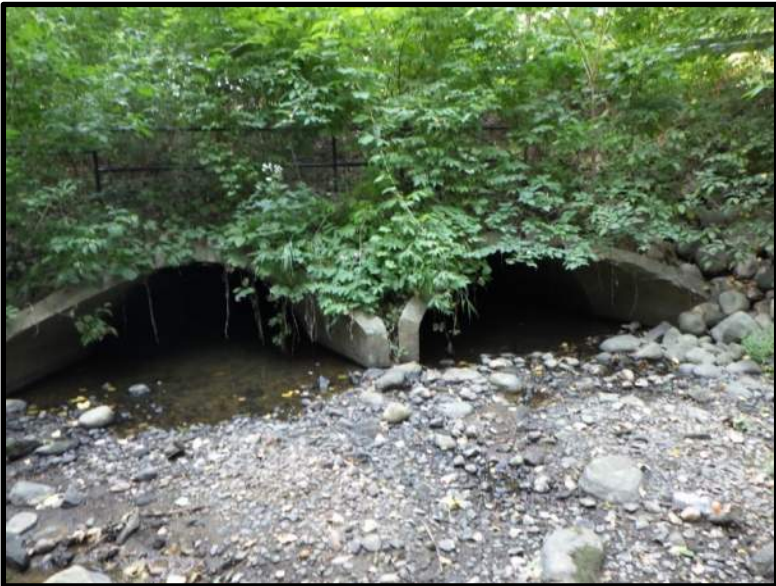
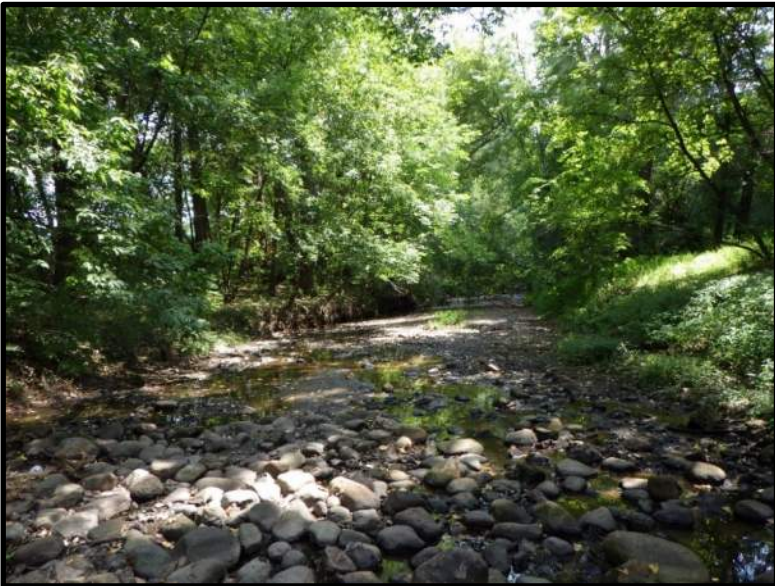
32nd Avenue Crossing (Crystal)

- a. The southwest (right) culvert is at a slightly lower elevation at the upstream end.
- b. The concrete culverts appeared to be in satisfactory condition. The culverts were only visually inspected from the outside at the upstream and downstream ends due to low clearance and high-water levels.
- c. Water was observed seeping into the north (left) culvert through the bottom of the first joint at the upstream end of the culvert. Water then seeped below the culvert through the second joint and back into the culvert through the third joint. These observations indicate

- d. Concrete erosion along the culvert invert was noted at the upstream side of the north (left) culvert and at the upstream joints.
- e. A downed tree was observed in the channel upstream of the culvert.

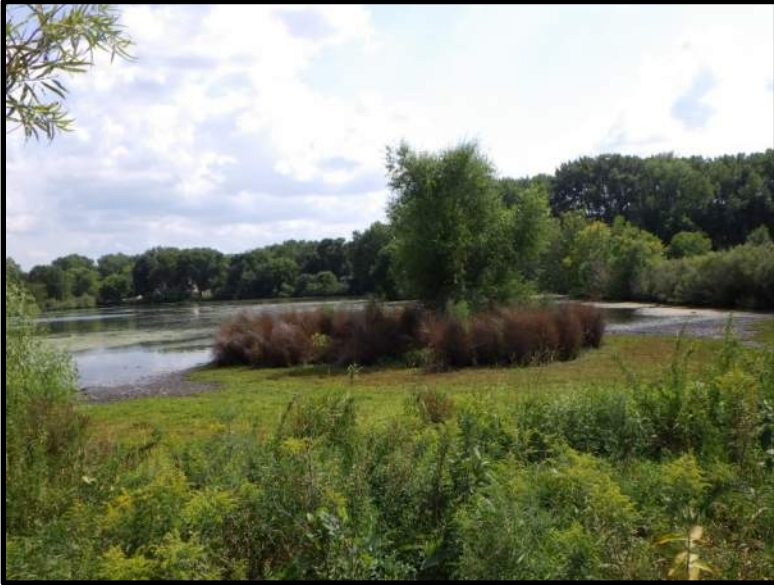
Bassett Creek Park Pond and Outlet (Crystal)

- a. Bassett Creek Park Pond appeared to be in satisfactory condition.
- b. Sediment has deposited in the northwest corner of Bassett Creek Park Pond and formed multiple deltas, which are overgrown with trees and vegetation. This has been noted since 2006 and the sediment deposition appears to be increasing.
- c. The outlet pipes appeared to be in satisfactory condition.

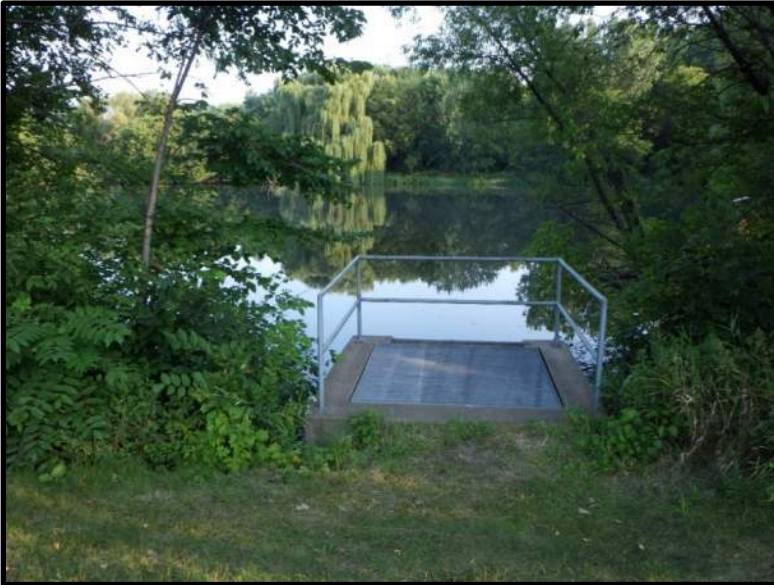
Detention Pond and Outlet Structure (Crystal)

- a. The outlet structure appeared to be in satisfactory condition.
- b. The detention pond appeared to be in satisfactory condition, but a survey is needed to assess accumulated sediment.

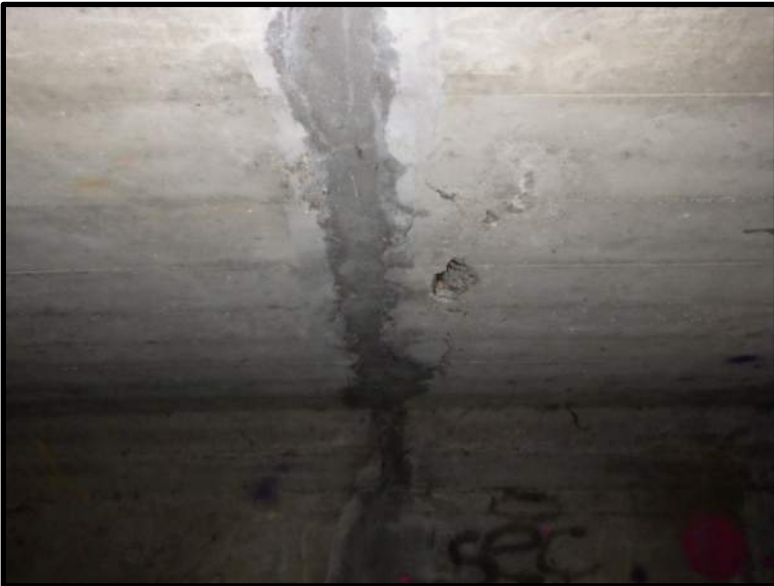
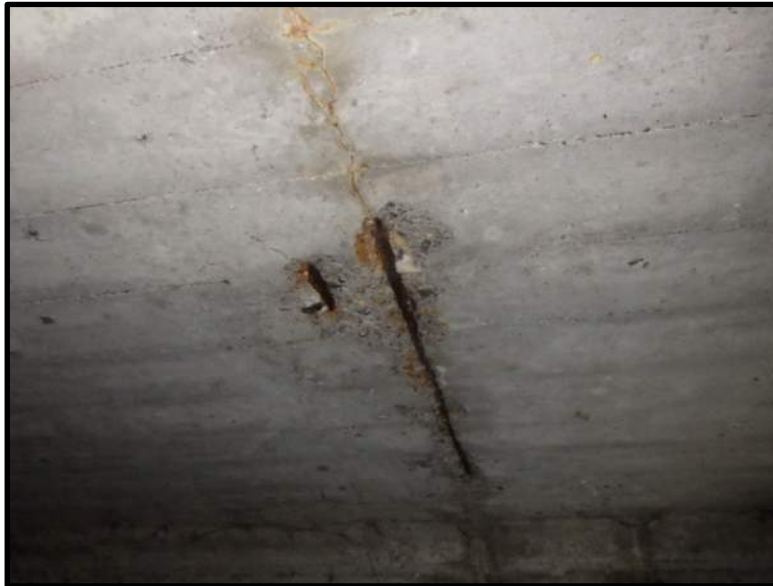
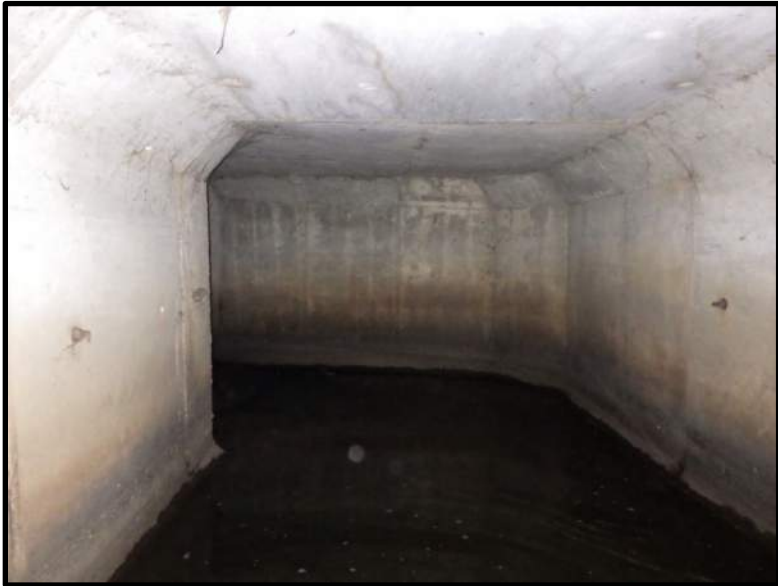
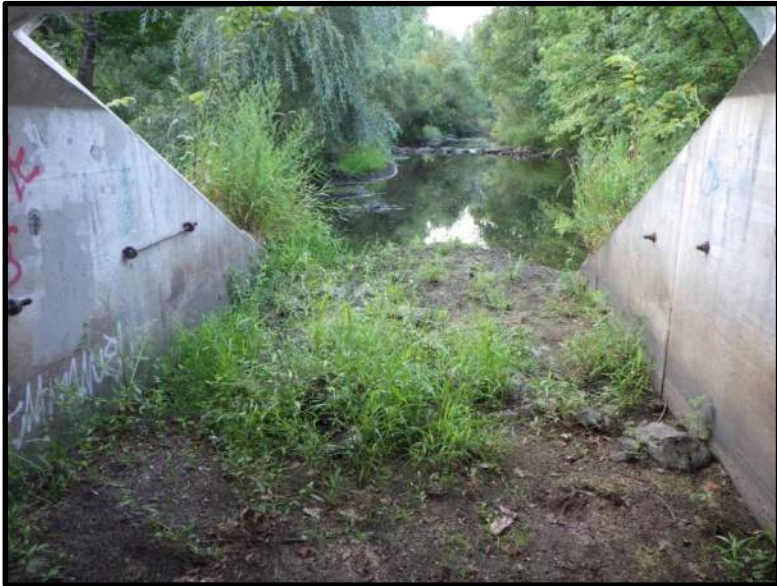
Highway 100 Double Box Culverts (Crystal/Golden Valley)

- a. The concrete box culverts and concrete inlet structure appeared to be in satisfactory condition.
- b. Circumferential cracks and areas of spalled concrete were observed in the north (left) box culvert.
- c. Longitudinal cracks, circumferential cracks, and areas of spalled concrete were observed along the top of the south (right) box culvert. MnDOT performed repairs to the culverts in 2007, but cracks have been noted since 2008 and areas of concrete spalling have been noted since 2014.
- d. Deposited sediment was observed in the north (left) box culvert, generally ranging from 6-24 inches deep. This is consistent with previous inspections and 6-24 inches of deposited sediment has been observed in the north (left) box culvert since 2002.
- e. The outlet portion of the structure appeared to be in satisfactory condition.

- Monitor accumulated sediment in north (left) box culvert and consider future removal.
- Monitor cracking and spalling concrete in both box culverts.

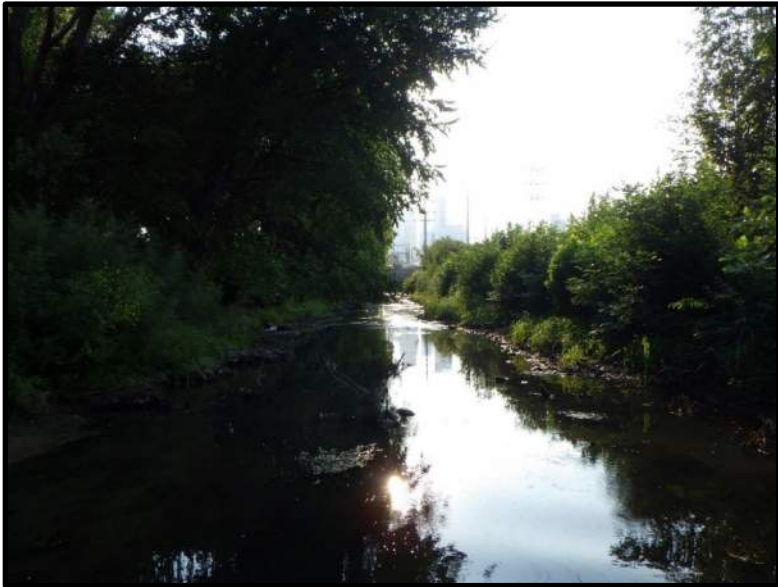
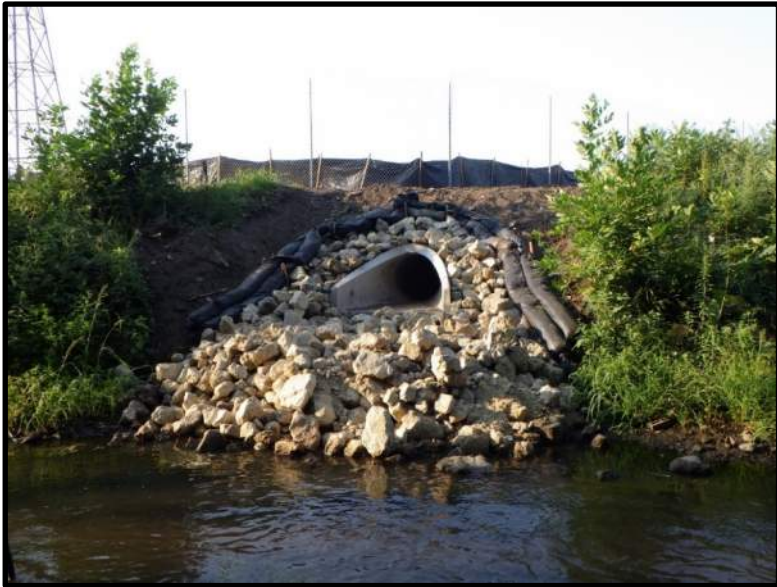
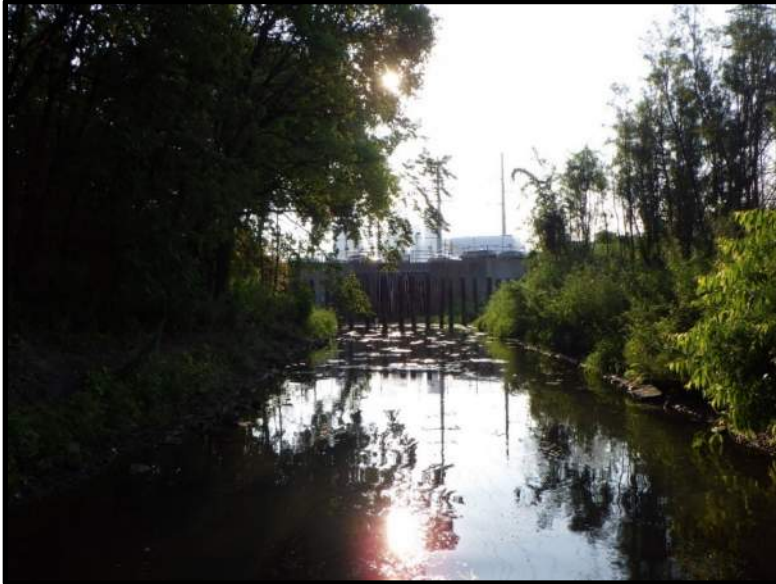
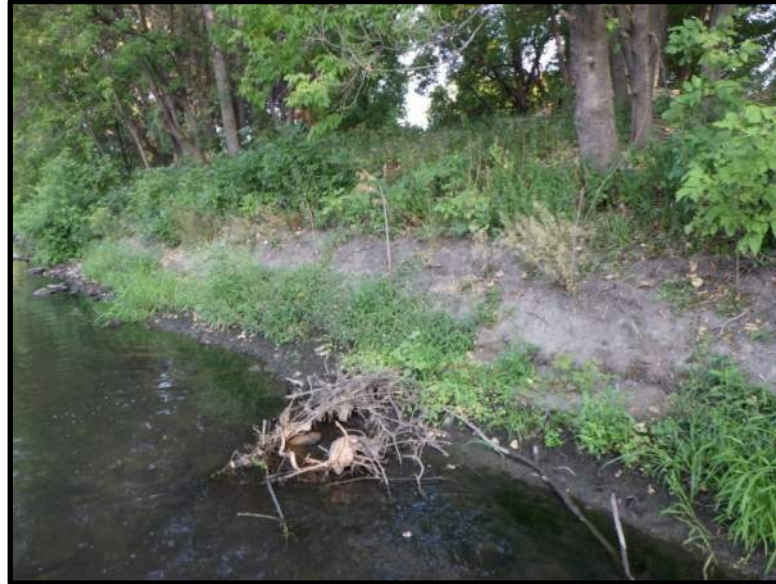
Open Channel (Minneapolis)

- a. The open channel, from Van White Memorial Boulevard to the inlet structure, appeared to be in satisfactory condition.
- b. The banks were generally vegetated. Some areas had exposed soil and steep slopes but seemed stable and no obvious signs of bank erosion were noted.
- c. Sediment has deposited and formed a delta on the south (right) side of the channel between the debris barrier and inlet structure. Vegetation was growing on the delta and approximately one-quarter of the channel was blocked by the sediment, debris, and vegetation. This is consistent with last year's observation.
- d. A new outfall with riprap armoring was installed from the Minneapolis impound lot.

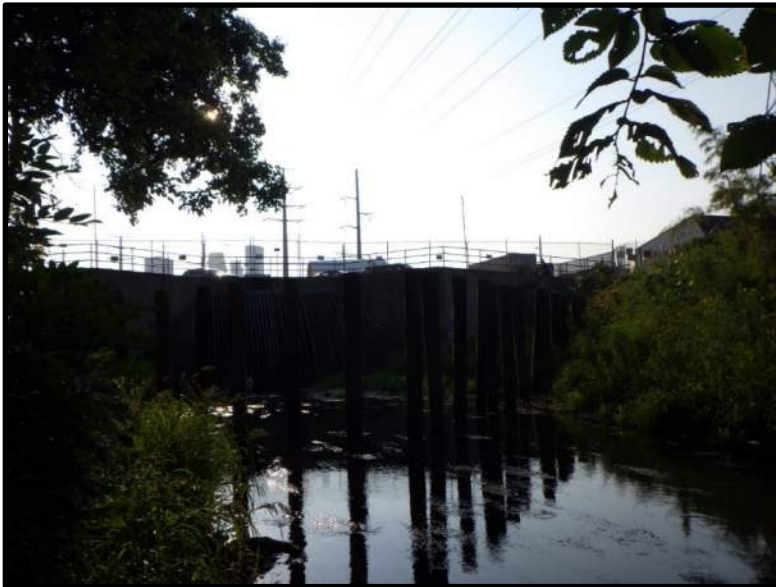
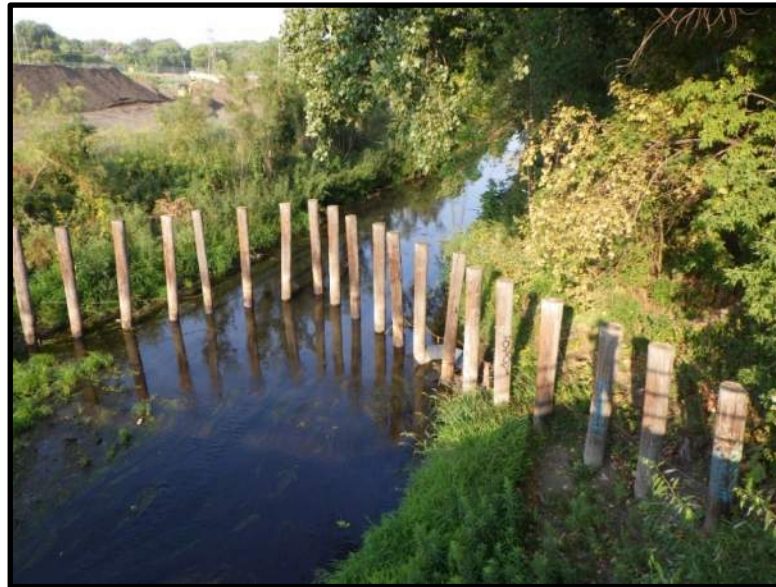
Debris Barrier (Minneapolis)

- a. The debris barrier piles appeared to be in satisfactory condition.
- b. The cable was missing or broken in the center portion of the channel. The middle seven barrier piles did not have a cable attached. The cable should extend from end to end, attached at each post.

- Repair or replace the steel cable on debris barrier.
- Monitor for debris and remove as needed.

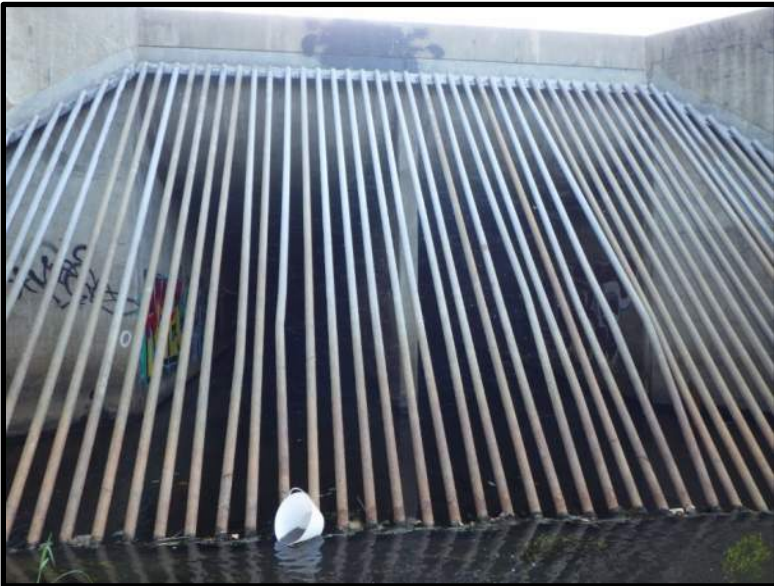
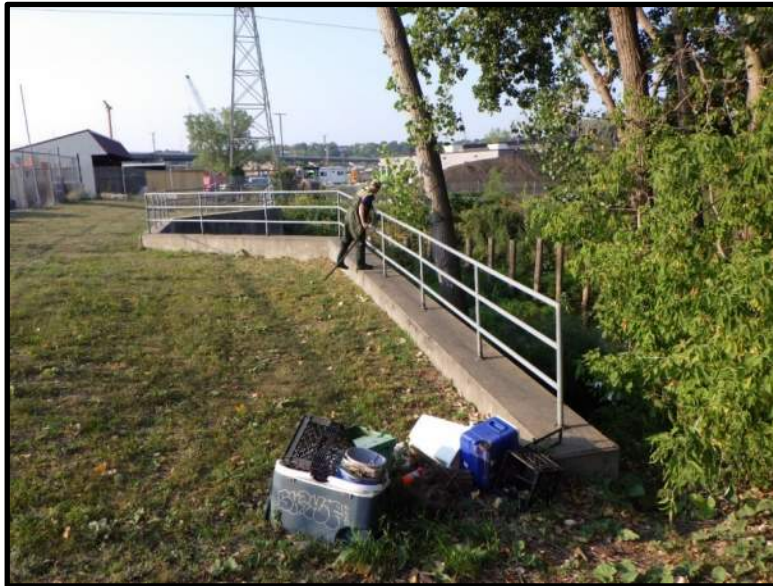
Inlet Structure (Minneapolis)

- a. The concrete inlet structure appeared to be in satisfactory condition.
- b. Vertical cracks were observed in the concrete on either side of the structure.
- c. Cracks were observed near where the handrail posts are embedded.
- d. The railings appeared to be in satisfactory condition.
- e. Some of the vertical bars have been bent and projecting a slight bow but generally appeared to be in satisfactory condition.
- f. The inlet structure was clear of debris.

- Monitor for debris and clear as needed.
- Monitor cracks in the concrete inlet structure.
