## Memorandum

**To:** Bassett Creek Watershed Management Commission (BCWMC)  
**From:** Barr Engineering Co.  
**Subject:** Bassett Creek 2022 Flood Control Project Inspection  
**Date:** November 9, 2022  
**Project:** 23270051.53 2022 4065

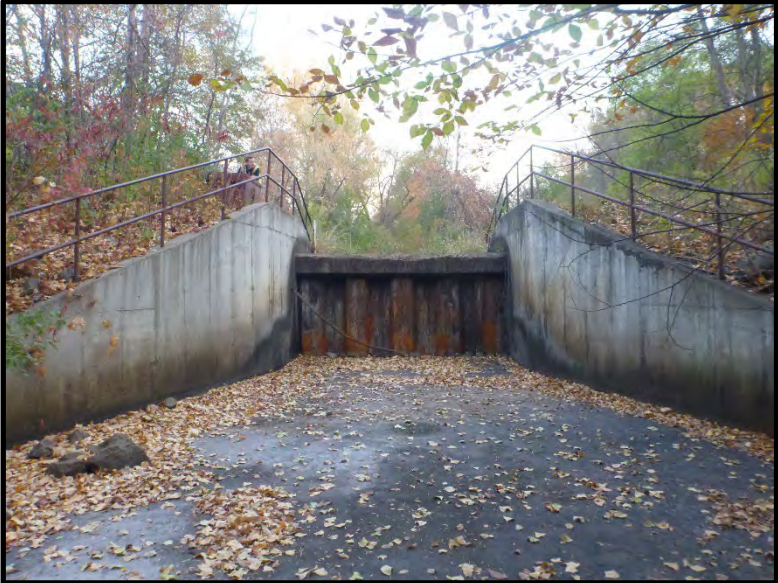
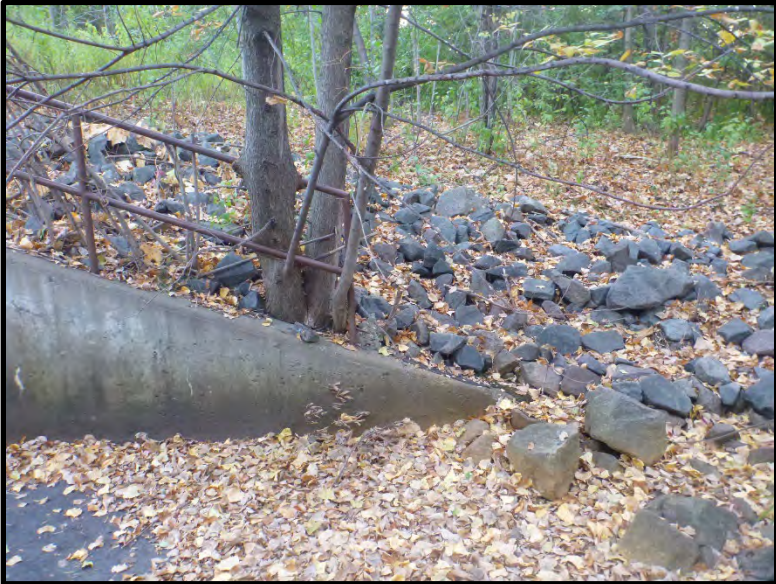
Plymouth Creek Fish Barrier (Plymouth)

- a. There was no flow overtopping the weir or in the creek.
- b. The structure appeared to be in satisfactory condition.
- c. The water level was 2.4 feet below the weir at the time of the inspection.

- d. Sediment has accumulated in the pool upstream of the structure and formed a delta, which was overgrown with vegetation. The deposited sediment was generally creating a meander in the creek toward the east (left) bank. Deposited sediment in the upstream pool has been noted since 2005. Deposited sediment also existed at the structure as shown in the photos.

- e. The railings at the upstream end of the structure, on the east (left) and west (right) sides, have rusted off below the weir level. This is consistent with previous inspections and has been noted since 2015.

- g. The top downstream edge of the concrete pile cap forming the weir has deteriorated along its entire length. Deterioration includes loss of cement paste and fines resulting in exposed aggregate. The weir appears to be functioning properly and controlling water to the design elevation.

- h. Three cracks were observed on the downstream west (right) wing wall. This is consistent with previous inspections and has been noted since 2004.
- i. Seven diagonal cracks were observed on the downstream east (left) wing wall. Three of the cracks are more prominently defined, closed cracks. Observation of the three prominent cracks is consistent with previous inspections and has been noted since 2002. The other four cracks are generally closed hairline cracks and less noticeable.

- j. A 14-inch diameter tree was observed growing adjacent to the downstream east (left) wing wall and through the railing.
- k. Small trees and shrubs were observed growing on the embankment and downstream channel banks, including some near the wing walls and railings.

- the City of Plymouth that the Clean Water Act expressly prohibits the use of creeks, streams, lakes, and wetlands from being used as a pollution treatment system except in extreme situations, therefore dredging of the sediment upstream of the fish barrier, in order to continue to utilize the area upstream of the fish barrier as a sedimentation pond, was prohibited by the MPCA and not permitted. It is recommended that the City of Plymouth coordinate with the MPCA to revisit this issue or discuss viable alternatives to remove the sediment since the project intent was not as a sediment basin but as a fish barrier.)
- Remove trees and vegetation on embankment and channel banks. Chemically treat stumps with Garlon 3A herbicide (or other specialty herbicide for use in wetland sites and waterways) to prevent regrowth.
  - Monitor concrete cracks and the width of the expansion joints.

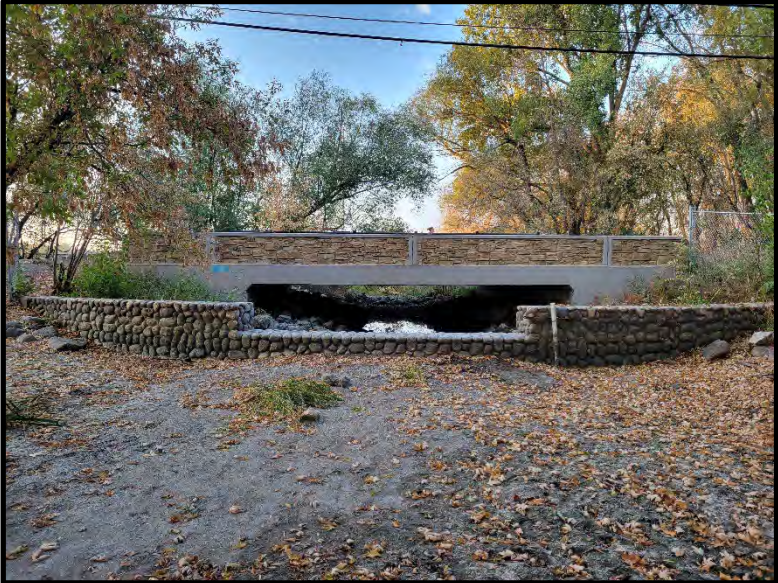
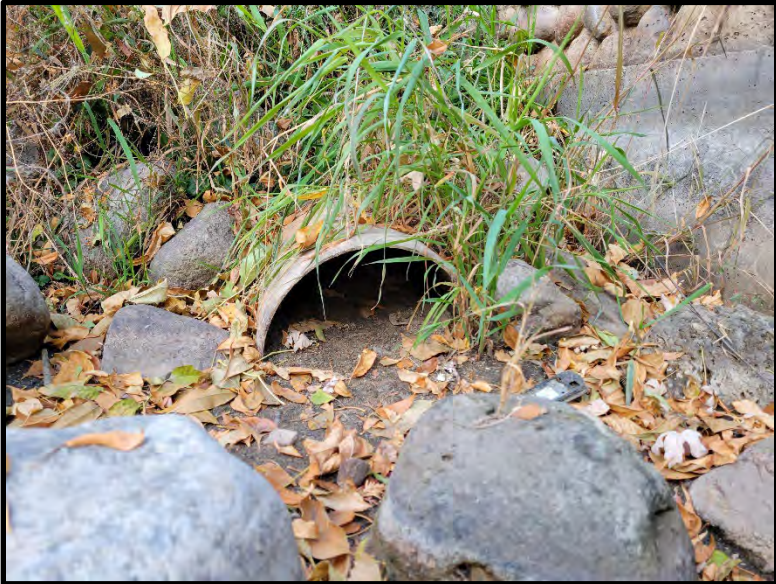
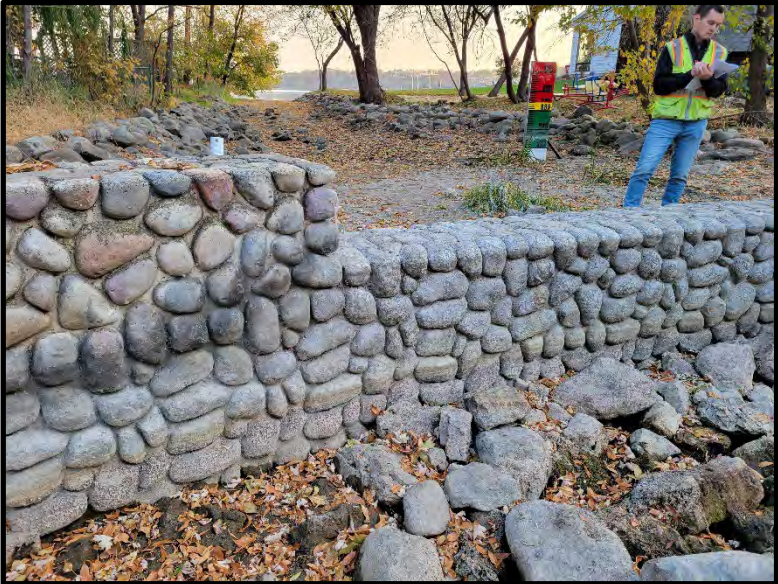
Medicine Lake Outlet (Plymouth)

- a. There was no flow passing over the weir or the channel between Medicine Lake and the outlet structure was dry and clear of debris.
- b. The outlet structure appeared to be in satisfactory condition.

- c. The staff gauge was "in the dry" due to "no flow" conditions during the inspection.
- d. Although not part of the flood control project, the storm sewer outfall for local drainage from South Shore Drive in the west (right) bank was nearly full of sediment.

- e. Woody vegetation was observed at either end of the dam where it ties into the banks.
- f. In late May 2019, City of Plymouth staff observed water flowing over the east side, but not the west side, of the Medicine Lake Outlet Structure. The city performed a baseline survey of the dam in the summer of 2019 and found that the east side of the dam was 0.15 feet lower than the west side. Future surveys can be performed to compare against the baseline.

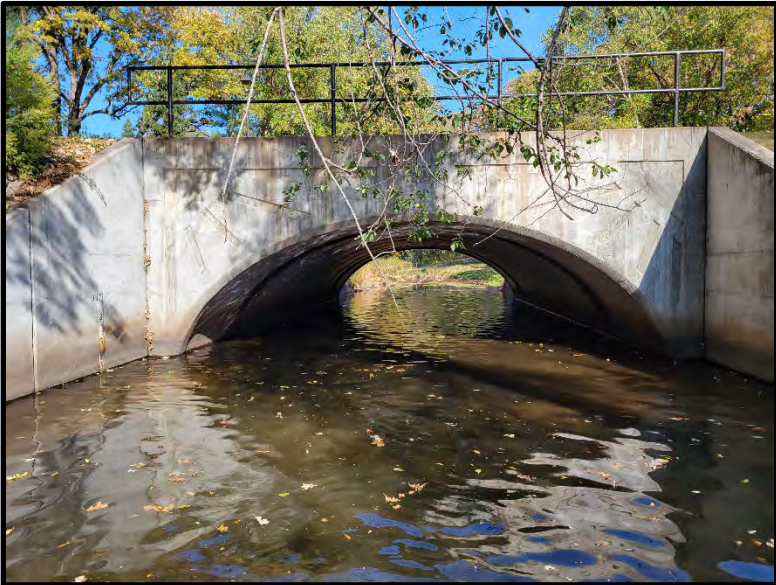
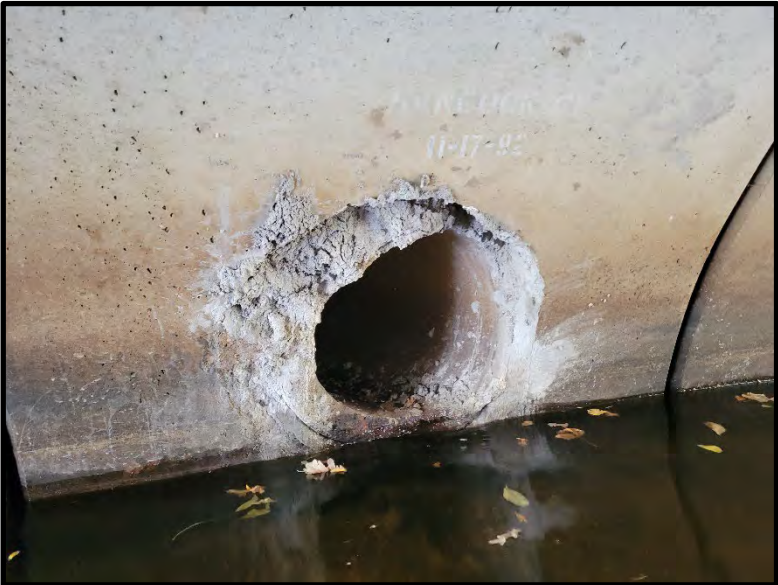
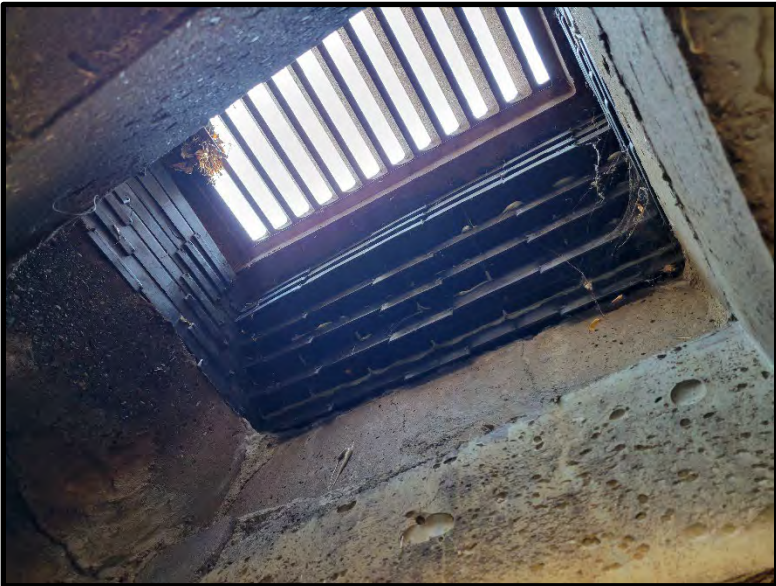
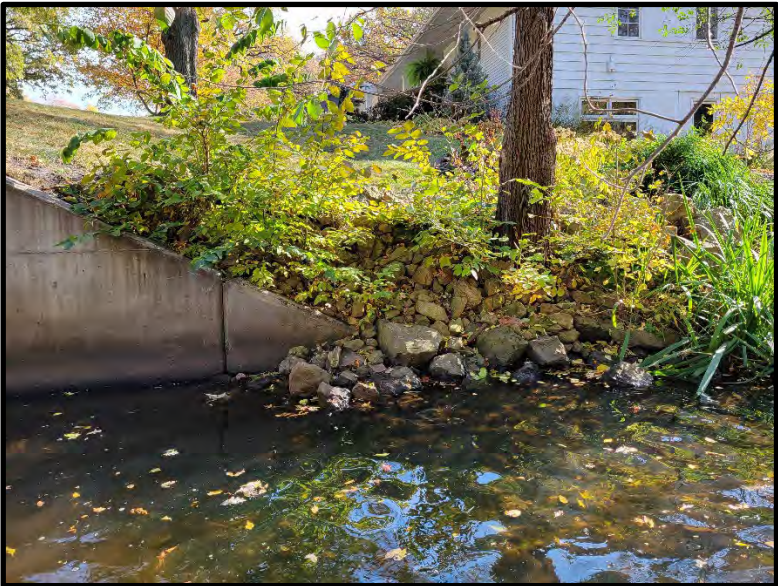
Westbrook Road Crossing (Golden Valley)

- a. The concrete Bebo culvert appeared to be in satisfactory condition.
- b. In 2022, City of Golden Valley staff repaired the spalled concrete and exposed rebar that were previously observed around the storm sewer pipe entering the culvert on the west (left) side.

- c. In 2022, City of Golden Valley staff repaired deteriorating grout and adjusting rings in the downstream east (right) catch basin.
- d. Longitudinal hairline cracks were observed on the top of sections of the Bebo culvert, extending across the entire section (pre-cast section) width. The cracks are approximately 2 feet off-center of the structure. These cracks are consistent with previous inspections and have been noted since 2002.

- e. A joint gap and separation were observed between the two furthest downstream sections of the culvert and there are signs of pressure points where the last section has pushed against the top of the two wing walls.

- f. Spalled concrete was observed at multiple locations upstream and downstream of the culvert at the top of the wing walls and head wall. This is consistent with previous inspections and has been noted since 2007.

- g. Westbrook Road over the culvert was repaved in 2022.
- h. The railings appeared to be in satisfactory condition.

- Monitor cracks in the culvert.
- Monitor joint gap at pressure points.
- Monitor spalled concrete at wing walls and head walls.

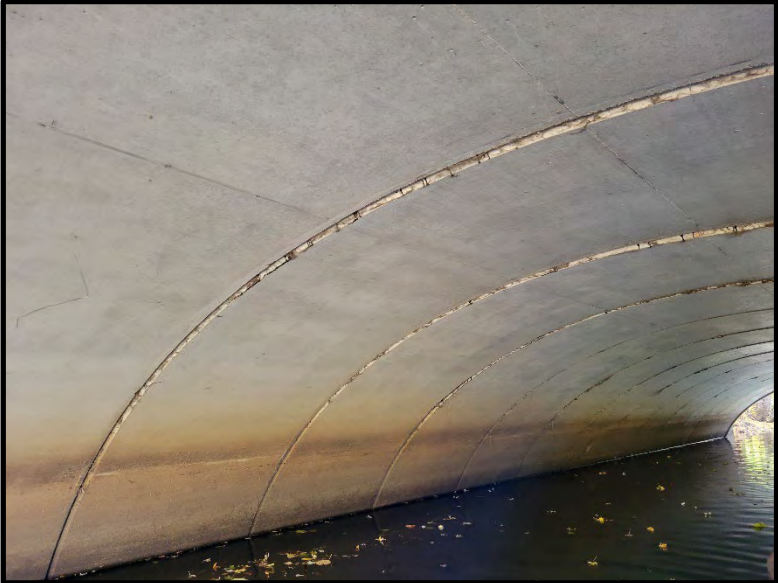
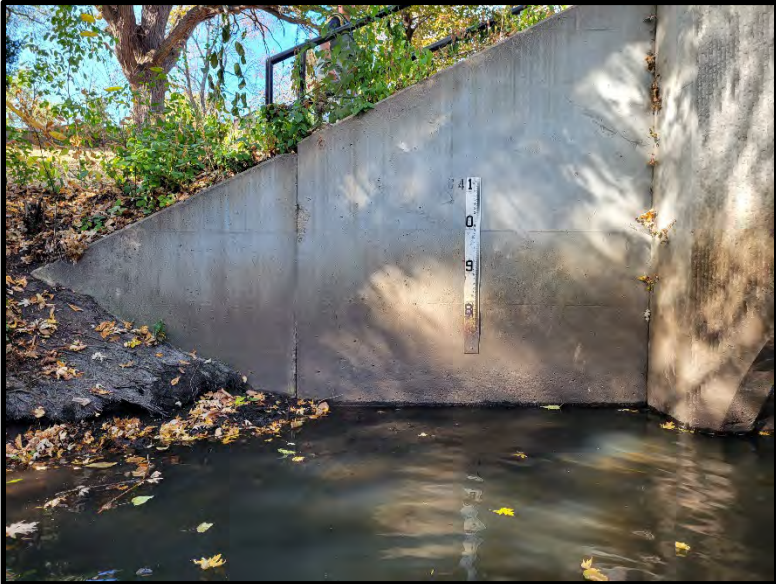
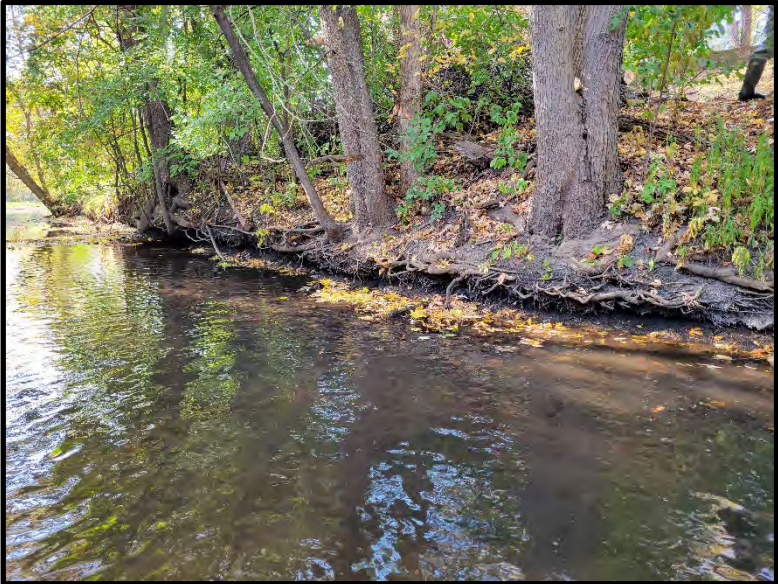
Regent Avenue Crossing (Golden Valley)

- a. The concrete Bebo culvert appeared to be in satisfactory condition.
- b. The channel bottom was soft and mucky, and the water level was below the bottom of the staff gauge and not measured.

- c. Spalled concrete was observed at the middle joint of the upstream north (left) wing wall. This is consistent with previous inspections and has been noted since 2002.

- d. A crack was observed at the upstream north (left) wing wall. The crack was near the top of the wing wall and travels at a 45-degree angle down to the headwall. This is consistent with previous inspections and has been noted since 2002.

- e. Multiple cracks were observed at the upstream south (right) wing wall. This is consistent with previous inspections and has been noted since 2008.

- f. A crack was observed at the downstream south (right) wing wall. The crack was near the top of the wing wall and travels at a 45-degree angle down to the headwall. This is consistent with previous inspections and has been noted since 2002.

- g. Flows appeared to have scoured the north (left) side of the creek bottom and deposited sediment on the south (right) side of the creek bottom.
- h. The railings appeared to be in satisfactory condition.

- Monitor spalled concrete at the upstream north (left) wing wall.

- Monitor crack at the upstream north (left) wing wall.
- Monitor cracks at the upstream south (right) wing wall.
- Monitor crack at the downstream south (right) wing wall.
- Monitor creek bottom for scouring and deposition and, as needed, armor creek bottom along culvert foundation.

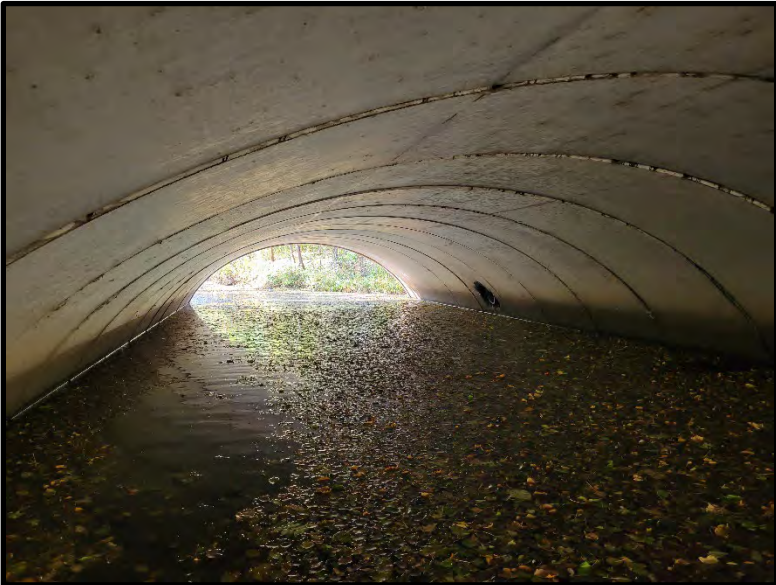
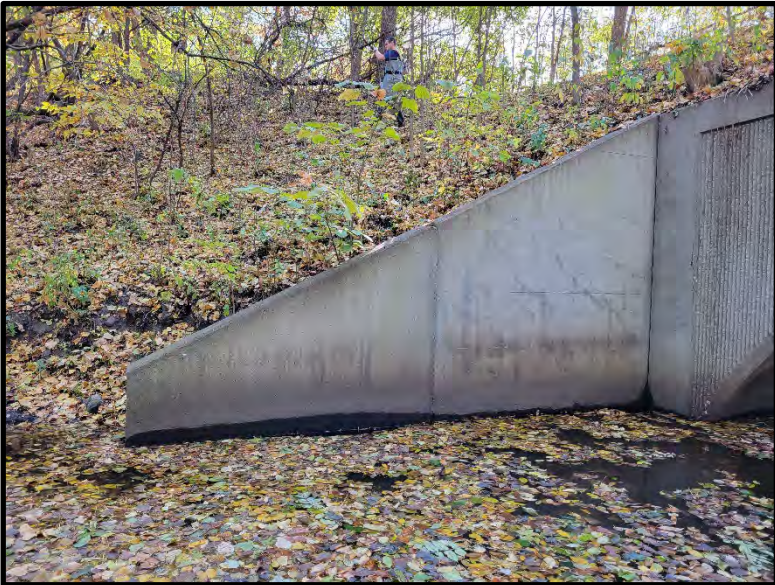
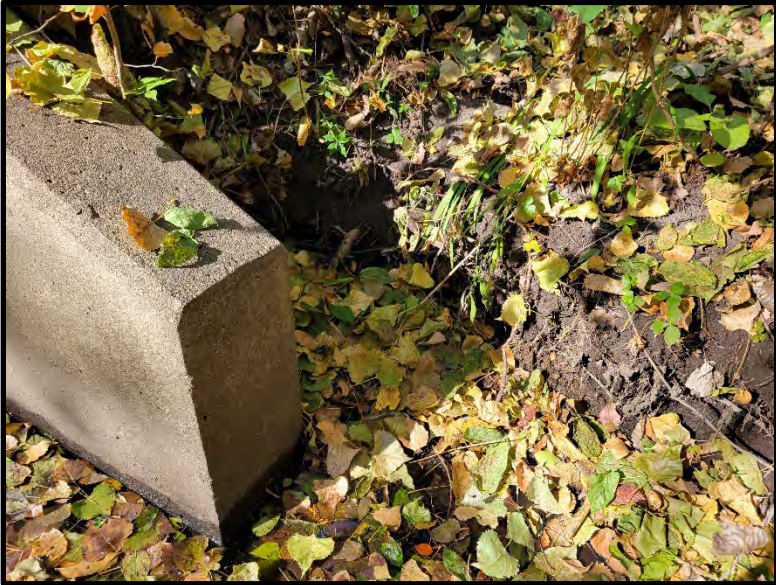
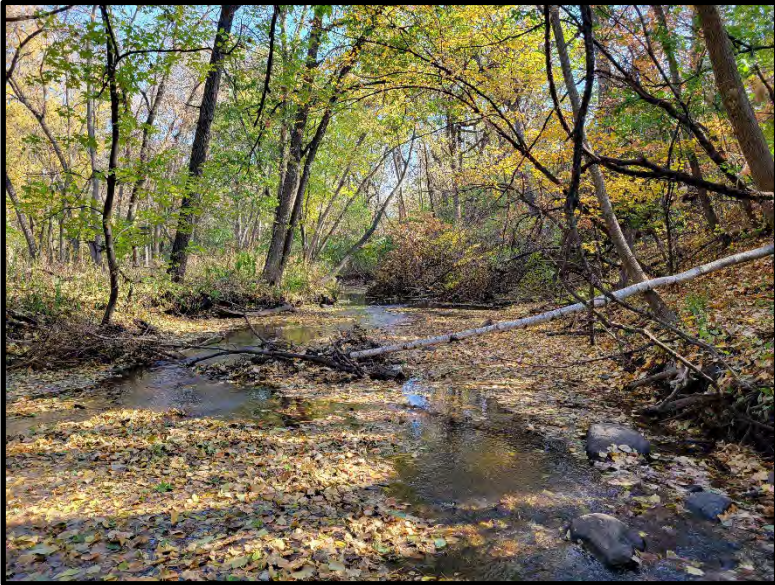
Noble Avenue Crossing (Golden Valley)

- a. The concrete Bebo culvert appeared to be in satisfactory condition.
- b. Longitudinal hairline cracks were observed throughout the length of the top of the culvert, extending across the entire (pre-cast) section width. The cracks were either in the center of the structure or approximately 2 feet off-center of the structure. This is consistent with previous inspections and has been noted since 2002.

- c. Spalled concrete and exposed plastic joint material were observed approximately two feet either side of center throughout the length of the top of the culvert. The cement paste covering the plastic joint material has separated and exposed the plastic. This is consistent with previous inspections and has been noted since 2002.

- d. Spalled concrete was observed at the downstream north (left) wing wall. This is consistent with previous inspections and has been noted since 2002.

- e. Multiple cracks and spalling were observed at the top of downstream north (left) wing wall. The cracking is consistent with previous inspections and has been noted since 2007.

- g. Minor bank erosion and scour was observed on both sides of the downstream wing walls. This is consistent with previous inspections and has been noted since 2002.
- h. Flows appeared to be scouring the north (left) side of the creek bottom.
- i. The railings appeared to be in satisfactory condition.
- j. The City of Golden Valley installed riprap in 2018 to reinforce the bank and minimize continued erosion at the outside edge of the upstream south (right) wing wall, however some erosion has perpetuated upstream.
- k. There are some downed trees in the creek channel downstream of the culvert.

- Remove downed trees in the creek channel downstream of the culvert.
- Monitor cracks and spalled concrete in the culvert and wing walls.
- Monitor bank erosion at downstream wing walls and upstream of installed riprap at upstream south (right) wing wall.
- Monitor creek bottom for scouring and, as needed, armor creek bottom along culvert foundation.

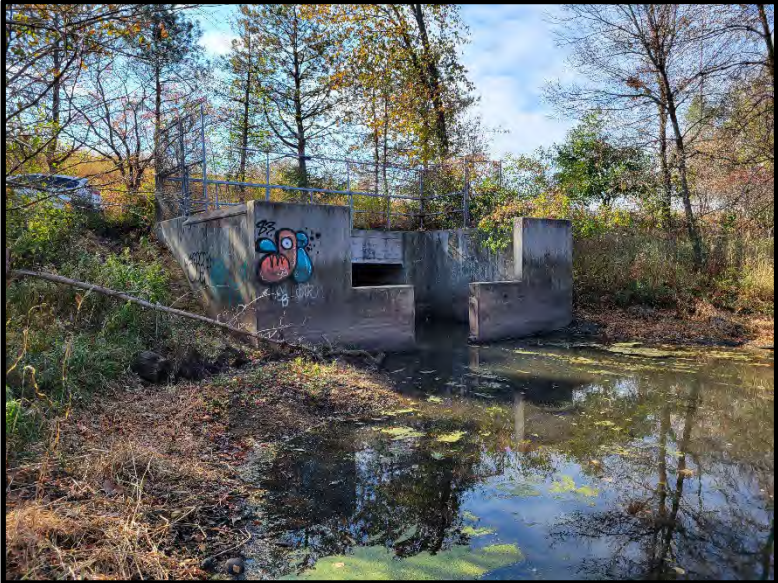
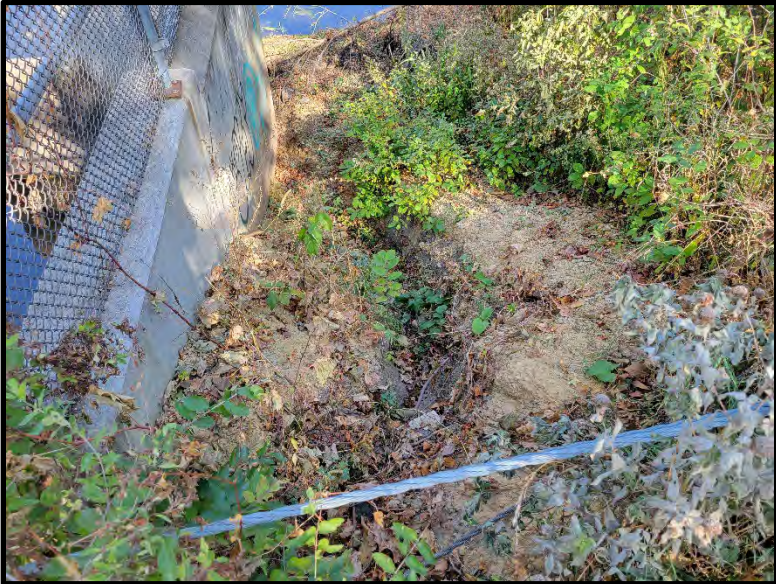
Highway 55 Control Structure (Golden Valley)

- a. The concrete control structure appeared to be in satisfactory condition.
- b. A hairline crack was observed in the east (left) wall of the inlet structure, although it appears that the crack may have been previously sealed with caulk. The crack is positioned in the middle of the wall extending full height. This is consistent with previous inspections and has been noted since 2002.

- c. Erosion was observed around the east (left) side of the structure, likely from road runoff. In the summer of 2021, Minnesota Department of Transportation (MnDOT) crews placed class 5 aggregate on the east (left) side of the structure to access the upstream end of the structure to perform repairs of the double box culvert below Highway 55. The new class 5 aggregate is actively eroding.

- d. MnDOT crews also drilled holes into the structure to install brackets and a temporary plate to block flows through the structure so they could perform repairs. MnDOT removed the plate, brackets, and bolts, but did not fill or repair the bolt holes.

- e. A piece of rebar and relatively small mass of concrete extended into the lower west (right) side of the opening of the low flow weir. A steel threaded rod extended approximately 2 inches from the south face of concrete on the east (left) side of low flow weir. These observations have not been noted in previous years' inspections, but water levels were lower in 2021 and 2022 than previous years, exposing this part of the structure.

- Protect the sides of the structure with armoring (rock or riprap) or reinforced vegetation to limit additional erosion. Alternatively, divert road runoff away from the structure.
- Request that MnDOT repair bolt holes with concrete grout.
- Sawcut and remove rebar and concrete chunk on east (left) side of low flow weir.
- Sawcut steel rod to be flush to concrete along south face of concrete on the east (left) side of the low flow weir.
- Monitor hairline crack in the control structure.

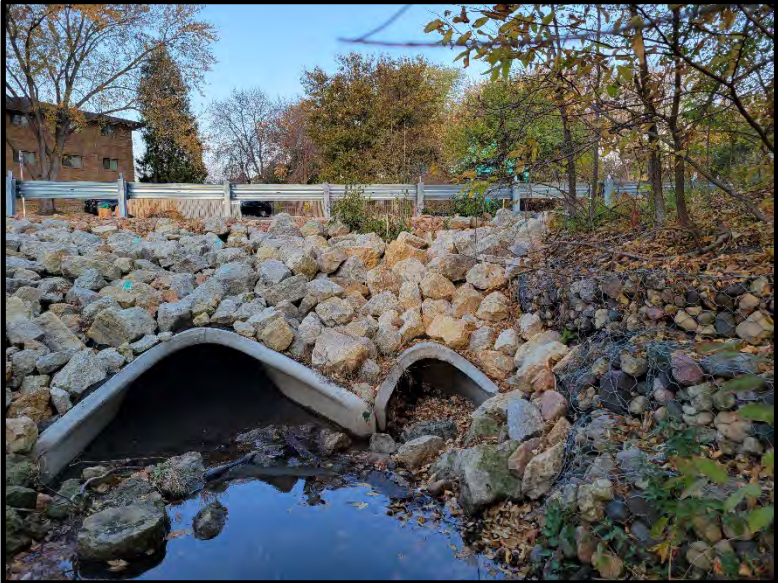
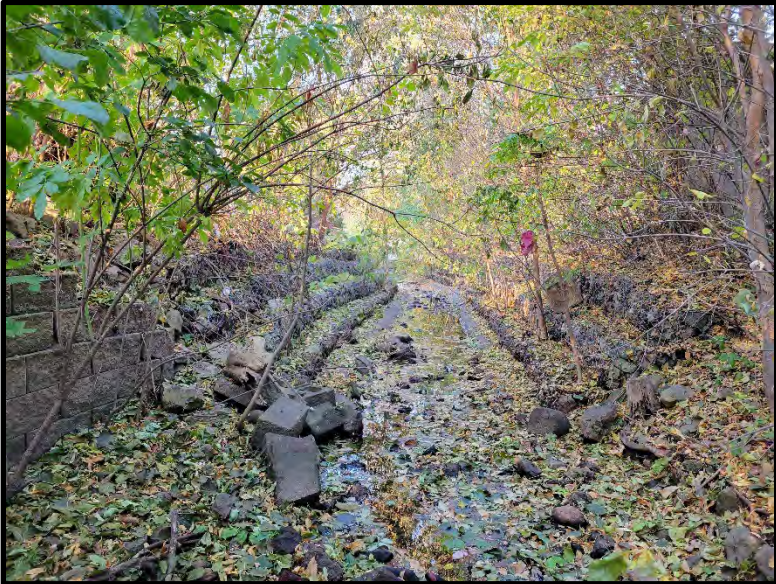
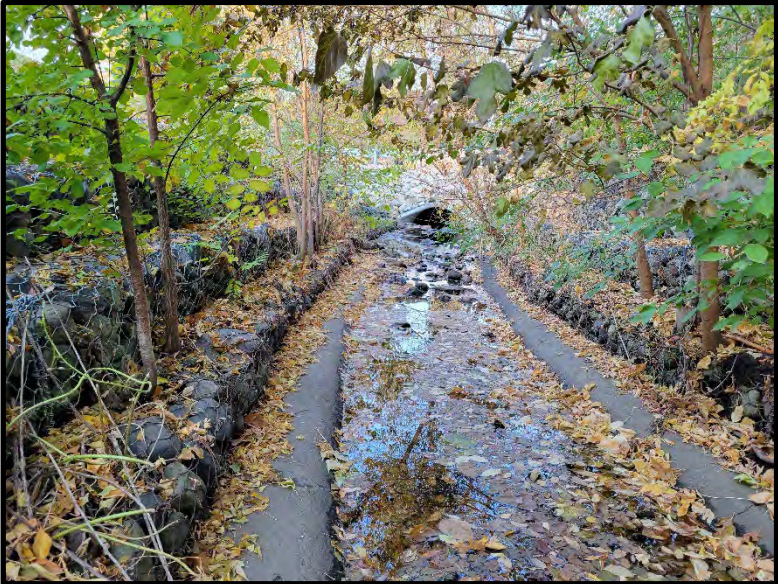
Markwood Open Channel - Gabion Section (Crystal)

- a. The channel appeared to be in satisfactory condition.
- b. Significant tree and vegetation growth was observed in the gabion section of the channel and the gabion wire is at risk of damage.

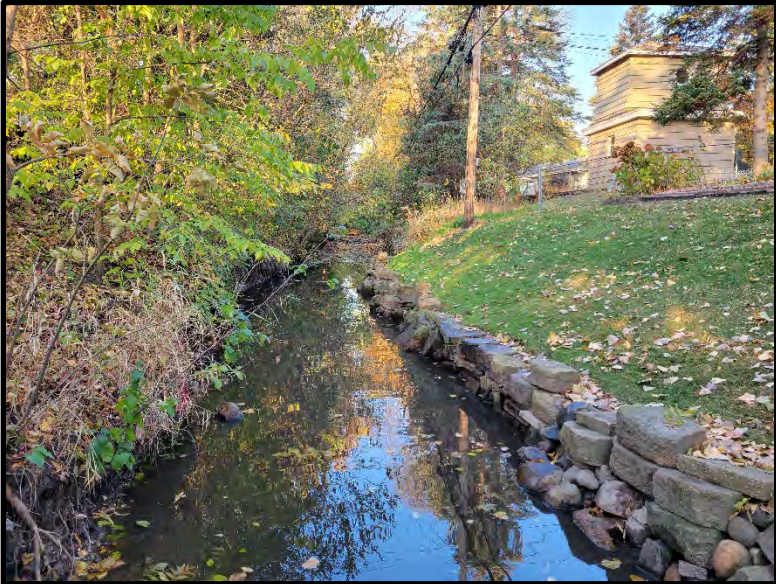
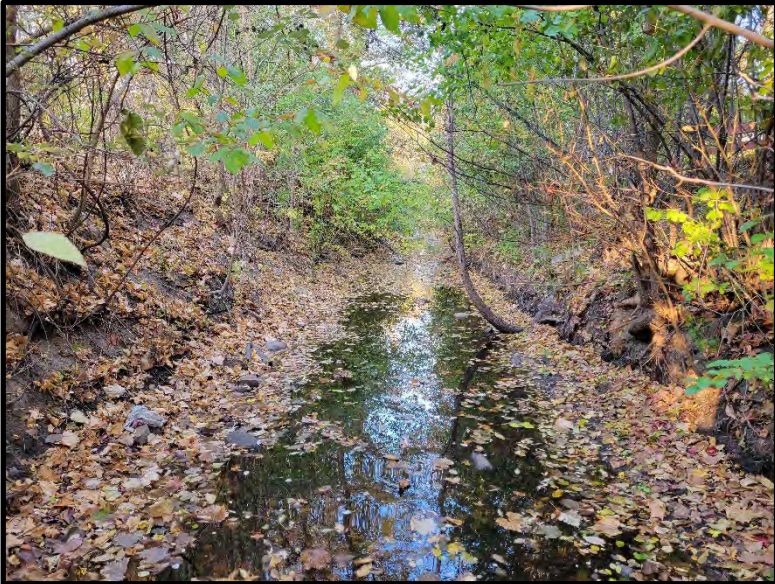
Markwood Open Channel (Crystal)

- a. The channel appeared to be in satisfactory condition.
- b. Vegetation growth was observed along the side slopes of the channel. Some areas appeared to have been cleared since the previous year's inspection.

- c. Erosion was observed along the toe of the north (left) and south (right) banks. This is consistent with previous inspections and has been noted since 2006.

- d. Some homeowner retaining walls and fences along the channel were leaning toward the channel and, in some cases, appeared to be failing. This is consistent with previous inspections and has been noted since 2009.

- e. The City of Crystal's corrugated metal pipe (CMP) storm sewer, discharging into the channel between 6833 and 6825 Markwood Drive, was in poor condition. The pipe bottom was corroded and there was erosion and undercutting around the pipe end. The pipe was exposed 8 feet, 3 inches, measured on the downstream side.

- Clear woody vegetation in the channel. Consider clearing vegetation every 3-5 years to maintain flow capacity and allow access through the open channel.
- Monitor erosion along the toe of the channel banks.
- Although not part of the flood control project, monitor retaining walls and fences for potential failure and obstruction of flow through the channel.
- Although not part of the flood control project, the city may want to consider repairing or replacing the CMP storm sewer.

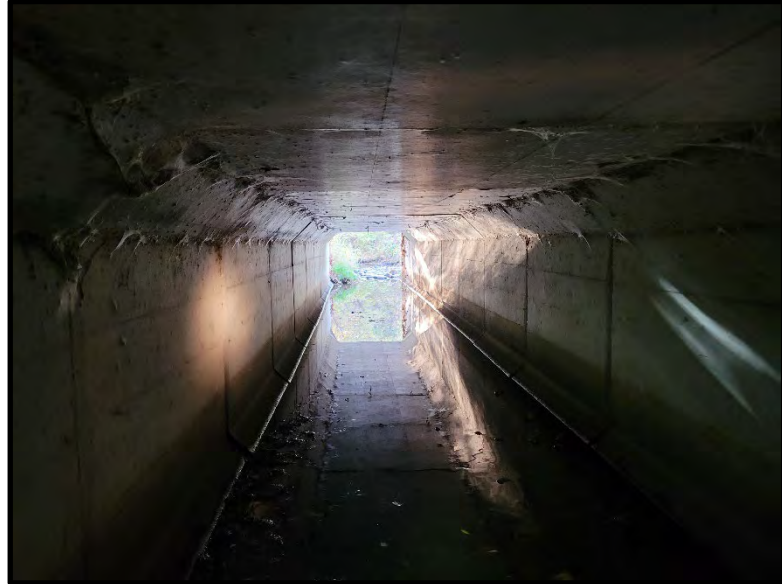
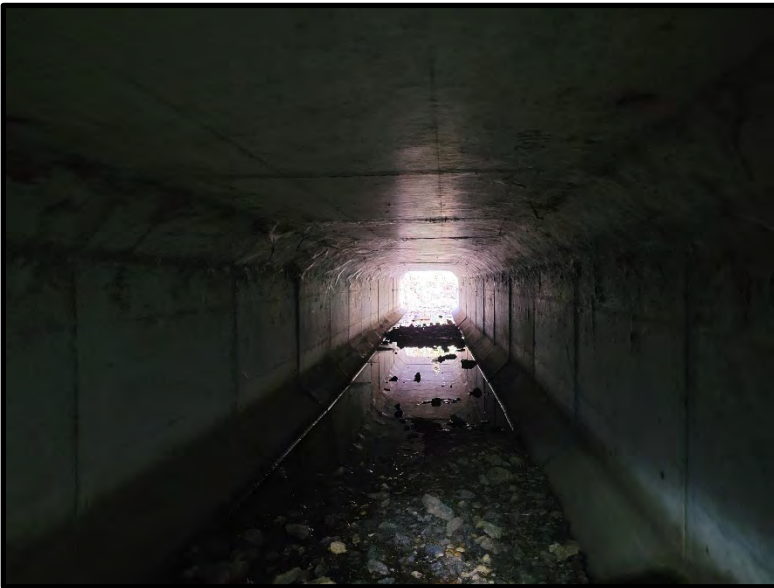
36th Avenue and Hampshire Avenue Crossing (Crystal)

- a. The concrete box culverts, joints and tie bars appeared to be in satisfactory condition.
- b. Riprap has deposited in the box culverts. Some may have washed through the culvert since last year's inspection.
- c. Sediment has deposited in the box culverts, mostly in the downstream half of the box culverts. This is consistent with previous inspections and has been noted since 2016.
- d. On both culverts, the fifth joint from the downstream end had a 2 ½ inch gap, which is a larger gap than the rest of the joints. This is consistent with previous inspections and has been noted since 2010.
- e. Various locations of spalled concrete and exposed reinforcing was observed through both culverts.
- f. Infiltration was observed into the culvert in some years in the past, but no infiltration into the culvert was observed in 2022 due to low water levels and dry conditions.

- Remove deposited riprap in the box culverts and replace upstream.
- Monitor sediment in the box culverts.
- Monitor the joint gaps in the box culverts.
- Monitor spalled concrete, and exposed reinforcing in the culverts.

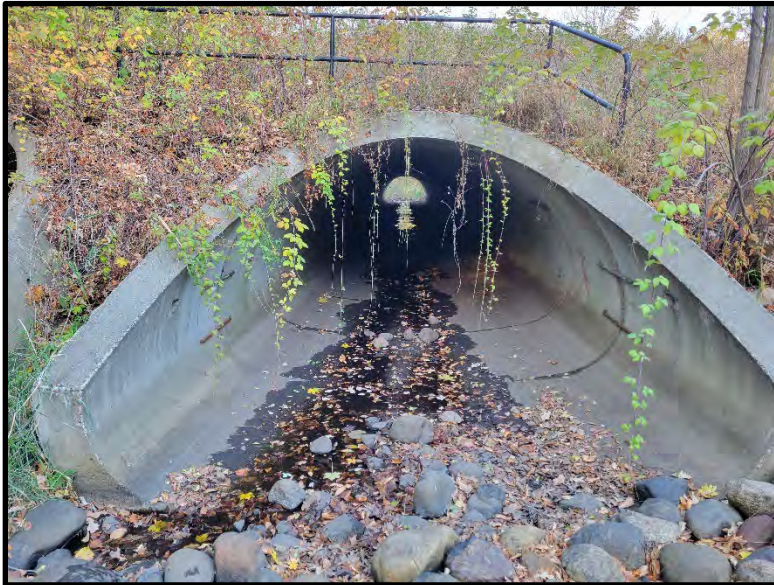
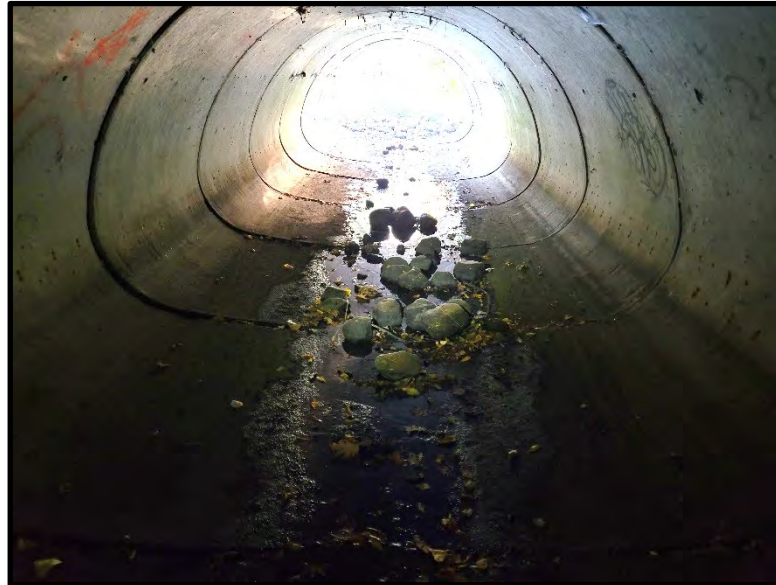
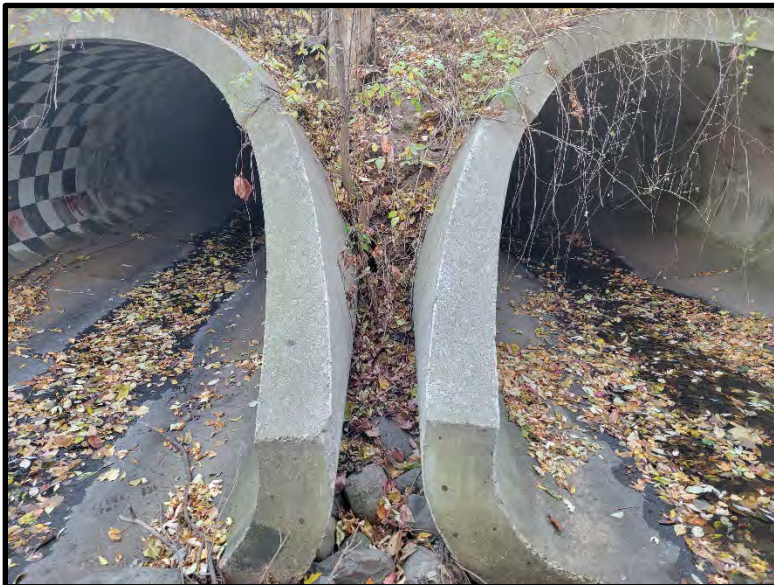
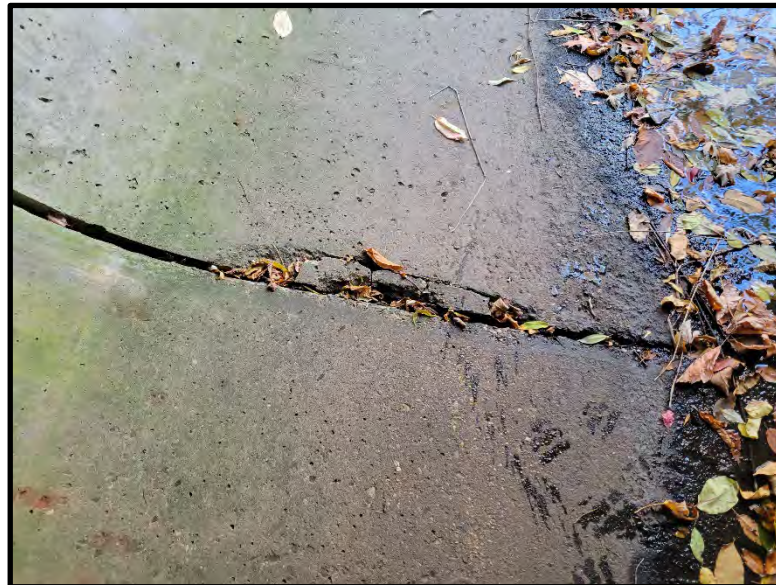
Georgia Avenue Crossing (Crystal)

- a. The concrete culverts appeared to be in satisfactory condition.
- b. Cracking and potential spalling was observed in the south (right) culvert at the second and fourth joints at approximately the five o'clock position.
- c. Minor erosion was observed between the concrete culverts at the upstream end.
- d. Both culverts appeared to begin to change slope around mid-channel.
- e. There is a downed tree upstream of the culvert that is partially in the creek.
- f. Some riprap has deposited in the north (left) culvert.

- Remove deposited riprap in the north (left) culvert and replace upstream.
- Monitor cracking and potential spalling in the south (right) culvert.
- Monitor minor erosion between the concrete culverts on the upstream end.

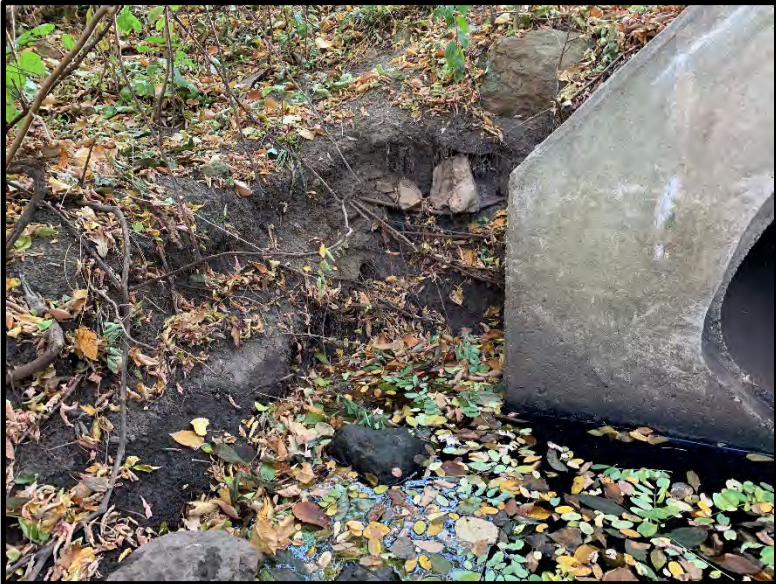
Edgewood Embankment (Crystal)

- a. The concrete culvert appeared to be in satisfactory condition.
- b. The embankment appeared to be in satisfactory condition.
- c. No visible settlement or erosion was observed along the embankment.

- d. Trees and shrubs were observed growing on the embankment.
- e. Three large trees (two oak trees and one maple tree) have fallen downstream of the culvert and the tree branches are extending into the creek channel and could obstruct creek flows.

- f. The natural boulder riprap between the Edgewood embankment and Douglas Drive crossing is significantly overgrown with vegetation.
- g. Spalled concrete was observed at the fifth joint from the upstream end at approximately the 7 o'clock position.

- h. Spalling observed on north (right) side of outlet.
- i. Moderate erosion is occurring on either side of the upstream end of the culvert.
- j. Sediment has accumulated in the pool downstream of the culvert and formed a delta, which had some vegetation growing on it. The deposited sediment was generally creating a meander in the creek toward the south (right) bank.

- Remove branches and downed trees that are in the creek channel and could obstruct creek flows.
- Remove trees, shrubs and woody vegetation growing on the embankment.
- Clear woody vegetation in the channel between the Edgewood Embankment and Douglas Drive crossing as needed to maintain flow capacity and allow access through the open channel.
- Monitor spalled concrete at the fifth joint from the upstream end in the culvert.
- Monitor spalling on outlet structure.
- Monitor sediment accumulation in the pool downstream of the culvert.

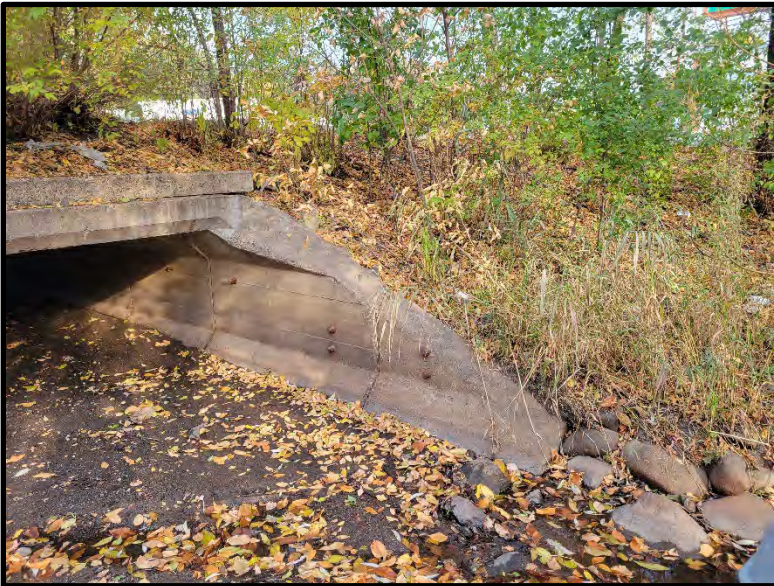
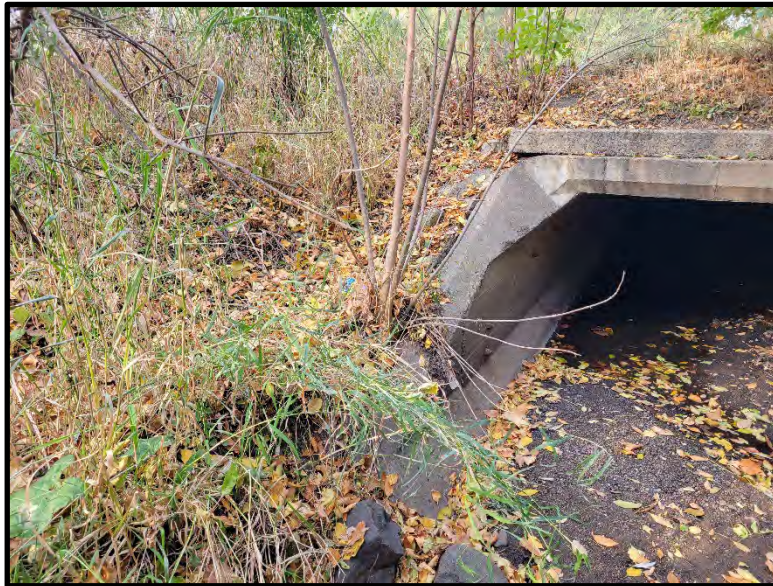
Douglas Drive Crossing (Crystal)

- a. The concrete box culvert was not entered due to low clearance but appeared to be in satisfactory condition.
- b. The grouted riprap installed on either side of the box culvert outlet has started to deteriorate, and a gap has opened between the grout and the wall of the box culvert. This is consistent with previous inspections and has been noted since 2016.

- c. Spalled concrete was observed at the downstream north (left) wing wall.
- d. Sediment has deposited in the bottom of the culvert, ranging from 0-2 inches deep.
- e. Some riprap was observed in the culvert.
- f. On the downstream end of the culvert, settling was observed in the sidewalk on either side of the culvert.
- g. Small trees were observed growing adjacent to the structure at the downstream end.
- h. Although not part of the flood control project, the privately-owned CMP culvert downstream of the Douglas Drive crossing is in poor condition. Sagging of this culvert has been observed during inspections since 2009. The culvert is significantly bowing and settling has occurred on either side of the culvert, which is evident in the road pavement above the structure.

- Consider adding a safety railing along the sidewalk at the upstream and downstream end of the culvert.
- Remove riprap from the culvert and replace upstream.
- Monitor deposited sediment in the culvert.
- Monitor grouted riprap at the downstream end of the box culvert.
- Monitor spalled concrete at the downstream north (left) wing wall.
- Monitor settling in the sidewalk at the downstream end of the culvert.
- Although not part of the flood control project, it is recommended that the city coordinate with the property owner to repair or replace the culvert downstream of Douglas Drive.

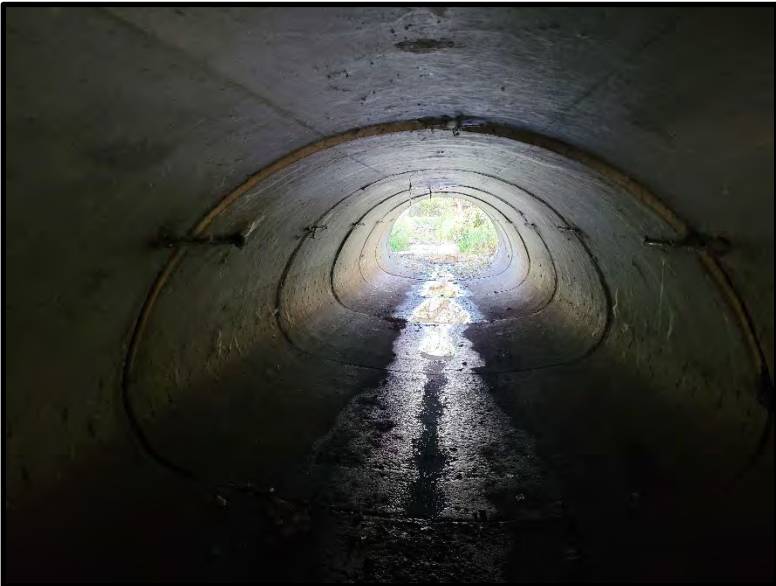
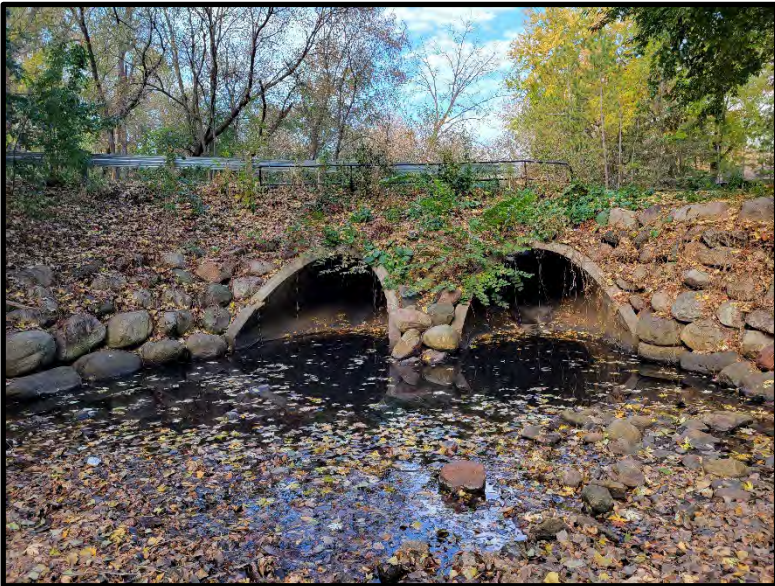
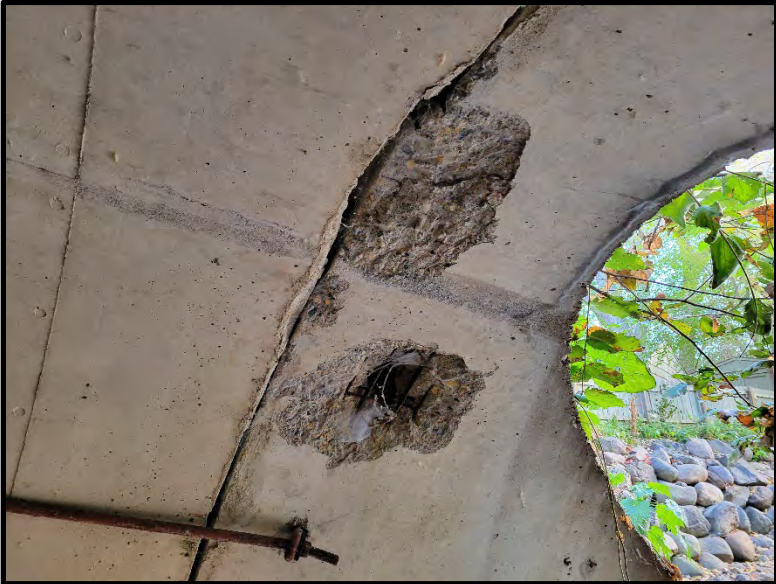
Brunswick Avenue Crossing (Crystal)

- b. Strained and detached tie bars were observed in the north (left) culvert. One joint with broken tie bars was previously re-grouted by the City of Crystal, but the joint reopened and a 1-1/2 inch gap in the joint was observed during the 2008 inspection. A 3-inch gap in the joint has been noted since 2009.

- c. Spalled concrete and exposed reinforcing were observed in various locations in the south (right) culvert.
- d. Fractured pieces of concrete and grout were observed at various joints in both culverts.

- e. Longitudinal and circumferential cracks were observed in both culverts.
- f. Cracks were observed in the road pavement above the structure.
- g. Sediment has deposited in the channel between the Brunswick Avenue crossing and the 32<sup>nd</sup> Avenue crossing and created two deltas in the channel. The channel was armored with boulder riprap in 2014. The sediment delta has been observed since 2017.

- Repair detached tie bars.
- Repair fractured concrete and grout at joints in the culverts.
- Replace boulders in the natural boulder wall between the Brunswick Avenue crossing and the 32<sup>nd</sup> Avenue crossing.
- Monitor deposited sediment and vegetation in the channel between the Brunswick Avenue crossing and the 32<sup>nd</sup> Avenue crossing.
- Monitor spalled concrete and exposed reinforcing in the culverts.
- Monitor minor cracks in the culverts and road.
- Monitor joint separation in north (left) side culvert.
