## Memorandum

**To:** Bassett Creek Watershed Management Commission (BCWMC)  
**From:** Barr Engineering Co.  
**Subject:** Bassett Creek 2022 Flood Control Project Inspection  
**Date:** November 9, 2022  
**Project:** 23270051.53 2022 4065

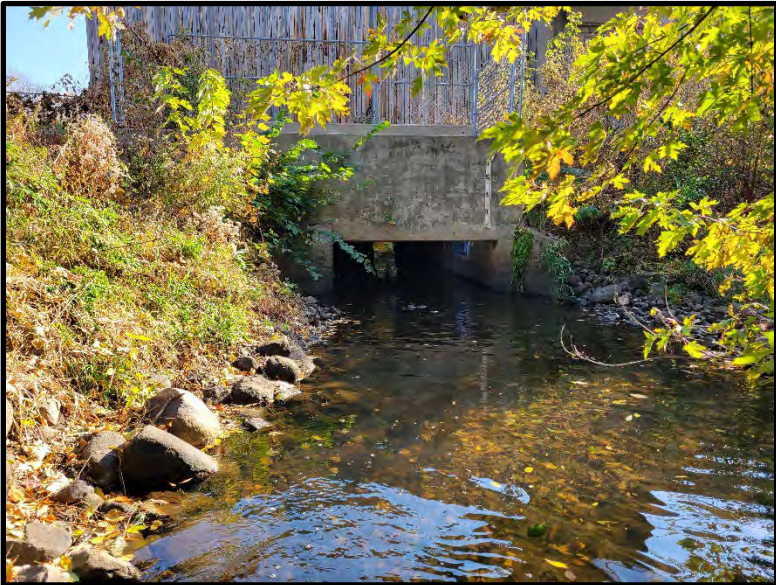
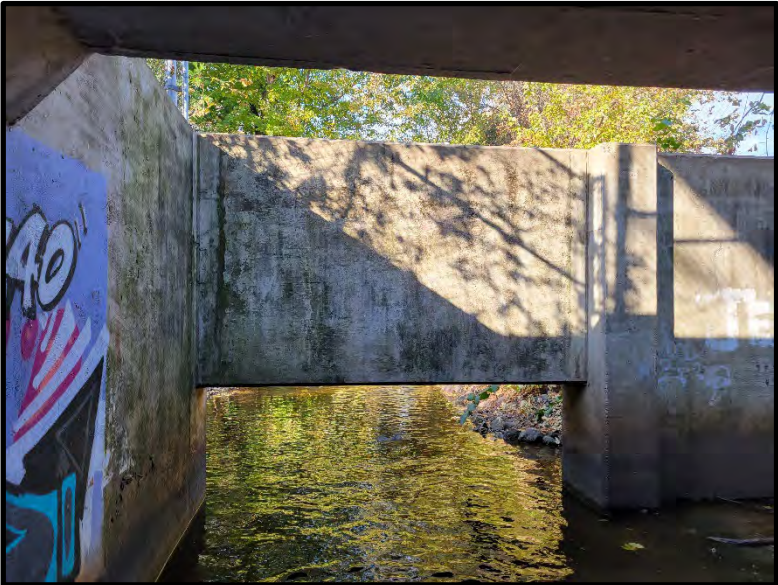
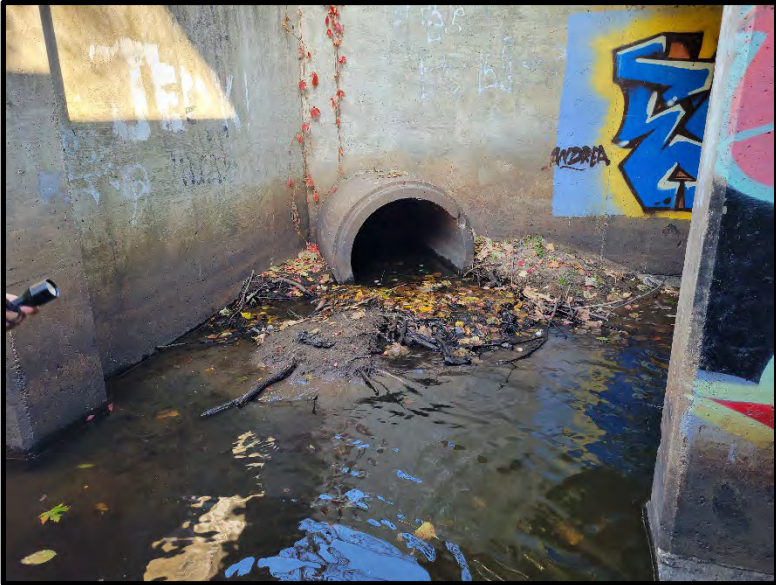
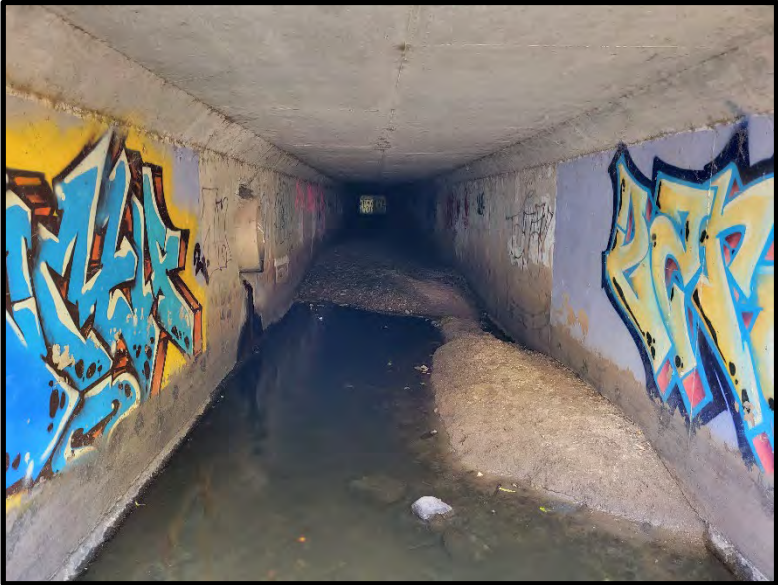
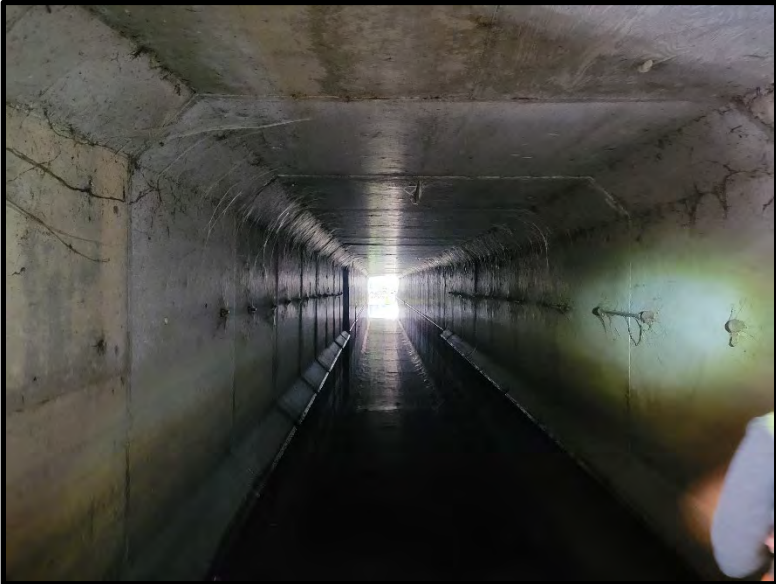
Highway 100 Double Box Culverts (MnDOT Responsibility, Located in Crystal/Golden Valley)

- a. The concrete inlet structure appeared to be in satisfactory condition.

- b. Circumferential cracks and areas of spalled concrete with exposed reinforcement were observed in the north (left) box culvert.
- c. Longitudinal cracks, circumferential cracks, and areas of spalled concrete with exposed reinforcement were observed along the top of the south (right) box culvert. MnDOT performed repairs to the culverts in 2007, but cracks have been noted since 2008 and areas of concrete spalling have been noted since 2014.
- d. Deposited sediment was observed in the north (left) box culvert, generally ranging from 6-24 inches deep. This is consistent with previous inspections and 6-24 inches of deposited sediment has been observed in the north (left) box culvert since 2002.
- e. The outlet portion of the structure appeared to be in satisfactory condition.

- Monitor accumulated sediment in north (left) box culvert and consider future removal.
- Monitor cracking, spalling concrete, and exposed reinforcement in both box culverts.
- MnDOT should assess the defects and repair, as necessary.

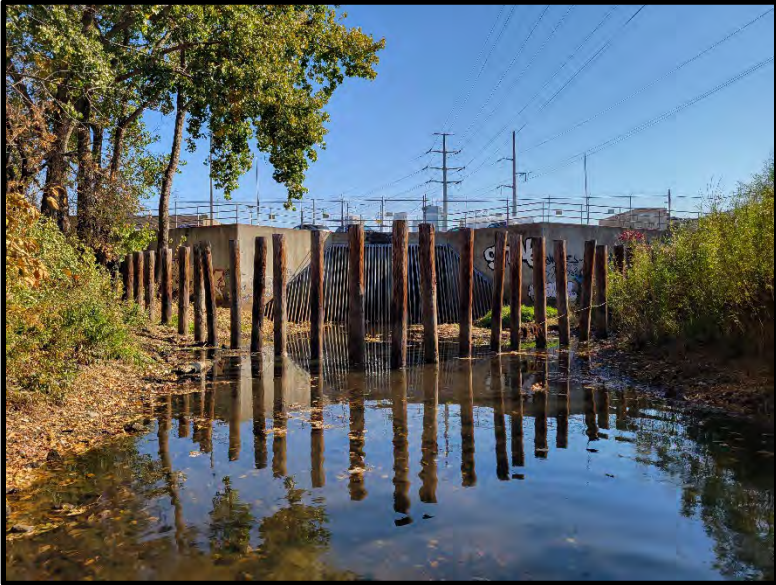
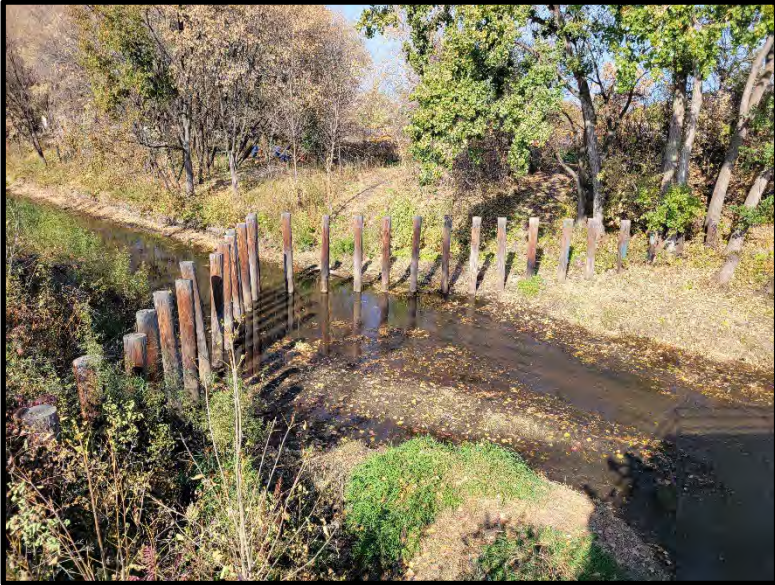
Debris Barrier (Minneapolis)

- a. The debris barrier piles appeared to be in satisfactory condition.
- b. The cable was missing or broken in the center portion of the channel. The middle seven barrier piles did not have a cable attached. The cable should extend from end to end, attached at each post.

- Repair or replace the steel cable on debris barrier.
- Monitor for debris and remove as needed.

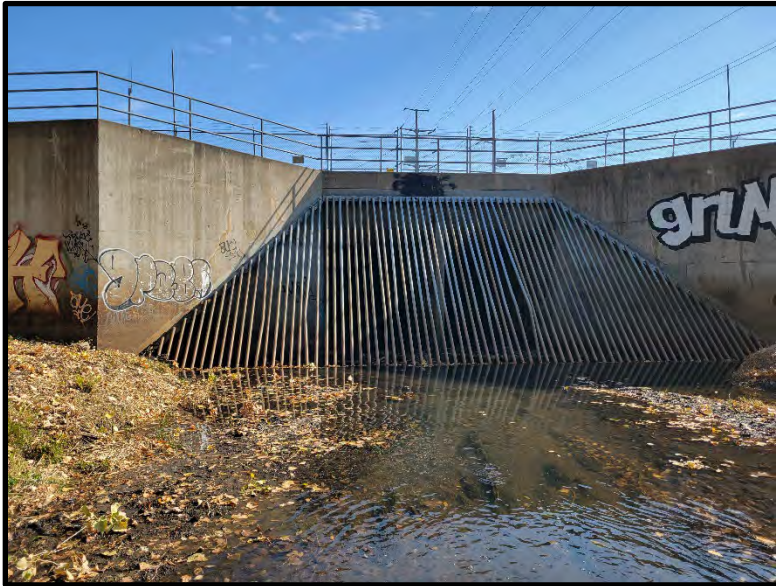
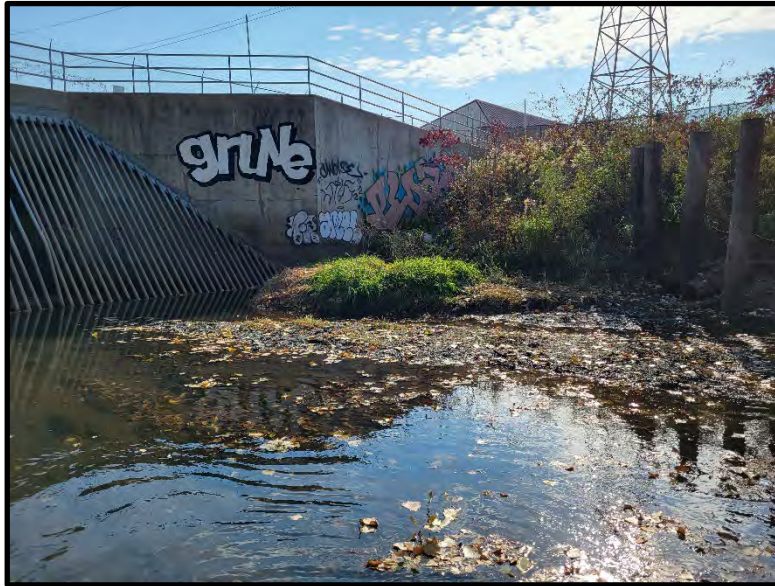
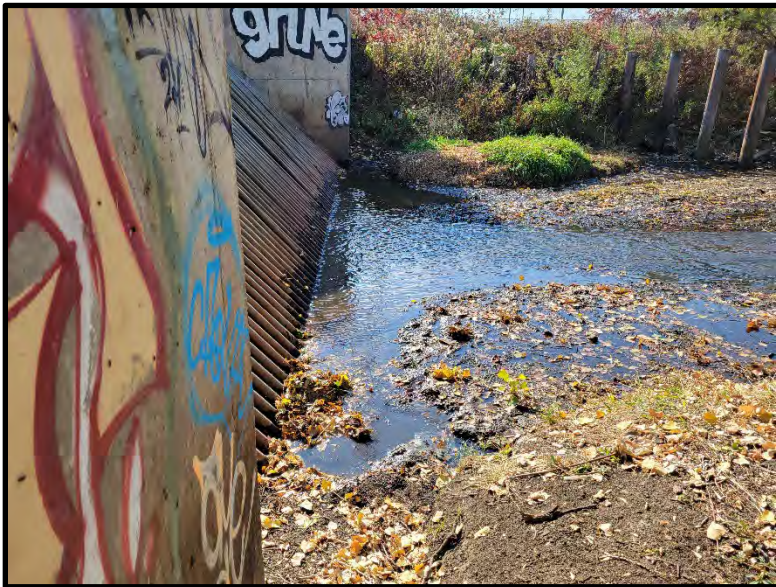
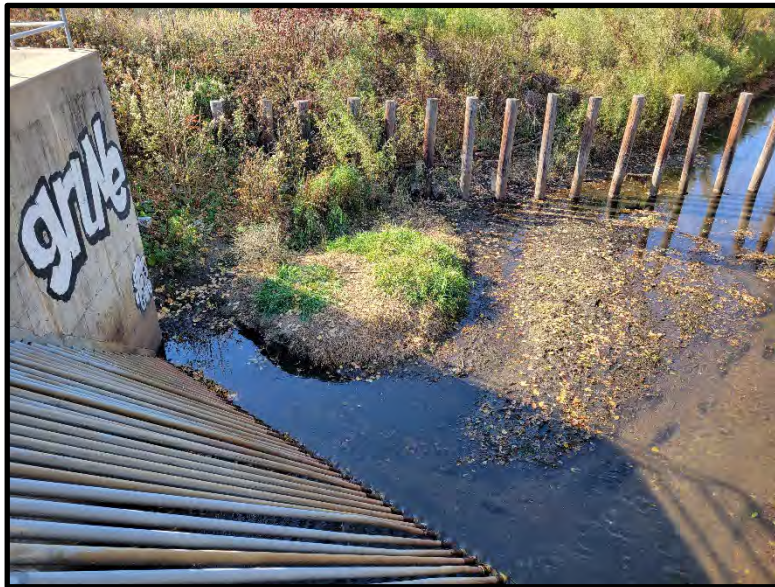
# Inlet Structure (Minneapolis)

- a. The concrete inlet structure appeared to be in satisfactory condition.
- b. Vertical cracks were observed in the concrete on either side of the structure.
- c. Cracks were observed near where the handrail posts are embedded.
- d. The railings appeared to be in satisfactory condition.
- e. Some of the vertical bars have been bent and projecting a slight bow but generally appeared to be in satisfactory condition.
- f. The inlet structure was clear of debris.

- Monitor for debris and clear as needed.
- Monitor cracks in the concrete inlet structure.
