To: Bassett Creek Watershed Management Commission
From: Barr Engineering Co.
Subject: Item 4I – 2014 Flood Control Project Inspection
BCWMC January 15, 2015 Meeting Agenda
Date: January 7, 2015
Project: 23270051 2014 065

4I 2014 Flood Control Project Inspection

To: Bassett Creek Watershed Management Commission
From: Barr Engineering Co.
Subject: Bassett Creek 2014 Flood Control Project Inspection
Date: January 6, 2015
Project: 23/27 0051.35 2014 065

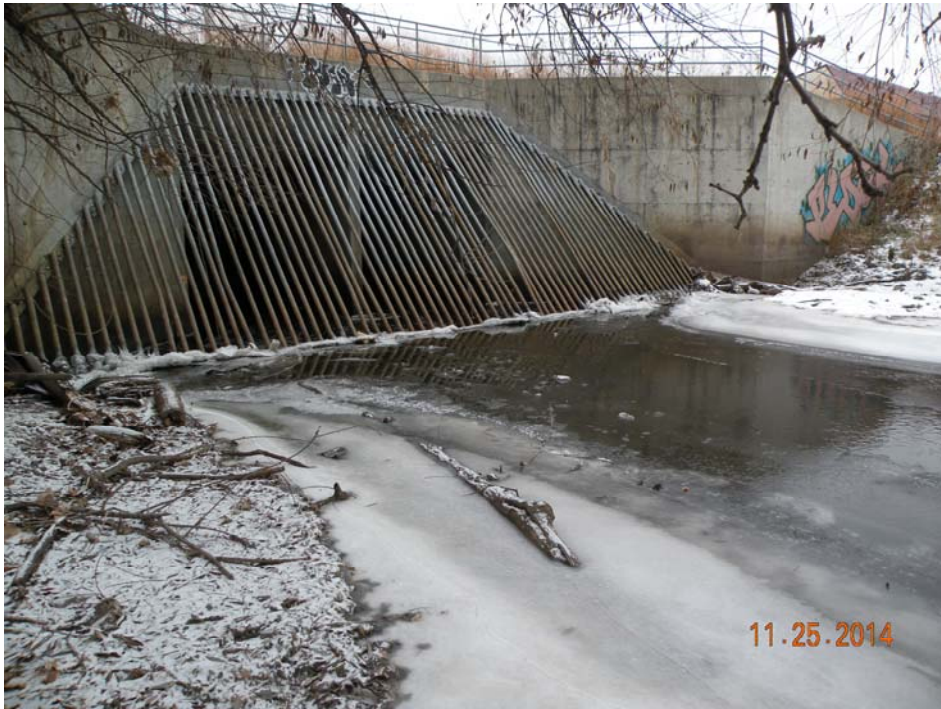
Inlet Structure

- a. The overall condition of the inlet structure appeared satisfactory
- b. The overall condition of the fence and railing appeared satisfactory.
- c. Minor cracks were noted in the concrete, especially where handrail posts were embedded. Some spalling was noted on the back of the south wing wall as were indicated in previous inspections.
- d. A new access gate has been installed in the school board property fence adjacent to the inlet structure allowing for easier access to clean the structure.
- e. Woody debris, from previous removal operations, has accumulated on the creek banks on either side of the creek and should be removed.
- f. There was only a minor amount of debris collected on the inlet structure grate at the time of the inspection.
- g. The creek channel was not observed during the 2014 inspection due to ice conditions.

- Remove woody debris from creek banks on each side of the inlet structure.

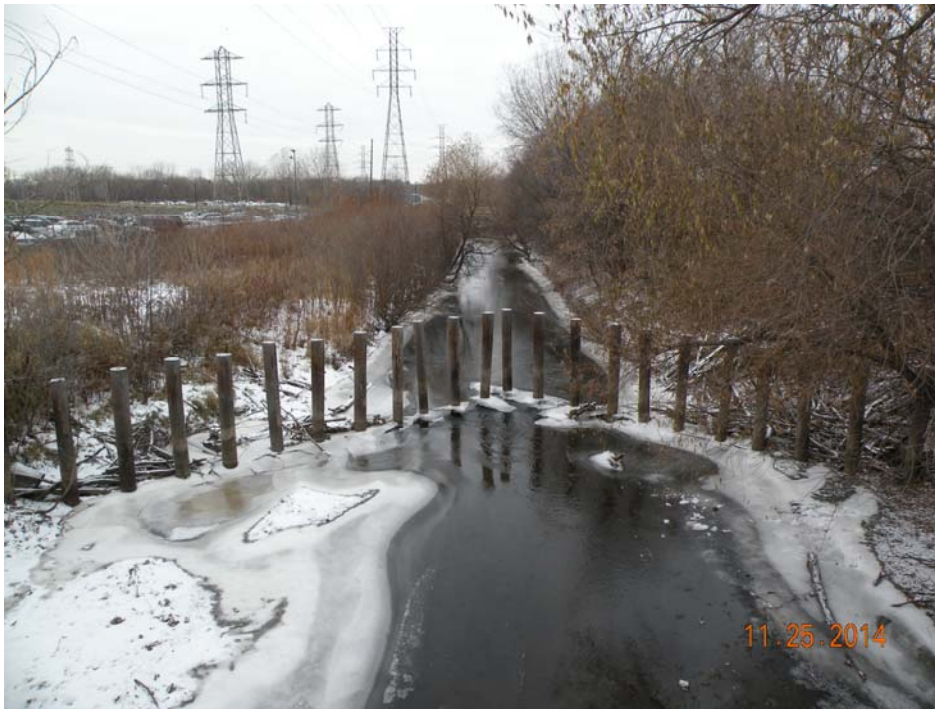
Debris Barrier

- a. The debris barrier cable has come detached from the wood poles and needs to be reinstalled or replaced.

- Repair/replace steel cable on debris barrier.

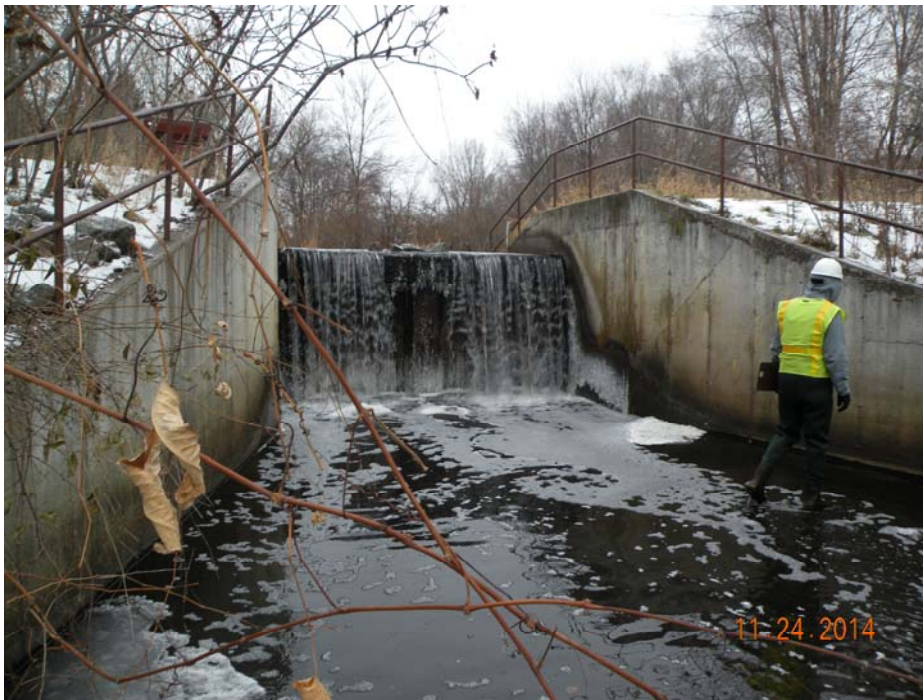
Plymouth Fish Barrier

- a. The water flow over the weir structure was about two inch in depth. There were riprap boulders on the overflow weir that were likely placed to dam up the creek.
- b. The overall condition of the structure was satisfactory and appeared similar to the previous inspection (the concrete appeared to be in good condition).
- c. There are a few small cracks in the downstream portion of the left wing wall. No change from previous inspection notes.

- d. The expansion joint in the middle of the right abutment wall appears to be consistent to last few years and the gap was measured at approximately $\frac{3}{4}$ inch.
- e. Both sides of the downstream banks were stabilized with riprap that was installed a few years ago. Some of the riprap on the west (right) slope downstream of the structure has slid exposing the filter fabric underlayment which was noted on the last inspection in 2012.
- f. Sediment has continued to accumulated upstream of the structure. The upstream pool is filling with sediment and has formed a delta/island with vegetation growing on it. The island is deflecting the creek current toward the west (right) bank and some erosion was noted along the west bank.
- g. Rust was noted on railings.

- Remove riprap from weir.
- Remove accumulation of sediment from upstream pool.
- Monitor west downstream slope and replace riprap as necessary.
- Monitor width of joint opening during future inspection.

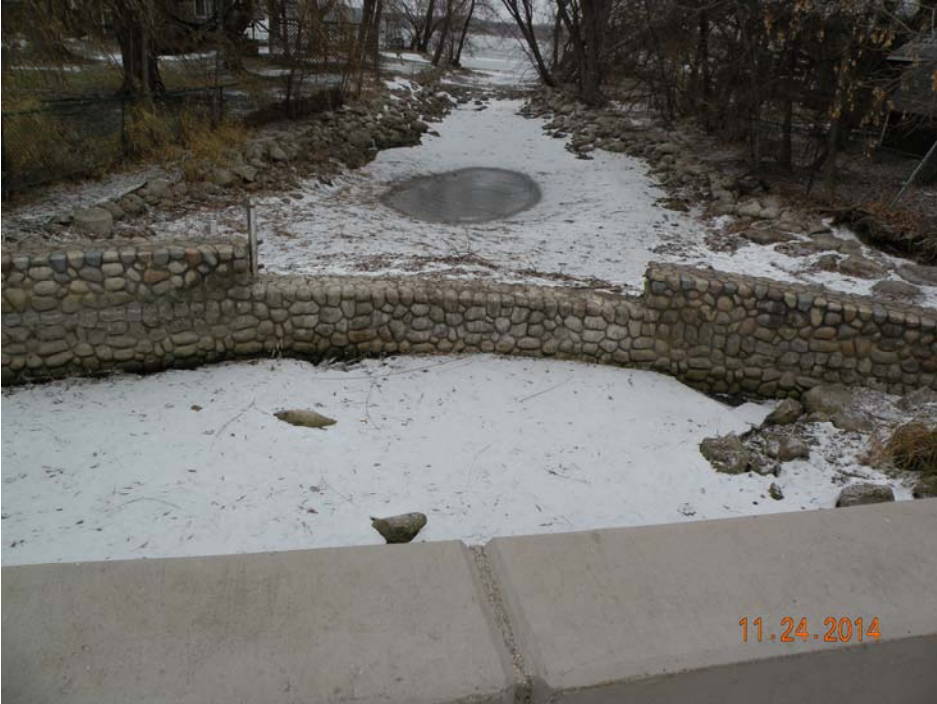
Medicine Lake Outlet

- a. The overall condition of the structure appeared satisfactory. The concrete appeared to be in good condition with no major cracks.
- b. There was no water flowing over the weir at the time of the inspection and there was thick ice on the downstream side of the weir limiting the inspection at the base of the weir.

- c. Some erosion was noted around the east end of the weir where it ties into the east bank of the creek. During high flow conditions this erosion could increase and flow could bypass the weir.

- d. There was a large tree on the east bank that is tipping and exposing soil and roots. If the tree falls, it will leave a void in the bank.
- e. The channel between the lake and the weir was generally dry except for a localized frozen pool in the middle. The lake staff gauge was removed for the season. Ice was noted along the shoreline at time of inspection.

- The tree that is falling over on the east bank should be removed along with the root ball and the bank should be stabilized with additional riprap.
- The erosion around the east end of the weir should be repaired with backfill, erosion control blanket or Turf Reinforcement Mats (TRM), and riprap to prevent further erosion around the end of the weir.

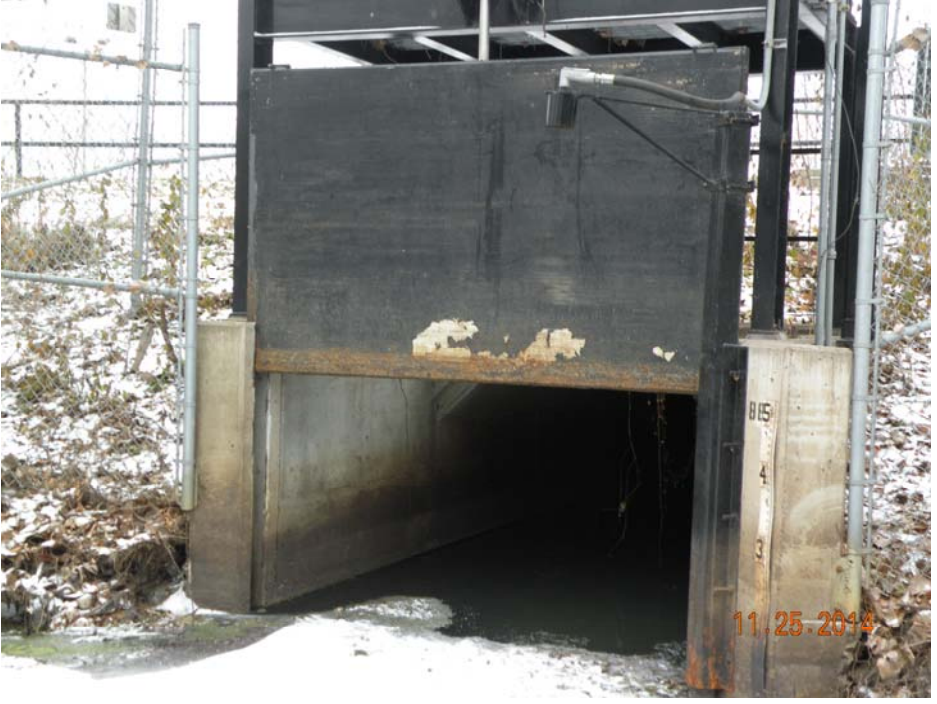
Wisconsin Ave. Structure

- a. The overall condition of the structure appeared to be satisfactory.
- b. The culverts appear to have settled approximately 3-4 inches directly under Wisconsin Avenue (water is deeper in the middle). This comment was noted in previous inspections and no noticeable change has occurred since 2005 inspection. Ice conditions prevented walking through the culvert at the time of the inspection.

- c. The portion of the gabion baskets that were below water have deteriorated and baskets are not intact; riprap has fallen out of the baskets at some locations (the deterioration has increased over the years and since the 2002 inspection). Deteriorated portion of the gabion baskets could not be inspected because they were under the ice at the time of the inspection.

- d. A small sediment delta has been forming on the south side (right) of the upstream end of the structure as noted in previous inspections.
- e. The flood gate was in the up-position at the time of the inspection; the gate has some rust forming along the bottom of the gate and there is some paint peeling off of the gate.

- Monitor gabion baskets and potential erosion during future inspections.
- Sand, prime and paint lower portion of gate and other steel members, as necessary.

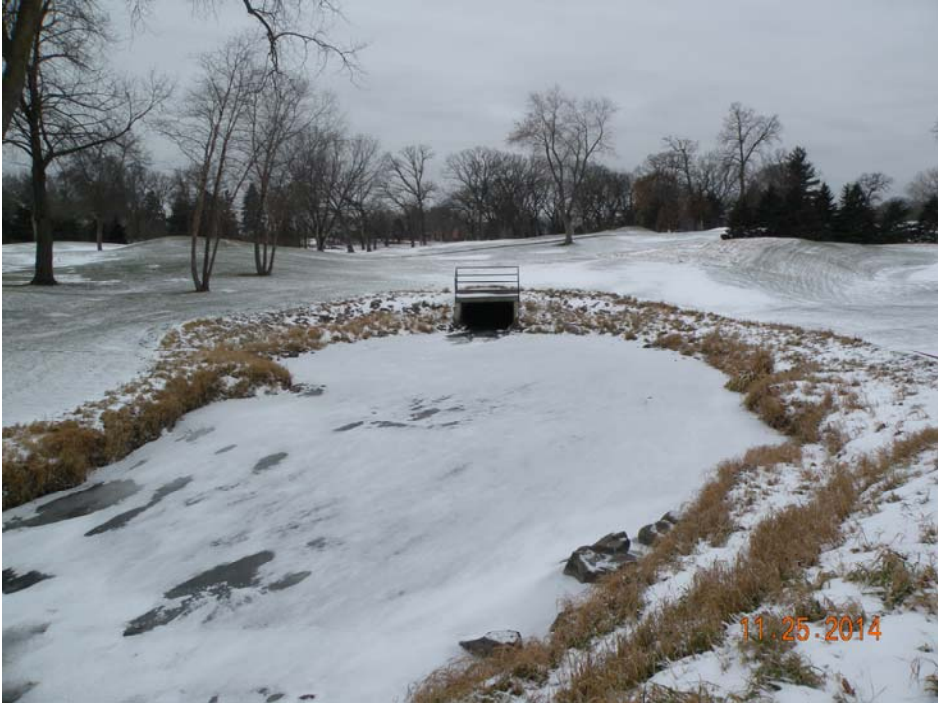
Golden Valley Country Club Control Structures

- a. The channel appeared to be in satisfactory condition with no change as stated in previous inspections. The riprap is in place along the channel and there was no erosion noted on either bank. Some riprap had collected in the channel bottom. Weeds and grass have grown in the riprap in the lower part of the channel. No debris, trees or brush have accumulated in the channel. The Channel was not walked during this inspection because of the ice conditions.
- b. The box culvert structure appears to be satisfactory. No debris was found around the structure to obstruct the flow.
- c. The handrails at each end of the box culvert appeared to be in good condition.
- d. The overflow weir (earth berm) appeared in good condition. The turf grass was in good condition and there was complete coverage of the overflow weir with manicured fairway turf.

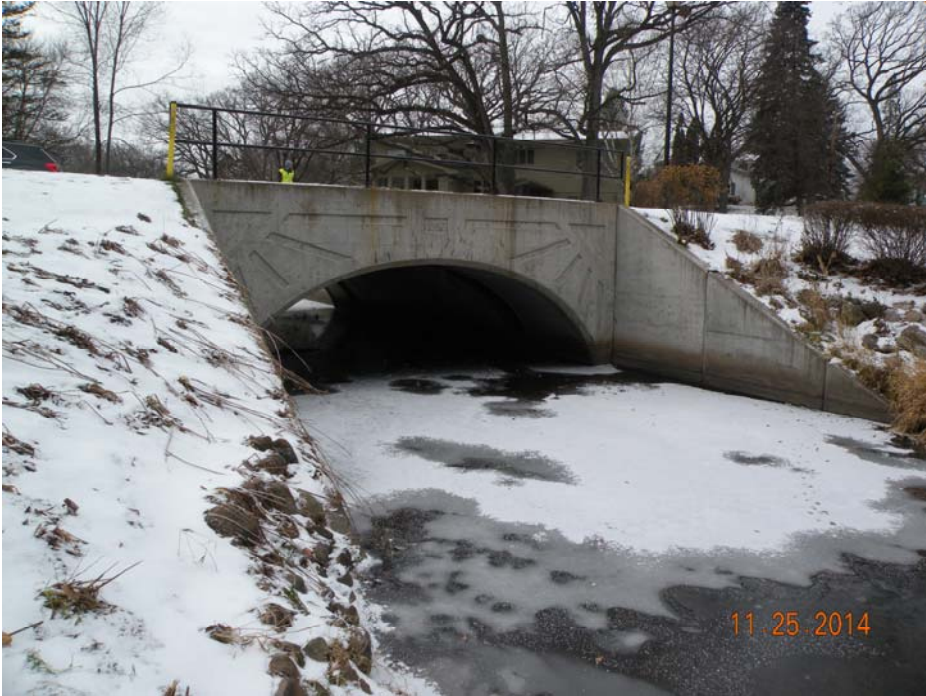
Westbrook Road Crossing

- a. The overall condition of the structure appeared satisfactory.
- b. The interior of the culvert could not be inspected because of the ice conditions at the time of the inspection.

- c. Spalled concrete (approx. 4 inch x 4 inch) noted at top of wing wall section at downstream right (east) side; there has been no change to the top of the wing wall since the 2007 inspection.

- d. Storm sewer pipe entering Bebo from left (west) side has exposed rebar and could use some mortar around the pipe to form a better seal to the Bebo. We were not able to observe the storm sewer connection due to the ice conditions at the time of inspection.

- e. Westbrook Road was resurfaced in 2010 and since that inspection three minor cracks have appeared in the bituminous road surface, across the road and parallel and directly over the Bebo culvert, during previous inspections. The pavement was not observed during this inspection because the road was covered with ice and snow.

- Monitor cracks in the Bebo arch sections and the road surface during future inspections.

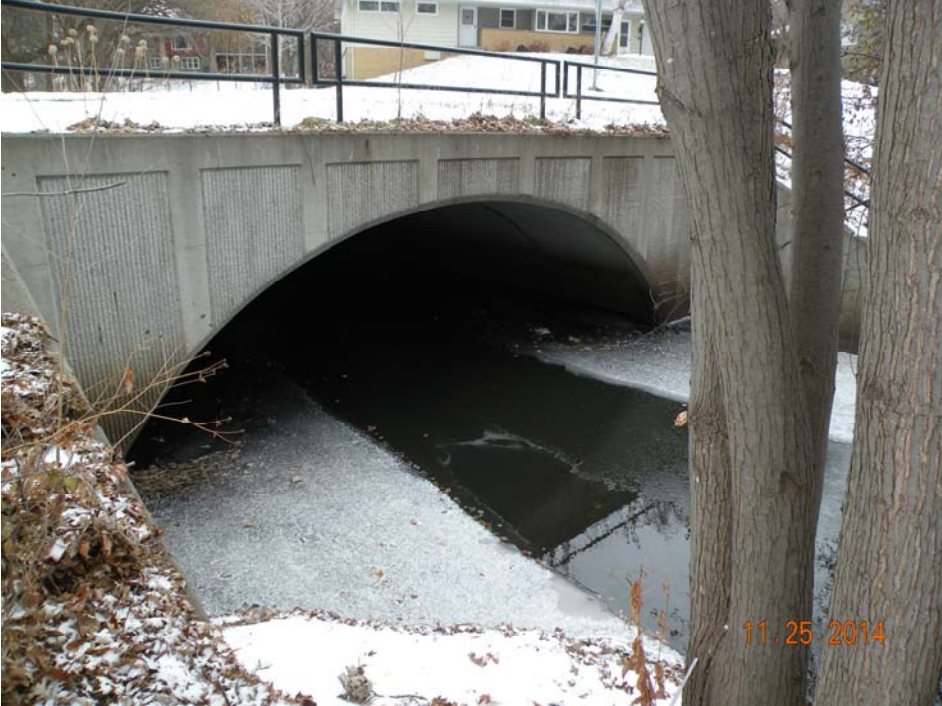
Regent Ave. Crossing

- a. The overall condition of the structure is satisfactory. Inspection of interior of culvert could not be completed because of ice conditions at the time of inspection.
- b. Some scour/erosion was observed around the end of the left downstream bank and at the upstream right side wing wall, as noted during previous years. Riprap is gone and filter fabric is now exposed on the south side (right) upstream end of the culvert.
- c. Top of upstream left/north wing wall has minor spalling with a long end section joint as noted in previous inspections.
- d. Diagonal hairline crack near top of upstream left wing wall as noted in previous inspections.
- e. Restoration work on the creek channel between Regent and Noble Ave. was observed during the time of inspection.

- Monitor erosion of bank at downstream of left wing wall and consider repair of bank with riprap.
- Repair erosion at upstream right wing wall by adding new fabric/filter and riprap on creek bank.

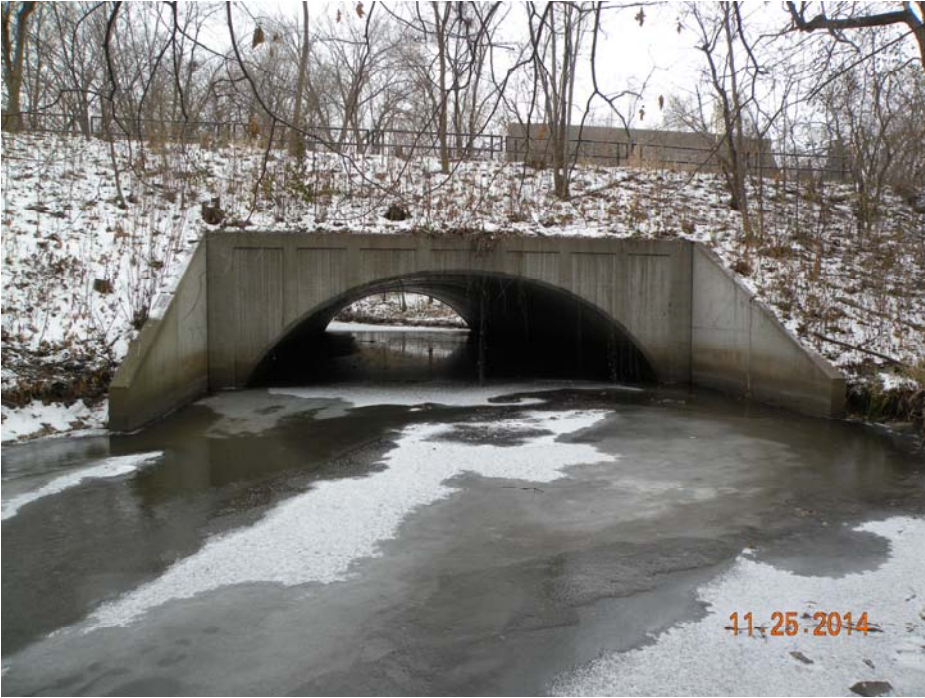
Noble Ave. Crossing

- a. The overall condition of the structure appeared satisfactory. Inspection of interior of culvert could not be completed because of ice conditions at the time of inspection.

- b. Hairline cracks were noted along the top of the Bebo arch culvert. Most Bebo pre-cast sections had 2-4 hairline cracks across each section. Most cracks were either along the center or spaced 2 ft. off-center (same comment noted in past inspections since 2002). Spalling has occurred exposing some plastic joint material in some of the culvert sections near the downstream end and along the cracks approximately two feet either side of center, as noted in previous inspections since 2012. The cement paste covering the plastic joint material is separating and exposing the plastic.

- c. Downstream right wing wall tilted in (toward creek) 1-1/8-inch. Measurement increased by 1/8 inch since 2008 inspection.
- d. The depth from the Bebo arch culvert crown to the creek bottom was measured this year at each end of the culvert. The measurements were 10.12 feet upstream side and 7.72 feet downstream

- e. Spalled concrete noted at top of the left downstream wing wall and cracks nearby as noted in previous inspections. Some of the cracking appears to be expanding.
- f. Erosion noted along outside edge of the upstream right wing wall. Filter fabric is exposed. Creek is entering the Bebo arch culvert at an angle. Additional riprap may minimize erosion.
- g. Storm sewer pipe on the north side entering the Bebo arch under the road has exposed rebar and should be patched with mortar. This has been noted in previous inspections since 2002.
- h. The hand rails are in need of some rust removal and painting.

- Monitor cracks, spalling and scour during future inspections, especially at the downstream left wing wall.
- Repair erosion at upstream wing wall by adding riprap.
- Monitor cracks in crown exposing plastic expansion material to see if spalling is from weathering or movement of the Bebo sections.

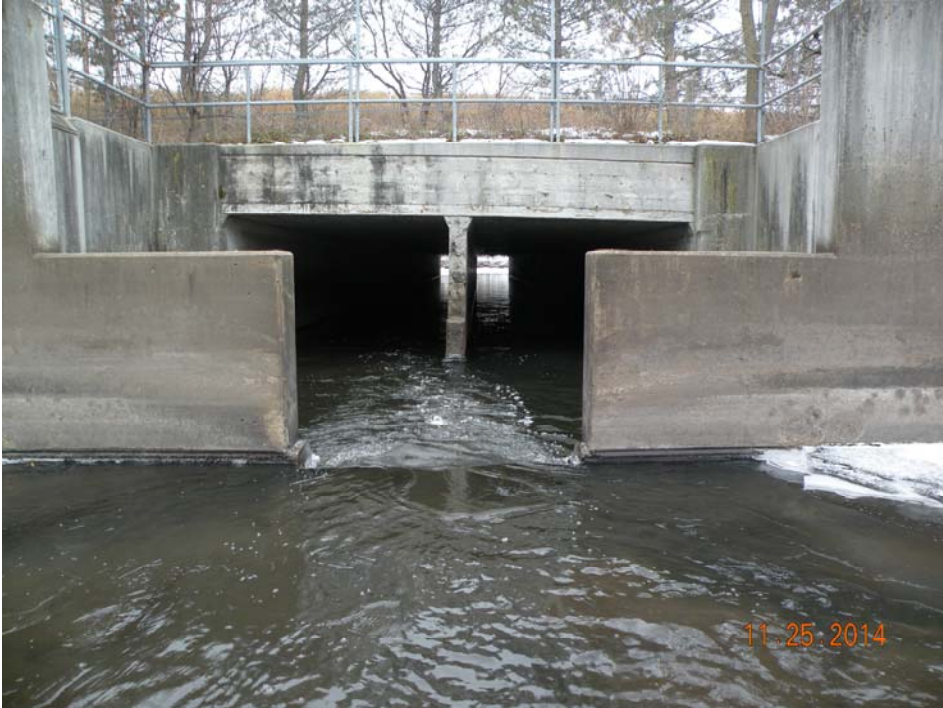
Highway 55 Control Structure

- a. The overall condition of the structure appeared satisfactory.
- b. Erosion was observed around both the east and west sides of the structure from water flowing along the sides of the structure that runs off of the bituminous path from above the structure as noted in 2007 inspection. The east side is more noticeable than the west side. Riprap and filter fabric could be placed on both sides.
- c. There is a small hairline crack in the left wall of the inlet structure. The crack is positioned in the middle of the wall extending full height, this crack has been noted in previous inspections and there is no apparent change.
- d. Steel cable guard rail between trail and structure has been replaced with a new metal guard rail system.

- e. Silt has accumulated at upstream pool in front of weir. Pool used to be relatively deep and was only 8 to 12 inches deep during inspection. The silt/sediment has filled the pool and was generally the same elevation as the overflow weir.

- Remove accumulation of sediment from upstream pool.
- Monitor cracks and erosion during future inspections
- Consider adding riprap and filter to each side of the structure, same comment since 2010 (not urgent).

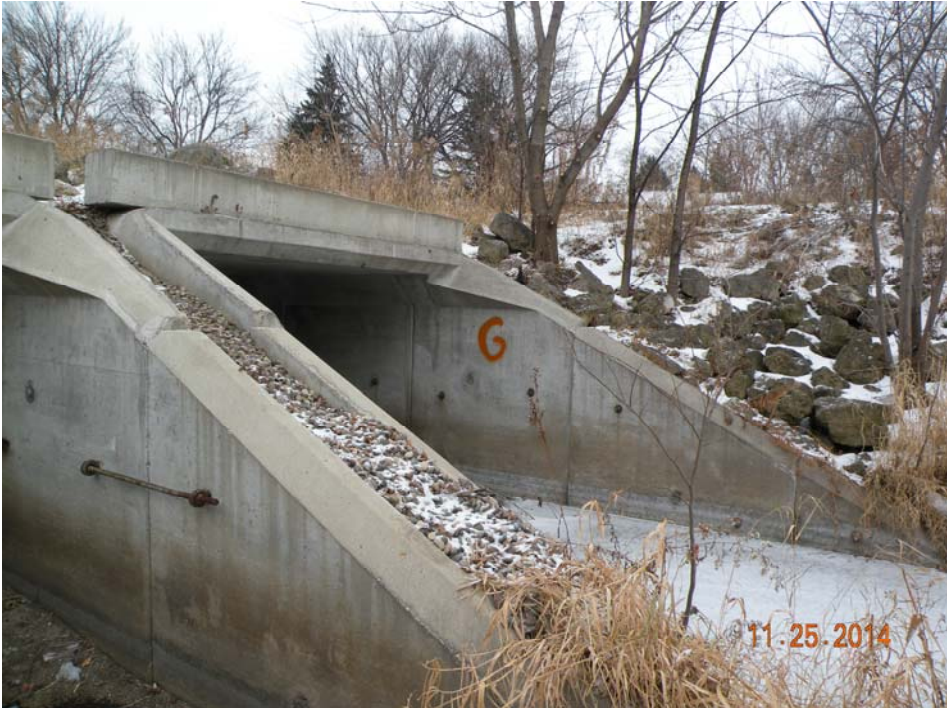
Highway 100 Double Box Culvert

- a. The control inlet structure condition appeared satisfactory.
- b. The creek channel upstream of the structure has been improved with new channel section, riprap banks, and rock riffles.

- c. The large cracks and transition joint damage as noted in previous inspections were repaired by Mn/DOT in 2007. The repairs still remain in good shape with just a few hairline cracks observed and should continue to be monitored. During this year's inspection it was noticed that some of the concrete patching has become dislodged at the top of the culvert.

- d. As noted in previous inspections sediment has accumulated in the northern (left) box culvert. The sediment is approximately 12 to 18 inches deep. In previous years the sediment had collected downstream of the right angled bend in the northern culvert and is now progressing further upstream in the culvert up to the Mn/DOT storm sewer connection.

- e. The outlet portion of the structure appeared in satisfactory condition some of the pea rock in between the box culvert sections has washed away.

- Monitor accumulated silt in northeasterly (left) box culvert and consider removal in future.
- Replace fill and riprap between box culvert end sections.

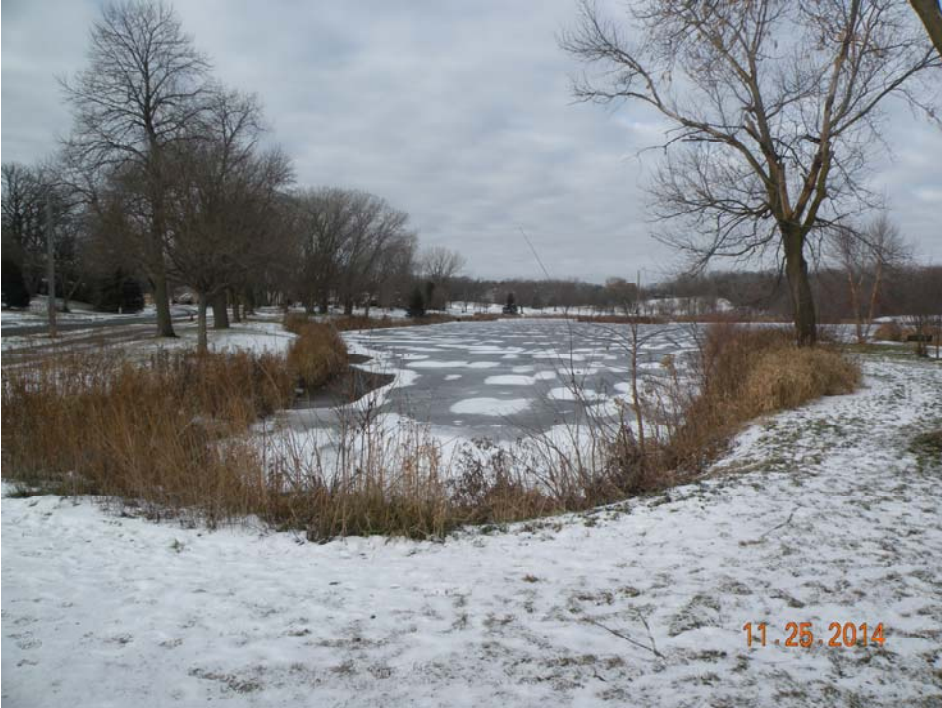
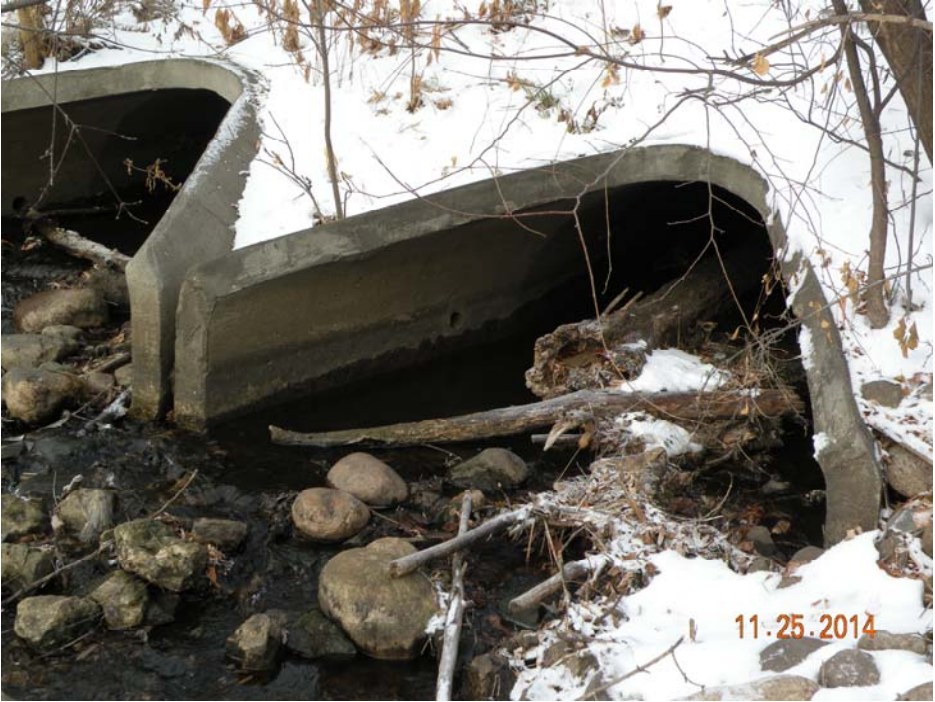
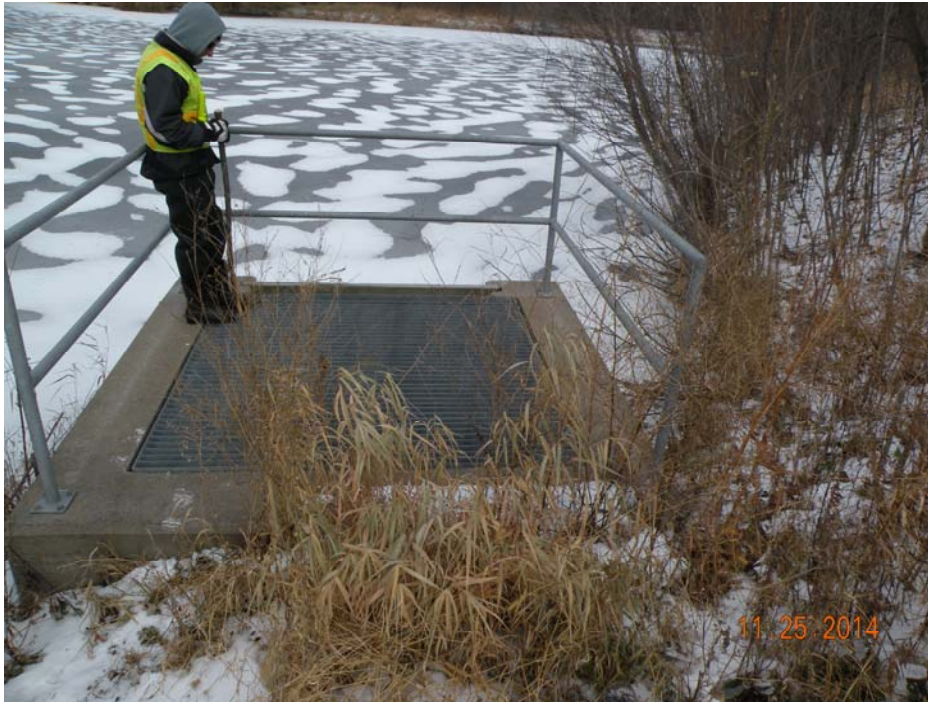
Bassett Creek Park Pond and Outlet Structures

- a. The overall condition of the outlet pipes appears satisfactory. There are large logs and boulders, woody debris, sticks, and branches in the outlet flared end sections that should be removed.
- b. The creek has been stabilized and new riprap was observed along the reach where the pond outlet culvert discharges to Bassett Creek.
- c. There is a large amount of sediment that has accumulated in the northwest corner of the pond where the creek enters. This has been noted in previous inspections; small trees, brush and vegetation is now growing in these areas on the sediment deltas.
- d. The shoreline of the pond could not be inspected at the time of construction because of the thin ice conditions.

- The logs, boulders, and debris should be removed as soon as possible from the pond outlet flared ends sections, at the least before spring to prevent any back-up or flooding.
- Survey existing pond bottom so it can be compared to the original design to determine the amount of accumulated sediment and consider future maintenance dredging project.

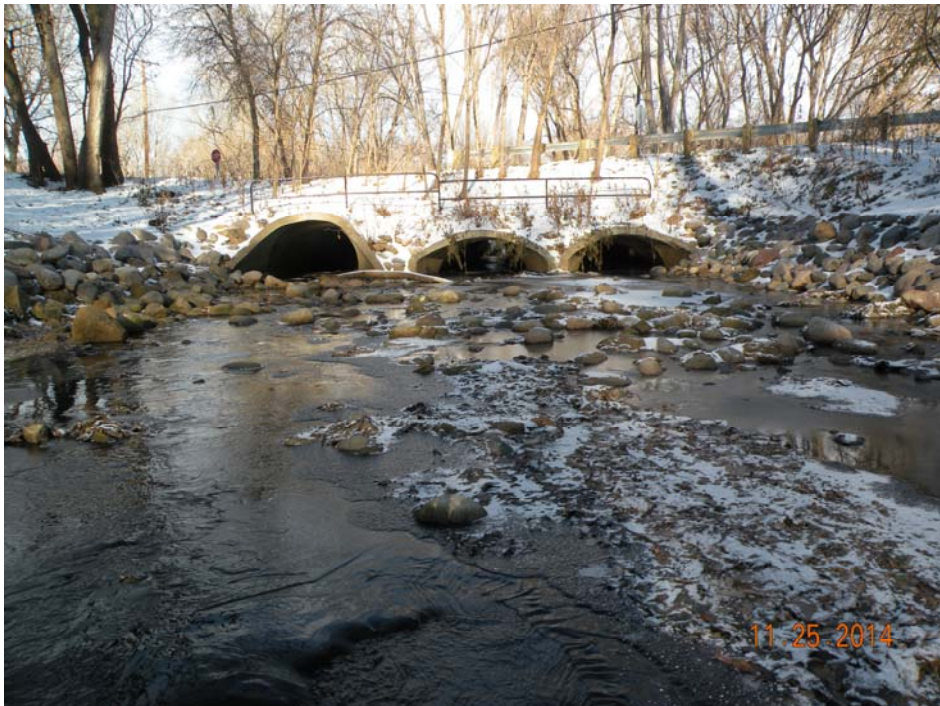
32nd Ave. Crossing

- a. The overall condition of the structure appeared satisfactory. Culvert interior could not be inspected because of ice conditions at time of inspection.
- b. The creek channel upstream of the culvert has been repaired and restored with new natural boulder riprap along each side of the creek.
- c. The upstream and downstream ends of the culvert have been restored and new natural boulder riprap has been installed.
- d. New galvanized guard rails have been installed on each side of the road.

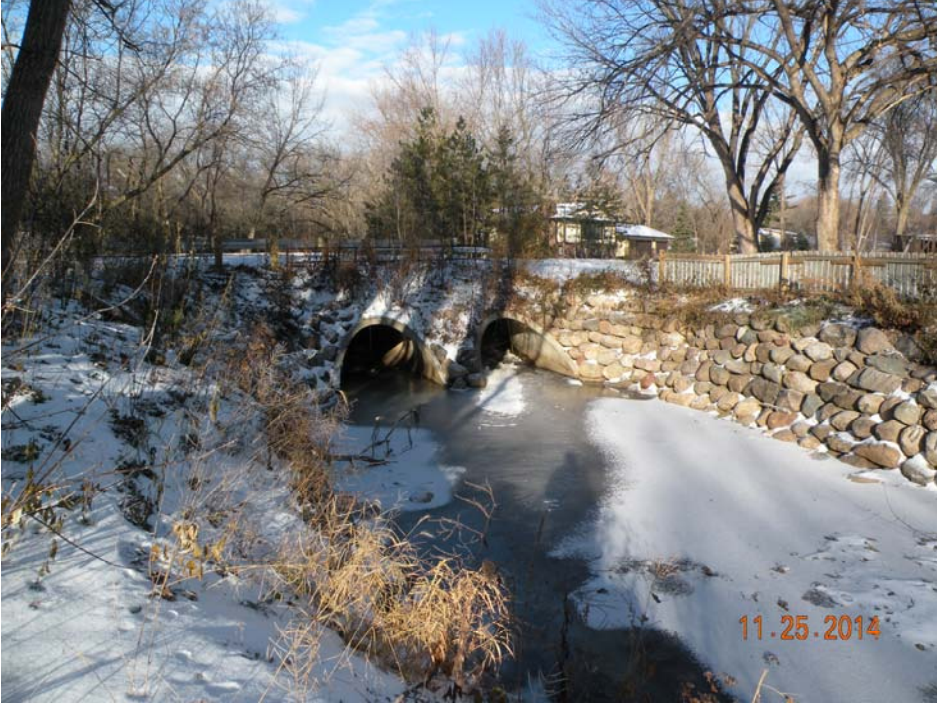
Brunswick Ave. Crossing

- a. The overall condition of the structure appeared satisfactory, but the tie rods are broken and the joints have opened up - similar as noted in previous inspections.

- c. The failing gabion baskets on the downstream end at the north side (left) adjacent to the private driveway has been removed and replaced with a new large boulder retaining wall.

- d. On the south culvert, the fourth pipe joint from the downstream side has two broken ties and had been re-grouted by the City. The joint appears to be moving and is now about a 3-inch opening, with a gap between the pipe joint and the new grout. There is little change with the several other broken culvert tie-rods along each culvert as noted in previous inspections, with joint offsets up to 3/4 inch. Grout that was placed to fill the separating joints has started to detach due to joint movement and is falling out.

- Repair pipe ties.
- Monitor concrete pipe joints condition during future inspections.
- Continue to monitor for cracks in pavement.

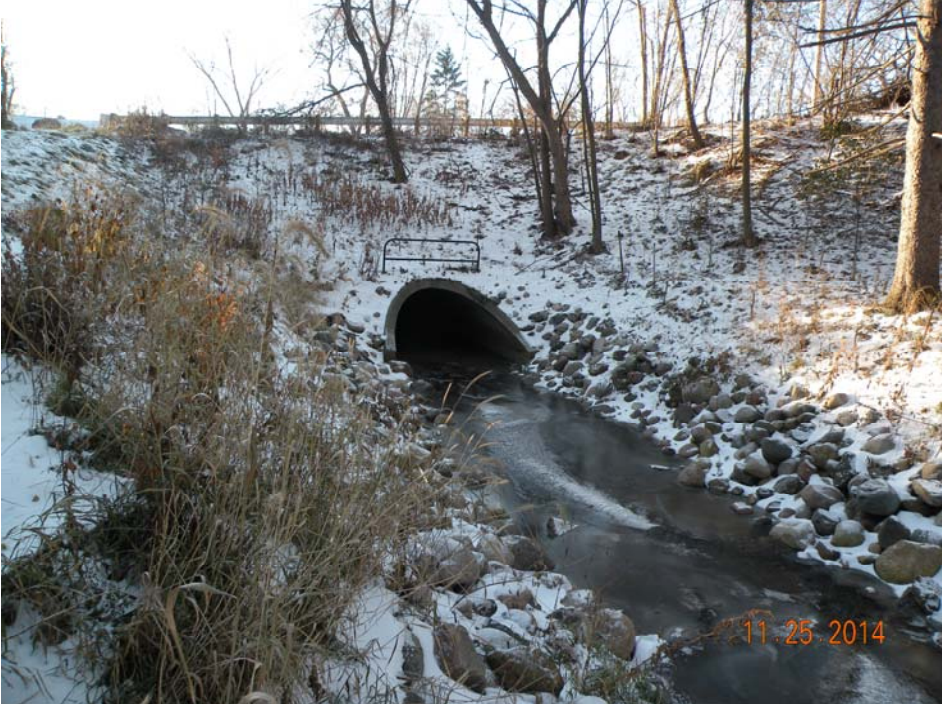
34th Ave. Crossing

- a. The overall condition of the structure is satisfactory.
- b. Erosion at upstream end of culvert has been repaired and natural boulder riprap has been installed.
- c. The creek channel has been restored upstream of the culvert and new natural boulder riprap has been installed and the sanitary sewer manhole in the middle of the creek has been relocated.
- d. Accept as noted, the invert of the culvert is generally clean. Twelve to eighteen inches of sediment was accumulated in the bottom of the culvert where a storm sewer discharges from a manhole into the culvert. This may be caused by riprap that has accumulated in front of the pipe and trapped sediment at the downstream end.

- e. The tie rods are rusty and flaking near the center section of the culvert, as noted in previous inspections.
- f. Handrails are rusted and need paint.
- g. Road guardrail cables have been replaced with new galvanized guard rails on both sides of the road.
- h. Sanitary sewer manhole exposed on west (right) creek bank downstream has been tucked into the bank and the channel downstream has been repaired and natural boulder riprap has been placed on both side of the creek.
- i. The home that was adjacent to the steep creek bank on the west side (right side) has been removed.

- Sand, prime and paint handrails, as necessary.

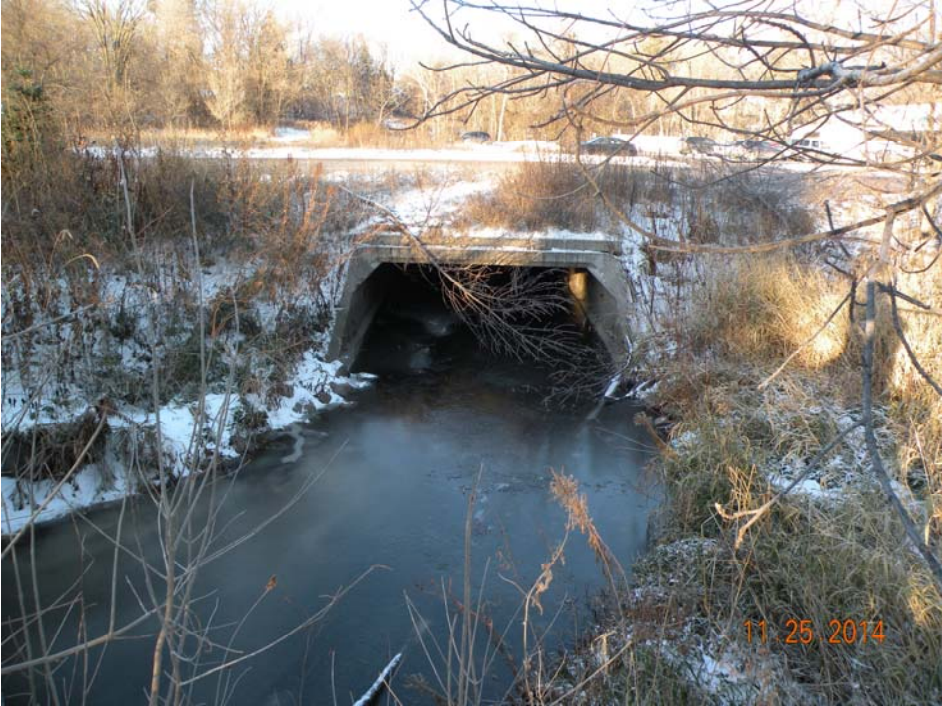
Douglas Drive Crossing

- a. The overall condition of the structure appeared satisfactory. Ice conditions prevented inspection of the culvert at the time of inspection.
- b. Erosion on north (left) side of the downstream end of the box culvert under Douglas was noted.
- c. All trees and brush that could have impeded flow have been removed.

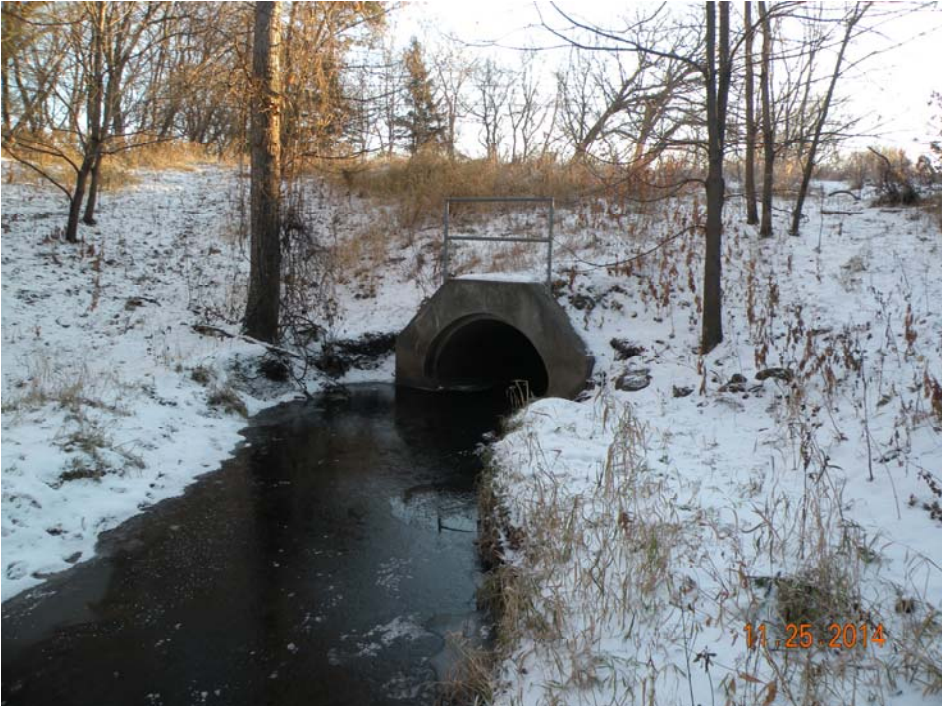
Edgewood Embankment and Ponding Area

- a. The overall condition of the feature appeared satisfactory.
- b. There is a small amount of erosion on the upstream end, north side (left) of the culvert at the embankment
- c. There is no visible settlement along the embankment
- d. The trees on the west side of the berm that have been referenced in previous inspections are now 6 to 8 inches in diameter or larger.
- e. The pool on the downstream side of the culvert and the creek banks downstream of the pool have been repaired and new natural boulder riprap has been installed.

- Remove trees along embankment, as necessary.

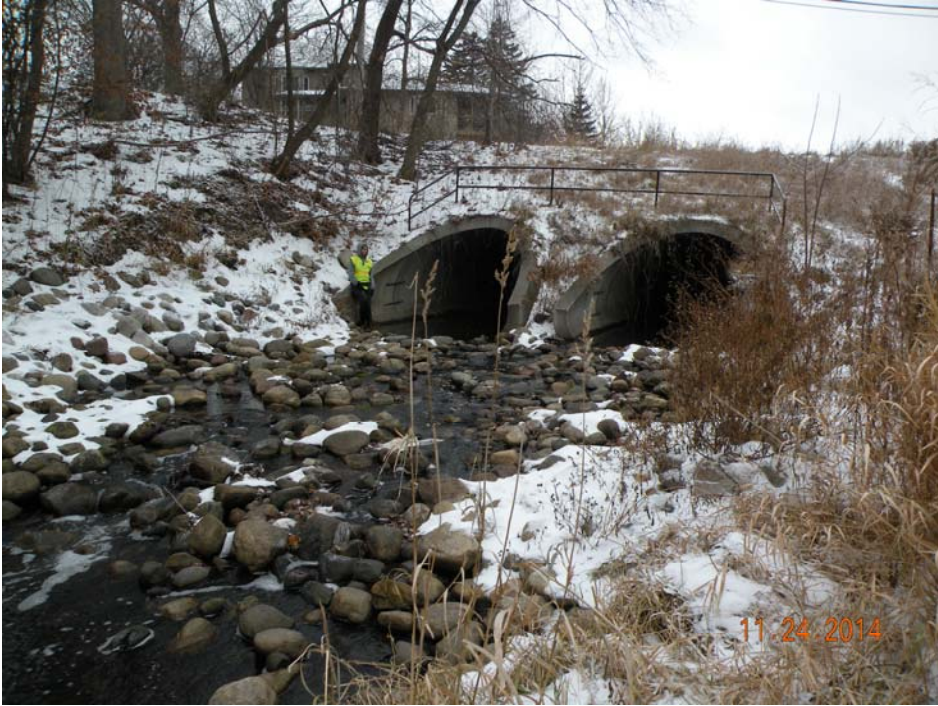
Georgia Ave. Crossing

- a. The overall condition of the two culverts is satisfactory.
- b. Repairs have been made to the channel banks, inlet section ends, and outlet section ends. The undermining at the end sections has been filled in and new natural boulder riprap has been placed on the inlet section ends, and outlet section ends.
- c. The casting assembly on the manhole over the north culvert on the east side of Georgia is off-set on the concrete opening of the manhole top exposing soil when observed from below. The manhole is in the boulevard area and the soil around it appears to be stable and should be reviewed in the future. This was first noted in the 2007 inspection and was noted again during 2014 inspection.
- d. The two large trees are growing on the upstream side between the culvert inlets, first noted in 2009 inspection, have been removed.

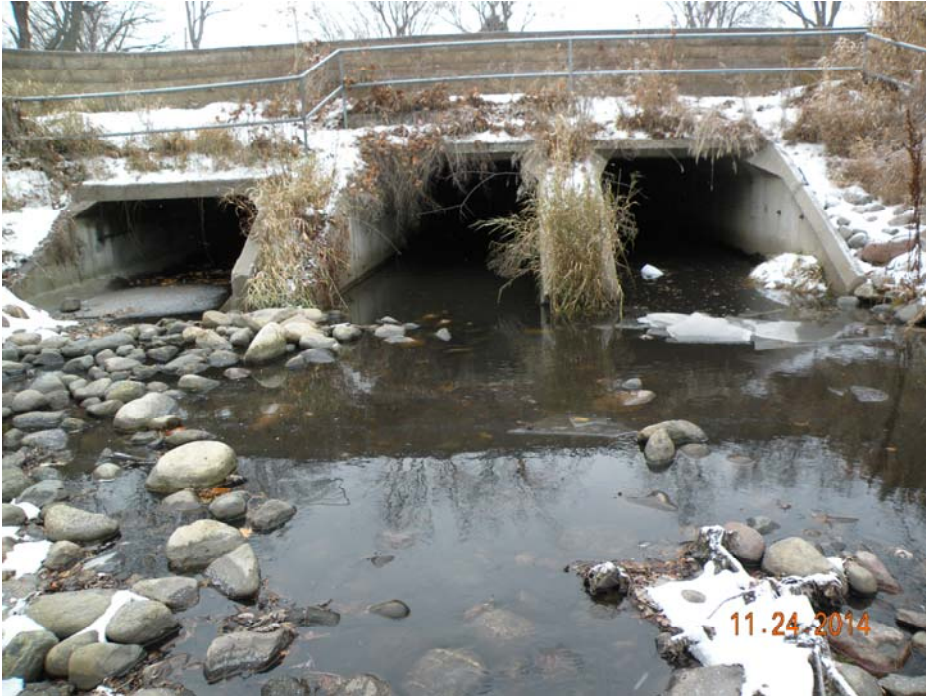
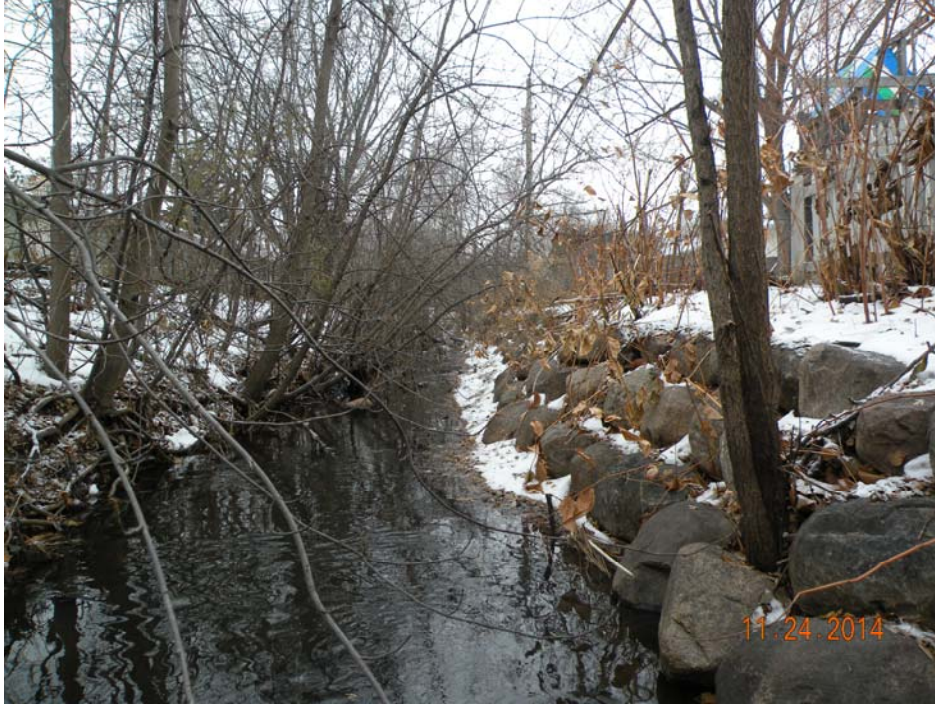
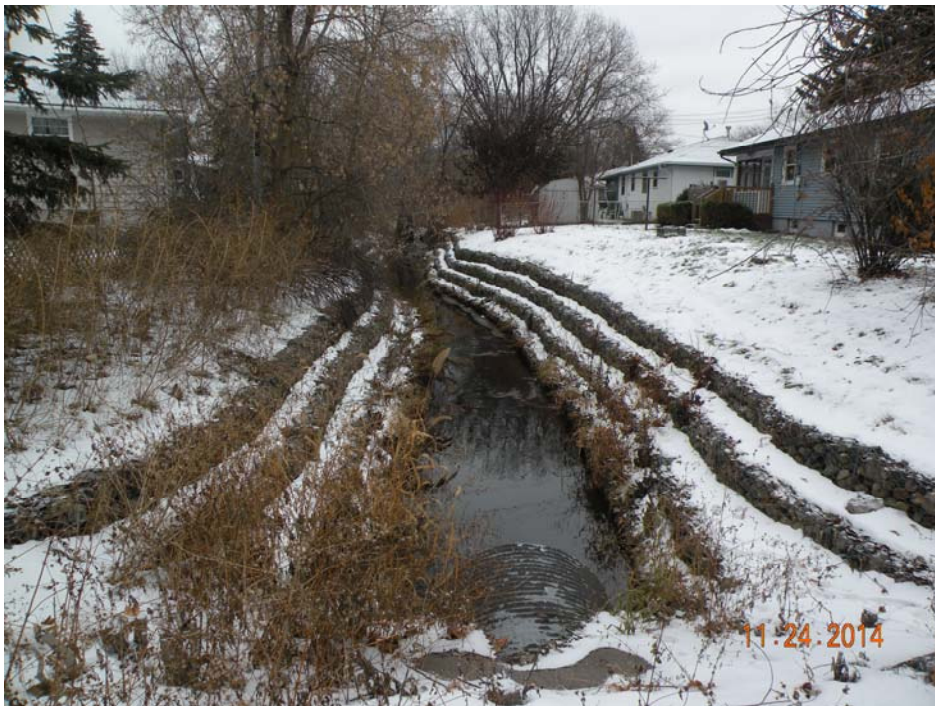
Markwood Box Culverts and Channel Improvements

- a. The overall condition of the structure appeared satisfactory.
- b. Riprap was in the box culverts as noted in previous inspections; most of the riprap was located in the upstream end of the left (north) box culvert. The amount of riprap in the box culverts has decreased since the last inspection in 2012; the riprap has either been removed or has flushed through the culverts.

- c. The crack located in the right/top of the south culvert noted in previous inspections has not changed.
- d. On both culverts, the fifth joint from the downstream end had a 2 ½ inch gap, no change from previous inspections.

- e. The RCP drainage pipe that was noted first in the 2004 inspection ties directly into the left (north) box. No mortar exists on the inside of the connection and exposed wire is visible (no change since 2004).

- a. Channel banks have become vegetated with trees and brush as noted in previous inspections. The trees are becoming large now and the brush thick; most of the brush is Buckthorn. The bottom of the channel is mostly free of vegetation, there was one large tree that was eroded away from the bank and is now sitting in the middle of the channel.
- b. Erosion exists at the toe of the both channel banks along most of the channel, cutting a vertical wall up 2 to 3 feet from the bottom of the channel. This erosion has expanded since the last inspection.
- c. Some retaining walls and fences (likely installed by homeowners) along the channel have are leaning toward the channel and appear to be failing.
- d. The C.M.P. storm sewer discharging into the channel between 6833 and 6825 Markwood Drive is in poor condition – the pipe bottom is corroded and there is erosion around the pipe.

- Monitor cracks and joint gaps during future inspections.
- Patch exposed end of RCP drain with mortar.

- All trees, limbs, and brush that may impede creek flows should be removed from the channel and banks.
- Downed trees and woody debris should be removed from the channel.
- Erosion on the banks should continue to be monitored.
- Although not part of flood control project, retaining walls should be inspected on regular basis in case they fail and impede the channel flow.
- Although not part of flood control project, CMP storm sewer should be repaired.
