Feasibility Report for Bassett Creek Main Stem Restoration, Regent Avenue to Golden Valley Road (2024 CR-M)—DRAFT

Golden Valley, Minnesota

Prepared for
Bassett Creek Watershed Management Commission

Appendix A
Site Visit Photos

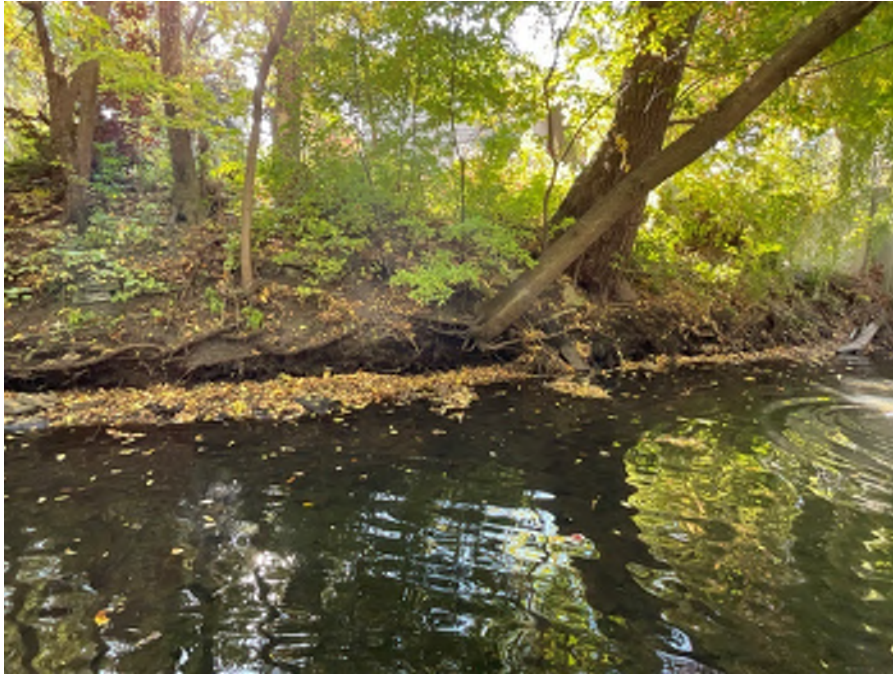
Photo 1: Site 1a. Bare soil on the right bank at station 0+40.

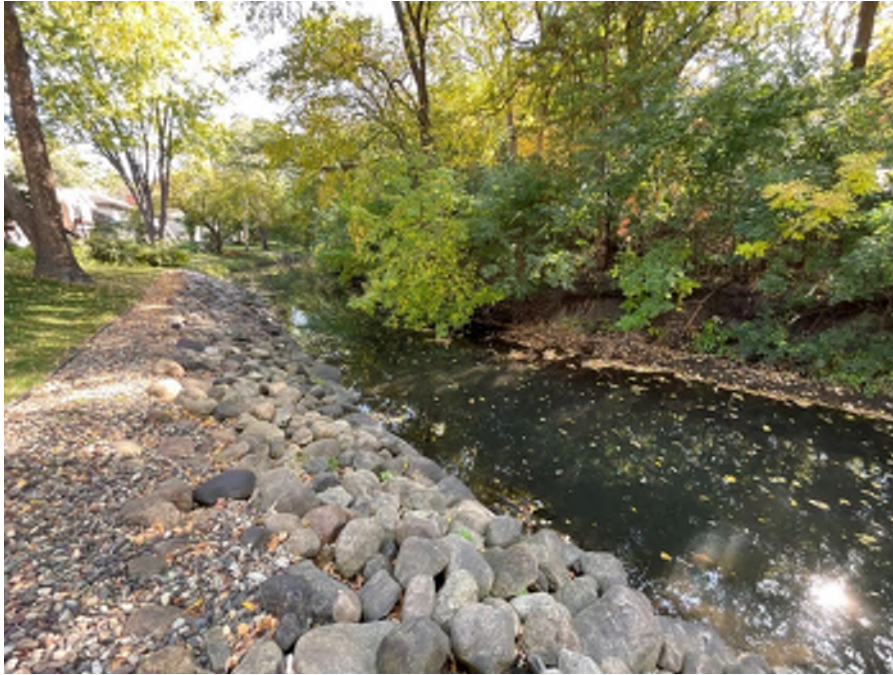
Photo 3: Site 1b. Downstream section at the right bank of station 4+50.

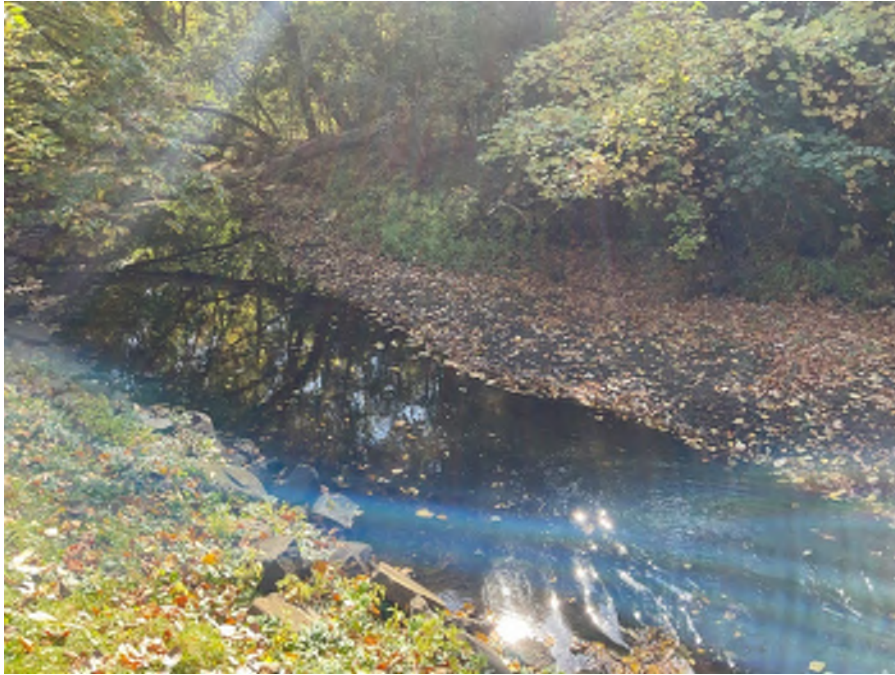
Photo 5: Site 1d. Large right bank deposition facing downstream of station 8+50.

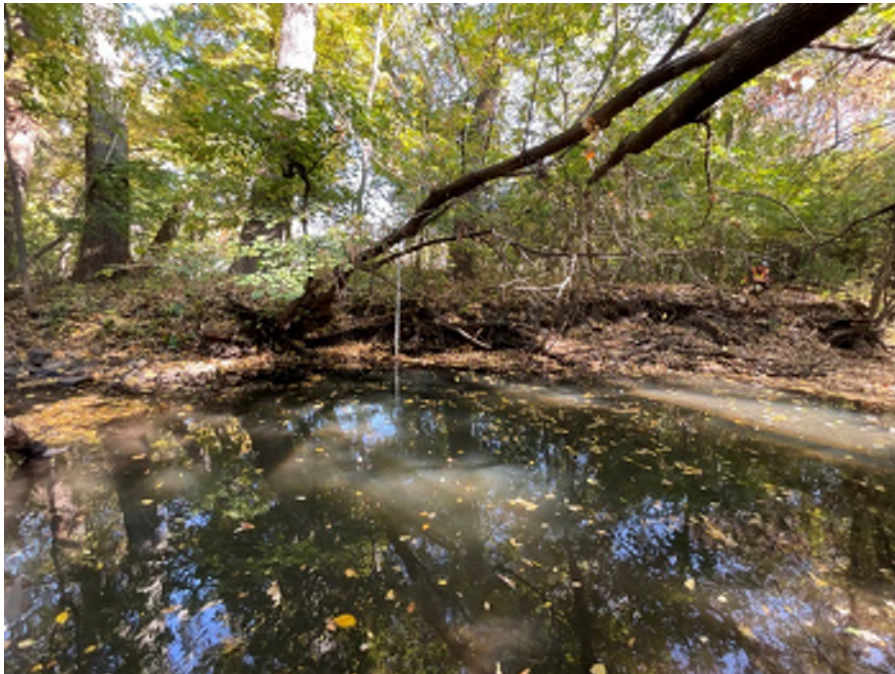
Photo 6: Site 1d. BEHI measurement at the left bank of station 9+10.

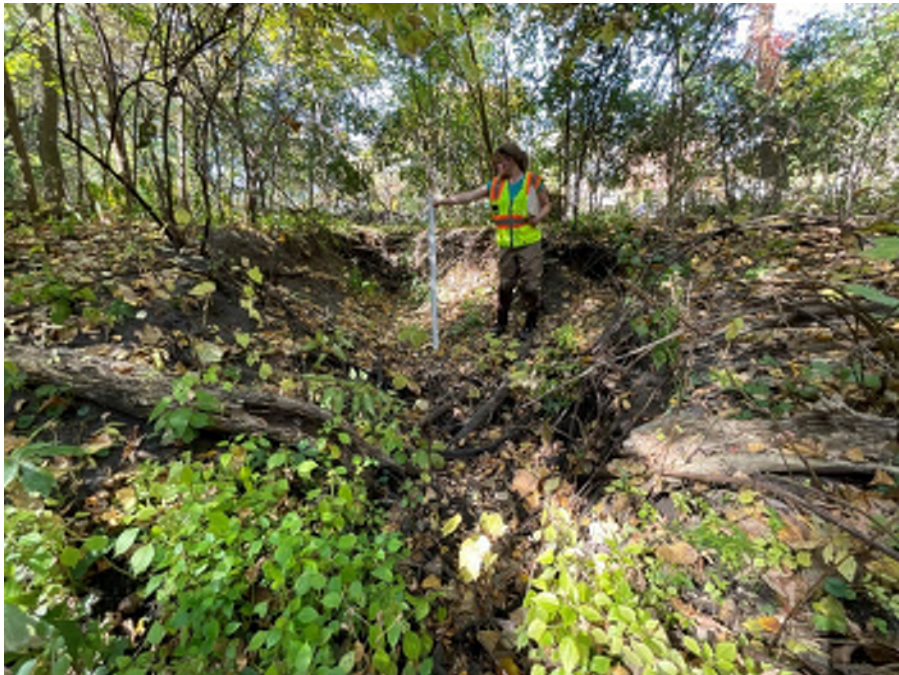
Photo 7: Site 1e. Gully formation from parking lot runoff on the left bank of station 12+20.

Left bank	12+20 to 12+45	Grade left bank as part of gully restoration	1e. Left bank stabilization with grading, vegetation, and section of toe wood (Sta. 12+20 to 14+00)	2	0	0	0	5	0	3	1	0	0	0	2	0	13	
Left bank	12+45 to 14+00	floodplain bench with toe wood		2	0	0	0	15	0	3	1	0	1	1	2	1	26	
Right bank	12+30 to 12+40	install j-hook downstream of 45 inch cottonwood	1f. Right bank stabilization with grading, vegetation, and j hooks (Sta. 12+30 to 14+90)	2	0	0	0	0	0	3	0	1	1	0	2	0	9	
Right bank	12+40 to 14+90	Grading with vegetation, with one or two j hooks as needed		2	0	0	0	0	0	3	1	1	1	1	2	0	11	Monitored for BCWMC CIP

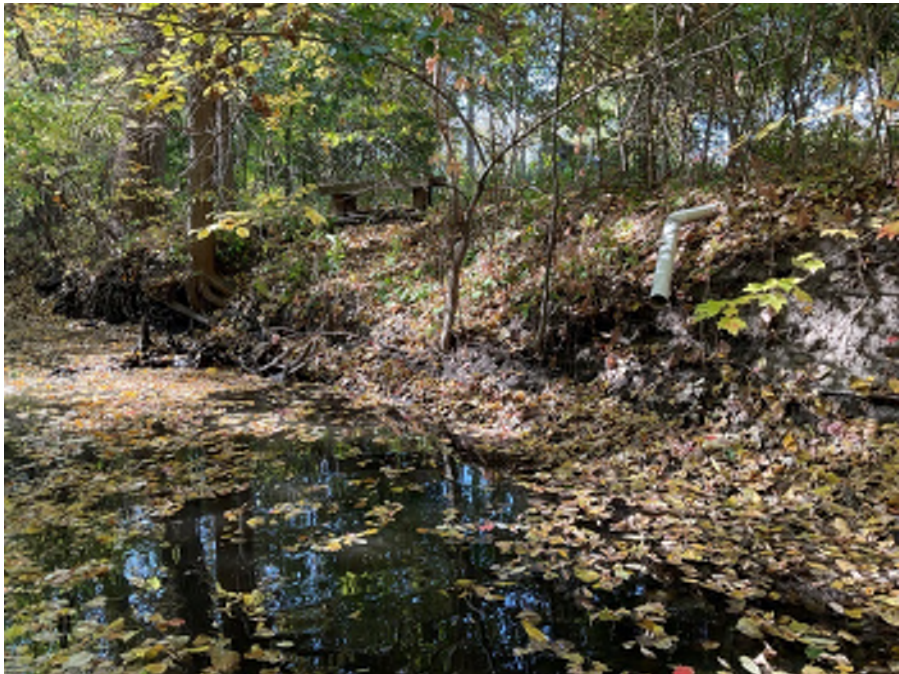
Photo 8: Site 1e. Drainpipe and bare soil on the left bank of station 13+50 (facing upstream).

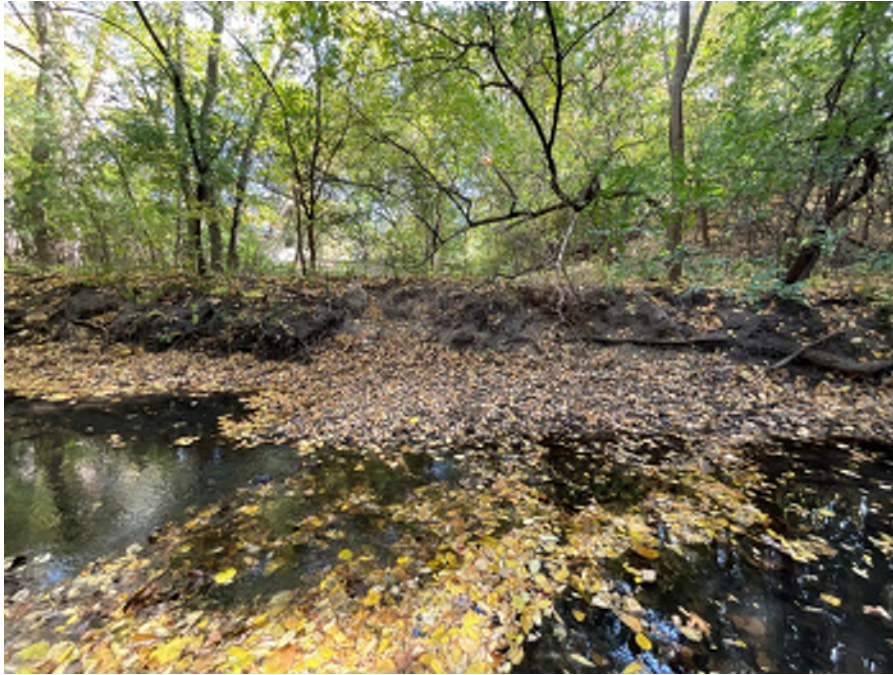
Photo 9: Site 1f. Bare soil at the right bank of station 12+30.

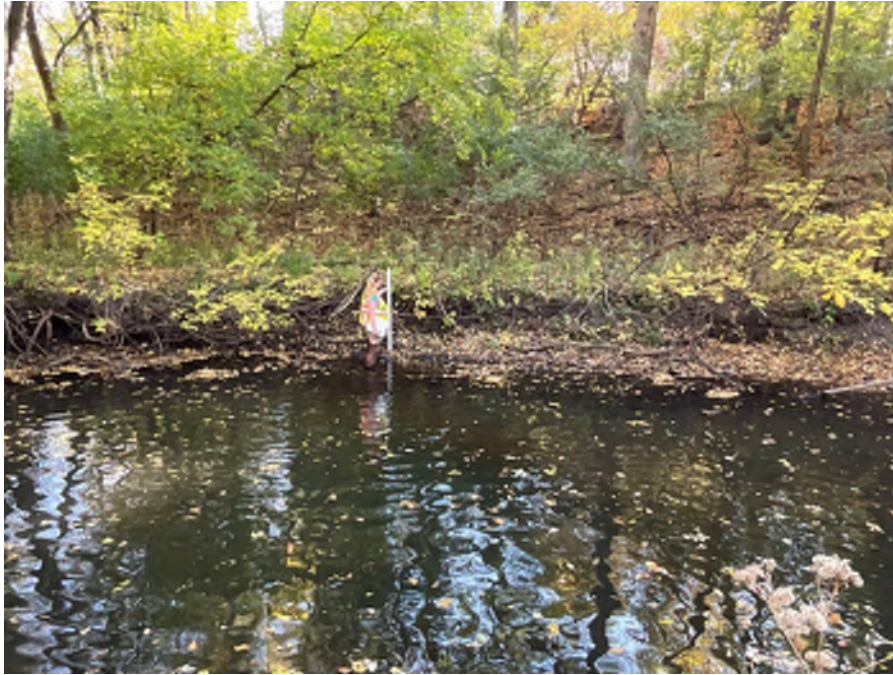
Photo 11: Site 2b. BEHI measurement at the right bank of station 18+50.

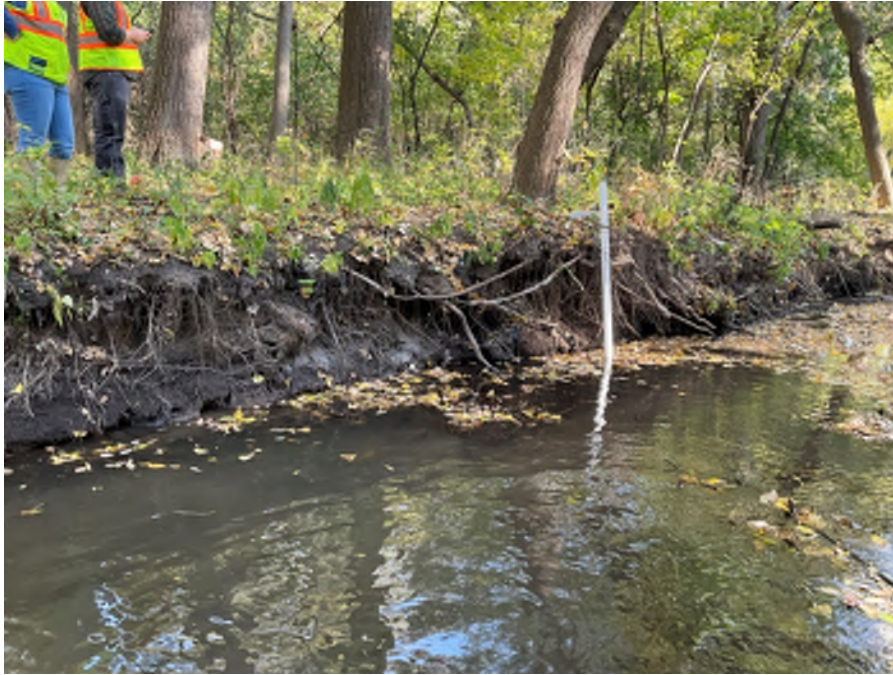
Photo 13: Site 2c. BEHI measurement and bare soil at the left bank of station 19+90 (facing downstream).

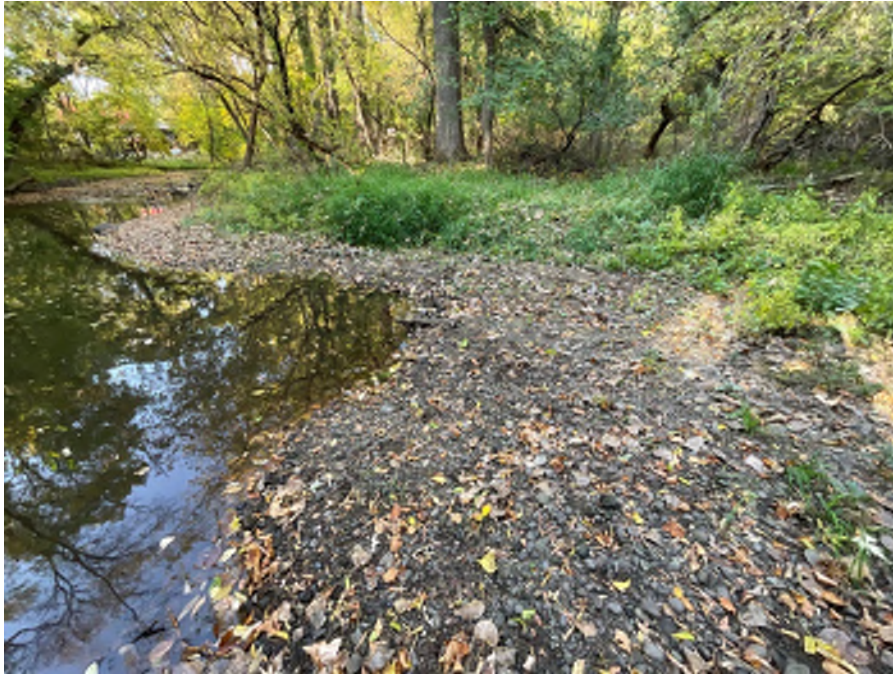
Photo 15: Site 2d. Upstream section of the left bank at station 21+10.

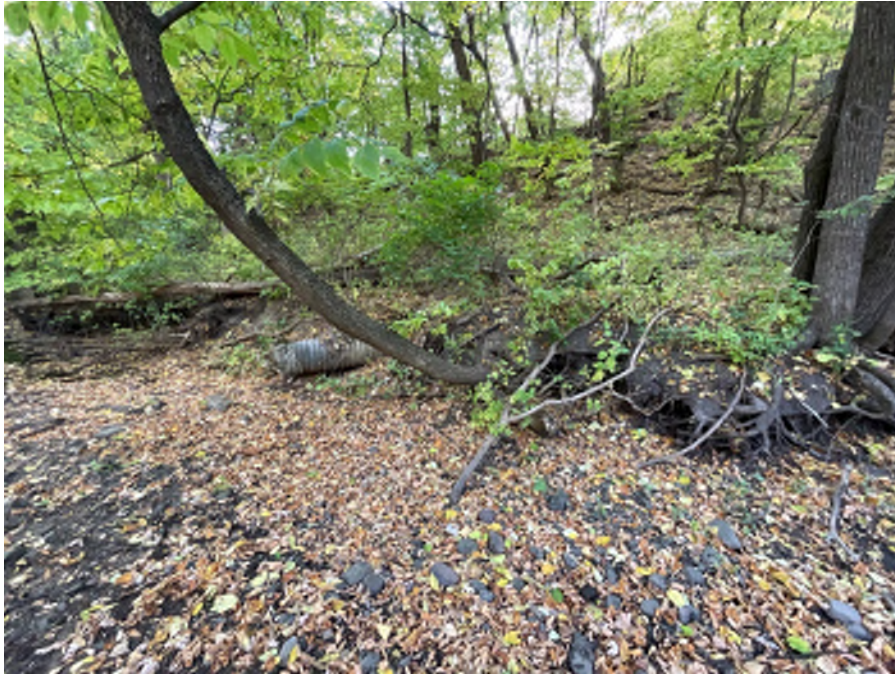
Photo 17: Site 2f. Concrete-filled pipe and right bank undercutting at station 22+75.

Left bank	22+75	J-hook	2f. Right and left bank stabilization with j hooks and section of toe wood (Sta. 22+75 to 27+75)	2	0	0	2	0	0	3	0	1	1	0	0	0	9	
Right bank	22+80 to 23+80	3 j-hook vanes		2	0	0	2	0	1	3	0	1	1	0	0	0	10	
Right bank	24+80 to 25+60	2 j-hooks and some toe wood		2	0	0	2	0	1	3	1	1	1	1	0	0	12	
Right bank	26+70 to 27+75	Toe wood		3	0	0	2	0	1	4	1	1	0	1	0	0	13	
Both banks	27+70	Cross vane	2g. Bank stabilization with cross vane (Sta. 27+70)	2	0	0	2	15	1	3	0	1	1	0	0	0	25	Protect sanitary
Right bank	28+00 to 29+50	Grading with vegetative buffer and floodplain bench	2h. Right bank stabilization with grading, vegetation, and floodplain bench (Sta. 28+00 to 29+50)	2	0	0	2	0	0	3	1	0	1	1	0	0	10	
Left bank	29+70	J-hook	2i. Right and left bank stabilization with j hooks (Sta. 29+70 to 30+00)	1	0	2	2	15	1	2	0	1	0	0	0	0	24	
Right bank	29+90	J hook, upstream healthy willow		2	0	0	2	0	1	3	0	1	1	0	0	0	10

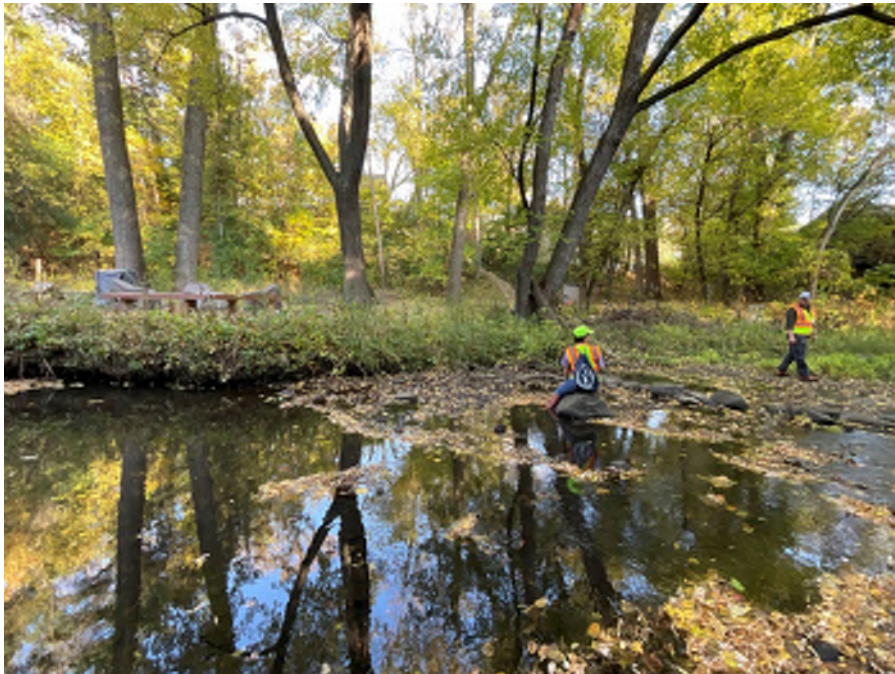
Photo 18: Site 2f. Left bank undercutting at station 23+10.

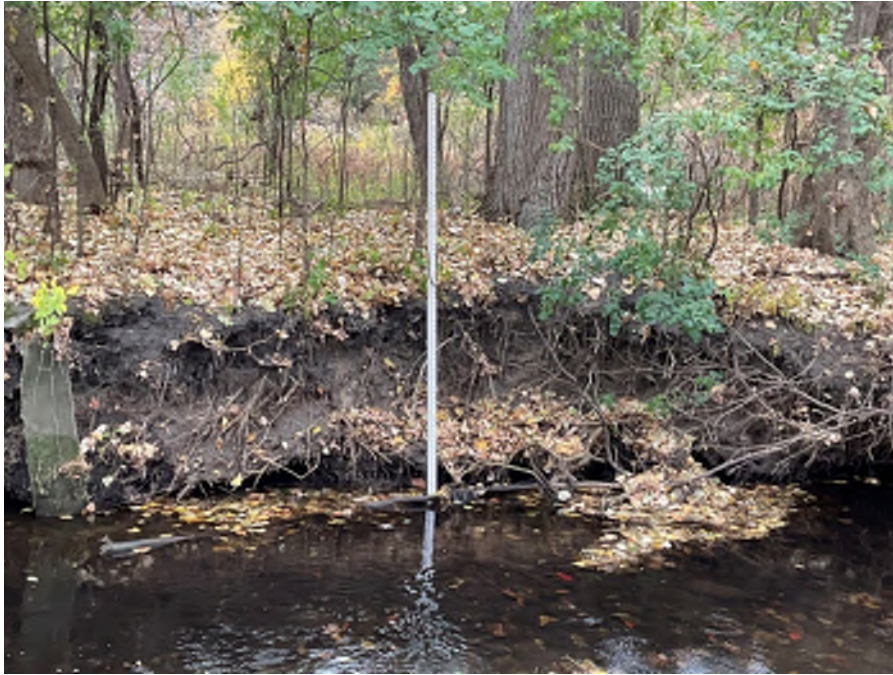
Photo 19: Site 2g. Bare soils and undercutting at the right bank of station 27+60.

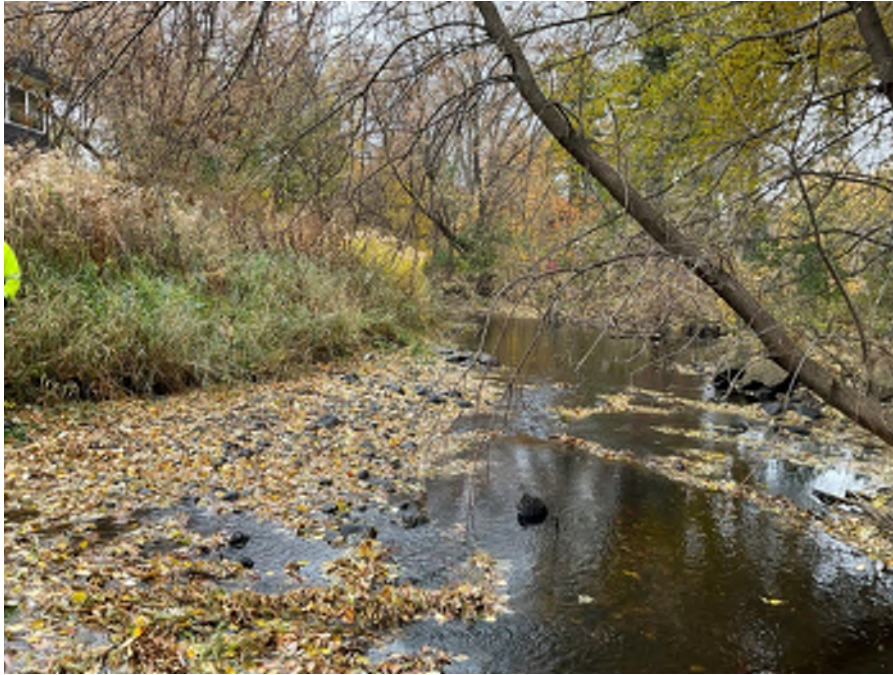
Photo 21: Site 2i. Downstream section at station 29+90.

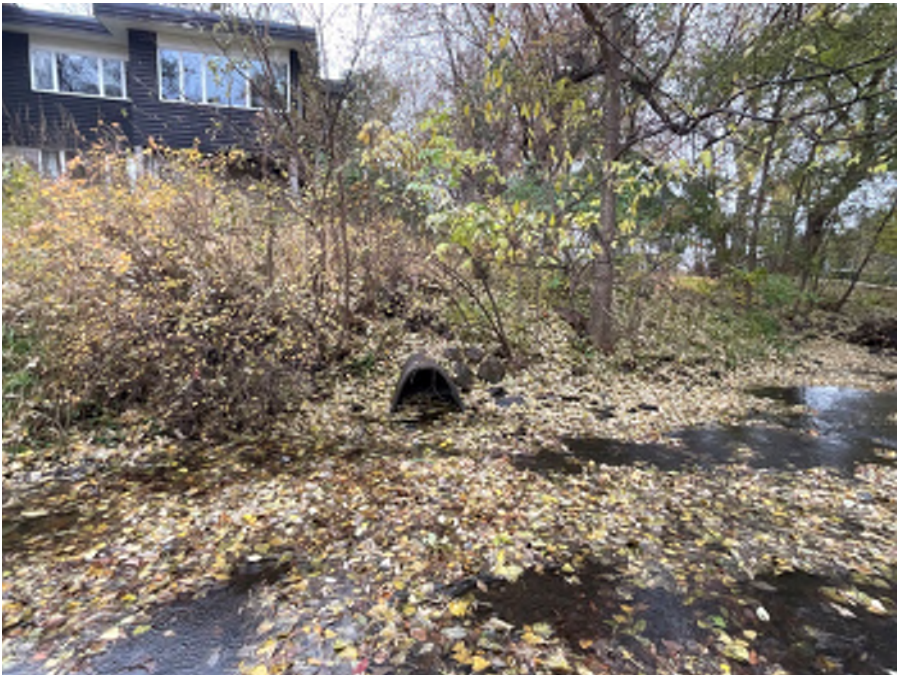
Photo 23: Site 2j. Left bank outlet at station 31+00 directly upstream of a sanitary sewer that crosses the creek.

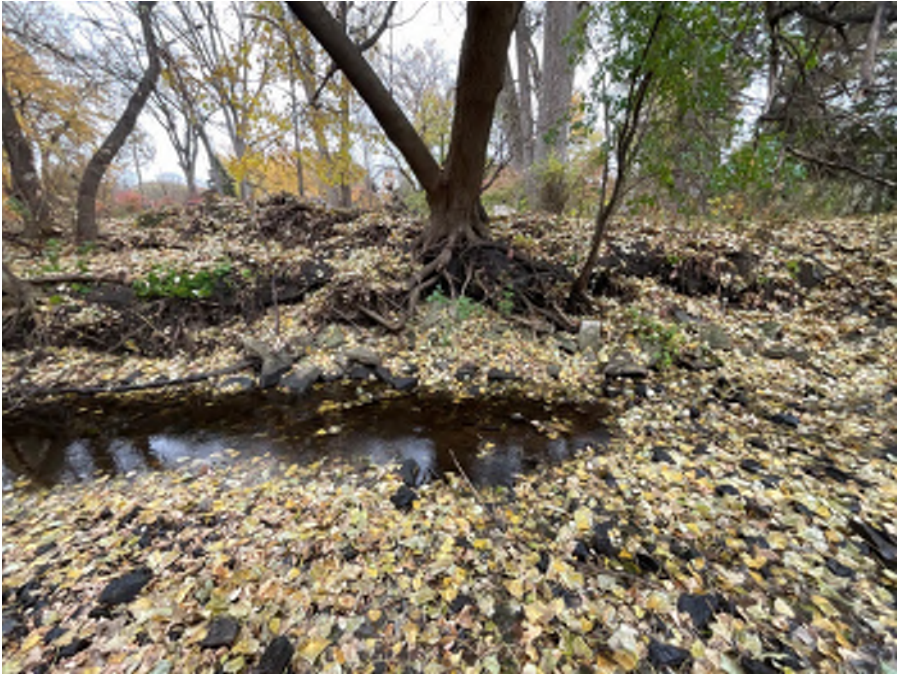
Photo 24: Site 2k. Undercutting at the right bank of station 32+25.

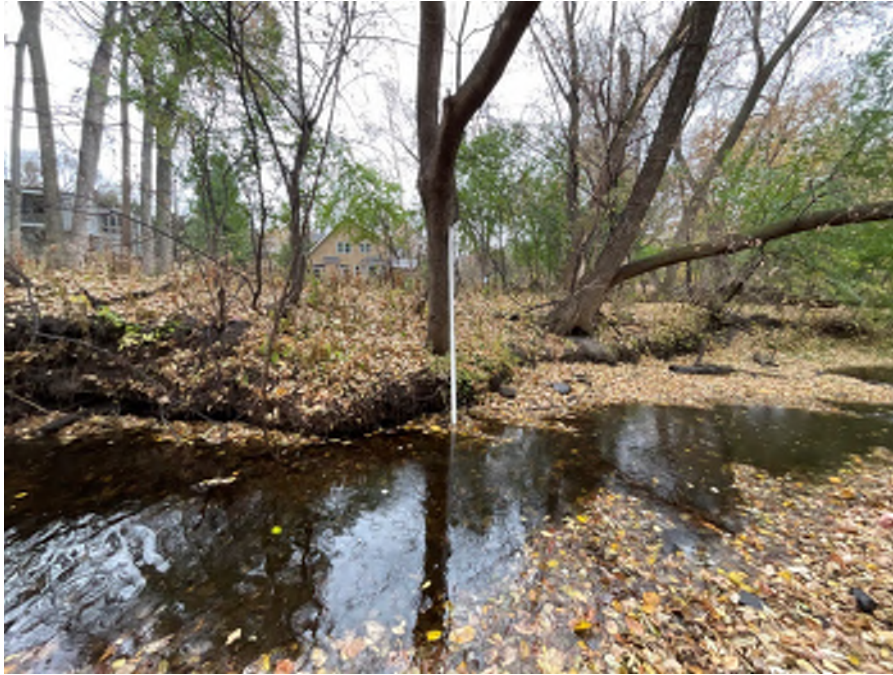
Photo 25: Site 2l. BEHI measurement and undercut at the left bank of station 34+25.

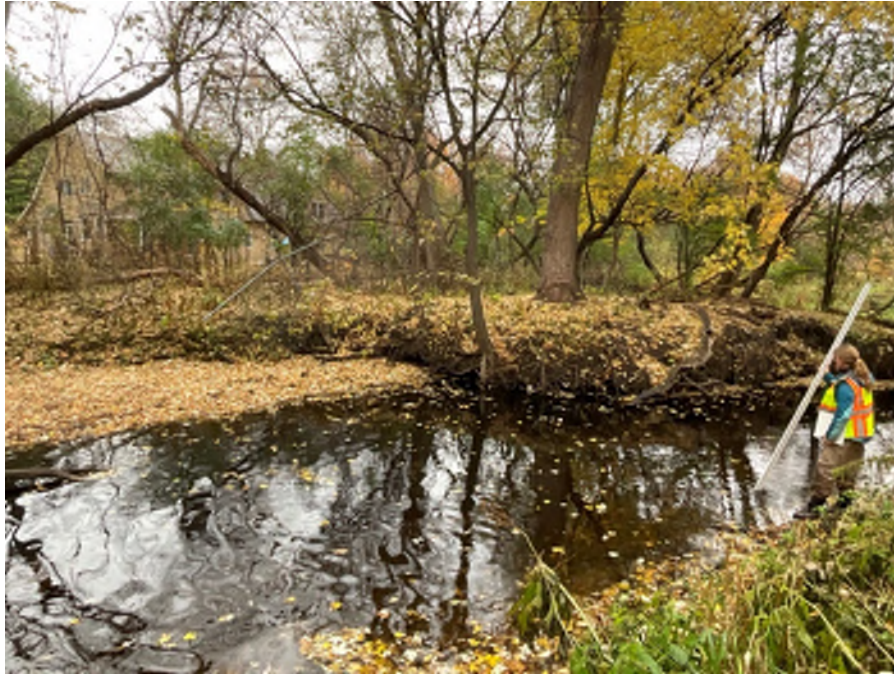
Photo 27: Site 2m. Deposition and undercut at the left bank of station 36+60.

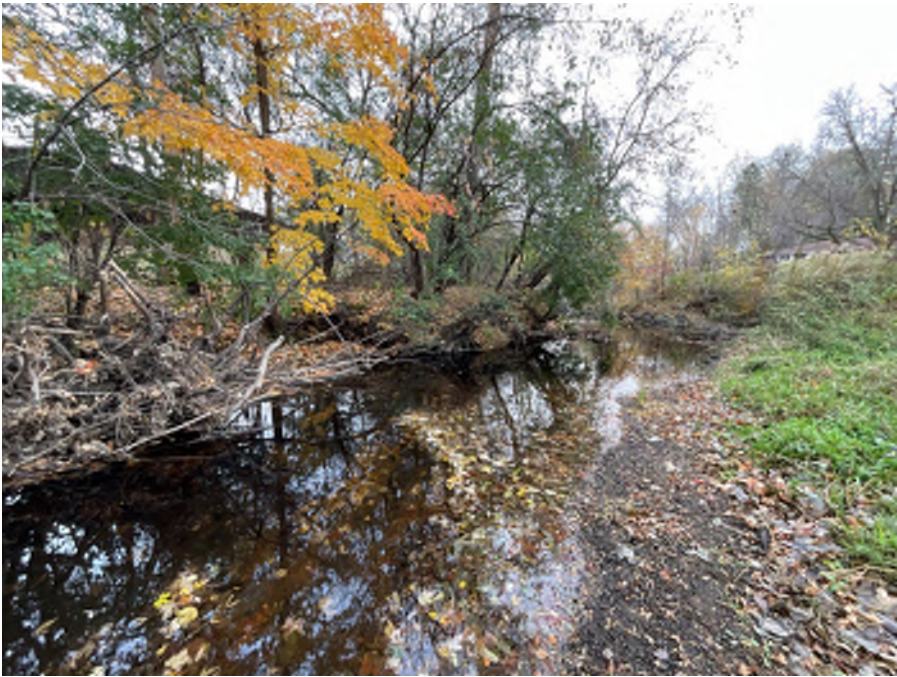
Photo 29: Site 2n. Undercut on the left bank of station 39+10. Deposition on the right bank (facing downstream).

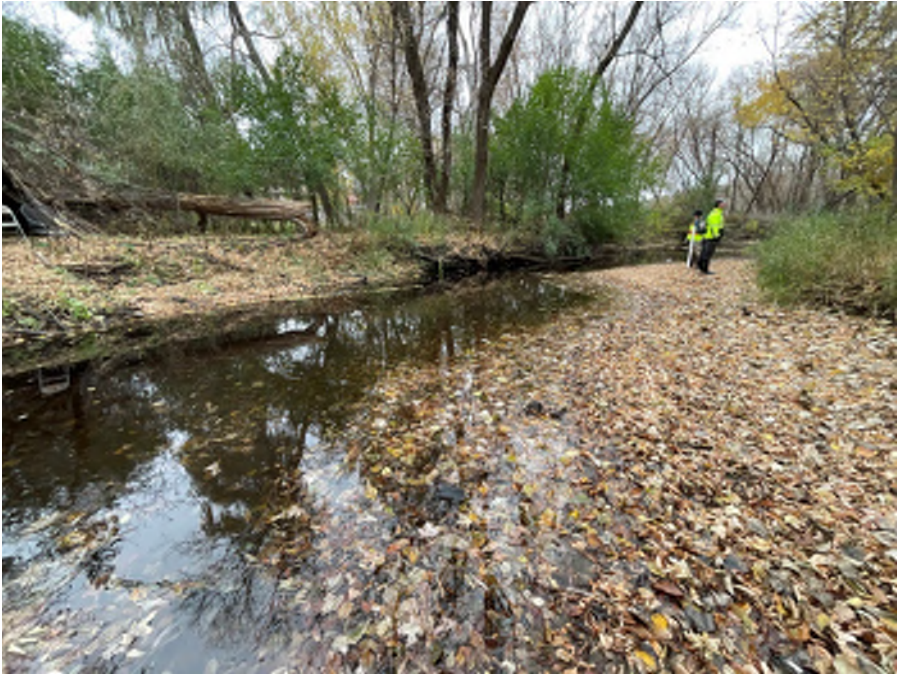
Photo 30: Site 3b. Undercut on the left bank of station 42+70. Deposition on the right bank (facing downstream).

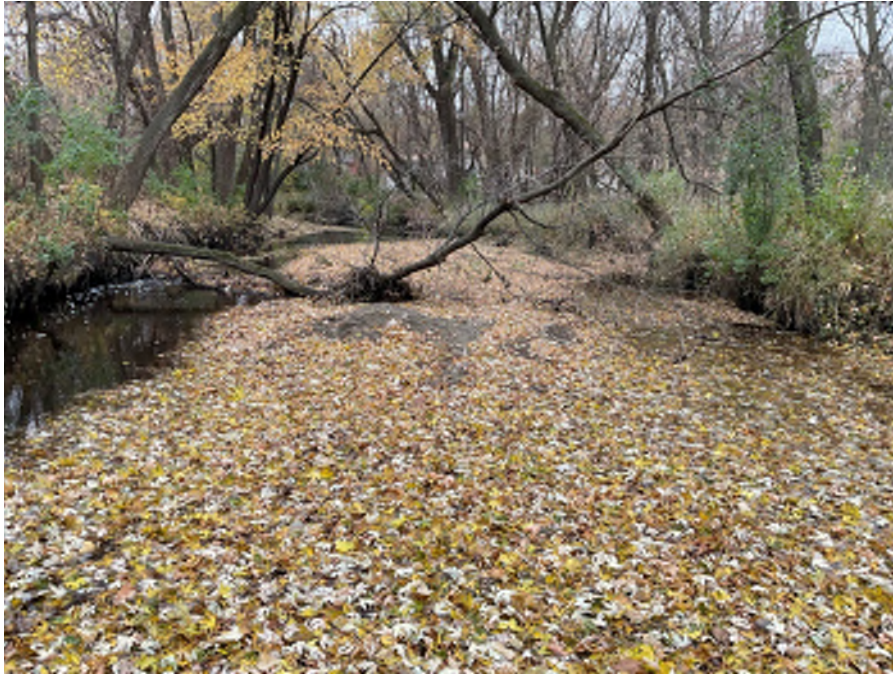
Photo 31: Site 3c. Undercut at the upstream section at station 46+50.

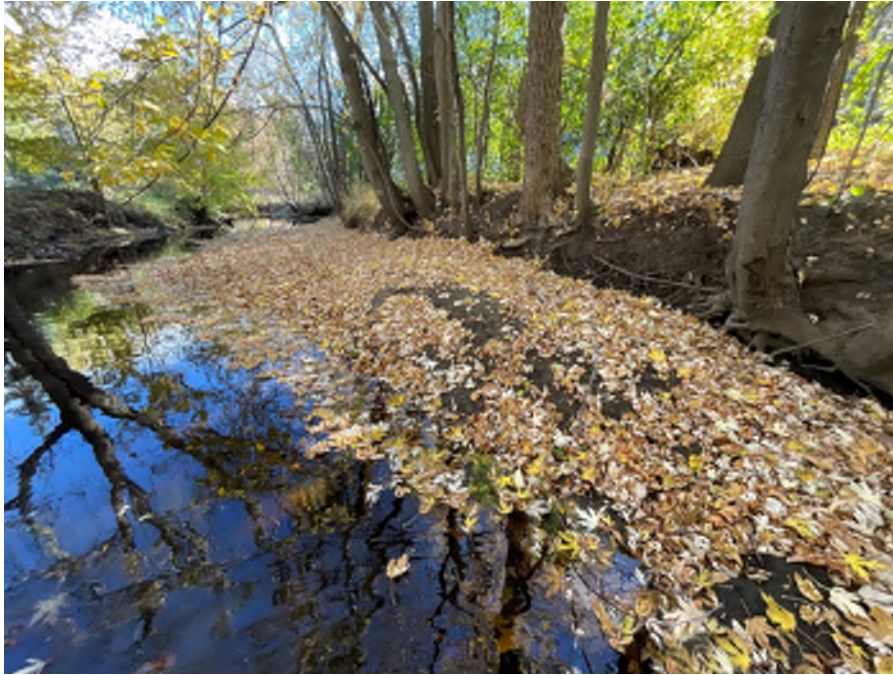
Photo 35: Site 3g. Undercut and deposition at right bank of station 50+20.

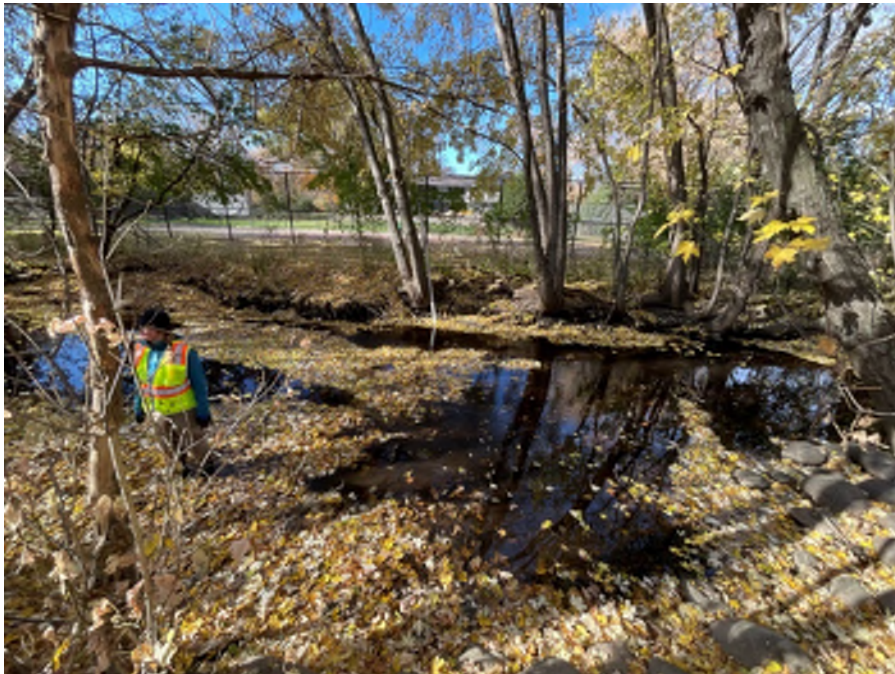
Photo 38: Site 3i. Left bank of station 53+50.

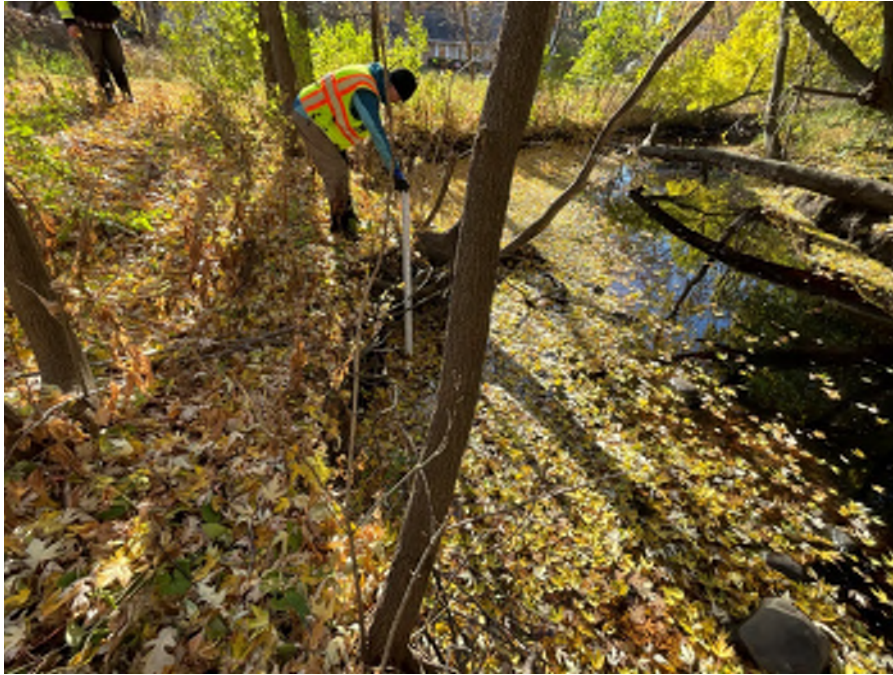
Photo 39: Site 3i. BEHI measurement at the right bank of station 53+00 (facing upstream).

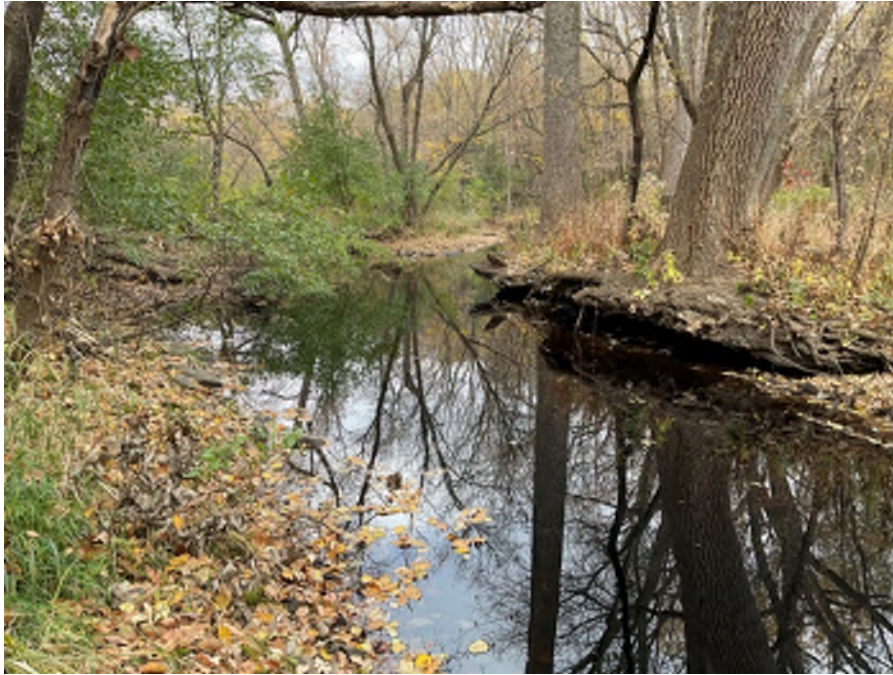
Photo 45: Site 4e. Undercut at station 65+50 (facing upstream).

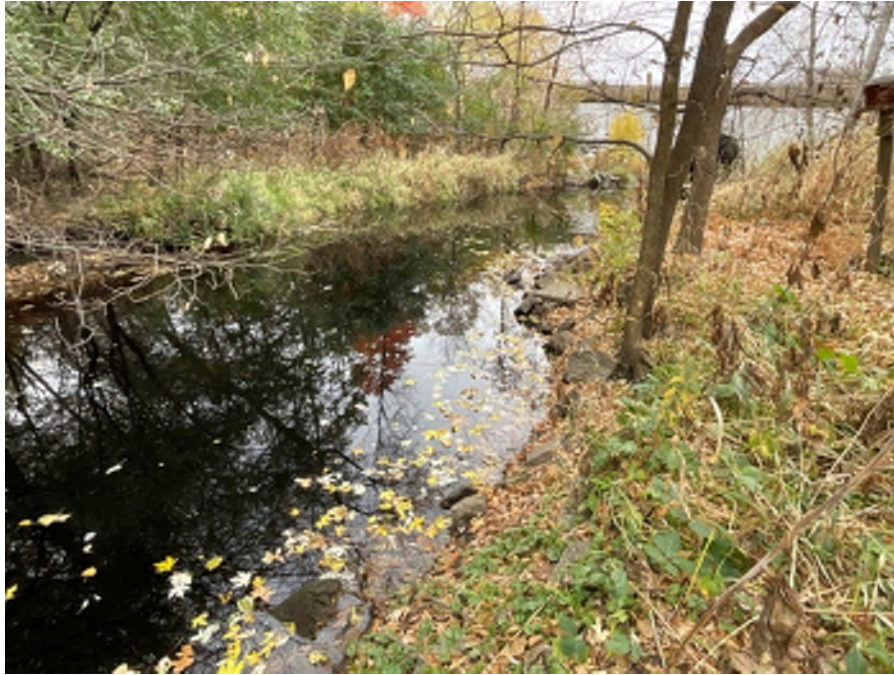
Photo 51: Site 4i. Poor riprap at the right bank of station 70+80 (facing downstream).
