Appendices

Appendix A

Stream Erosion Site Photos

Ponderosa Woods Stream Tree Survey - 2023

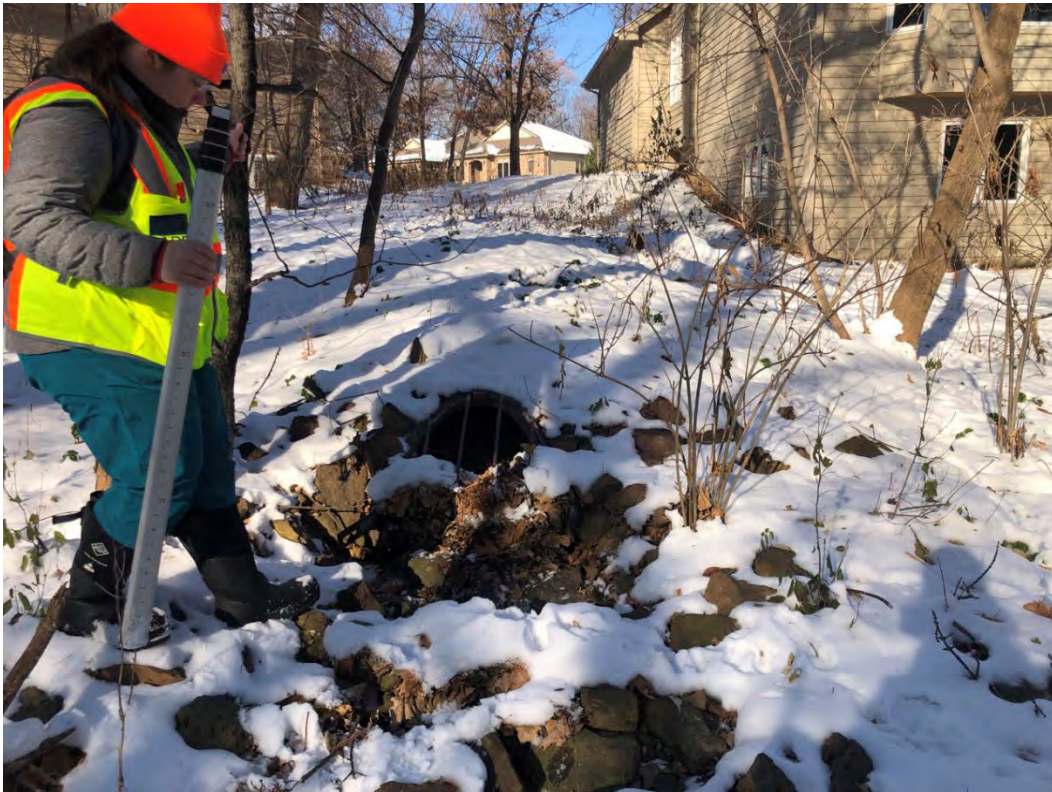
Figure A- 6 **Upstream end of north stormwater side-channel.**

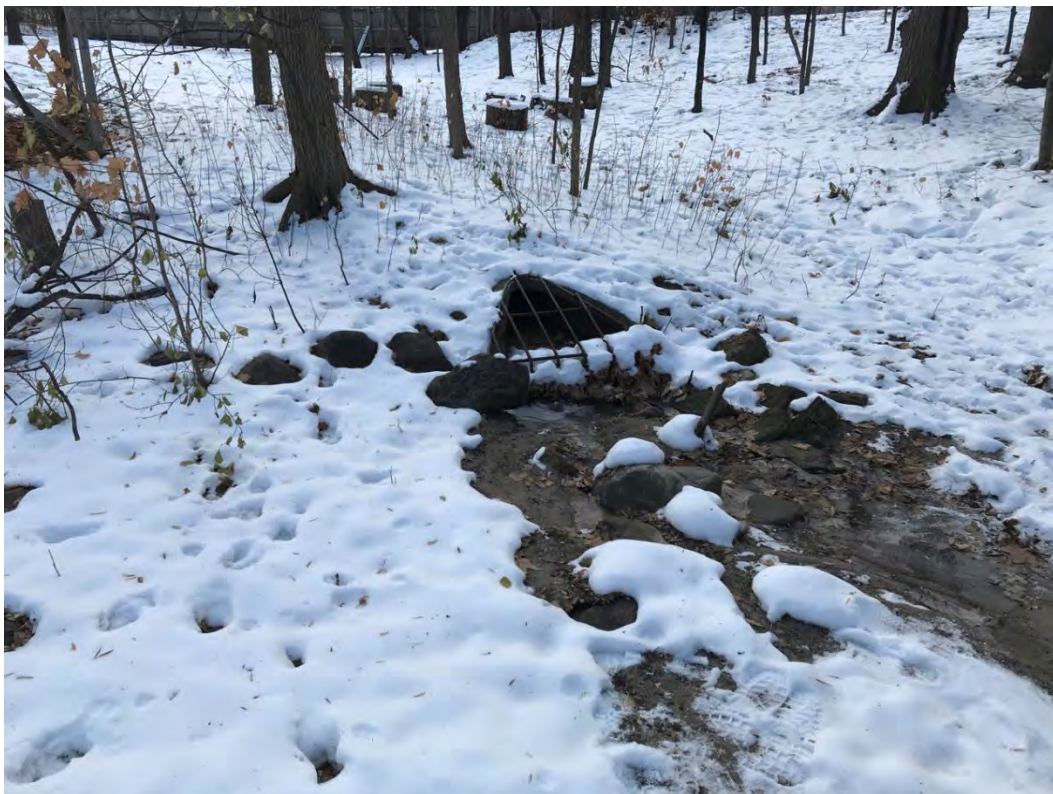
Figure A- 14 *Upstream end of southwest stormwater side-channel.*

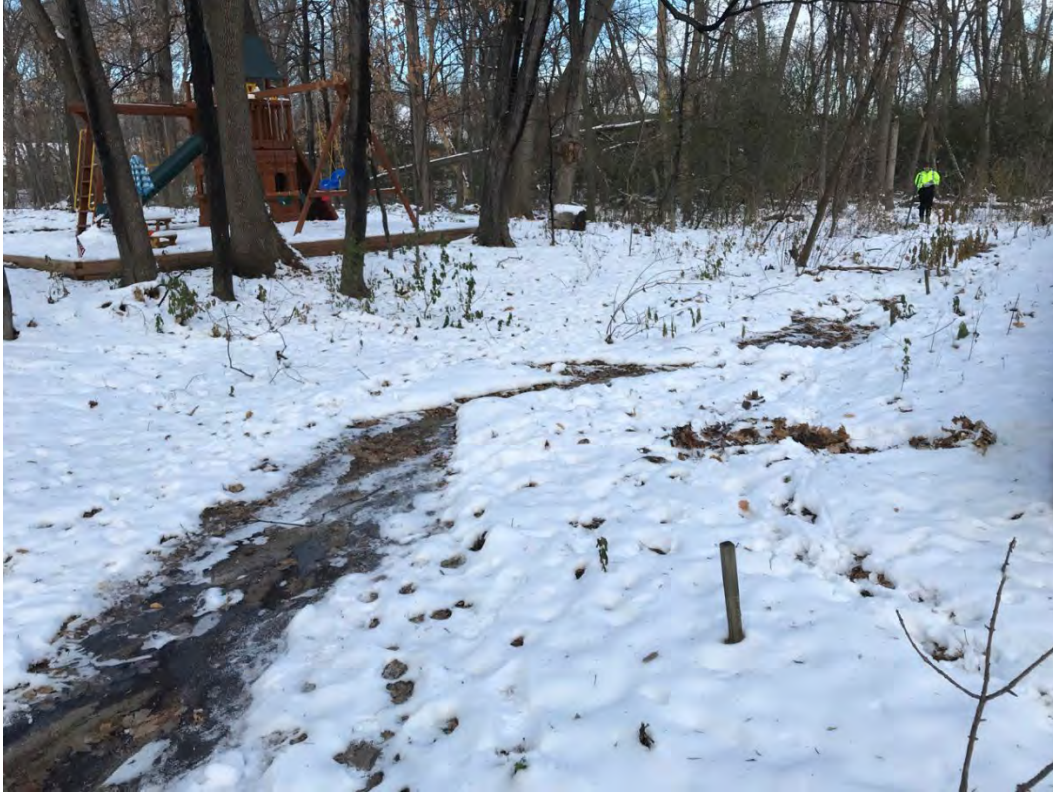
Figure A- 15 *Southwest stormwater side-channel looking downstream.*

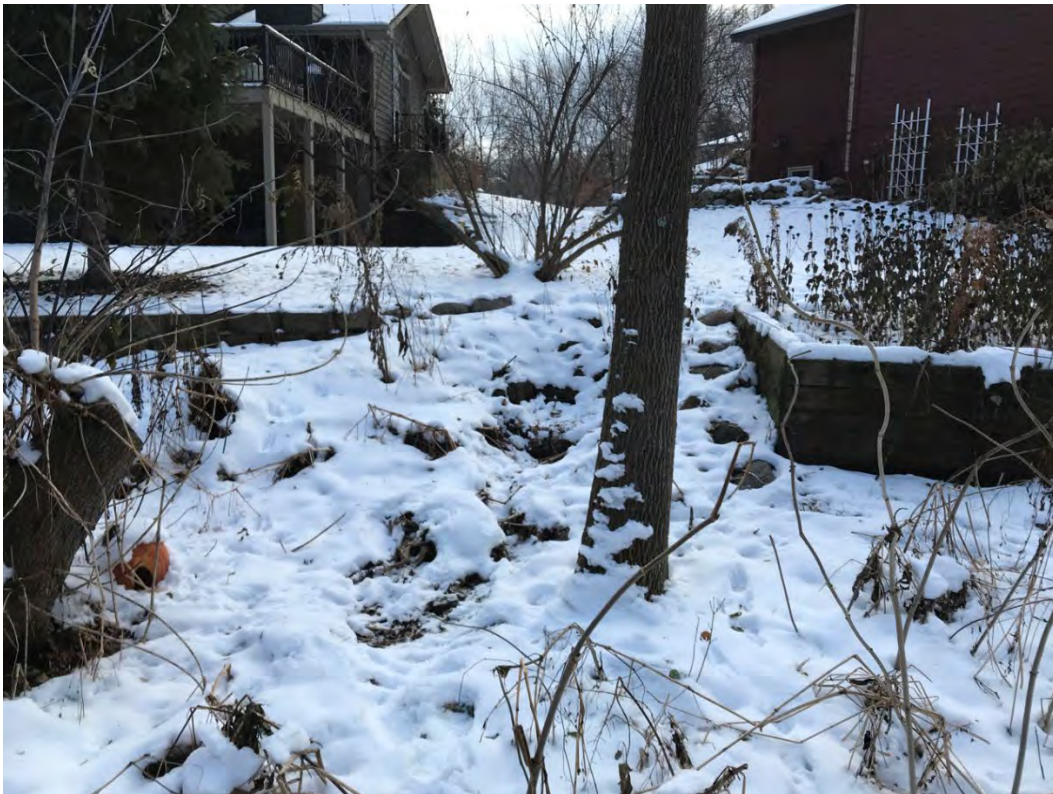
Figure A- 16 *Upstream end of southeast stormwater side-channel.*

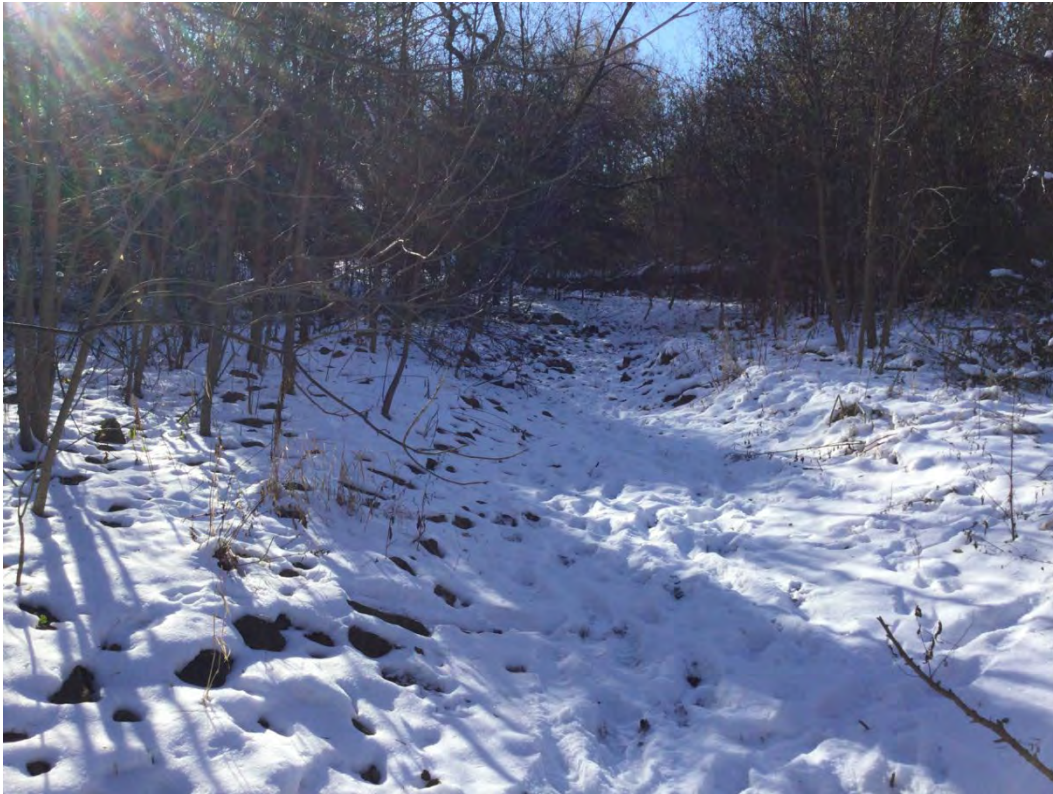
Figure A- 28 *Downstream end of reach (looking upstream)*
