Appendices

Appendix A
Site Visit Photos

Bassett Creek Main Stem Erosion Issues and Restoration Prioritization

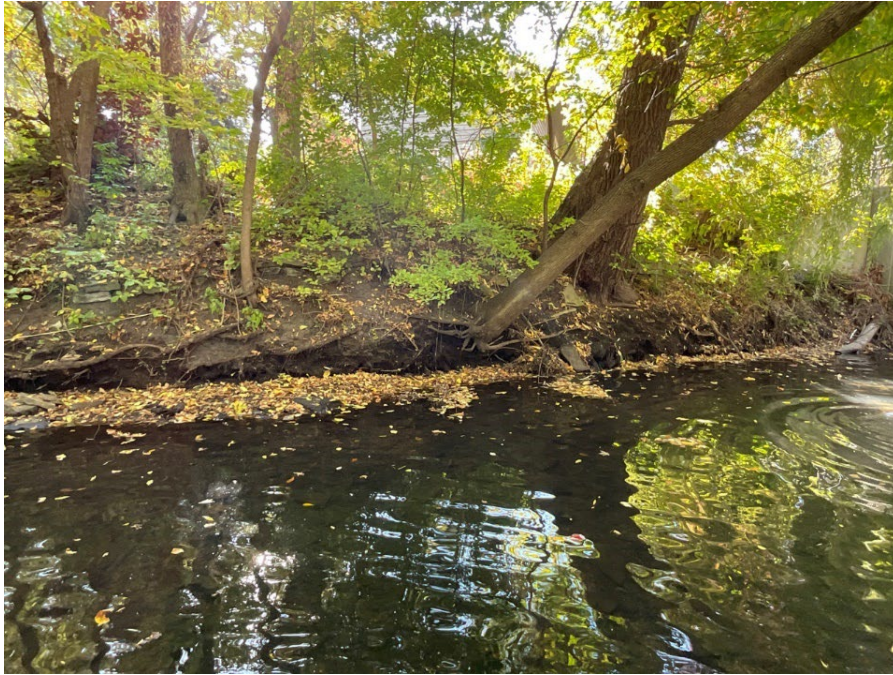
Photo 1: Site 1a. Bare soil on the right bank at station 0+40.

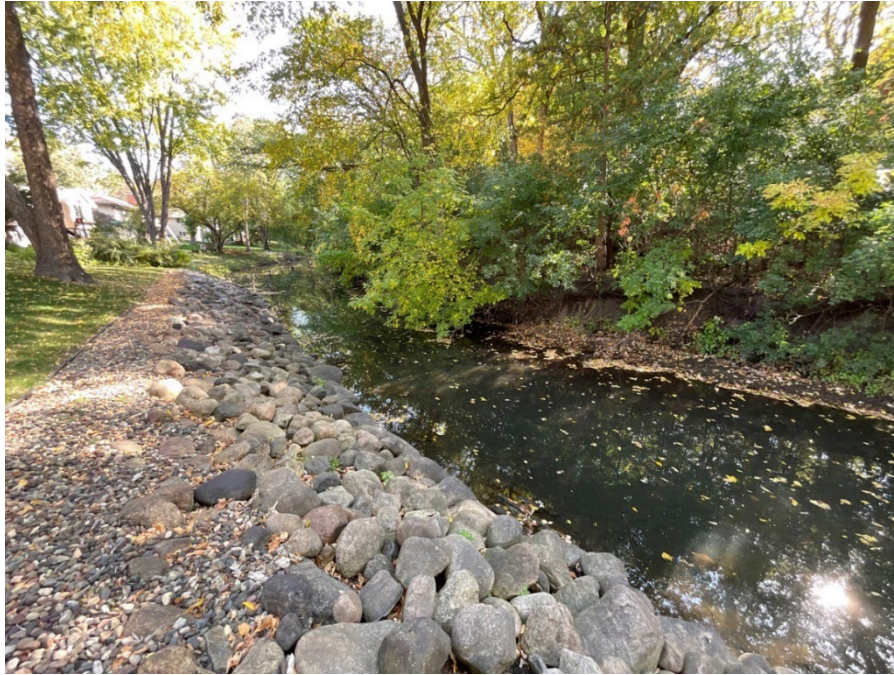
Photo 3: Site 1b. Downstream section at the right bank of station 4+50.

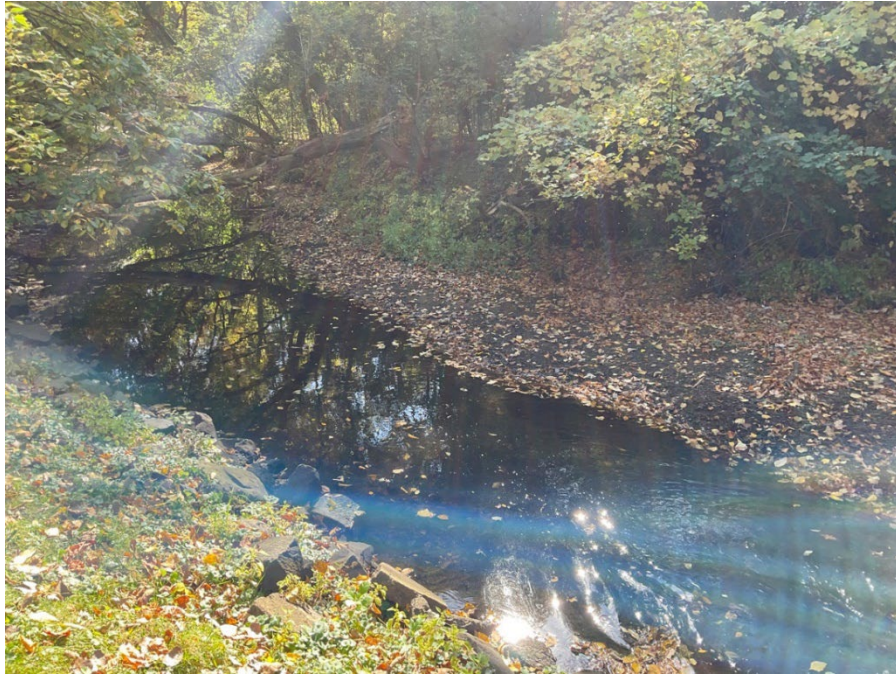
Photo 5: Site 1d. Large right bank deposition facing downstream of station 8+50.

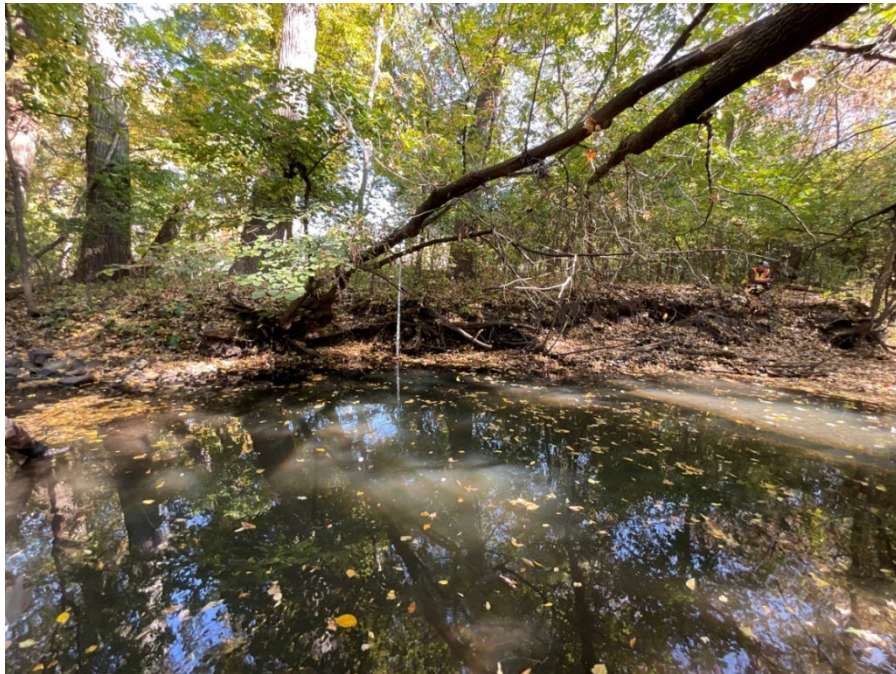
Photo 6: Site 1d. BEHI measurement at the left bank of station 9+10.

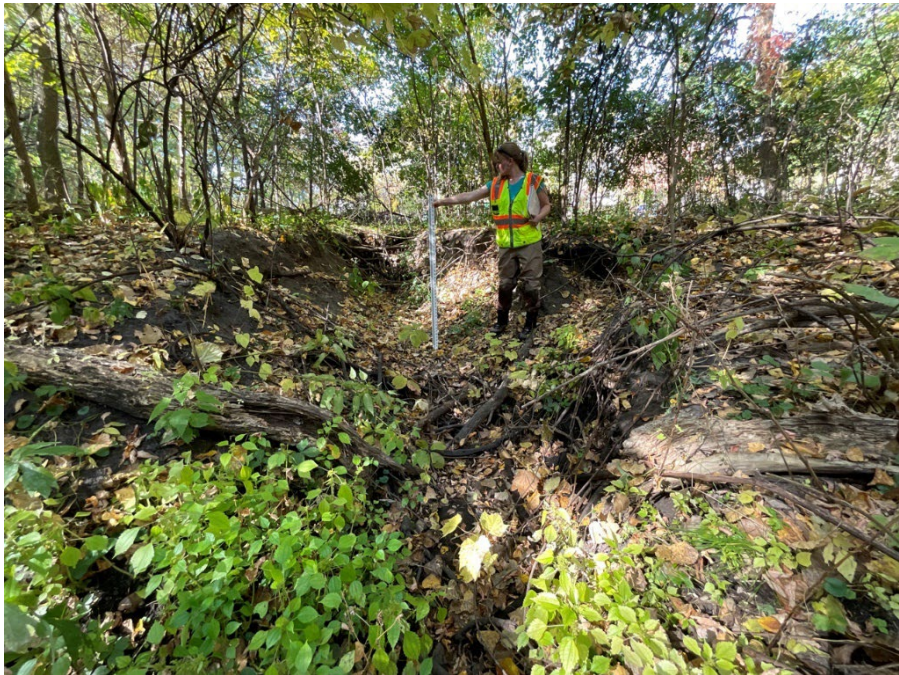
Photo 7: Site 1e. Gully formation from parking lot runoff on the left bank of station 12+20.

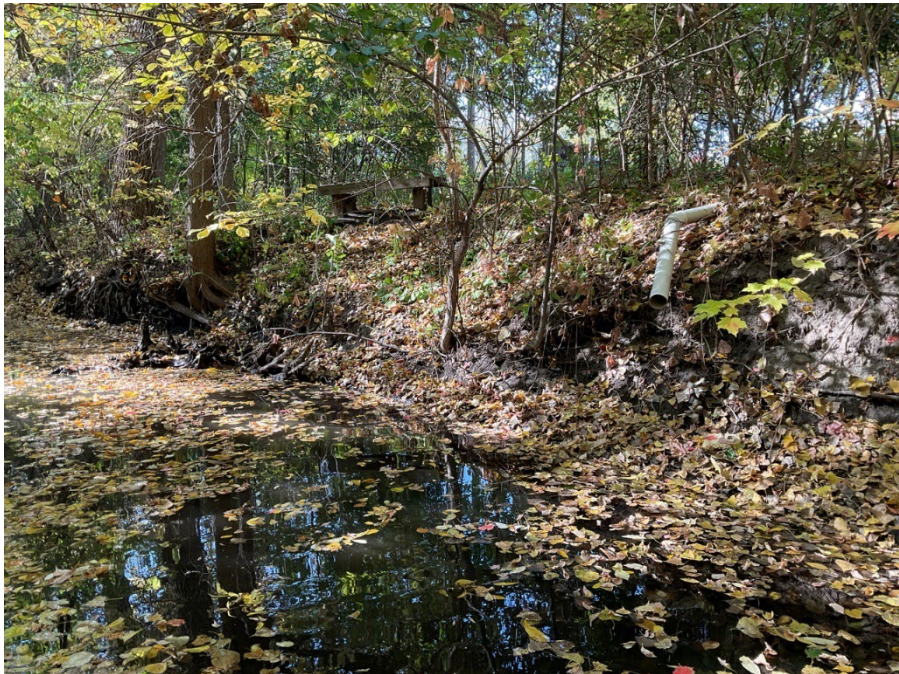
Photo 8: Site 1e. Drainpipe and bare soil on the left bank of station 13+50 (facing upstream).

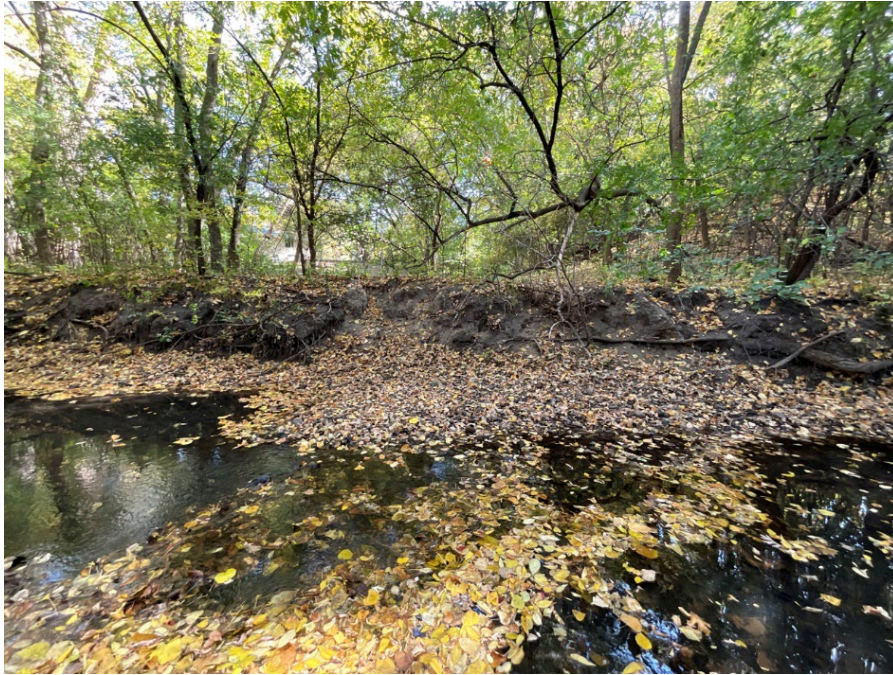
Photo 9: Site 1f. Bare soil at the right bank of station 12+30.

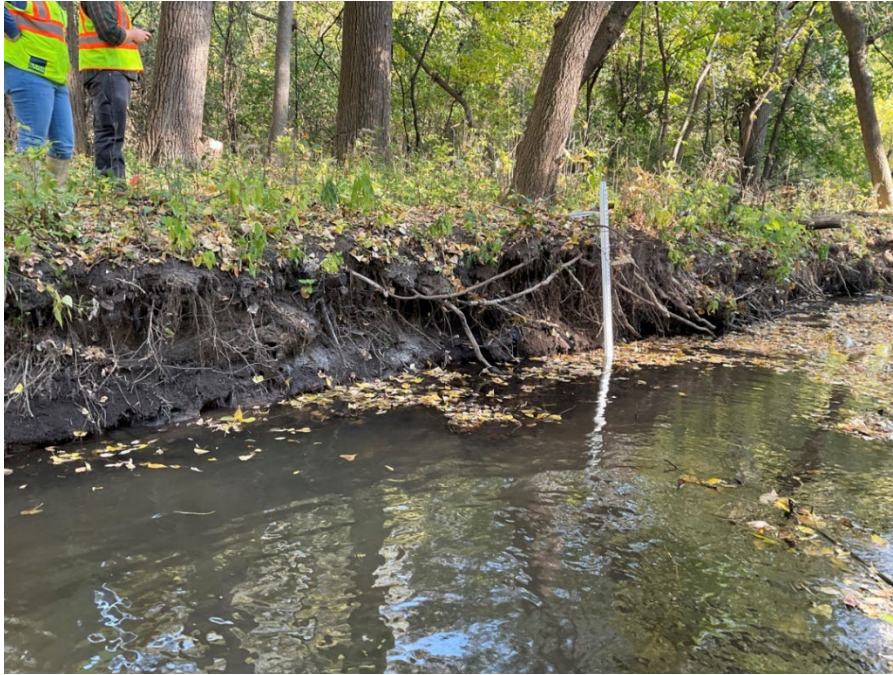
Photo 13: Site 2c. BEHI measurement and bare soil at the left bank of station 19+90 (facing downstream).

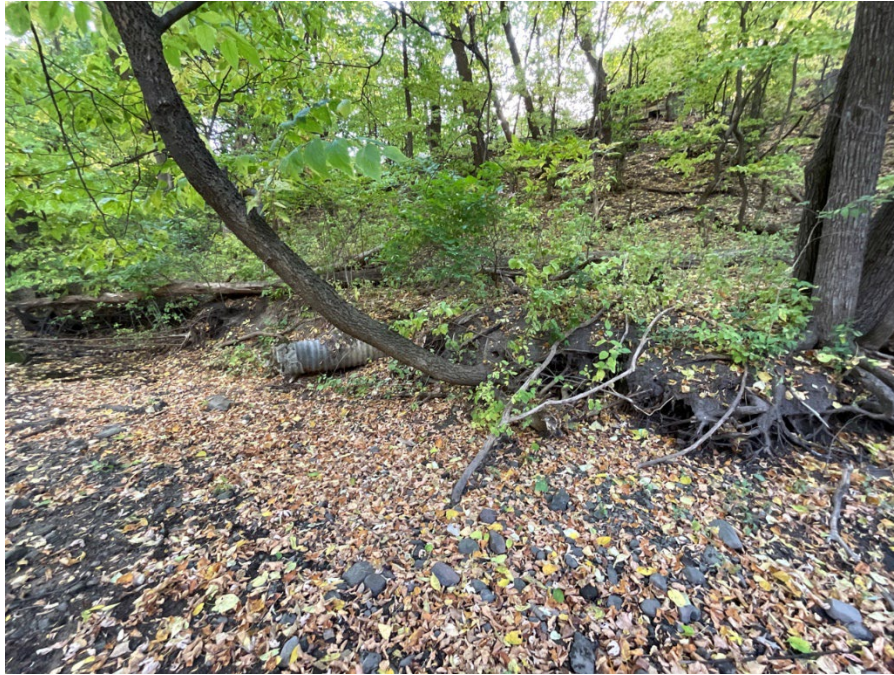
Photo 17: Site 2f. Concrete-filled pipe and right bank undercutting at station 22+75.

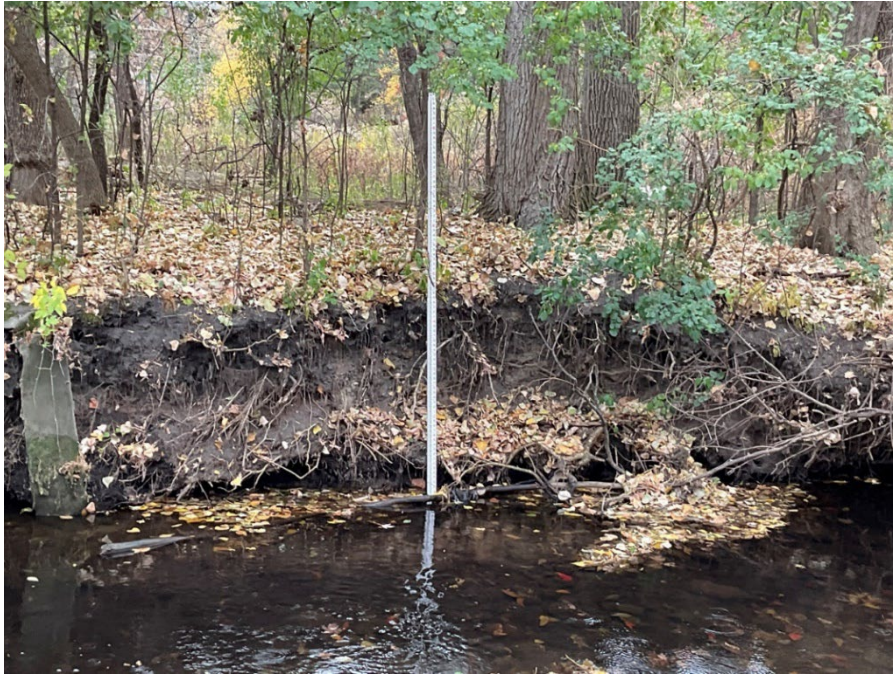
Photo 19: Site 2g. Bare soils and undercutting at the right bank of station 27+60.

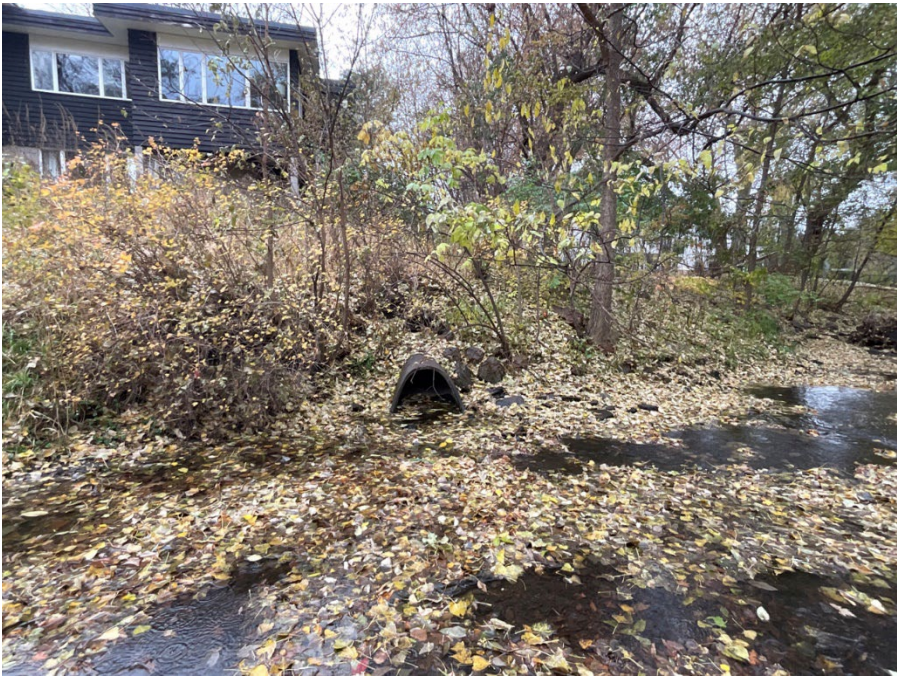
Photo 23: Site 2j. Left bank outlet at station 31+00 directly upstream of a sanitary sewer that crosses the creek.

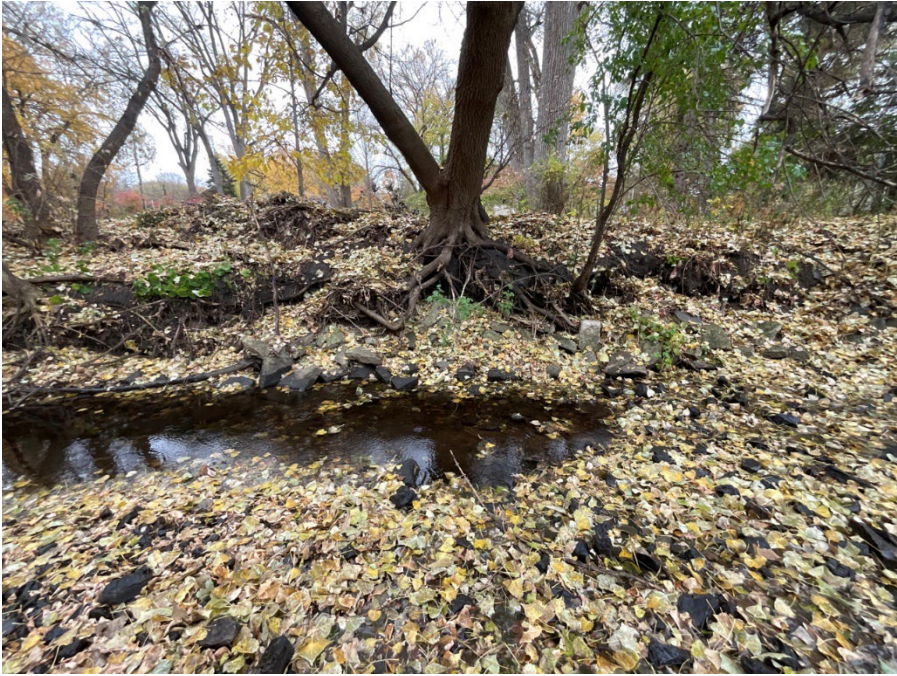
Photo 24: Site 2k. Undercutting at the right bank of station 32+25.

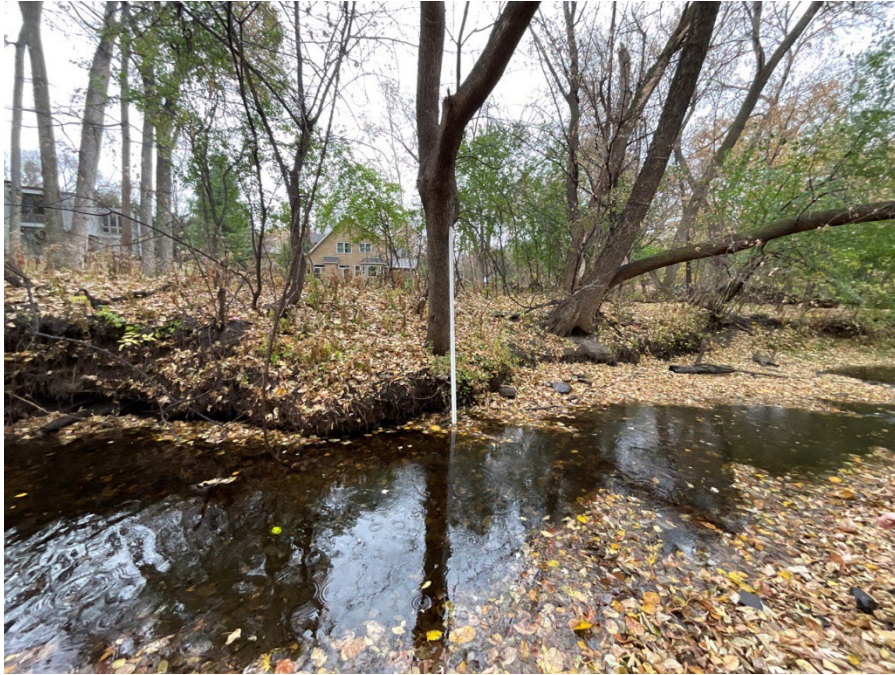
Photo 25: Site 2l. BEHI measurement and undercut at the left bank of station 34+25.

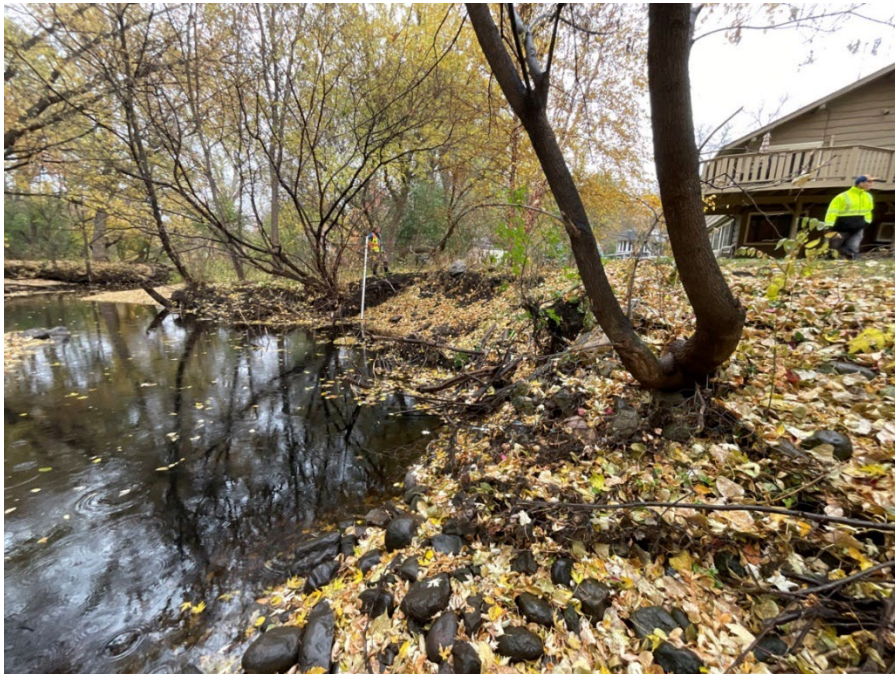
Photo 26: Site 2m. Soil exposure and deposition at the right bank of station 35+60 (facing downstream).

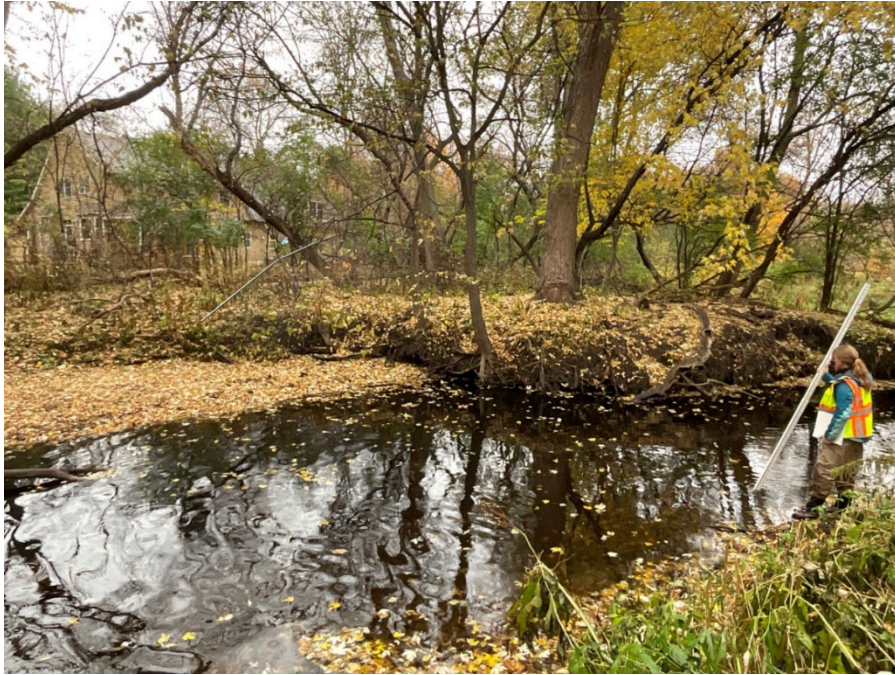
Photo 27: Site 2m. Deposition and undercut at the left bank of station 36+60.

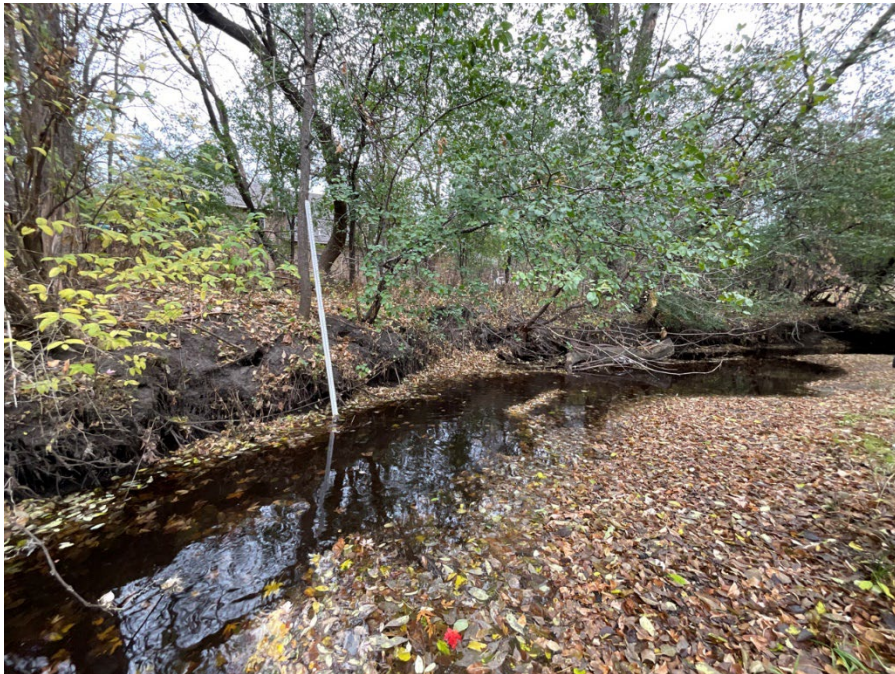
Photo 28: Site 2n. Undercut on the left bank of station 37+90; deposition on the right bank (facing downstream).

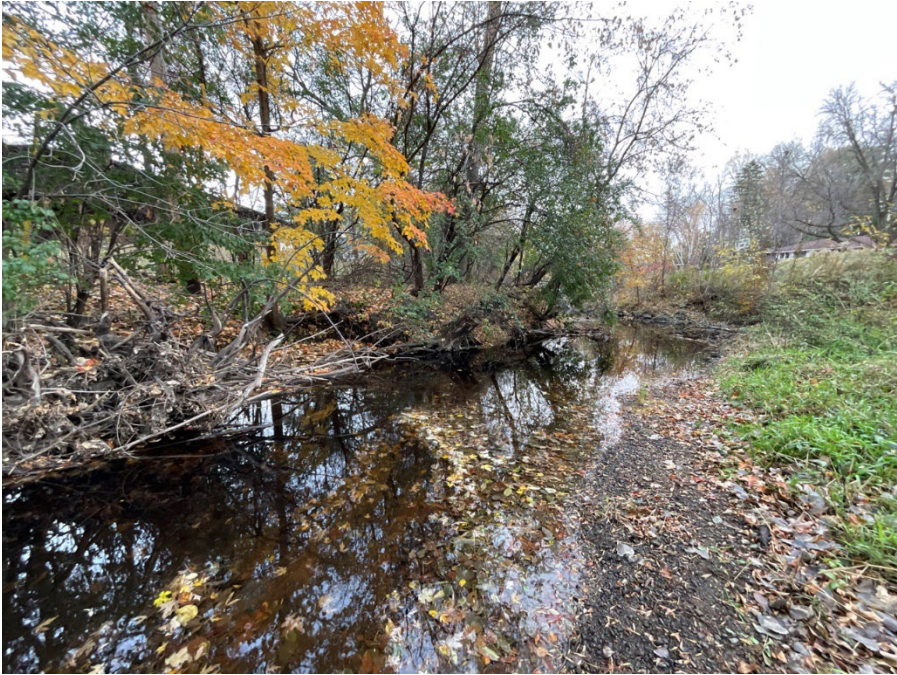
Photo 29: Site 2n. Undercut on the left bank of station 39+10. Deposition on the right bank (facing downstream).

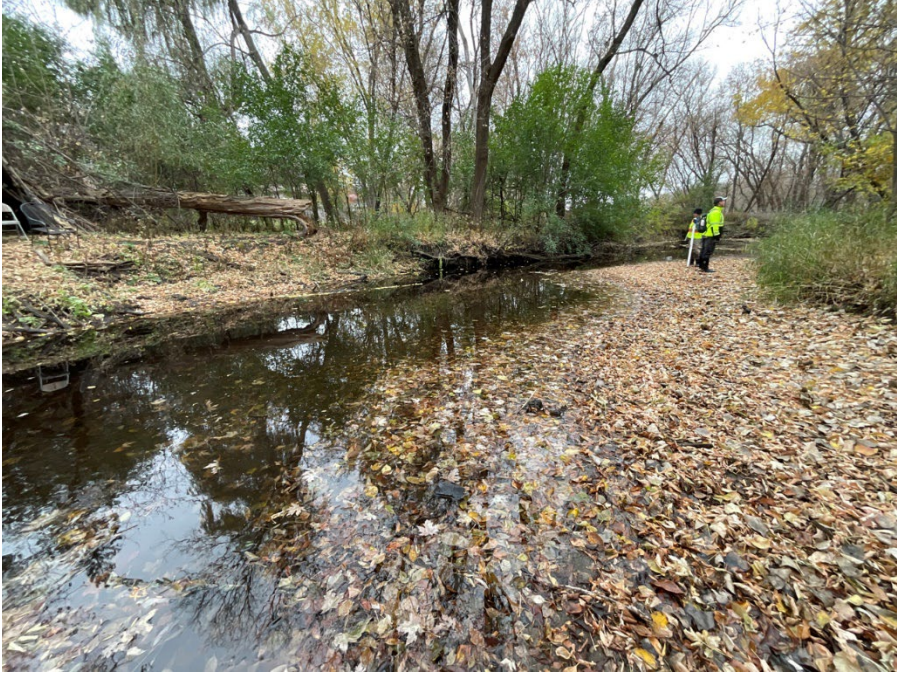
Photo 30: Site 3b. Undercut on the left bank of station 42+70. Deposition on the right bank (facing downstream).

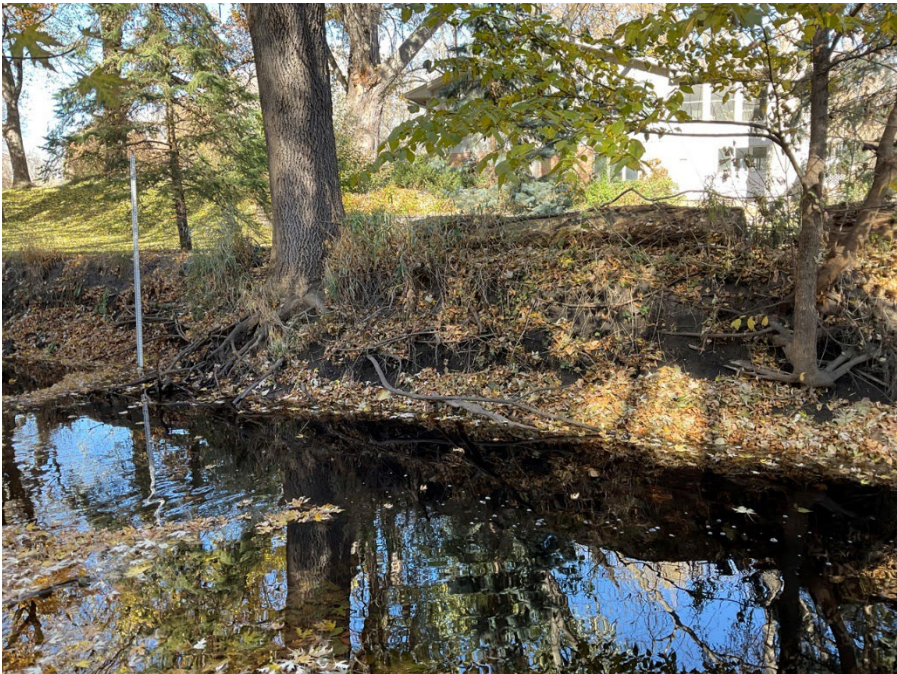
Photo 34: Site 3f. Bare soil at the upstream section at station 50+90.

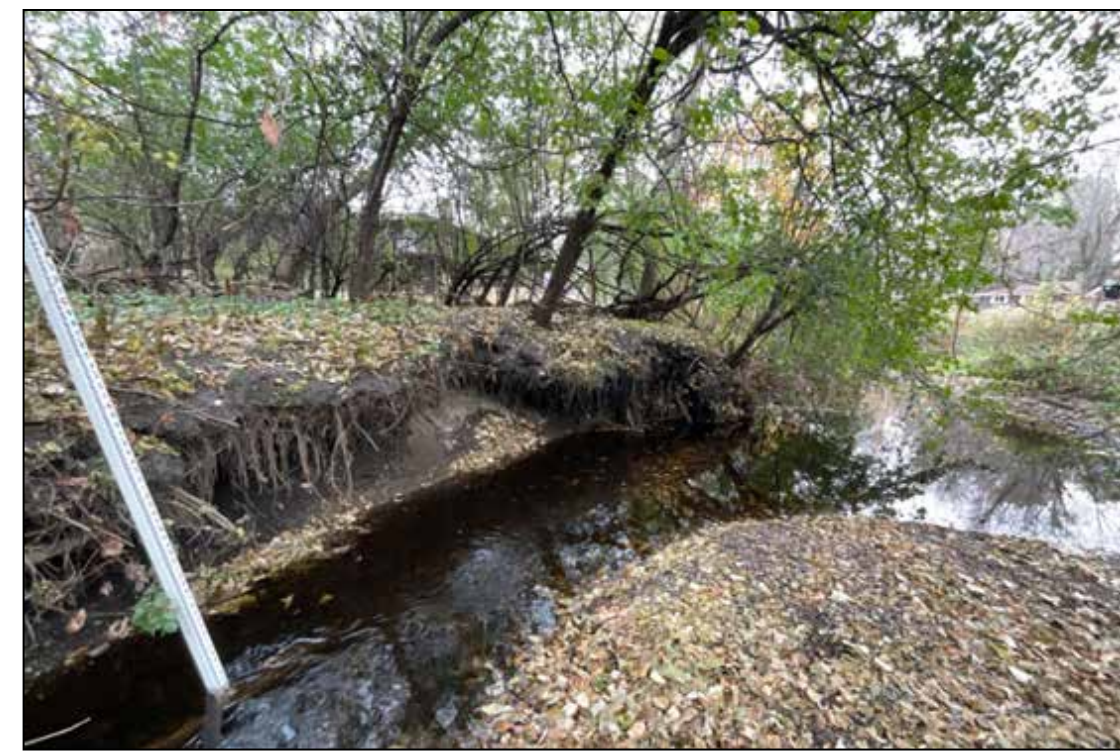
Streambank undercutting

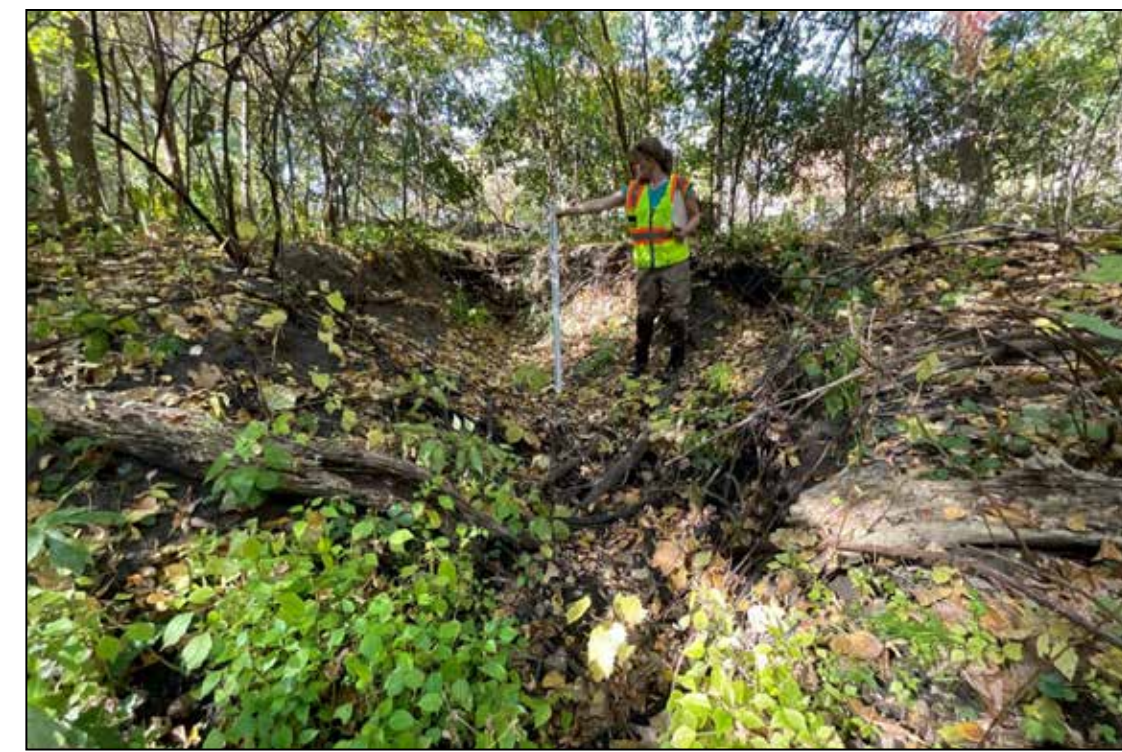
Tributary erosion

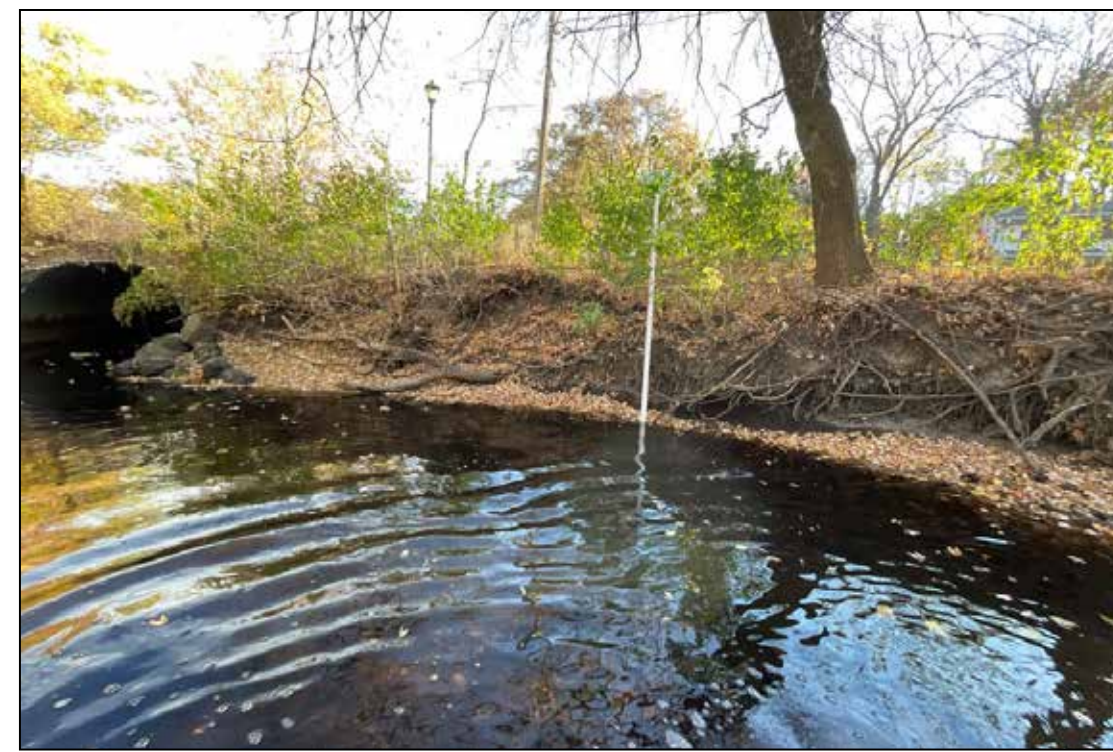
Scour near culverts
