Appendices

Appendix A
Site Visit Photos

Bassett Creek Main Stem Restoration (2024 CR-M)

Bassett Creek Main Stem Erosion Issues and Restoration Prioritization

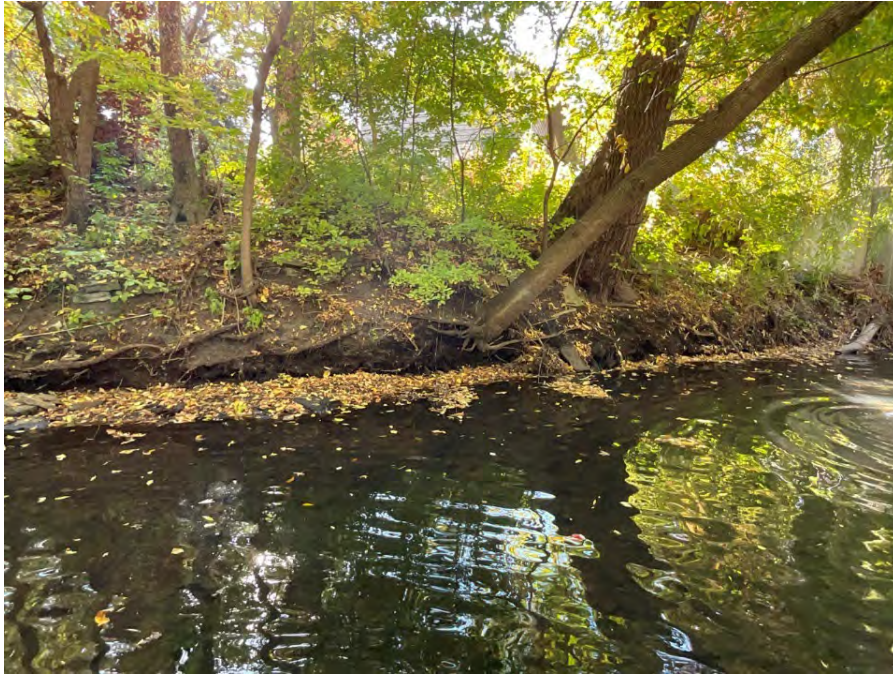
Photo 1: Site 1a. Bare soil on the right bank at station 0+40.

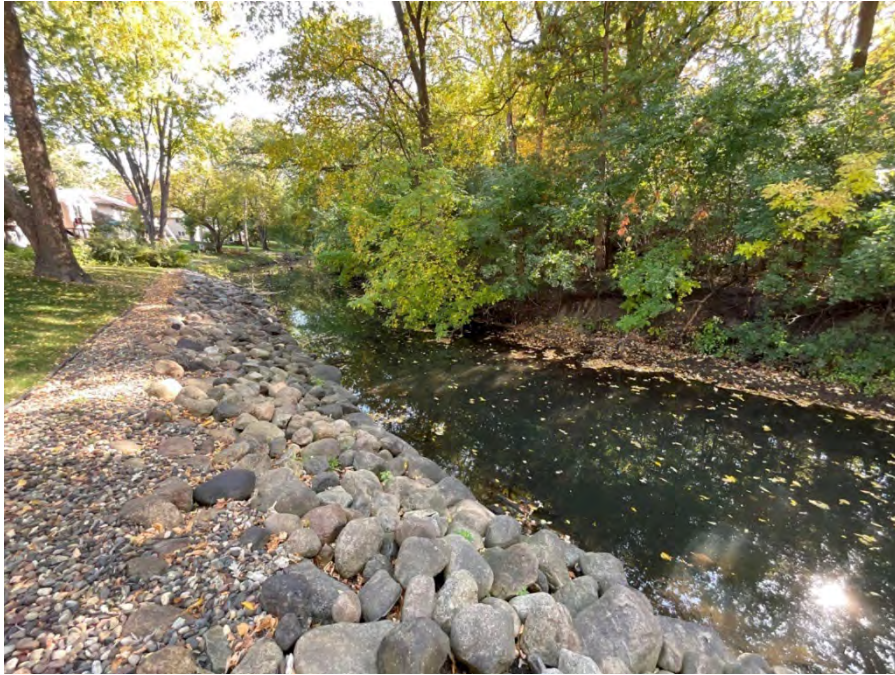
Photo 3: Site 1b. Downstream section at the right bank of station 4+50.

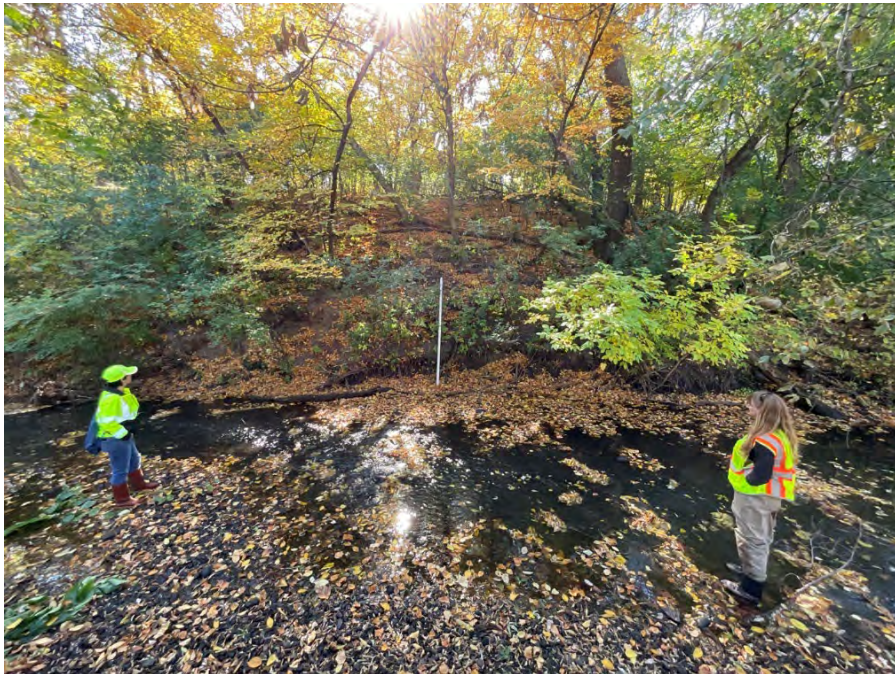
Photo 4: Site 1c. BEHI measurement at the right bank of station 7+20.

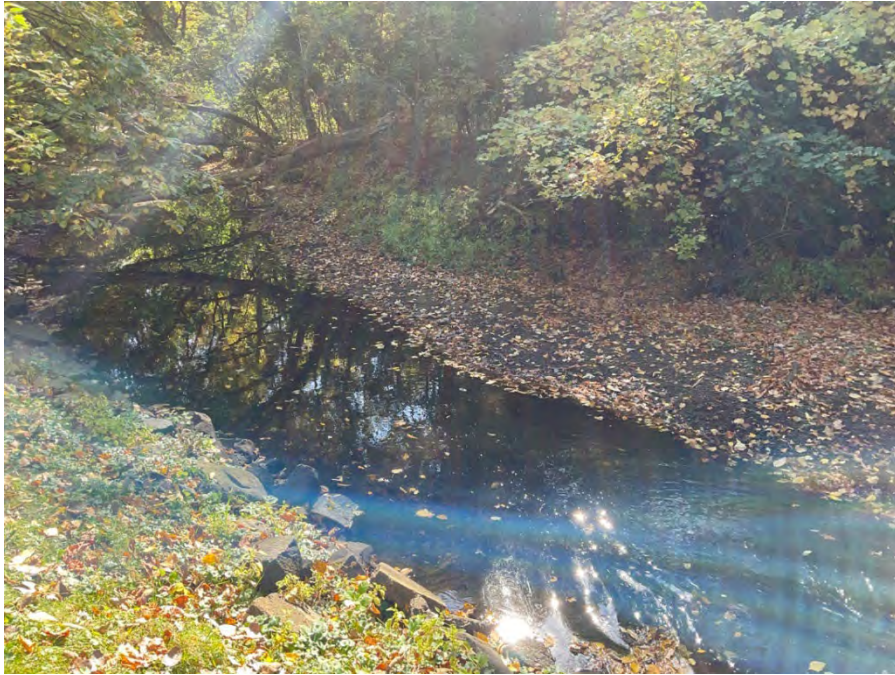
Photo 5: Site 1d. Large right bank deposition facing downstream of station 8+50.

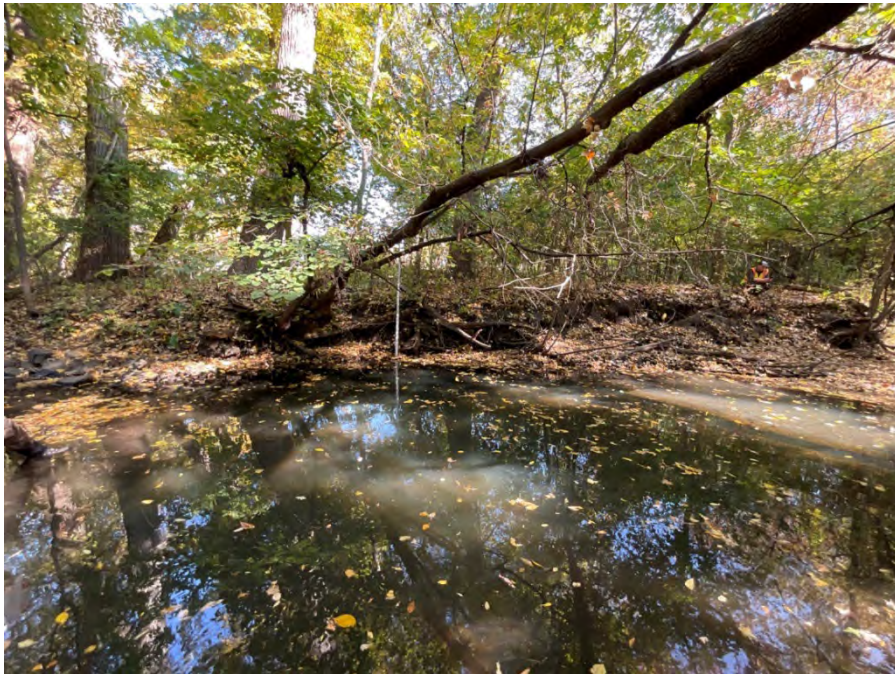
Photo 6: Site 1d. BEHI measurement at the left bank of station 9+10.

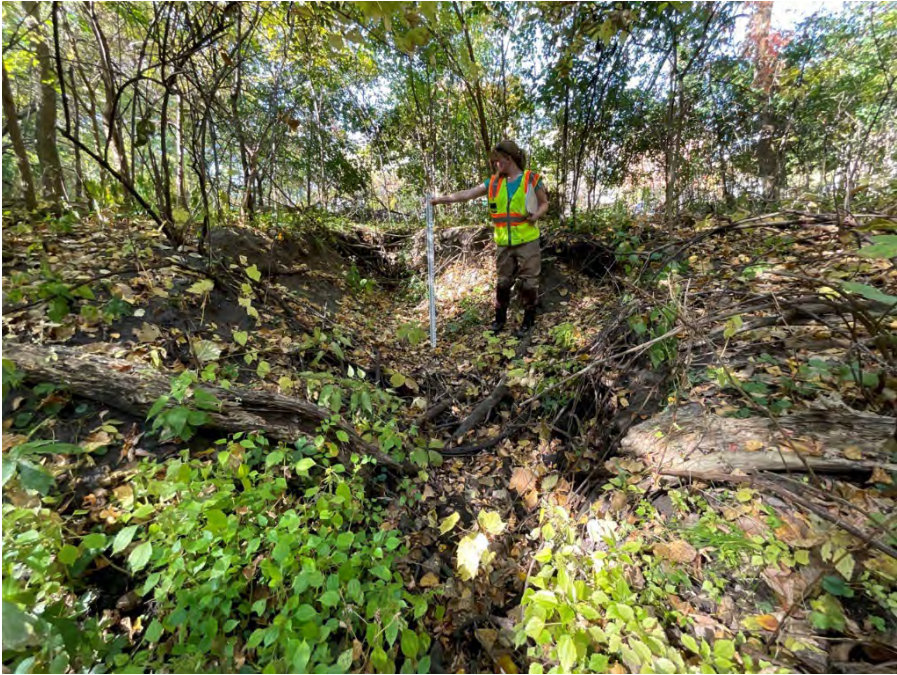
Photo 7: Site 1e. Gully formation from parking lot runoff on the left bank of station 12+20.

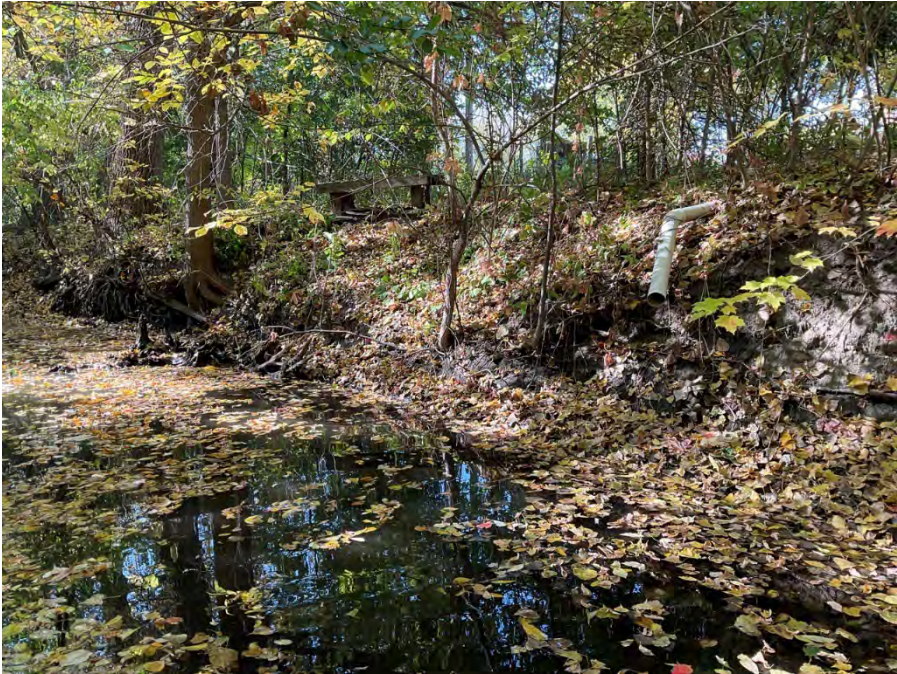
Photo 8: Site 1e. Drainpipe and bare soil on the left bank of station 13+50 (facing upstream).

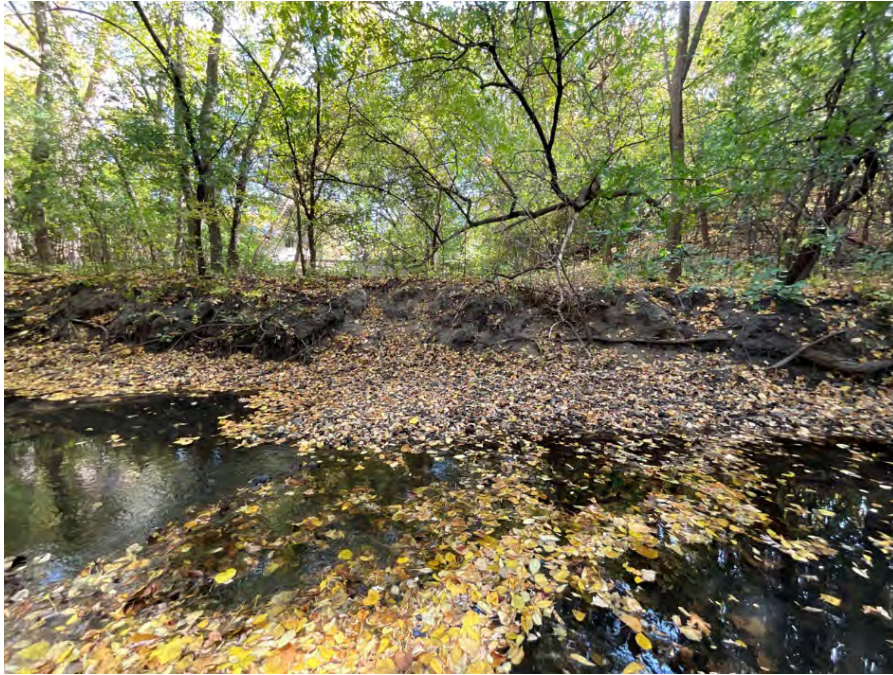
Photo 9: Site 1f. Bare soil at the right bank of station 12+30.

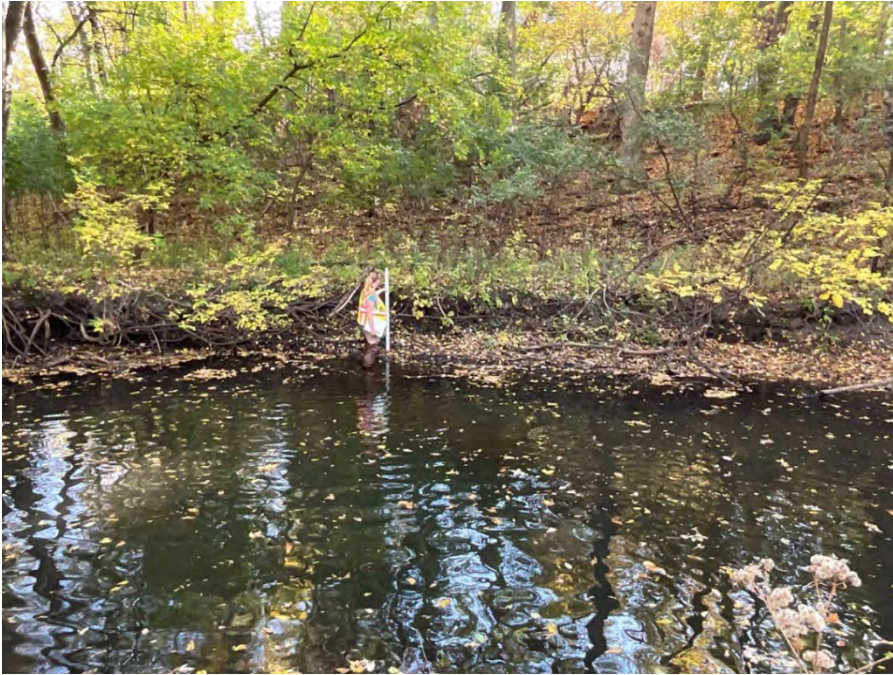
Photo 11: Site 2b. BEHI measurement at the right bank of station 18+50.

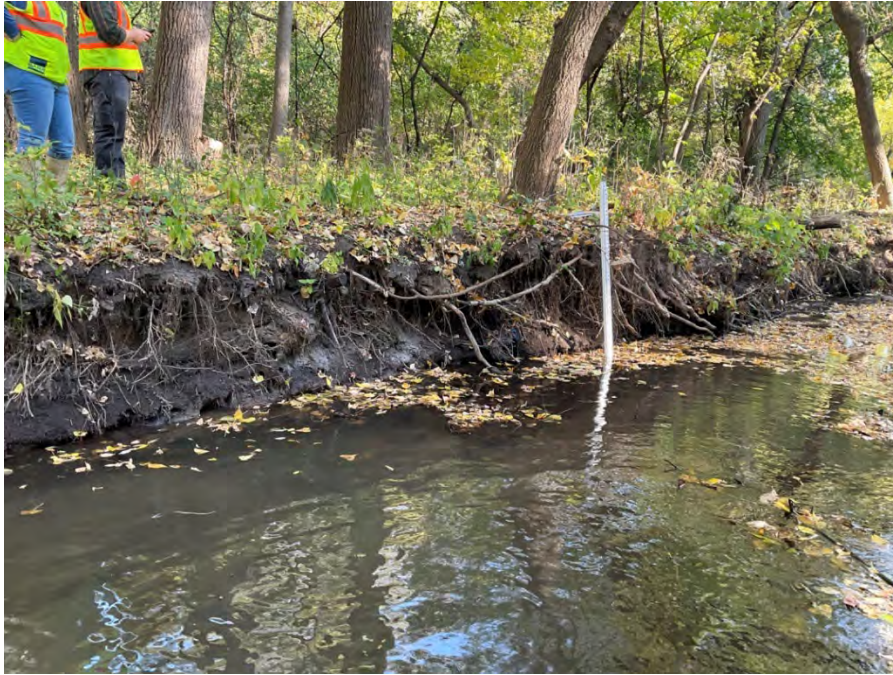
Photo 13: Site 2c. BEHI measurement and bare soil at the left bank of station 19+90 (facing downstream).

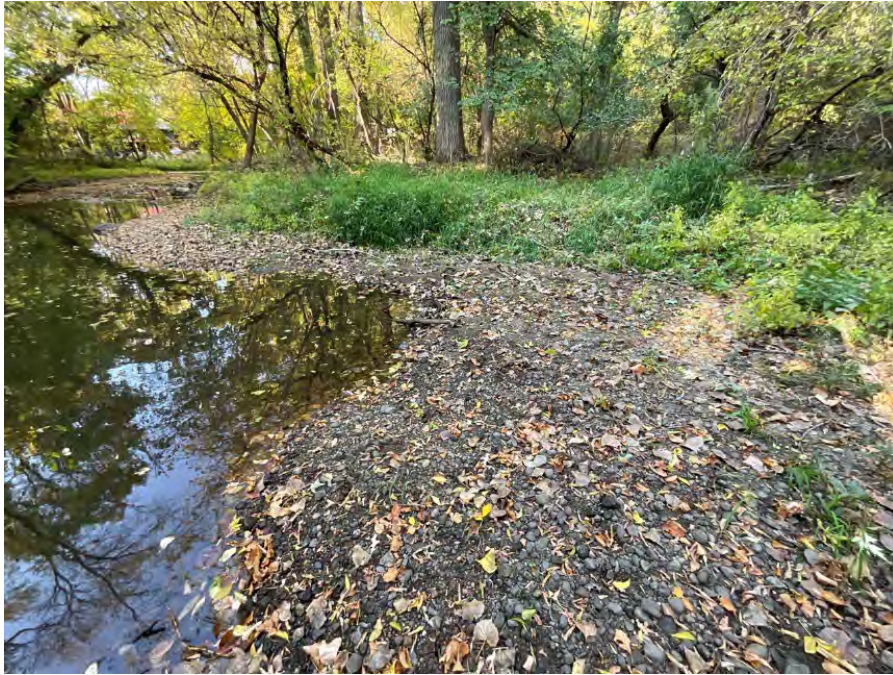
Photo 15: Site 2d. Upstream section of the left bank at station 21+10.

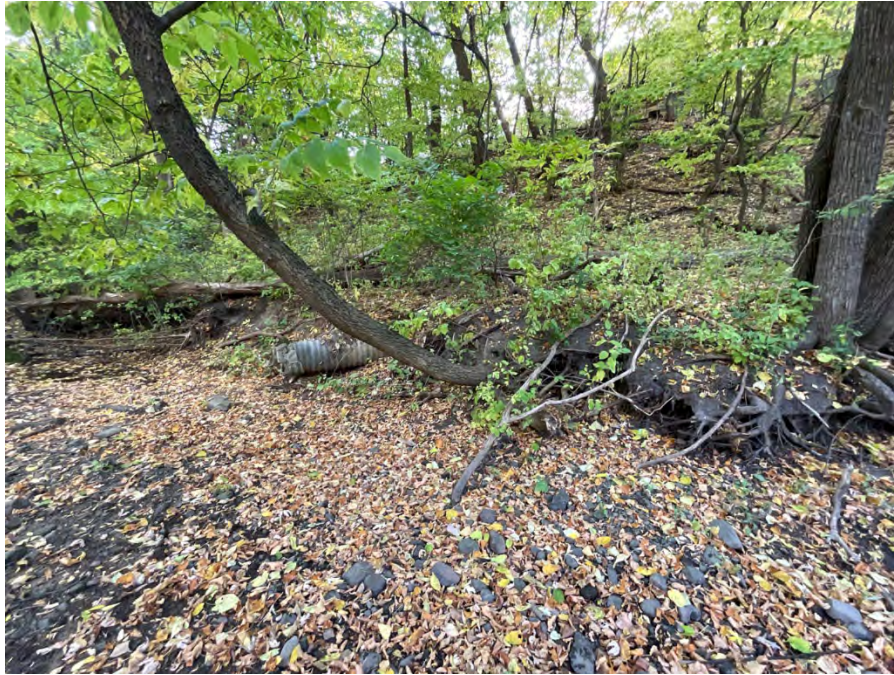
Photo 17: Site 2f. Concrete-filled pipe and right bank undercutting at station 22+75.

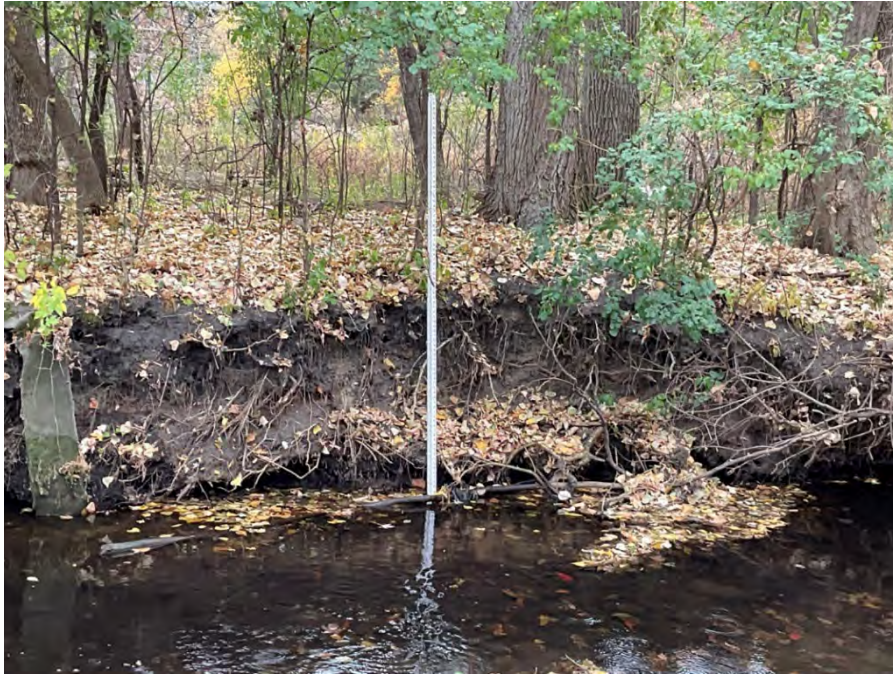
Photo 19: Site 2g. Bare soils and undercutting at the right bank of station 27+60.

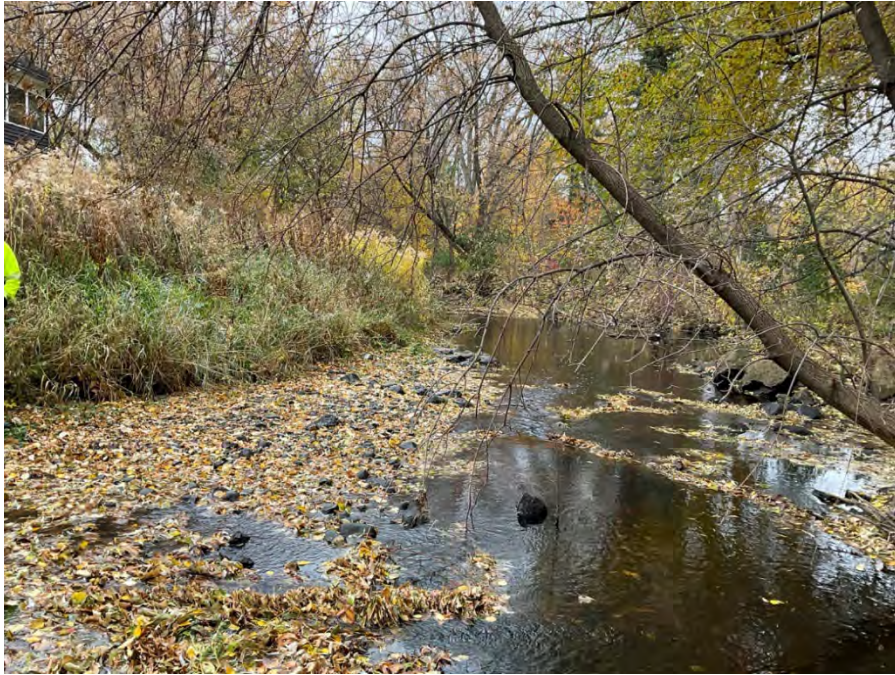
Photo 21: Site 2i. Downstream section at station 29+90.

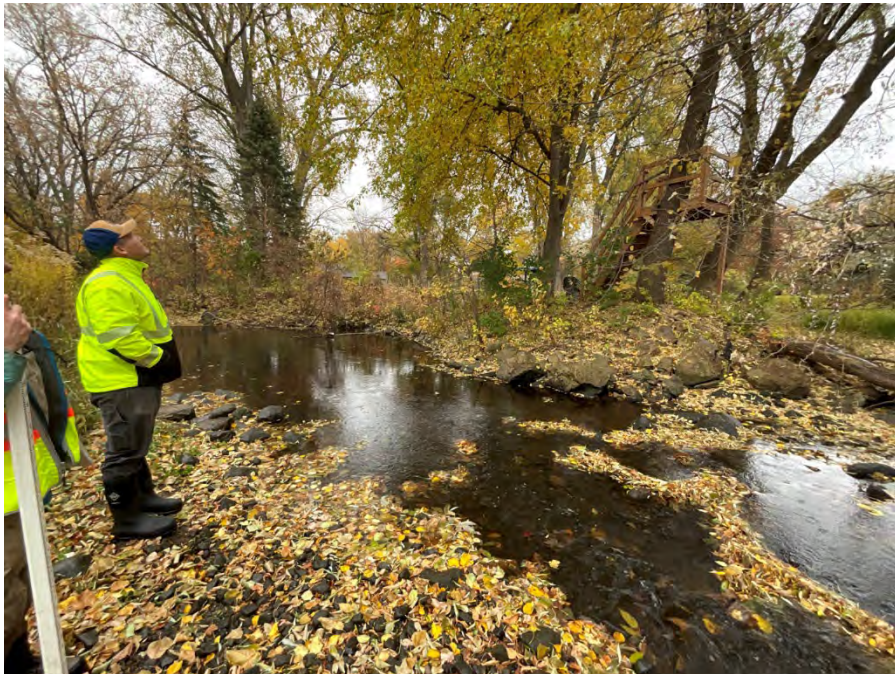
Photo 22: Site 2i. Right bank of station 30+10.

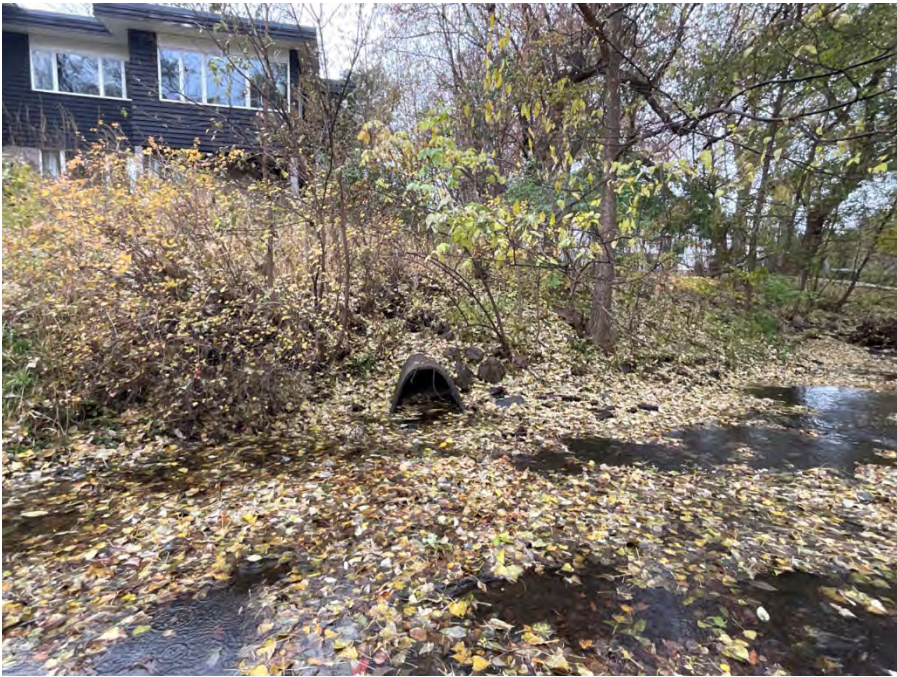
Photo 23: Site 2j. Left bank outlet at station 31+00 directly upstream of a sanitary sewer that crosses the creek.

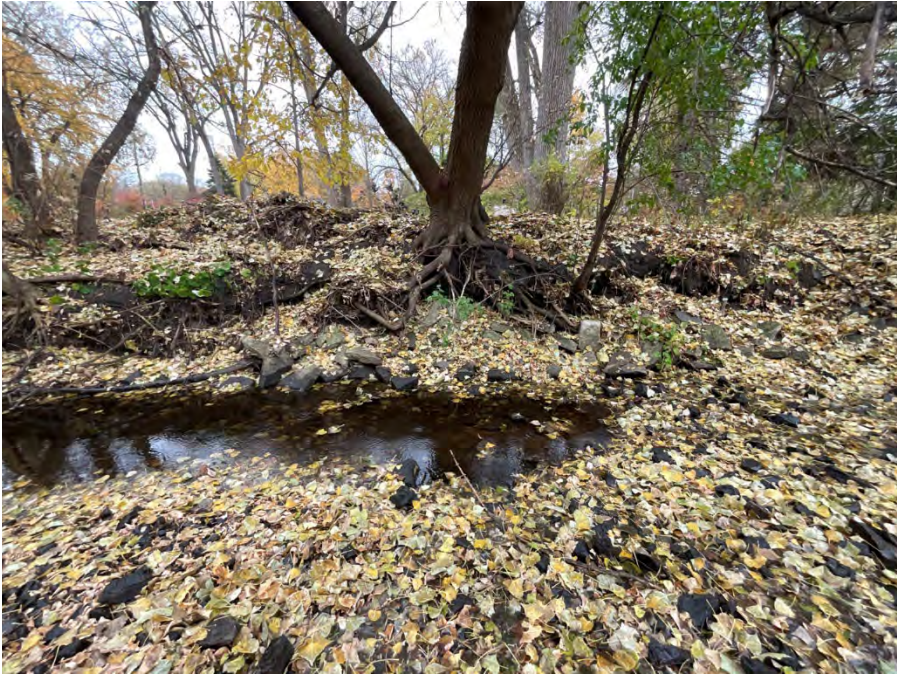
Photo 24: Site 2k. Undercutting at the right bank of station 32+25.

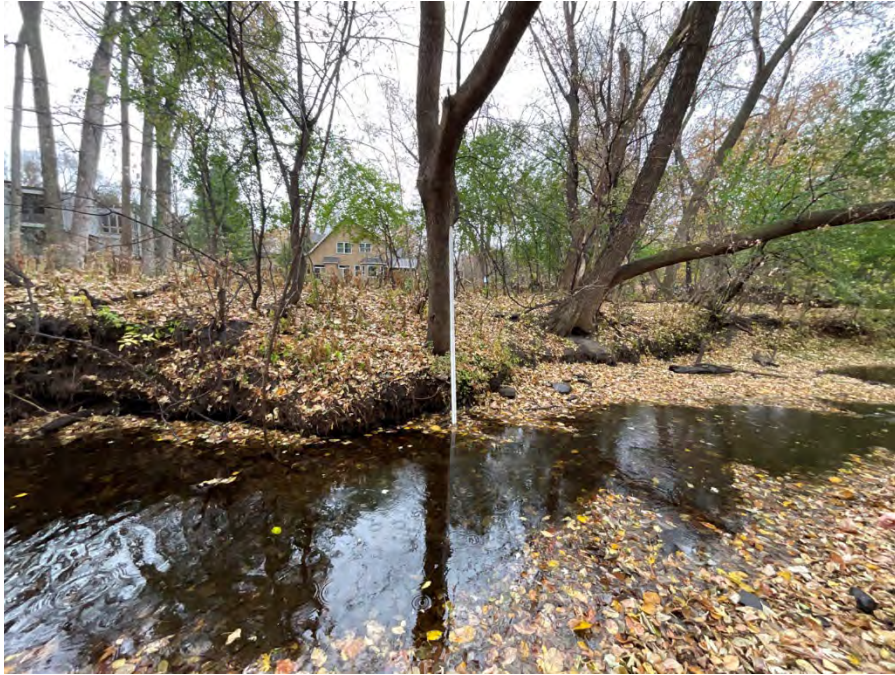
Photo 25: Site 2l. BEHI measurement and undercut at the left bank of station 34+25.

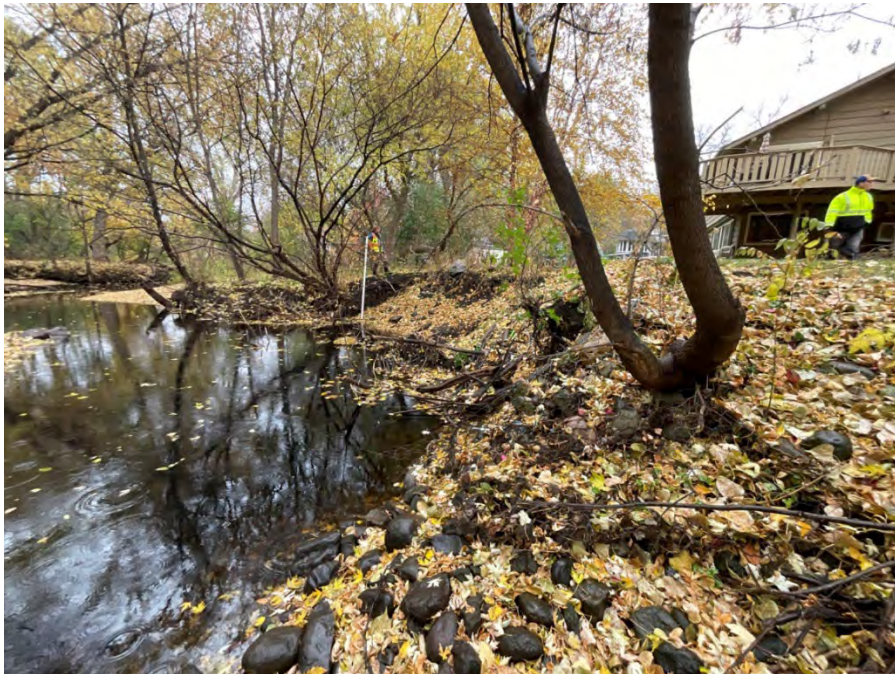
Photo 26: Site 2m. Soil exposure and deposition at the right bank of station 35+60 (facing downstream).

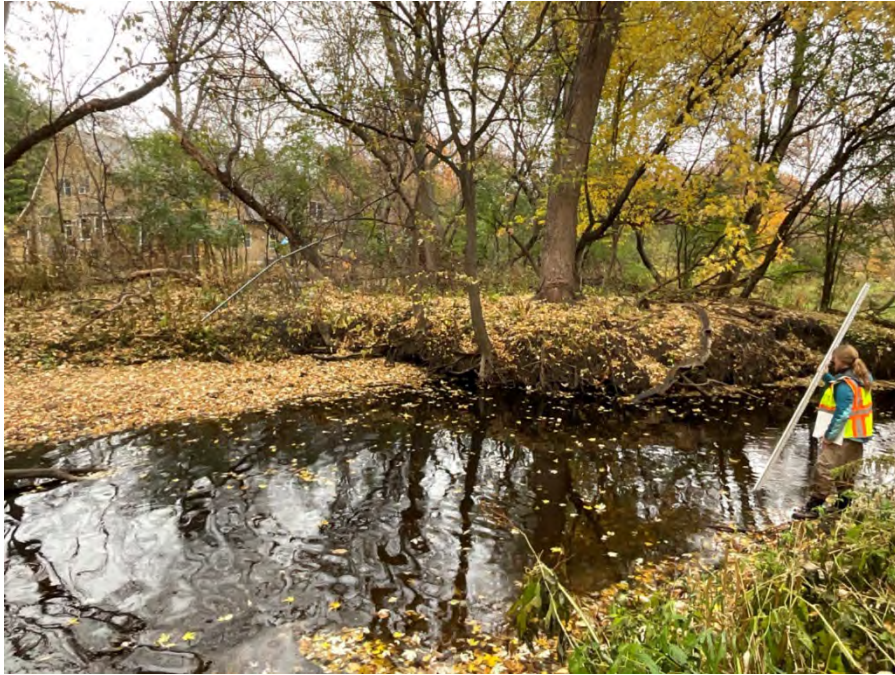
Photo 27: Site 2m. Deposition and undercut at the left bank of station 36+60.

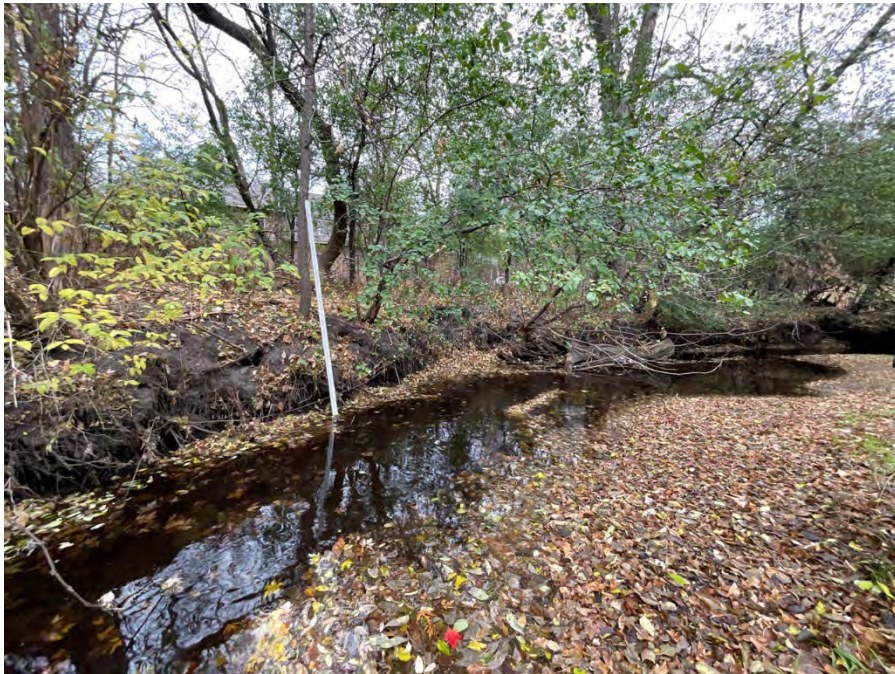
Photo 28: Site 2n. Undercut on the left bank of station 37+90; deposition on the right bank (facing downstream).

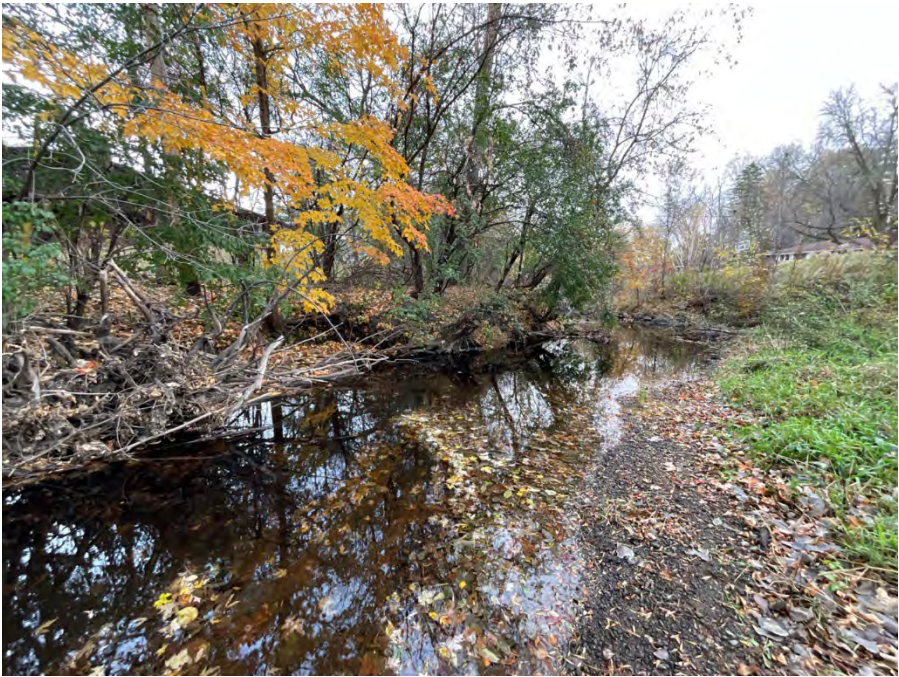
Photo 29: Site 2n. Undercut on the left bank of station 39+10. Deposition on the right bank (facing downstream).

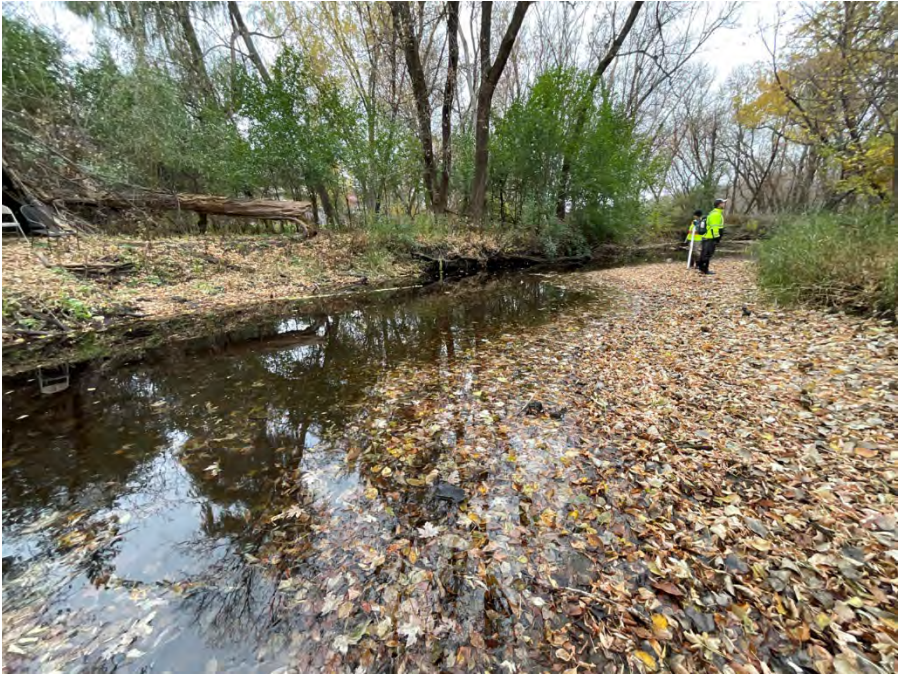
Photo 30: Site 3b. Undercut on the left bank of station 42+70. Deposition on the right bank (facing downstream).

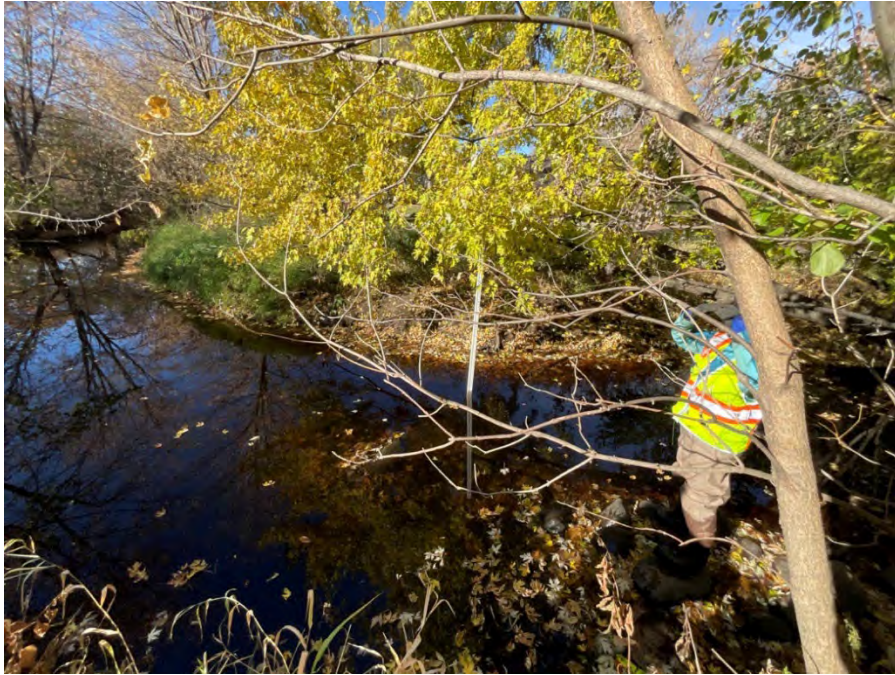
Photo 37: Site 3i. Left bank of station 52+30.

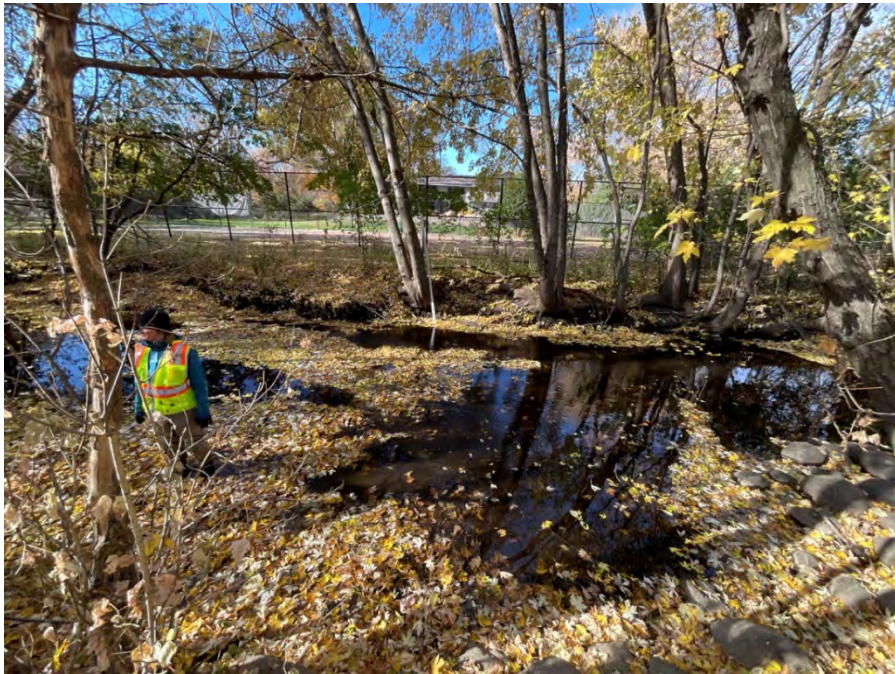
Photo 38: Site 3i. Left bank of station 53+50.

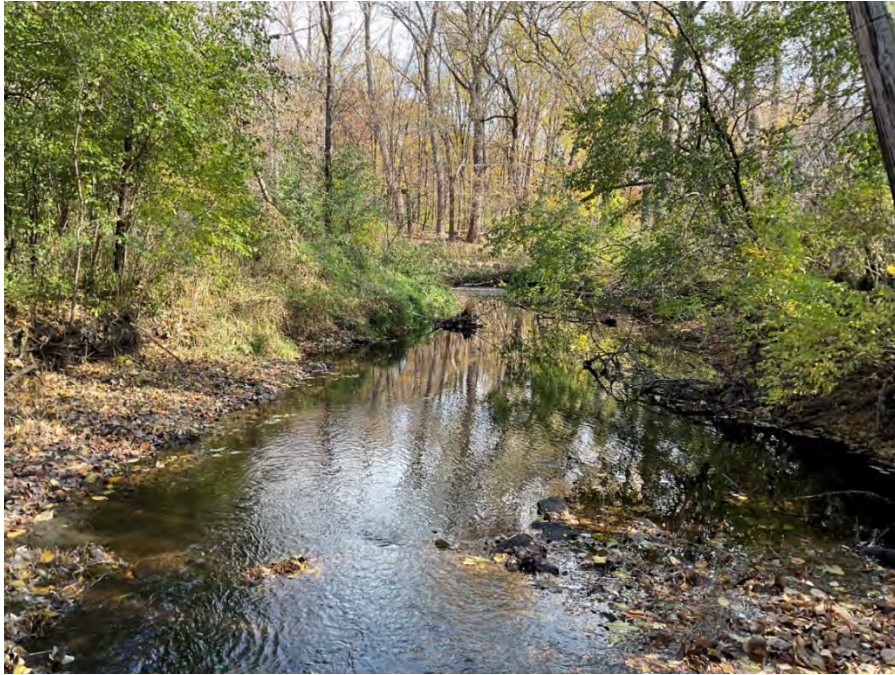
Photo 43: Site 4c. Downstream section before oxbow at station 61+40.

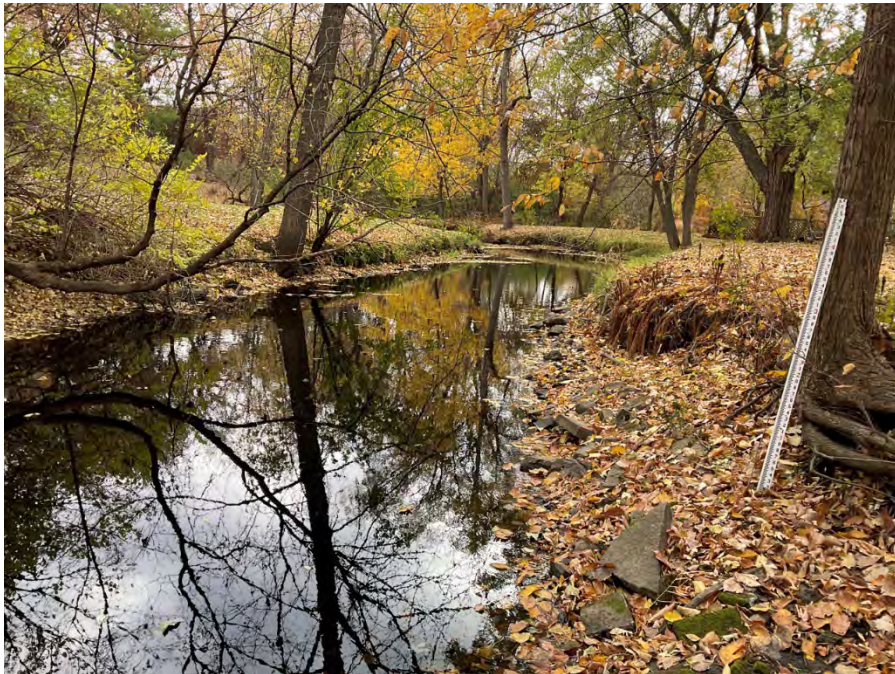
Photo 44: Site 4d. Right bank of station 65+70 (facing downstream).

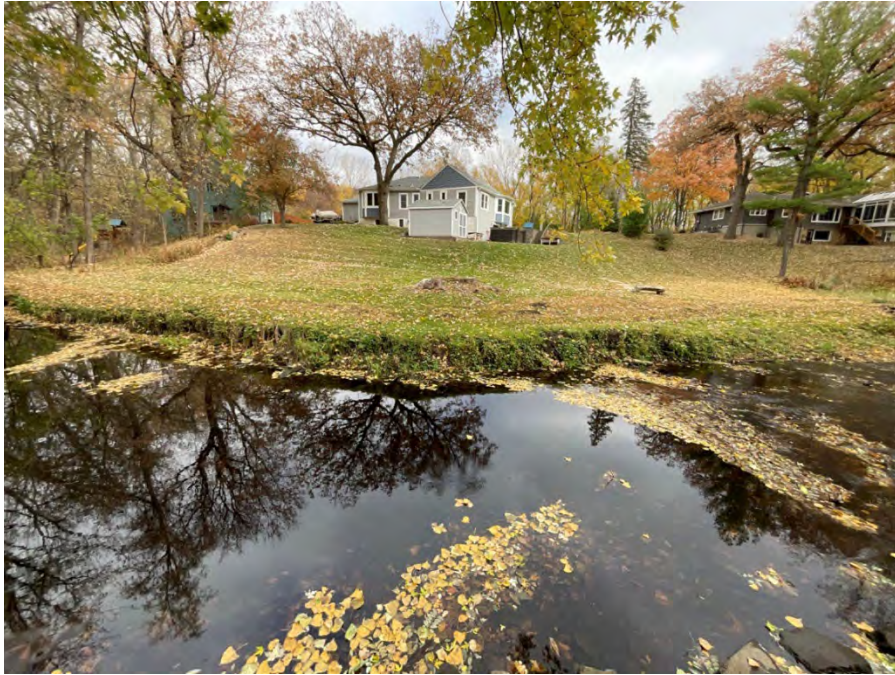
Photo 47: Site 4f. Left bank of station 66+70.

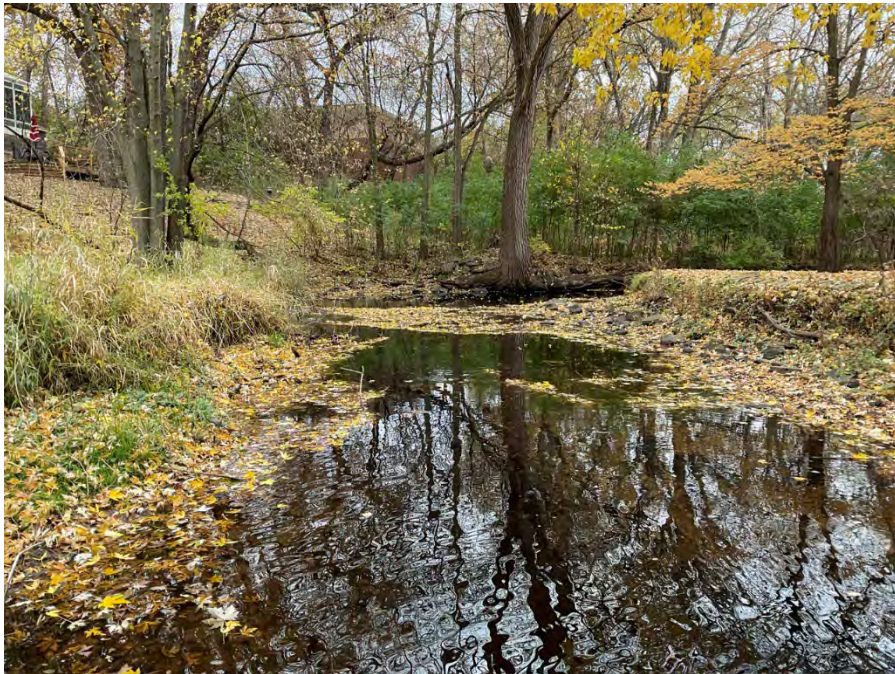
Photo 48: Site 4g. Downstream section of station 67+50.

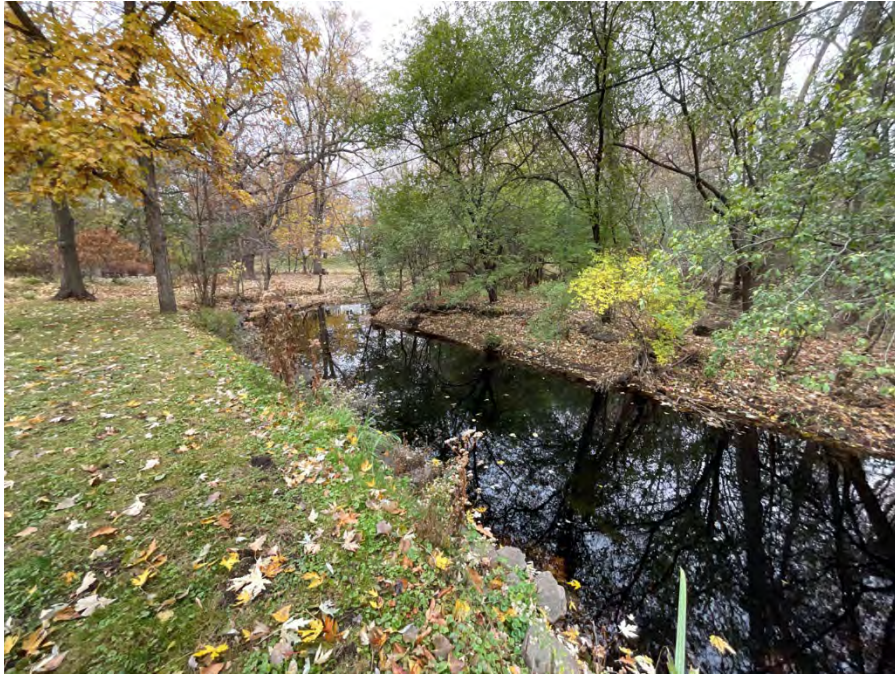
Photo 49: Site 4h. Left bank at station 68+80 (facing upstream).

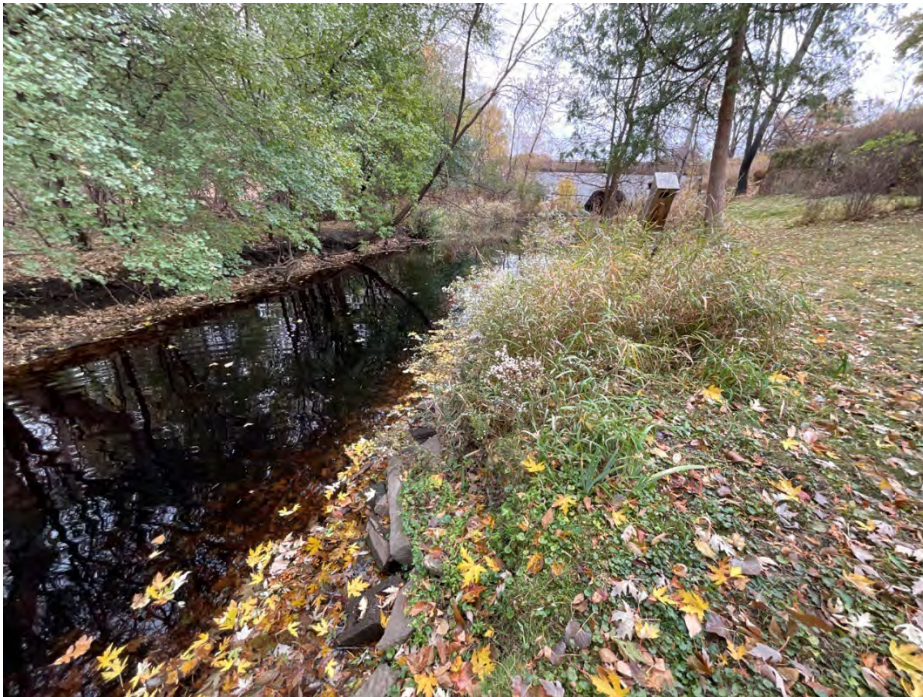
Photo 50: Site 4h. Downstream section at station 70+70.

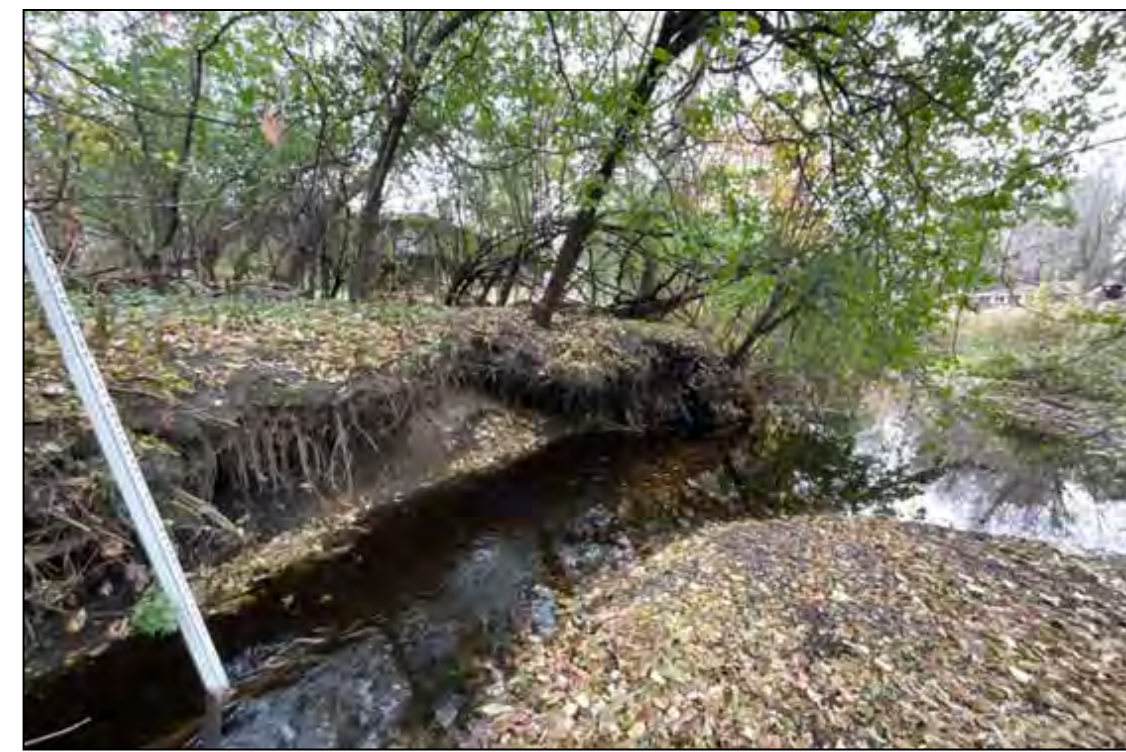
Streambank undercutting

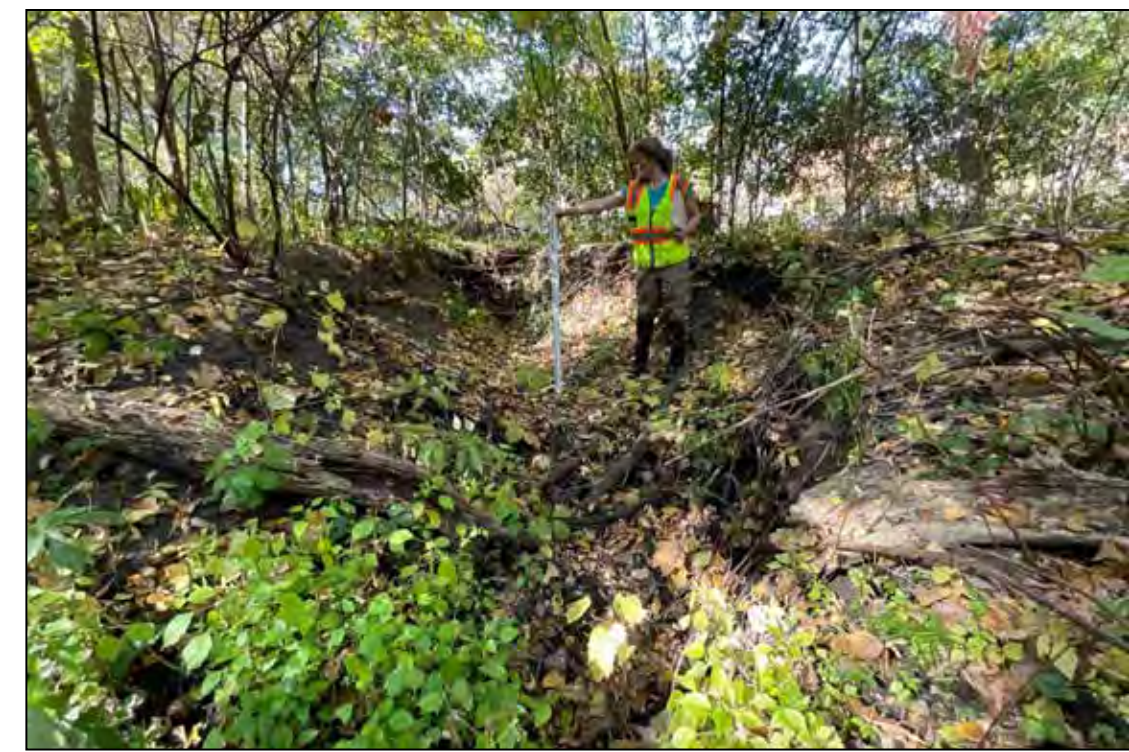
Tributary erosion

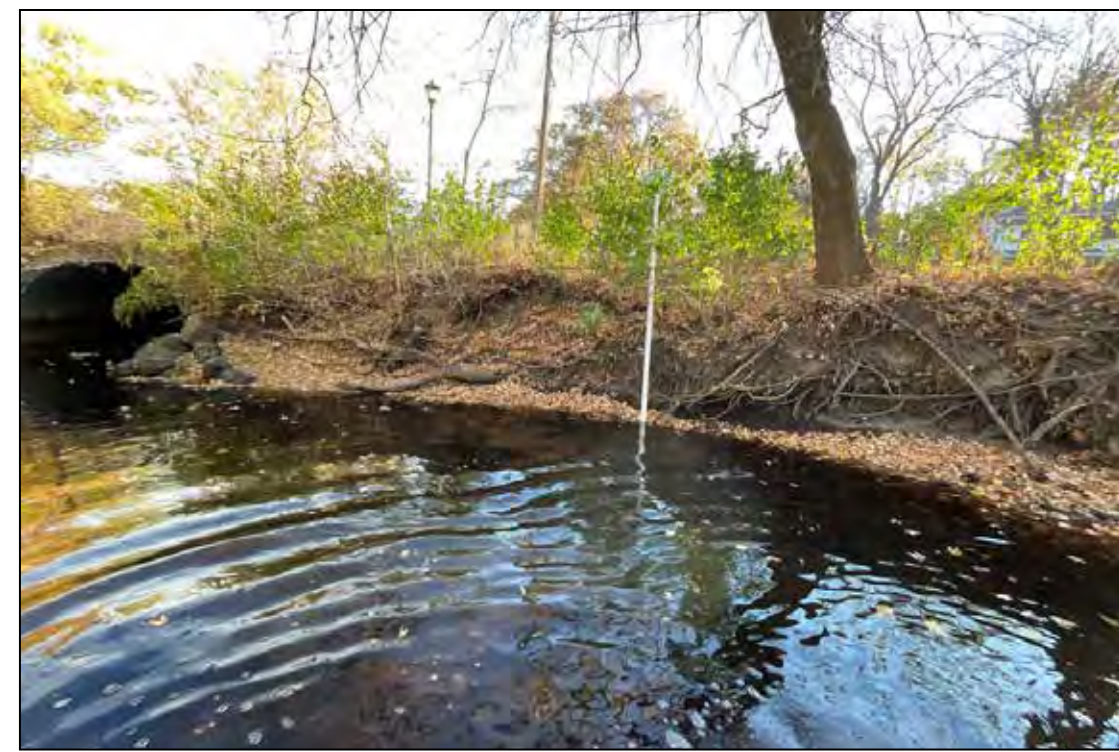
Scour near culverts
