# Feasibility Report for Ponderosa Woods Stream Restoration Project—FINAL

*Plymouth, Minnesota*

Prepared for  
Bassett Creek Watershed Management Commission

June 2023

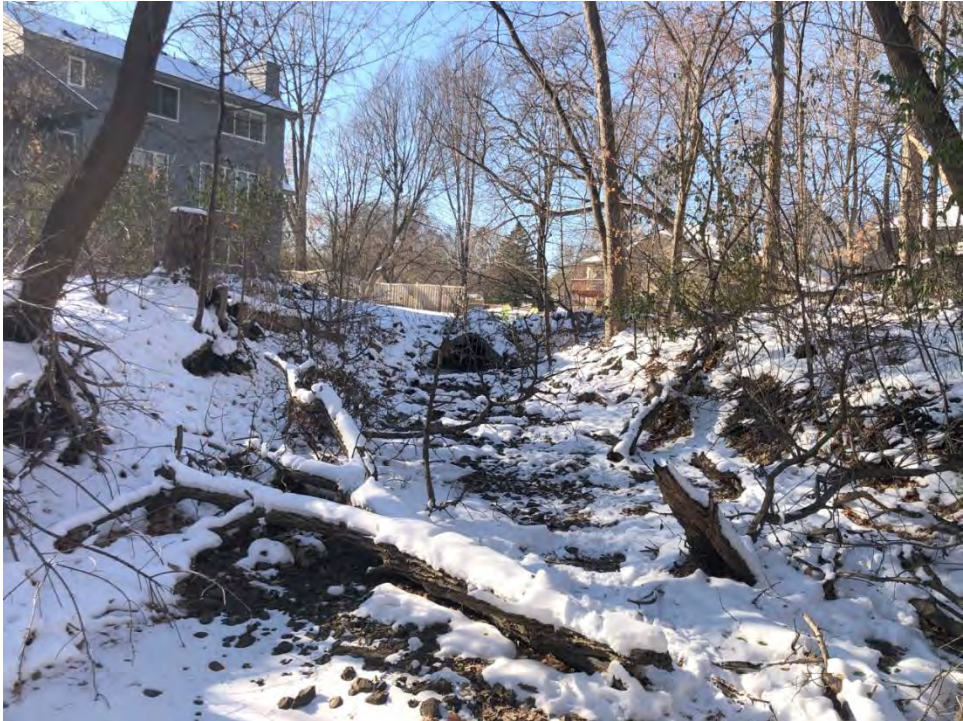
Figure 3-2 Upstream Section with Channel Debris and Bank Erosion (Reach 1)

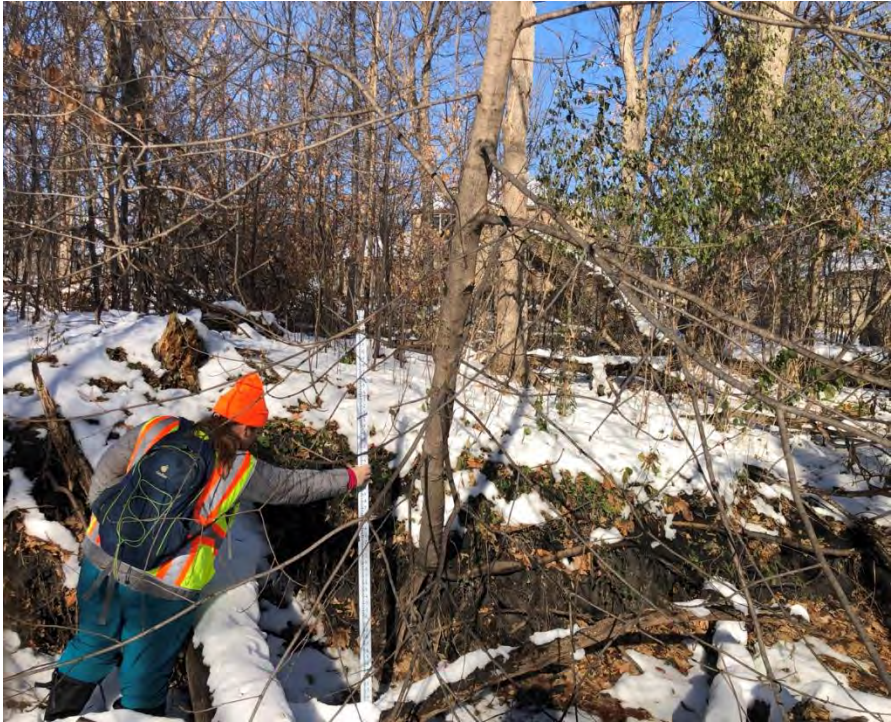
Figure 3-3 Left Bank Erosion (Reach 1)

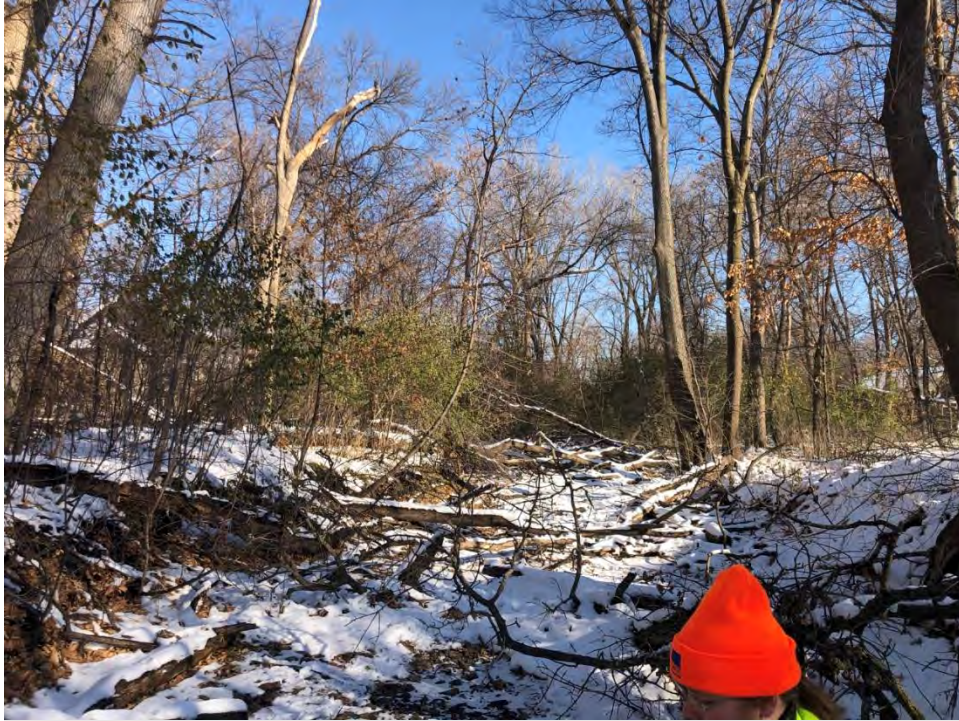
Figure 3-4 Debris and Left Bank Erosion (Reaches 1 and 2, downstream of upstream flared end section)

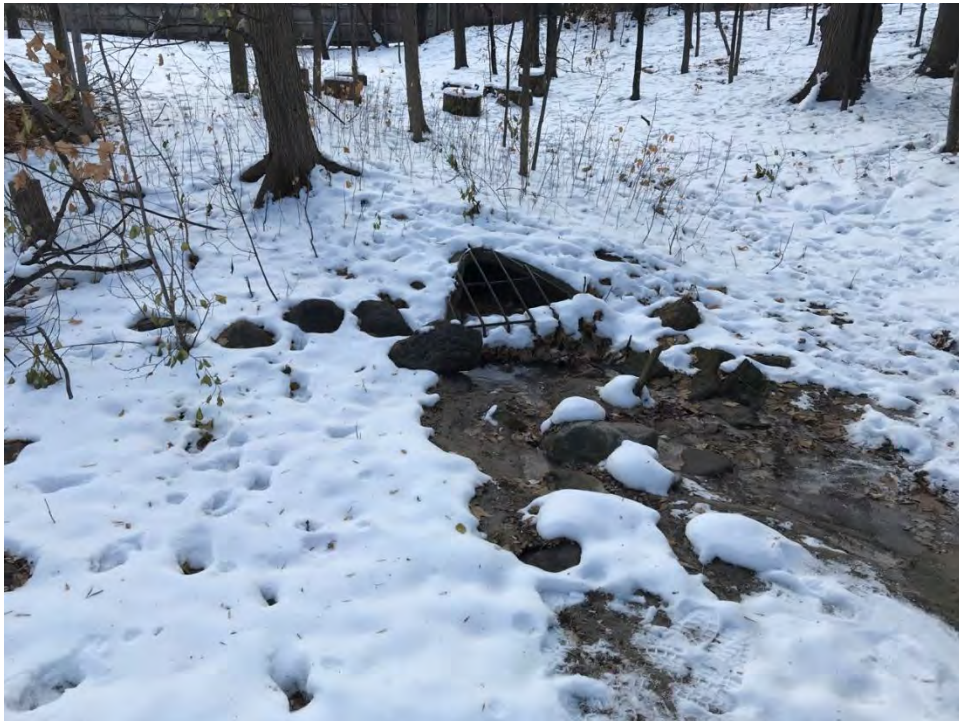
Figure 3-5 Erosion and Sediment Deposition at a Stormwater Side-channel

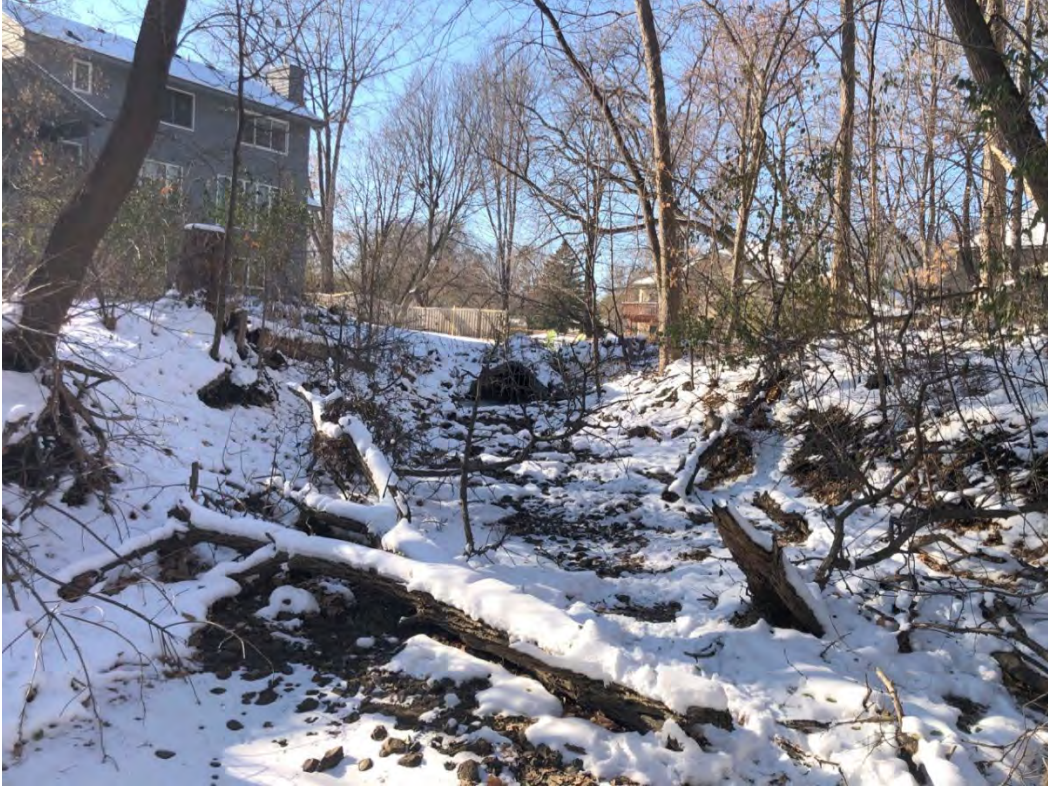
**Figure A- 1** *Upstream end of reach with in-channel debris and bank erosion.*

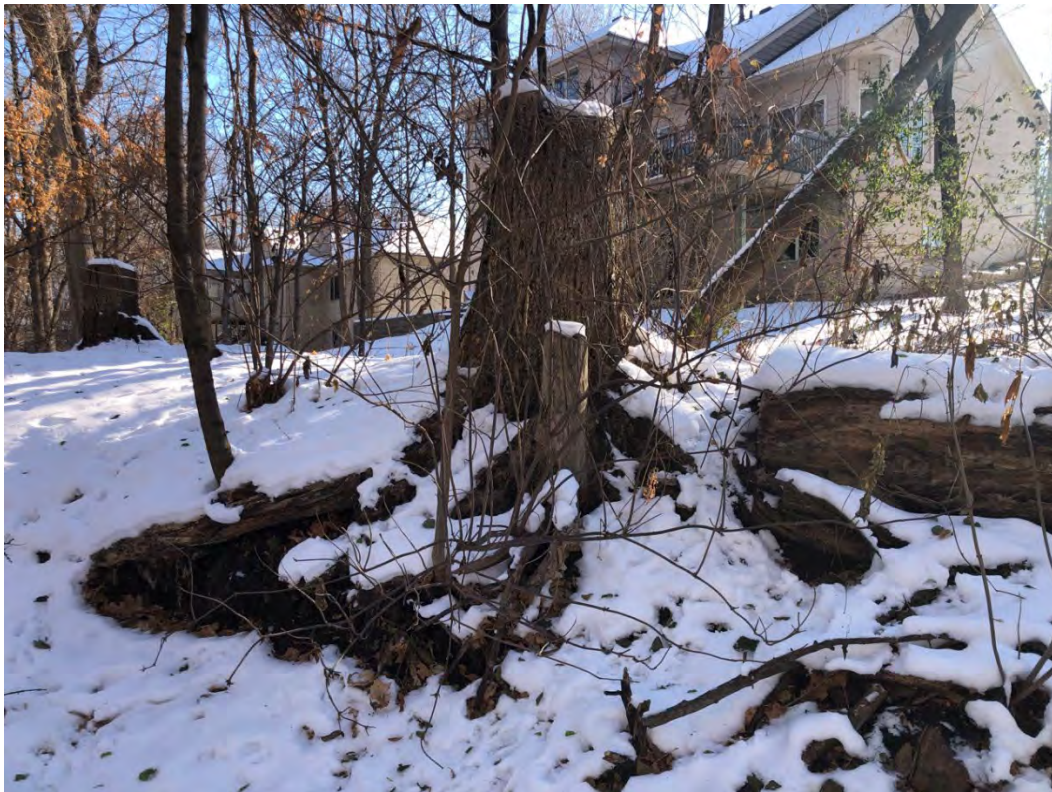
**Figure A- 2***Right bank erosion.*

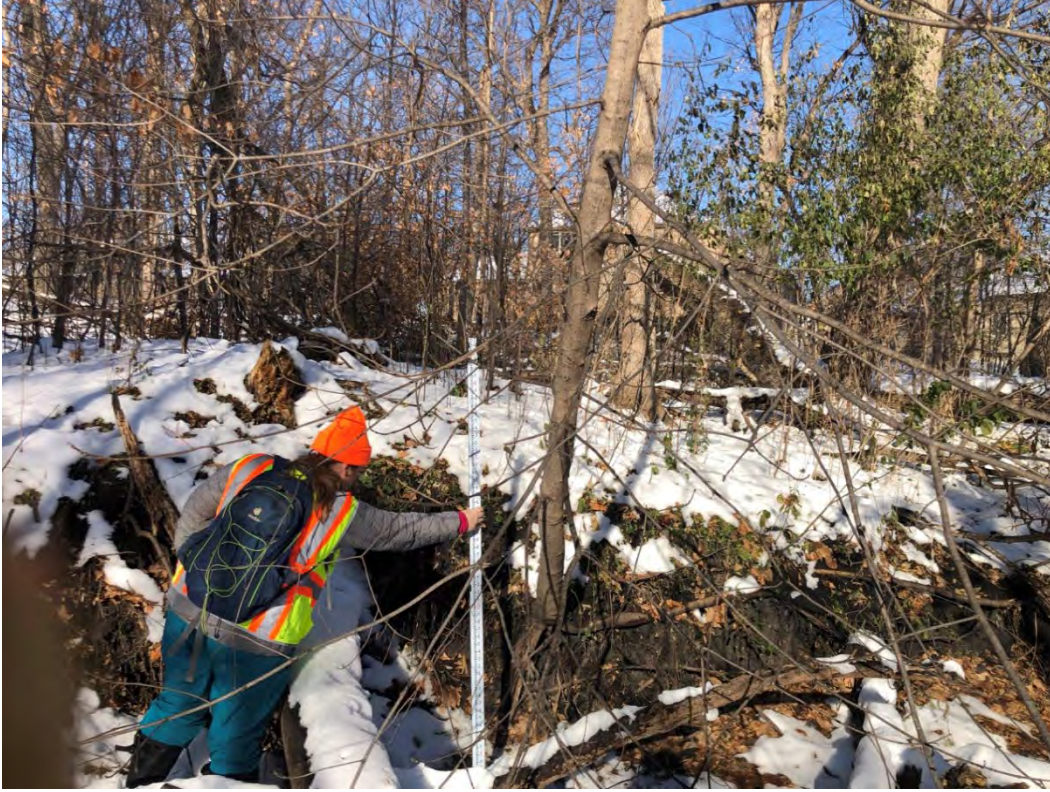
**Figure A- 3**      *Left bank erosion.*

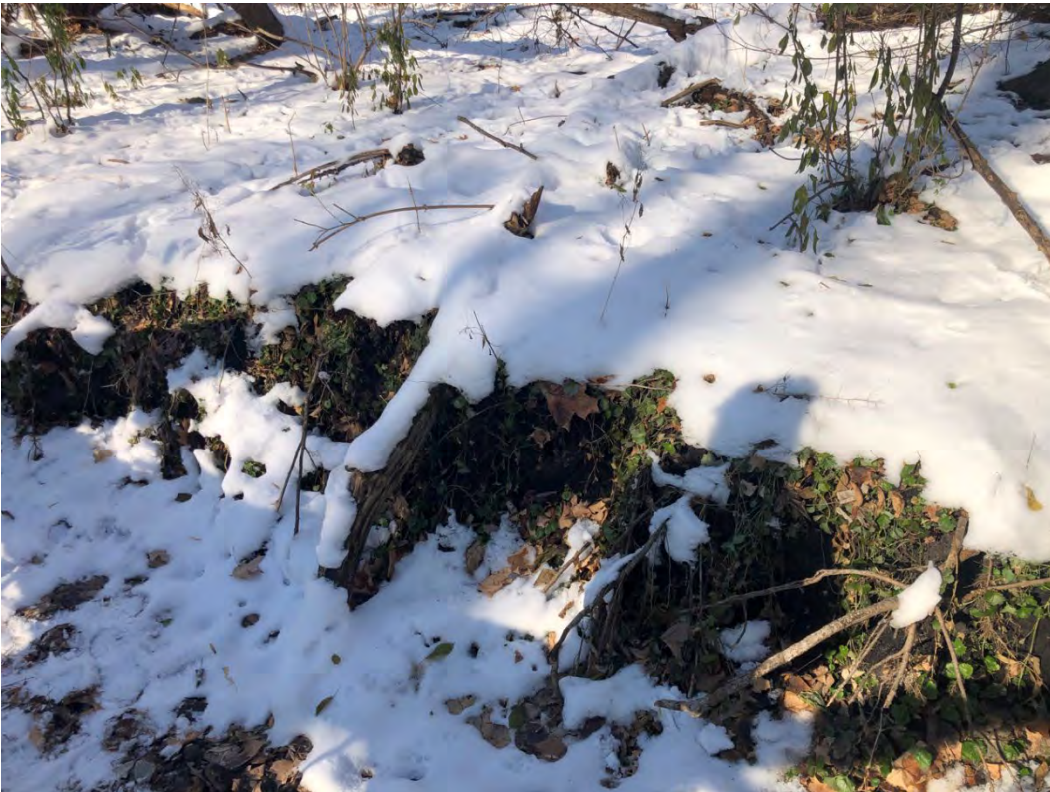
**Figure A- 4**      *Bank erosion with undercutting.*

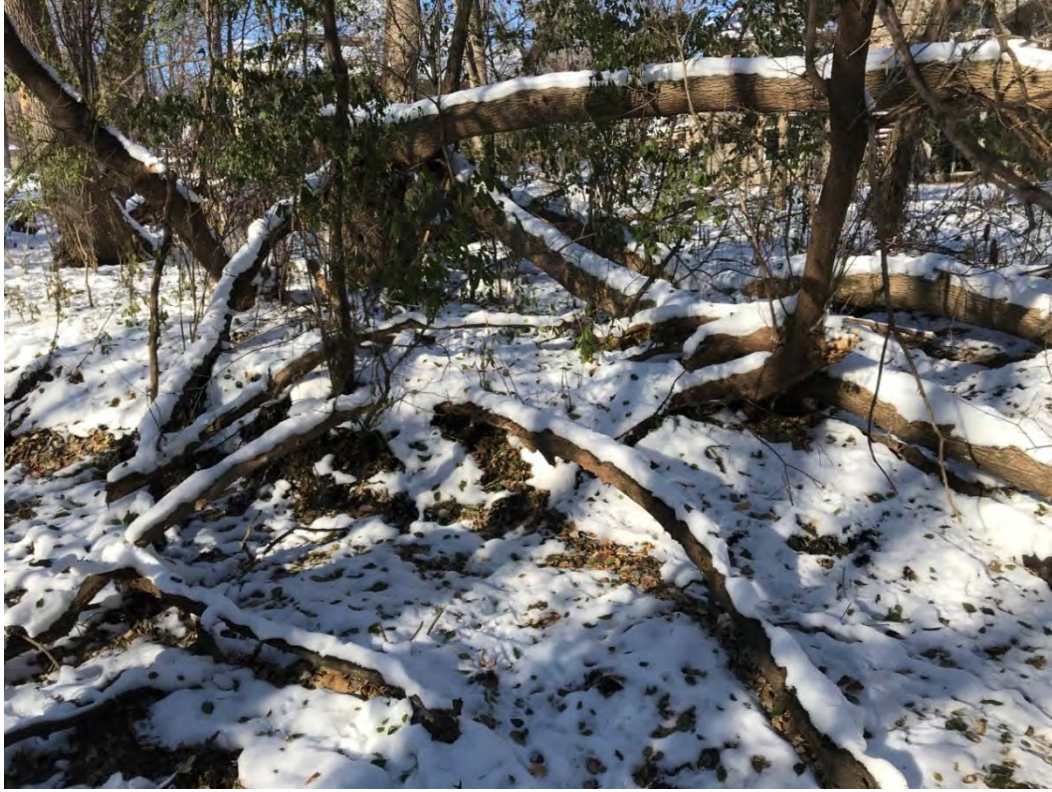
**Figure A- 5**      **Bank erosion and in-channel debris.**

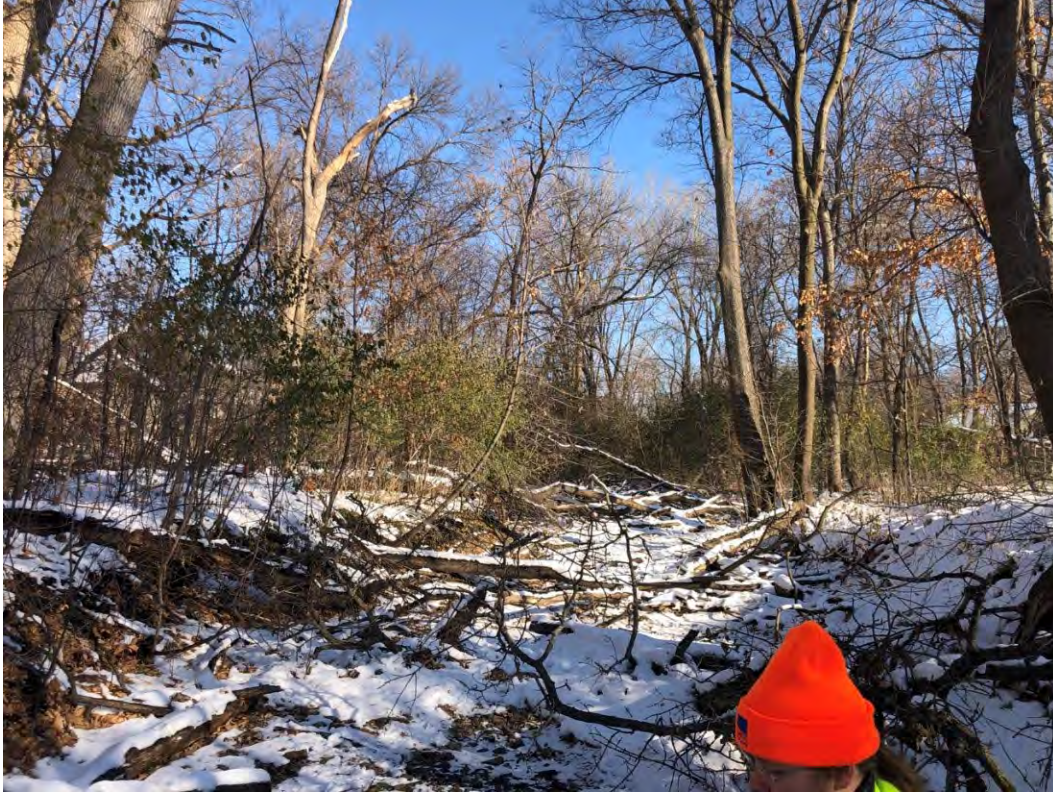
**Figure A- 7** *In-channel debris leading to bank erosion and sediment aggradation.*

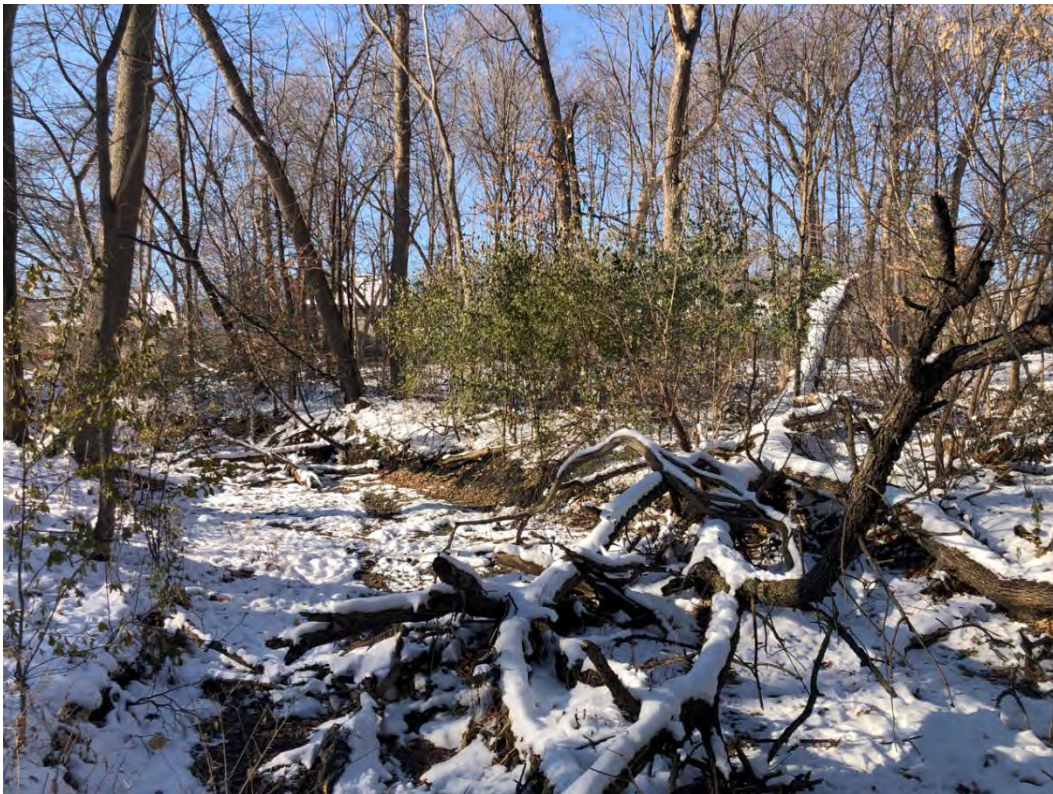
**Figure A- 8** *In-channel debris leading to bank erosion and sediment aggradation.*

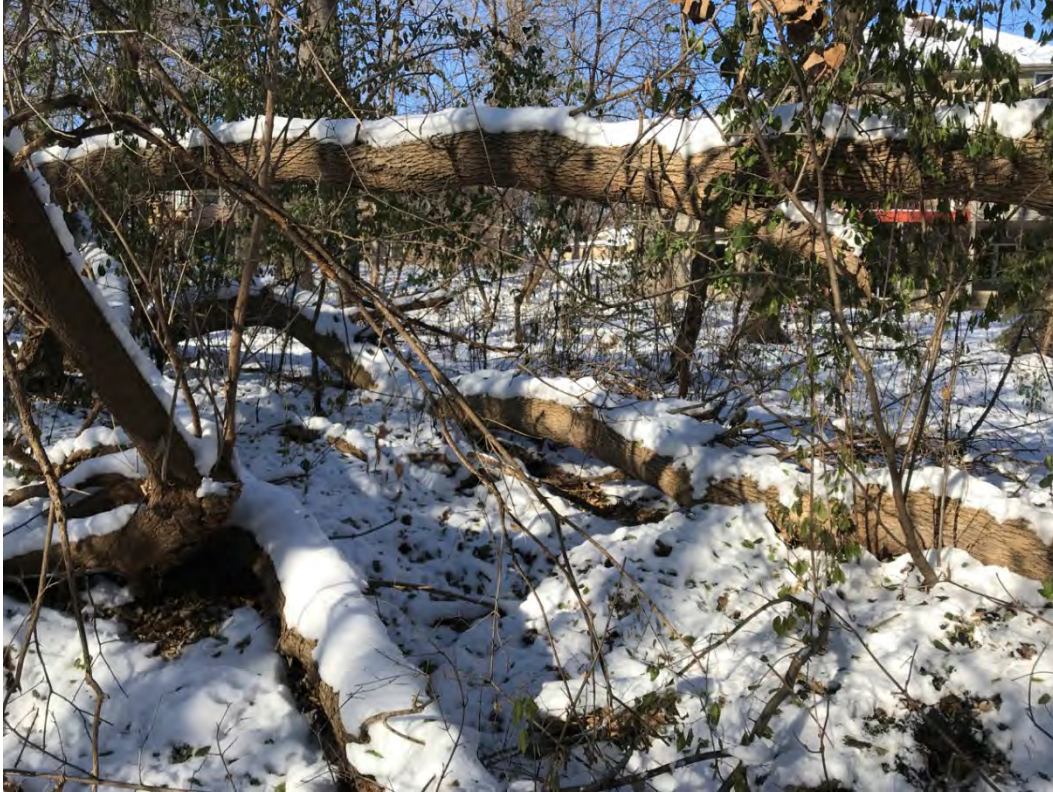
**Figure A- 9** *In-channel debris leading to bank erosion and sediment aggradation.*

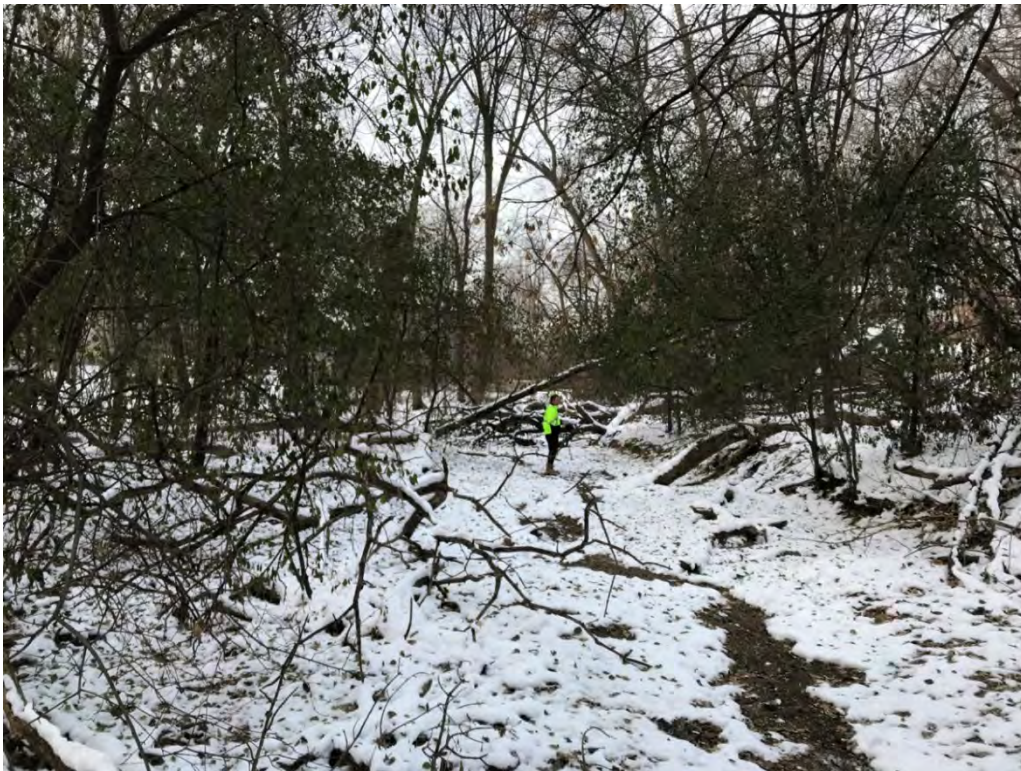
**Figure A- 10** *In-channel debris leading to bank erosion and sediment aggradation.*

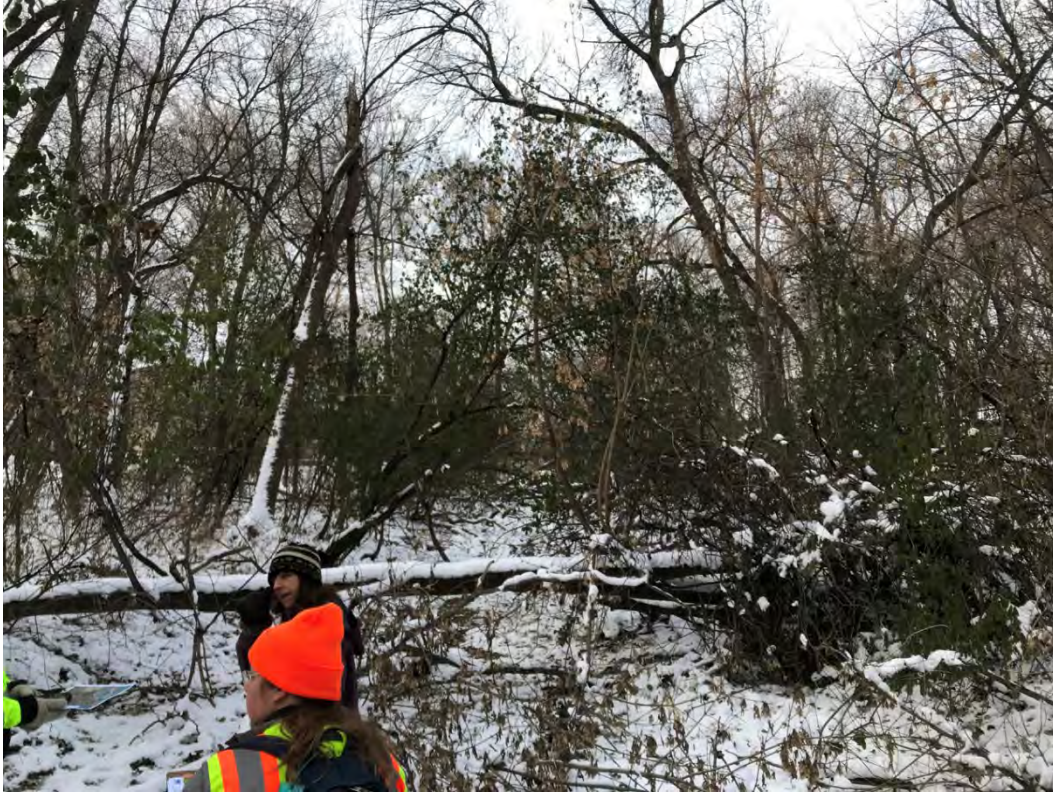
**Figure A- 11** *In-channel debris leading to bank erosion and sediment aggradation.*

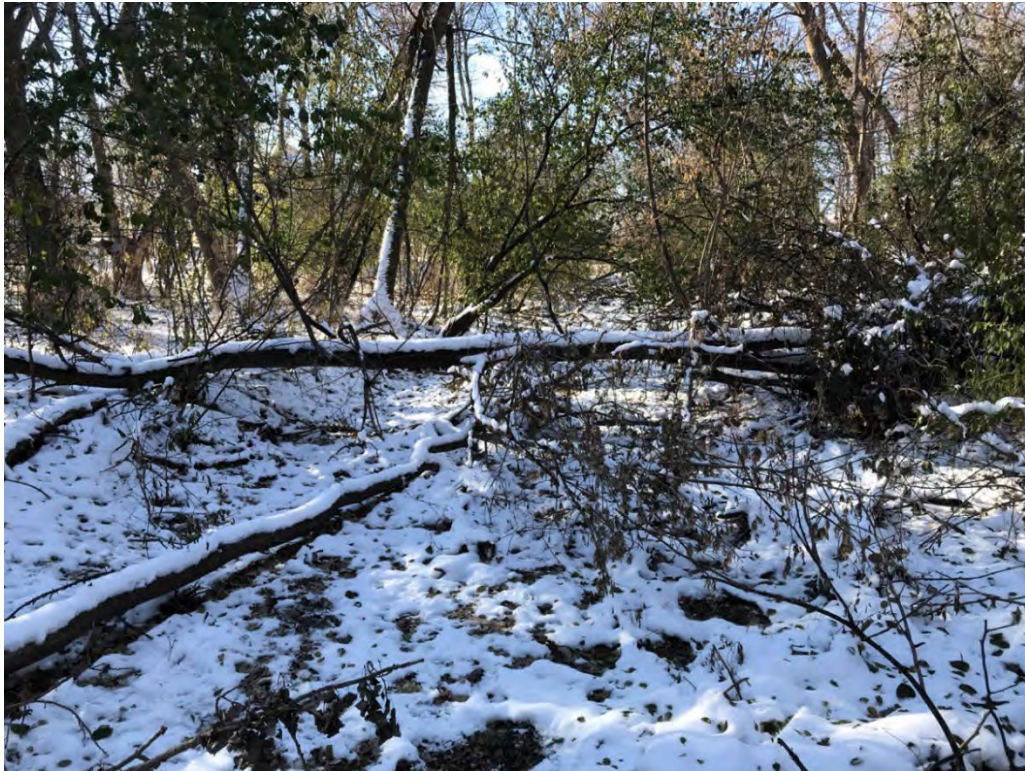
**Figure A- 12** *In-channel debris leading to bank erosion and sediment aggradation.*

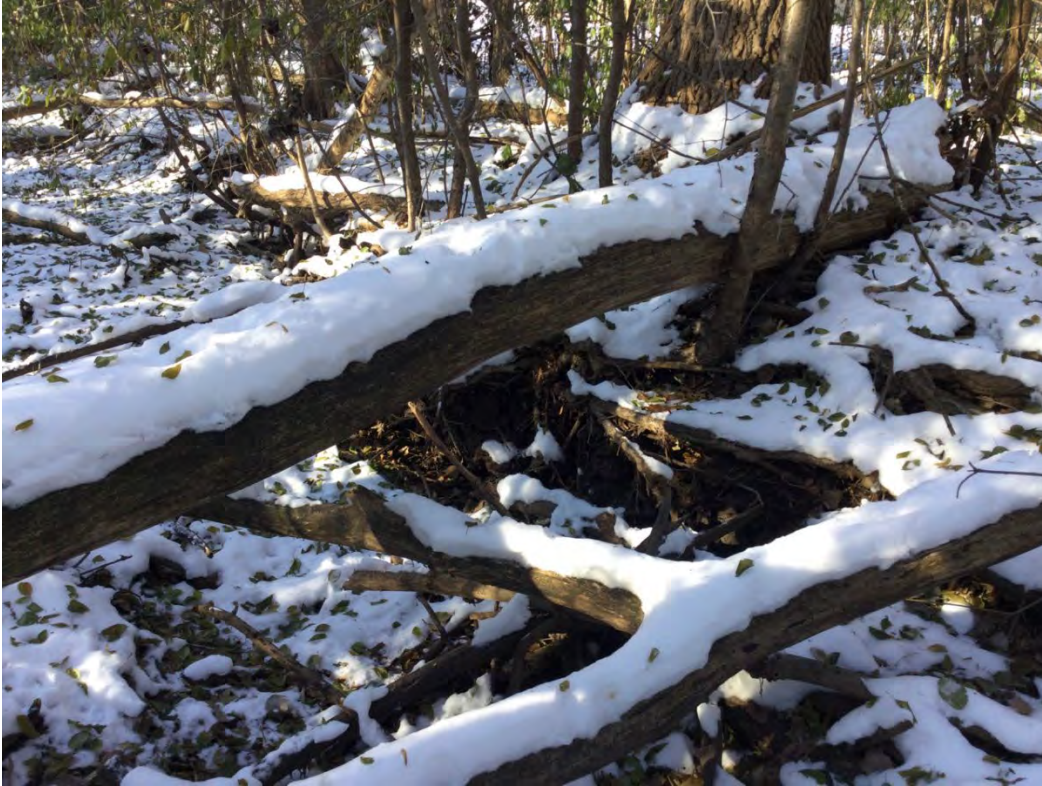
**Figure A- 17** *Left bank undercutting with in-channel debris.*

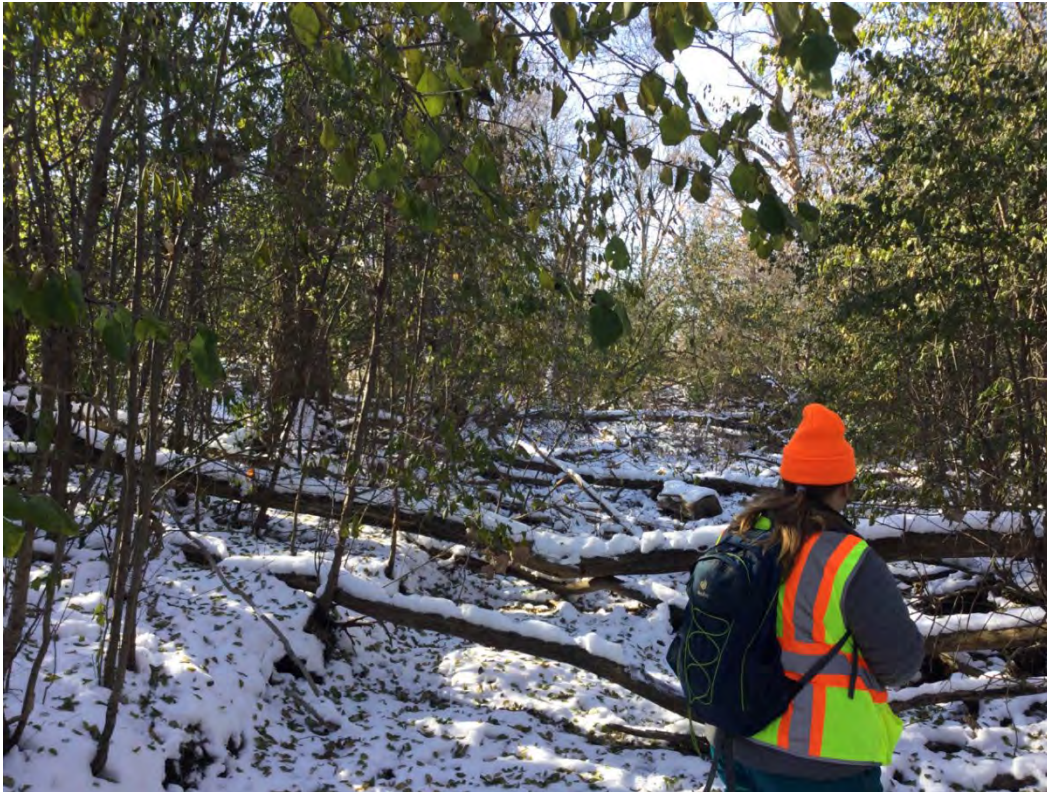
**Figure A- 18** *In-channel debris leading to bank erosion and sediment aggradation.*

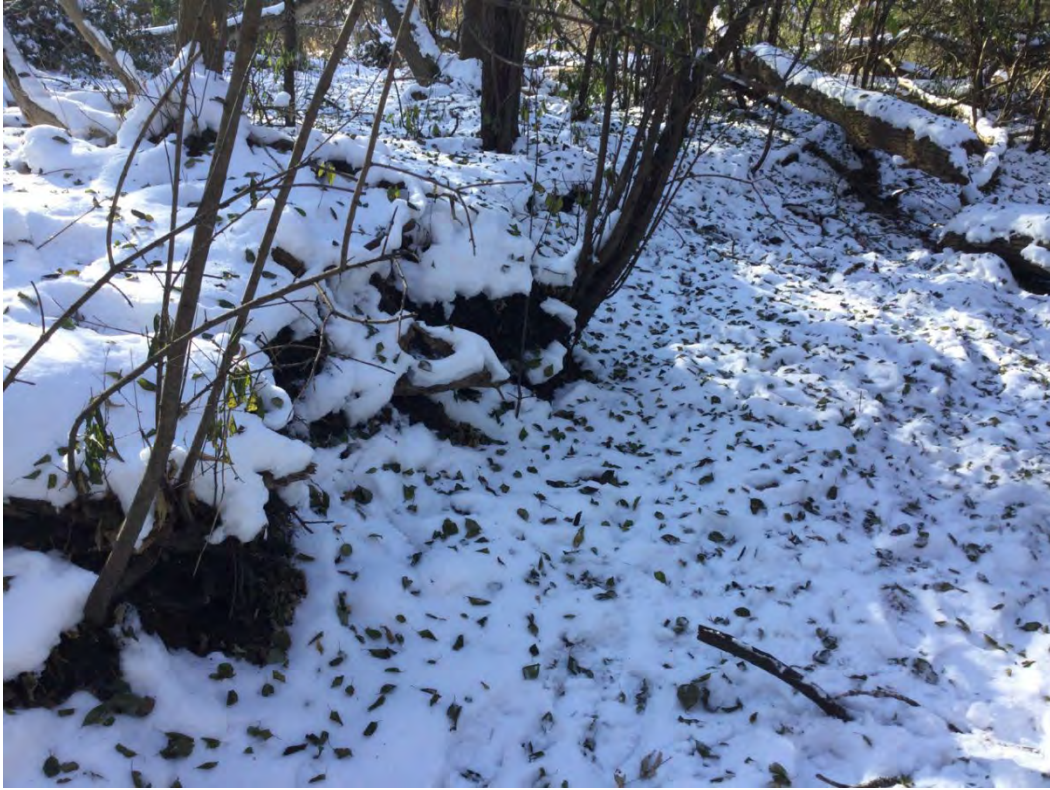
**Figure A- 19**     **Right bank erosion.**

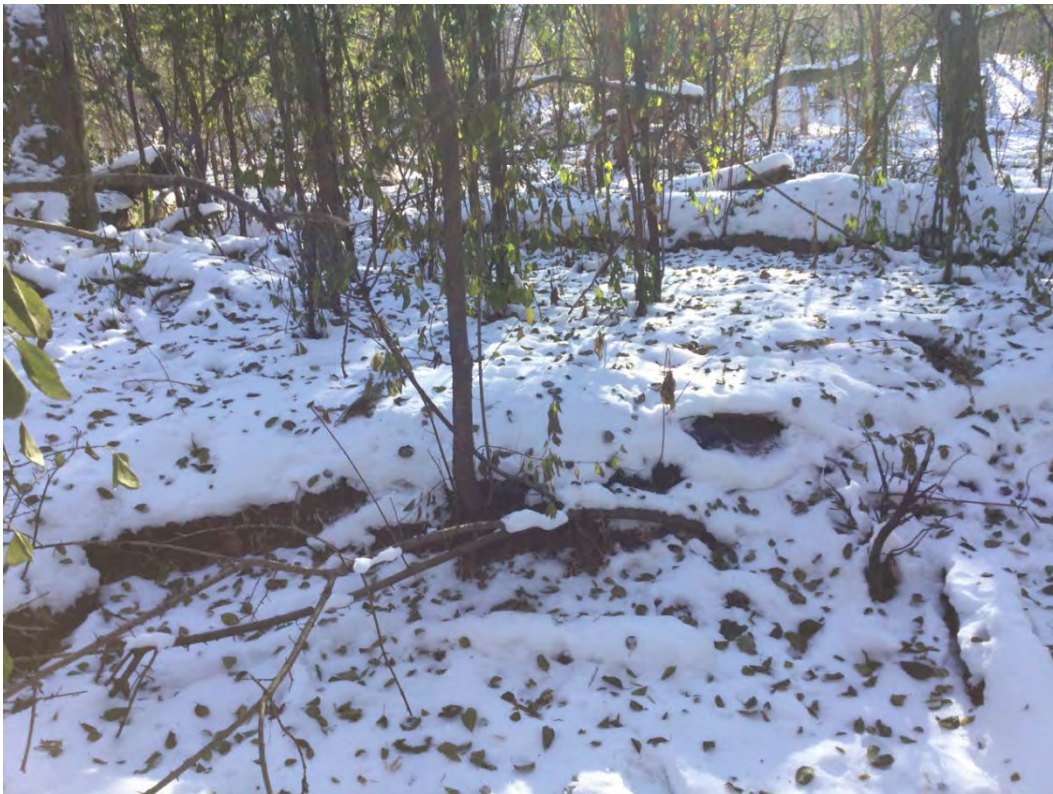
**Figure A- 20**     **Right bank erosion.**

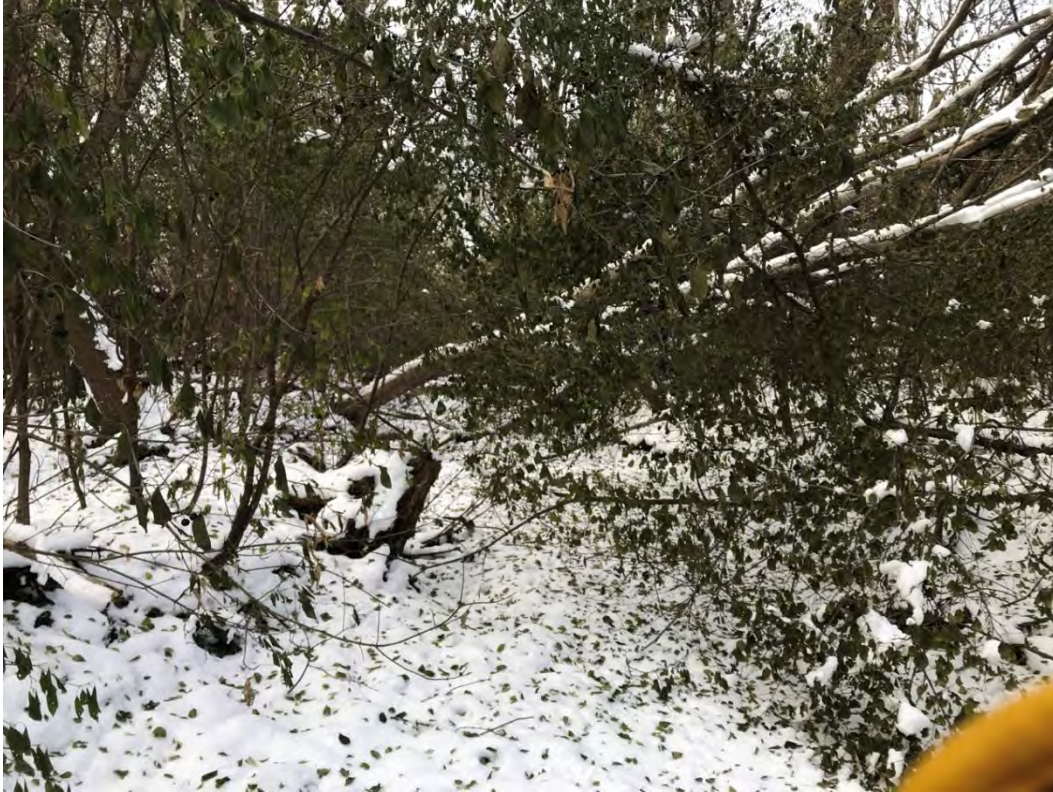
**Figure A- 21** *In-channel debris leading to bank erosion and sediment aggradation.*

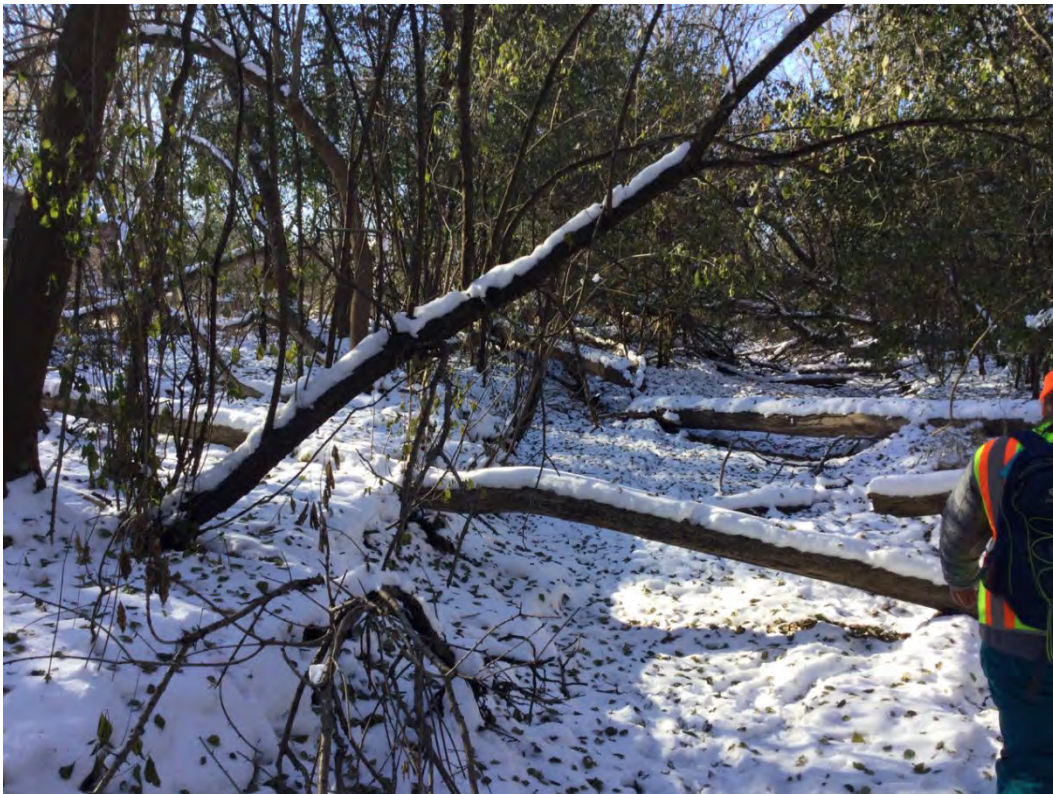
**Figure A- 22** *In-channel debris leading to bank erosion and sediment aggradation.*

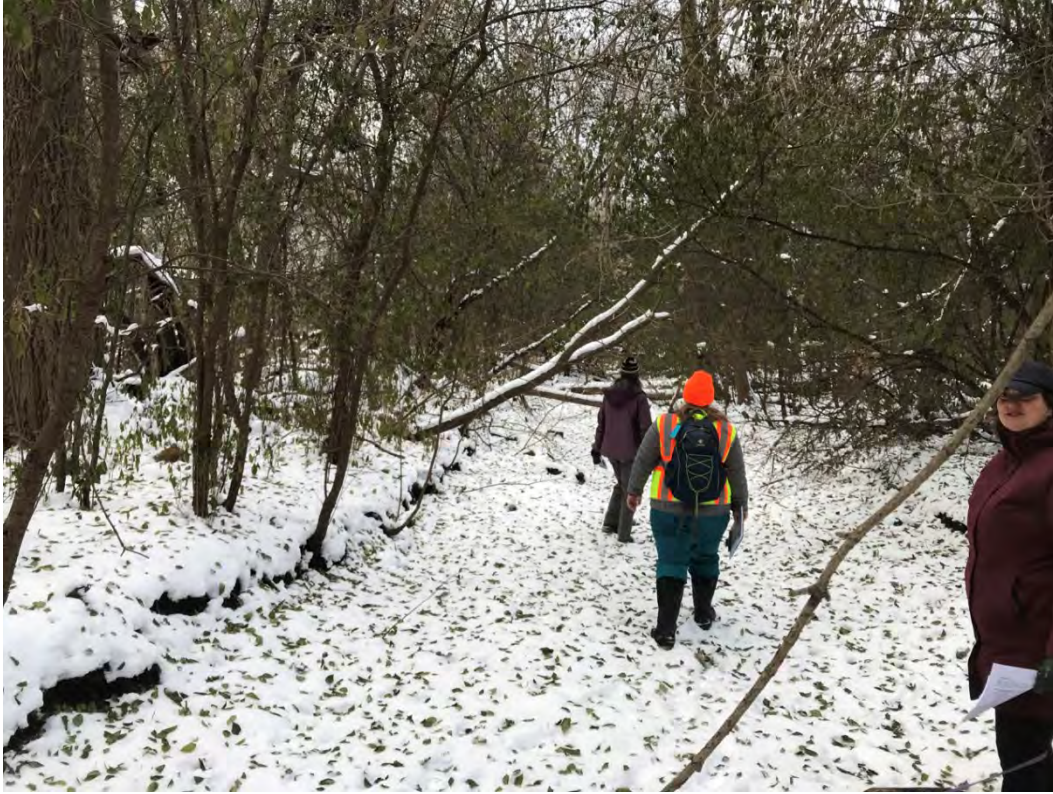
**Figure A- 23** *In-channel debris leading to bank erosion and sediment aggradation.*

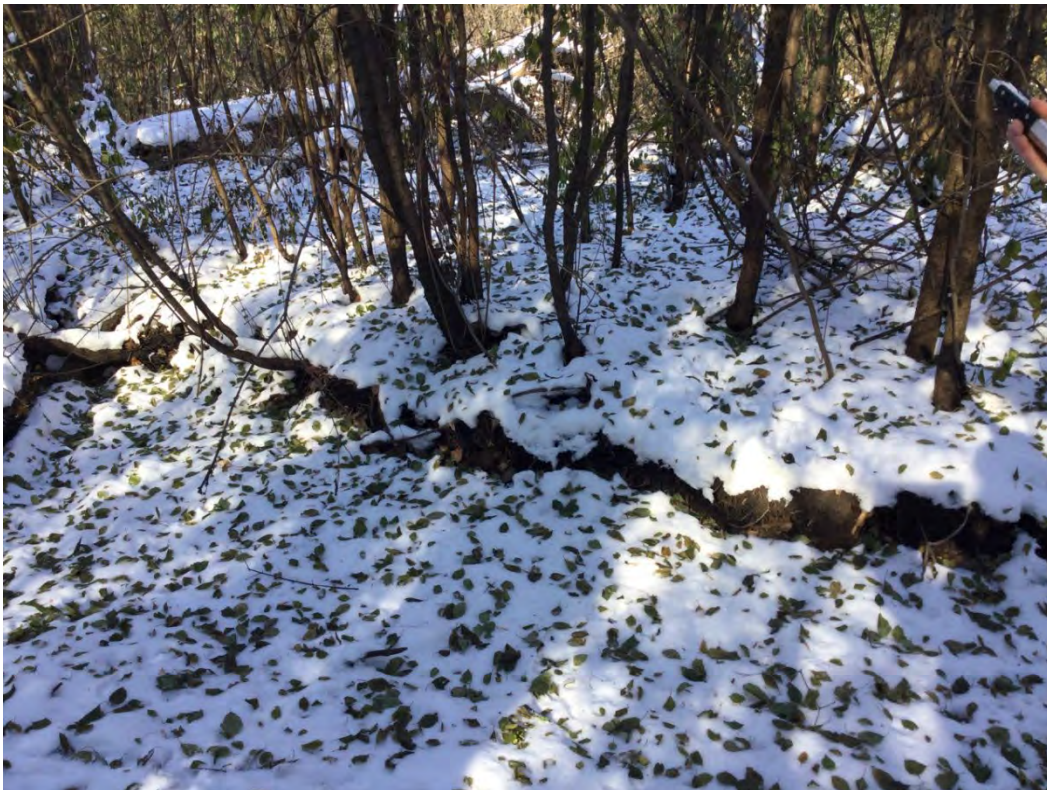
**Figure A- 24** *Left bank erosion with undercutting.*

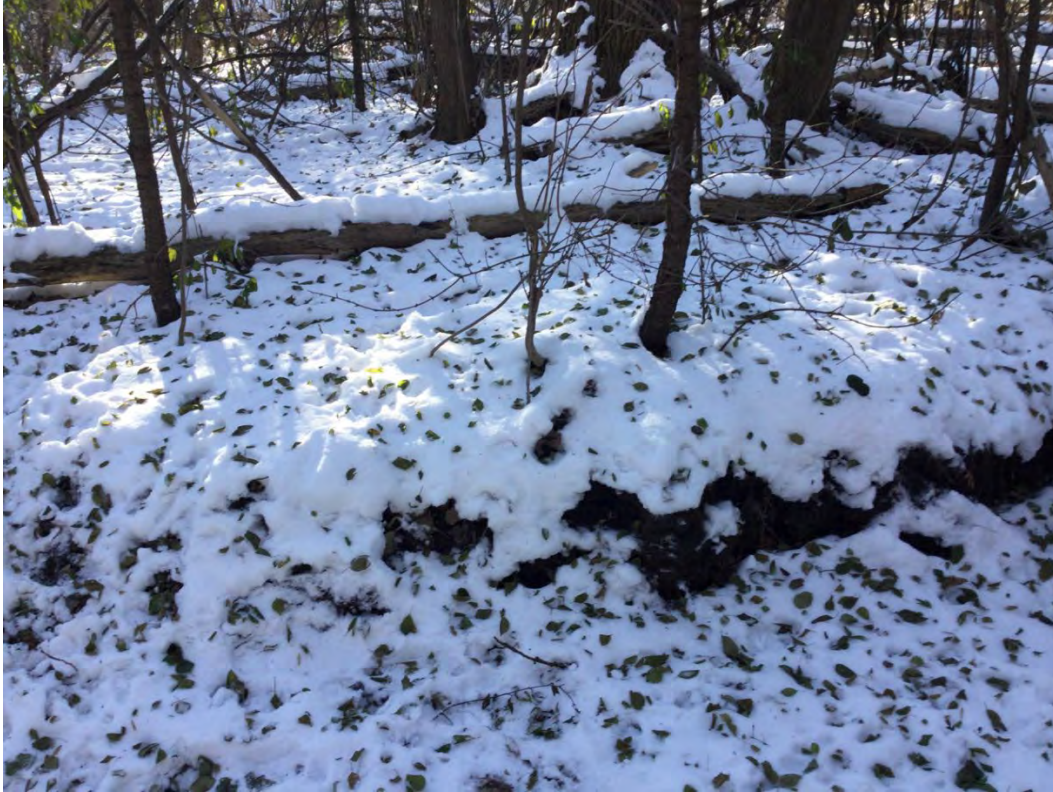
**Figure A- 25** *Right bank erosion with undercutting.*

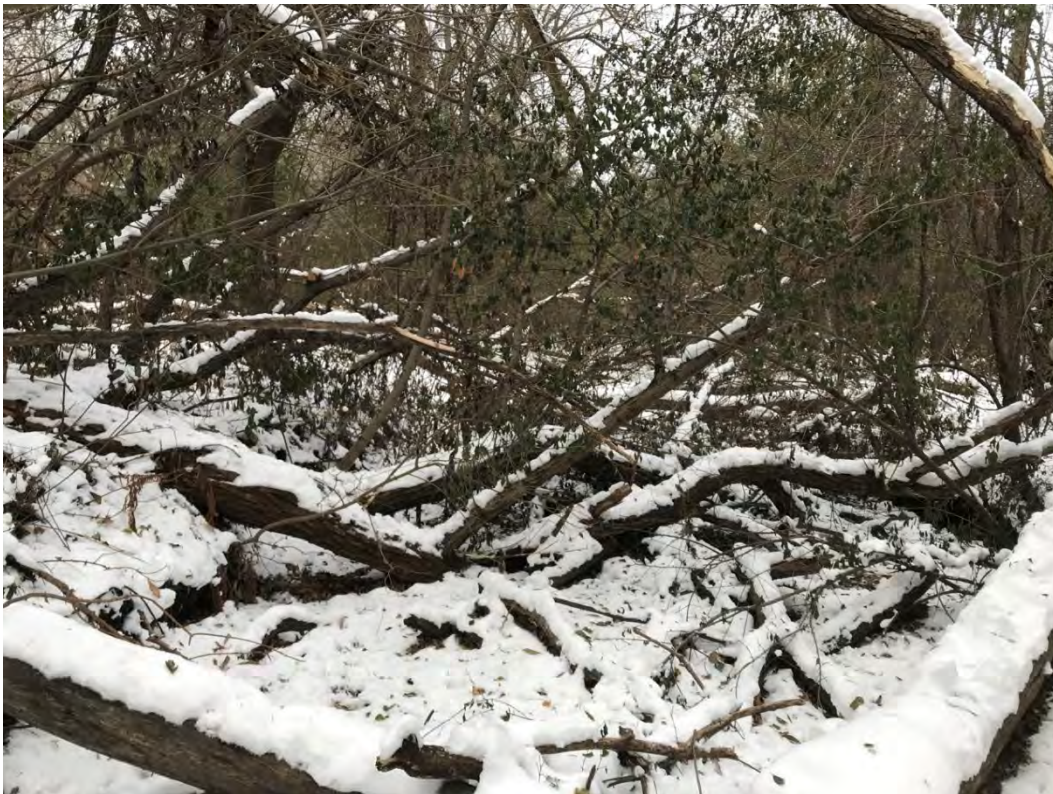
**Figure A- 26** *In-channel debris leading to bank erosion and sediment aggradation.*

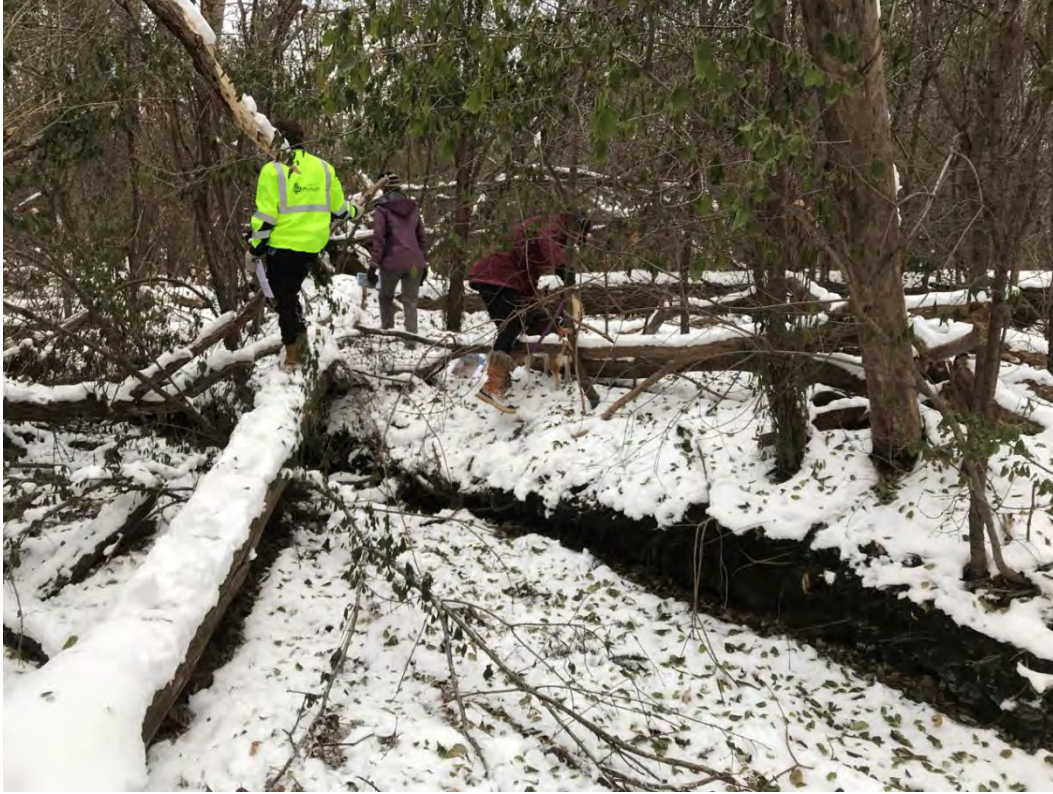
**Figure A- 27** *In-channel debris leading to bank erosion (close up of bank at same location as above figure).*
