Feasibility Report for Ponderosa Woods Stream Restoration Project—**F I N A L**

Appendix A

Stream Erosion Site Photos

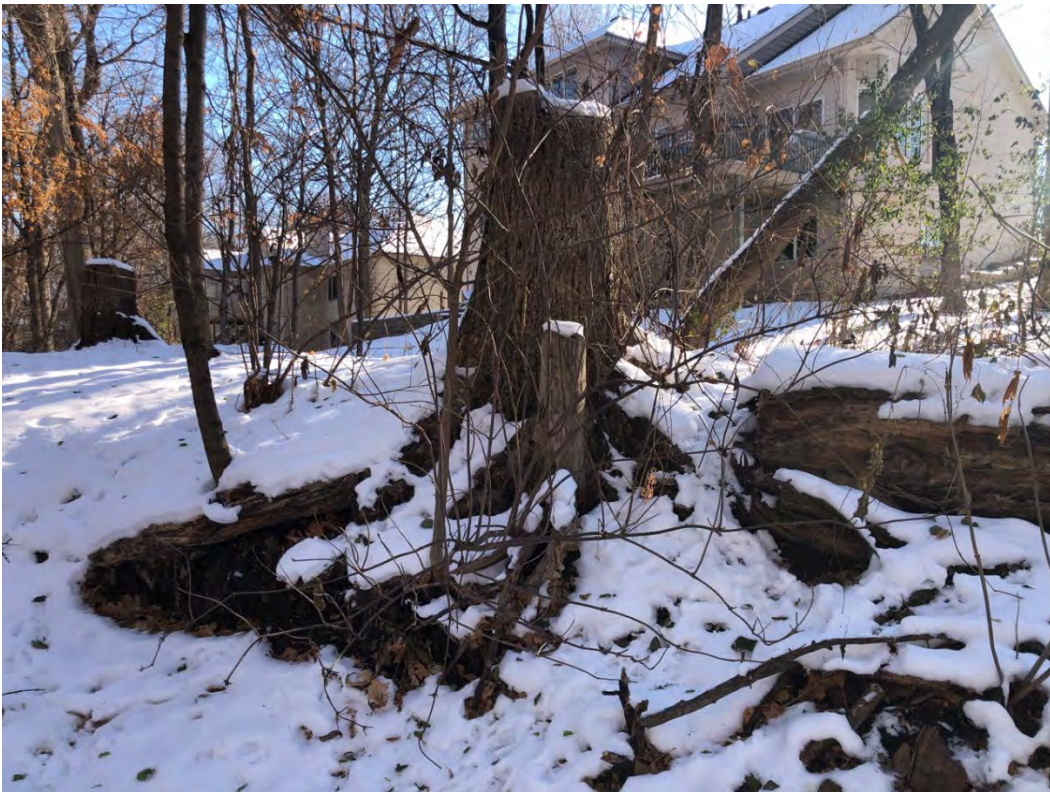
Figure A- 2*Right bank erosion.*

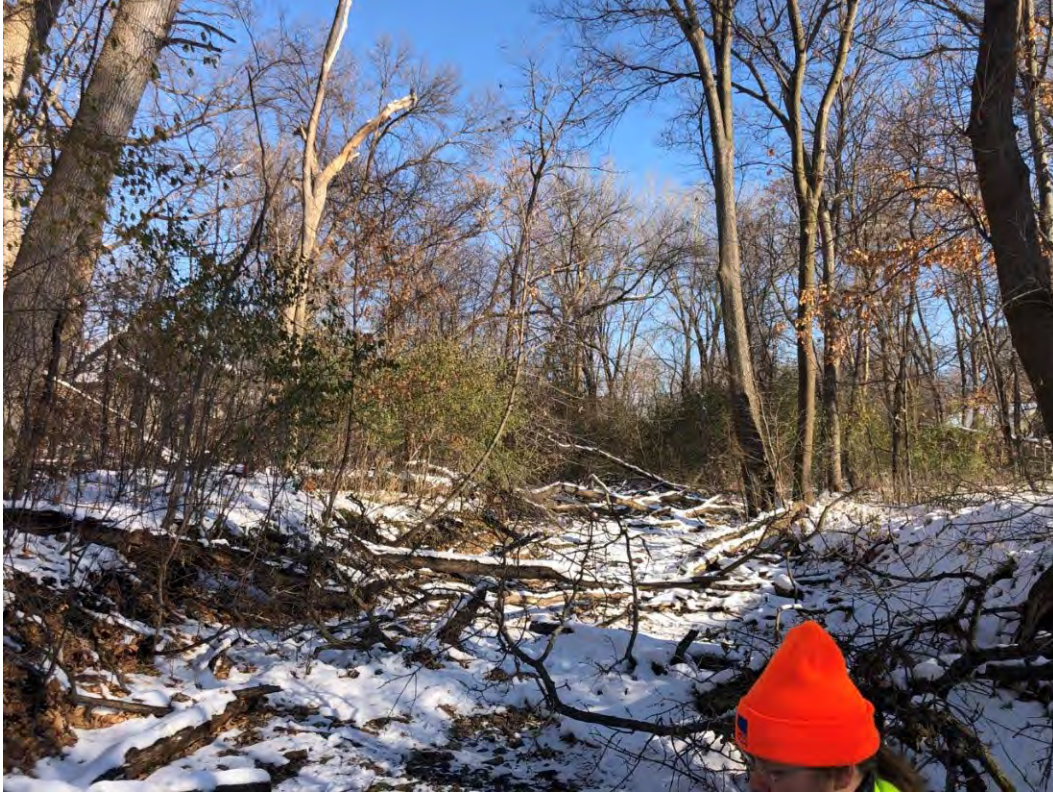
Figure A- 7 *In-channel debris leading to bank erosion and sediment aggradation.*

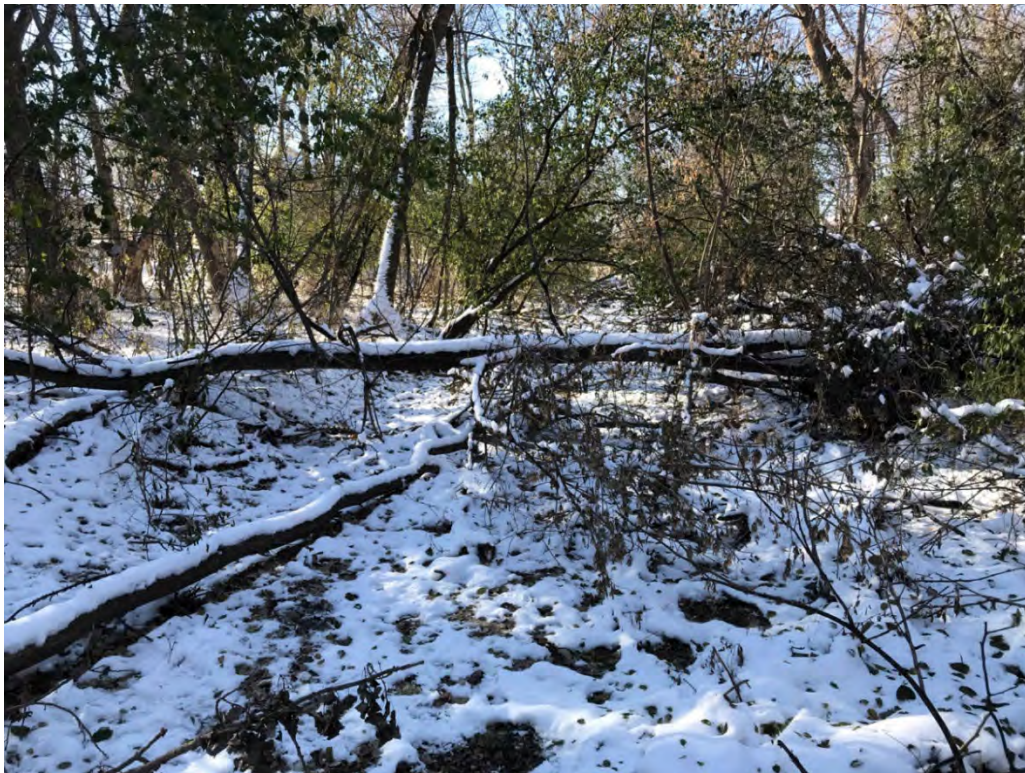
Figure A- 12 *In-channel debris leading to bank erosion and sediment aggradation.*

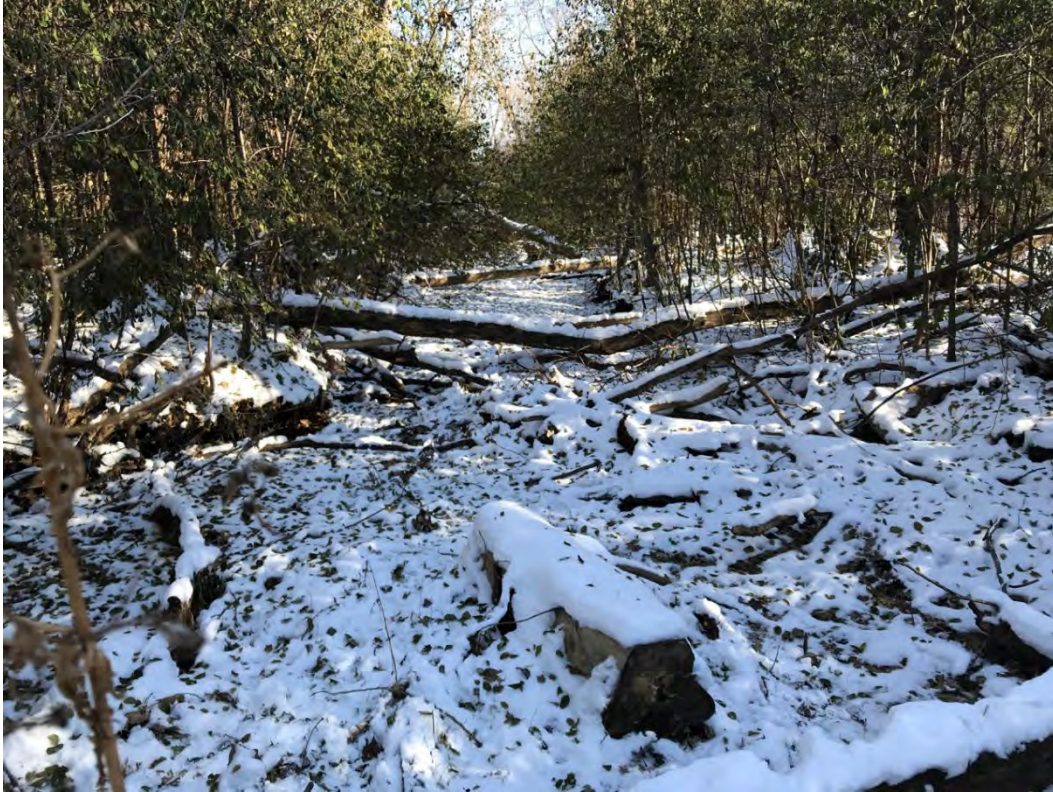
Figure A- 13 *In-channel (same location but different angle as figure above).*
