Memorandum

To: Bassett Creek Watershed Management Commission (BCWMC)
From: Barr Engineering Co. (Josh Phillips, Gabby Campagnola, Jim Herbert)
Subject: Bassett Creek 2023 Flood Control Project Inspection
Date: December 13, 2023
Project: 23270051.58 2023 4065

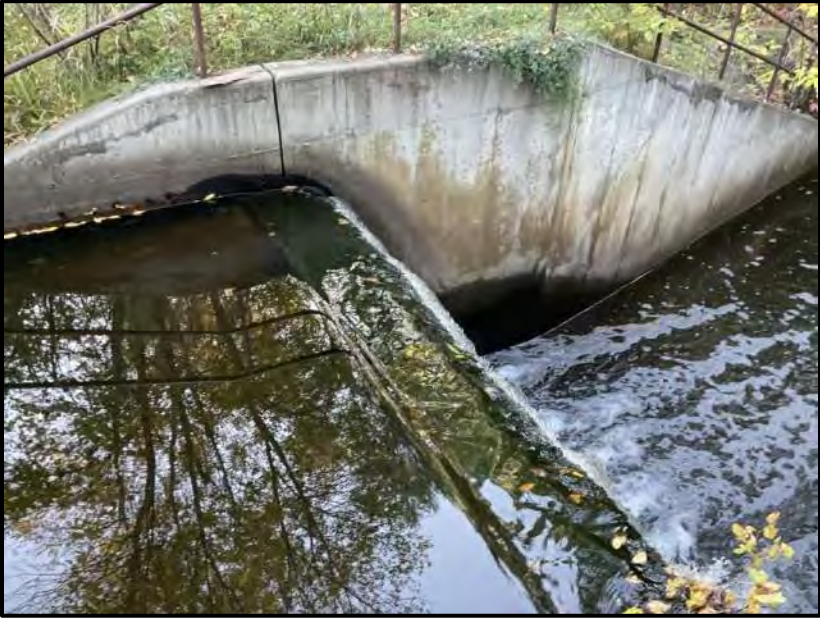
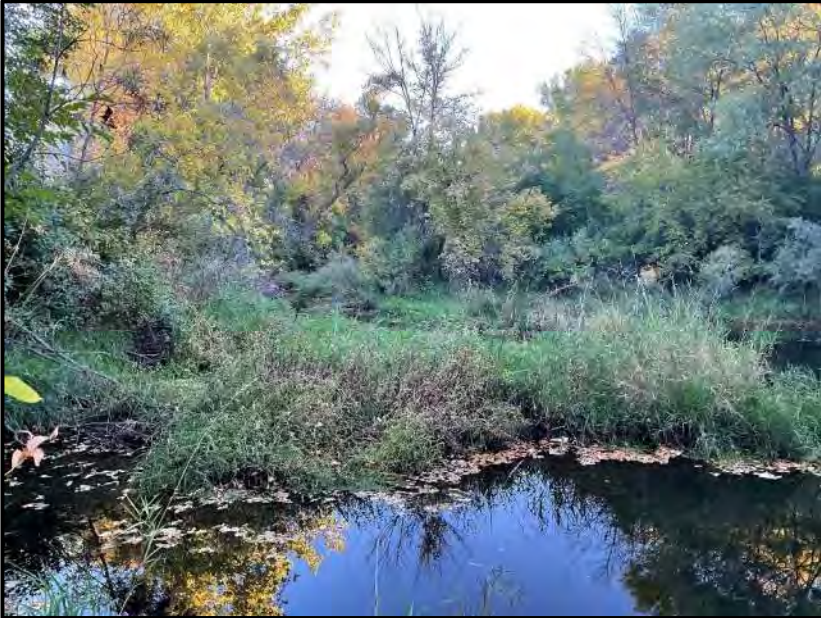
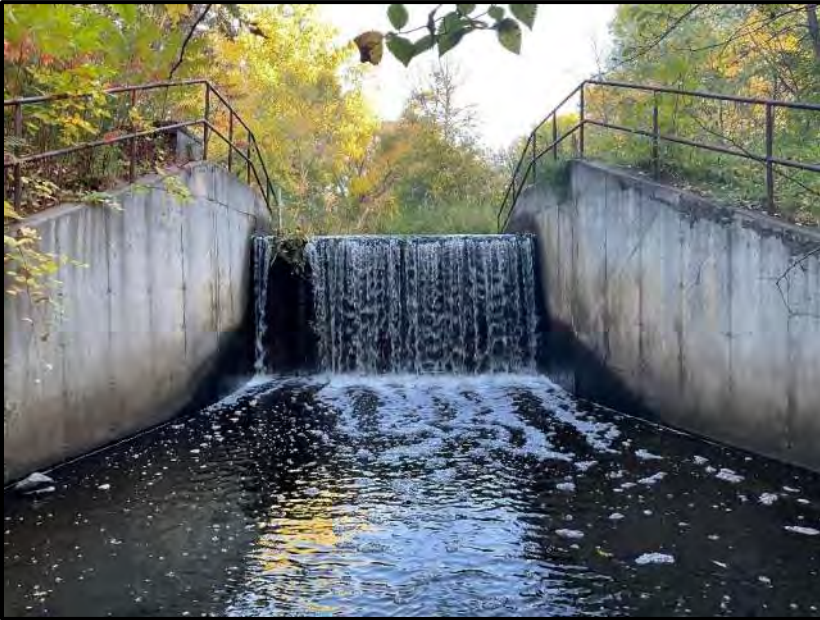
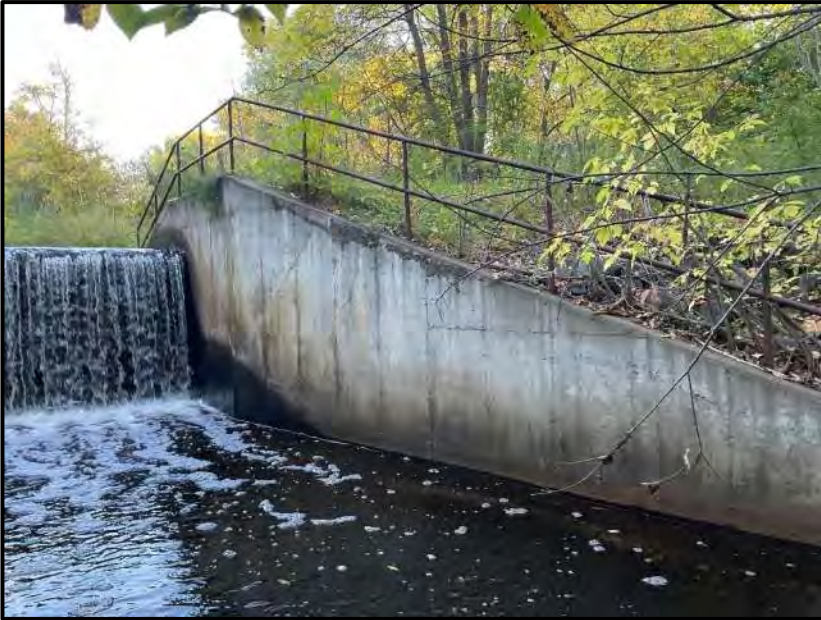
Plymouth Creek Fish Barrier (Plymouth)

- a. The structure appeared to be in satisfactory condition.
- b. The water level at the staff gage was at 0.35 feet and the depth of water flowing over the weir was 0.1 feet at the time of the inspection.

- c. Woody debris accumulated on the weir was removed during the inspection.
- d. Sediment has accumulated in the pool upstream of the structure and formed a delta, which was overgrown with vegetation. The deposited sediment was generally creating a meander in the creek toward the east (left) bank. Deposited sediment in the upstream pool has been noted since 2005.

- e. The railings at the upstream end of the structure, on the east (left) and west (right) sides, have rusted off below the weir level. This is consistent with previous inspections and has been noted since 2015.

- g. The top downstream edge of the concrete pile cap forming the weir has deteriorated along its entire length. Deterioration includes loss of cement paste and fines resulting in exposed aggregate. The weir appears to be functioning properly and controlling water to the design elevation.

- h. Three cracks were observed on the downstream west (right) wing wall. This is consistent with previous inspections and has been noted since 2004.
- i. Seven diagonal cracks were observed on the downstream east (left) wing wall. Three of the cracks are more prominently defined, closed cracks. Observation of the three prominent cracks is consistent with previous inspections and has been noted since 2002. The other four cracks are generally closed hairline cracks and less noticeable.

- j. A 15-inch diameter tree was observed growing adjacent to the downstream east (left) wing wall and through the railing.
- k. Small trees and shrubs were observed growing on the embankment and downstream channel banks, including some near the wing walls and railings.

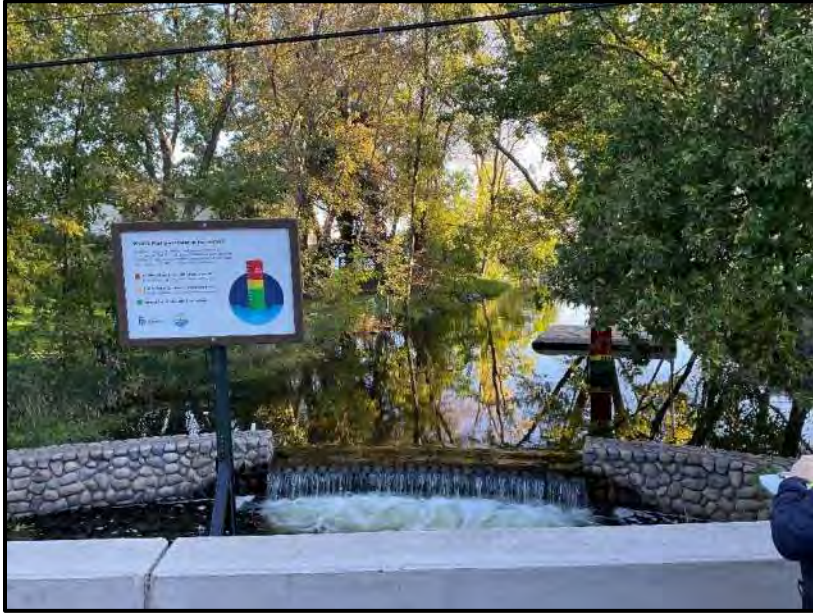
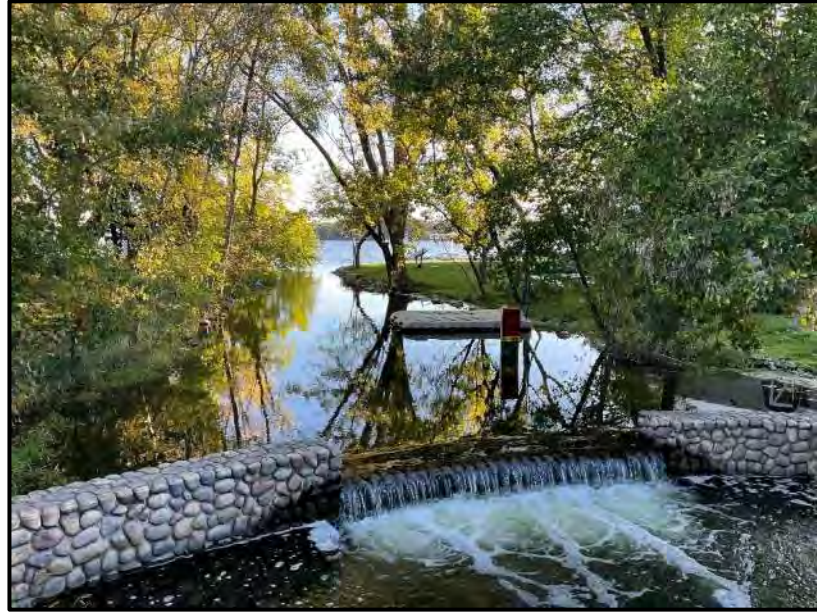
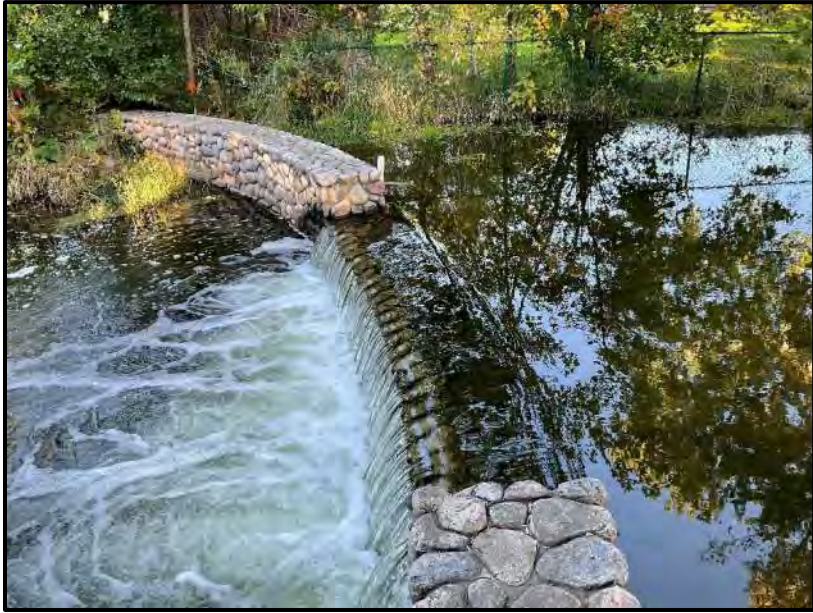
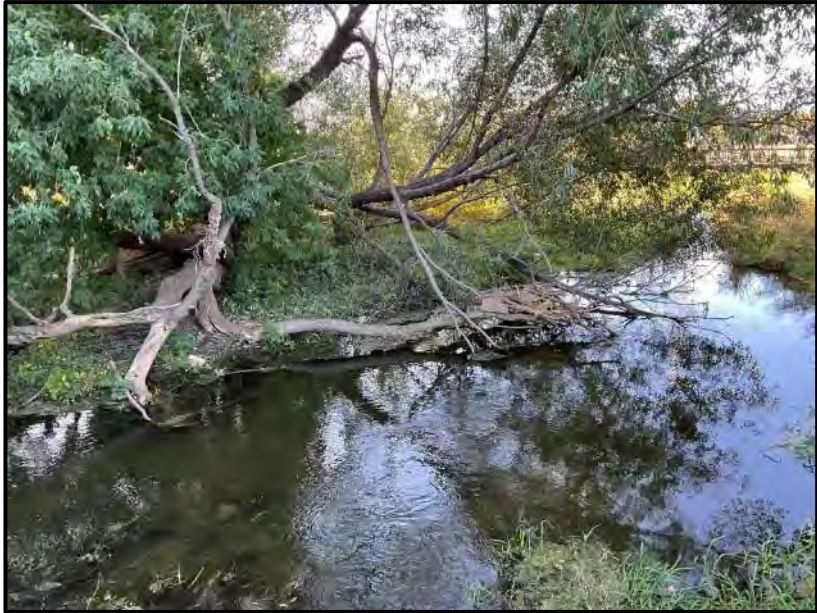
Medicine Lake Outlet (Plymouth)

- c. The outlet structure appeared to be in satisfactory condition.
- d. Although not part of the flood control project, the storm sewer outfall for local drainage from South Shore Drive in the west (right) bank has previously been nearly full of sediment, but this could not be observed during the inspection due to water levels.

- e. Woody vegetation was observed at each end of the dam where it ties into the banks.
- f. In late May 2019, City of Plymouth staff observed water flowing over the east side, but not the west side, of the Medicine Lake Outlet Structure. The city performed a baseline survey of the dam in the summer of 2019 and found that the east side of the dam was 0.15 feet lower than the west side. Future surveys can be performed to compare against the baseline.

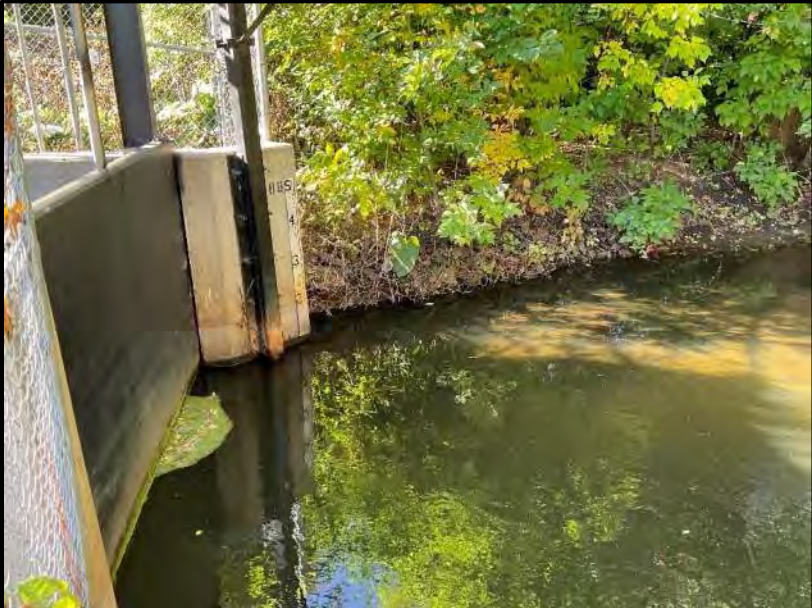
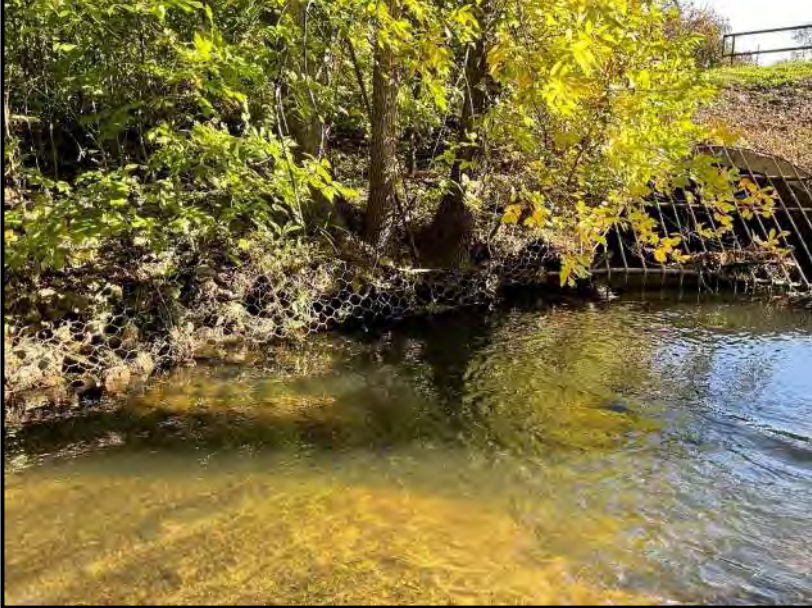
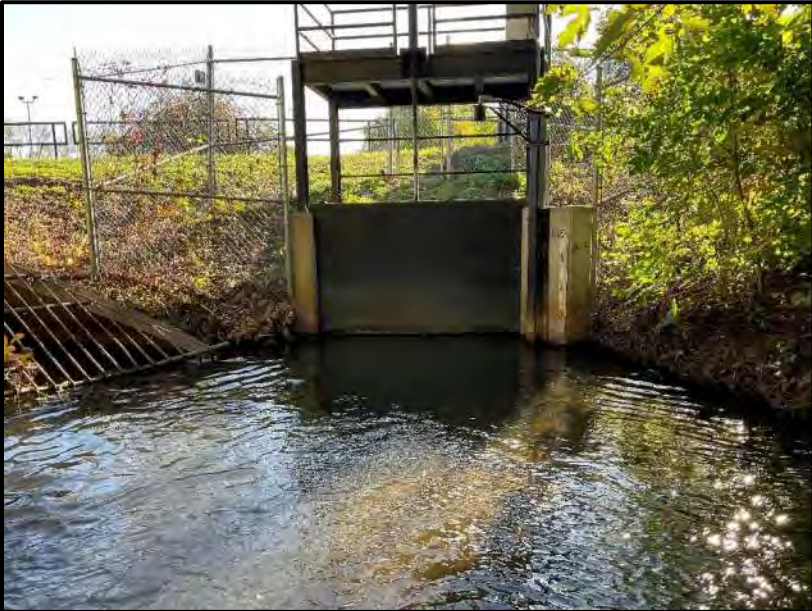
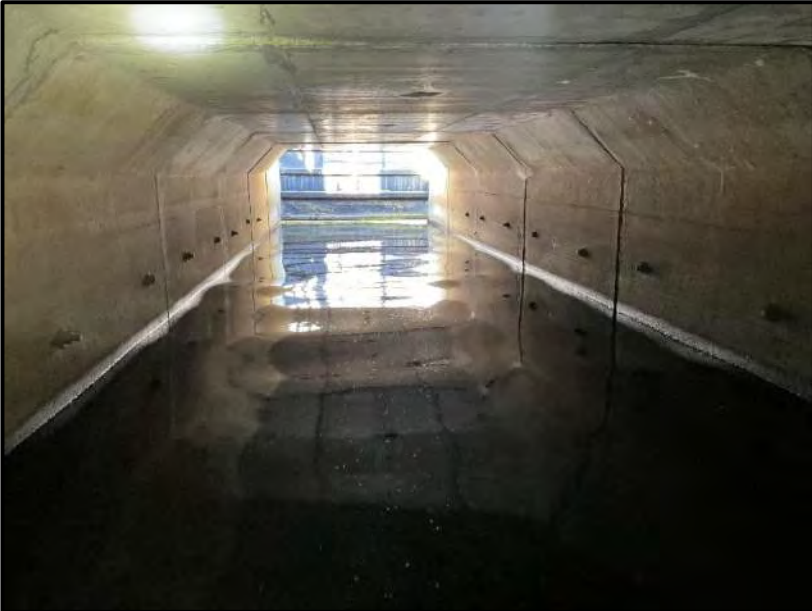
Wisconsin Avenue Control Structure (Golden Valley)

- a. The water level was below the lowest staff gauge reading upstream and downstream of the culvert.
- b. The flood gate was closed (down) at the time of the inspection and appeared to be in satisfactory condition.

- c. Deposited sediment was observed in the bottom of the culvert, ranging from 2-6 inches deep. The deposited sediment is consistent with previous inspections and has been noted since 2006.

- d. Some of the gabion baskets upstream and downstream of the culvert have deteriorated or broken and riprap had fallen out of the baskets at some locations. Although the gabion baskets are no longer functioning as installed, no significant erosion was observed. There is evidence of some minor erosion near the staff gauge and left bank upstream of large culvert.

- e. Cracks were observed along the crown of the culvert.
- f. Upstream of the gate, the left bank has begun to scour, and deposition is occurring on the right bank.

- g. Scour of the creek bed was observed downstream of culvert. The scour appeared to start at the end of the culvert and continued for roughly 40 feet.

- h. The railings at the upstream and downstream ends of the culvert were in satisfactory condition.
- i. City of Golden Valley staff had recently cleared brush at both the upstream and downstream ends of the culvert.

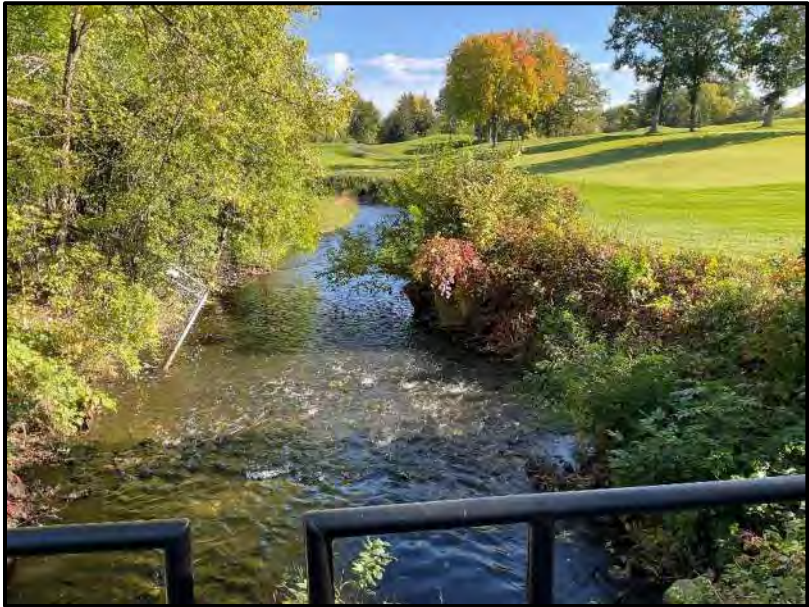
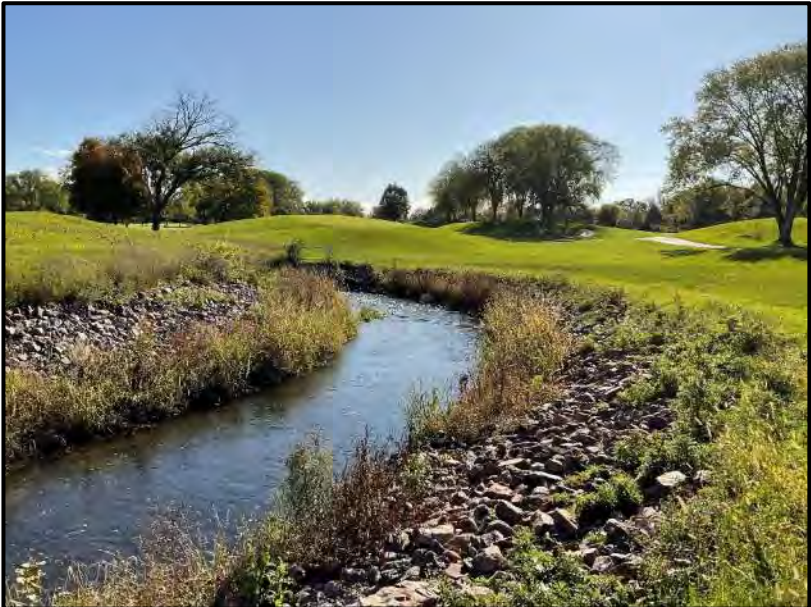
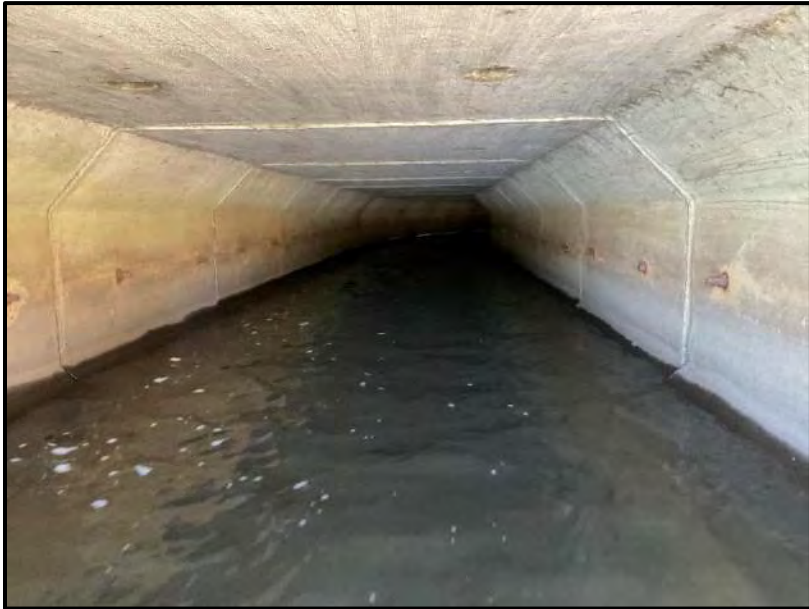
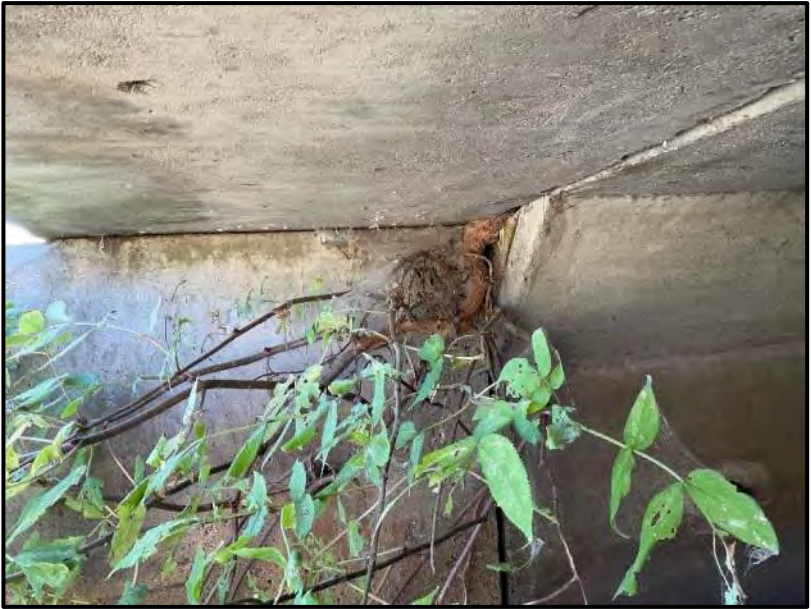
Golden Valley Country Club (Golden Valley)

- a. The channel and riprap armoring from Pennsylvania Avenue to the box culvert appeared to be in satisfactory condition.
- b. The box culvert, joints, and railings appeared to be in satisfactory condition.

- c. The overflow weir (earth berm) appeared to be in satisfactory condition and has been maintained by the Golden Valley Country Club staff as manicured fairway turf.

- d. Some sediment deposition was observed on the north (left) bank just upstream of the box culvert on top of the riprap, consistent with previous years.

- e. Some sediment deposition in other upstream areas was observed. This may have been due to low water levels.
- f. A new outfall into the creek has been installed from the development north of the creek along Pennsylvania Avenue.

- g. A tree is growing into the downstream side of the box culvert. The tree is growing through the last joint on the top right of the culvert.
- h. Near Pennsylvania avenue, a large chunk of concrete was observed in the channel near the right bank. At roughly the same cross section of the creek, a fence was observed on the left bank. The fence starts on the hill of the right bank and extends to be partially in the creek.

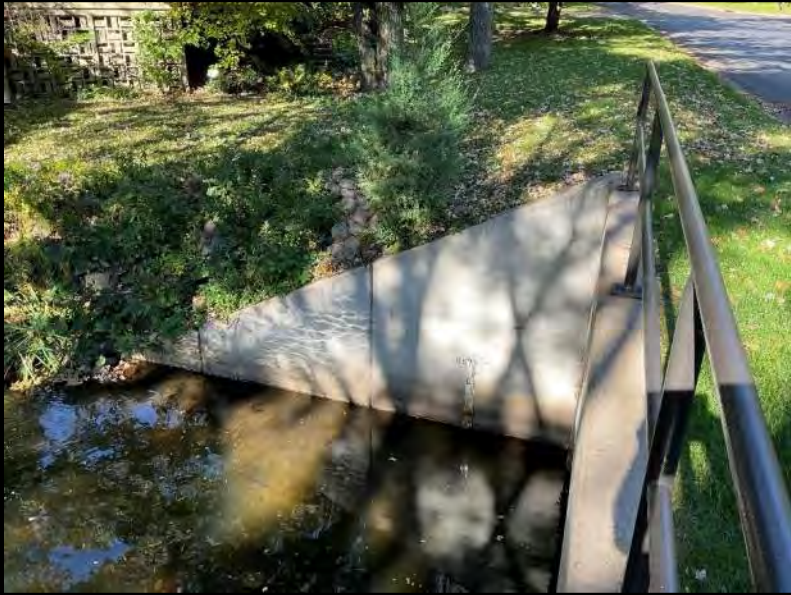
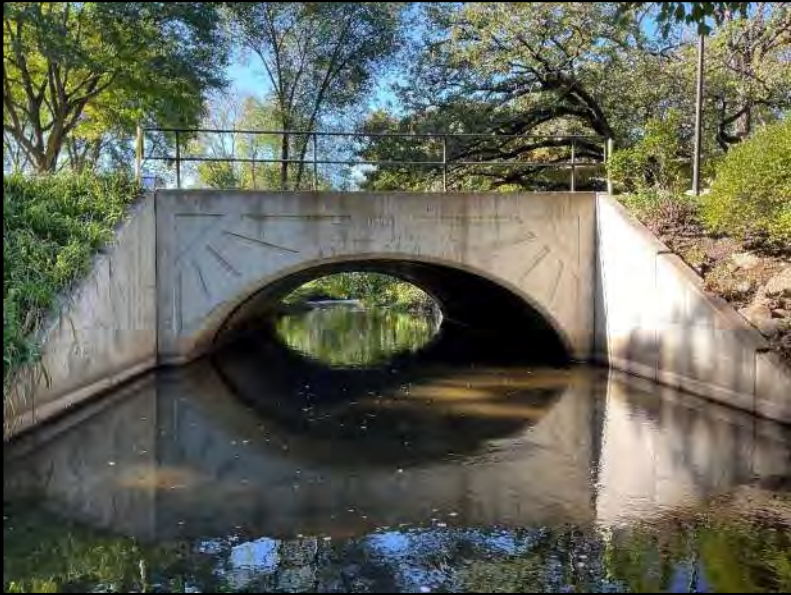
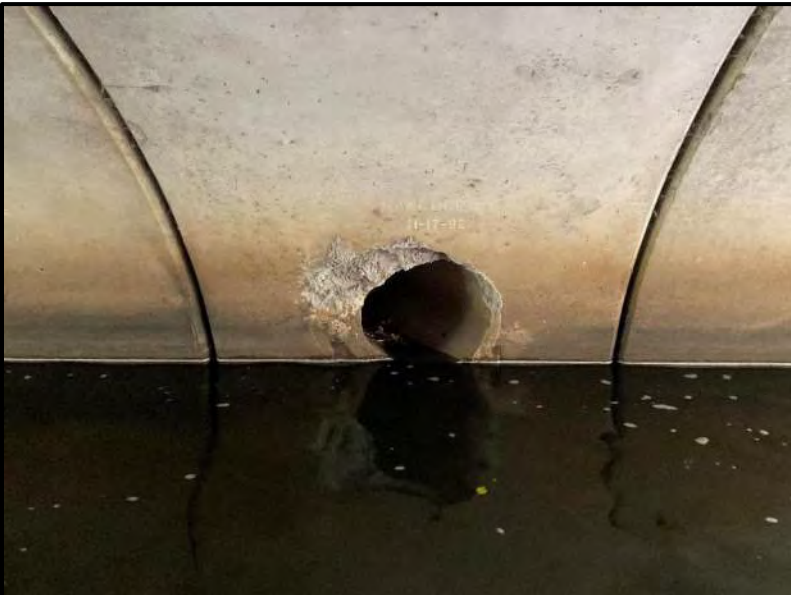
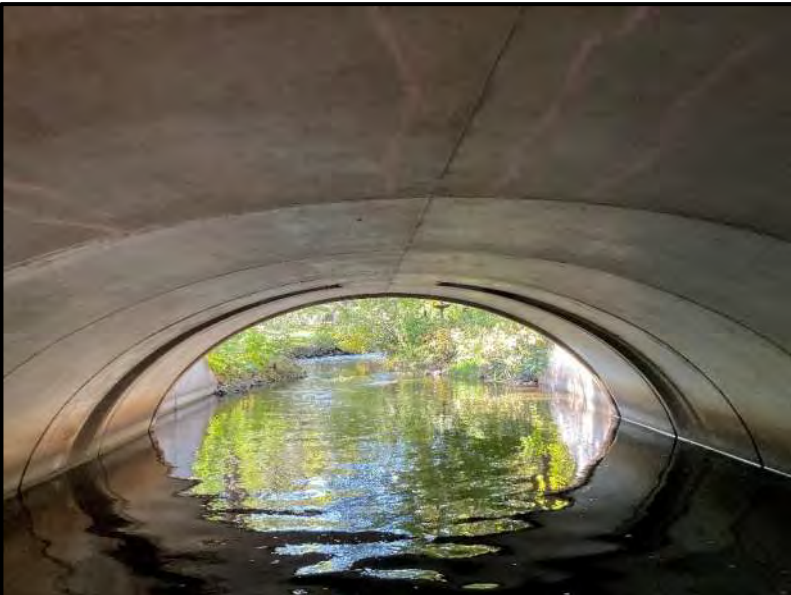
Westbrook Road Crossing (Golden Valley)

- a. The concrete Bebo arch culvert appeared to be in satisfactory condition.
- b. The water level at the staff gauge was measured at 854.91 feet.
- c. In 2022, City of Golden Valley staff repaired the spalled concrete and exposed rebar that were previously observed around the storm sewer pipe entering the culvert on the west (left) side.

- d. In 2022, City of Golden Valley staff repaired deteriorating grout and adjusting rings in the downstream east (right) catch basin.
- e. A scour hole was observed by the inlet pipe.

- f. Longitudinal hairline cracks were observed on the top of sections of the Bebo culvert, extending across the entire section (pre-cast section) width. The cracks are approximately 2 feet off-center of the structure. These cracks are consistent with previous inspections and have been noted since 2002.

- g. Spalled concrete was observed at multiple locations upstream and downstream of the culvert at the top of the wing walls and head wall. This is consistent with previous inspections and has been noted since 2007.

- h. Spalled concrete was observed in the downstream left catch basin.
- i. Westbrook Road over the culvert was repaved in 2022.

- j. The railings appeared to be in satisfactory condition.

- Monitor cracks in the culvert.
- Monitor joint gap at pressure points.
- Monitor spalled concrete at wing walls, head walls, and catch basin.

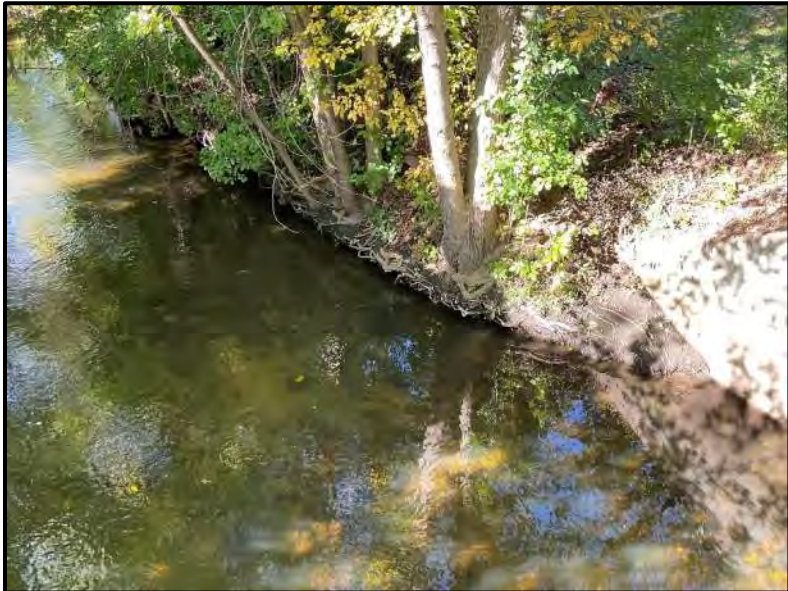
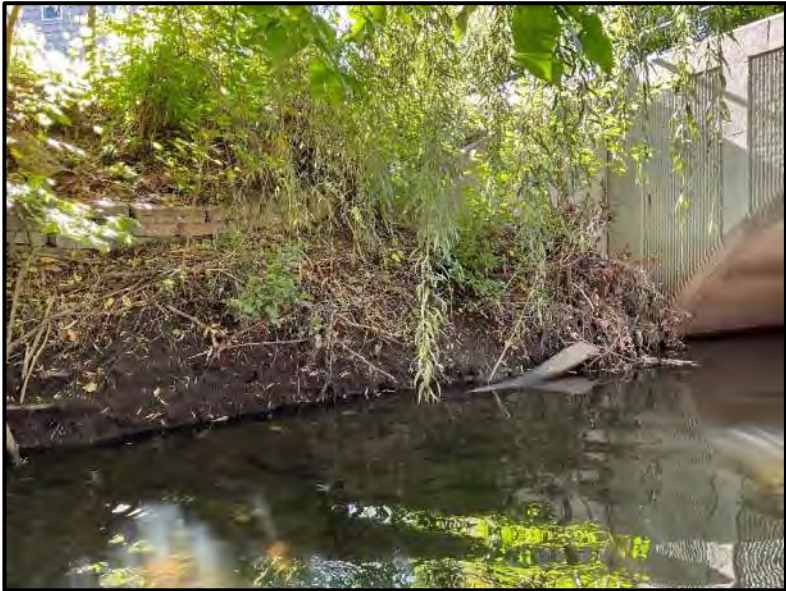
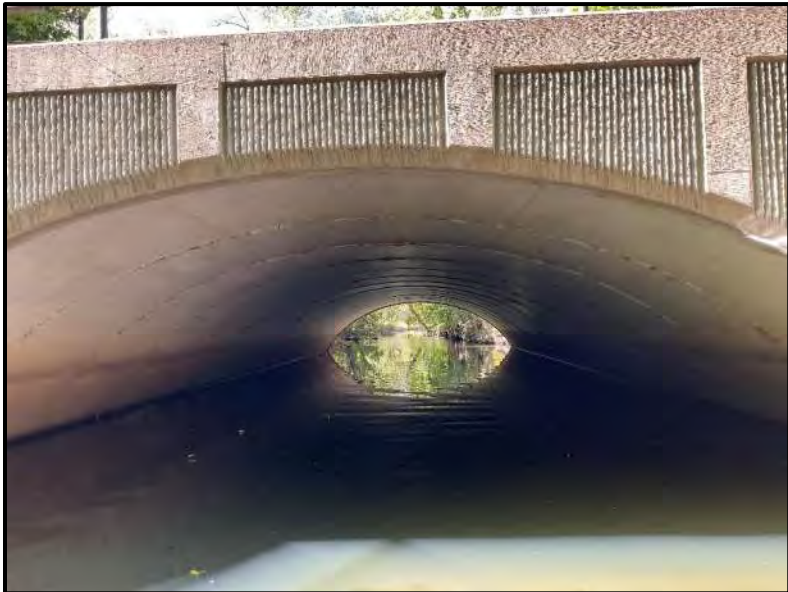
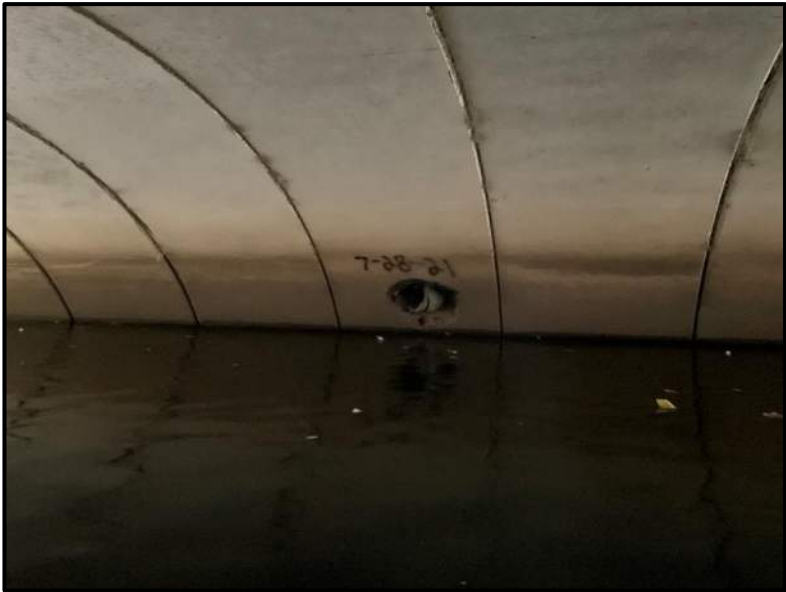
Regent Avenue Crossing (Golden Valley)

- a. The concrete Bebo arch culvert appeared to be in satisfactory condition.
- b. The channel bottom was soft and mucky, and the water level was below the bottom of the staff gauge and not measured.

- c. Spalled concrete was observed at the middle joint of the upstream north (left) wing wall. This is consistent with previous inspections and has been noted since 2002.

- d. A crack was observed at the upstream north (left) wing wall. The crack was near the top of the wing wall and travels at a 45-degree angle down to the headwall. This is consistent with previous inspections and has been noted since 2002.

- e. A crack was observed at the downstream south (right) wing wall. The crack was near the top of the wing wall and travels at a 45-degree angle down to the headwall. This is consistent with previous inspections and has been noted since 2002.

- f. Minor erosion was observed on the downstream side of the north (left) wing wall.
- g. Flows appeared to have scoured the north (left) side of the creek bottom and deposited sediment on the south (right) side of the creek bottom.

- h. The railings appeared to be in satisfactory condition.

- Monitor spalled concrete at the upstream north (left) wing wall.
- Monitor cracks at the upstream north (left) wing wall, upstream south (right) wing wall, and downstream south (right) wing wall.
- Monitor creek bottom for scour and deposition.

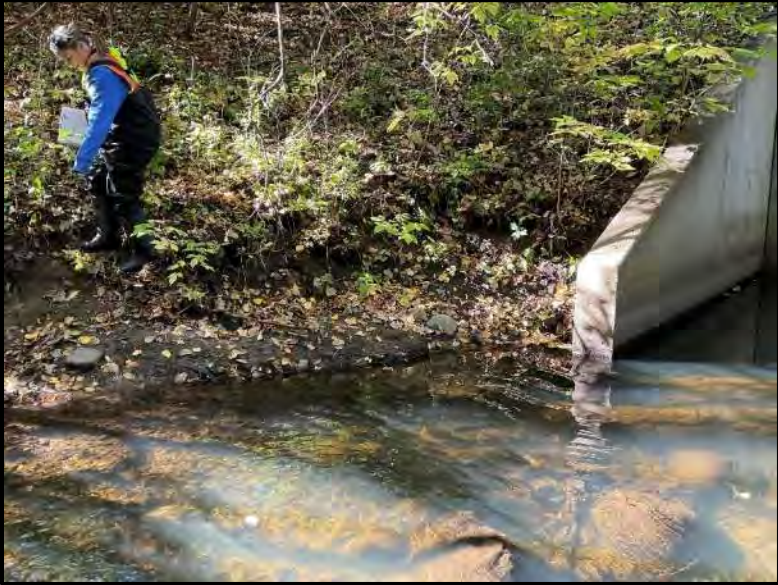
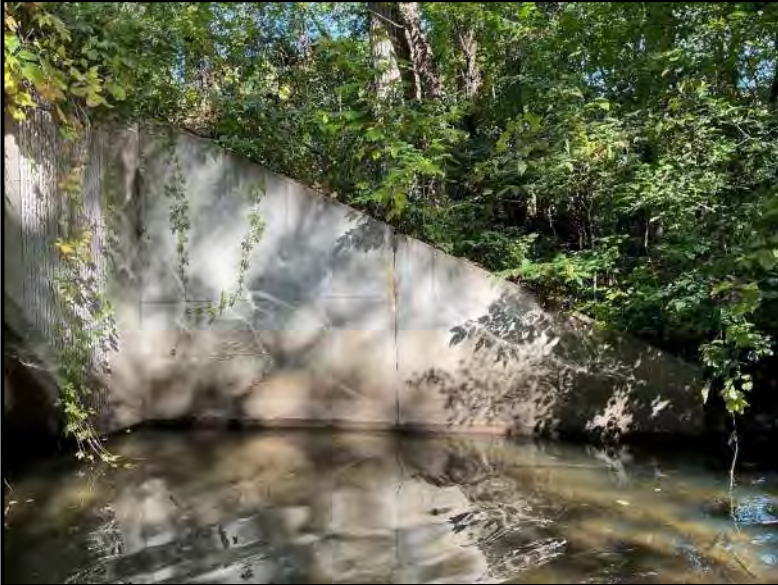
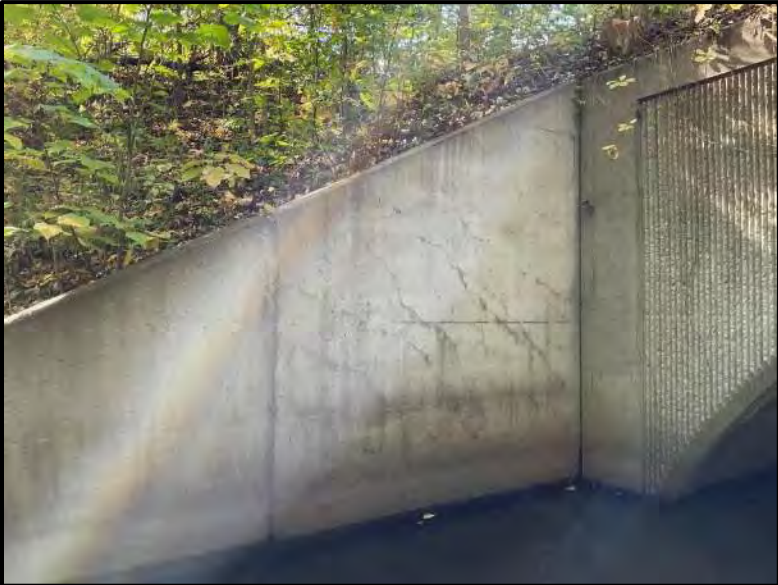
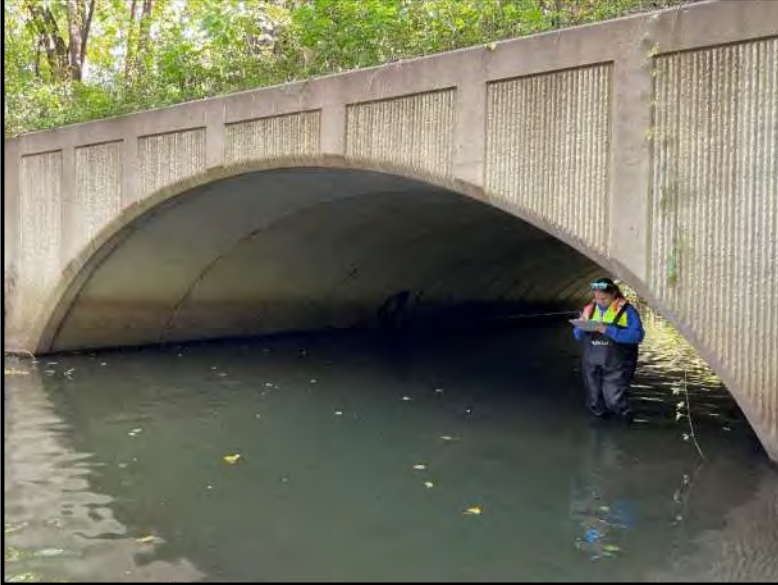
Noble Avenue Crossing (Golden Valley)

- a. The concrete Bebo arch culvert appeared to be in satisfactory condition.
- b. Longitudinal hairline cracks were observed throughout the length of the top of the culvert, extending across the entire (pre-cast) section width. The cracks were either in the center of the structure or approximately 2 feet off-center of the structure. This is consistent with previous inspections and has been noted since 2002.
- c. Spalled concrete and exposed plastic joint material were observed approximately two feet either side of center throughout the length of the top of the culvert. The cement paste covering the plastic joint material has separated and exposed the plastic. This is consistent with previous inspections and has been noted since 2002.

- d. Spalled concrete was observed at the downstream north (left) wing wall. This is consistent with previous inspections and has been noted since 2002.
- e. Multiple cracks and spalling were observed at the top of downstream north (left) wing wall. The cracking is consistent with previous inspections and has been noted since 2007.
- f. The downstream south (right) wing wall was slightly leaning toward creek. Inspection staff have monitored the offset between the upper portion of the wing wall and the lower portion of the wing wall, which is leaning toward the creek, since 2002 to document movement. The inspection staff's measurements are listed below:

- g. Minor bank erosion and scour was observed on both sides of the downstream wing walls. This is consistent with previous inspections and has been noted since 2002.
- h. Flows appeared to be scouring the north (left) side of the creek bottom.
- i. The paint on the railings has begun peeling.
- j. The City of Golden Valley installed riprap in 2018 to reinforce the bank and minimize continued erosion at the outside edge of the upstream south (right) wing wall, however some erosion has perpetuated upstream.

- Monitor cracks and spalled concrete in the culvert and wing walls.
- Monitor bank erosion at downstream wing walls and upstream of installed riprap at upstream south (right) wing wall.
- Monitor creek bottom for scour and deposition.

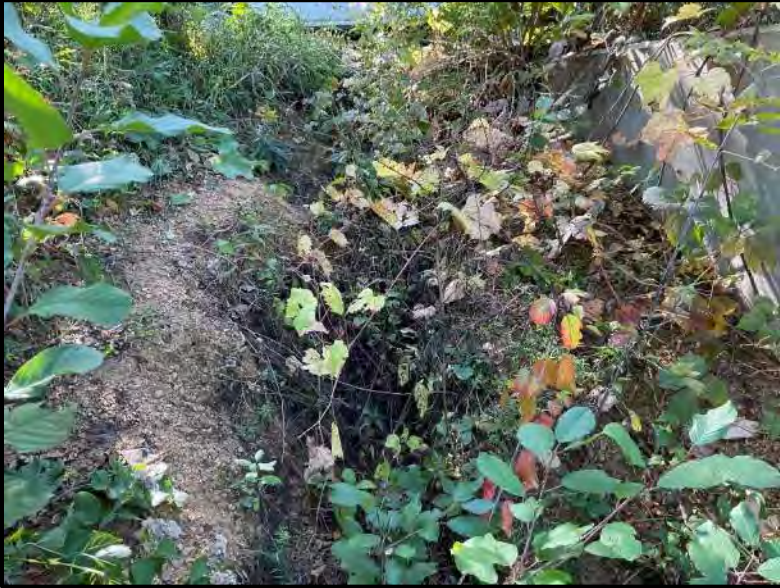
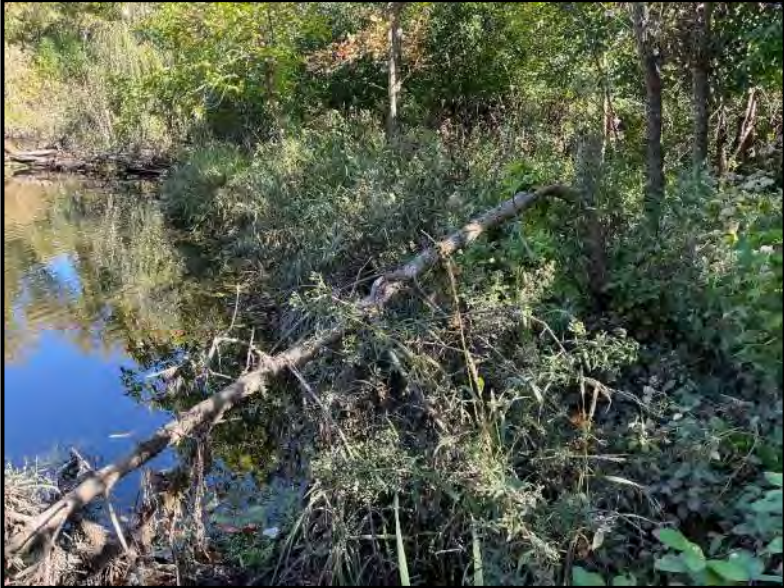
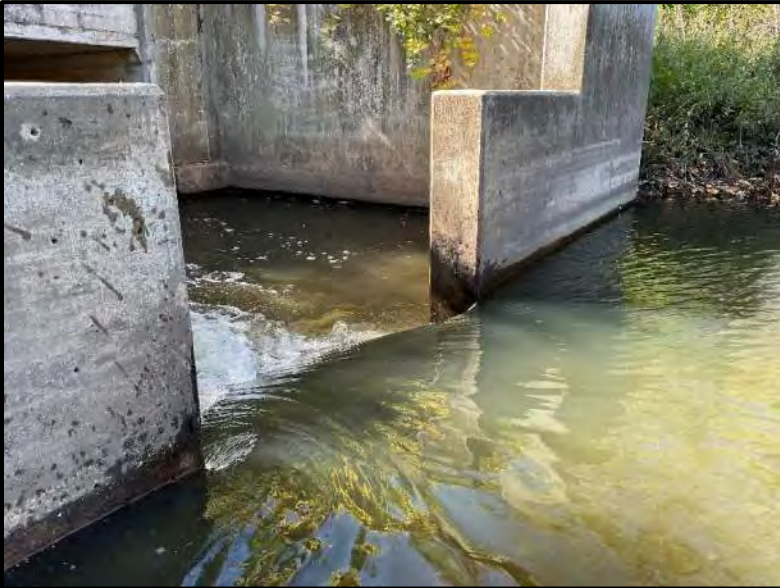
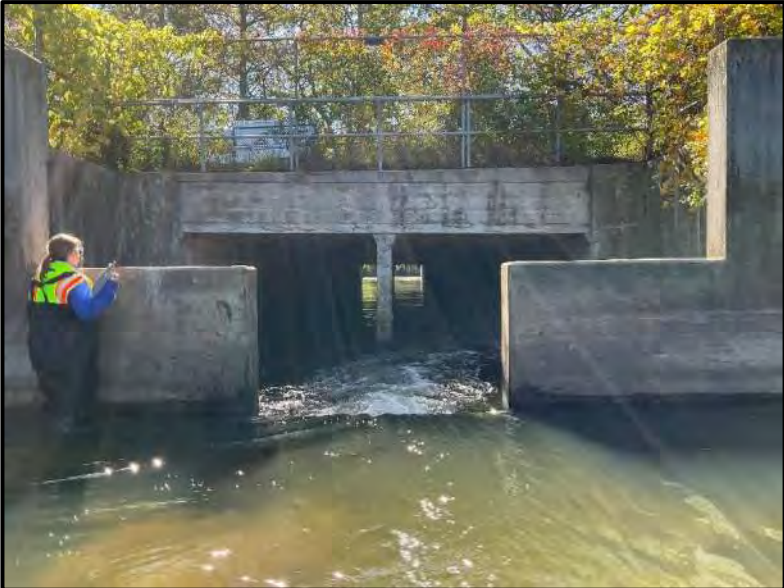
Highway 55 Control Structure (Golden Valley)

- a. The concrete control structure appeared to be in satisfactory condition.
- b. Woody debris, including multiple logs and branches were lodged across the bottom of the low-flow notch on upstream side of structure and partially obstructing flow. These logs and branches were removed during the inspection.
- c. A hairline crack was observed in the east (left) wall of the inlet structure, although it appears that the crack may have been previously sealed with caulk. The crack is positioned in the middle of the wall extending full height. This is consistent with previous inspections and has been noted since 2002.
- d. Erosion was observed around the east (left) side of the structure, likely from road runoff. In the summer of 2021, Minnesota Department of Transportation (MnDOT) crews placed

class 5 aggregate on the east (left) side of the structure to access the upstream end of the structure to perform repairs of the double box culvert below Highway 55. The new class 5 aggregate is actively eroding. The erosion appears to have worsened since last year.

- e. MnDOT crews also drilled holes into the structure to install brackets and a temporary plate to block flows through the structure so they could perform repairs. MnDOT removed the plate, brackets, and bolts, but did not fill or repair the bolt holes.
- f. Downed trees are located near the left corner on the upstream side of the structure.
- g. In 2021 and 2022 a piece of rebar and relatively small mass of concrete were observed extending into the lower west (right) side of the opening of the low flow weir. A steel threaded rod extended approximately 2 inches from the south face of concrete on the east (left) side of low flow weir. These observations could not be confirmed in this year's inspections due to higher water levels.
- h. The left (east) side of the chain link fence around the control structure was not fully reattached at the downstream left corner.

- Protect the sides of the structure with armoring (rock or riprap) or reinforced vegetation to limit additional erosion. Alternatively, divert road runoff away from the structure.
- Request that MnDOT repair bolt holes with concrete grout.
- Remove downed trees near the upstream side of the structure.
- Sawcut and remove rebar and concrete chunk on east (left) side of low flow weir.
- Sawcut steel rod to be flush to concrete along south face of concrete on the east (left) side of the low flow weir.
- Repair chain link fence
- Monitor hairline crack in the control structure.

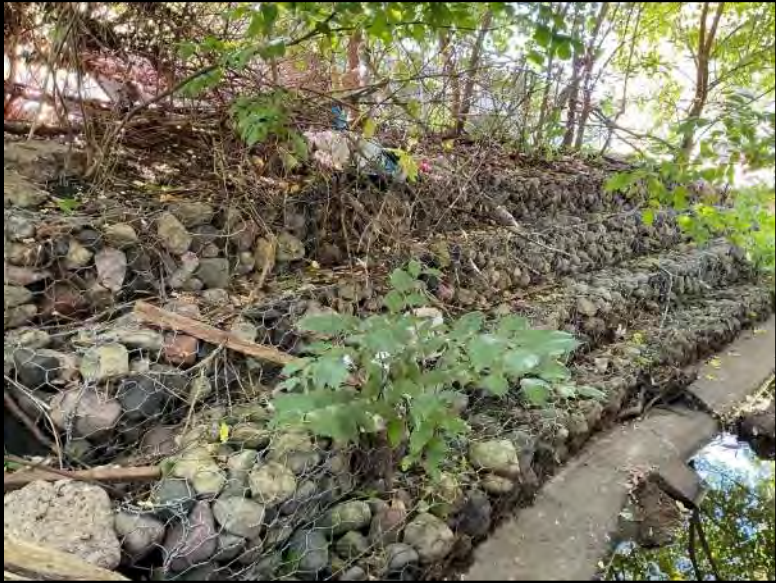
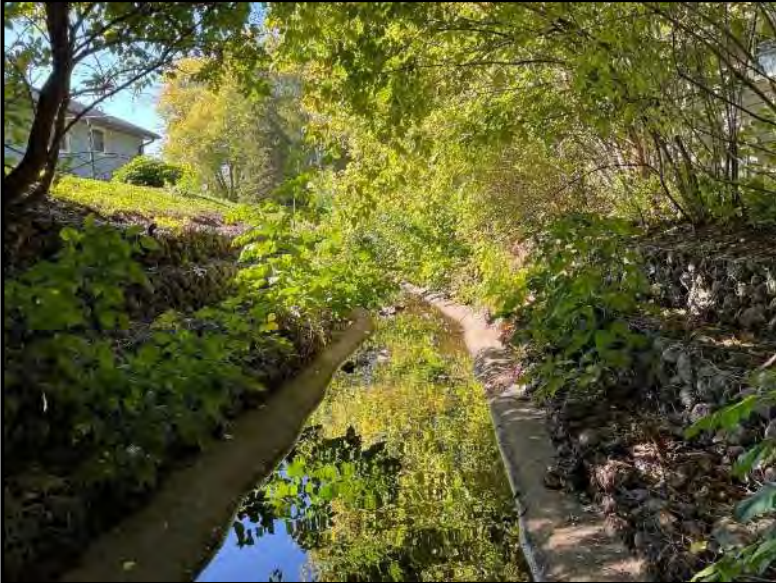
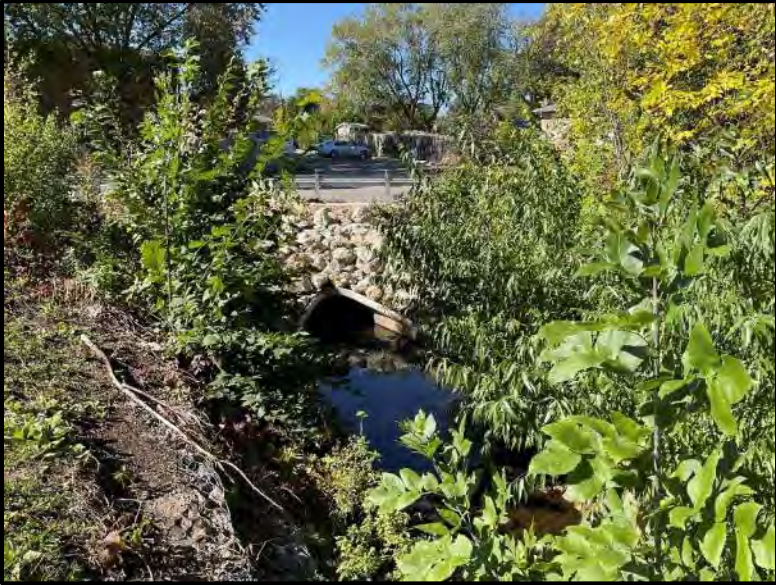
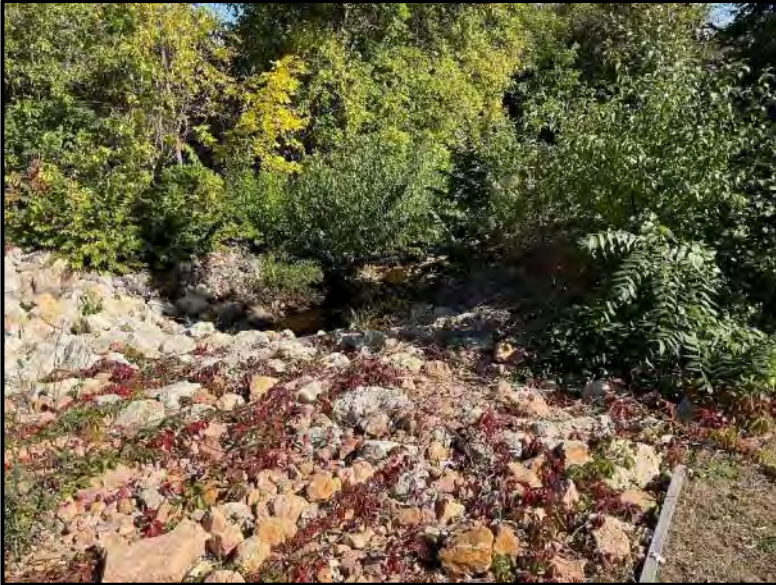
Markwood Open Channel – Gabion Section (Crystal)

- a. The channel appeared to be in satisfactory condition.
- b. While recent vegetation clearing appeared to have occurred along the gabion baskets section, the clearing could only be done above the top of the baskets and vegetation is still growing through the baskets. It was unclear if herbicide was used to prevent regrowth, but this vegetation may continue to pose a risk of damage to the gabion baskets.
