Memorandum

To: Bassett Creek Watershed Management Commission (BCWMC)
From: Barr Engineering Co. (Josh Phillips, Gabby Campagnola, Jim Herbert)
Subject: Bassett Creek 2023 Flood Control Project Inspection
Date: December 13, 2023
Project: 23270051.58 2023 4065

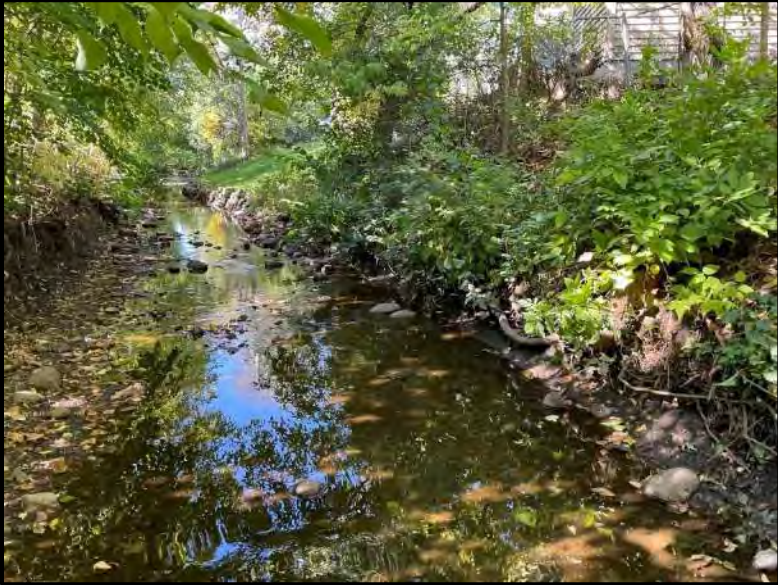
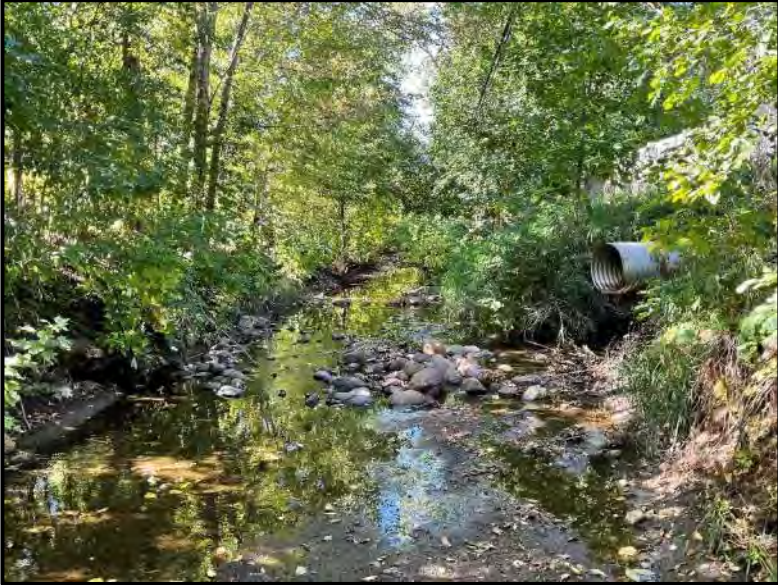
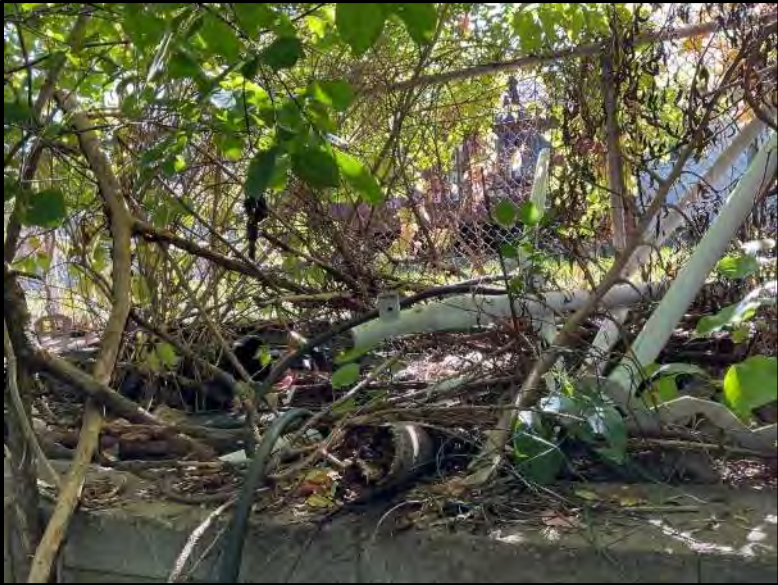
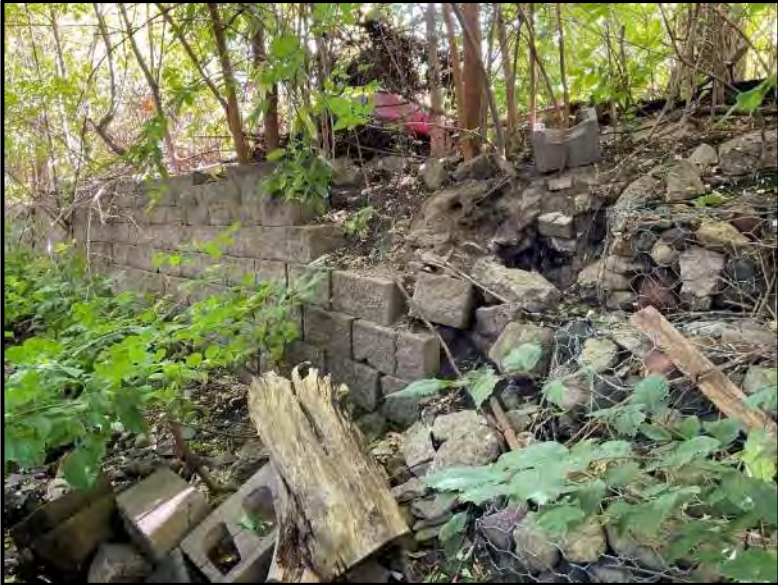
Markwood Open Channel (Crystal)

- a. The channel appeared to be in satisfactory condition.
- b. Vegetation growth was observed along the side slopes of the channel. Some areas appeared to have been cleared since the previous year's inspection.

- c. Erosion was observed along the toe of the north (left) and south (right) banks. This is consistent with previous inspections and has been noted since 2006.

- d. The retaining wall along the channel at 7010 36th Avenue is failing and falling into the channel, potentially impacting high flows and causing erosion. There was a 1-inch diameter black hose that appeared to be discharging to the channel.

- e. Other downstream retaining walls and fences along the channel were leaning toward the channel and, in some cases, appeared to be failing. This is consistent with previous inspections and has been noted since 2009.

- f. The City of Crystal's corrugated metal pipe (CMP) storm sewer, discharging into the channel between 6833 and 6825 Markwood Drive, was in poor condition. The pipe bottom was corroded and there was erosion and undercutting around the pipe end. The pipe was exposed approximately 10 feet, measured on the downstream side.

- g. Cinder blocks were observed in the creek.

- Clear woody vegetation in the channel. Consider clearing vegetation every 3-5 years to maintain flow capacity and allow access through the open channel.
- Remove cinder blocks in the creek.
- Although not part of the flood control project, repair the failing retaining wall and/or stabilize the area at 7010 36th Avenue to prevent erosion and potential obstruction of channel flows.
- Inspect the referenced hose at 7010 36th Avenue for potential illicit discharge directly to the channel.
- Monitor remaining retaining walls and fences for potential failure and obstruction of flow through the channel.
- Monitor erosion along the toe of the channel banks.
- Although not part of the flood control project, the city may want to consider repairing or replacing the CMP storm sewer.

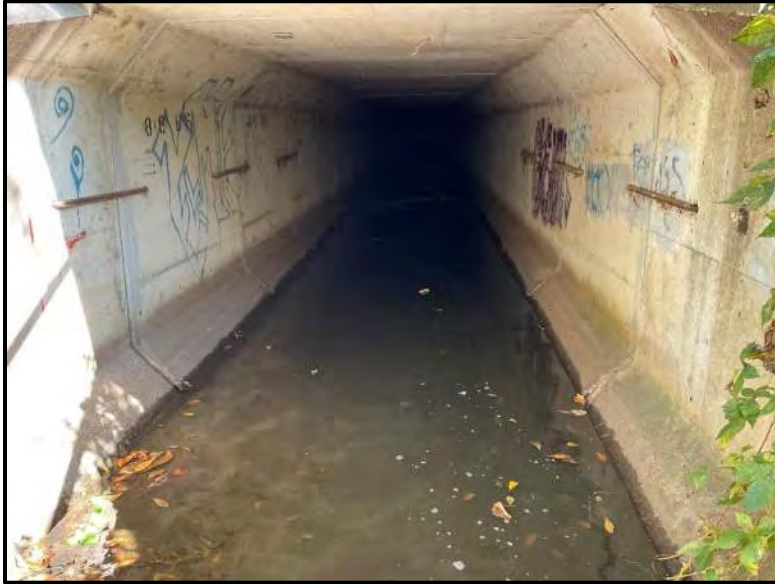
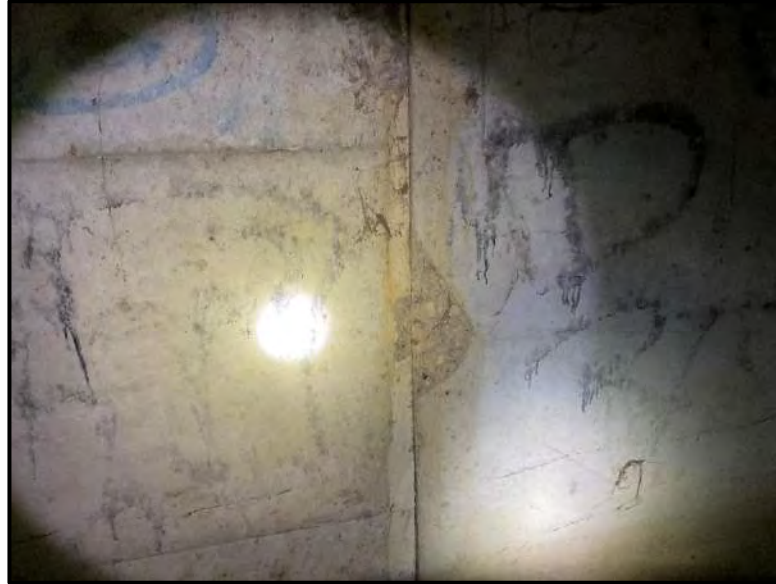
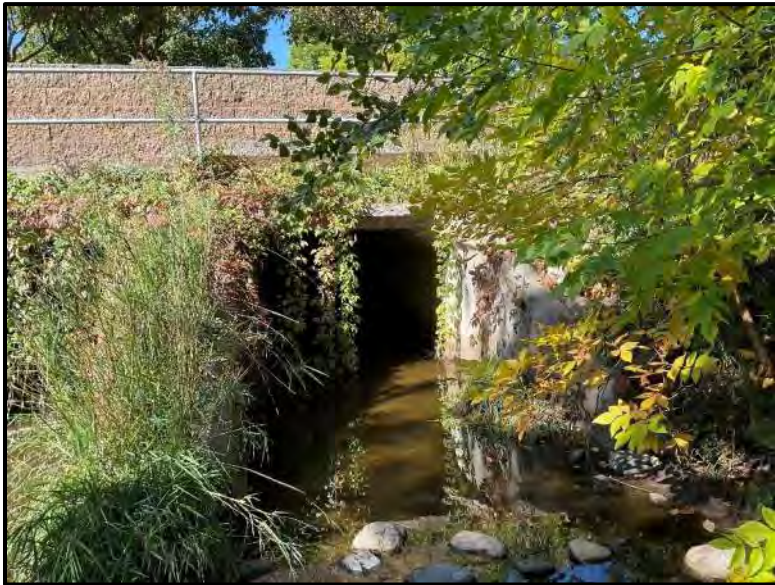
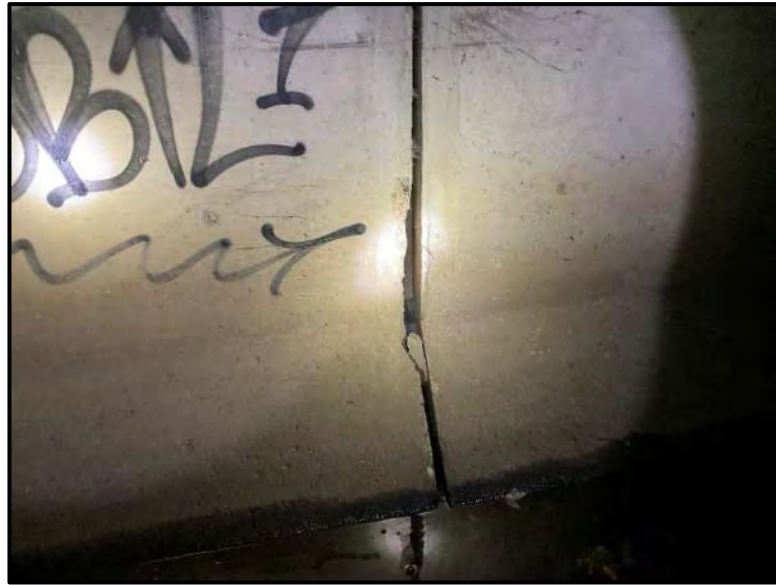
36th Avenue and Hampshire Avenue Crossing (Crystal)

- a. The concrete box culverts, joints and tie bars appeared to be in satisfactory condition.

- b. Some riprap has deposited in the box culverts.
- c. Sediment has deposited in the box culverts, mostly in the downstream half of the box culverts. This is consistent with previous inspections and has been noted since 2016.

- d. On both culverts, the fifth joint from the downstream end had a 2 ½ inch gap, which is a larger gap than the rest of the joints. This is consistent with previous inspections and has been noted since 2010.

- e. Various locations of spalled concrete and exposed reinforcing was observed through both culverts.
- f. Infiltration was observed into the north (left) culvert in 2019 and 2020 at the storm pipe connection upstream of the first culvert bend. Infiltration was not observed into the culvert at this location in 2021, 2022, or 2023, potentially due to low water levels and dry conditions.

- g. Approximately 6 inches of sediment was observed on the downstream side of both culverts.

- Remove deposited riprap in the box culverts and replace upstream.
- Monitor sediment in the box culverts.
- Monitor the joint gaps in the box culverts.
- Monitor spalled concrete, and exposed reinforcing in the culverts.

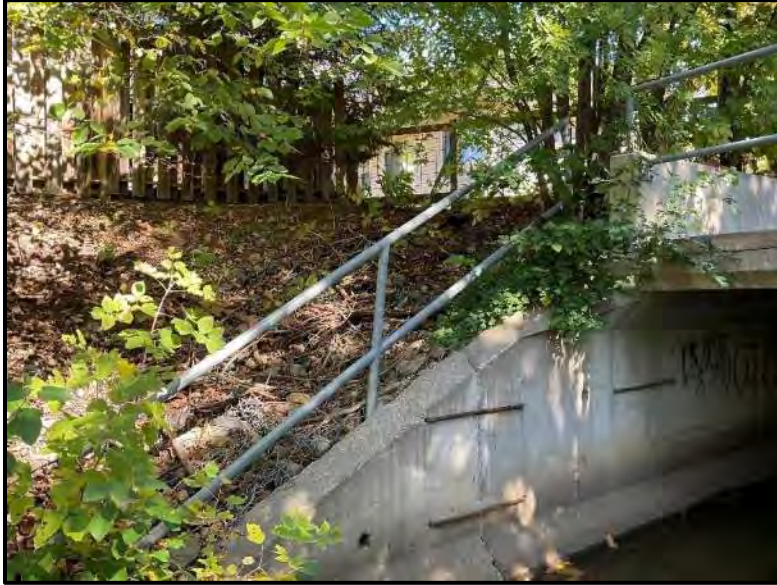
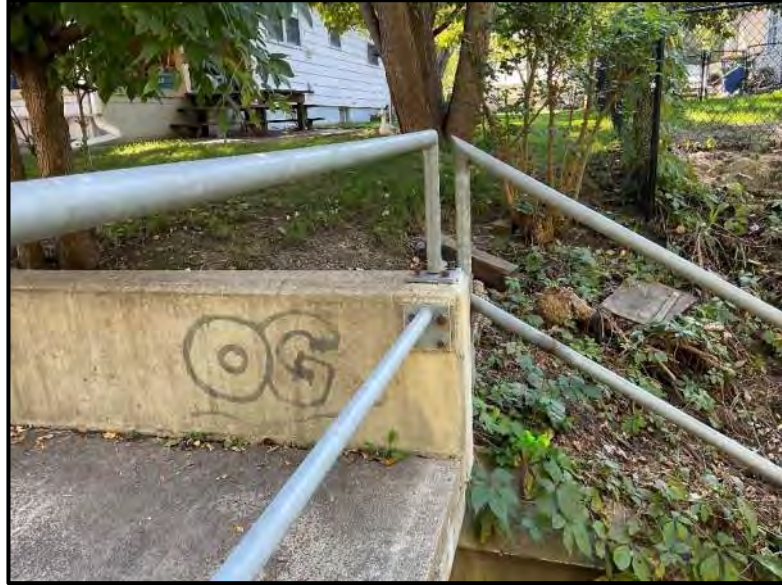
Markwood Downstream Overflow (Crystal)

- a. Approximately 75% of the bolts on the railing of the overflow appeared to be missing.

- Add replacement bolts to the railing.

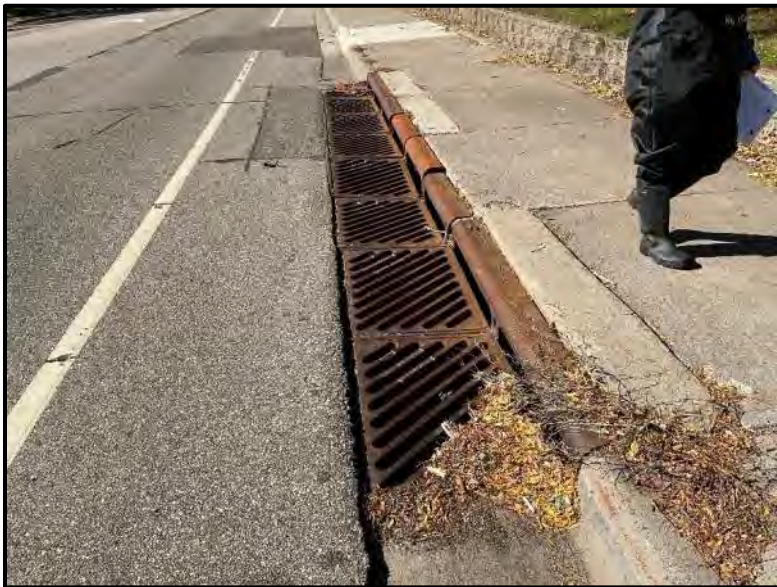
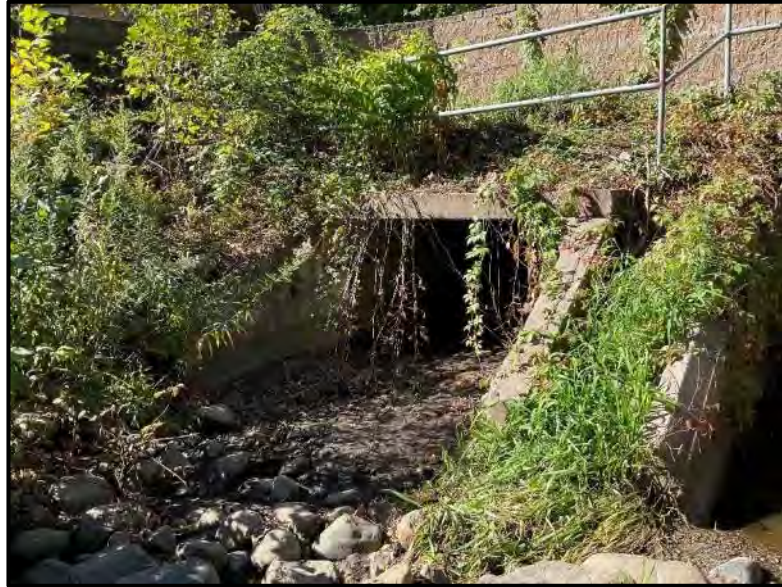
Markwood 8 feet x 4 feet Box Culvert (Crystal)

- a. The box culvert was not entered due to low clearance and was visually inspected from the outside at the downstream end. The box culvert appeared to be in satisfactory condition.
- b. Approximately 2-4 inches of sediment was observed at the downstream side of the culvert.
- c. The upstream catch basins appeared to be in satisfactory condition.

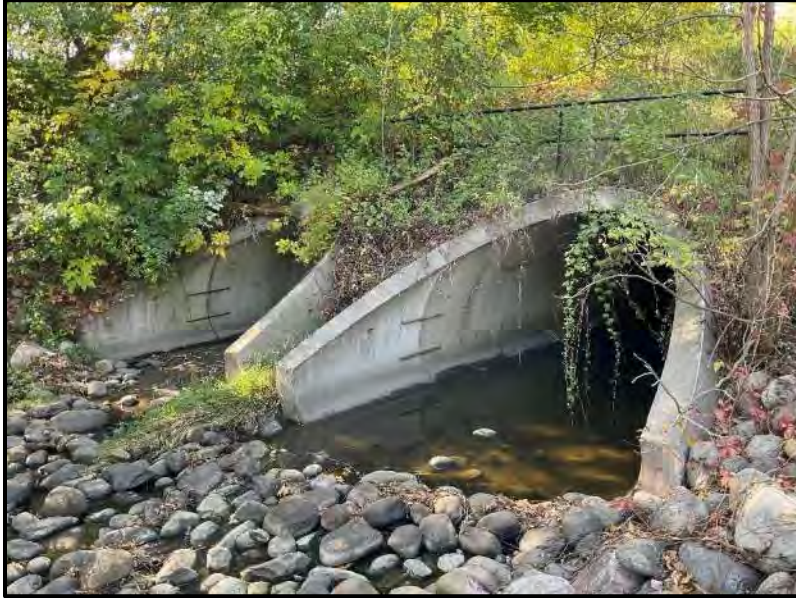
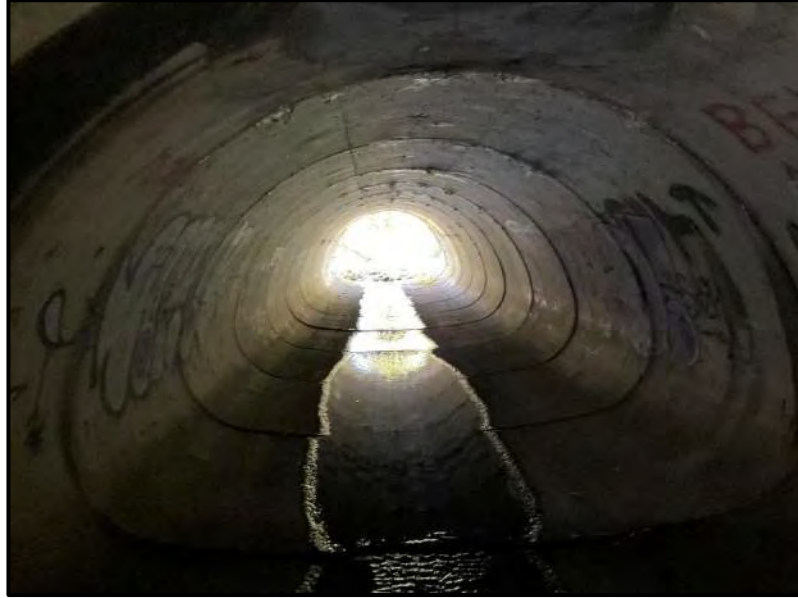
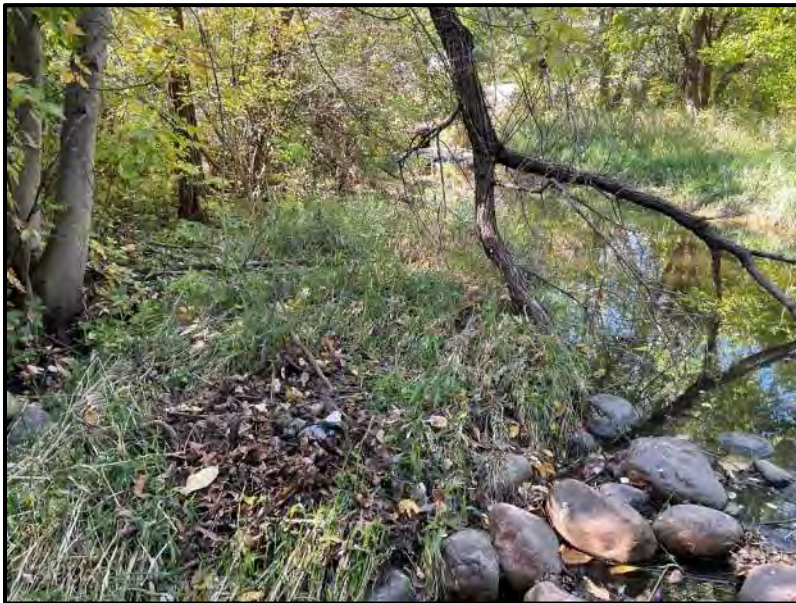
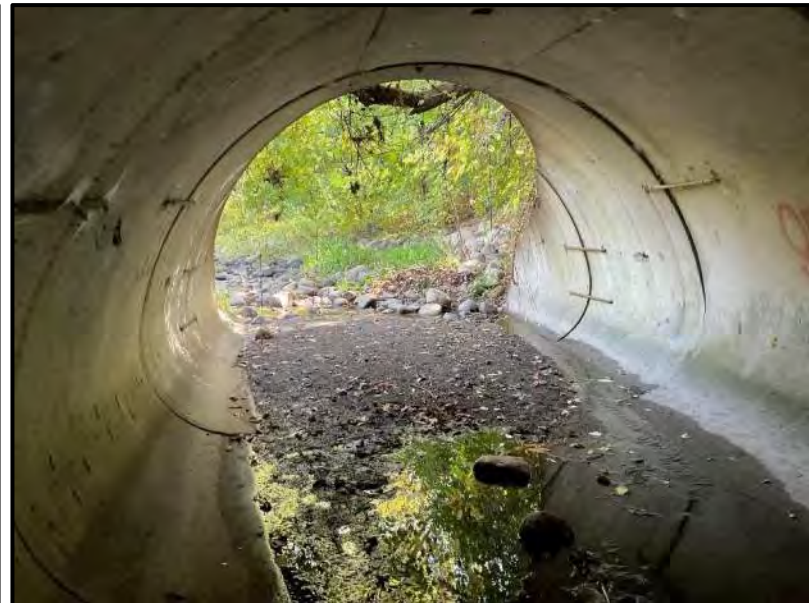
Georgia Avenue Crossing (Crystal)

- a. The concrete culverts appeared to be in satisfactory condition.
- b. Cracking and spalling were observed in the south (right) culvert at the second and fourth joints at approximately the five o'clock position.

- c. Cracking was observed in multiple joints in the north (left) culvert on the right side.
- d. Minor erosion was observed between the concrete culverts at the upstream end.
- e. Approximately two inches of sediment has accumulated downstream of the culverts, especially near the north (right) culvert and right bank.
- f. Sediment has accumulated on the right bank upstream of the culverts.
- g. Both culverts appeared to begin to change slope around mid-channel.
- h. There is a downed tree upstream of the culvert that is partially in the creek.

- Monitor cracking and spalling in the south (right) culvert.
- Monitor minor erosion between the concrete culverts on the upstream end.
- Remove downed tree upstream of the culvert.

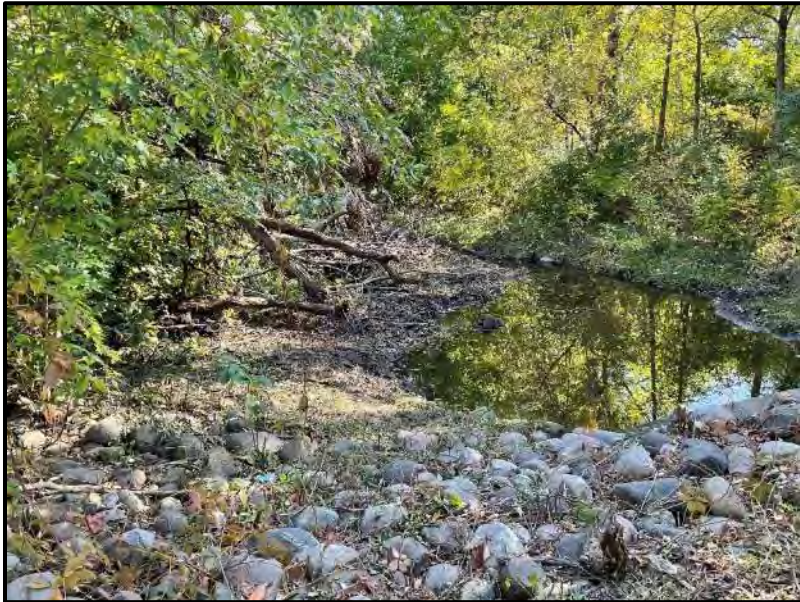
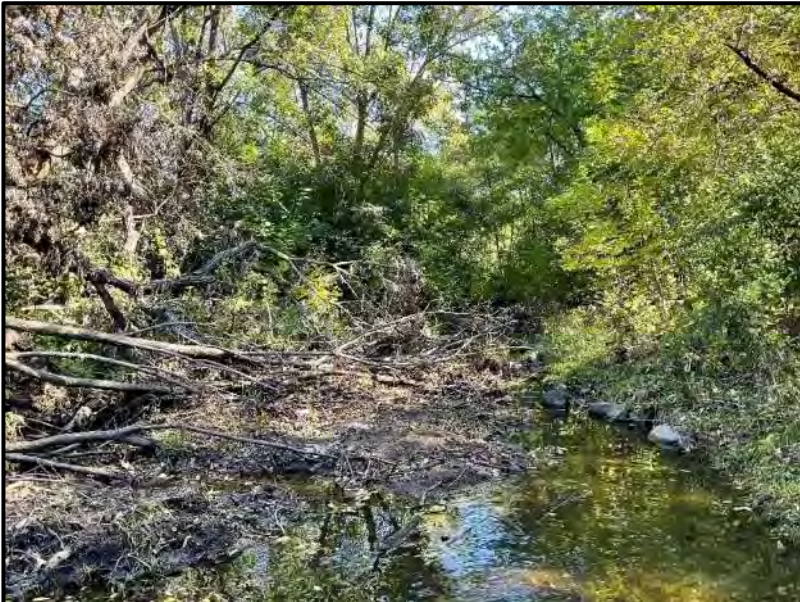
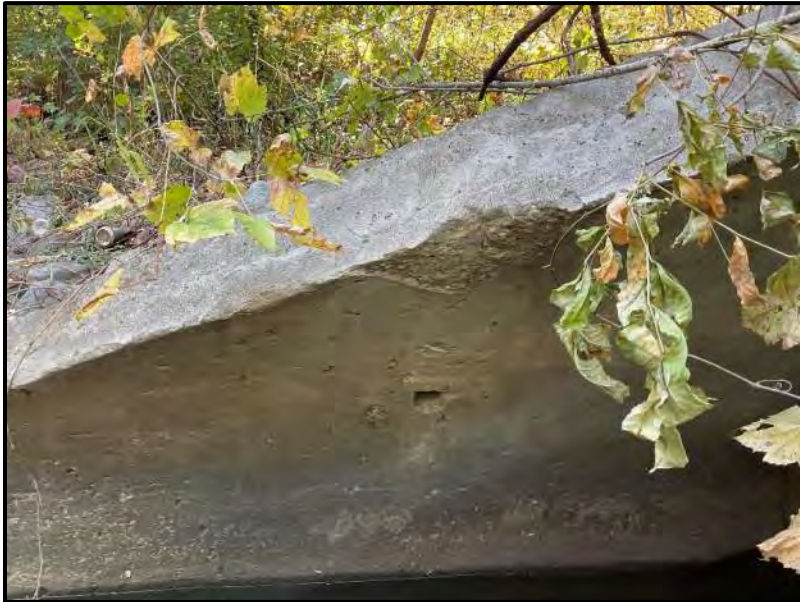
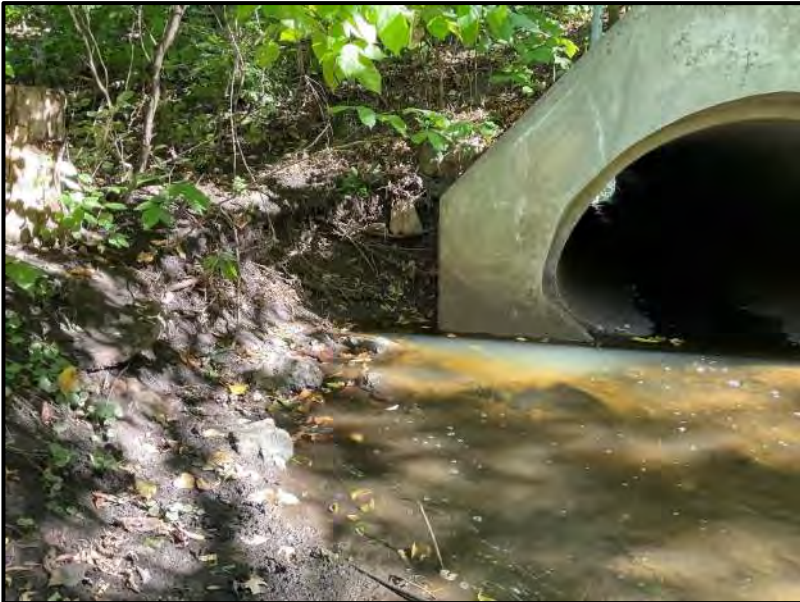
Edgewood Embankment (Crystal)

- a. The concrete culvert appeared to be in satisfactory condition.
- b. The embankment appeared to be in satisfactory condition.
- c. No visible settlement or erosion was observed along the embankment.

- f. The natural boulder riprap between the Edgewood embankment and Douglas Drive crossing is significantly overgrown with vegetation.
- g. Spalled concrete was observed at four joints in the culvert.

- h. Spalled concrete was observed on the north (right) and south (left) side of the downstream flared end section of the culvert.
- i. Moderate erosion is occurring on each side of the upstream end of the culvert.

- Remove branches and downed trees that are in the creek channel to prevent obstructing creek flows.
- Remove trees, shrubs and woody vegetation growing on the embankment.
- Clear woody vegetation in the channel between the Edgewood Embankment and Douglas Drive crossing as needed to maintain flow capacity and allow access through the open channel.
- Monitor spalled concrete at the fifth joint from the upstream end in the culvert.

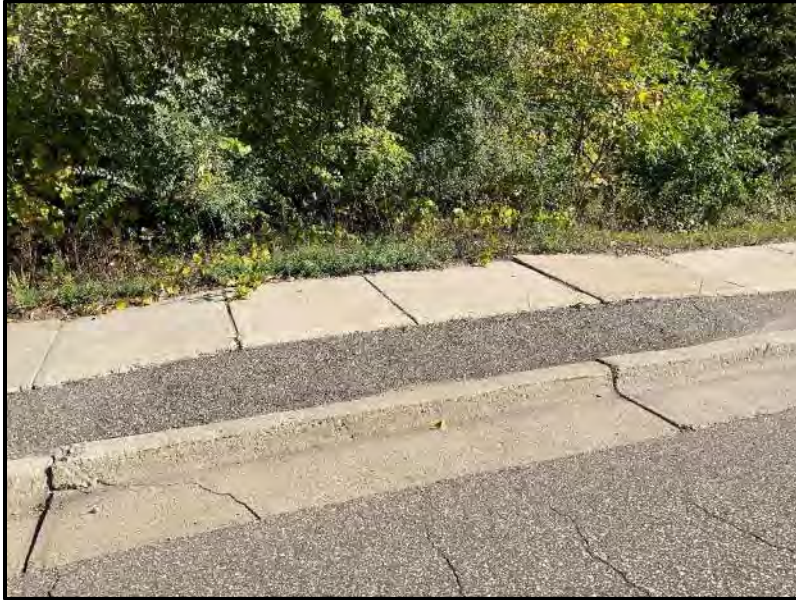
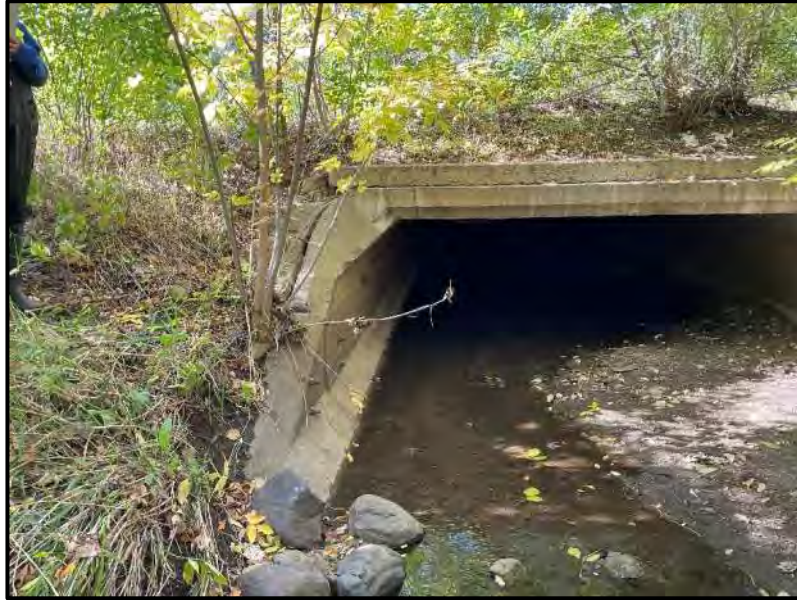
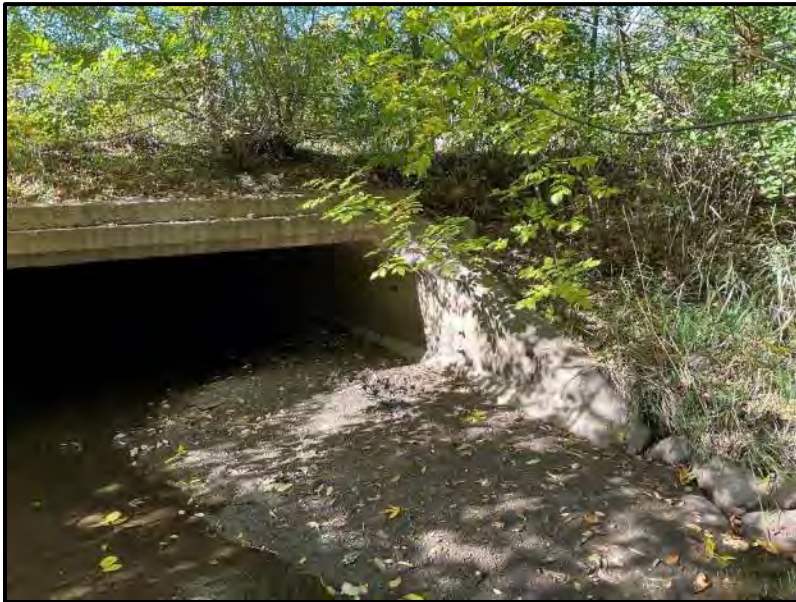
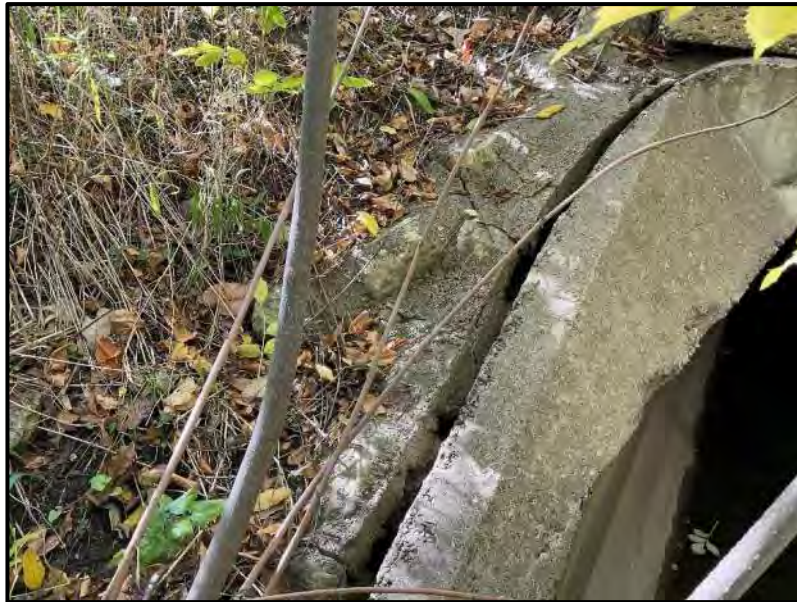
Douglas Drive Crossing (Crystal)

- a. The concrete box culvert was not entered due to low clearance but appeared to be in satisfactory condition, based on visual inspection.
- b. The grouted riprap installed on each side of the box culvert outlet has started to deteriorate, and a gap has opened between the grout and the wall of the box culvert. This is consistent with previous inspections and has been noted since 2016.

- c. Spalled concrete was observed at the downstream north (left) wing wall.
- d. Sediment has deposited in the bottom of the culvert, ranging from 0-4 inches deep.

- e. Some riprap was observed in the culvert.
- f. On the downstream end of the culvert, settling was observed in the sidewalk on either side of the culvert.

- g. Spalled concrete was observed on the top of the culvert on the downstream end.
- h. There are two reinforced concrete storm pipes in Douglas Drive that connect on the left (north) side and right (south side) of the culvert. The reinforced concrete storm pipe on the right (south) side of the culvert appeared to be significantly cracked.

- i. Small trees were observed adjacent to the structure at the downstream end.
- j. Although not part of the flood control project, the privately-owned CMP culvert downstream of the Douglas Drive crossing is in poor condition. Sagging of this culvert has been observed during inspections since 2009. The culvert is significantly bowing and settling has occurred on either side of the culvert, which is evident in the road pavement above the structure.

- Remove riprap from the culvert and replace upstream.
- Consider adding a railing along the sidewalk at the upstream and downstream end of the culvert.
- Consider inspecting the reinforced concrete storm pipe in Douglas Drive that connects to the culvert on the right (south) side and repair as necessary.
- Monitor deposited sediment in the culvert.
- Monitor grouted riprap at the downstream end of the box culvert.
- Monitor spalled concrete at the downstream north (left) wing wall.
- Monitor settling in the sidewalk at the downstream end of the culvert.
- Although not part of the flood control project, it is recommended that the city coordinate with the property owner to repair or replace the culvert downstream of Douglas Drive.

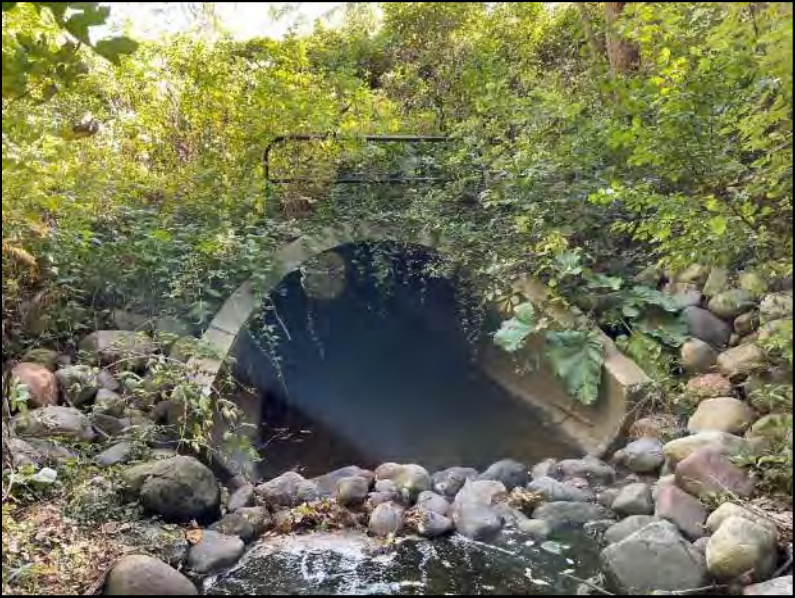
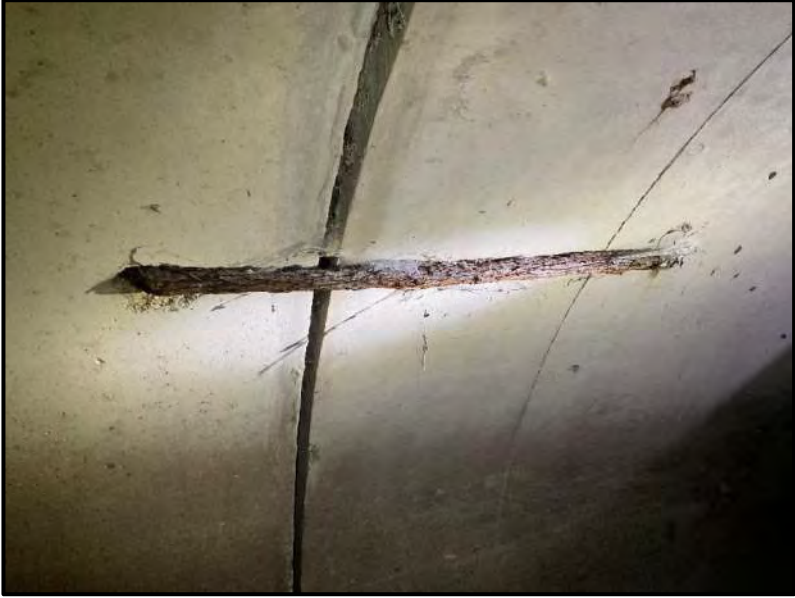
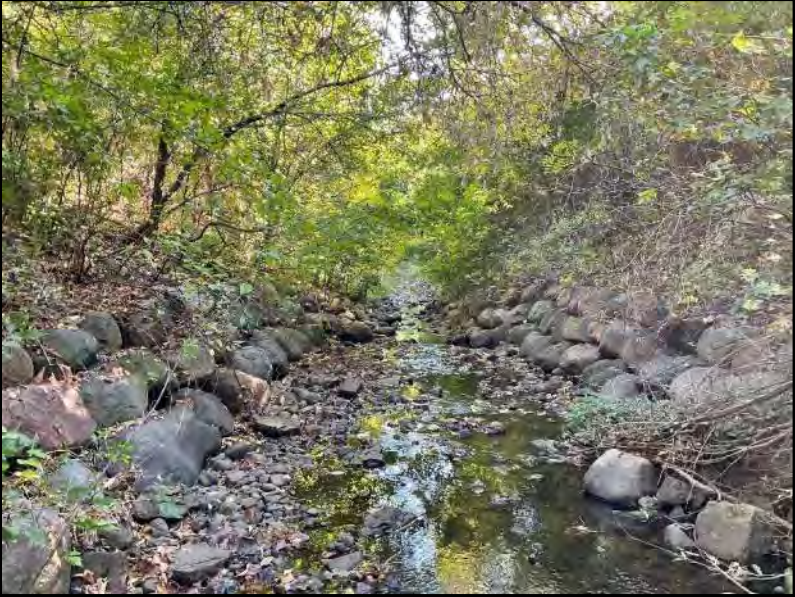
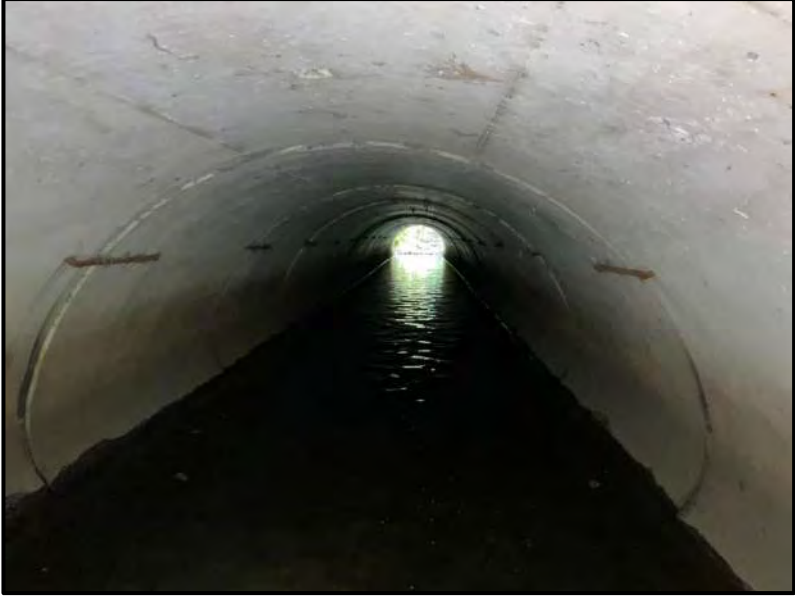
34th Avenue Crossing (Crystal)

- a. The concrete culvert appeared to be in satisfactory condition.

- b. Sediment has deposited in the bottom of the culvert, ranging from 0-4 inches deep. This is consistent with previous inspections and 0-12 inches of sediment has been noted in the culvert since 2002.
- c. The tie bars directly upstream and downstream of the manhole connection to the culvert were rusty and flaking. This is consistent with previous inspections and has been noted since 2008.

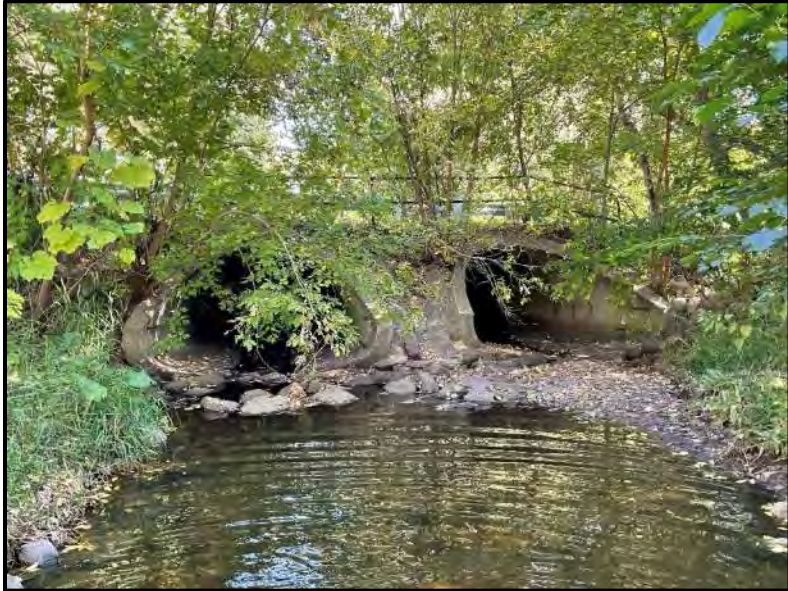
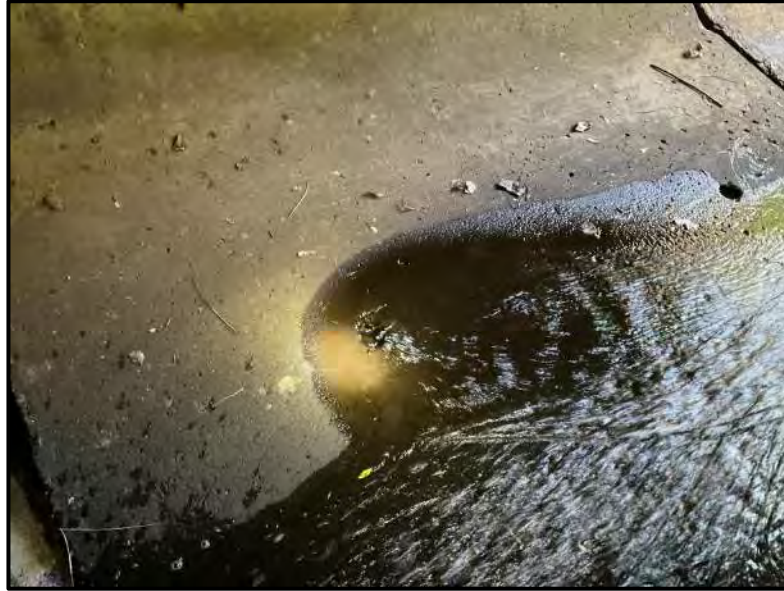
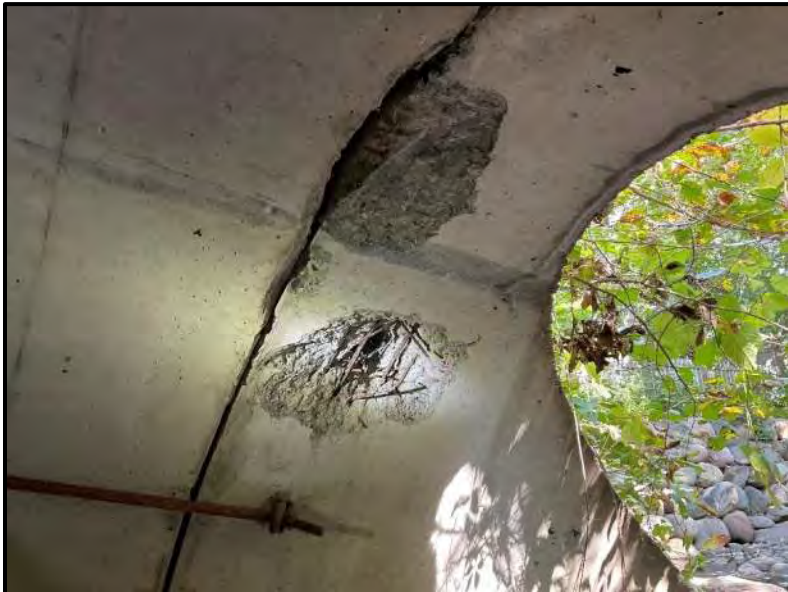
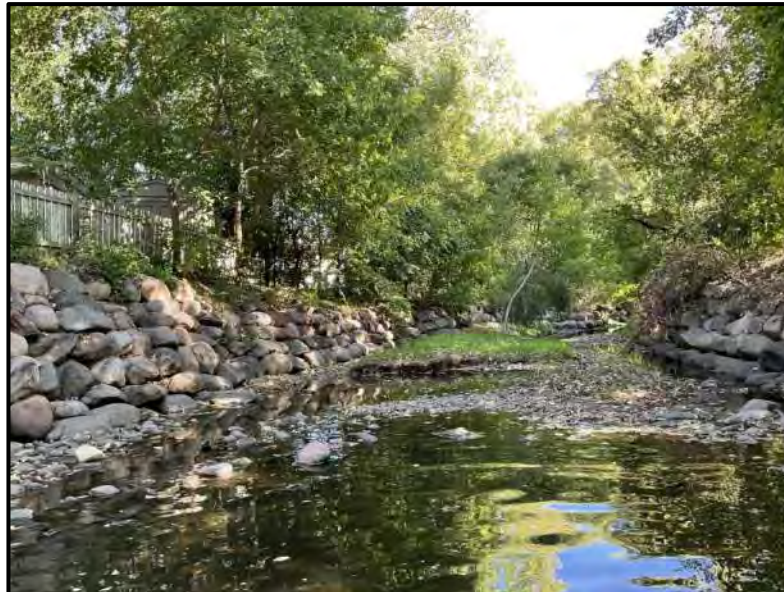
Brunswick Avenue Crossing (Crystal)

- a. Trees are growing around the upstream end of the structure.
- b. Water was primarily flowing through the north (left) culvert with less than an inch of water present. This aligns with previous inspections that have noted the north (left) culvert is at a slightly lower elevation at the upstream end.

- c. A grade change occurs for both culverts at the 4th joint from the downstream side.
- d. Grout and grout repair appeared to be failing at all joints in both culverts. Fractured pieces of concrete and grout were observed at multiple joints in both culverts.

- e. Longitudinal and circumferential cracks were observed in both culverts.
- f. Strained and detached tie bars were observed in the north (left) culvert. One joint with broken tie bars was previously re-grouted by the City of Crystal, but the joint reopened and a 1.5-inch-gap in the joint was observed during the 2008 inspection. A 3-inch gap in the joint has been noted since 2009.

- g. At the 2nd and 5th joint from the downstream side of the north (left) culvert, broken tie bars on both sides of the culvert were observed.
- h. A hole was observed at the 2nd joint from the downstream side of the north (left) culvert. Water appeared to be seeping through 2nd downstream joint and coming out of the hole.

- k. Spalled concrete and exposed reinforcing were observed from the furthest downstream joint to 4th joint from the downstream in the south (right) culvert.
