Appendix A
Site Visit Photos

Plymouth Creek Restoration (2026 CR-P)

Plymouth Creek Erosion Issues and Restoration Prioritization

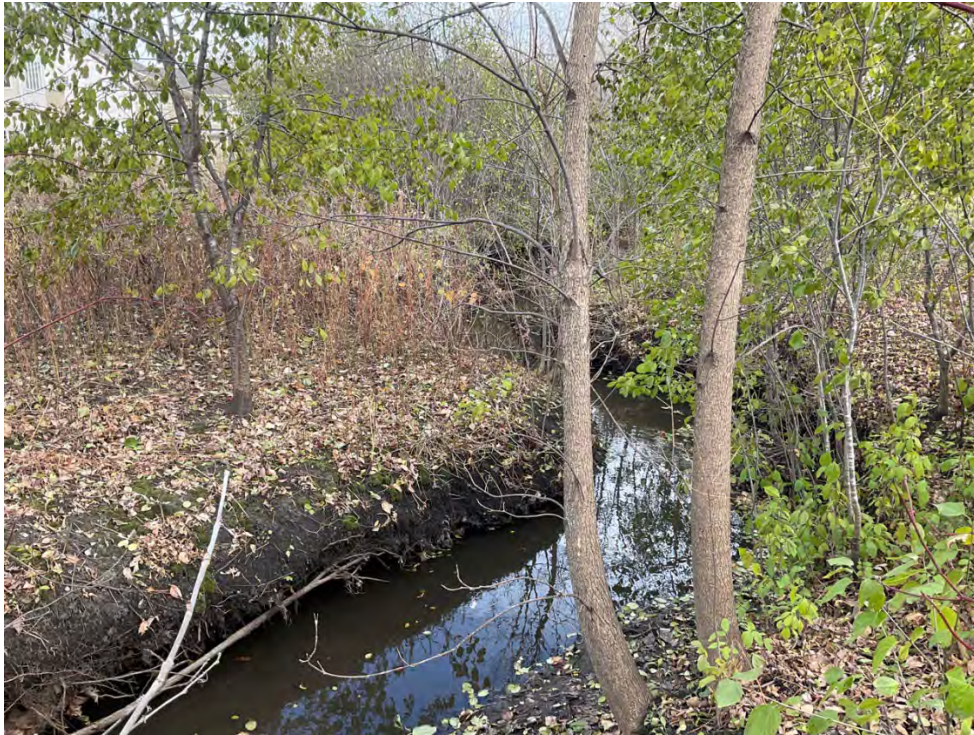
Photo 9: Site 1f. The creek begins to become more sinuous at station 11+40 and the left bank has undercut.

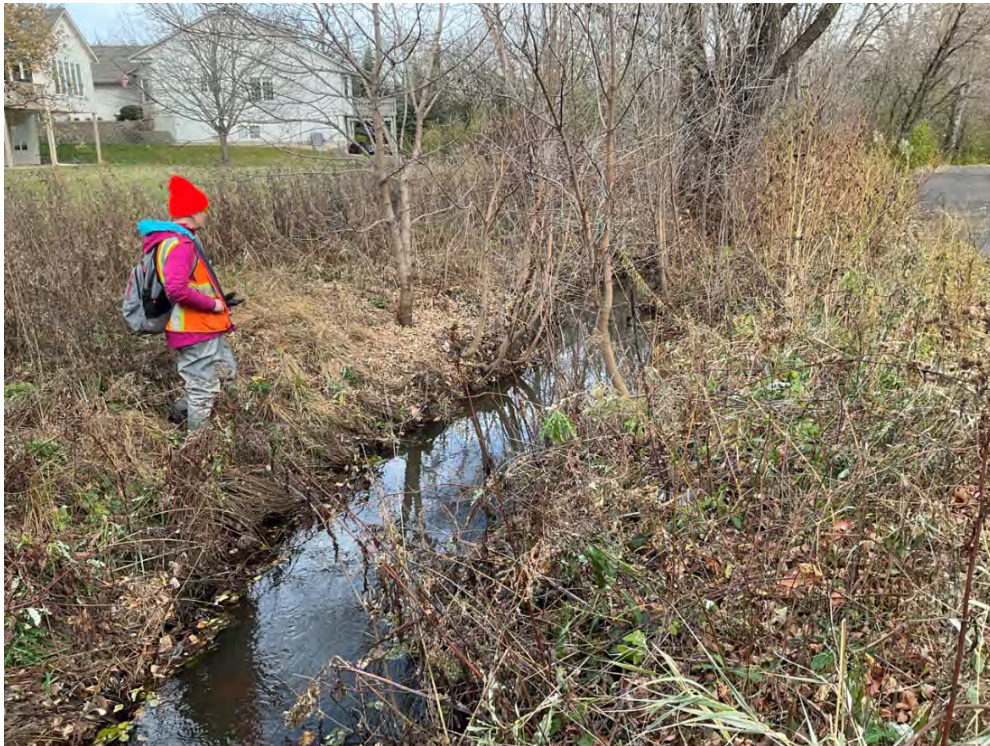
Photo 10: Site 1f. Looking downstream at station 12+50, low bank on left side, higher bank on right side, plant cover is intermittent.

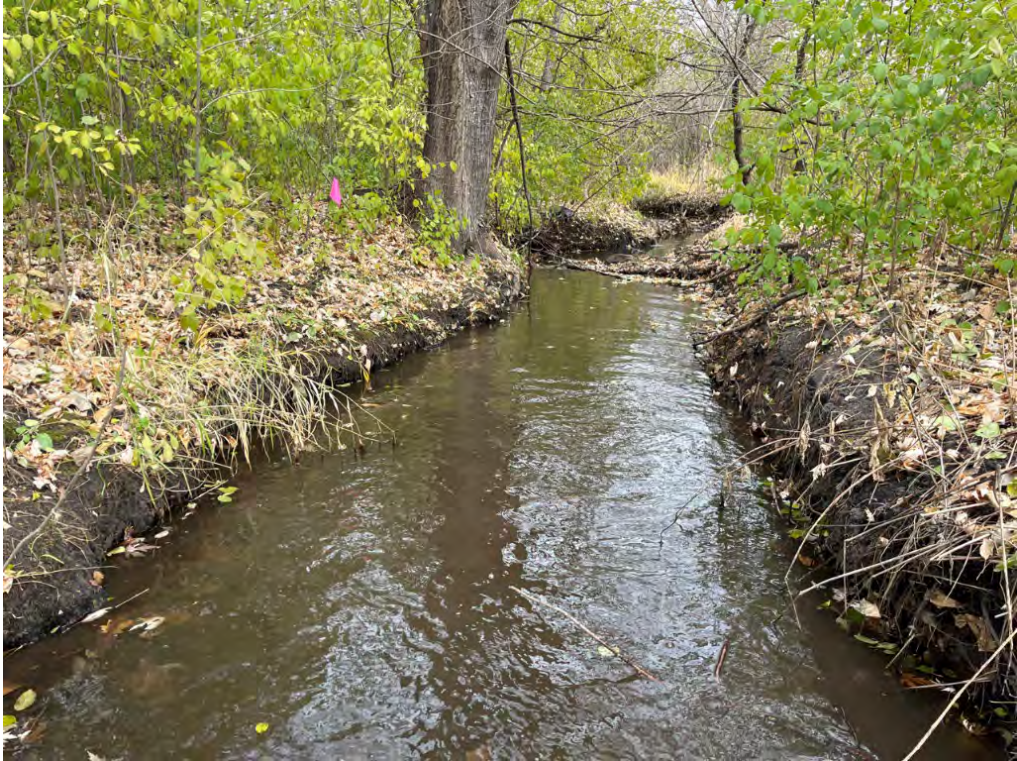
Photo 11: Site 1g. Looking downstream at station 14+00, both banks are low with some undercutting.

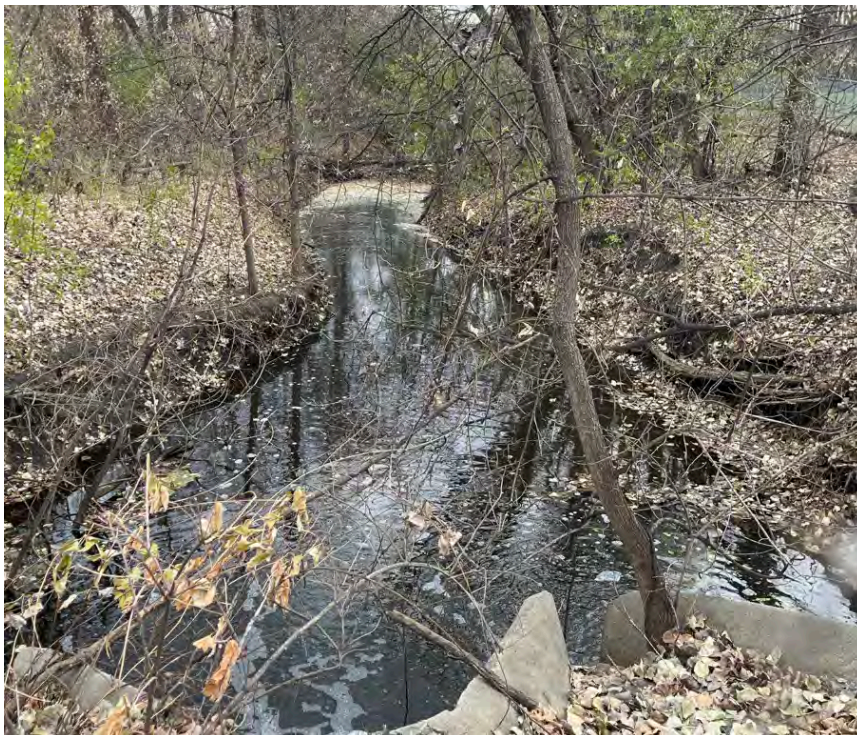
Photo 19: Site 2c. Looking downstream at station 23+50 from the pedestrian trail.

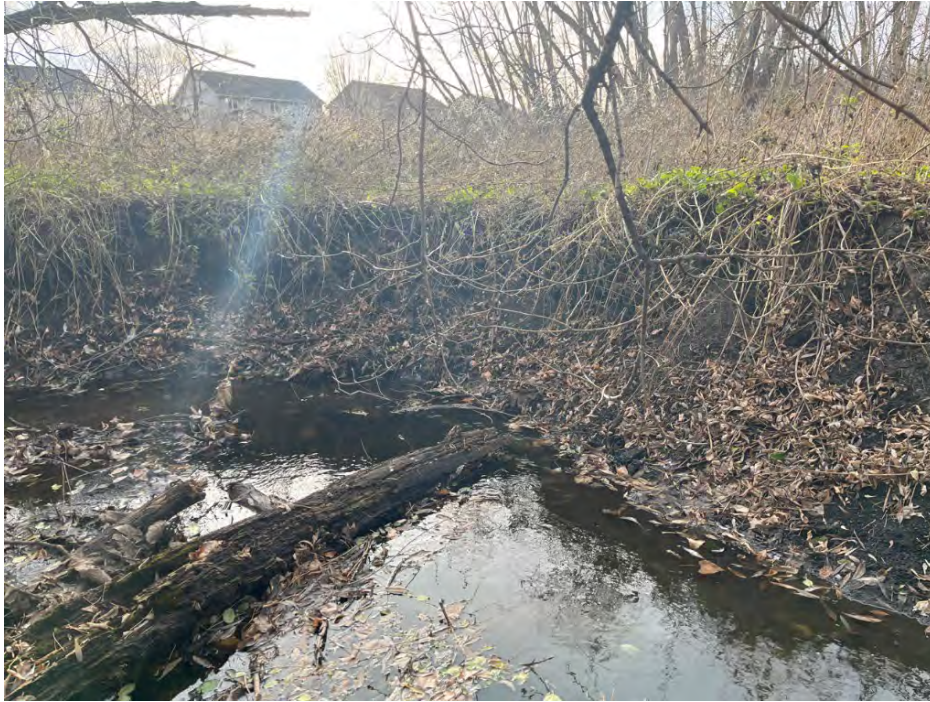
Photo 22: Site 2d. Looking at the right bank at station 27+90, the bank is mostly exposed.

2d. Right and left bank stabilization with grading, root wads, log vanes, woody debris removal, and vegetation establishment (Sta. 25+40 to 29+30)	3	3	3	3	3	0	0	4	2	2	0	2	1	26	Medium
2e. Right and left bank stabilization with grading banks and side channels, log vanes, woody debris removal, and vegetation establishment (Sta. 29+30 to 33+90)	2	1	1	1	3	0	0	8	2	2	0	2	1	23	Medium
2f. Right and left bank stabilization with grading, woody debris removal, log vanes, and vegetation establishment (Sta. 33+90 to 36+00)	1	1	1	1	3	0	0	3	2	2	2	2	1	19	Medium

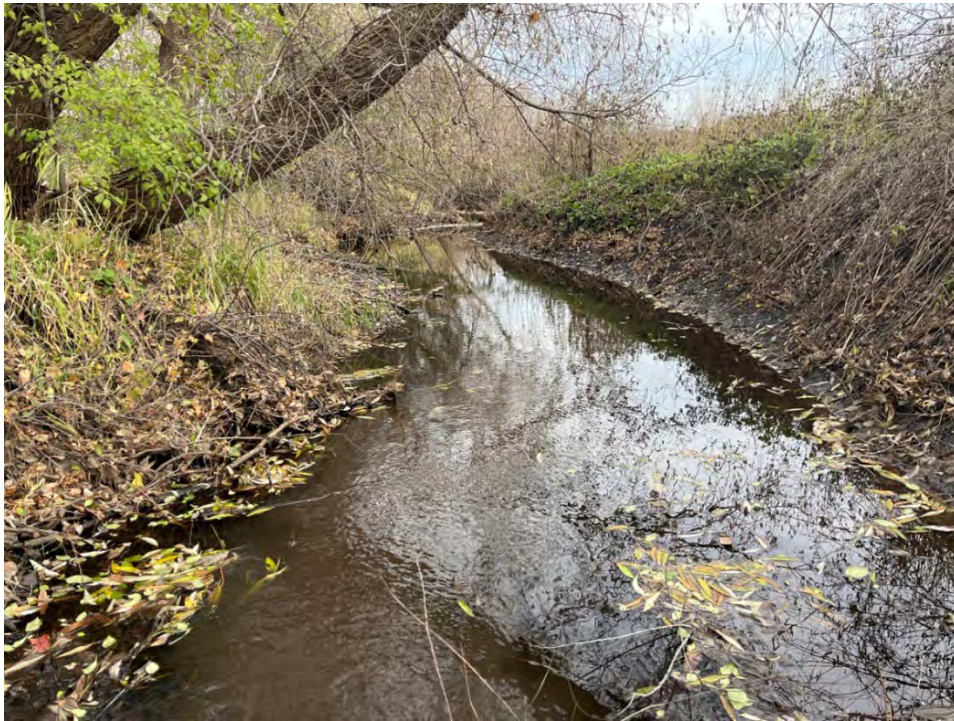
Photo 23: Site 2e. Looking downstream at station 30+30, the right bank is bare while the left bank had moderate cover.

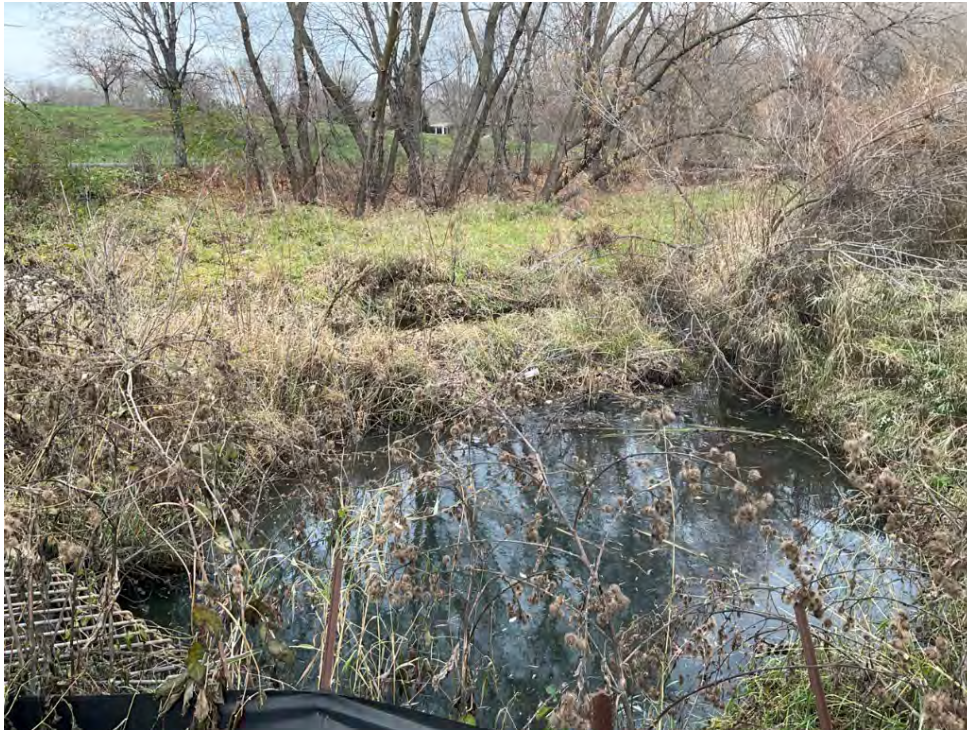
Photo 26: Site 3a. Looking downstream at the sediment island formed at station 37+00 due to the pipe crossing at Vicksburg Road. The island width ranges from 1 to 10 feet wide, is 30-feet long, and roughly 1 foot above the water surface level.

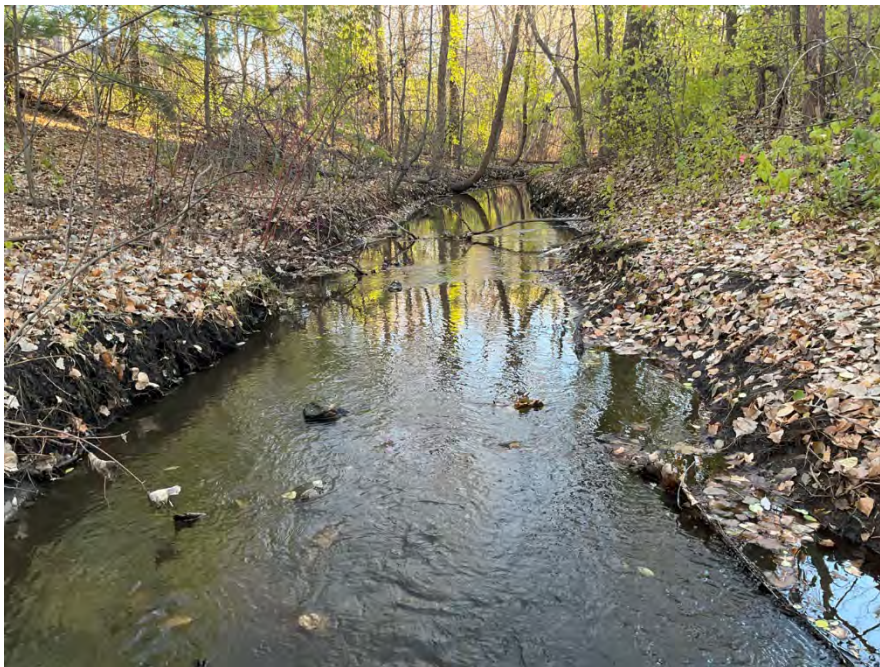
Photo 27: Site 3c. Looking downstream at station 42+90, both banks have minimal vegetative surface protection.

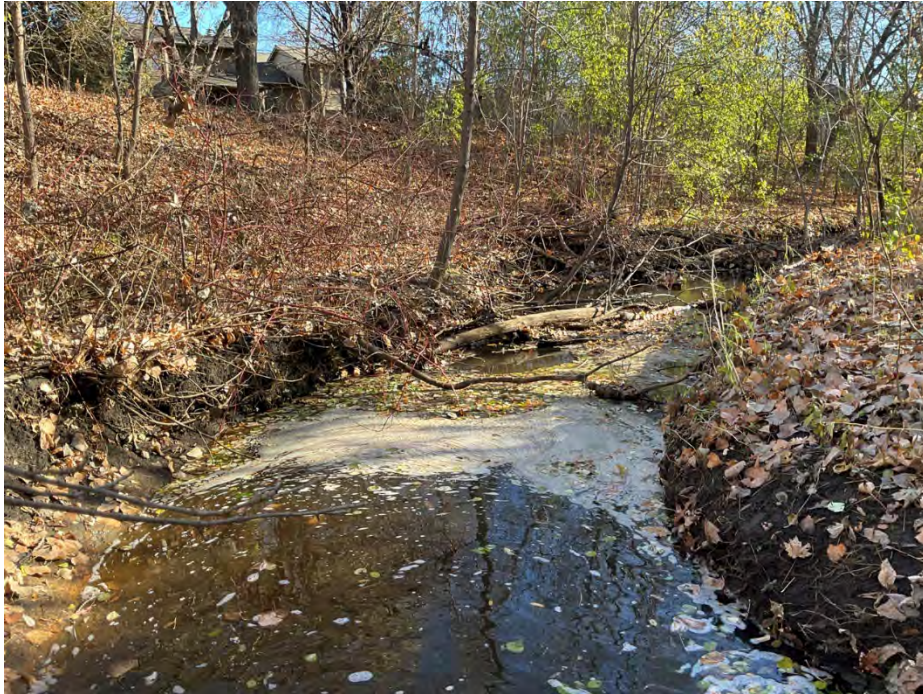
Photo 28: Site 3c. Looking downstream at a bend at station 45+20.

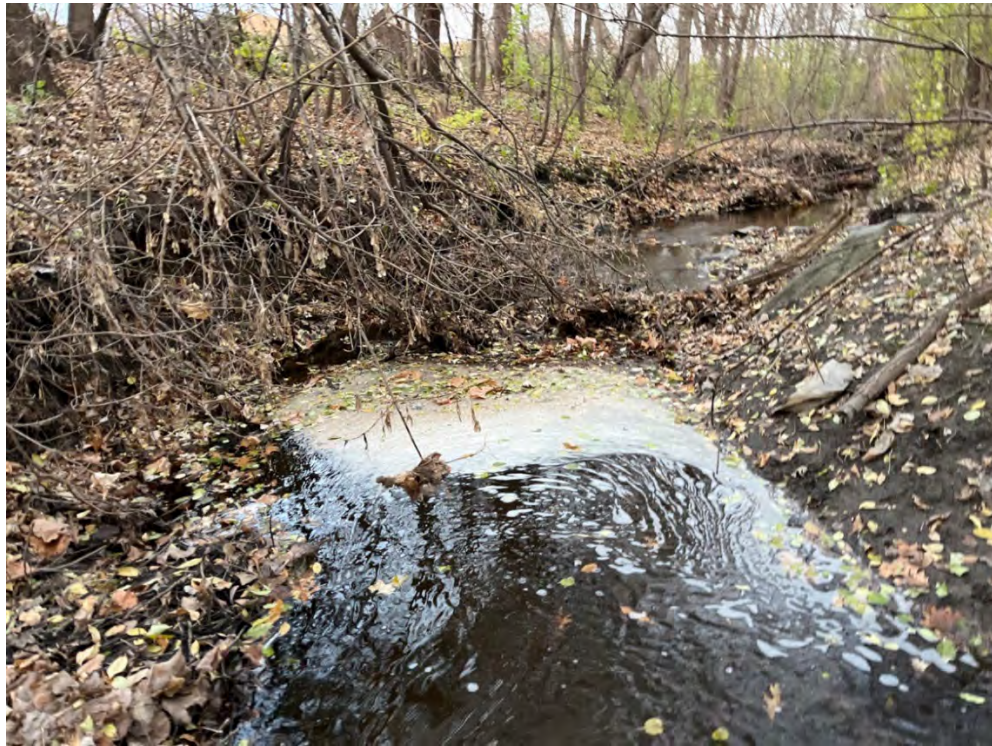
Photo 38: Site 4e. Looking downstream at station 63+00, mild channel blockage.

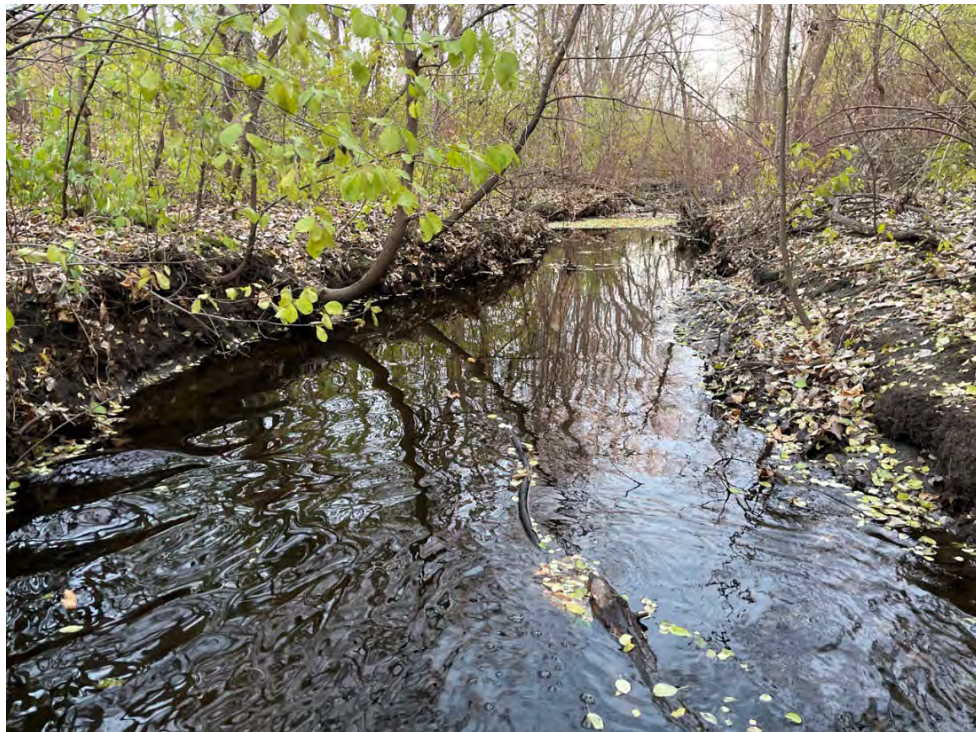
Photo 39: Site 4e. Looking downstream at station 64+20, upstream of a larger deep pool.

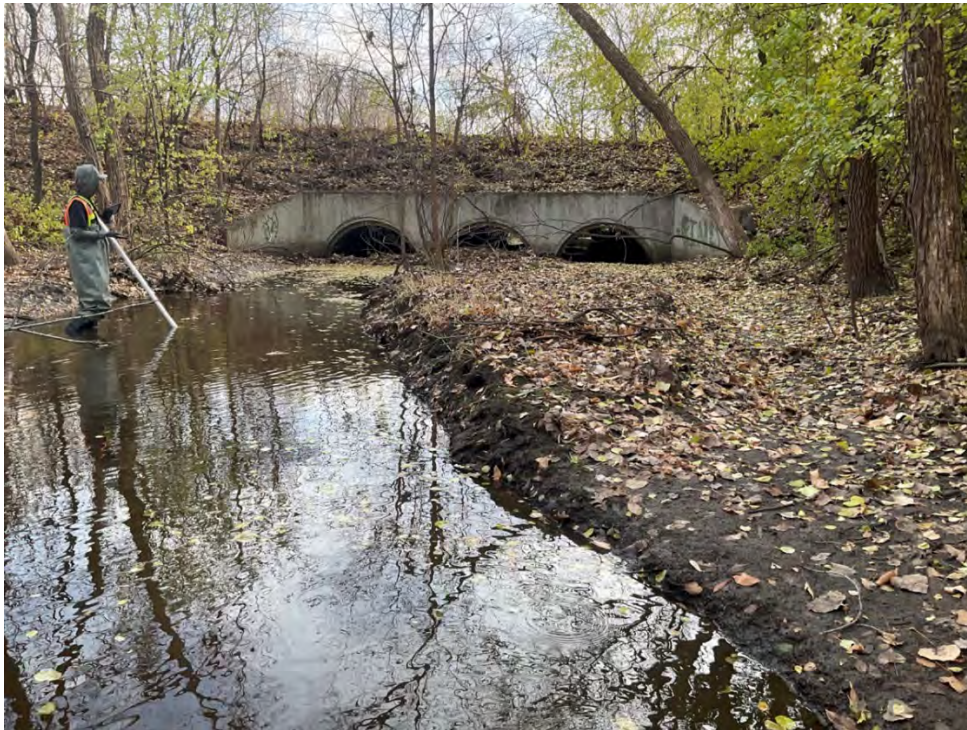
Photo 41: Site 4f. Looking downstream at station 66+90 towards the 38th Avenue crossing. The center and right culvert are partially blocked by sediment deposition.

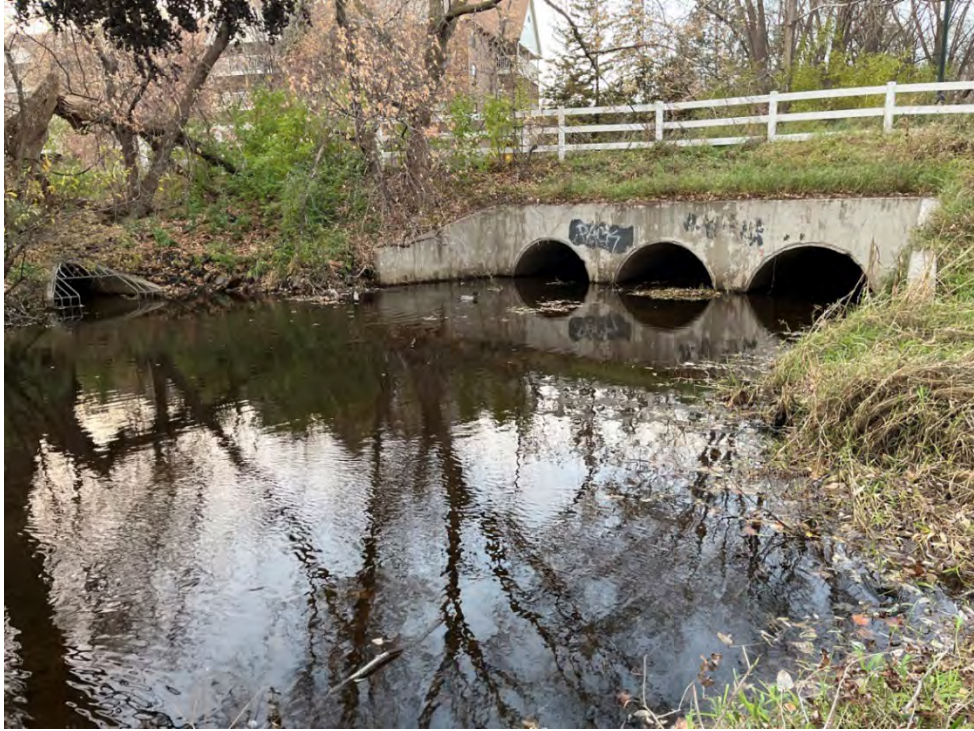
Photo 42: Site 4g. Looking upstream at station 69+00 towards the 38th Avenue crossing. Slight sediment build up in center of channel near the culverts.
