**ARCHAEOLOGICAL INVESTIGATION CONDUCTED FOR THE
PLYMOUTH CREEK STREAM CHANNEL RESTORATION FEASIBILITY STUDY,
CITY OF PLYMOUTH,
HENNEPIN COUNTY, MINNESOTA**

Bassett Creek Watershed Management Commission

**Barr Engineering
4300 MarketPointe Dr
Minneapolis, MN 55435**

January 2016

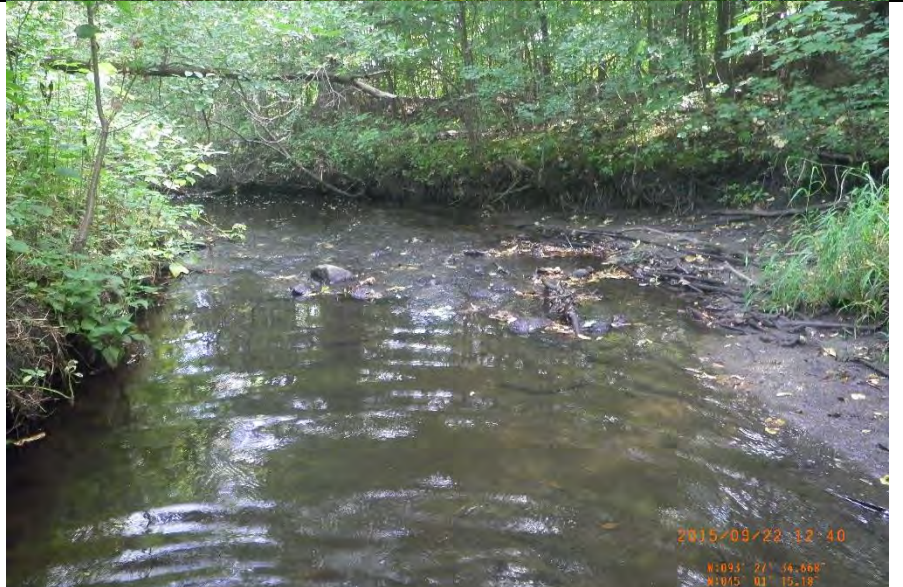
Photo 9 – September 22, 2015

Study Reach
(East of Fernbrook Ln. N)

Many areas within the stream reach east of Fernbrook Lane have snags that obstruct water flow

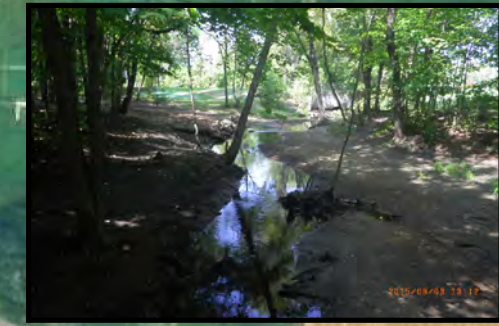
Site 1: Stabilize straightened stream segment (Sta. 26+50 to 28+00)

- a) Re-meander into historic channel
- b) Stabilize local erosion sites with hard armor/riprap
- c) Stabilize local erosion sites with bioengineering*

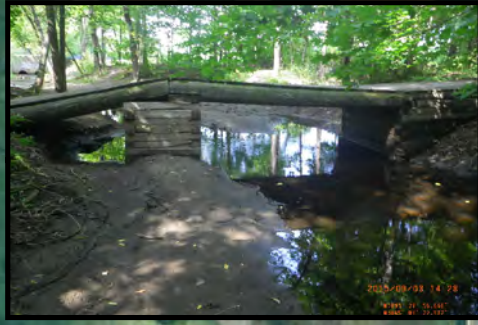
Site 6: Stabilize bridge abutments (Sta. 26+50)

- a) Stabilize with hard armor and log vanes*
- b) Stabilize with hard armor only

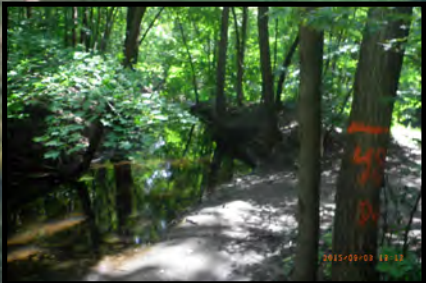
Site 2: Stabilize straightened stream segment (Sta. 25+00 to 26+50)

- a) Narrow the stream channel and construct bank/bench
- b) Install log vanes within reach*
- c) Upper bank vegetation establishment*

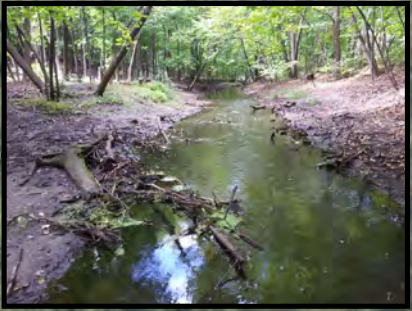
Site 4: Stabilize overbank areas on both sides of creek (Sta. 20+00 to 28+00)

- a) Establish vegetated buffer*
- b) Re-align disc golf course

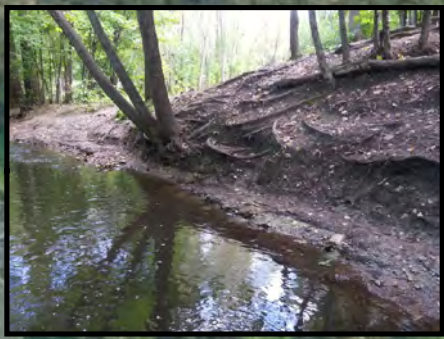
Site 5: Stabilize steep eroding bank (Sta. 20+25 to 20+75)
