Feasibility Report for North Branch Bassett Creek Restoration Project

Crystal, Minnesota

September 2010

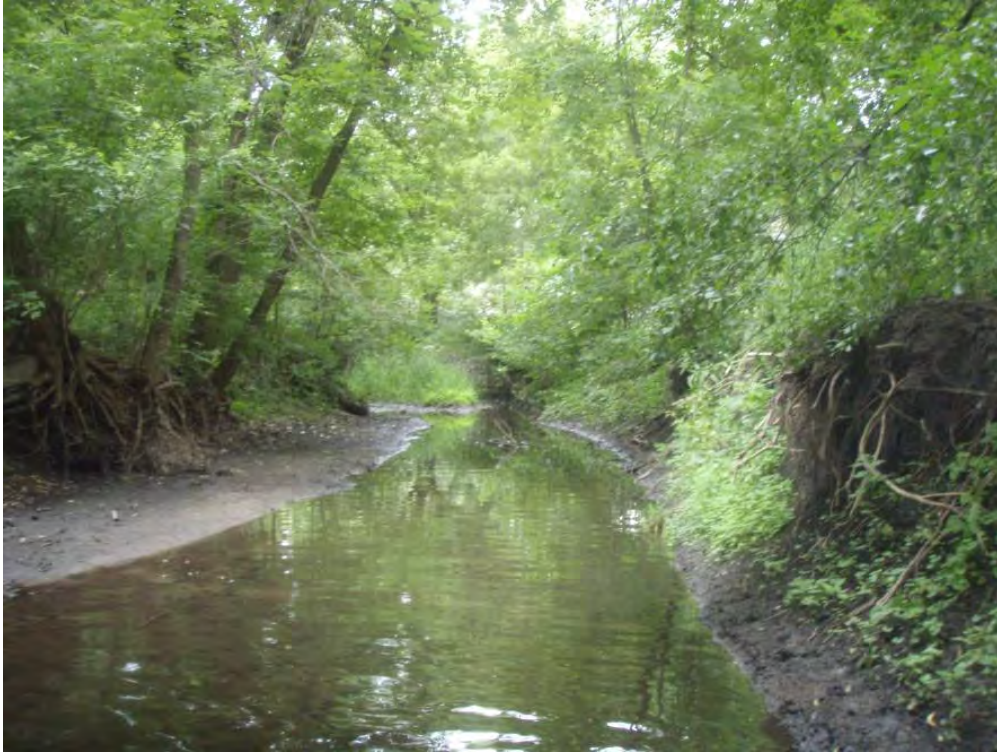
Photo 1. *Site 1.* Looking upstream at both banks.

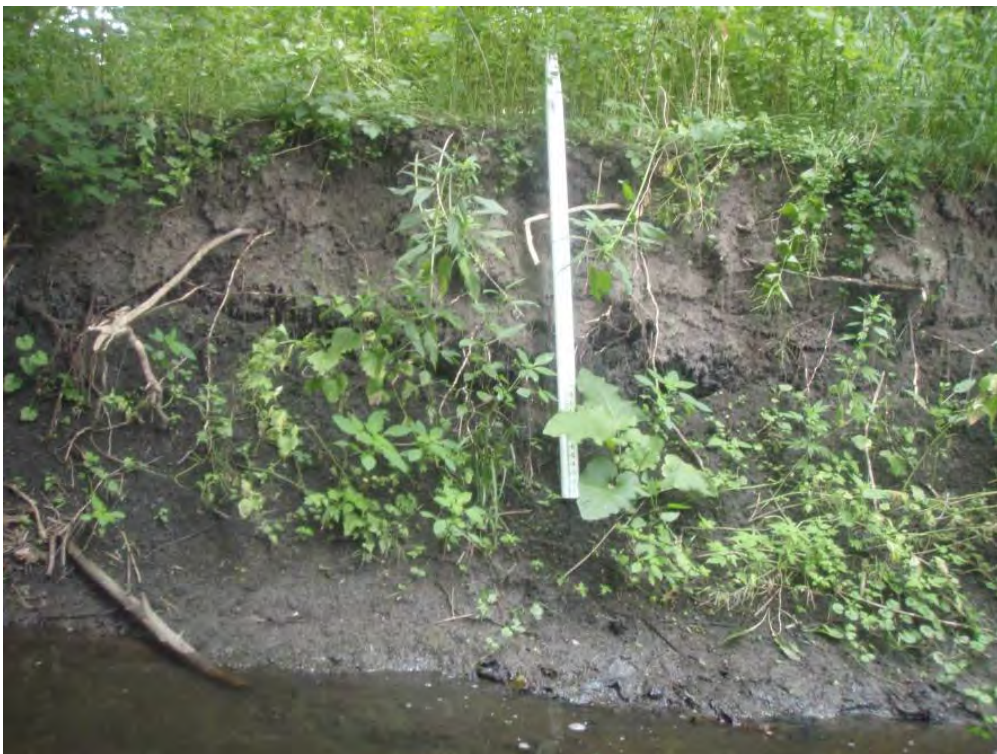
Photo 2. *Site 2.* Moderate erosion.

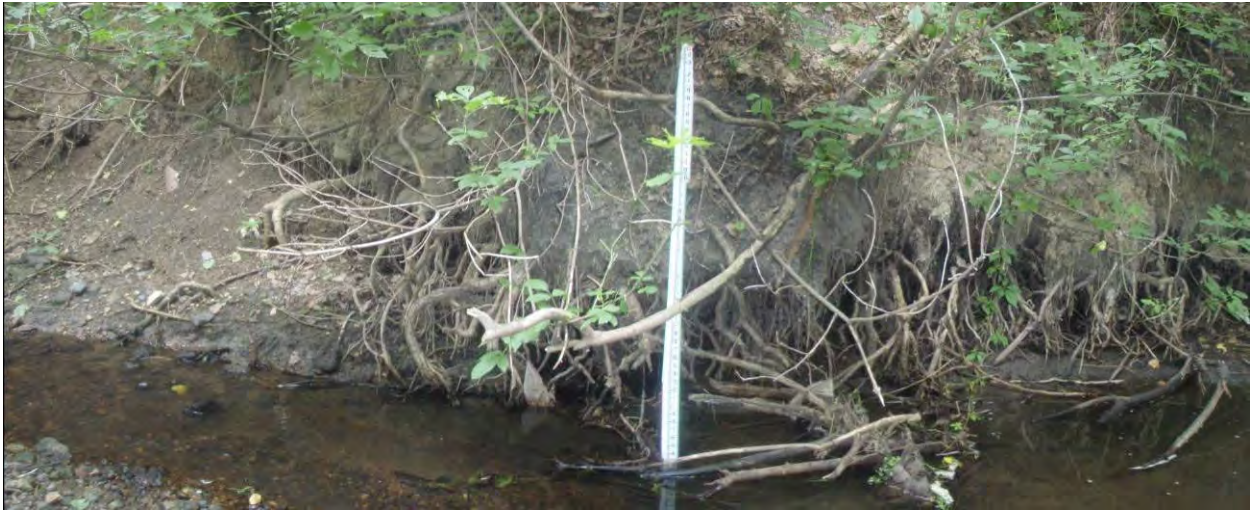
Photo 3. *Site 2.* Severely eroding bank.

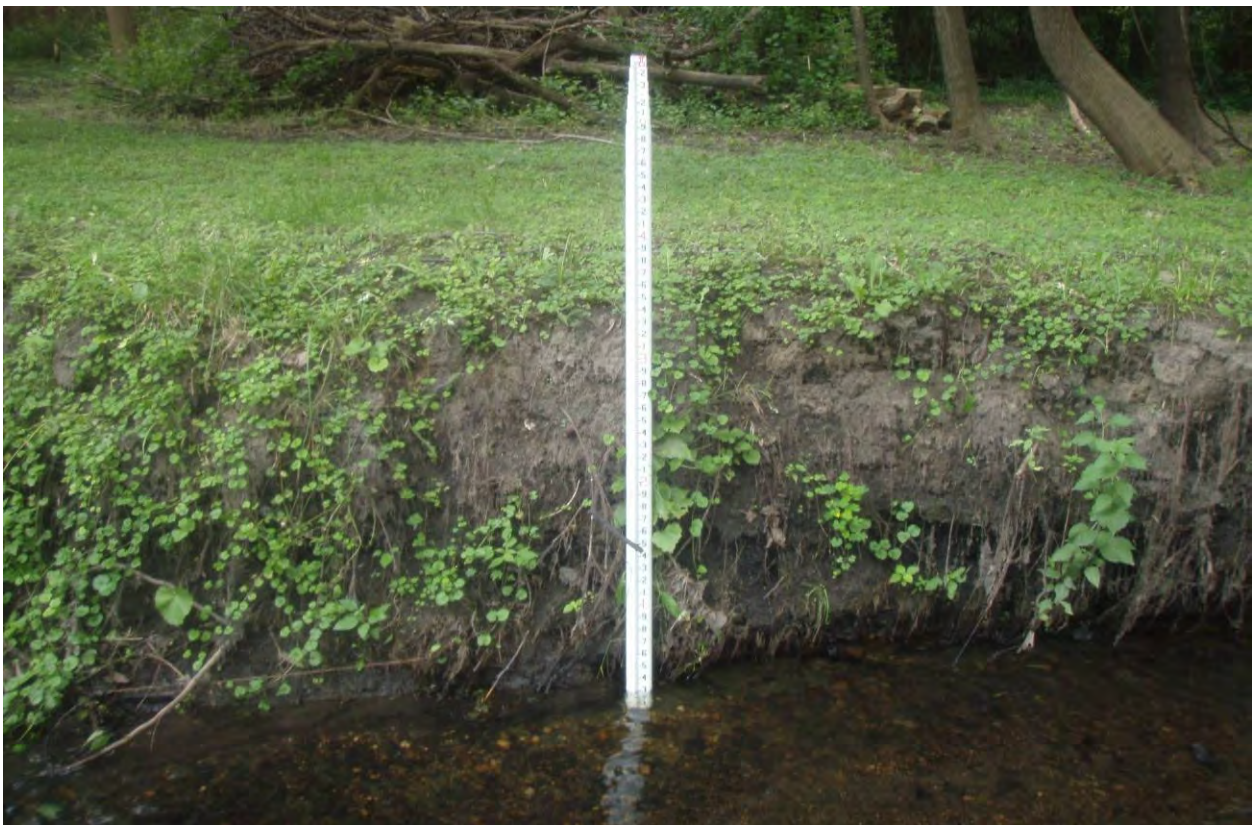
Photo 4. *Site 3.* Moderately eroding bank

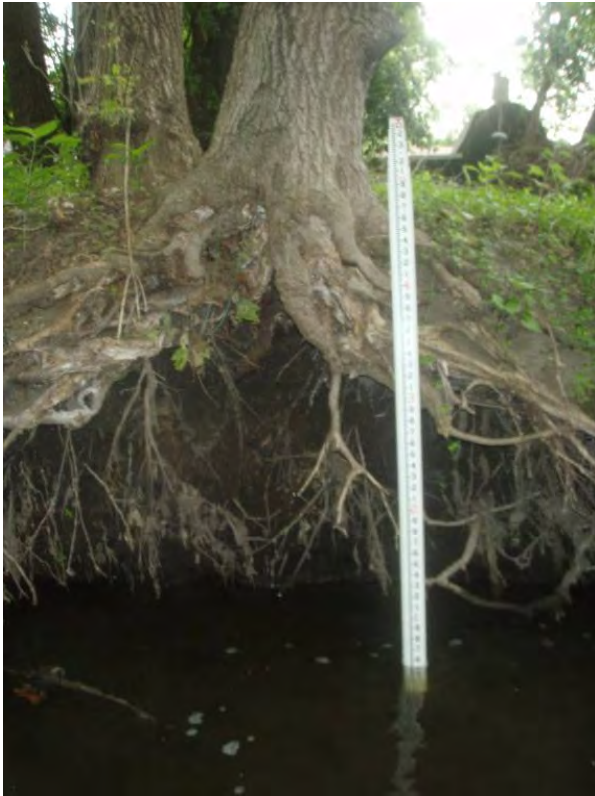
Photo 5. *Site 4.* Erosion being curtailed by tree roots.

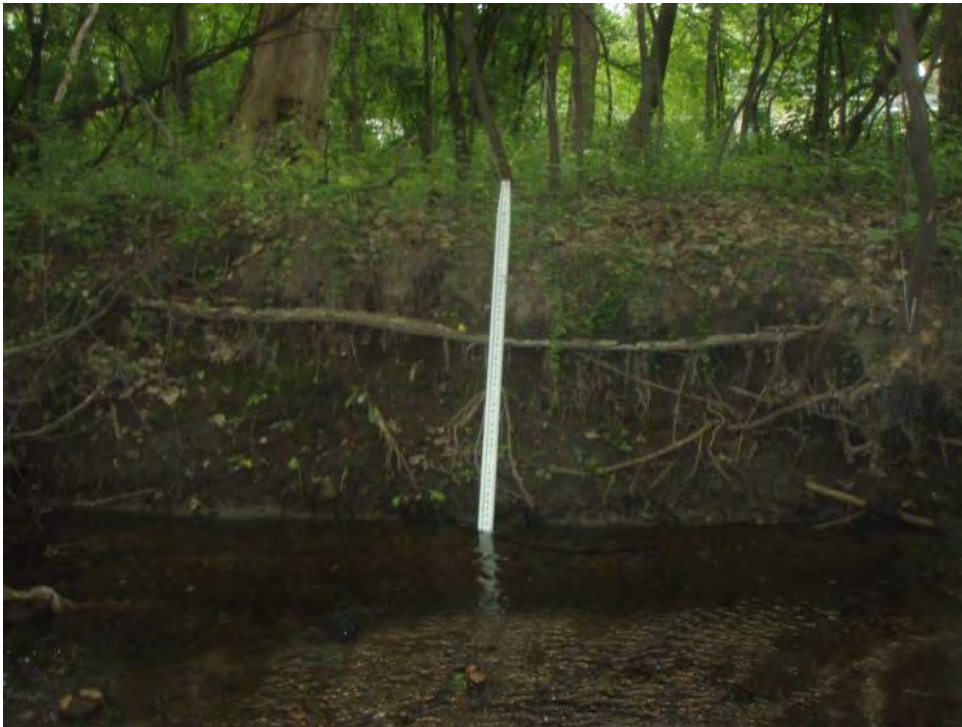
Photo 6. *Site 5.* Moderate to severe erosion.

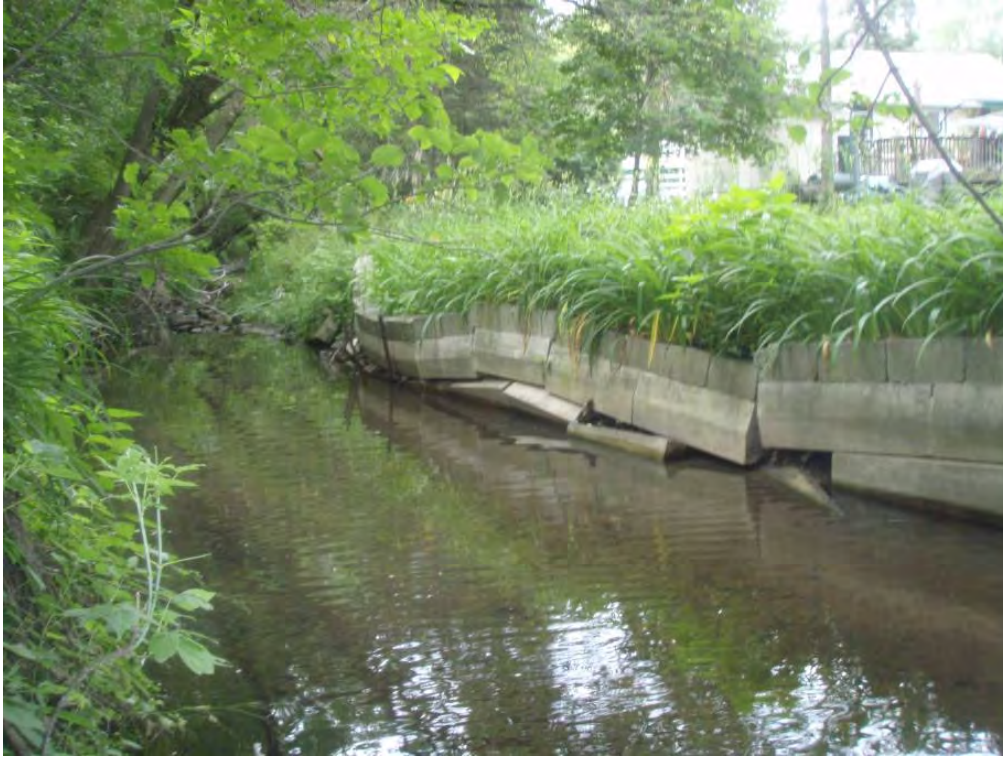
Photo 7. *Site 6.* Banks being held by failing wall.

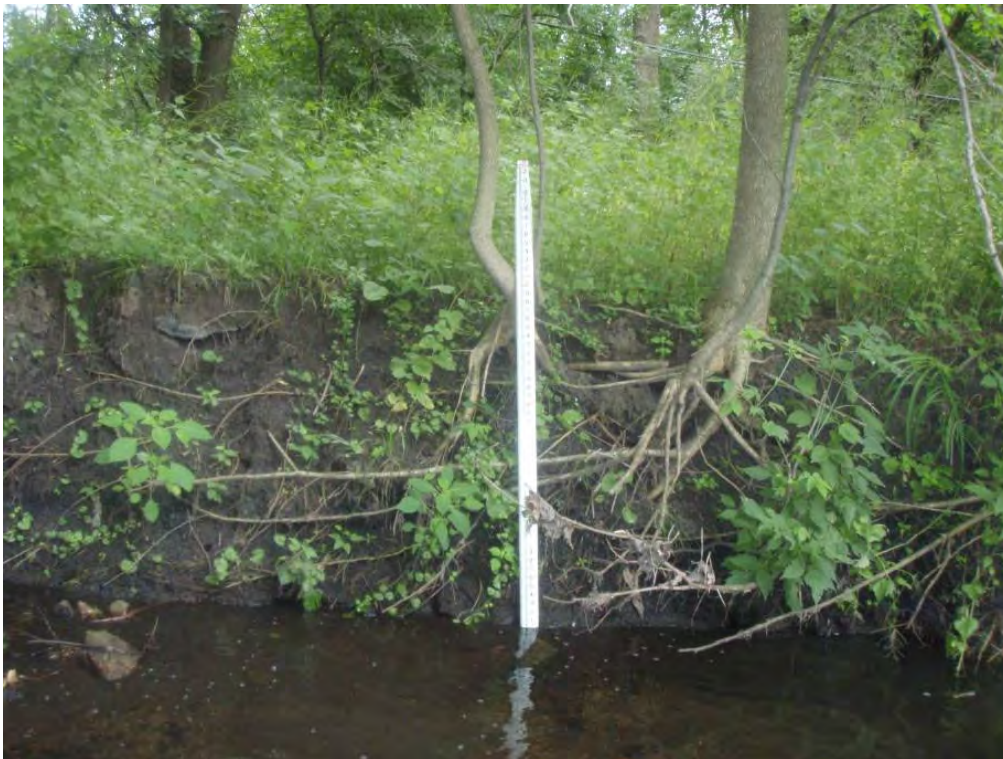
Photo 8. *Site 6.* Opposite bank without wall.

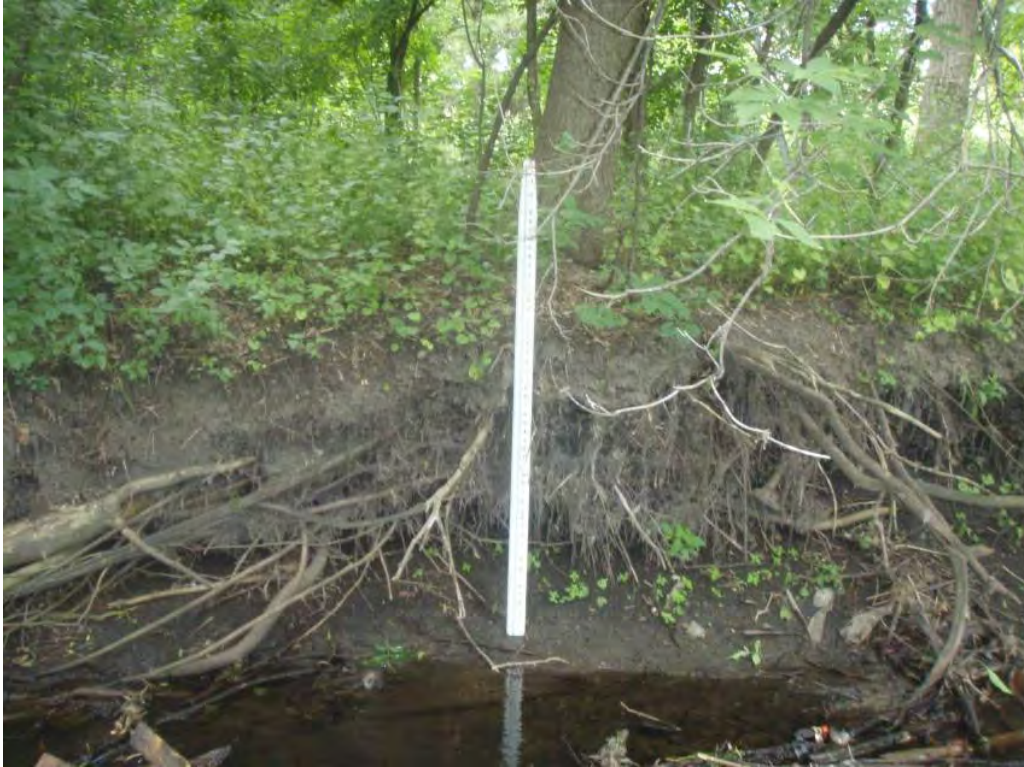
Photo 9. *Site 7.* Moderate erosion.

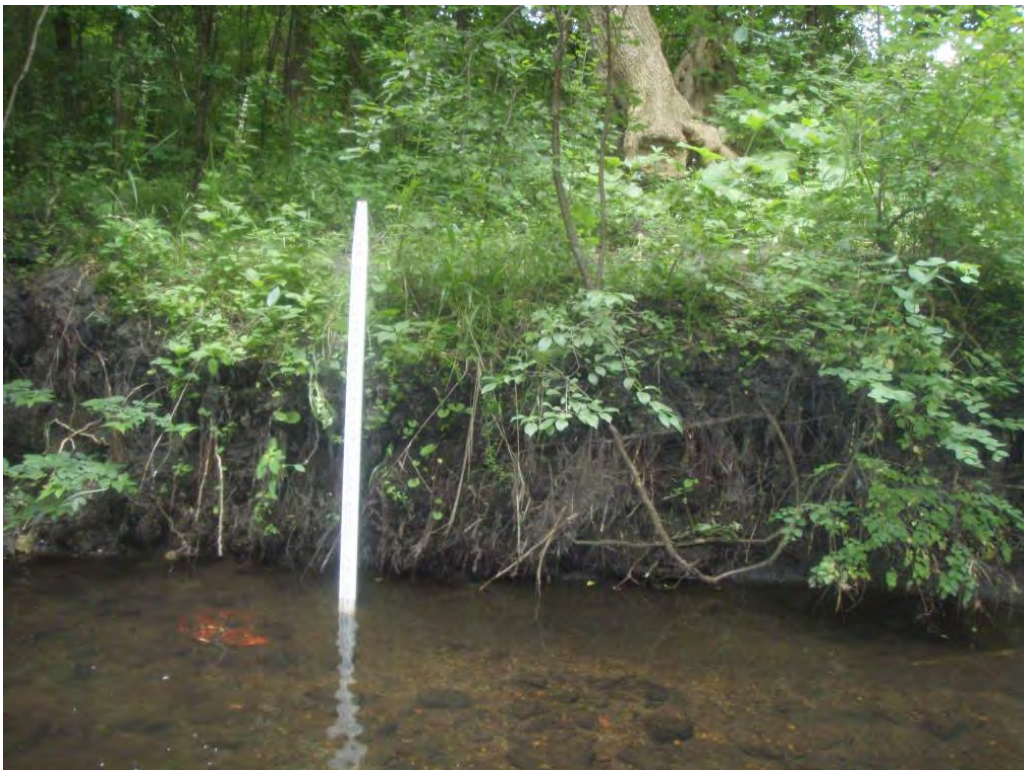
Photo 10. *Site 8.* Moderate erosion

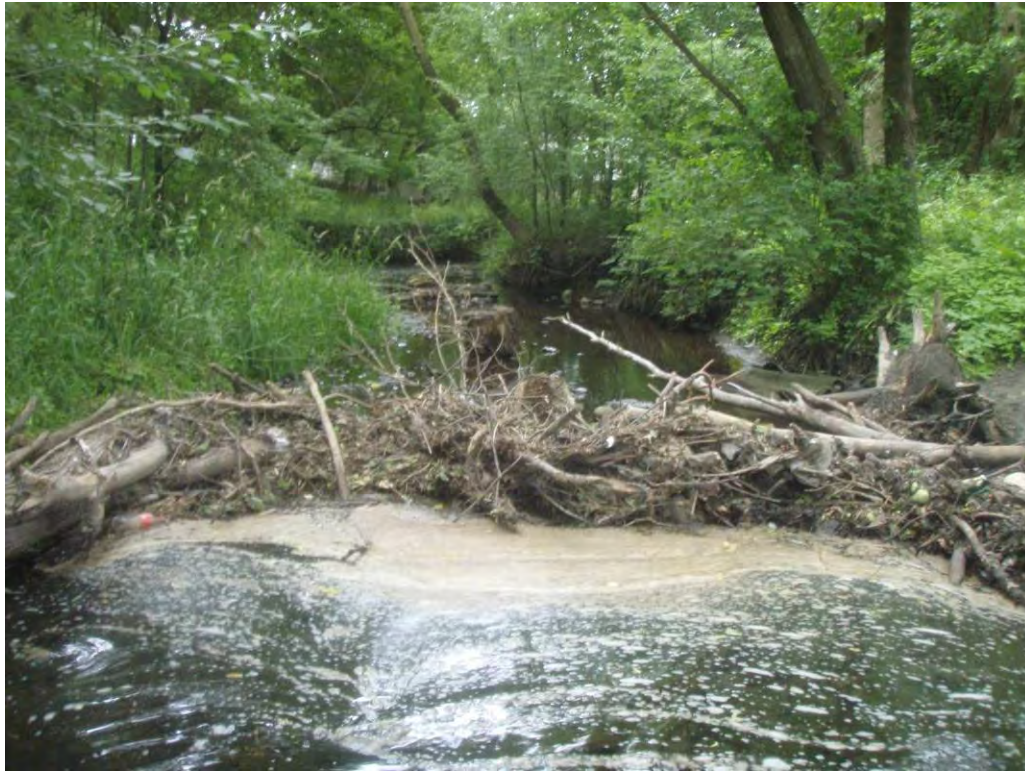
Photo 11. *Site 9.* Debris jam.

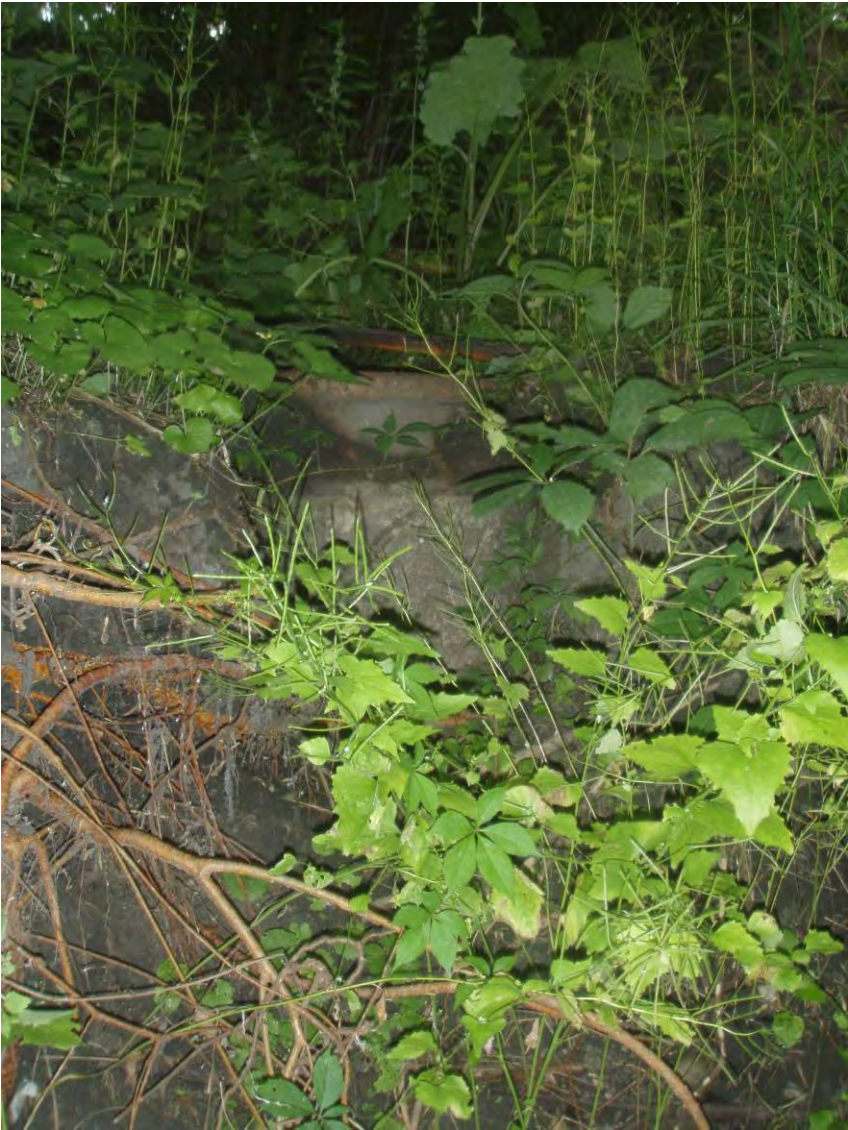
Photo 12. *Site 10.* Manhole in need of additional support and protection.

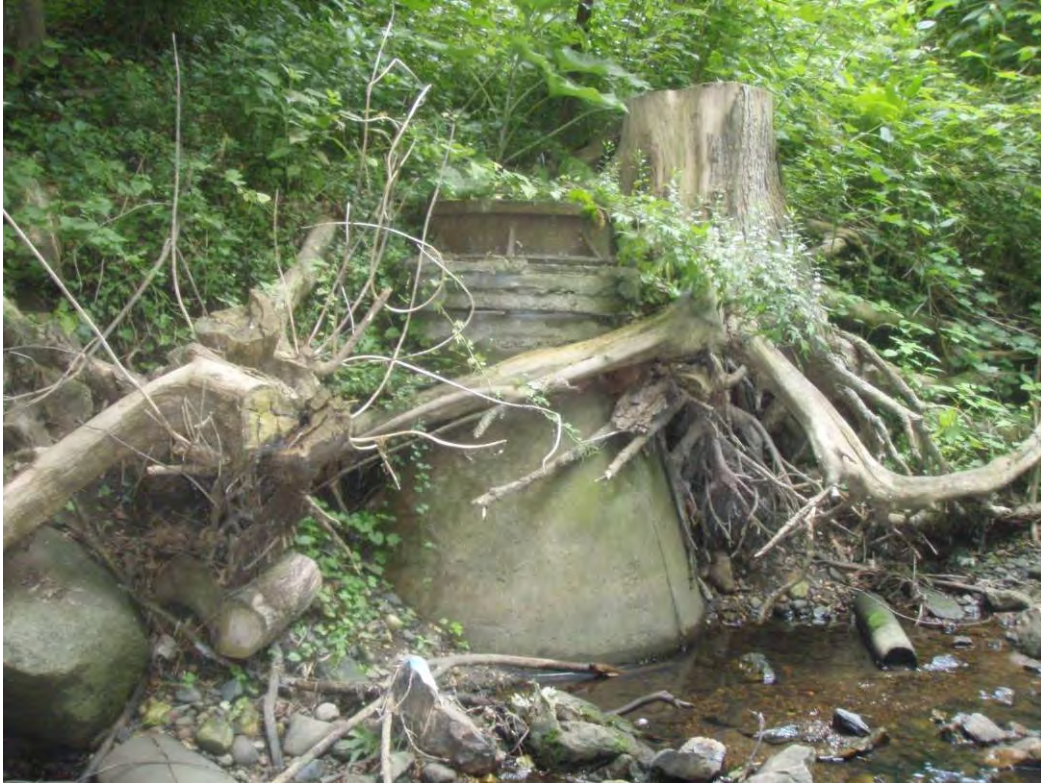
Photo 13. *Site 11.* Exposed manhole.

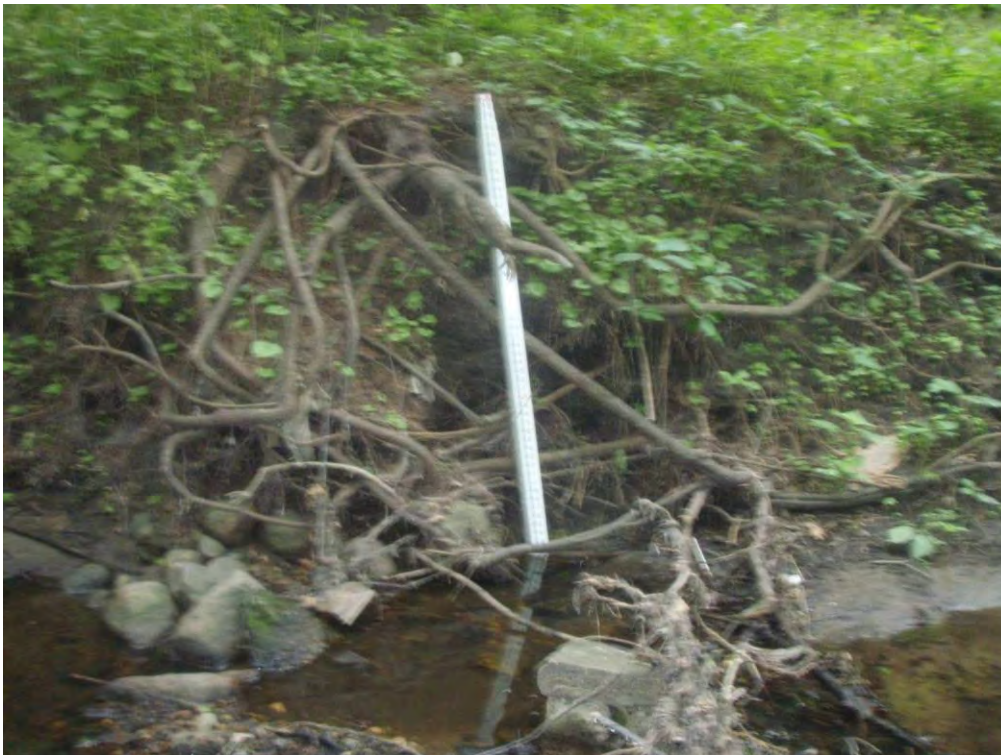
Photo 14. *Site 12.* Moderate erosion.

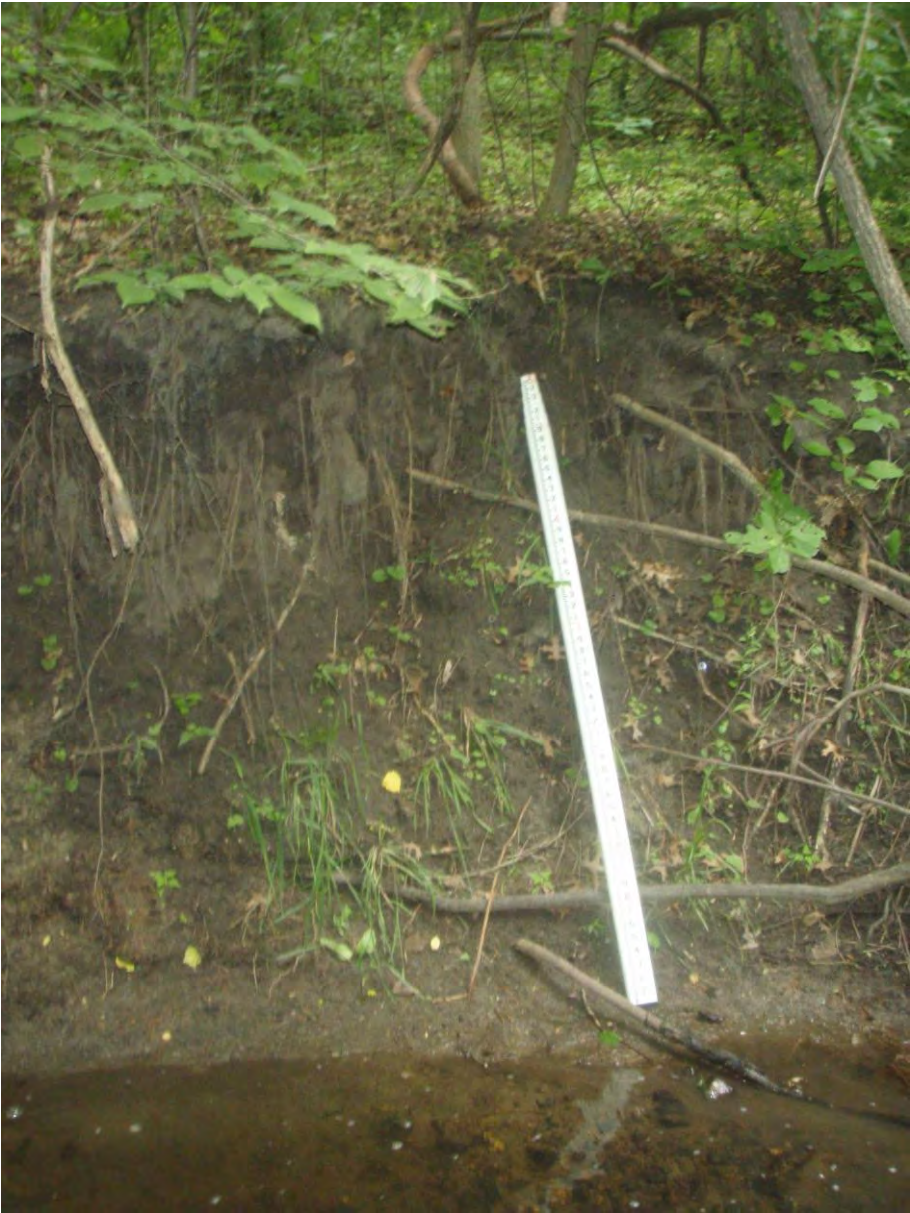
Photo 15. *Site 13.* Scarp formation with severe erosion

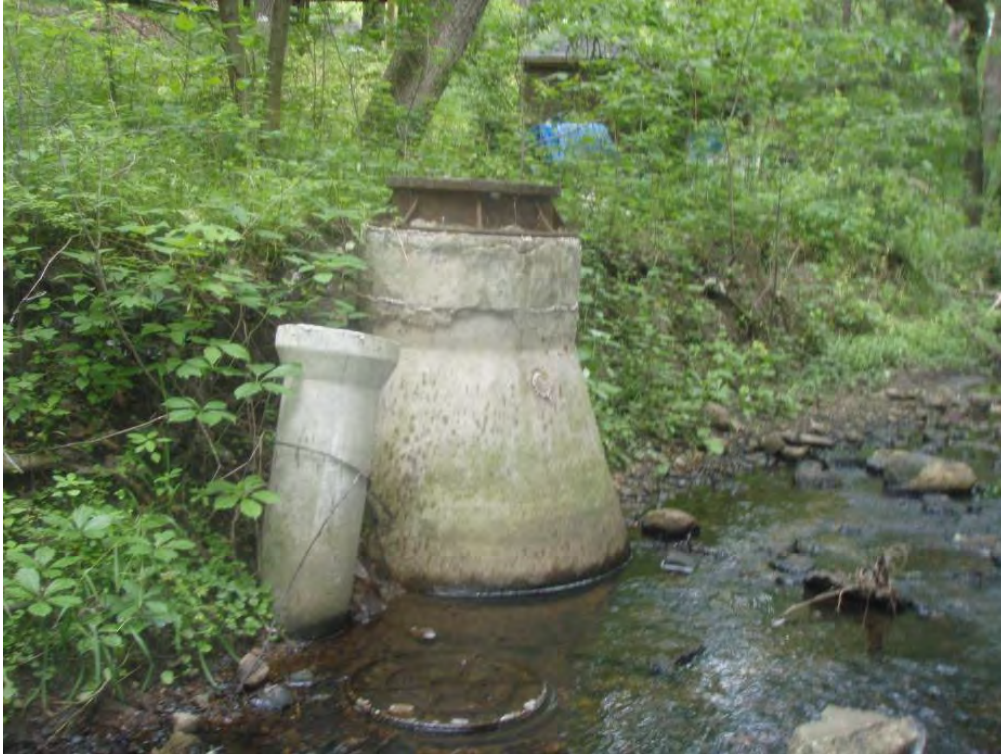
Photo 16. *Site 14.* Exposed manhole at outside of stream bend.

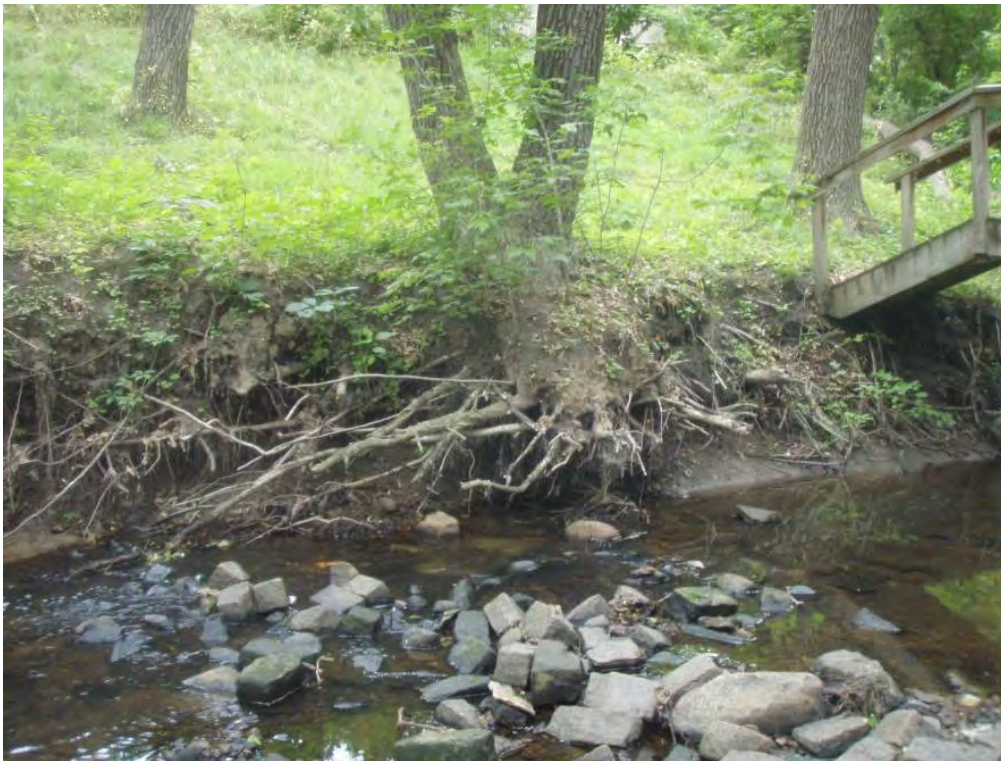
Photo 17. *Site 15.* Minor bank erosion with undercut trees.

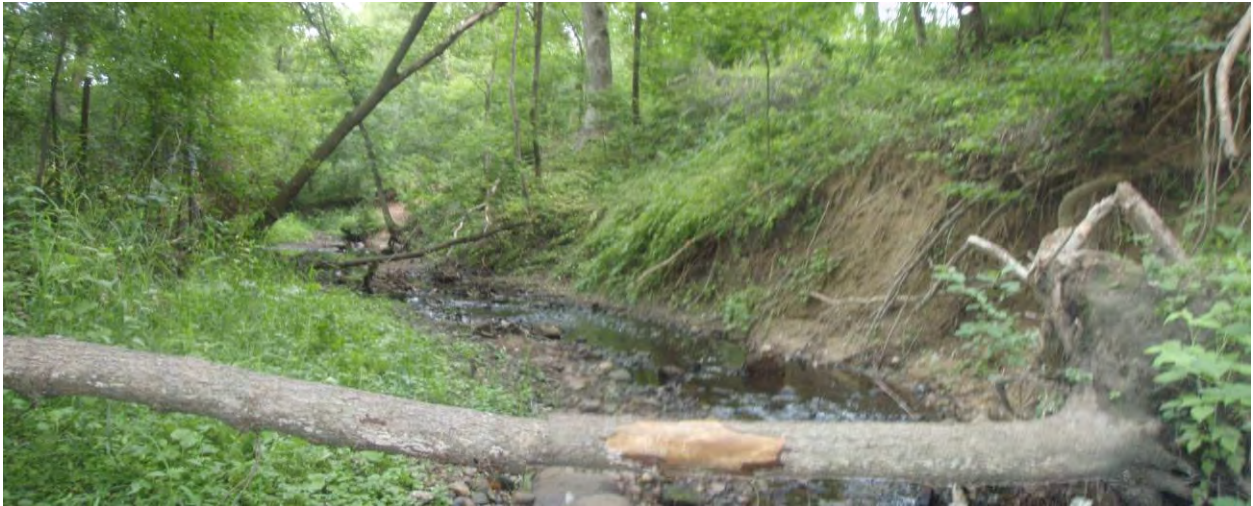
Photo 18. *Site 16* Fallen tree with large scarp in background.

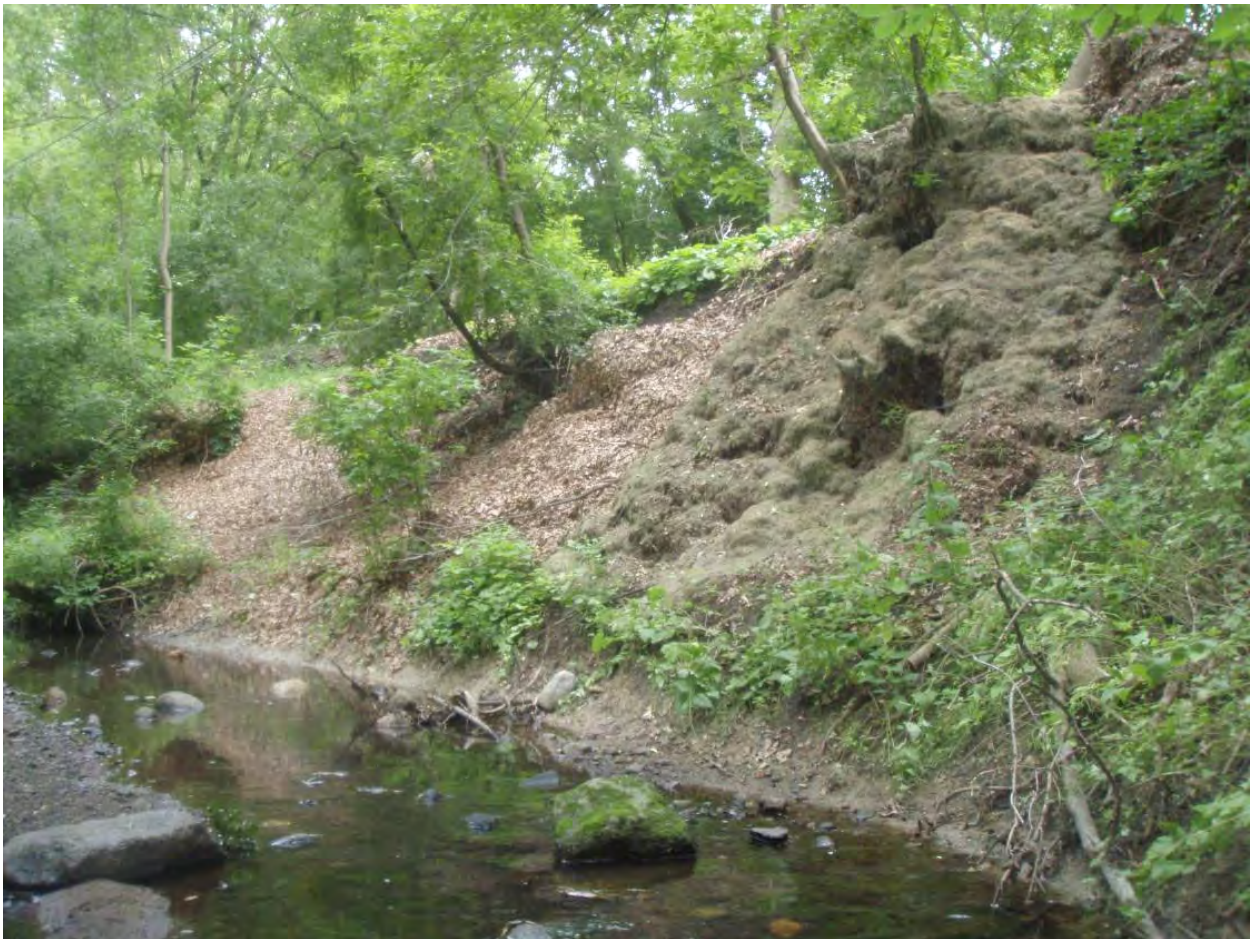
Photo 19. *Site 17.* Steep bank with some litter and soil present.

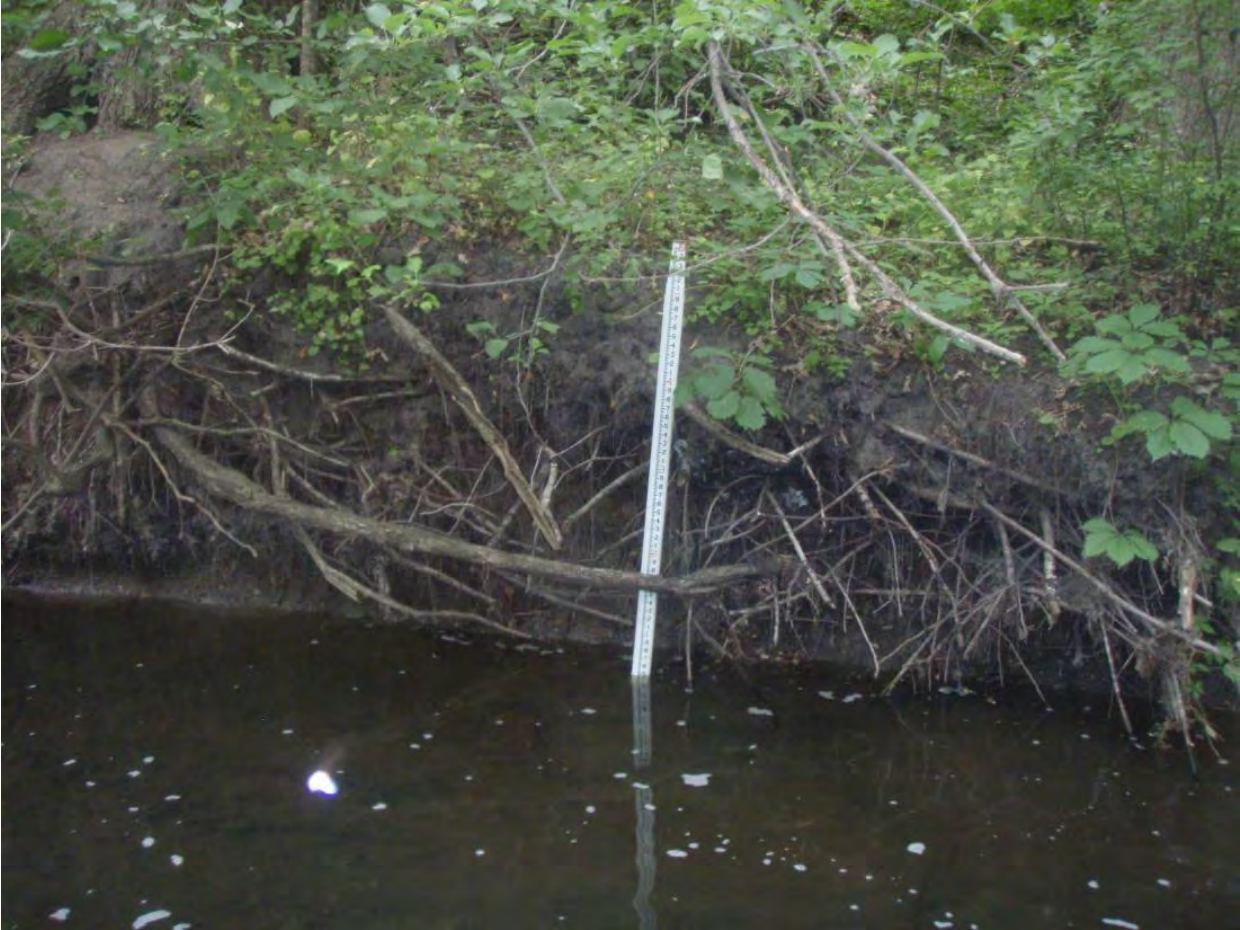
Photo 20. *Site 18.* Moderate erosion with undercut trees.

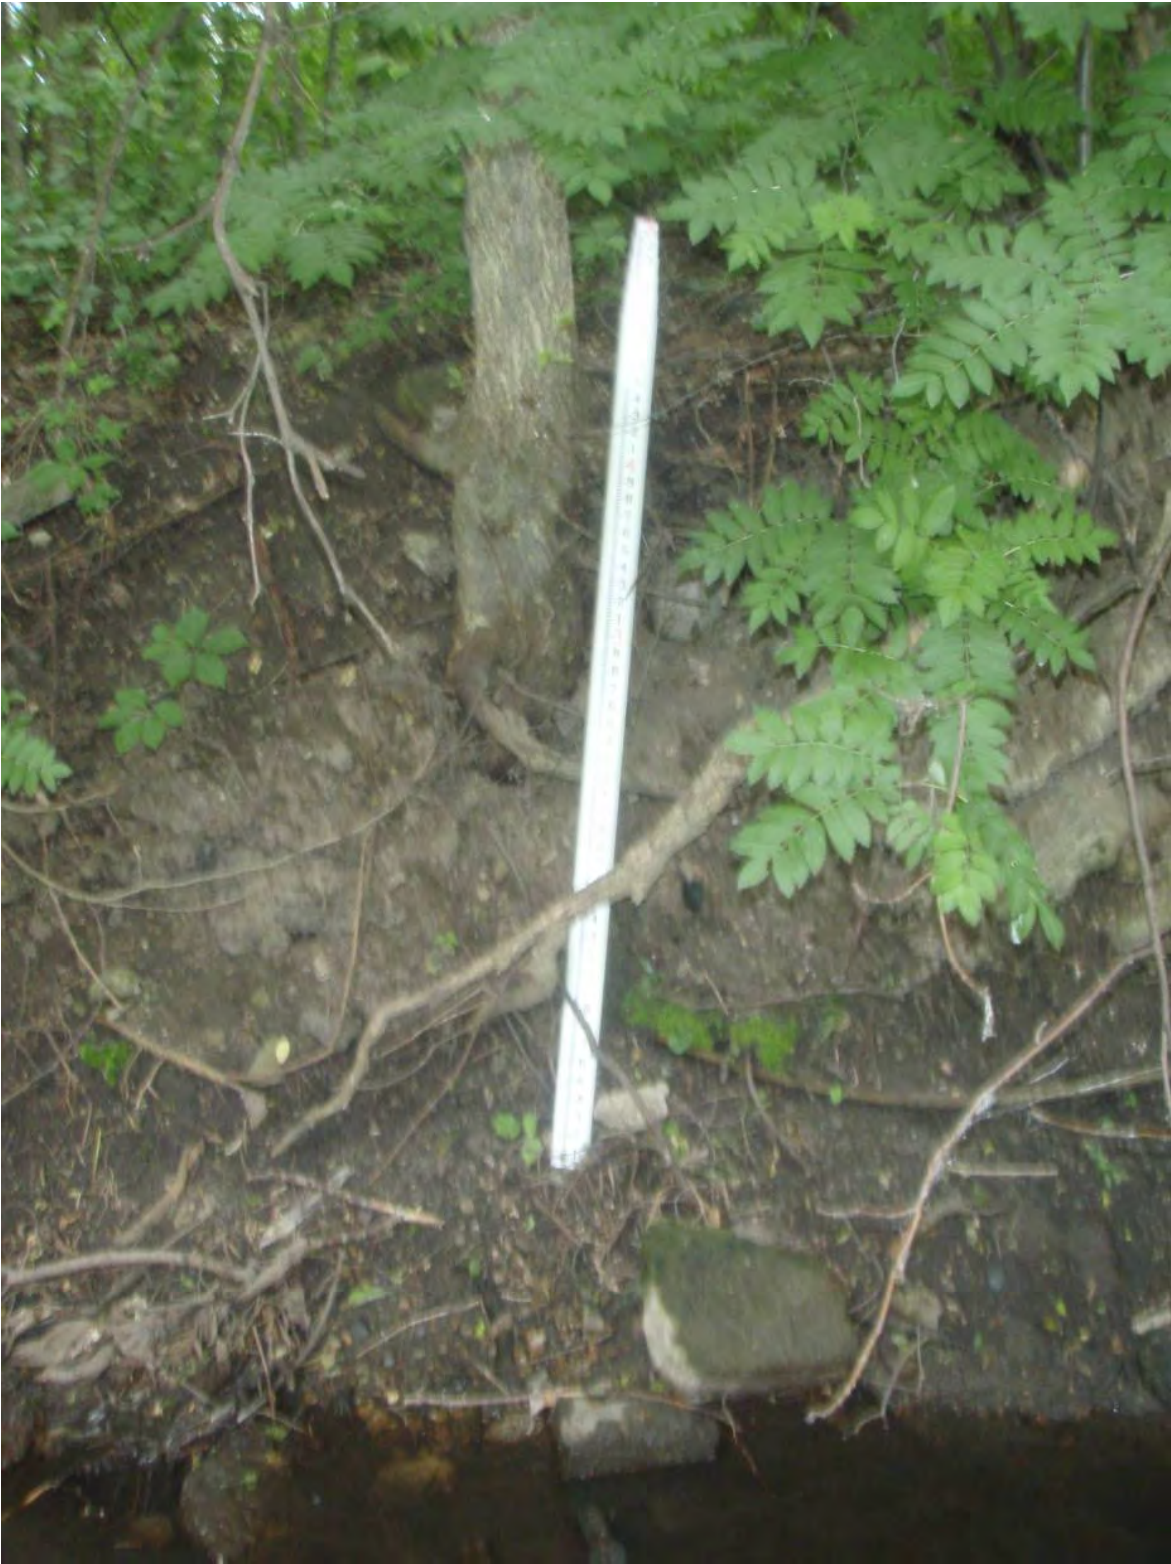
Photo 21. *Site 19.* Steep bank with erosion present.

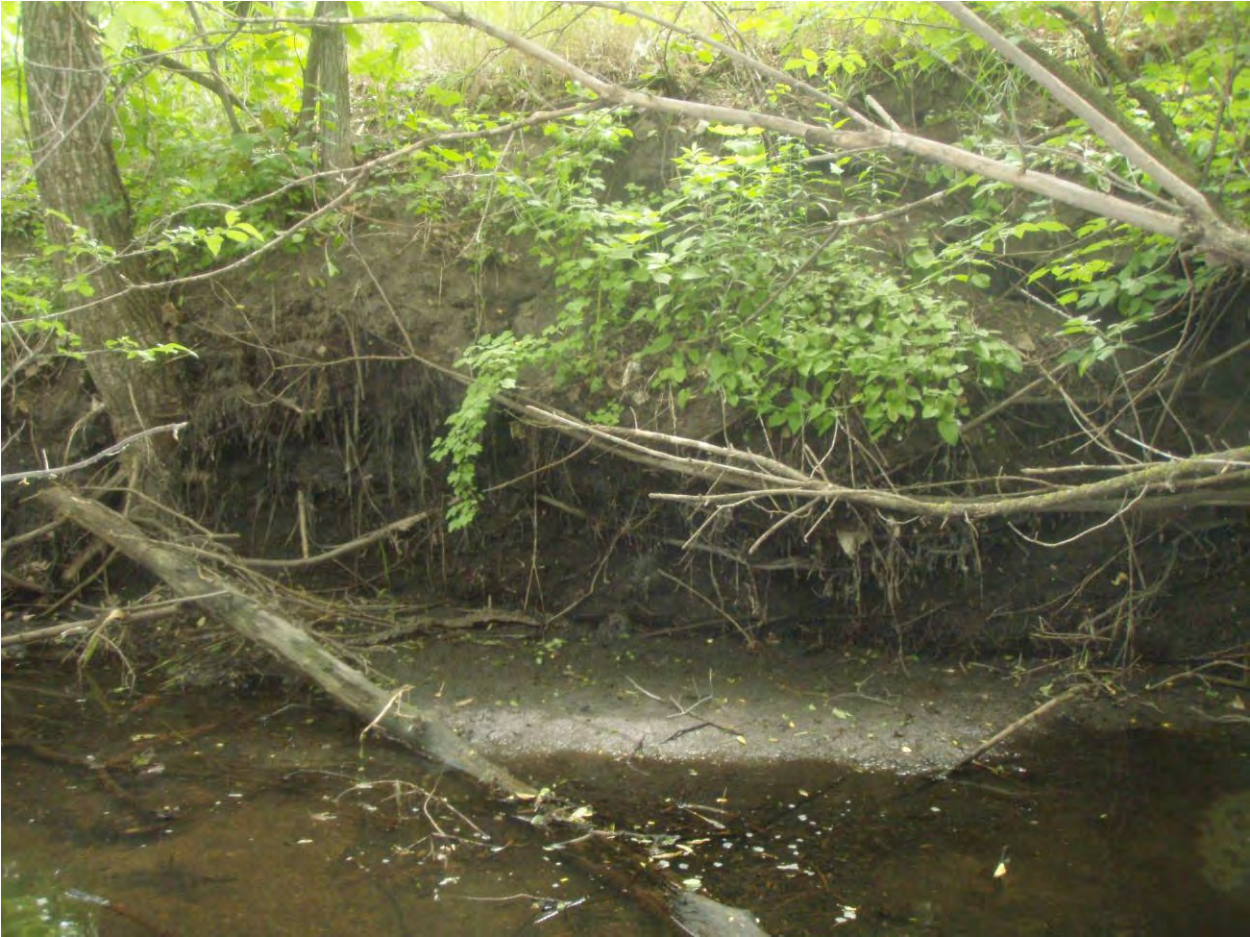
Photo 22. *Site 20.* Minor bank erosion with undercut trees.
