# **Feasibility Report for Bassett Creek Restoration Project**

**Golden Valley, Minnesota**

**Prepared for  
Bassett Creek Watershed Management Commission**

***DRAFT***  
**July 2009**

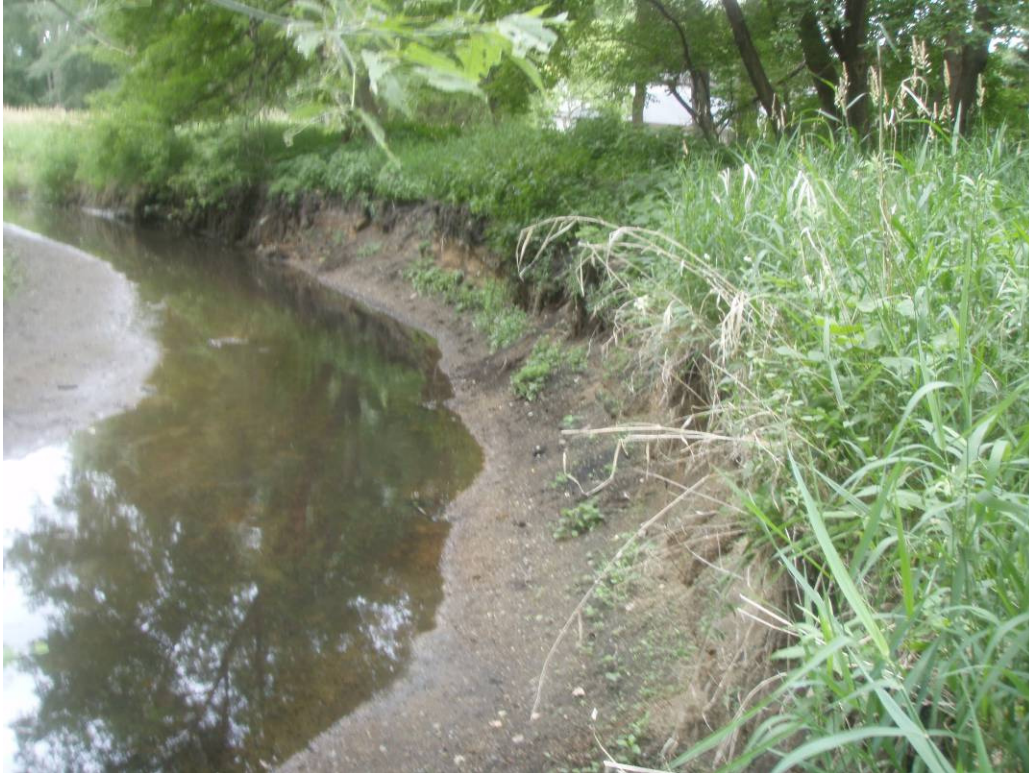
**Photo 1.** *Site 1.* Moderate to severe erosion on an outside bank of a meander

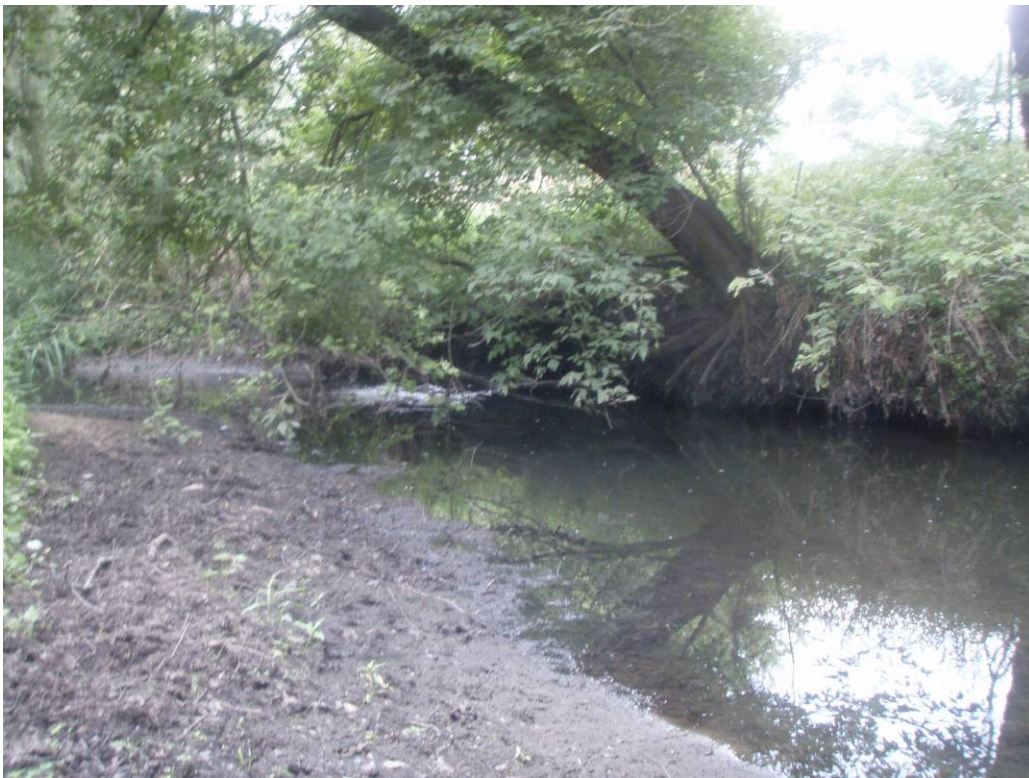
**Photo 2.** *Site 2.* Minor erosion and undercut bank.

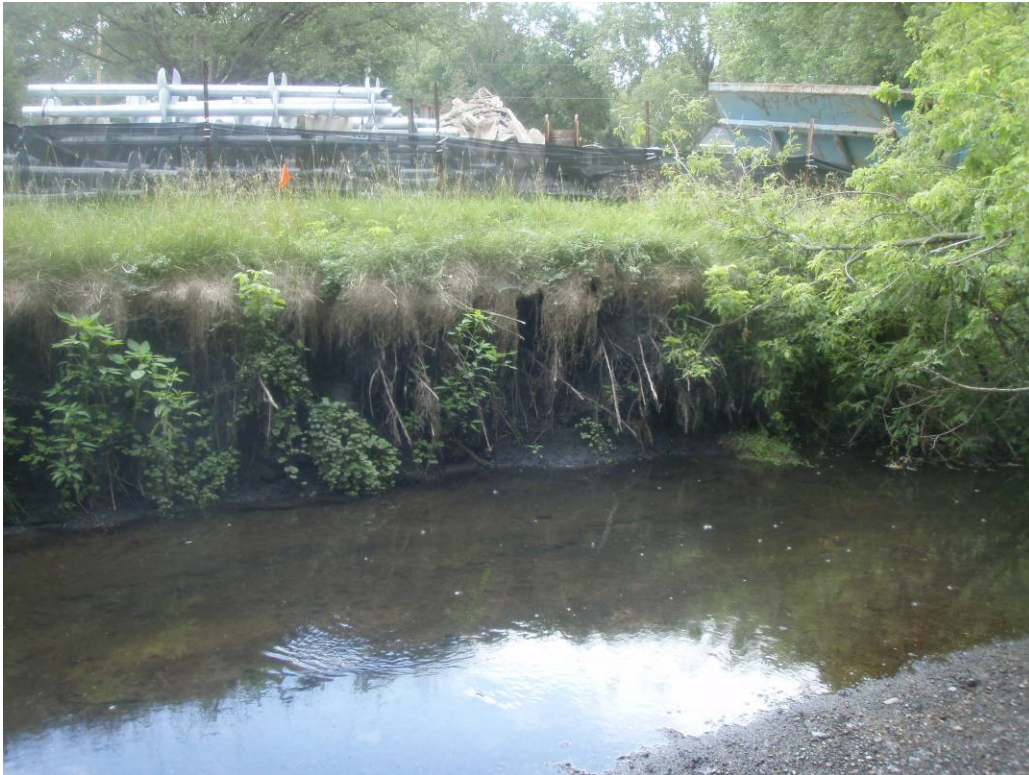
**Photo 3.** *Site 3.* Moderately eroding bank.

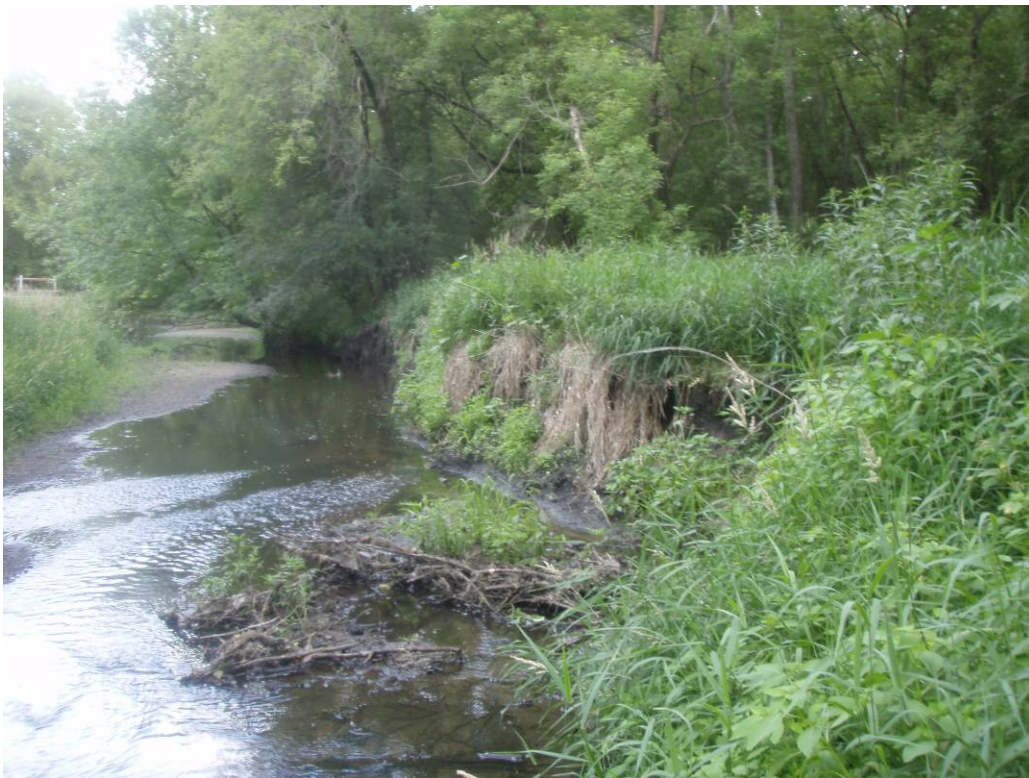
**Photo 4.** *Site 4.* Moderately eroding bank

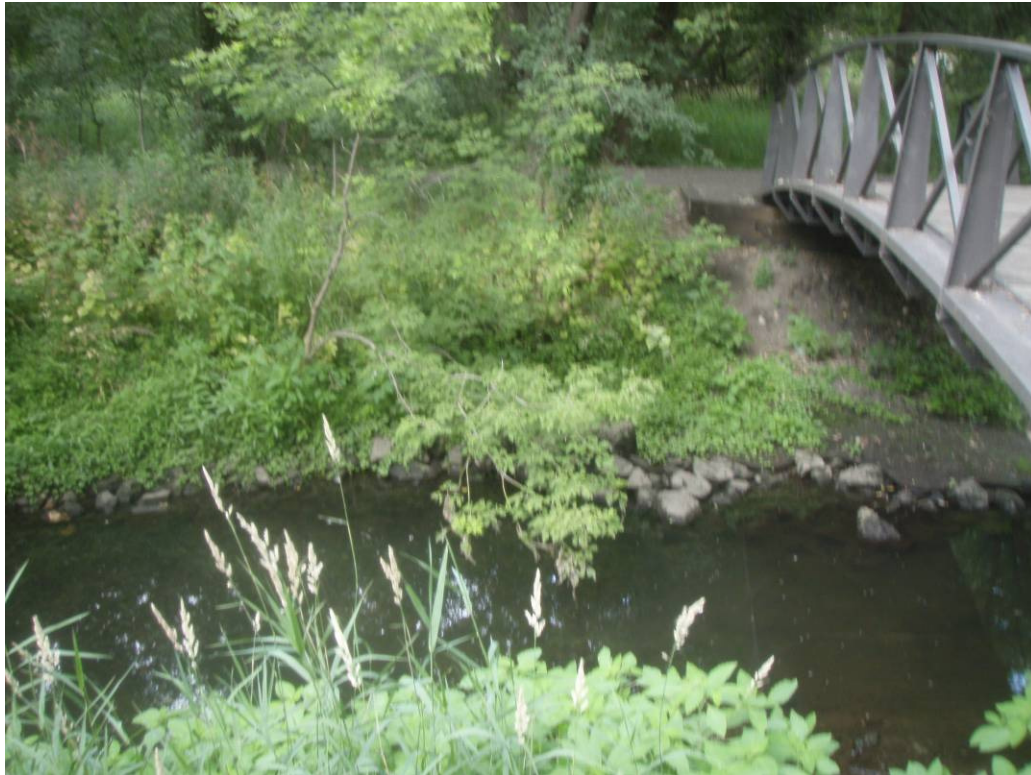
**Photo 5.** *Site 5.* Bank at pedestrian bridge on outside bank of a meander.

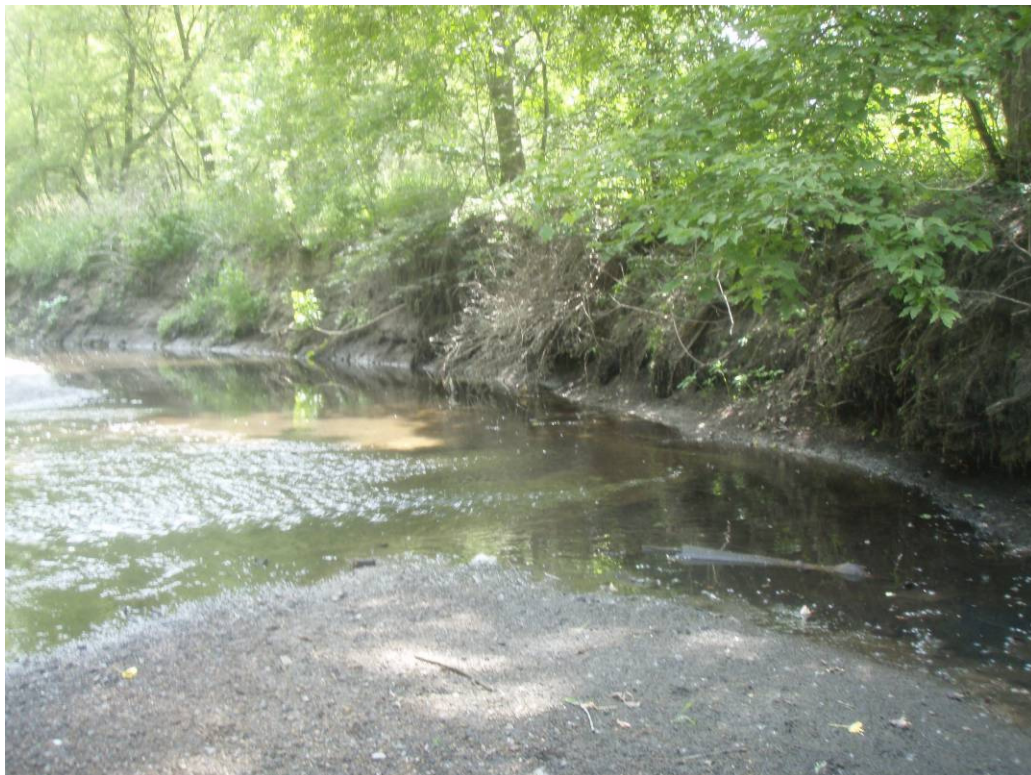
**Photo 6.** *Site 6.* Severe erosion on outside bank of a meander.

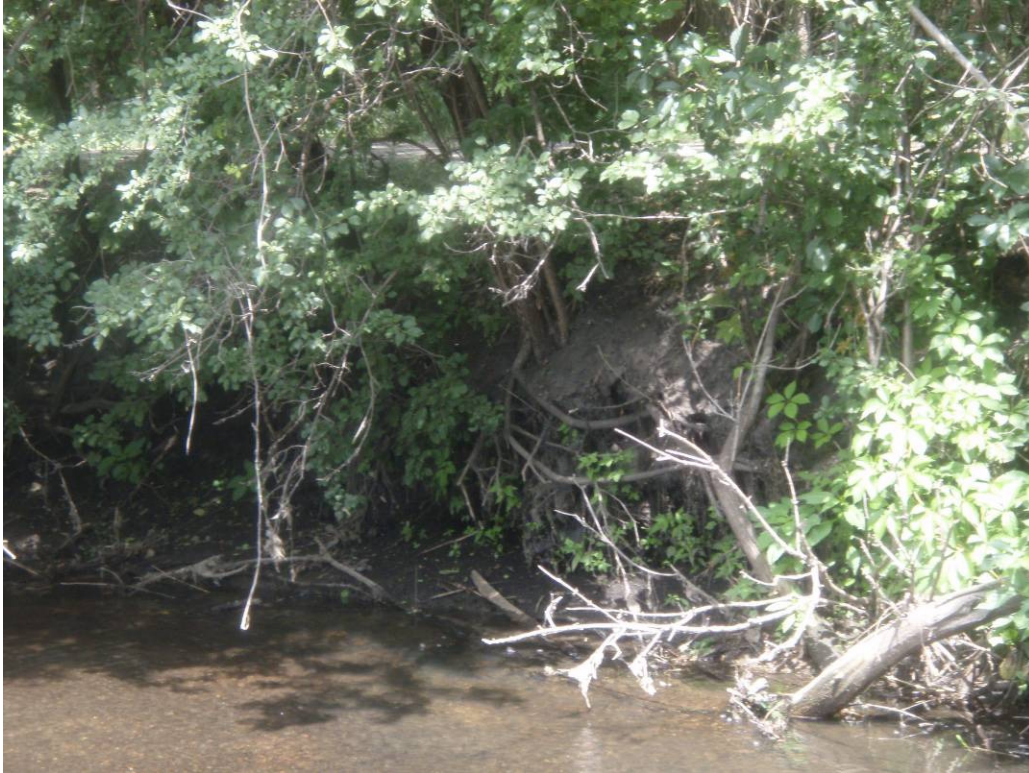
**Photo 7.** *Site 7.* Erosion threatening walking trail.

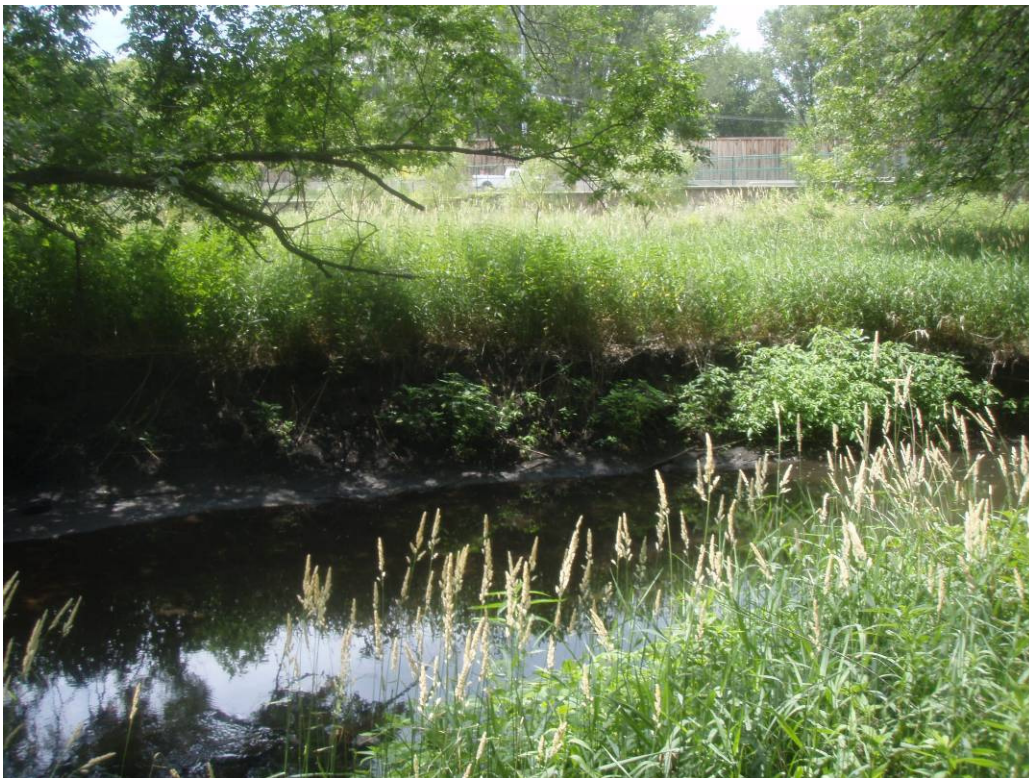
**Photo 8.** *Site 8.* Moderate erosion.

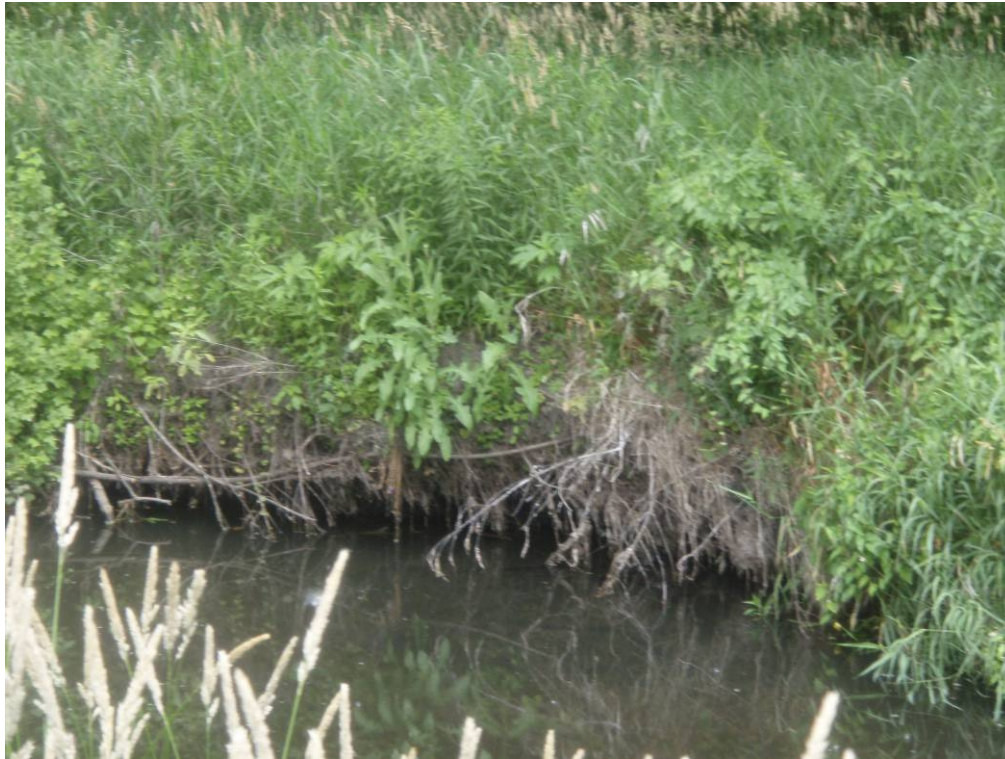
**Photo 9.** *Site 9.* Bank is being undercut and will likely fall into stream in the future

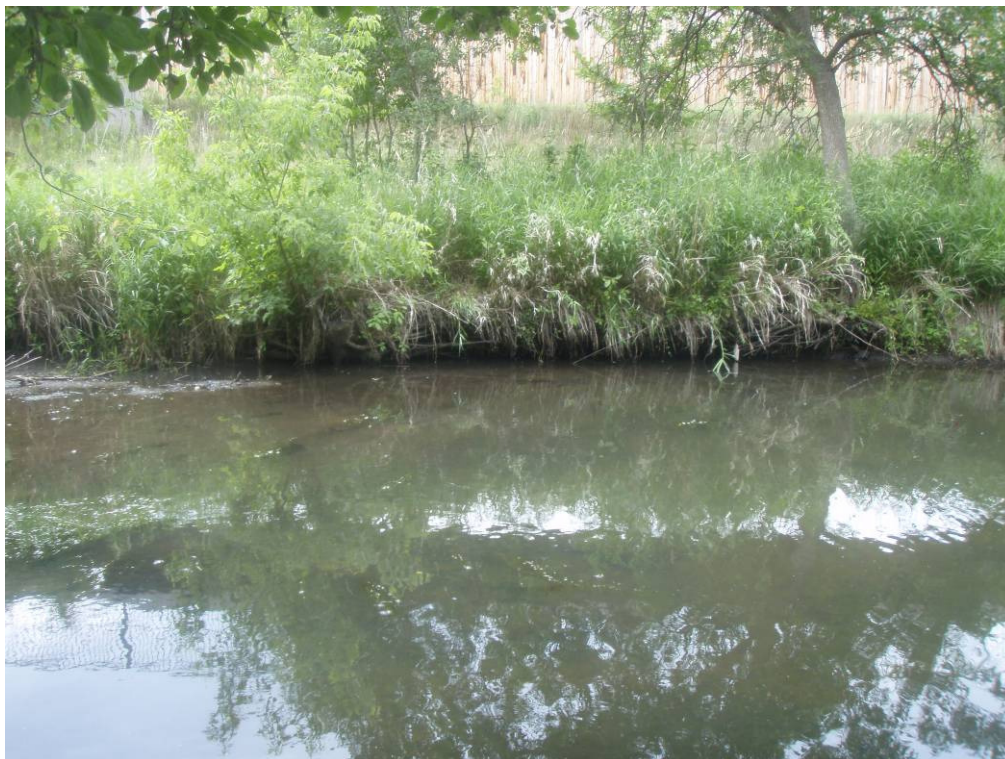
**Photo 10.** *Site 10.* Minor bank undercutting that could lead to future erosion.

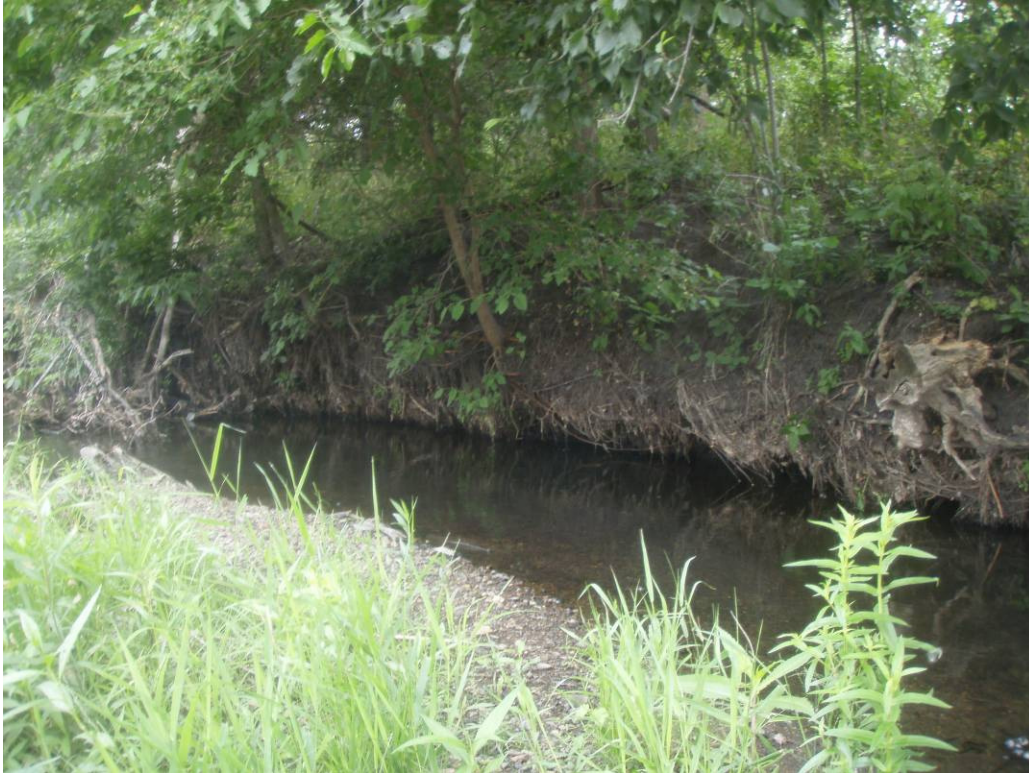
**Photo 11.** *Site 11.* Bank erosion near culvert under Highway 100.

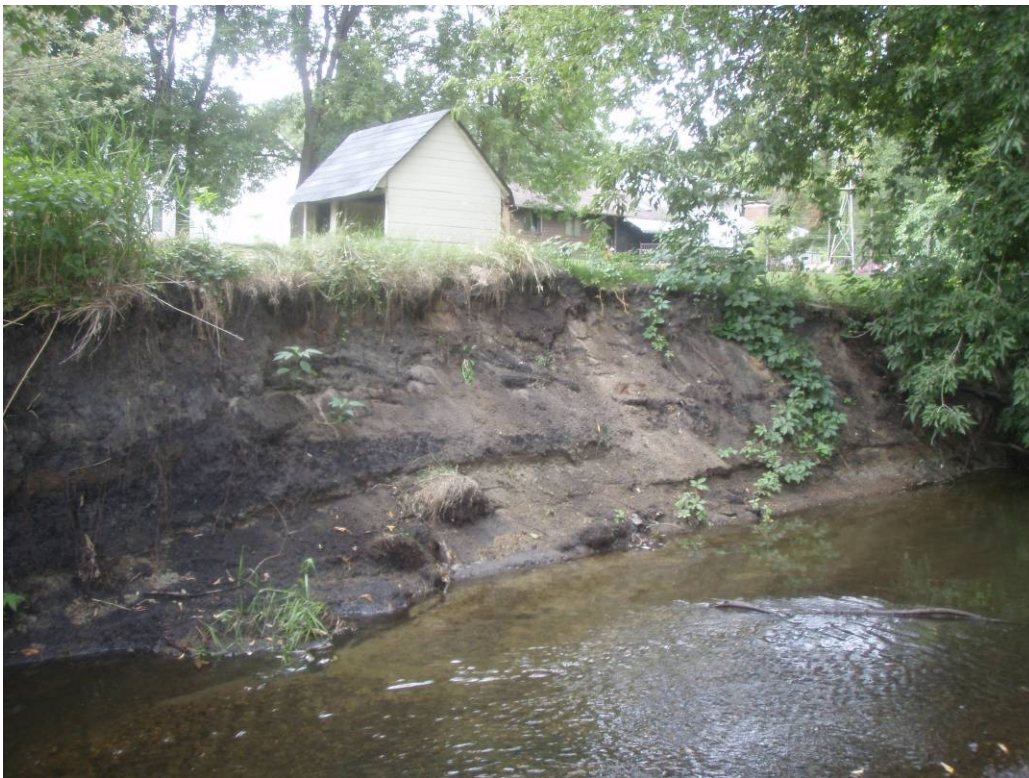
**Photo 12.** *Site 12.* Severe bank erosion on private property.

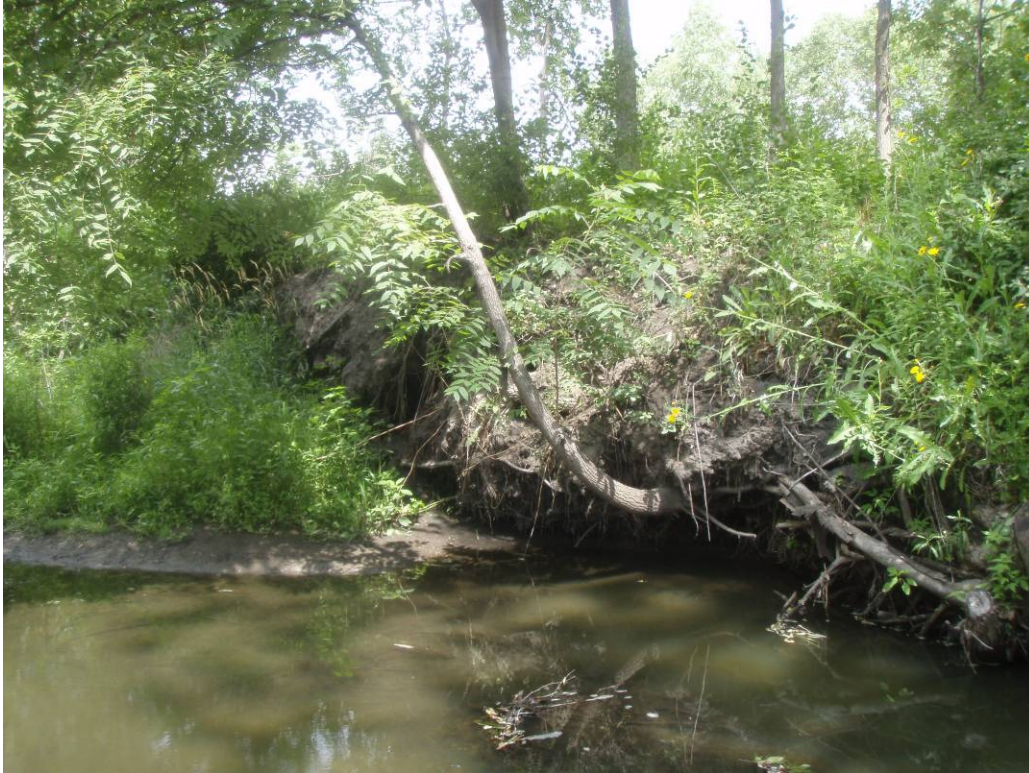
**Photo 13.** *Site 13.* Moderate bank erosion.

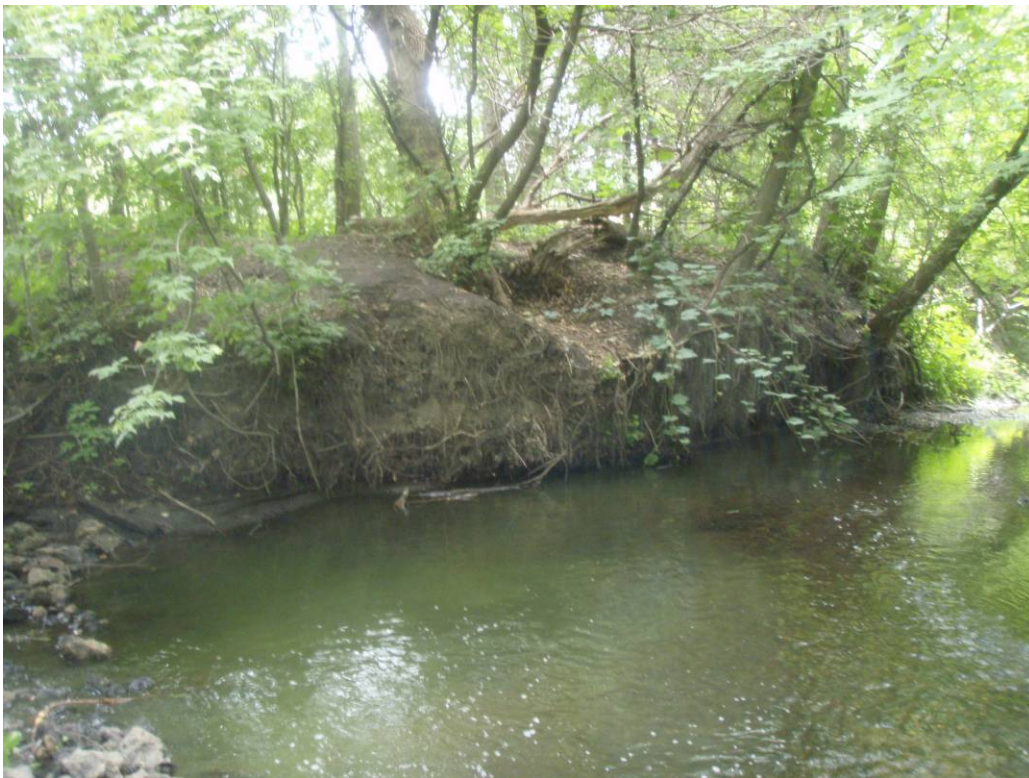
**Photo 14.** *Site 14.* Moderate bank erosion.

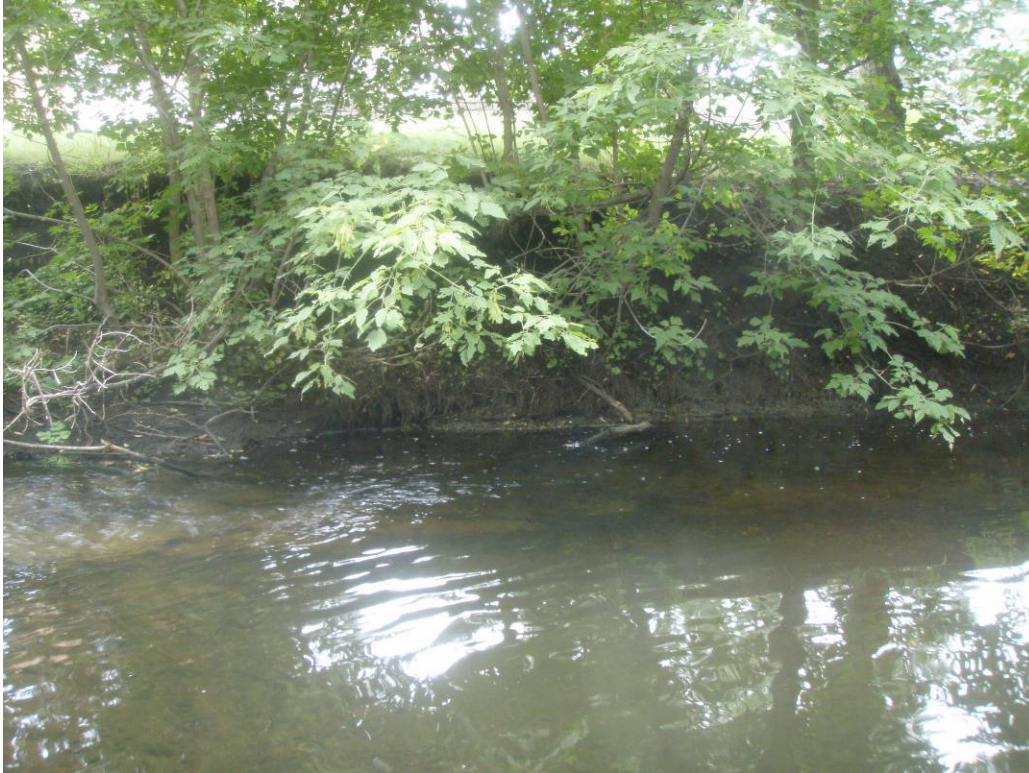
**Photo 15.** *Site 15.* Minor bank erosion.
