**Feasibility Report for the 2012
Bassett Creek Main Stem Restoration Project
Golden Valley Road to Irving Avenue North**

June 2011

Golden Valley & Minneapolis, Minnesota

***Prepared for
Bassett Creek Watershed Management Commission
June 2011***

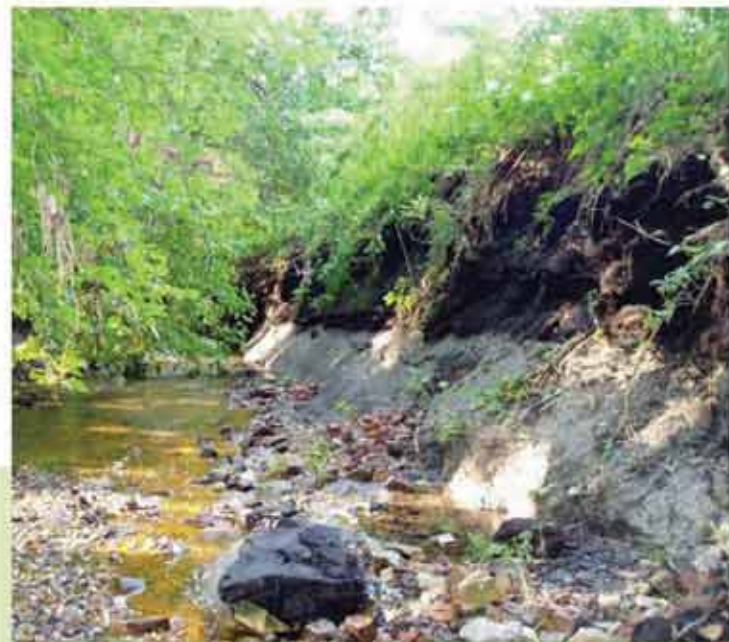
EXISTING CONDITIONS

Fluvial bank erosion is caused by water in the stream moving past the streambanks. The shear stress caused by the flow entrains soil particles into the flow, causing the stream bank to erode away. This is the most common type of erosion that occurs in streams. Virtually all streams experience this type of erosion as their flow path evolves over time. However, the rate of fluvial bank erosion can increase when the stream is out of equilibrium with its watershed. Increased flow from a watershed will increase the rate of fluvial bank erosion. In many cases, it appears to be a part of the natural process of stream evolution. In places where the channel is confined by the valley walls, however, fluvial bank erosion can lead to failure of the high banks. It can also undermine storm sewer inlets.

Stone Toe Protection is constructed from cobble-sized rock on the creek edges. It extends to approximately the bankfull level, which will protect the channel banks for flow events that occur every 1 to 2 years or less. The material will extend into the ground to resist scour. Coarse gravel is used to separate the larger rock material from underlying soil. Stone toe protection is typically used in conjunction with revegetation of the upper banks.

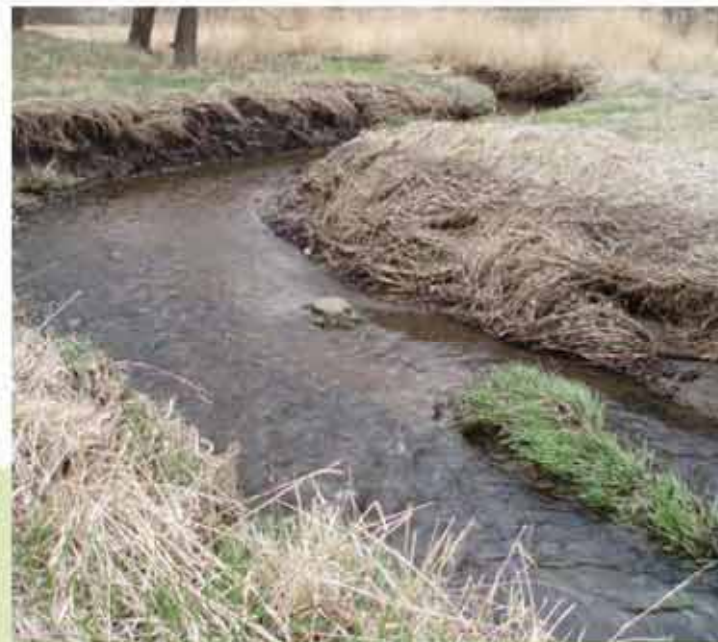
EXISTING CONDITIONS

Fluvial bank erosion is caused by water in the stream moving past the streambanks. The shear stress caused by the flow entrains soil particles into the flow, causing the stream bank to erode away. This is the most common type of erosion that occurs in streams. Virtually all streams experience this type of erosion as their flow path evolves over time. However, the rate of fluvial bank erosion can increase when the stream is out of equilibrium with its watershed. Increased flow from a watershed will increase the rate of fluvial bank erosion. In many cases, it appears to be a part of the natural process of stream evolution. In places where the channel is confined by the valley walls, however, fluvial bank erosion can lead to failure of the high banks. It can also undermine storm sewer inlets.

Root wads are constructed using sections of tree trunks with their root balls attached. The trunks extend into the stream bank leaving only the roots exposed, partially submerged. The root wads are spaced to protect a given length of bank. Footer logs and boulders are often used to help stabilize the root wads. Root wads work well where the water is deep, such as on the outside of bends, and where there is adequate sunlight to allow vegetation to grow around the exposed root wads. As the vegetation becomes established, it becomes difficult to distinguish the root wads from their natural surroundings.

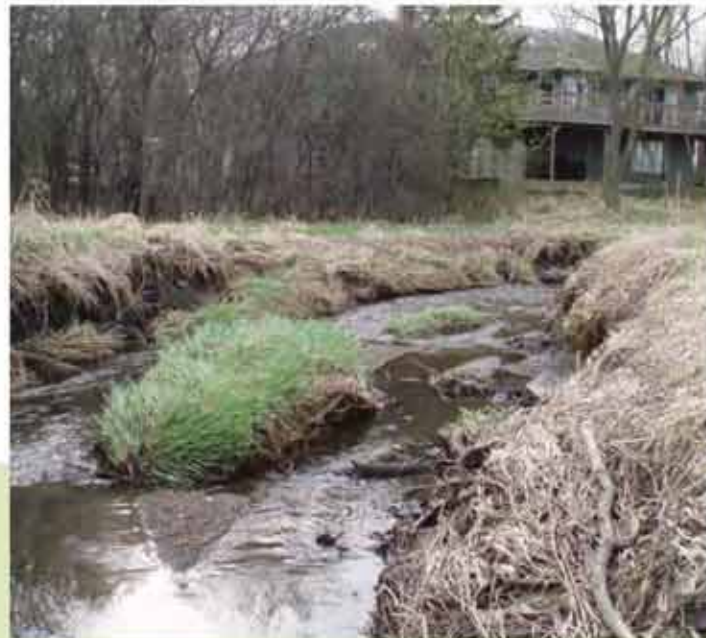
EXISTING CONDITIONS

Fluvial bank erosion is caused by water in the stream moving past the streambanks. The shear stress caused by the flow entrains soil particles into the flow, causing the stream bank to erode away. This is the most common type of erosion that occurs in streams. Virtually all streams experience this type of erosion as their flow path evolves over time. However, the rate of fluvial bank erosion can increase when the stream is out of equilibrium with its watershed. Increased flow from a watershed will increase the rate of fluvial bank erosion. In places where the channel is confined by the valley walls, however, fluvial bank erosion can lead to failure of the high banks. It can also undermine storm sewer inlets.

Rock vanes are constructed from boulders on the creek bottom. They function by diverting channel flow toward the center and away from the bank. They are typically oriented in the upstream direction and occupy no more than one third of the channel width. Vanes are largely submerged and inconspicuous. The rocks are chosen such that they will be large enough to resist movement during flood flows or by vandalism, with additional smaller rock material to add stability. Rock vanes function in much the same way as root wads in that they push the stream thalweg (zone of highest velocity) away from the outside bend. They also promote sedimentation behind the vane, which adds to the toe protection.

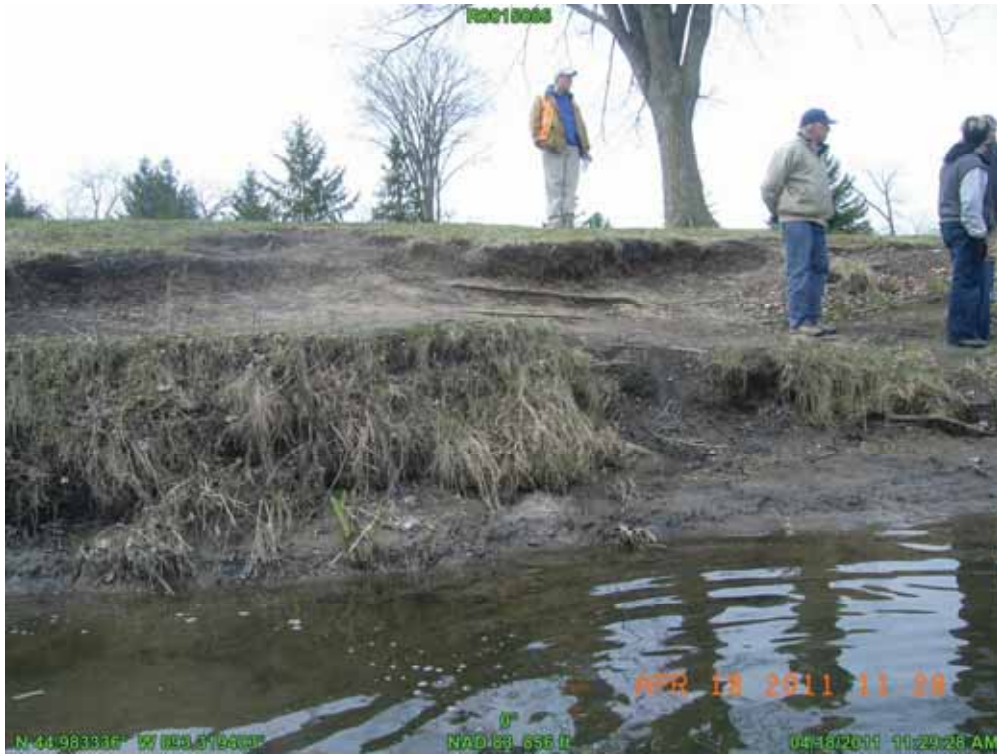
Photo 3. Site 2. Severely eroding bank.

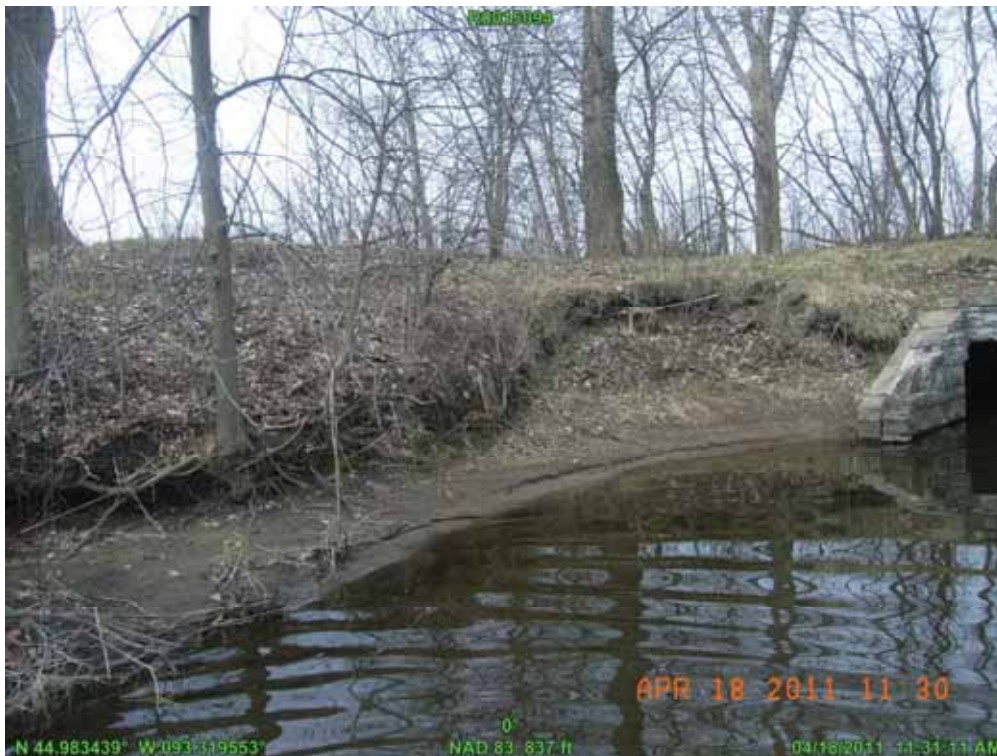
Photo 4. Site 2. Severely eroding bank near box culvert entrance
