Reach 3

PLYMOUTH CREEK STUDY REACH 3
Plymouth Creek Feasibility Study
Bassett Creek Watershed
Management Commission

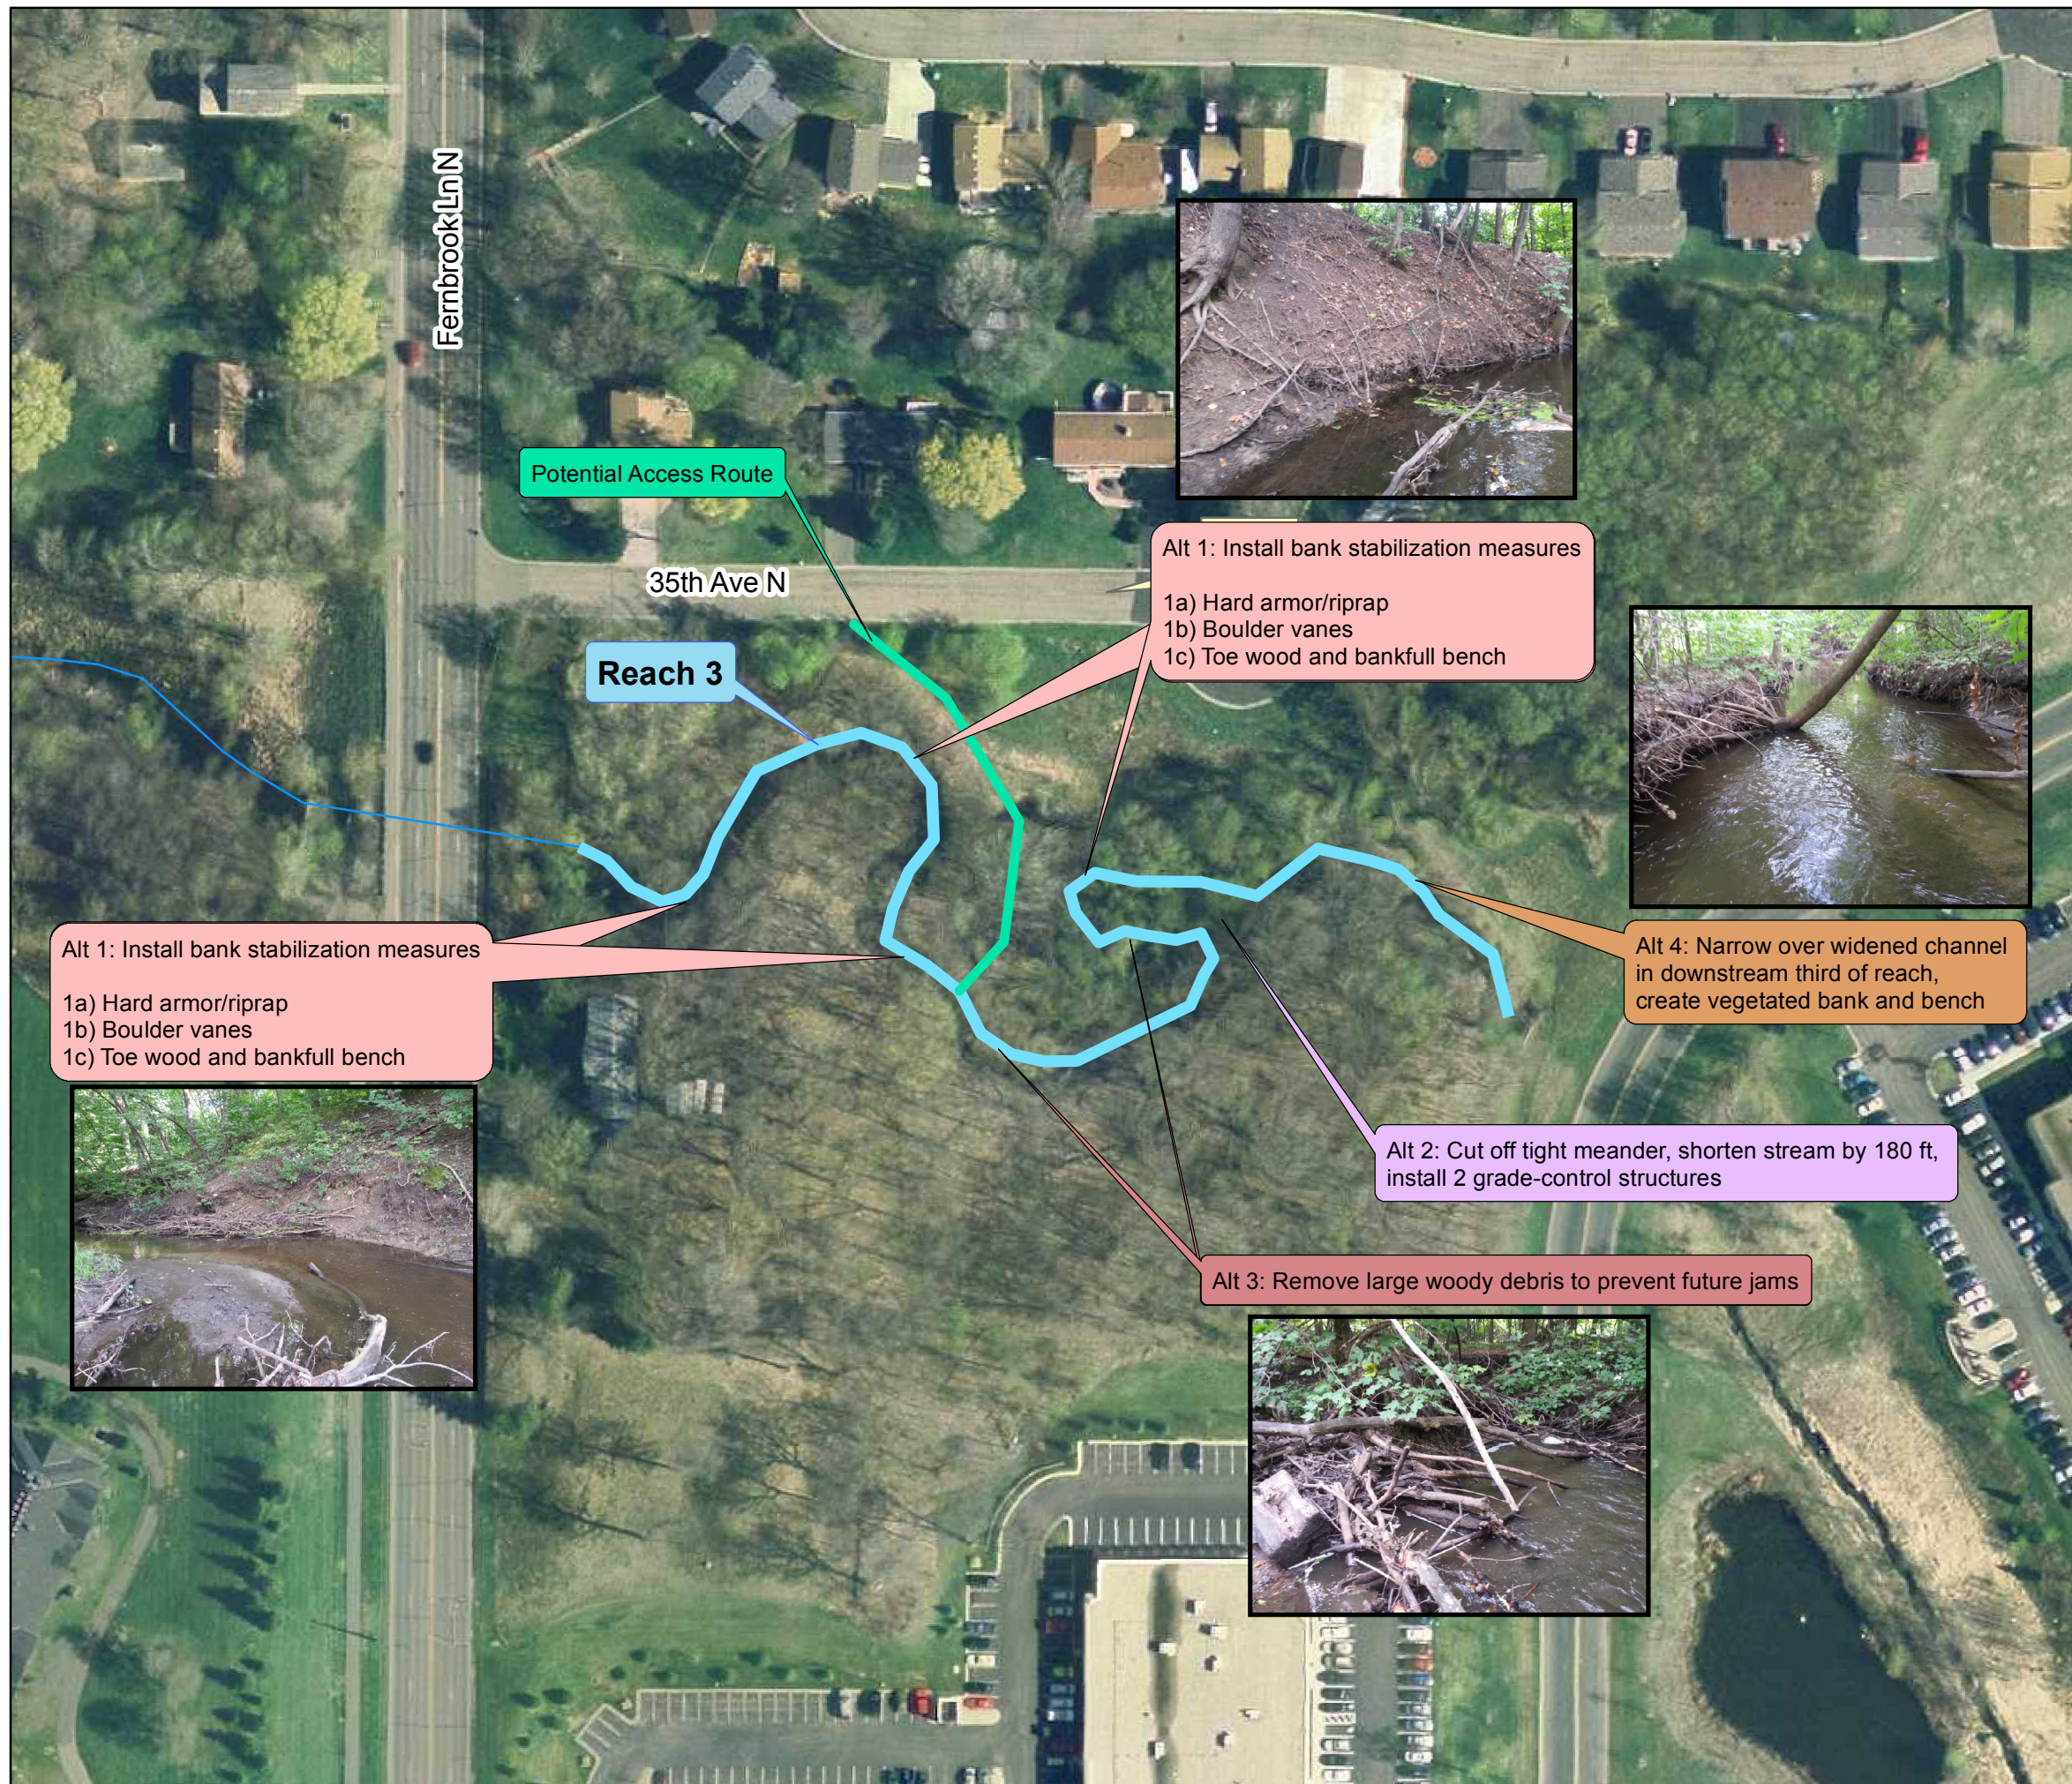
Figure 3

Issues: Several large eroding outer banks. Significant woody debris causing jams that redirect flow at banks. Unstable tight meander in downstream third in the process of being cut off.

Constraints: Narrow valley and low slope limit meandering potential, Deep shade limits vegetation options. Meander cutoff and loss of stream length could be permitting issue. Some existing trees may need preservation, inhibiting work access in their vicinity.

Alt 1: Install bank stabilization measures

- 1a) Hard armor/riprap
- 1b) Boulder vanes
- 1c) Toe wood and bankfull bench

Alt 4: Narrow over widened channel in downstream third of reach, create vegetated bank and bench

Alt 2: Cut off tight meander, shorten stream by 180 ft, install 2 grade-control structures

Alt 3: Remove large woody debris to prevent future jams
