**Reach 2**

PLYMOUTH CREEK STUDY REACH 2  
 Plymouth Creek Feasibility Study  
 Bassett Creek Watershed  
 Management Commission

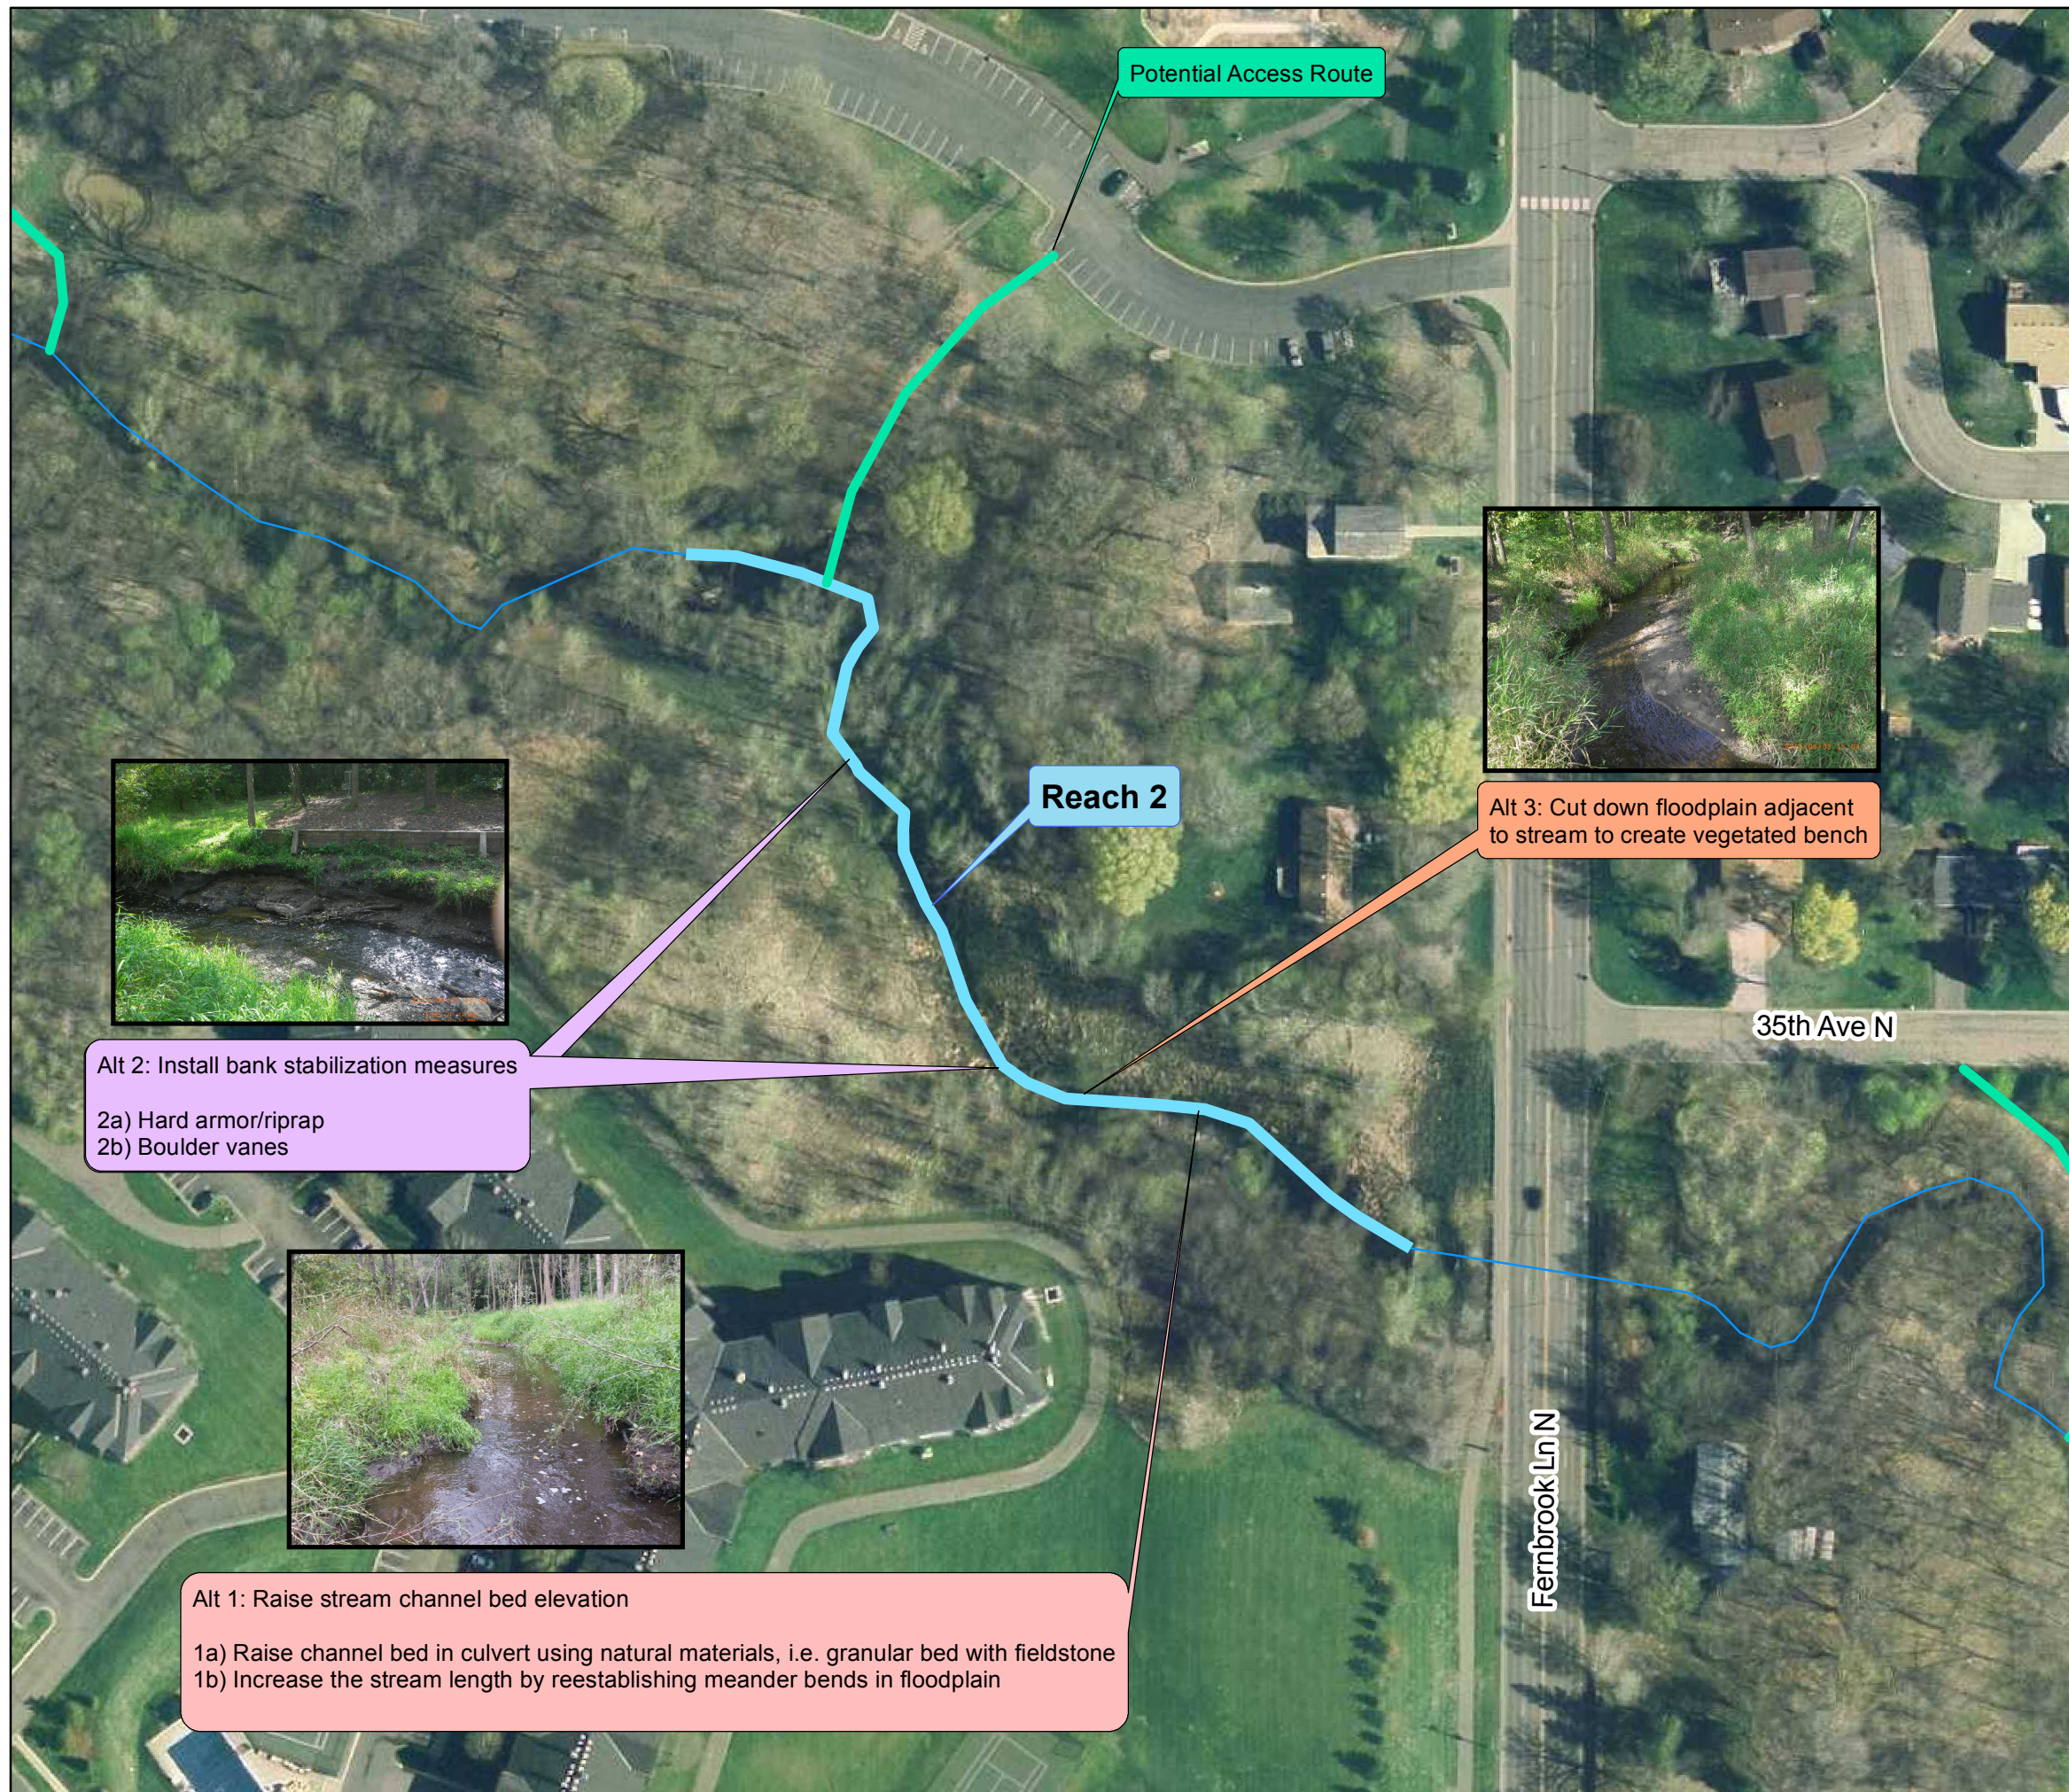
Figure 2

**Issues:** Erosion of the stream bed (incision) has resulted in limited access to floodplain. Incision perhaps due to culvert grade on downstream end of reach. Pockets of granular soils prone to bank erosion.

**Constraints:** Culvert limits flow in floods. Nearby home impacted if flood levels increase. Low slope.
