Appendices

Appendix A	Sediment Sampling Memo—Bassett Creek Park Pond
Appendix B	Sediment Sampling Memo—Winnetka Pond East
Appendix C	Wetland Delineation Report
Appendix D	Bathymetric Survey Figures
Appendix E	Detailed Cost Estimates

Sediment Sampling Memo—Bassett Creek Park Pond

To: Bassett Creek Watershed Management Commission
From: Kevin Menken and Candice Kantor
Subject: Bassett Creek Park Pond Sediment Characterization
Date: February 27, 2017
Project: 23/27-0051

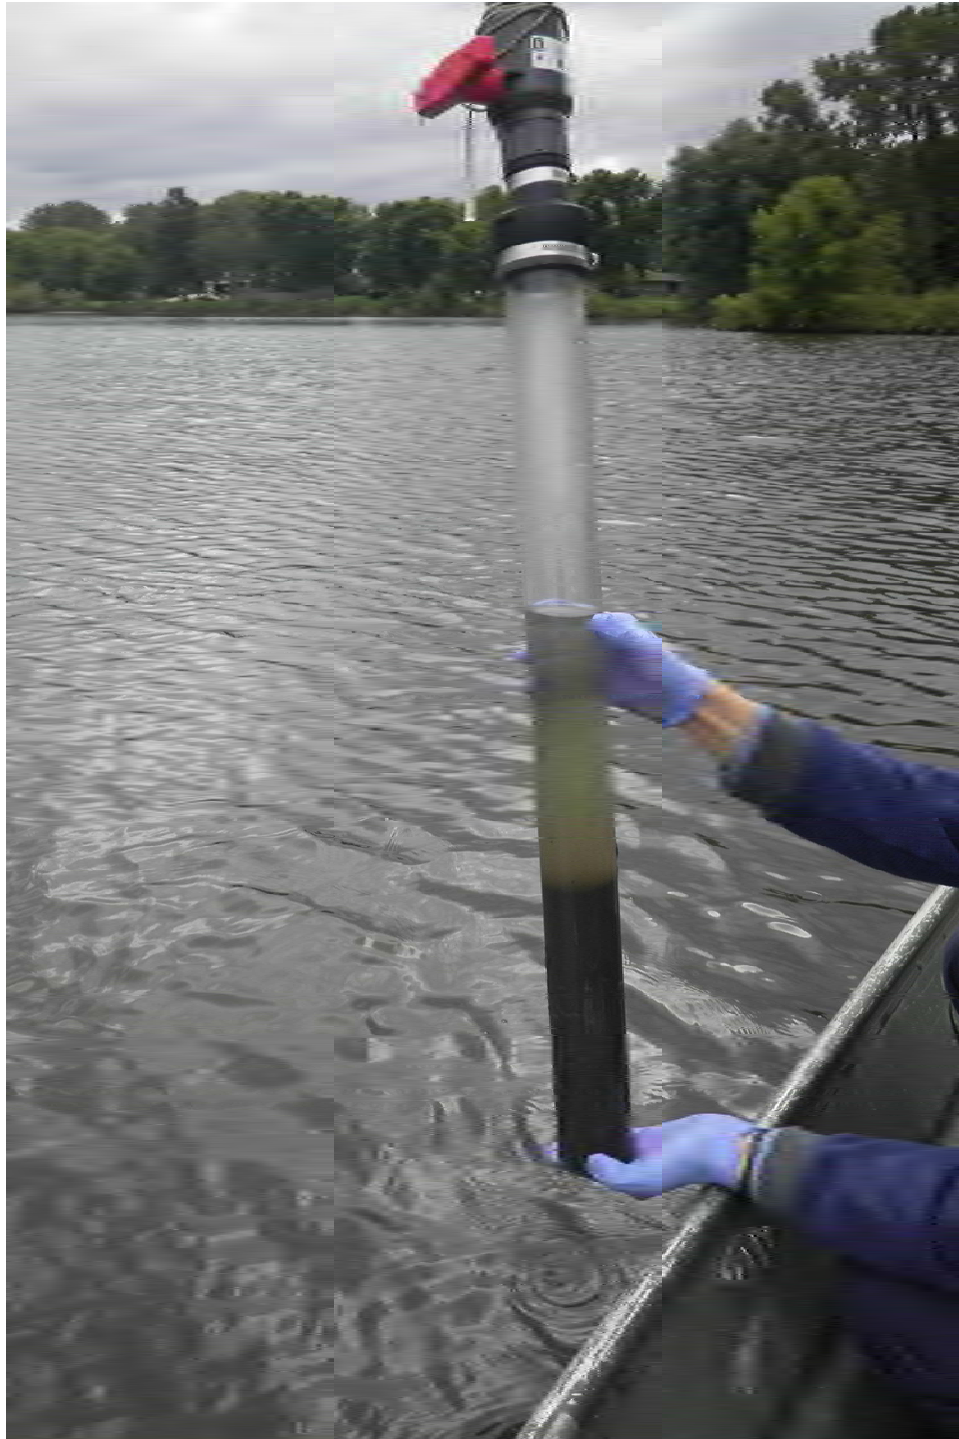
Photograph #1: Sediment core collected with push core sampling device.

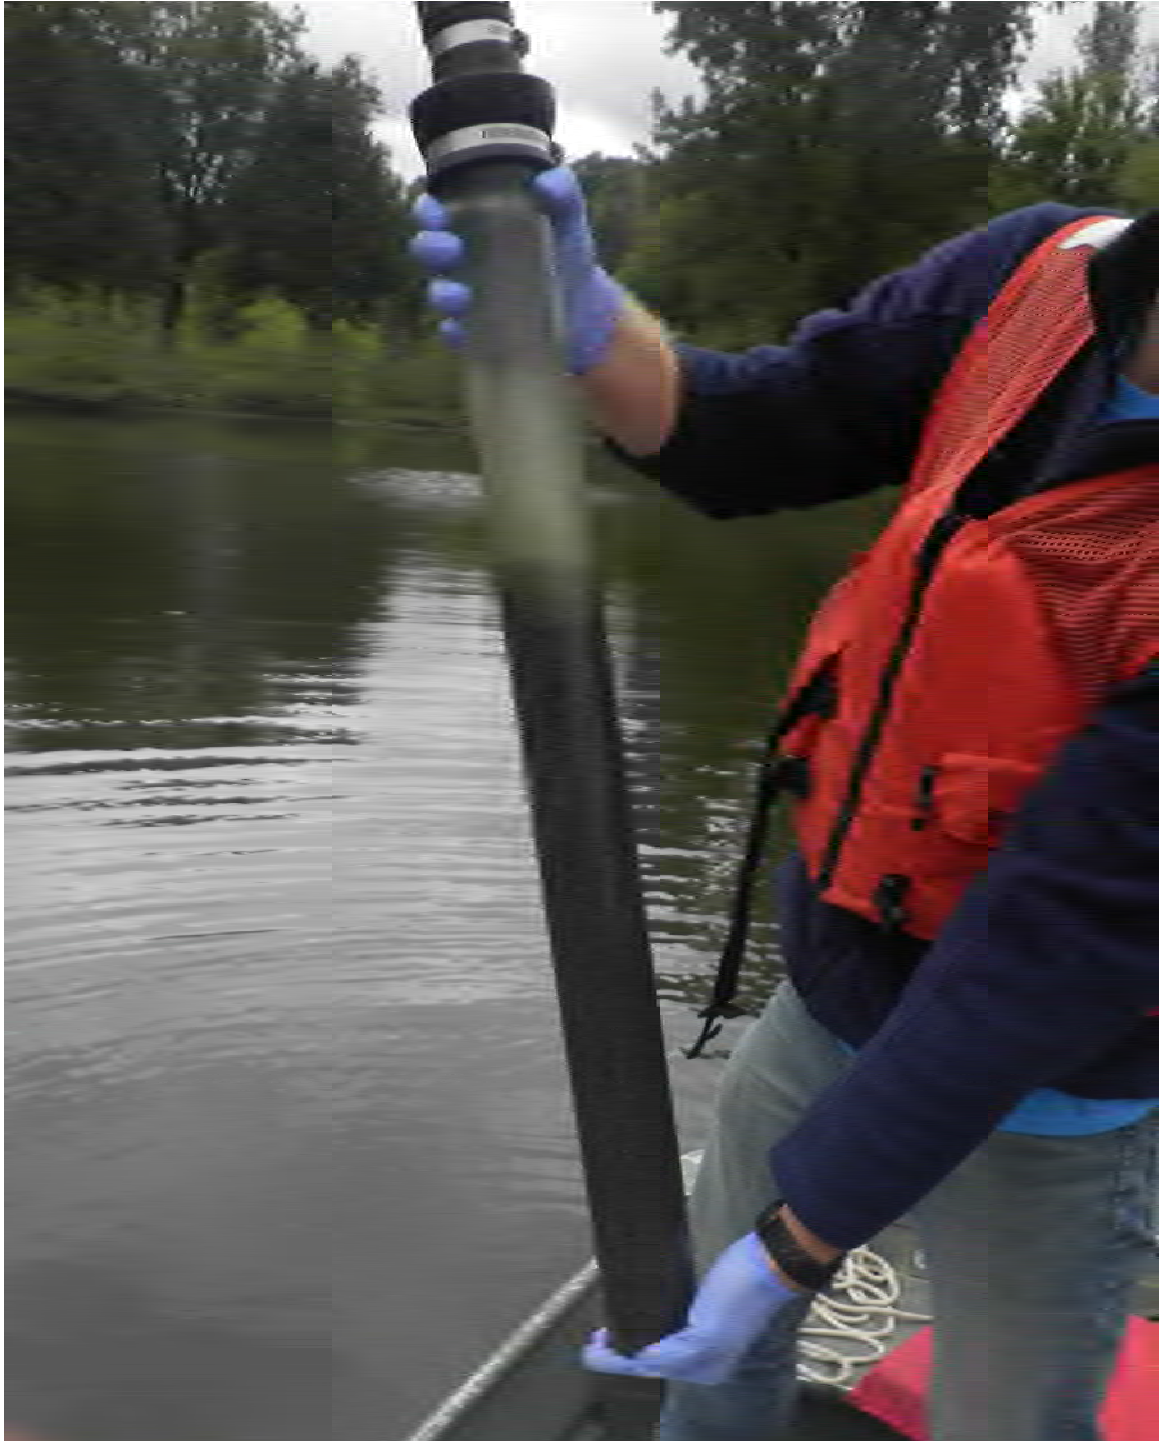
Photograph #2: Sediment core collected with push core sampling device.

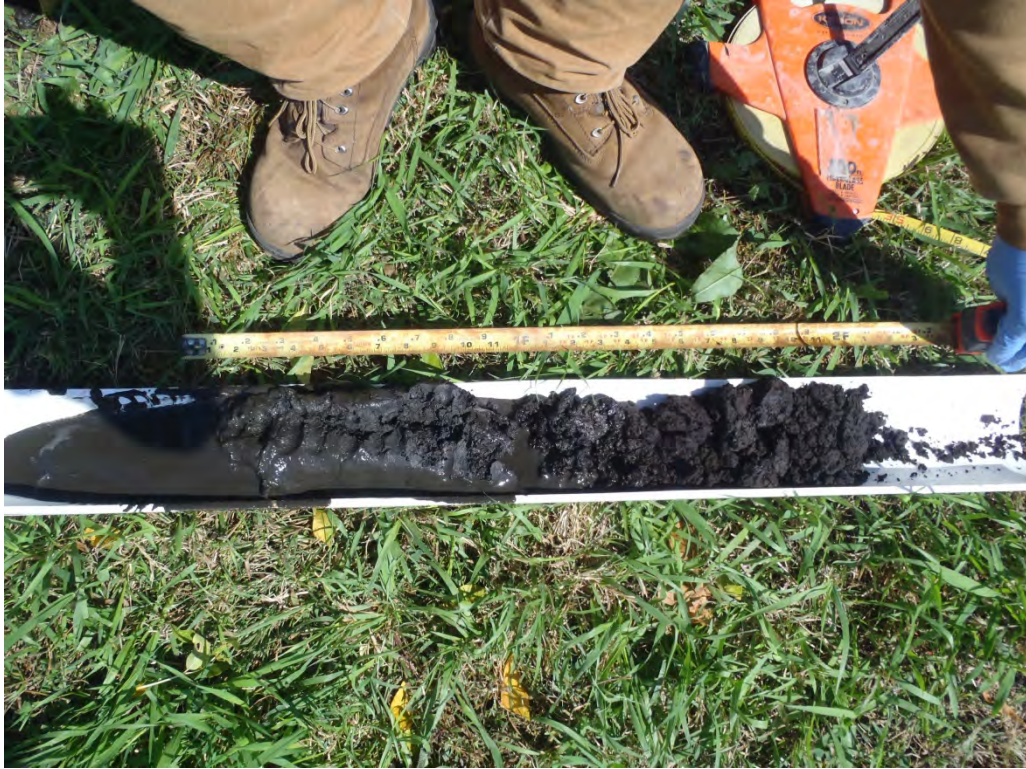
Photograph #1: Sediment core WPE-01.

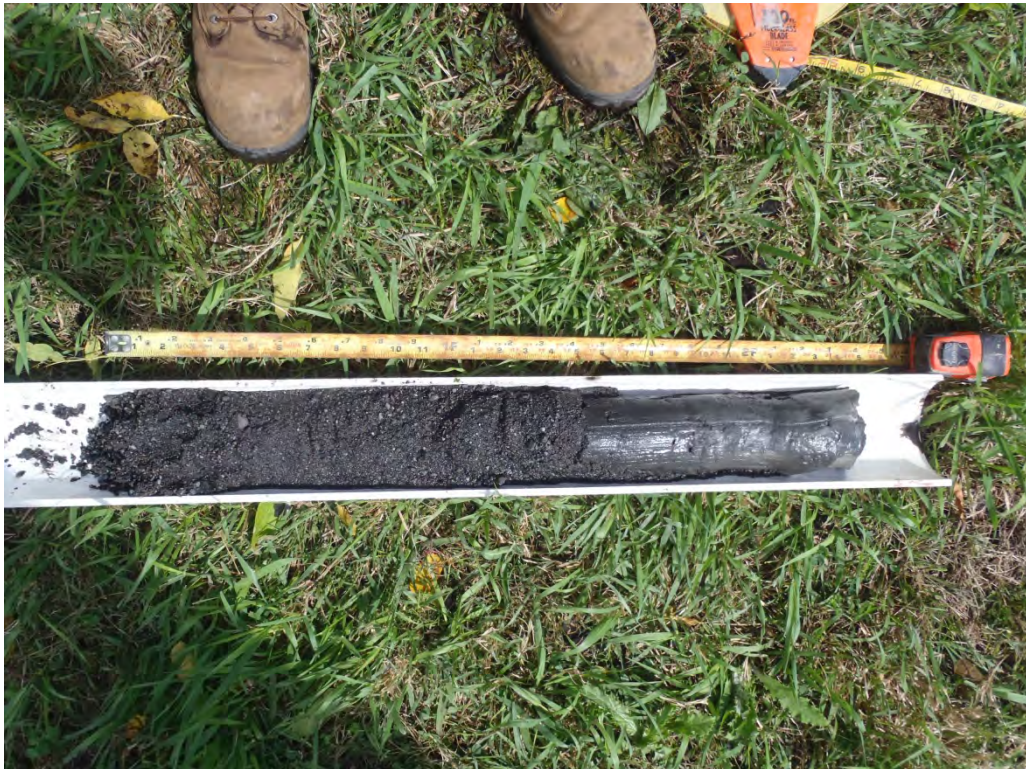
Photograph #2: Sediment core WPE-02.

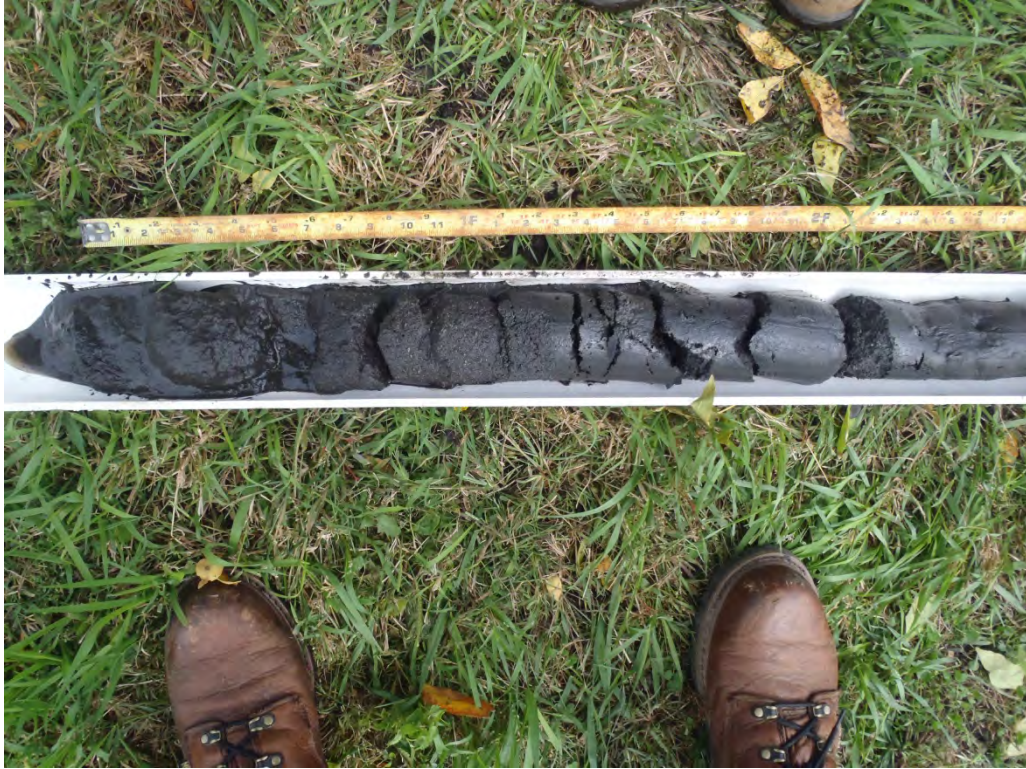
Photograph #3: Sediment core WPE-03, 0-2.5' interval.

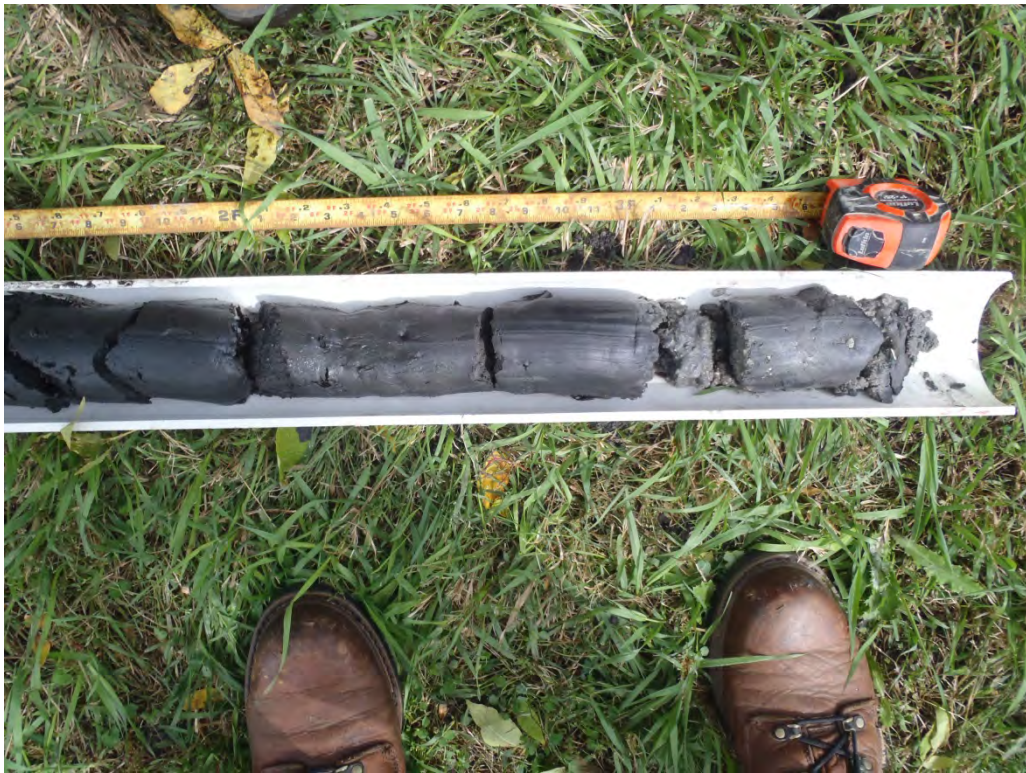
Photograph #4: Sediment core WPE-03, 1.5-3.5' interval.

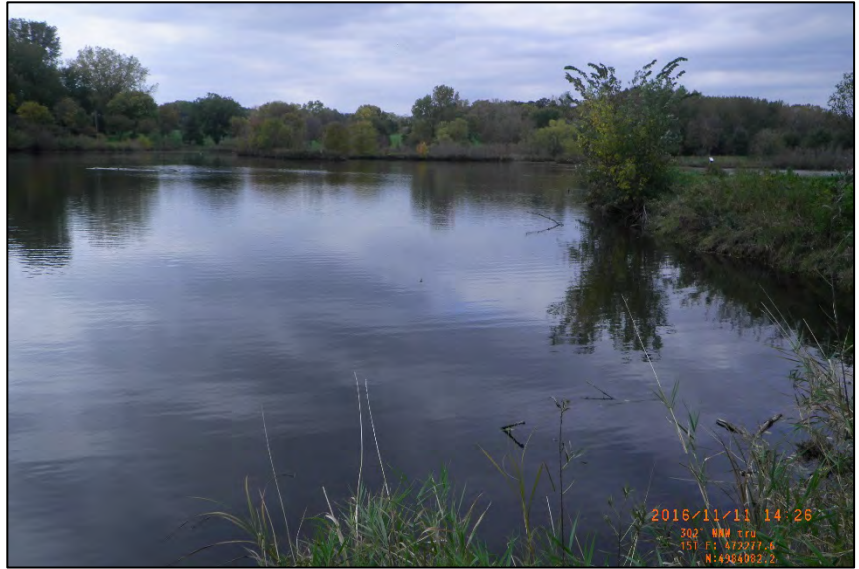
General view of the shallow open water community of Bassett Creek Park Pond.

Shallow open water community is the dominant wetland type within Bassett Creek Park Pond and totals approximately 9.3 acres. Shallow open water community is mostly located in the central and southern areas of Bassett Creek Park Pond and generally has a steep and abrupt wetland boundary. Dominant vegetation observed was lesser duckweed (*Lemna minor*) near the shoreline in some areas, but no other emergent, floating-leaf, or submerged aquatic vegetation was observed from the shoreline within shallow open water community. Reed canary grass (*Phalaris arundinacea*) was dominant along the periphery of shallow open water community.

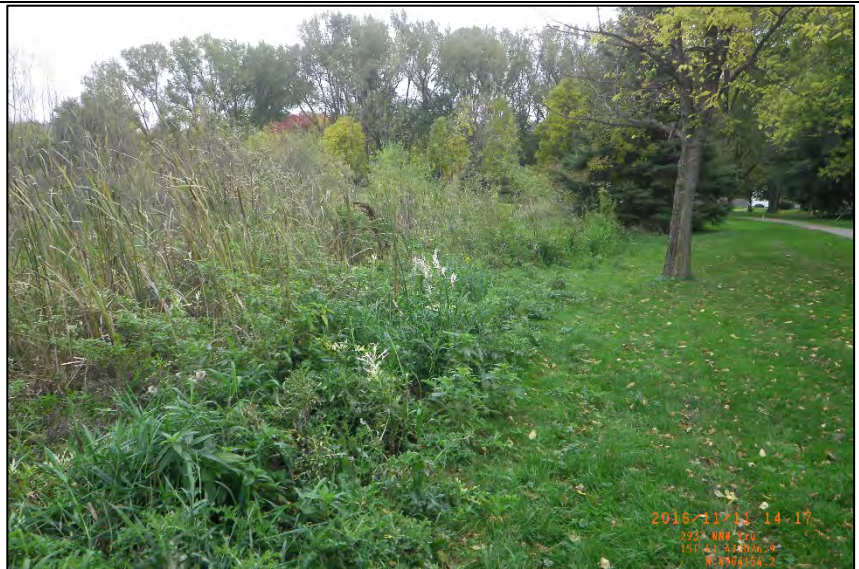
Photo 2 – October 11, 2016

Shallow marsh fringe area located on the west side of the pond.

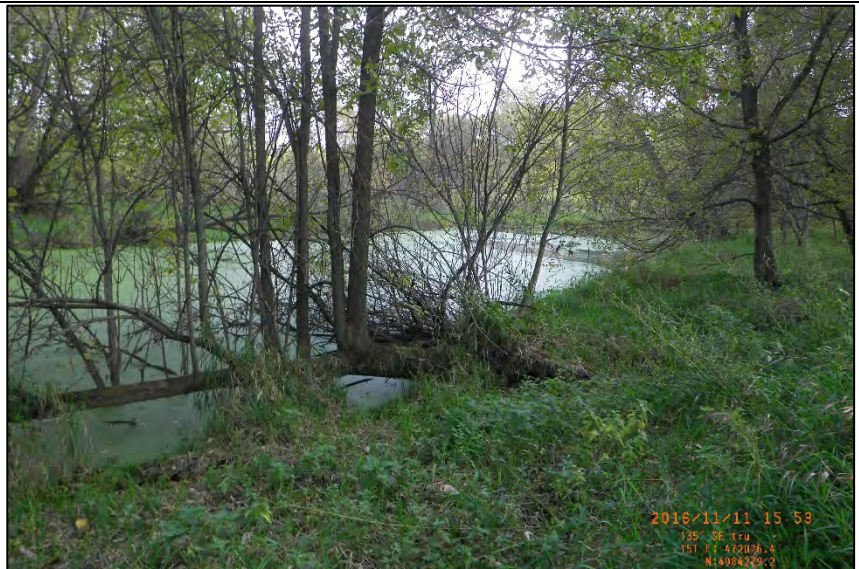
Photo 3 – October 11, 2016

Excavated deep marsh community located on the northwest side of the basin within shrub swamp.

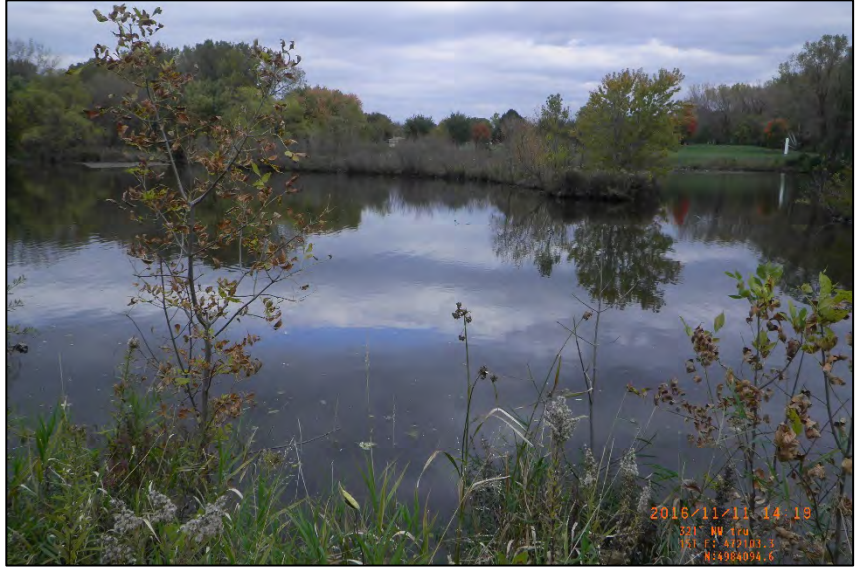
Photo 4 – October 11, 2016

Shrub swamp "island" community surrounded by shallow open water community located beyond open water.

Shrub swamp community is located on the northwest side of Bassett Creek Park Pond (0.9 acres); and in the west-central (0.3 acres) and southwest-central (0.1 acres) areas of the pond surrounded by shallow open water community. The total area of shrub swamp community located in Bassett Creek Park Pond is 1.2 acres. Dominant shrubs observed were sand-bar willow (*Salix interior*). Topography within both areas is generally flat or moderately undulating. Bassett Creek extends south through floodplain forest community and then through shrub swamp community toward the shallow open water areas of Bassett Creek Park Pond.

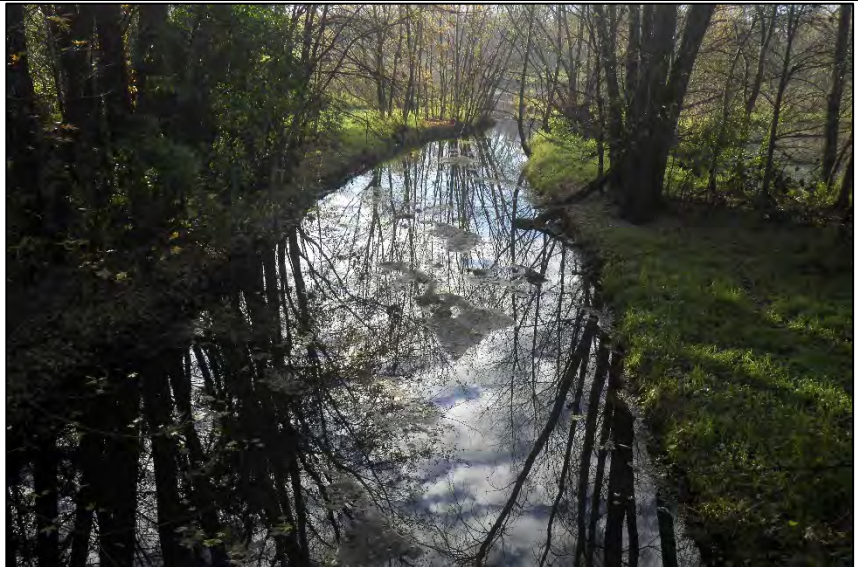
Photo 5 – October 11, 2016

Bassett Creek extending through floodplain forest community on the northwest side of the basin.

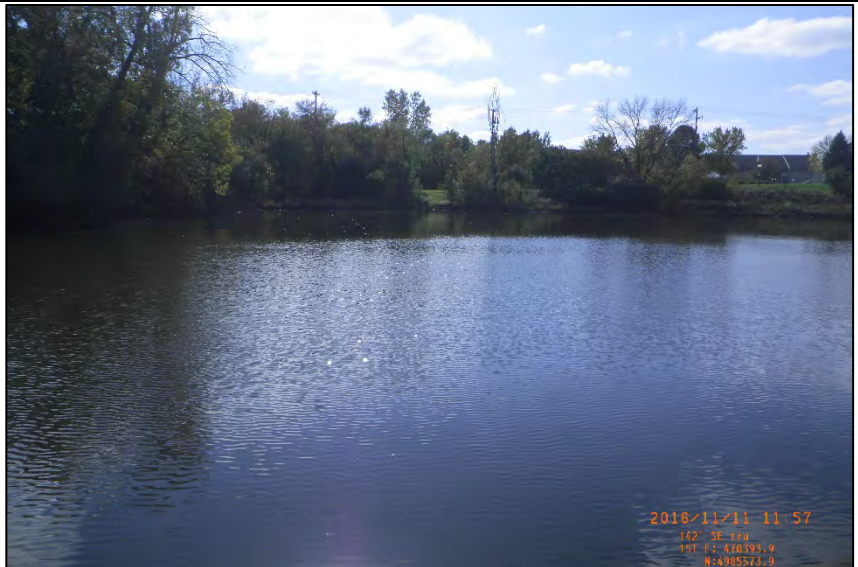
Photo 6 – October 11, 2016

Typical view of the shallow open water community.

Shallow open water community is the dominant wetland type within Winnetka Pond and totals approximately 3.2 acres. Topography is generally steep and abrupt along the wetland boundary leading into the pond. No emergent, floating-leaf, or submerged aquatic vegetation was observed within shallow open water community during the time of the site visit. Reed canary grass and Canada goldenrod was present along the fringes of the shallow open water community mostly in uplands.

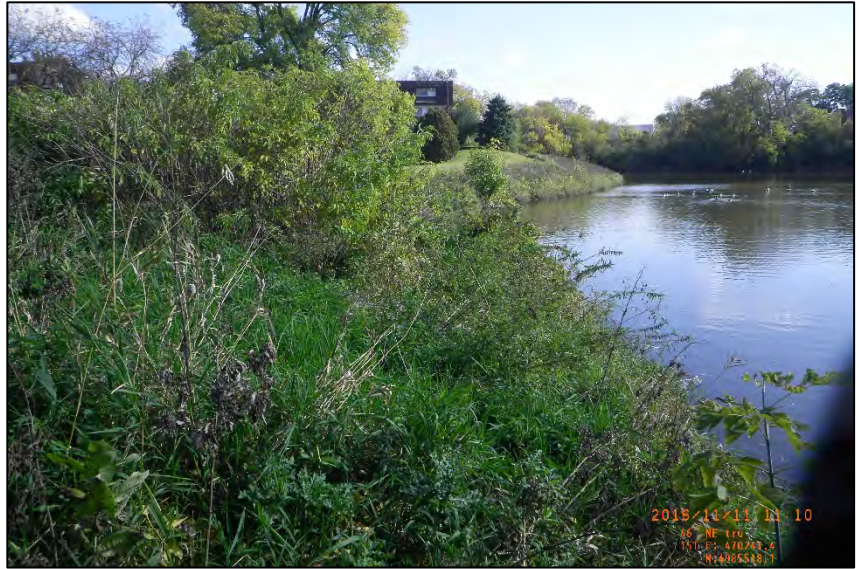
Photo 7 – October 11, 2016

Steep and abrupt wetland edge leading into shallow open water community on the north side.

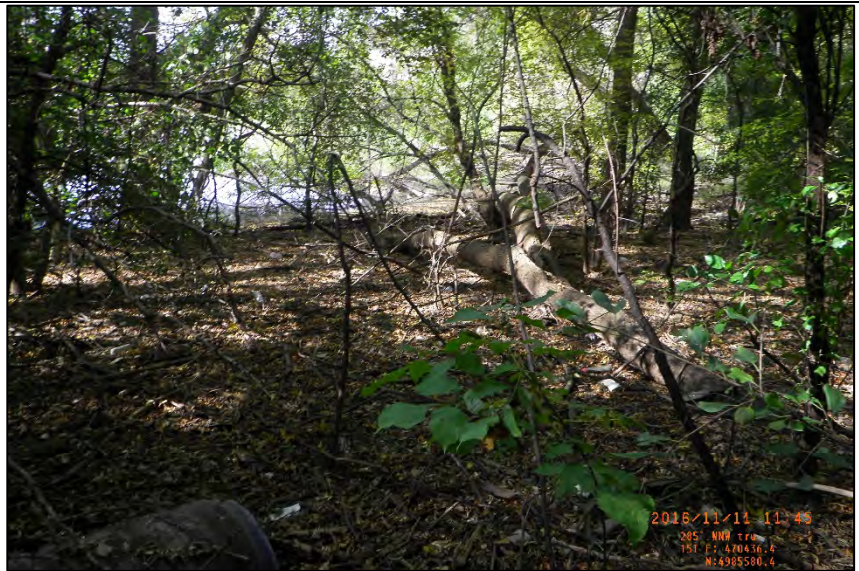
Photo 8 – October 11, 2016

Typical view of floodplain forest community on the west side of the basin.

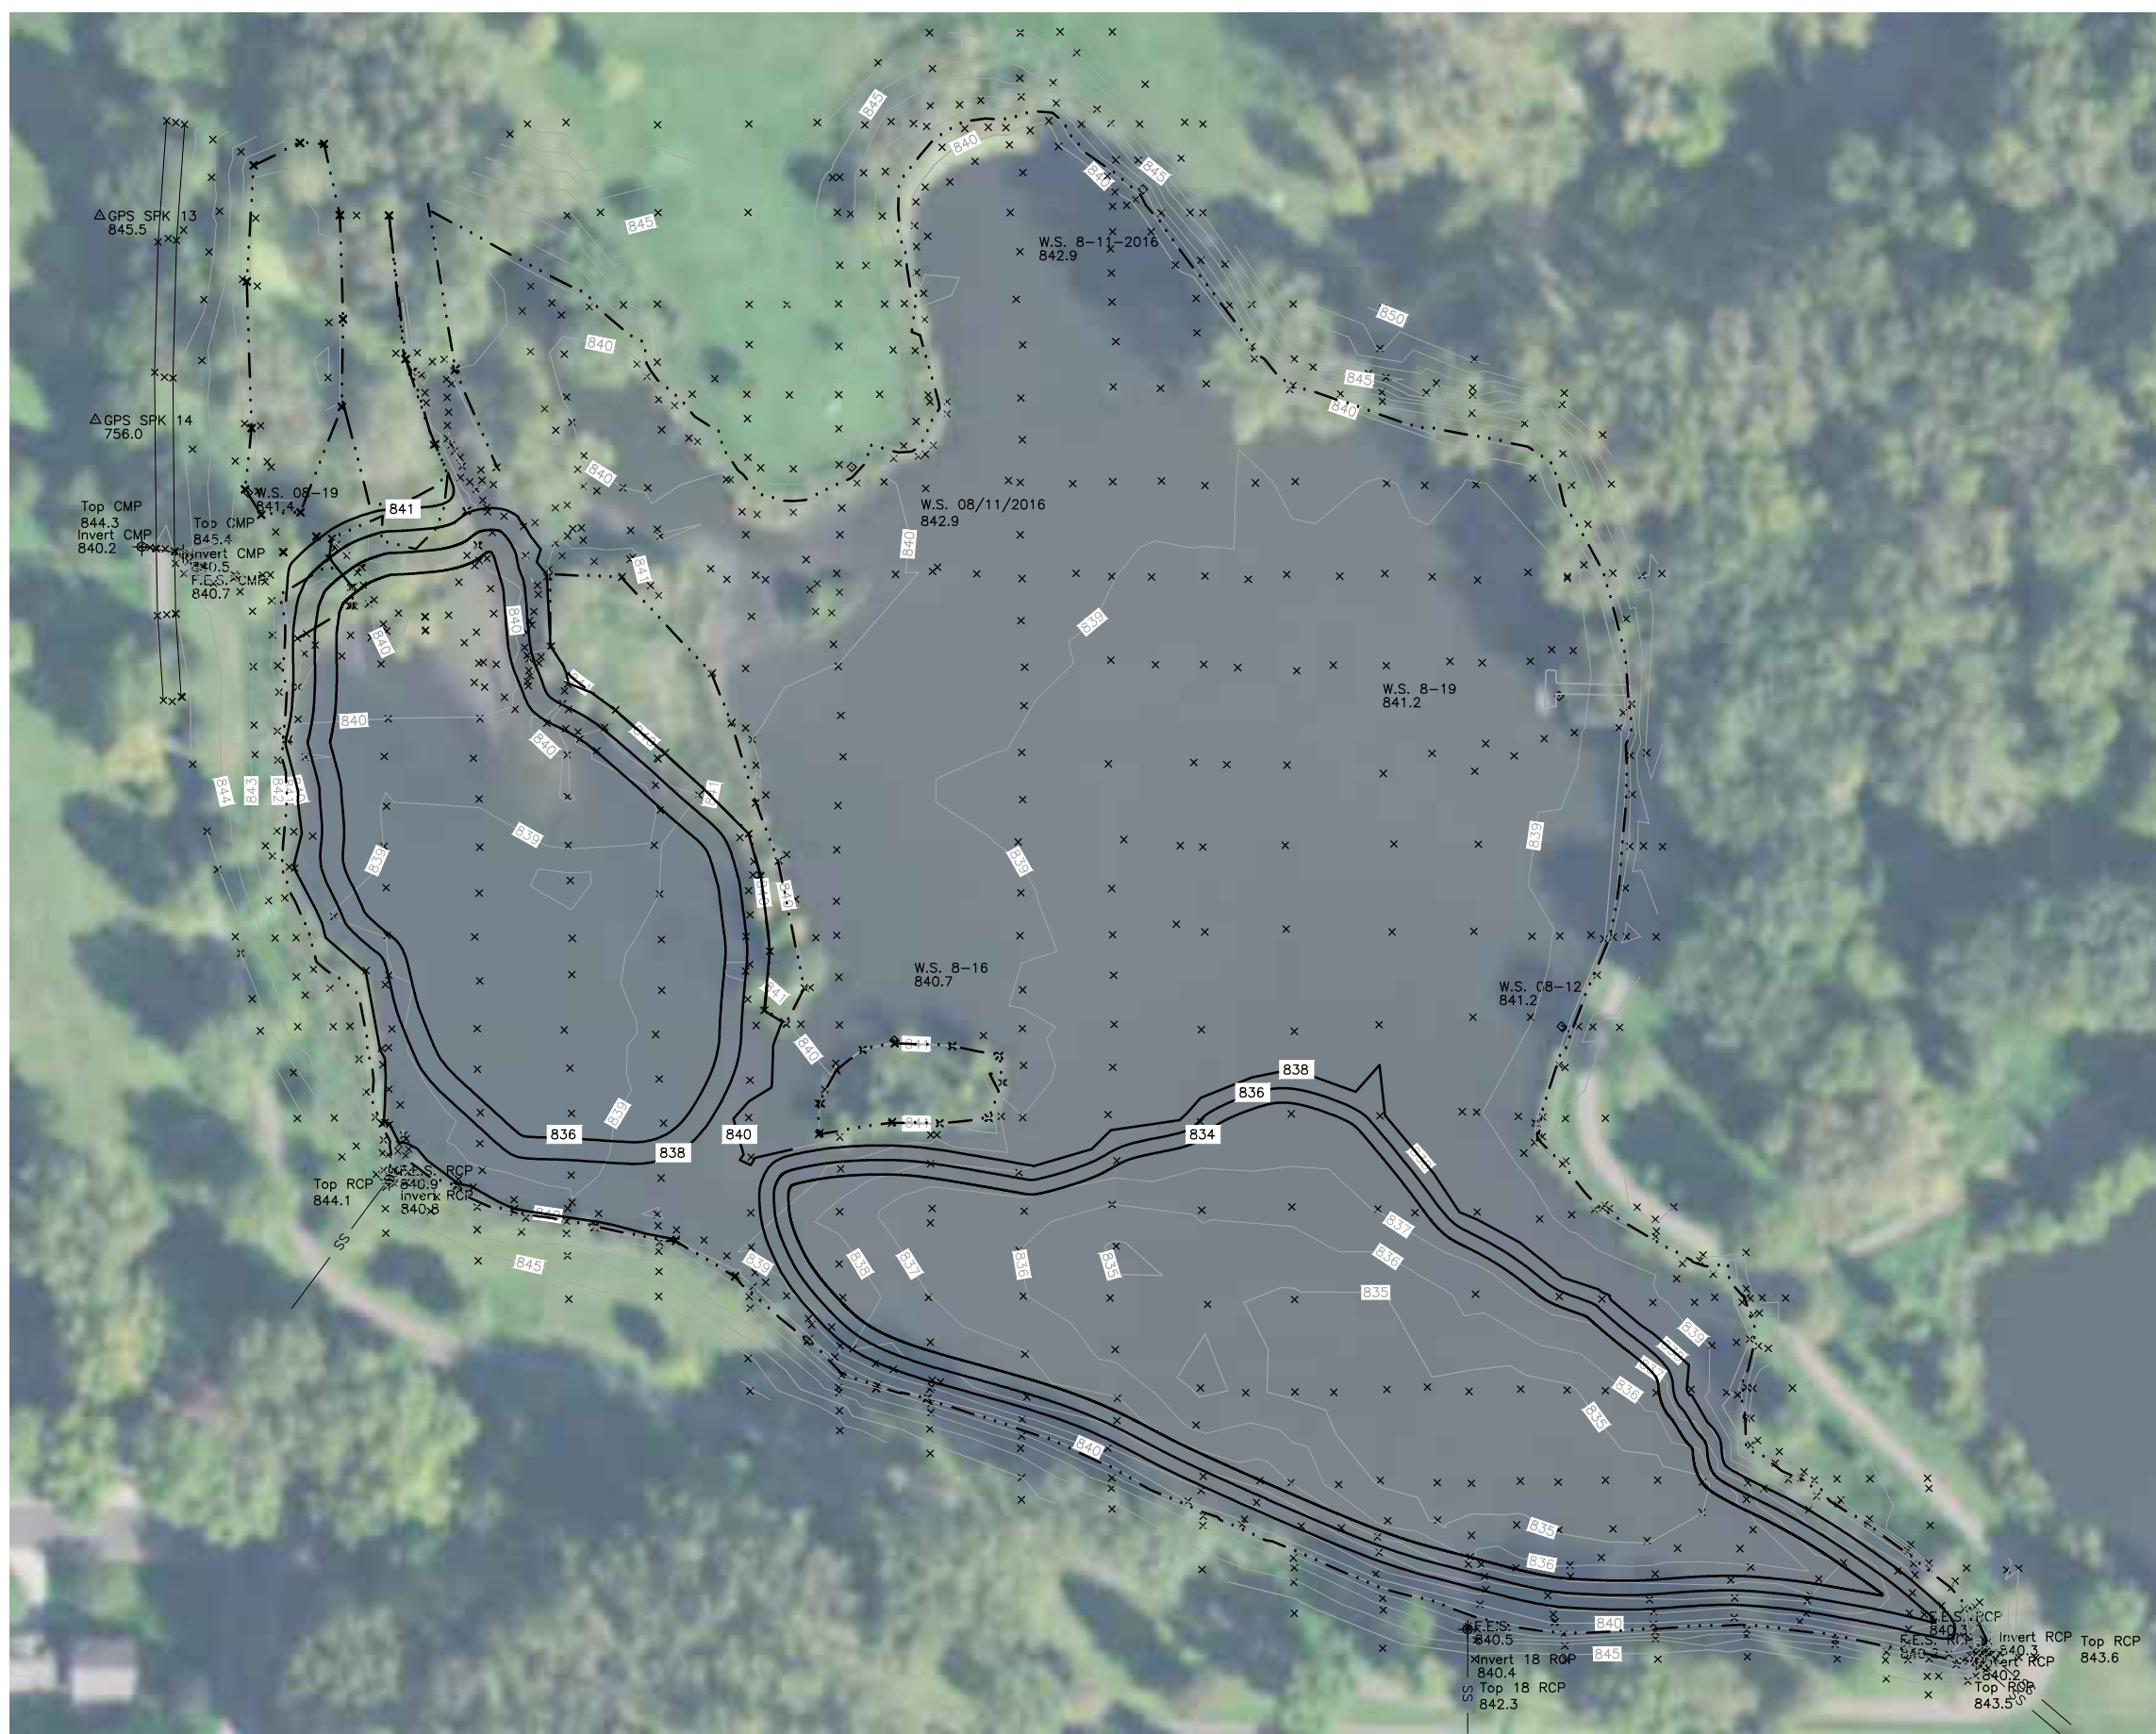
BASSETT CREEK PARK POND
 EXISTING CONTOUR COMPARISON

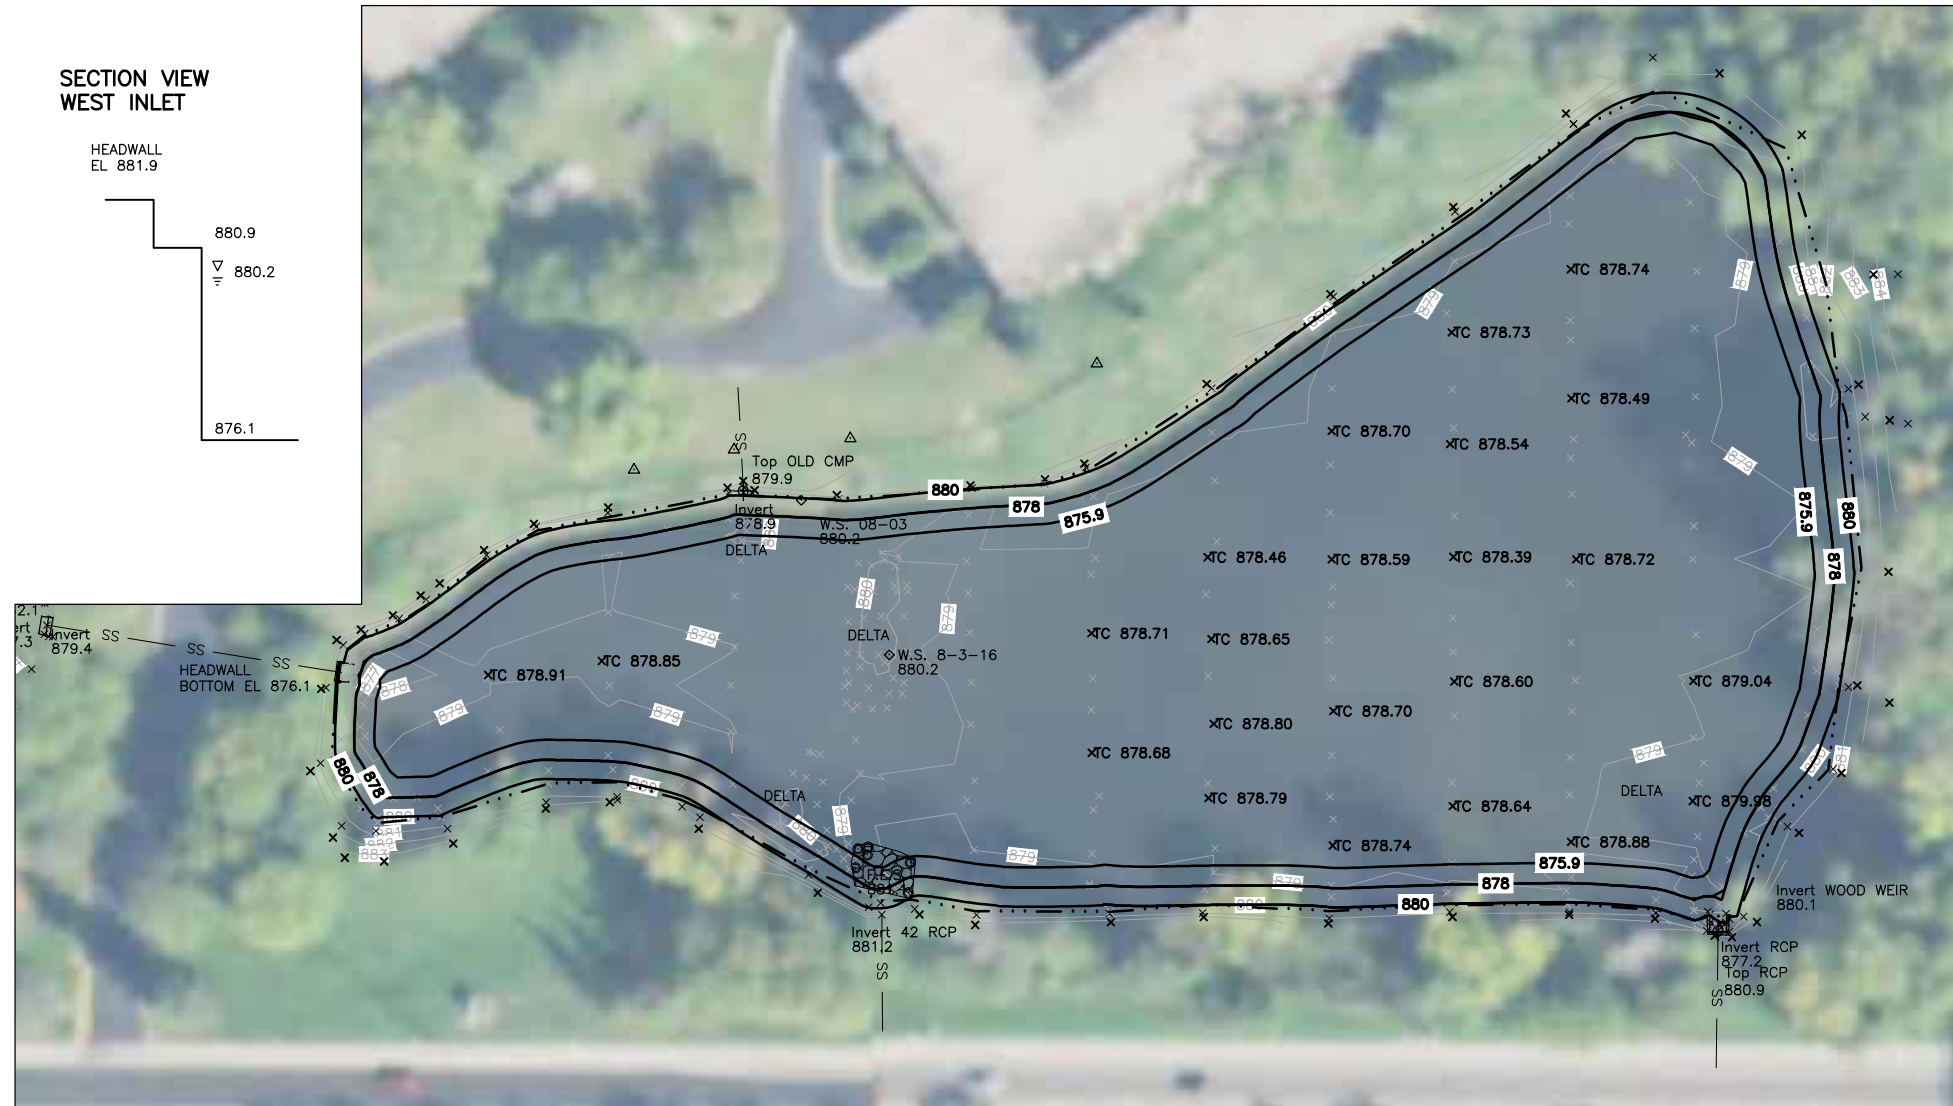
SECTION VIEW WEST INLET
