DeCola Ponds B and C Improvement Project Feasibility Study

Golden Valley, Minnesota

May 2018

Prepared for
Bassett Creek Watershed Management Commission

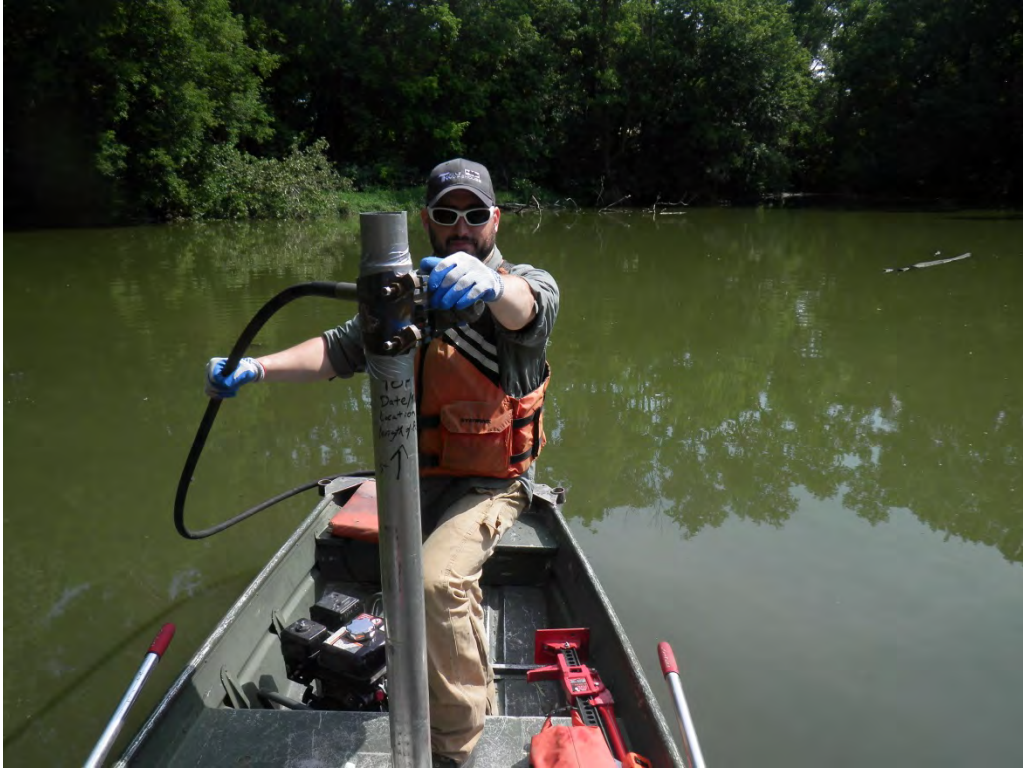
Photograph #1: Barr staff using vibra-core equipment to collect sediment core from Decola Pond B.

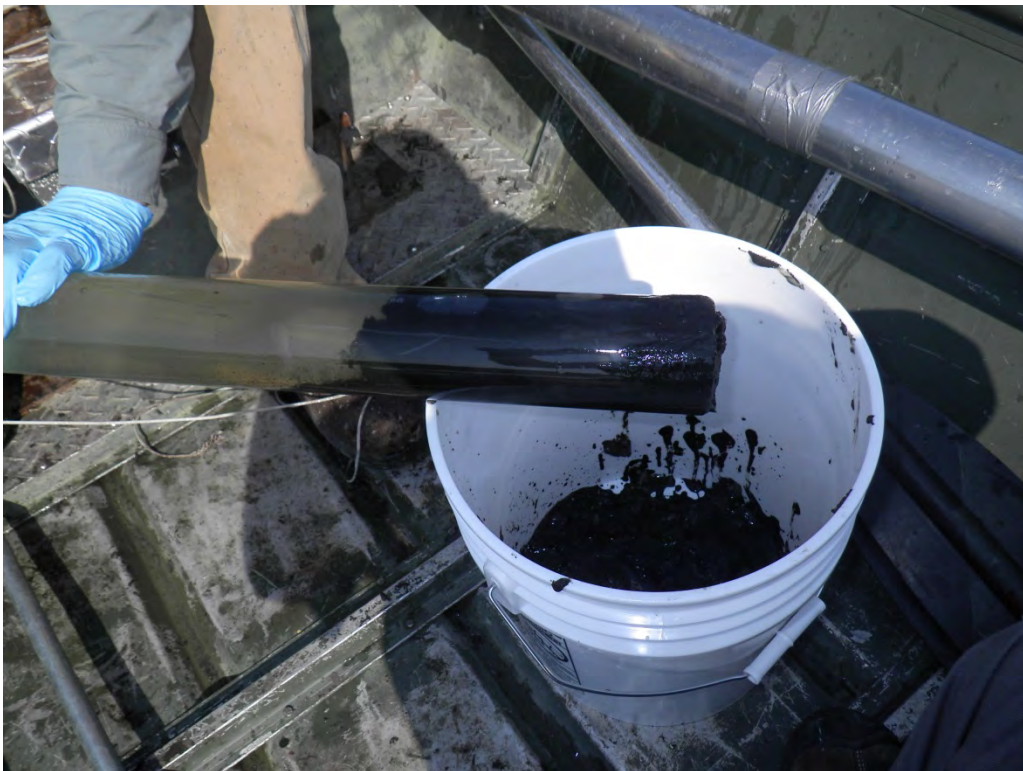
Photograph #2: Barr staff using push-core equipment to collect sediment core from Decola Pond A.

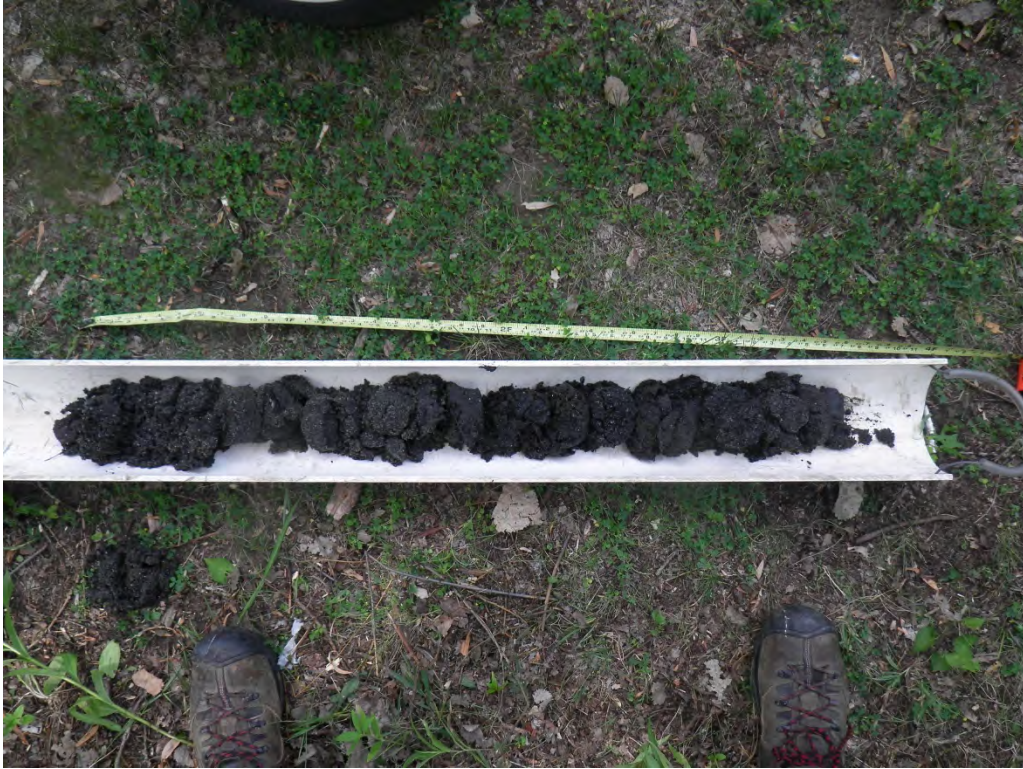
Photograph #3: Sediment core S-01 from Decola Pond B.

The results of the bathymetry surveys are shown on Figures 3, 4 and 5. The bathymetry survey of Decola Pond B indicated much of the northern portion of the pond is shallow due to a large volume of accumulated sediment. Sediment core S-01 collected from this area of accumulated sediment indicated the material is silty sand, with sporadic layers of decaying plant matter. Bathymetry data and sediment cores from Decola Ponds A and C did not indicate any areas of large sediment accumulation.

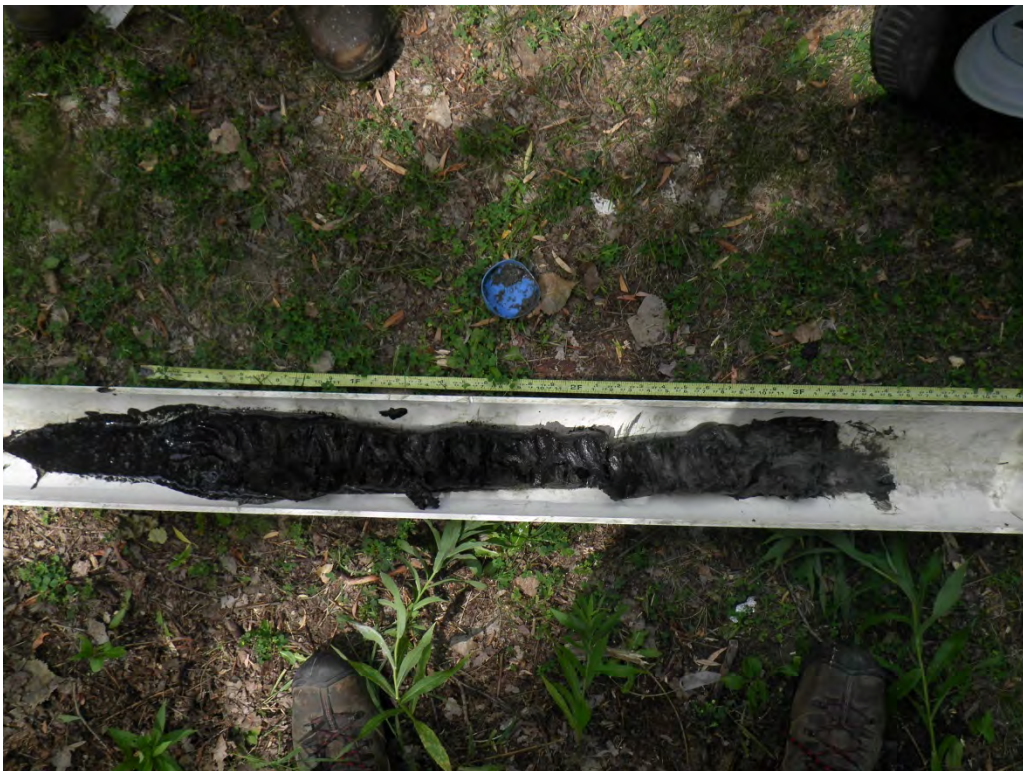
Photograph #4: Sediment core S-02 from Decola Pond B.

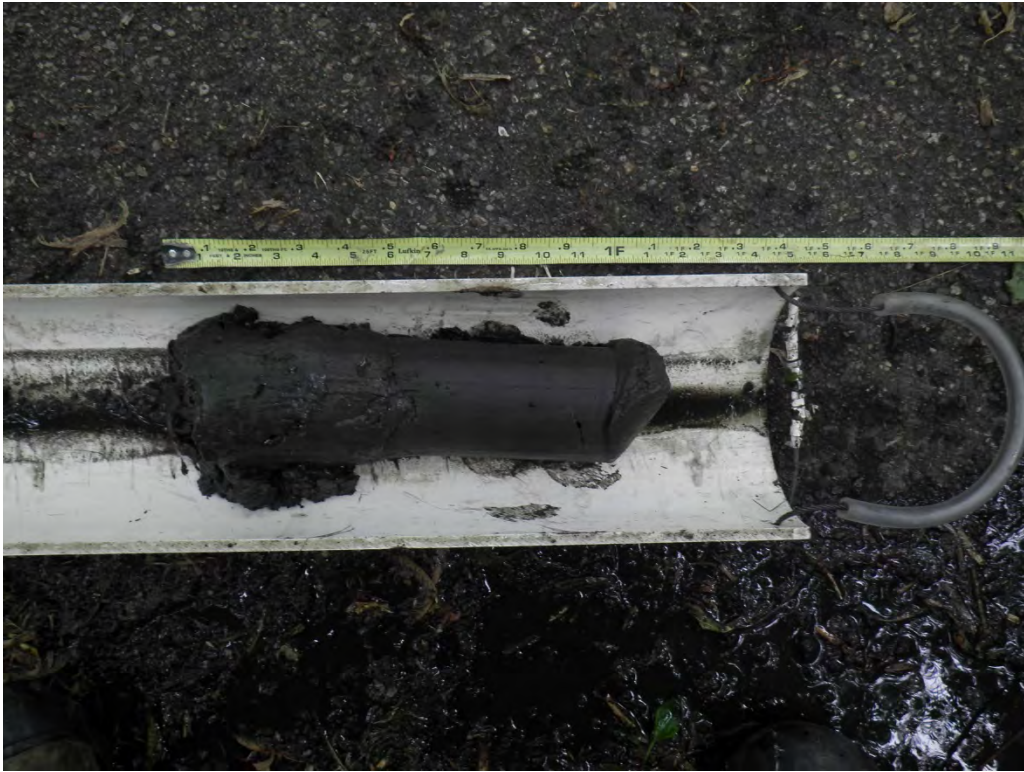
Photograph #5: Sediment core S-03 from Decola Pond C.

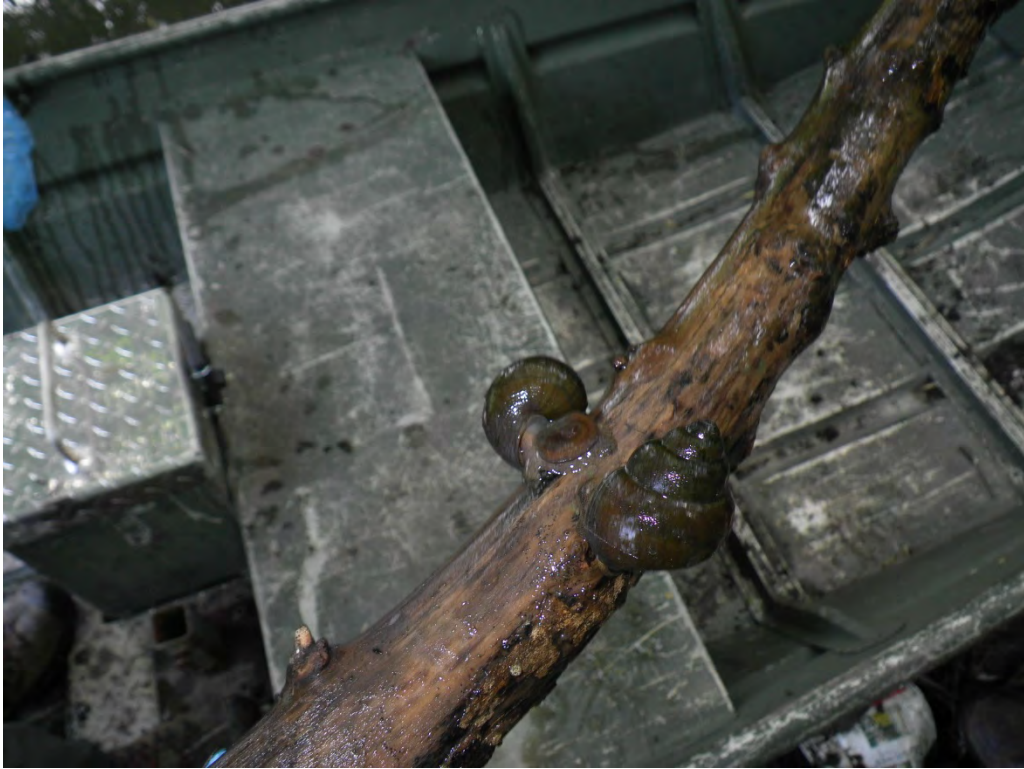
Photograph #7: Chinese mystery snails attached to stick in Decola Pond C.

While collecting sediment samples in Decola Pond C, field staff noted large numbers of large round snails in the near shore areas of the pond. The snails were recognized as being an invasive species – the non-native Chinese mystery snail. The Chinese mystery snail has a hard plate attached to its foot that acts like a trap door, allowing the snail to tightly seal itself in its shell. This allows the snail to withstand being out of water for a considerable length of time. Although the snails were discovered in Pond C, it is likely the snails are present in all 3 ponds given their close proximity and connection via ditch or culvert. Ponds A and B were experiencing algae blooms during sediment sampling, and the low water clarity prevented viewing of the pond bottom. Because the snails are an invasive, non-native species that could invade other waterbodies, consideration of the proximity of other waterbodies to the sediment disposal or re-use sites should be considered if and when the Decola ponds are dredged.

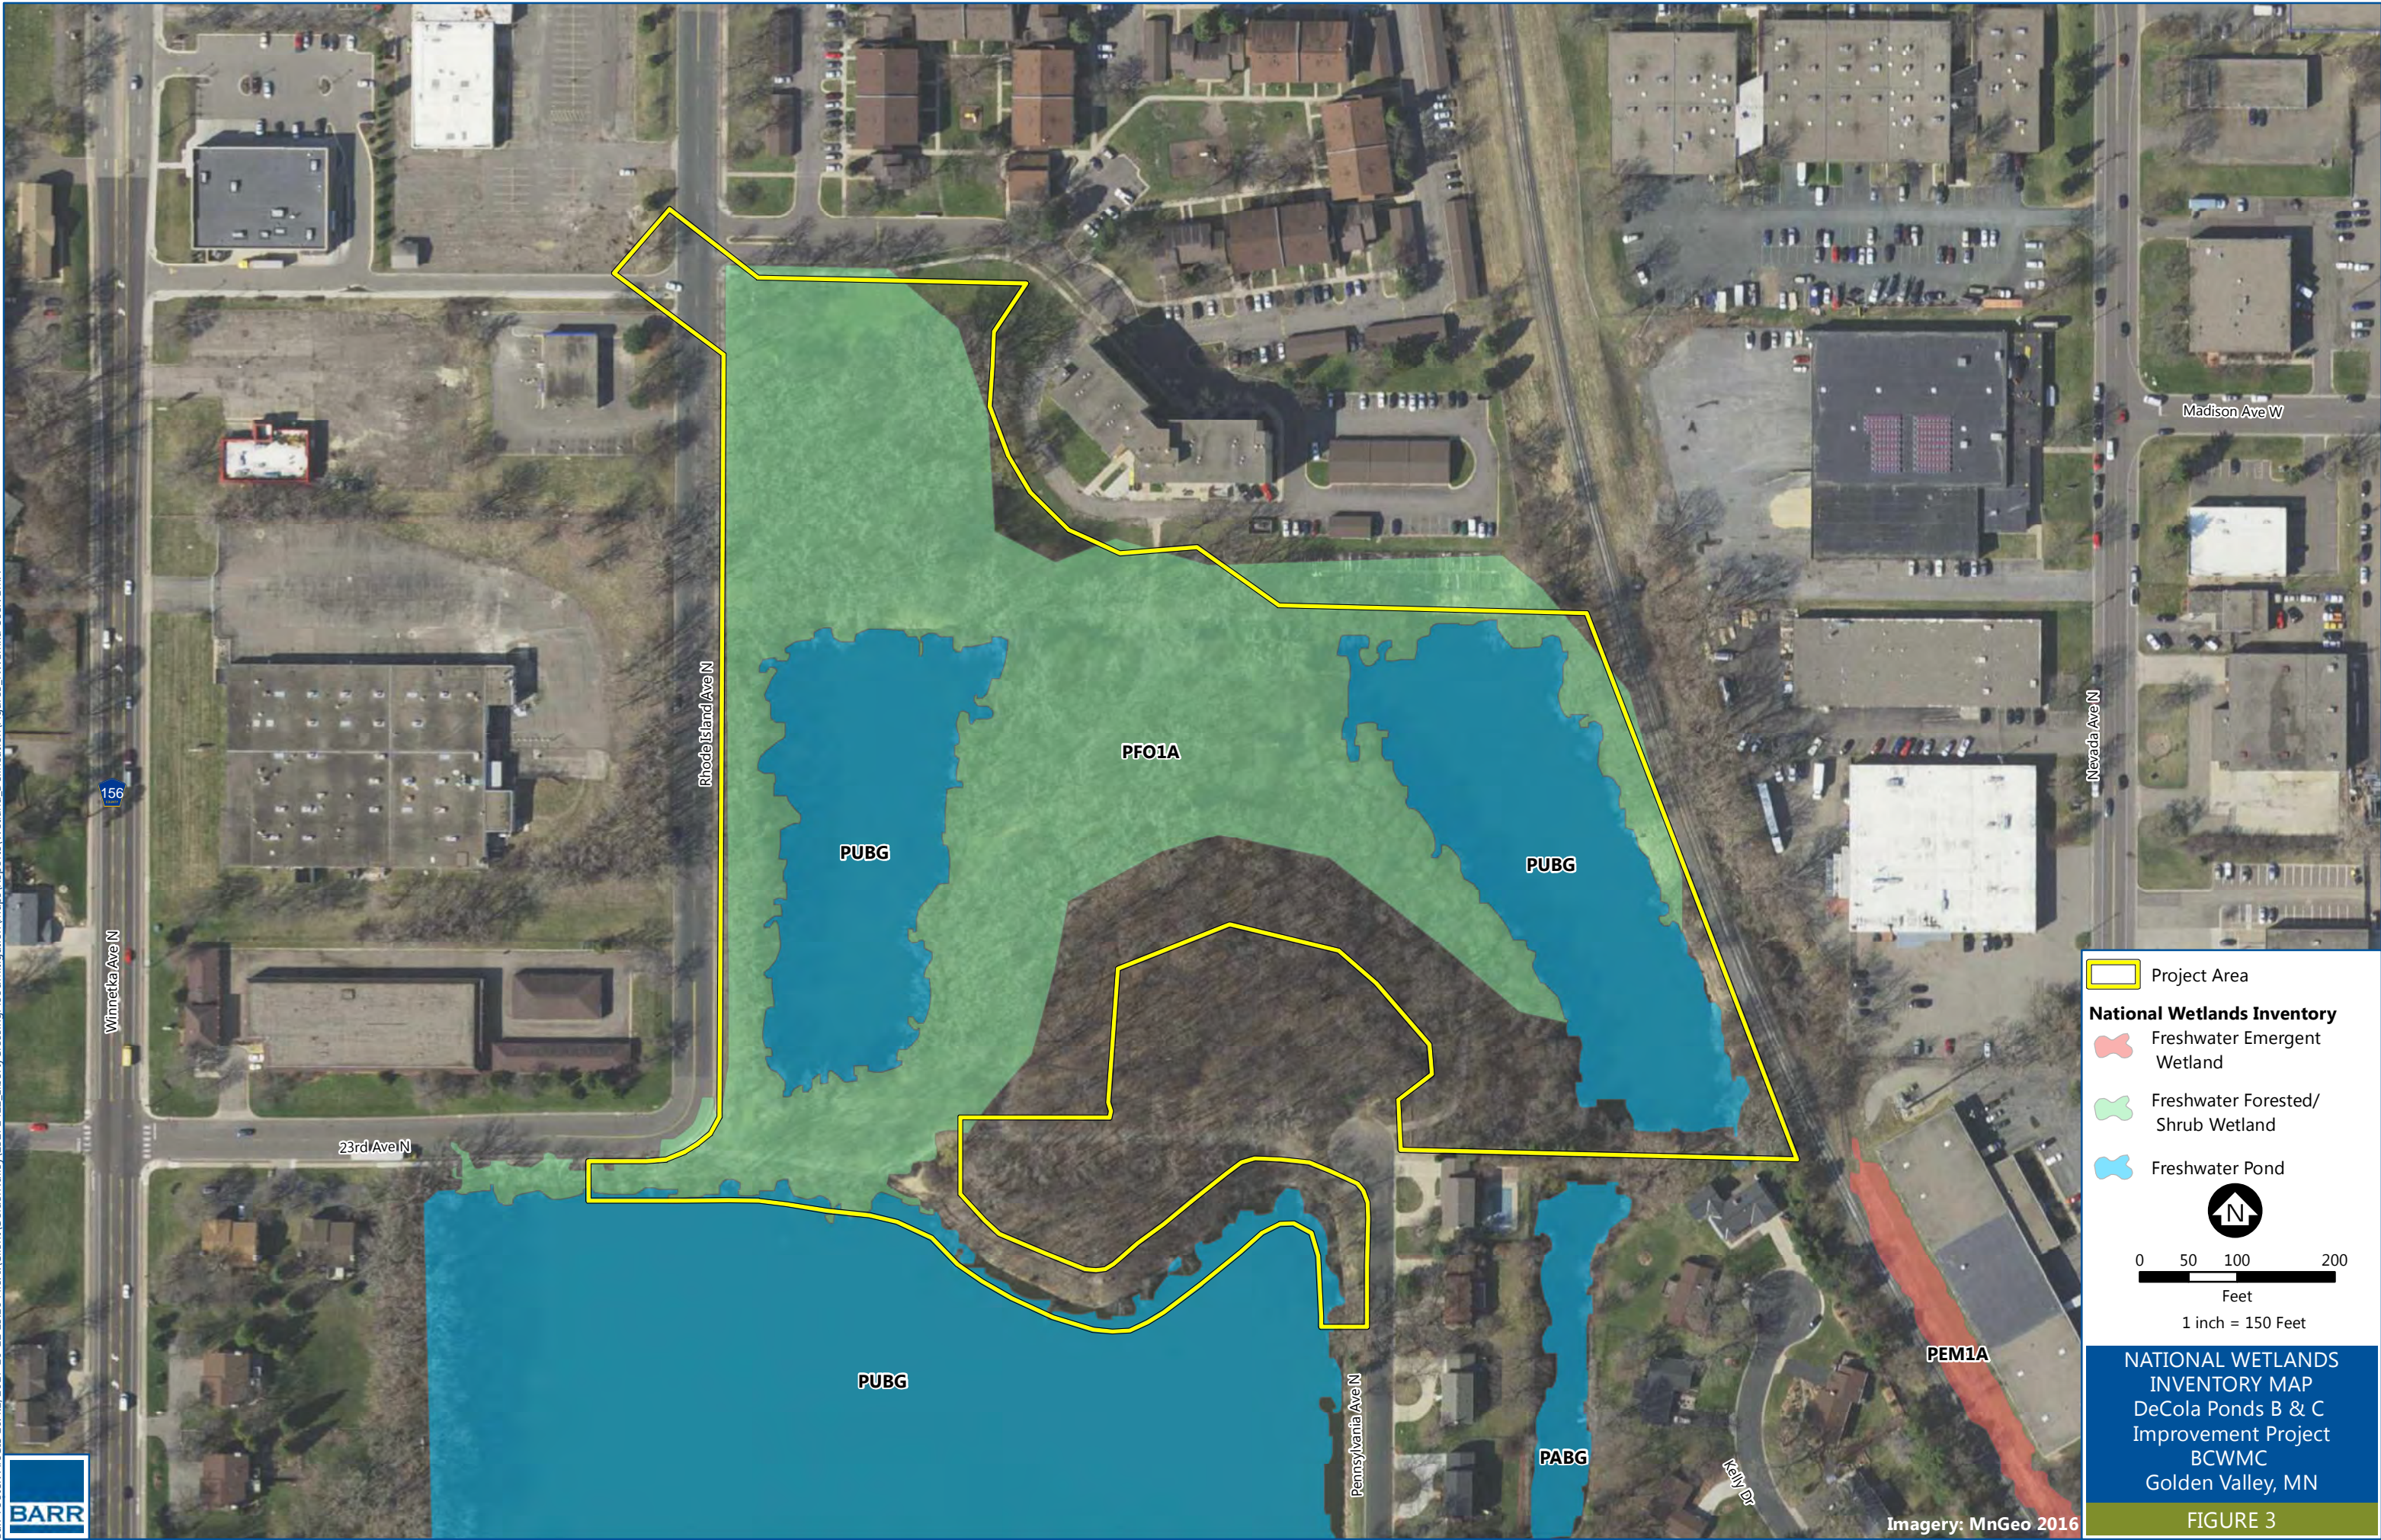
NATIONAL WETLANDS INVENTORY MAP
DeCola Ponds B & C Improvement Project
BCWMC
Golden Valley, MN
FIGURE 3

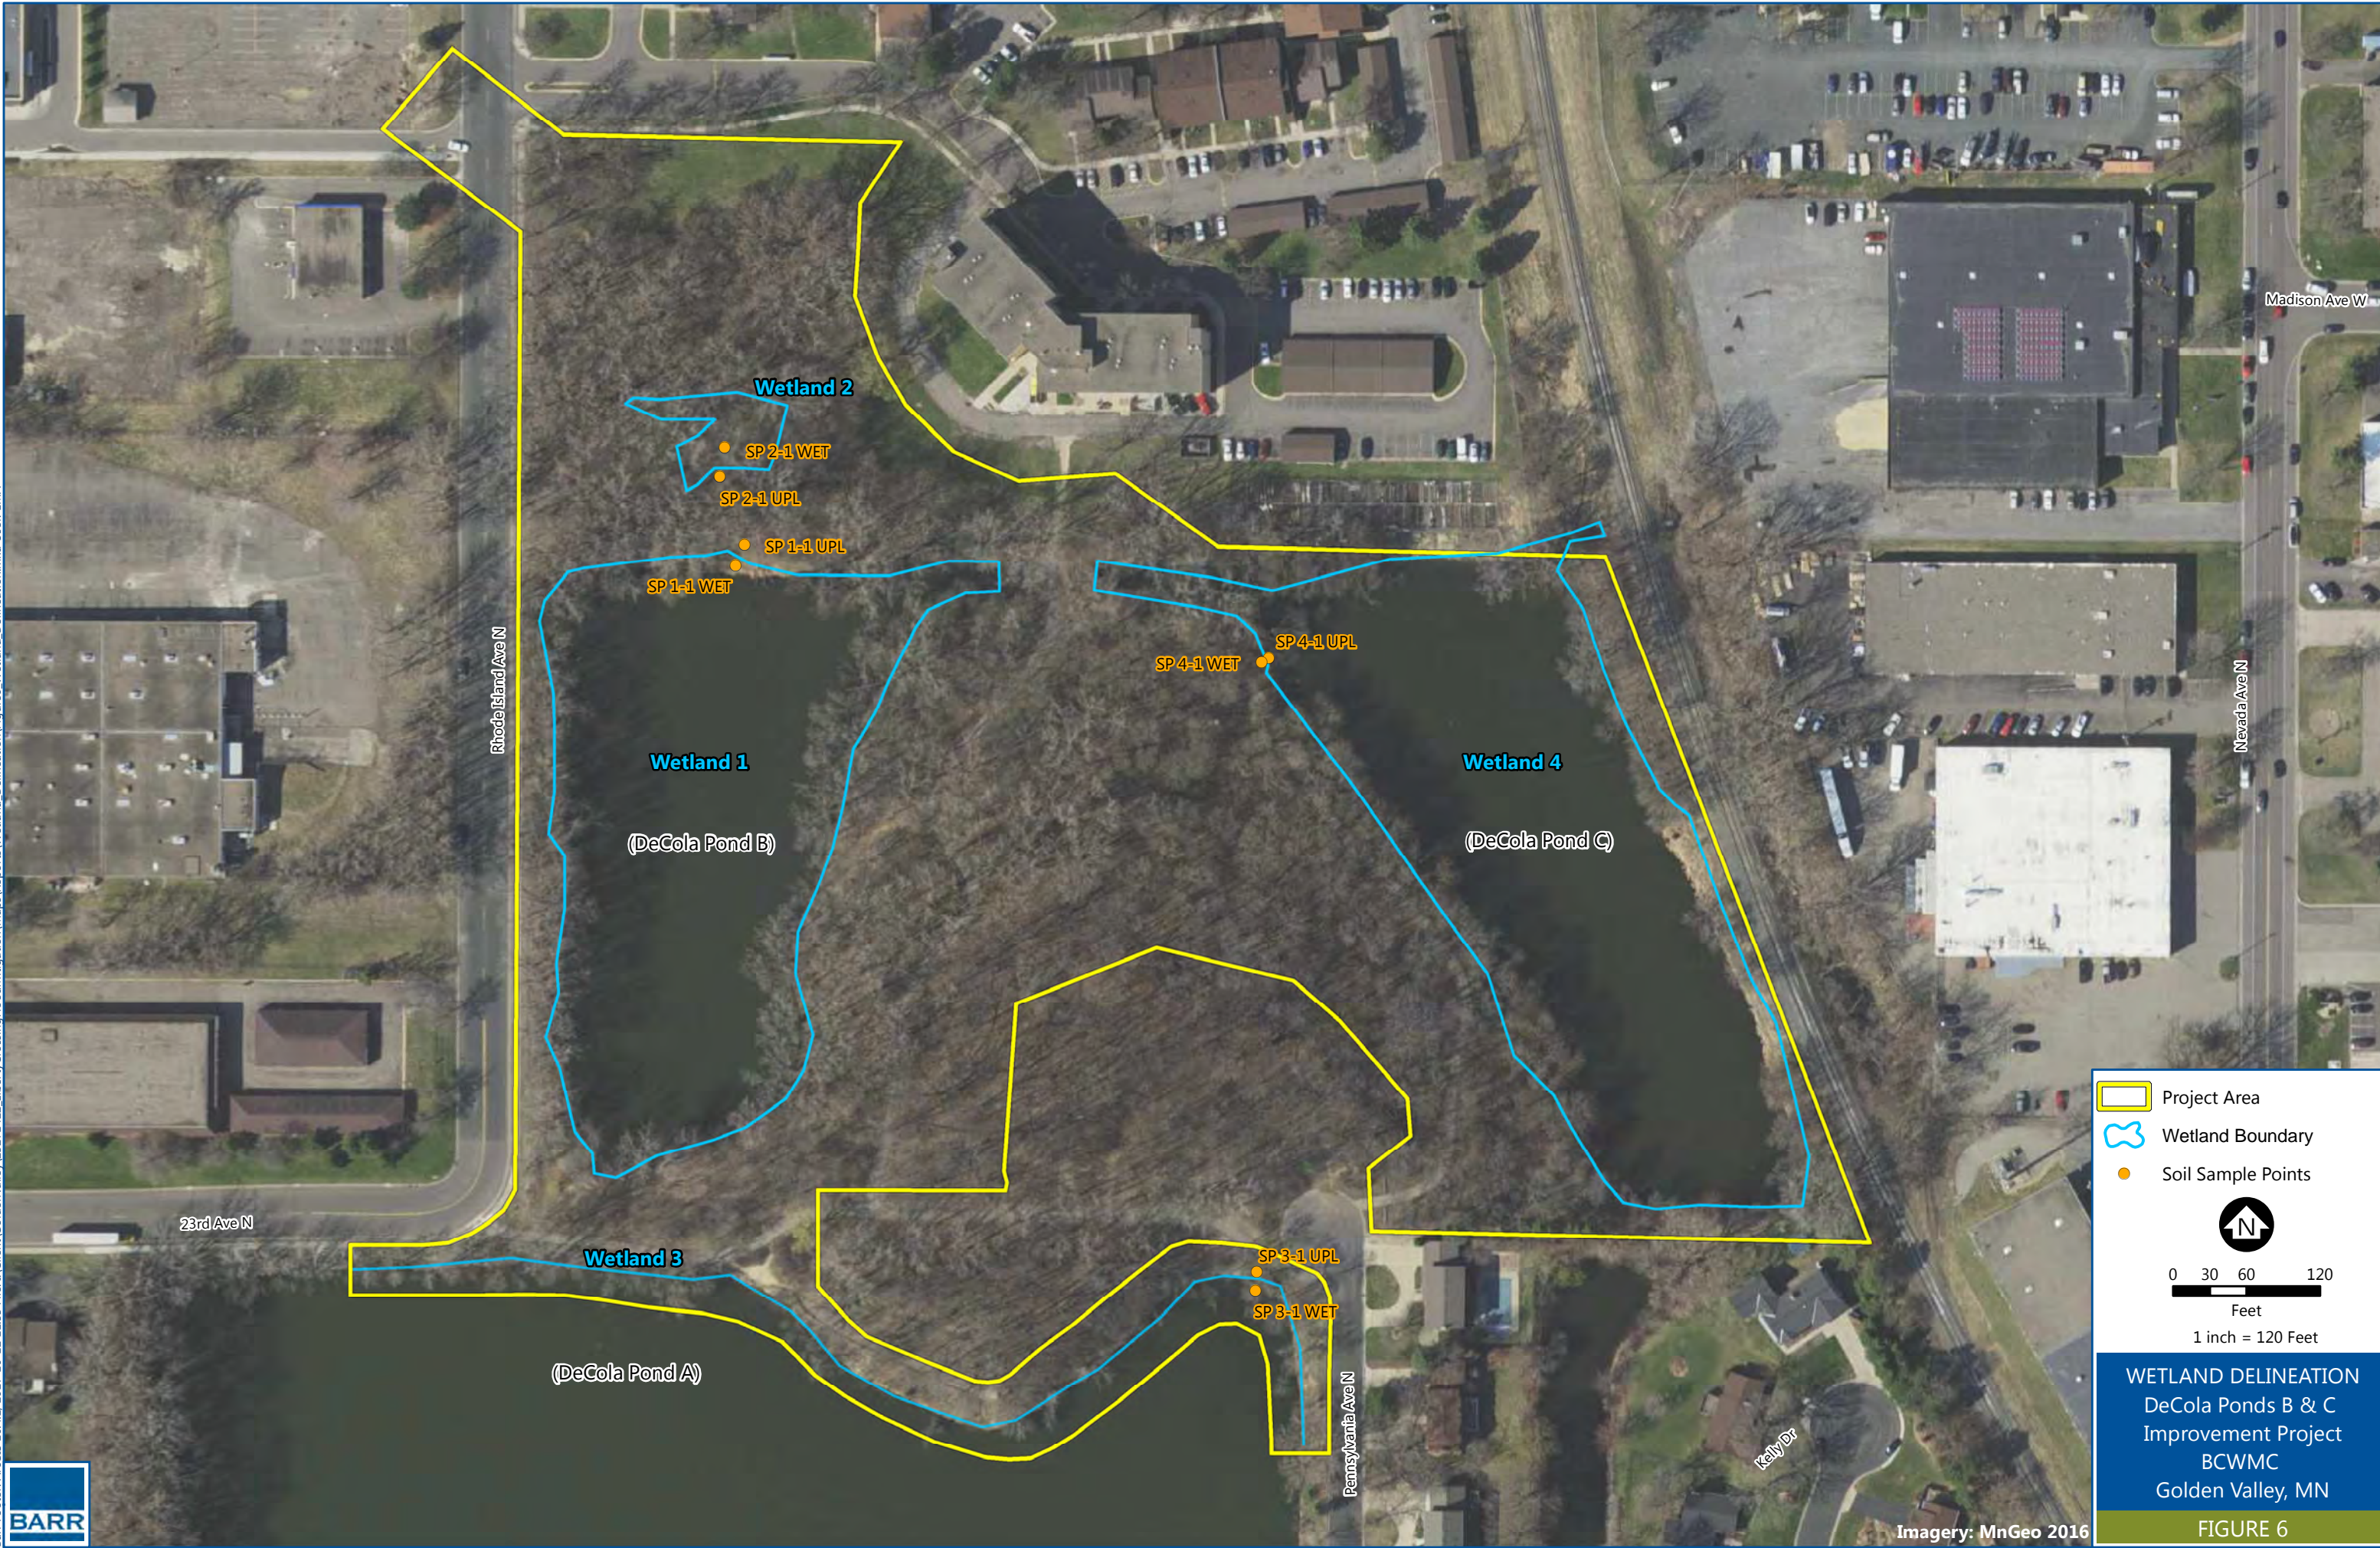
FIGURE 6

WETLAND DELINEATION
DeCola Ponds B & C
Improvement Project
BCWMC
Golden Valley, MN

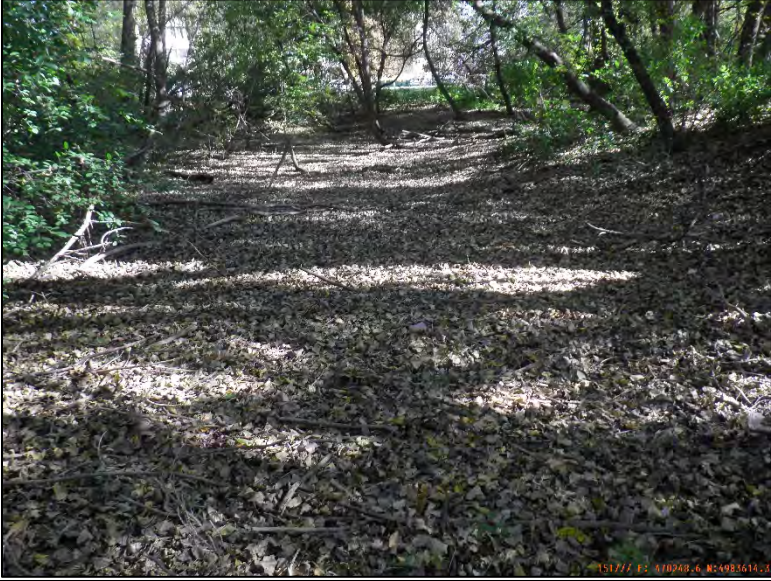
<p>Photo 4 – October 16, 2015</p> <p>Wetland 2</p> <p>Facing east from the western edge of Wetland 2. This photo shows that Wetland 2 has a lack of herbaceous vegetation due to seasonal flooding.</p> <p>Wetlands 1 and 2 are separated by an upland berm shown on the right side of Photo 4.</p>

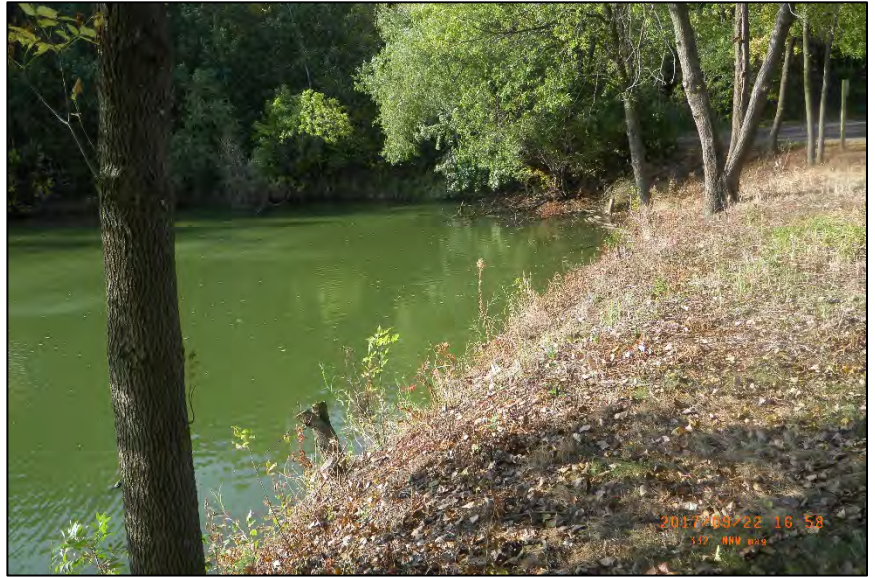
Wetland 3 (DeCola Pond A) facing north along the western edge of the delineated boundary. This photo shows an abrupt transition to shallow open water wetland from upland area. This abrupt transition zone is typical along the delineated portion of Wetland 3.

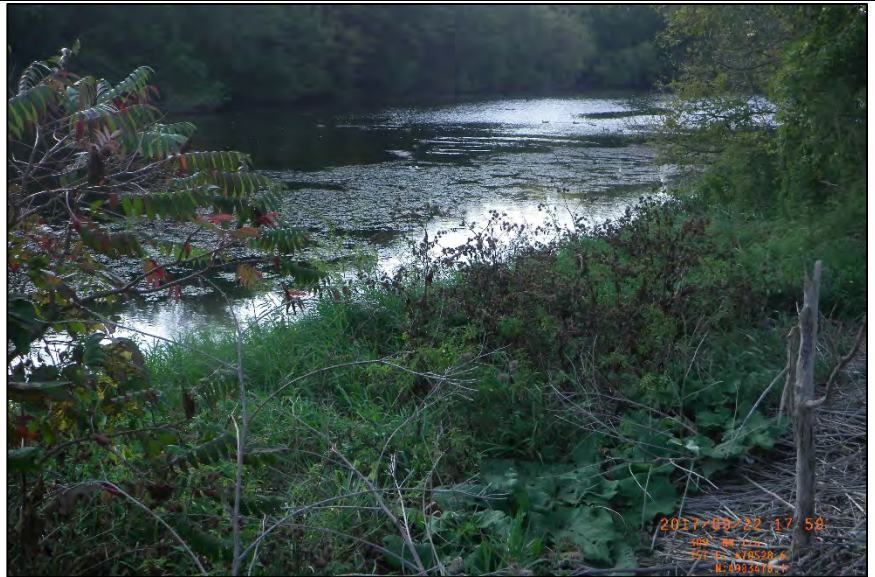
Wetland 4 (DeCola Pond C) facing NW on the east side of the wetland. This photo shows a narrow Type 2, wet meadow fringing shallow open water wetland. Dominant vegetation in this area is reed canary grass.
