# Bassett Creek Main Stem Restoration Project

## 10th Avenue to Duluth Street, Golden Valley (2015CR)

FINAL REPORT  
March 10, 2019

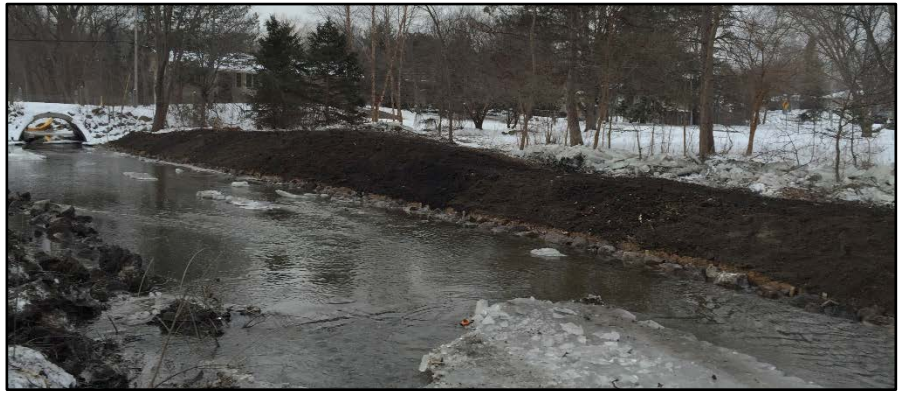
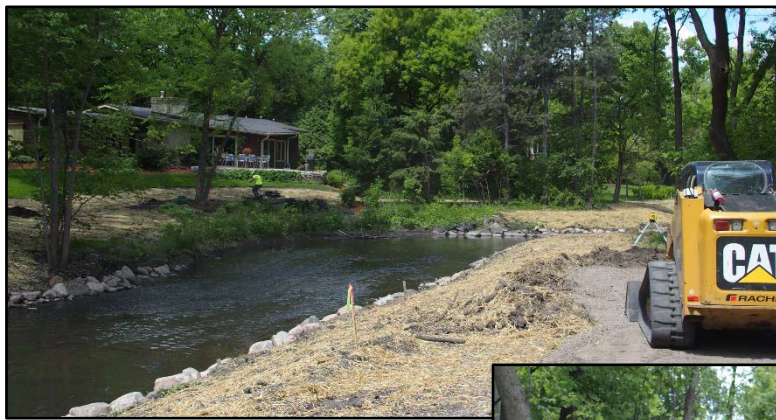
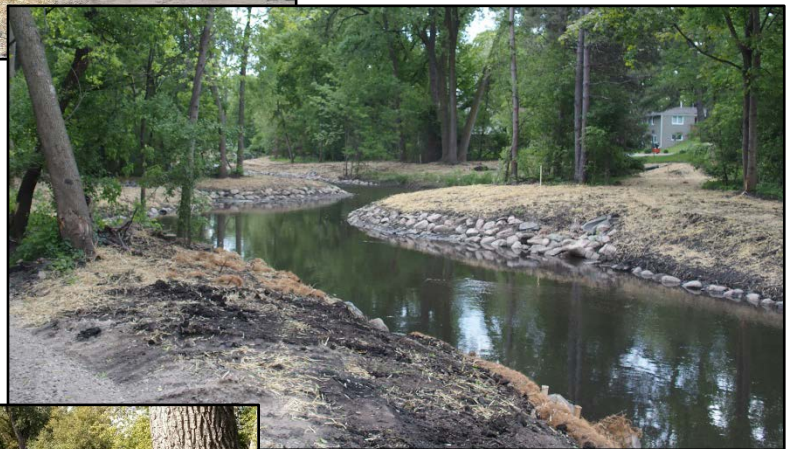
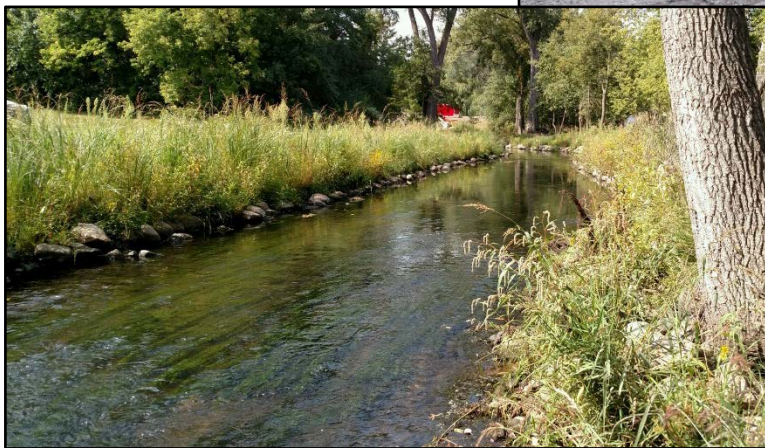
Project construction began in the winter of 2015. The project was constructed in two phases, each under a separate contract. Phase One was construction including stream bank shaping, placement of field stone rock and 12-inch bio-logs, and repair of storm sewer outlets. Phase one was completed in 2016. Phase Two began

immediately following construction and included the establishment of native vegetation along the stream. Phase two continued through the growing season of 2018.
