Carp population study on Schaper Pond and Sweeney Lake

October 17, 2019 Commission meeting

Barr Engineering Company

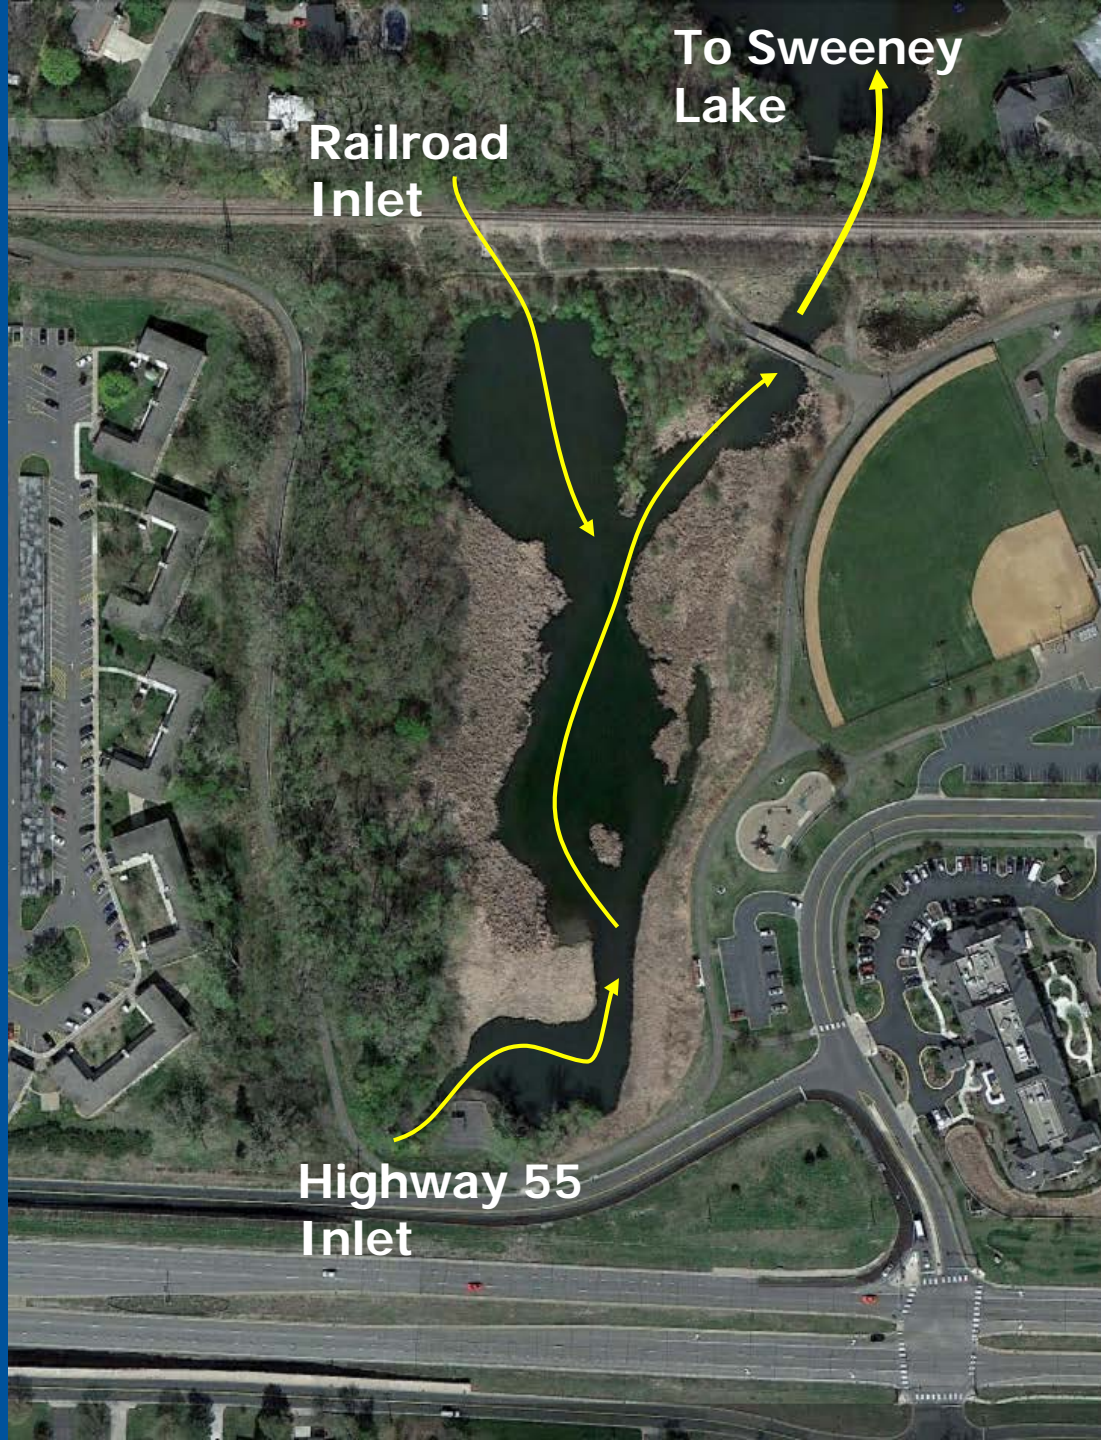
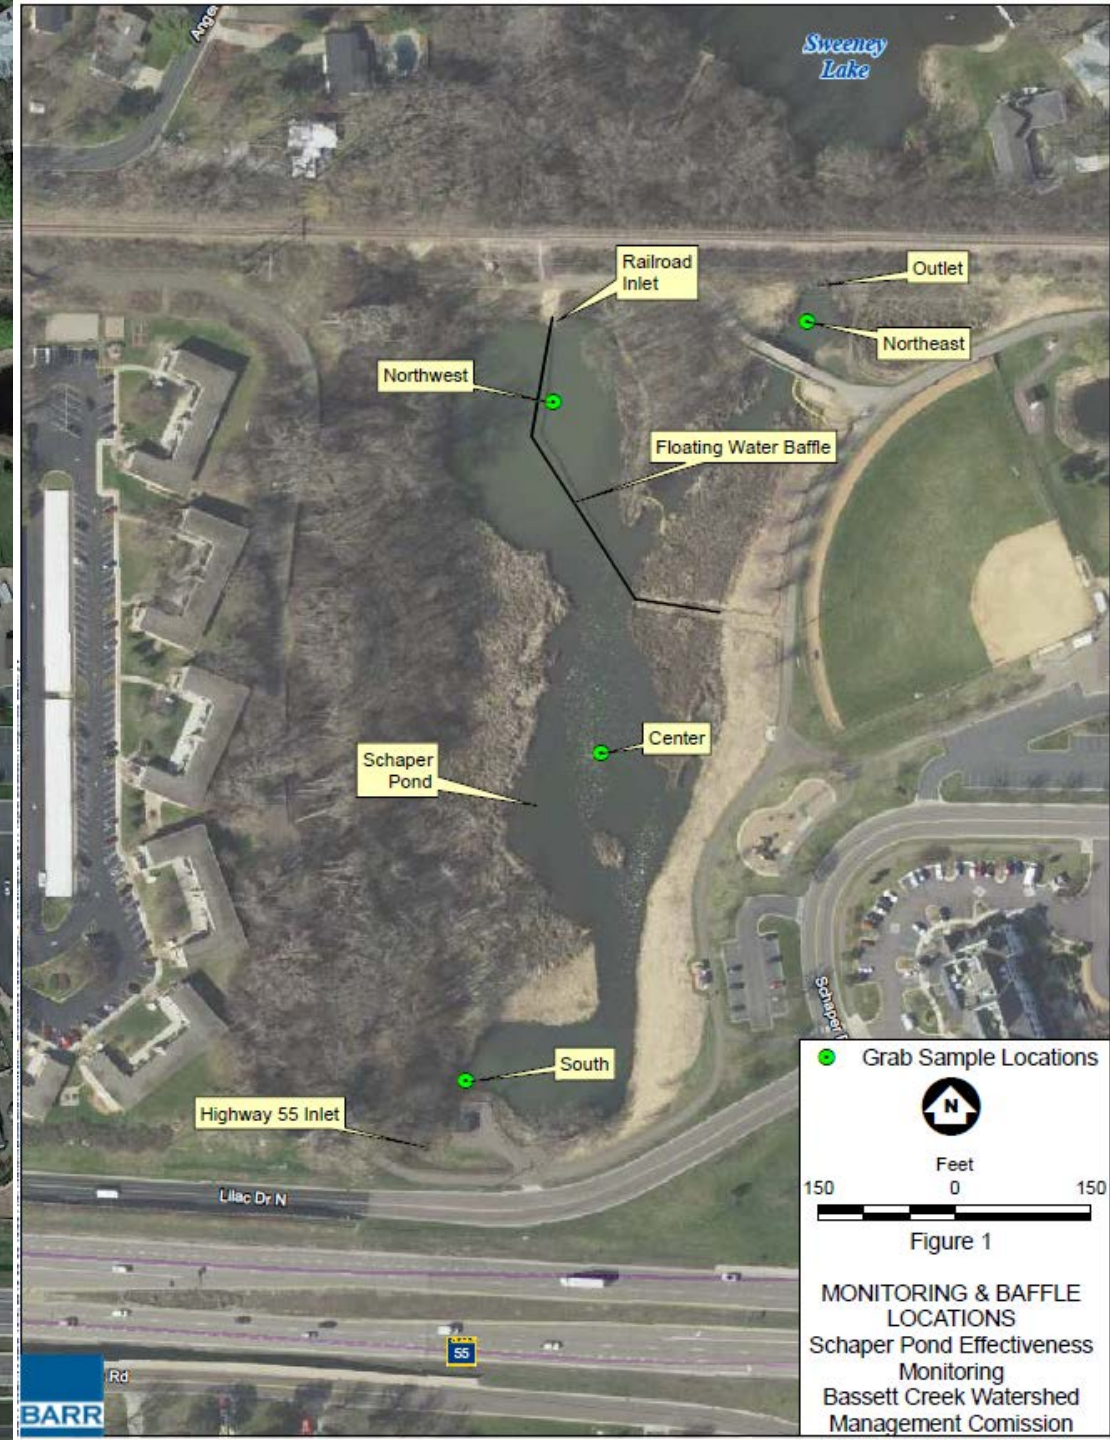
2017 effectiveness monitoring indicates that Schaper Pond is not removing TSS or TP as well as it did in 2011—TP leaving the pond was higher than TP entering the pond

2011

phosphorus
($\mu\text{g/L}$)

2017
2011

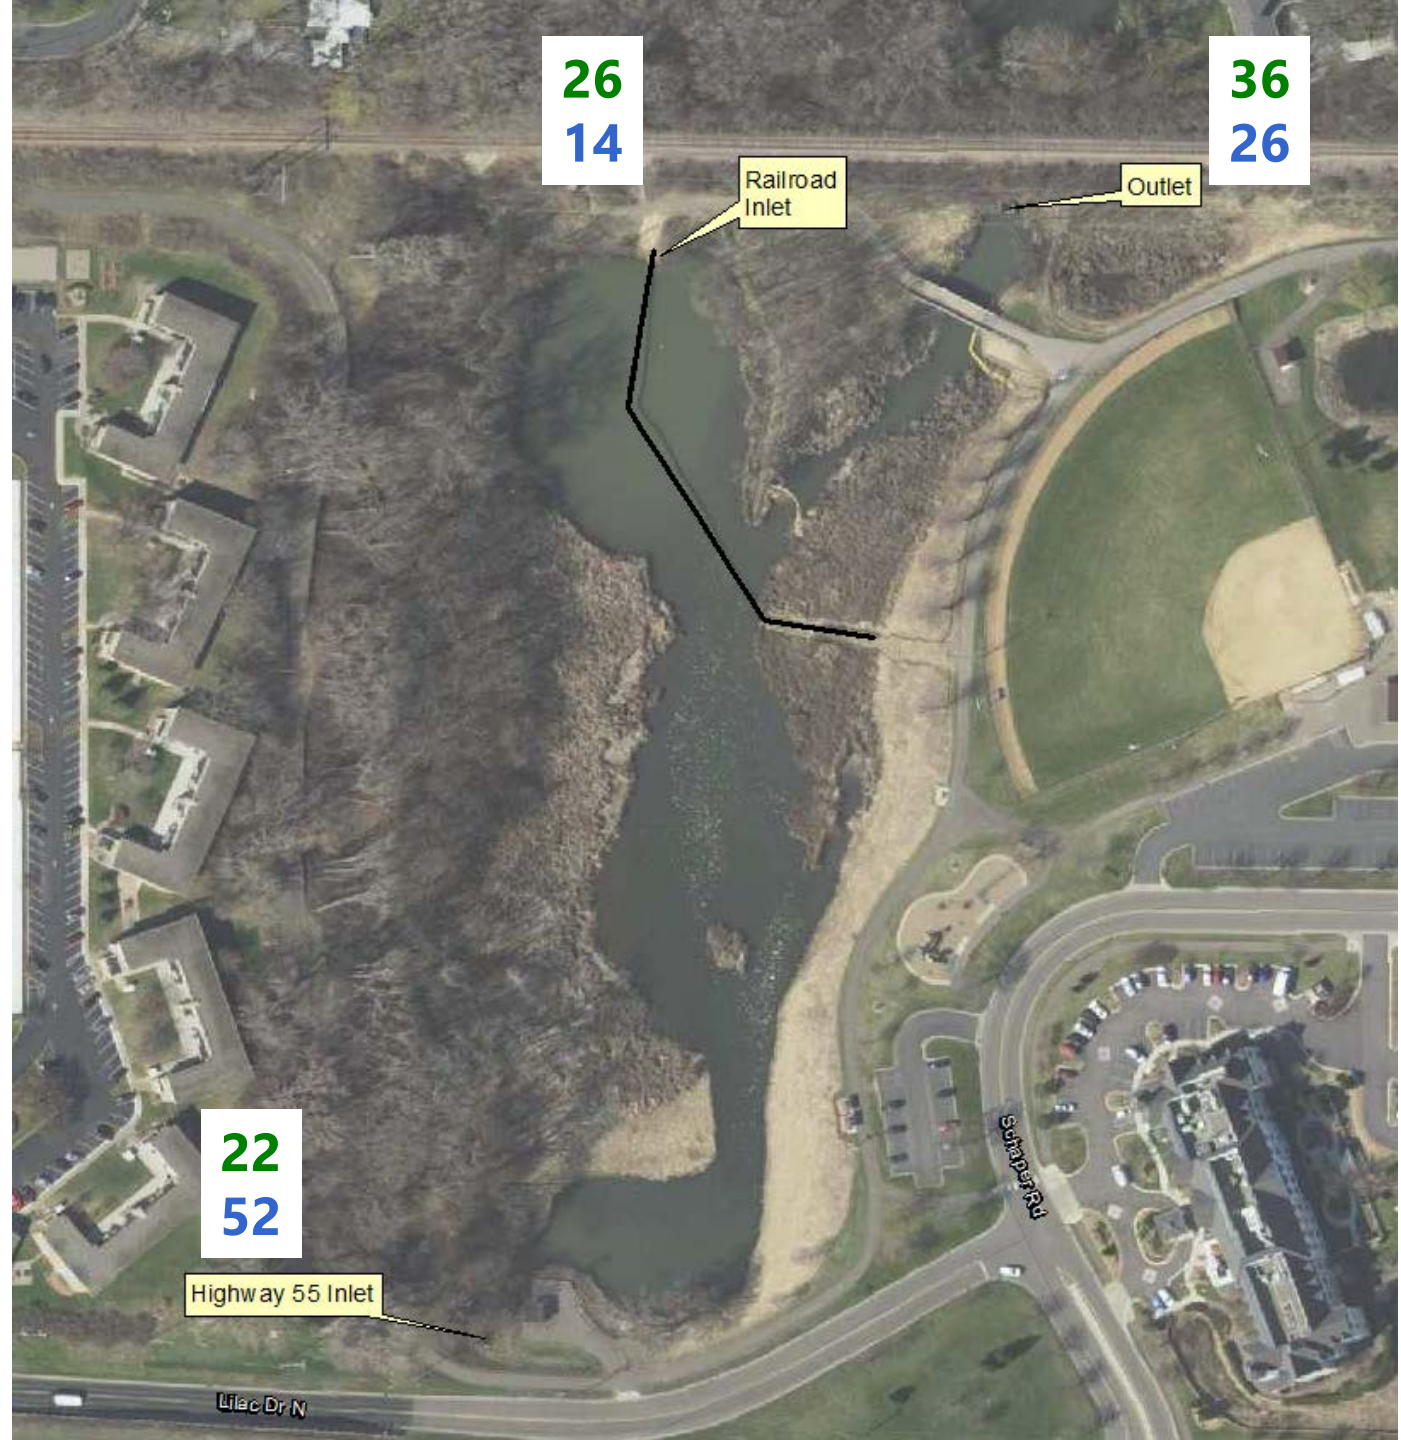
total
suspended
solids (mg/L)

2017

2011

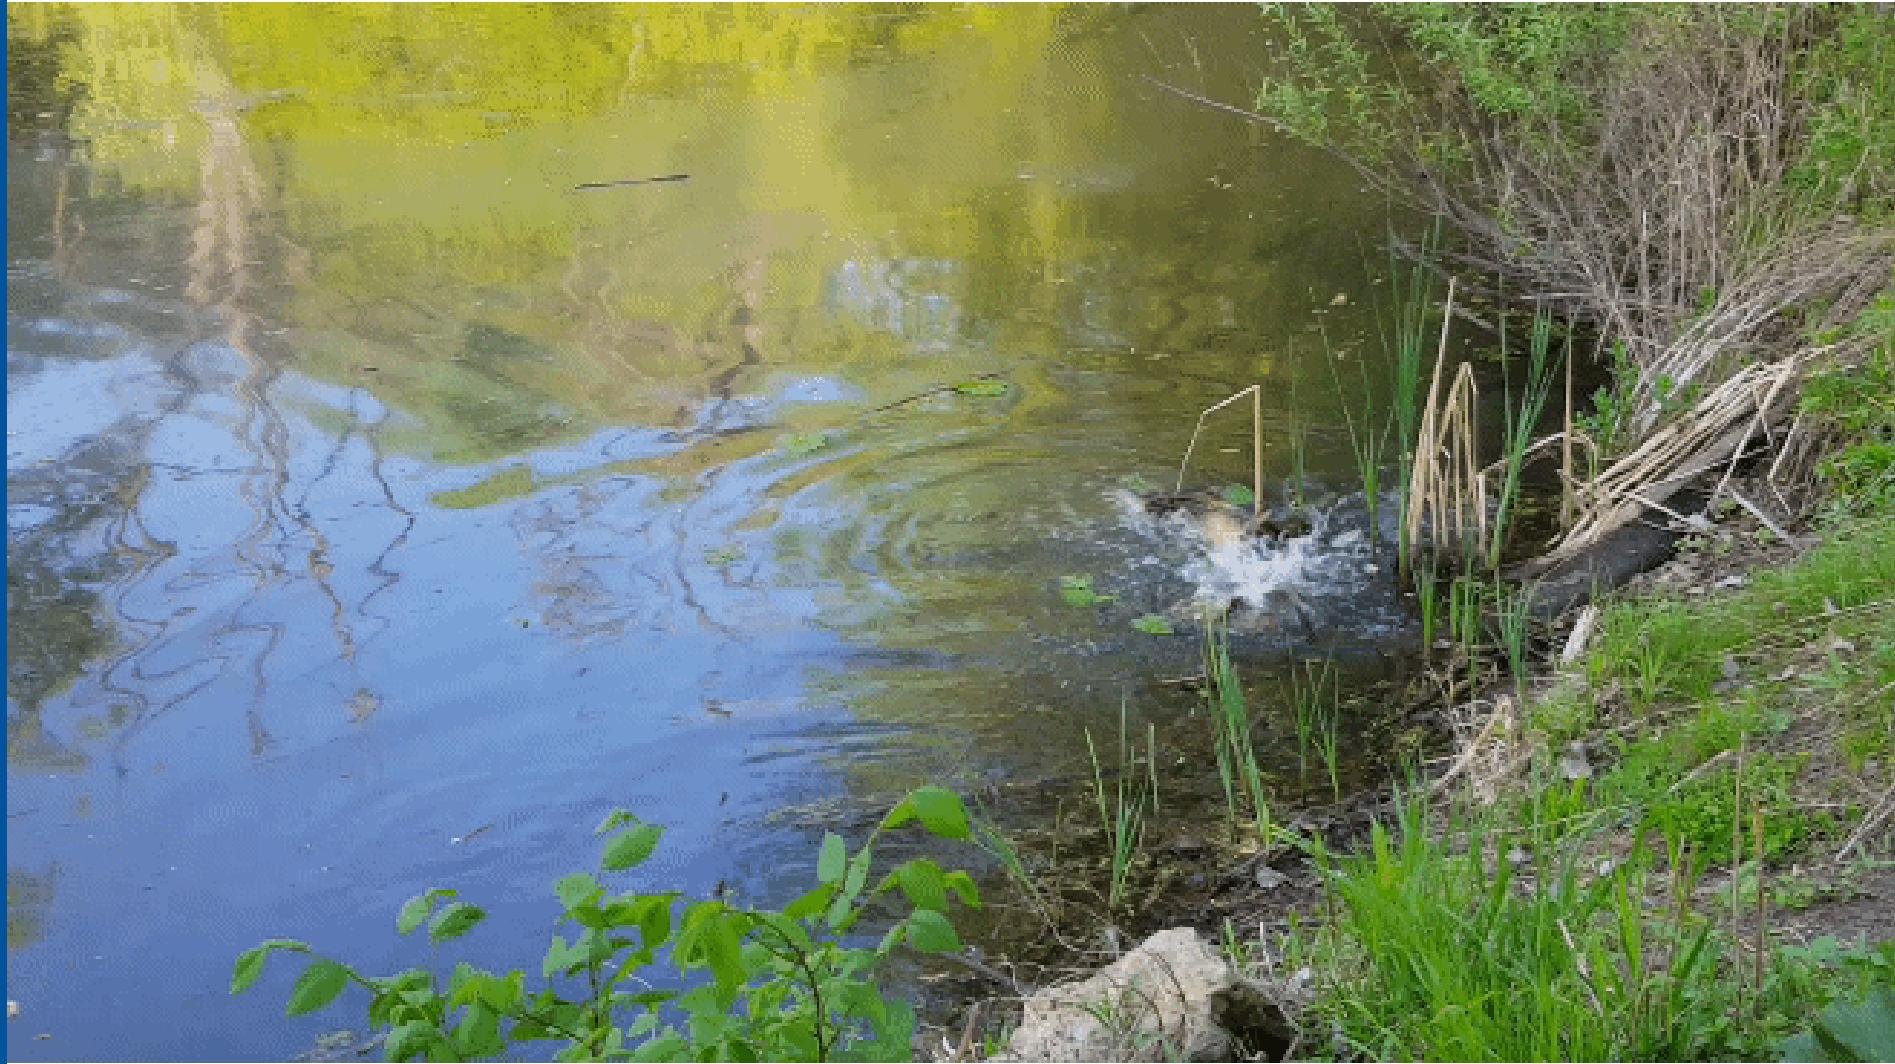
effects of
carp in
Schaper Pond

- limited time to equilibrate to start-up conditions
- high water—flows above 25 cfs would lift curtain off bottom of pond
- carp—resuspend TSS in NW corner
- watershed construction—Douglas Dr.
- upstream water treatment—several projects since 2011
- changes to bathymetry

- bathymetry indicates sedimentation has occurred—unlikely to alter treatment capacity
- longitudinal water quality monitoring confirms increasing TP/TSS concs. as flow moves through pond
- spring carp survey—biomass 4 times higher than management threshold
- Summer carp survey—included several YOY carp; likely hatched in the pond
- Recommended more carp monitoring

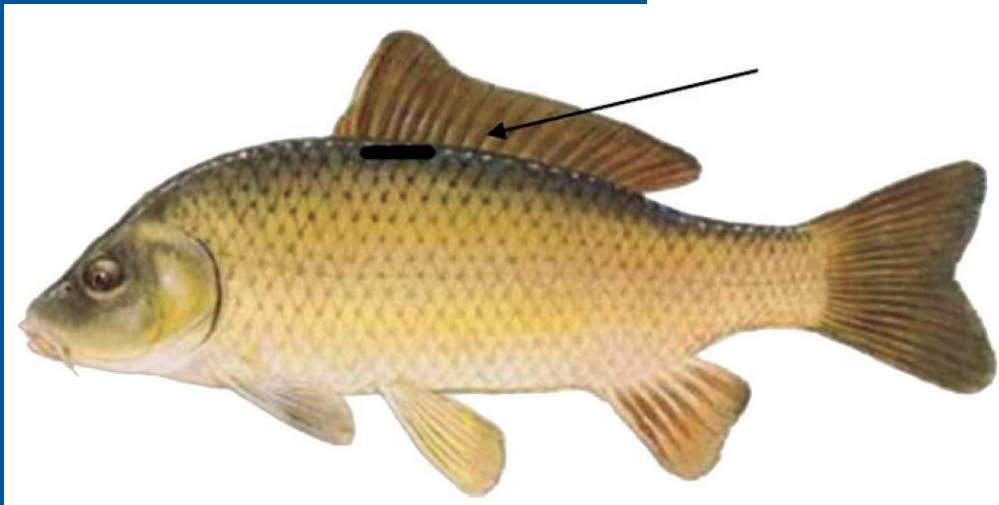
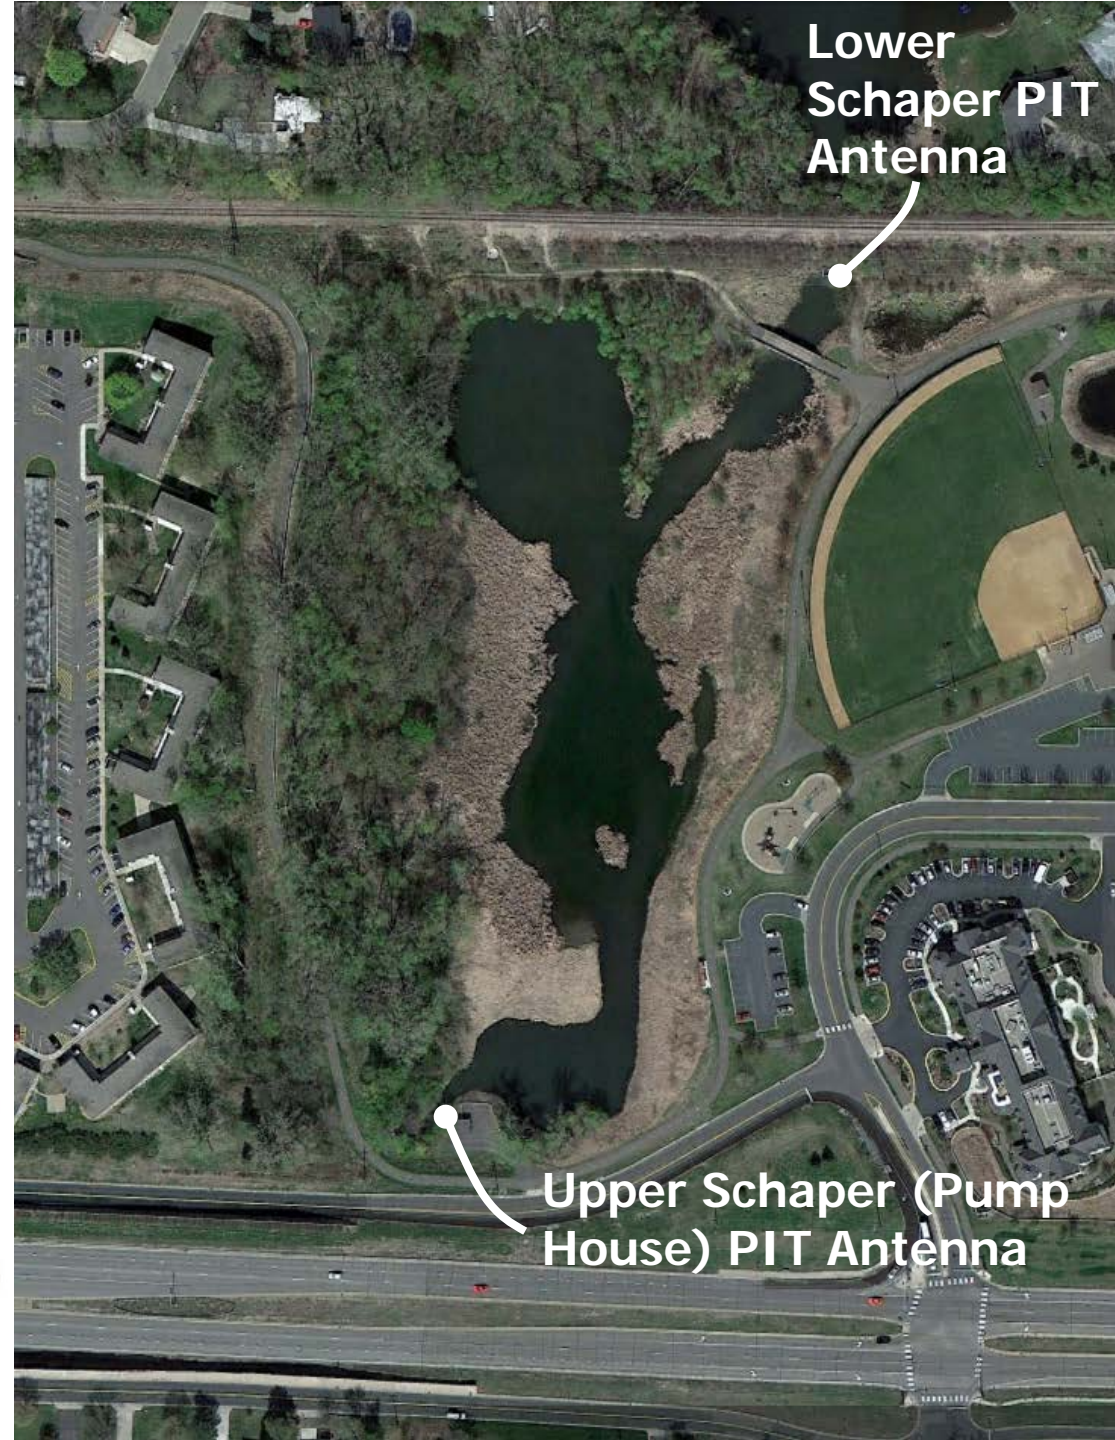
Table 1. Carp captured and PIT tagged in Schaper Pond and Sweeney Lake

2018-19 carp
monitoring—
PIT tagging

Date	Lake	Survey Method	# adult Carp PIT Tagged	# YOY Carp PIT Tagged
October 1, 2018	Schaper	Electrofishing	20	50
October 1, 2018	Sweeney	Electrofishing	29	0
October 2, 2018	Sweeney	Electrofishing	73	0

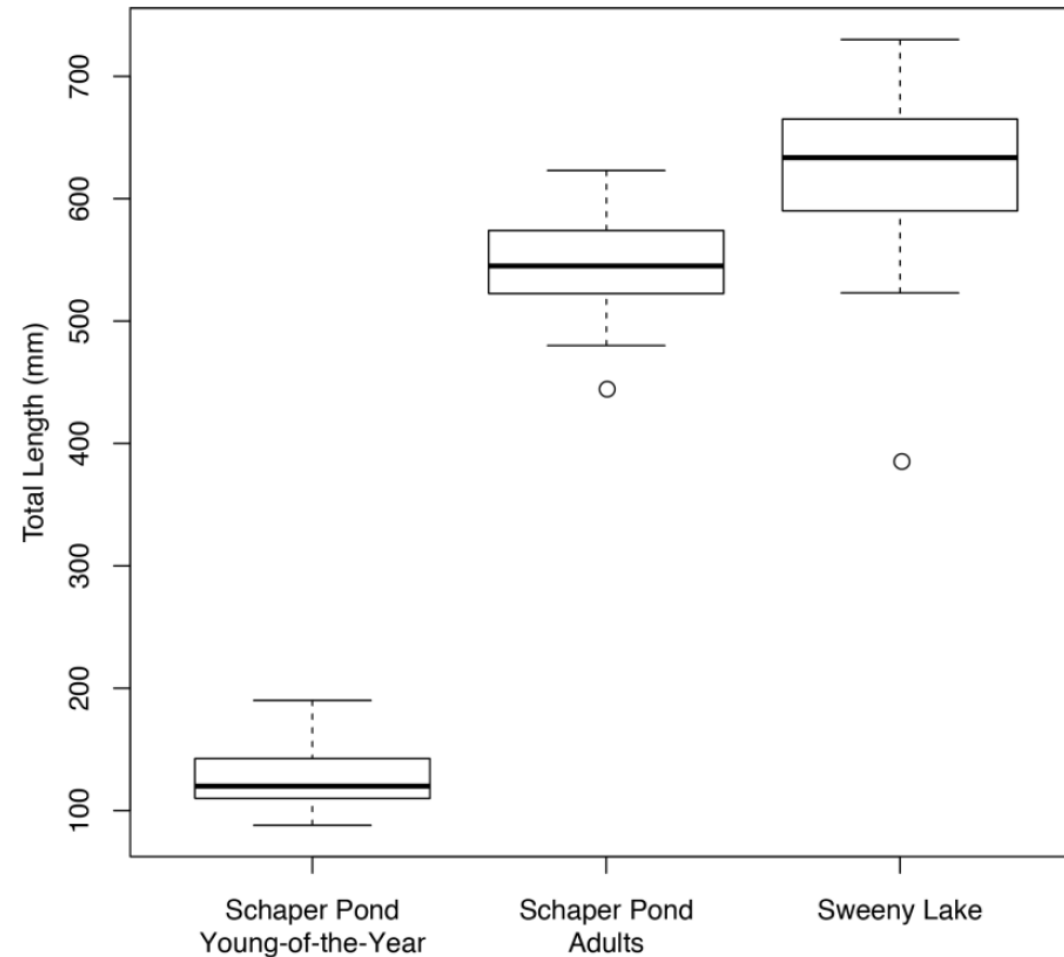
2018-19 carp
monitoring—
capture
statistics

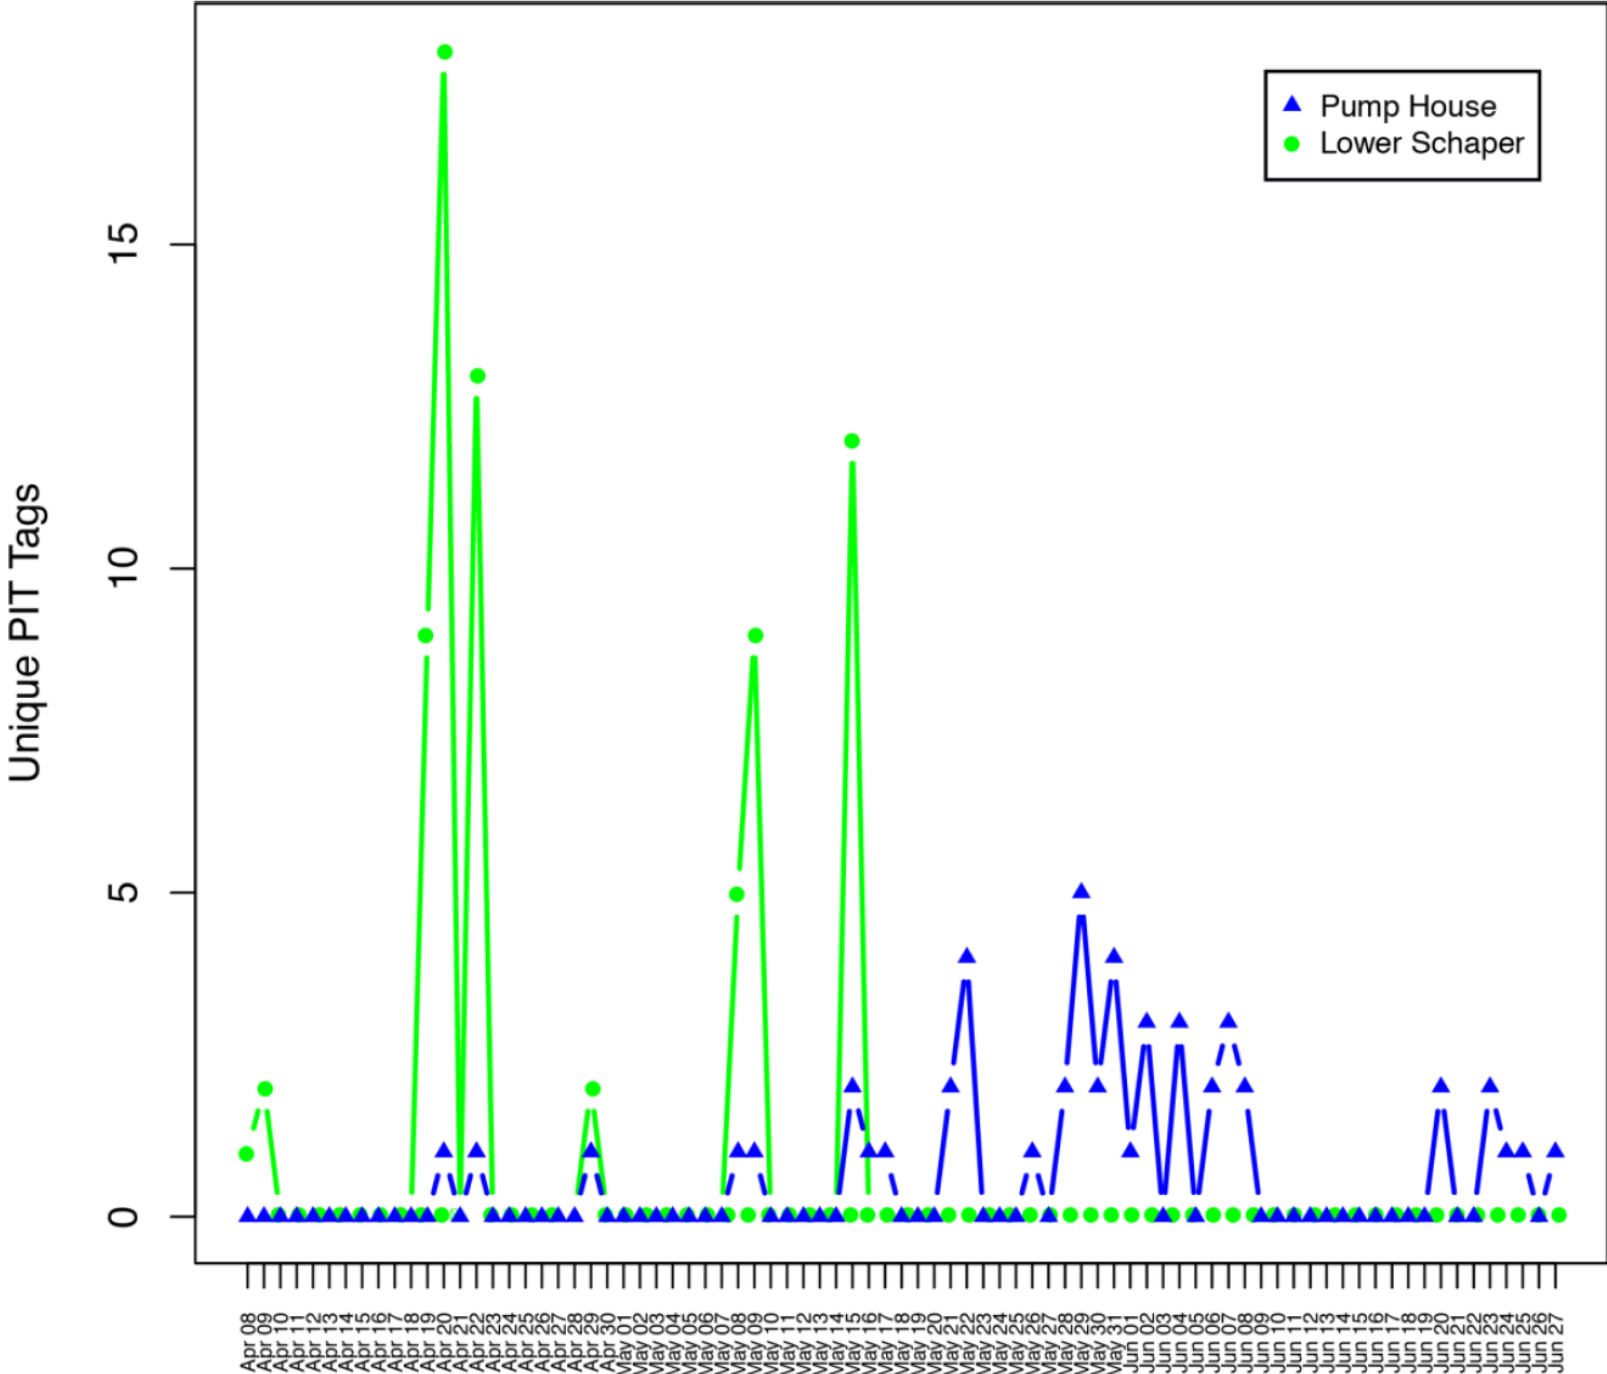
2018-19 carp monitoring— timing of migration

- confirmed large numbers of carp inhabit Schaper Pond and Sweeney Lake
 - five to ten times higher than threshold for water quality impacts
- PIT tag monitoring indicated
 - movement between Schaper and Sweeney in spring, along with upstream movement
 - no movement from young of year carp—confirming that Schaper functions as a nursery

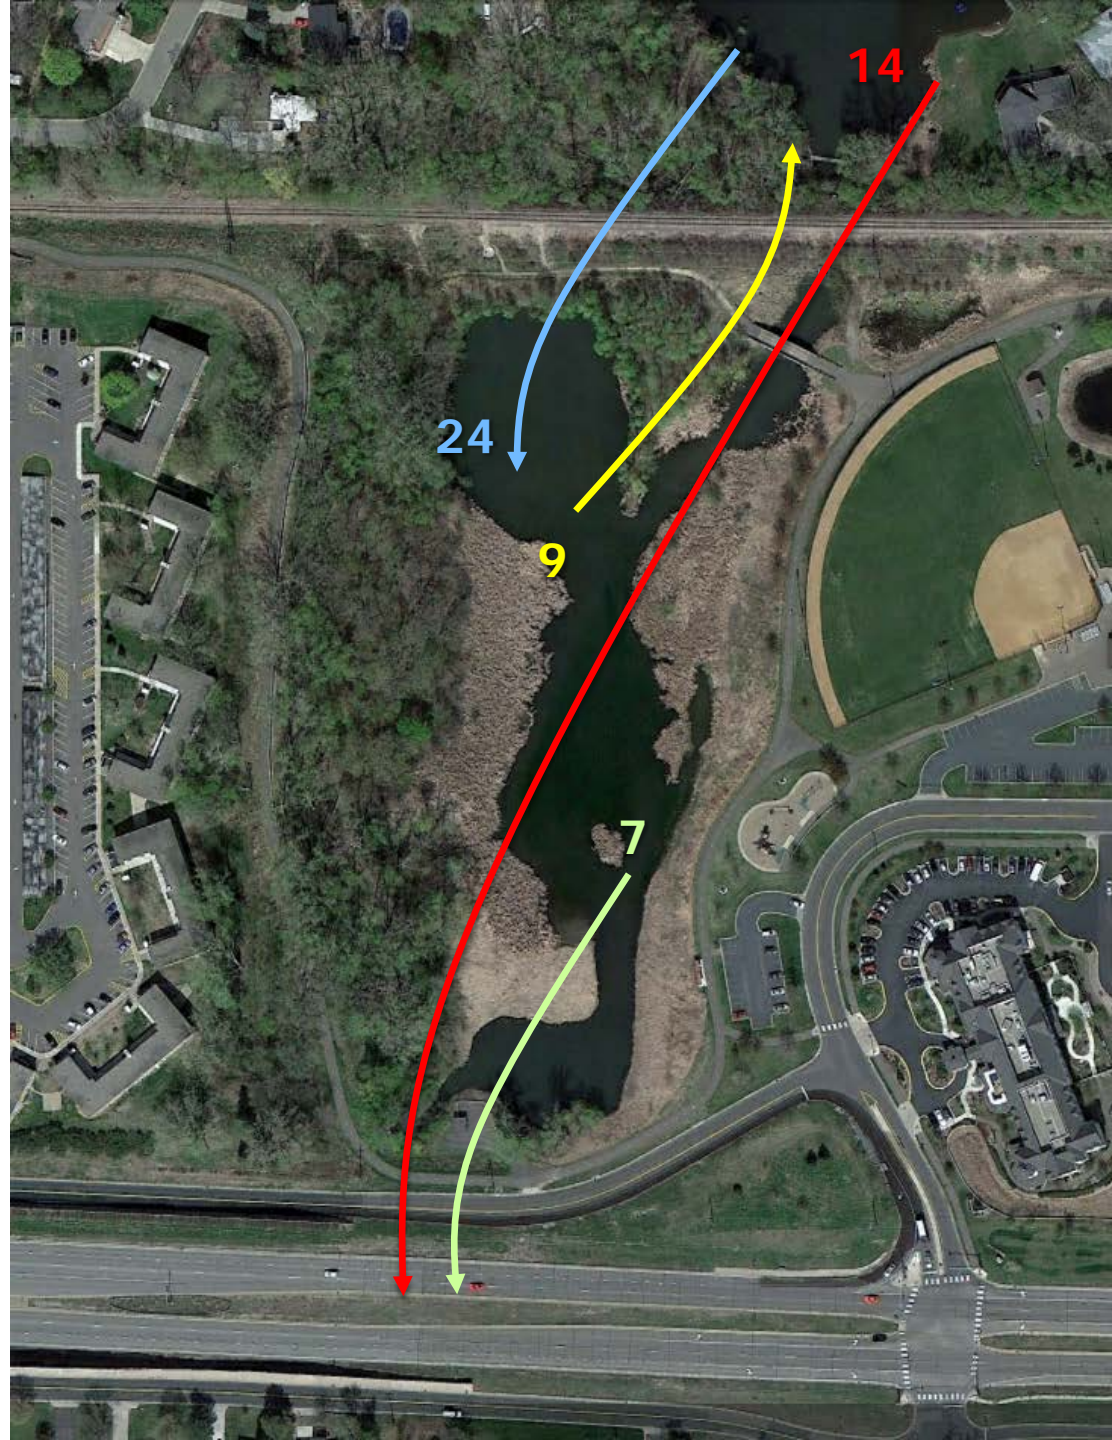
2018-19 carp
monitoring—
migration
based on PIT
tag results
