# Bassett Creek Park Pond Phase I Dredging Project Winnetka Pond 2018 BCP-2

FINAL REPORT  
September 2020

## I. Project Overview

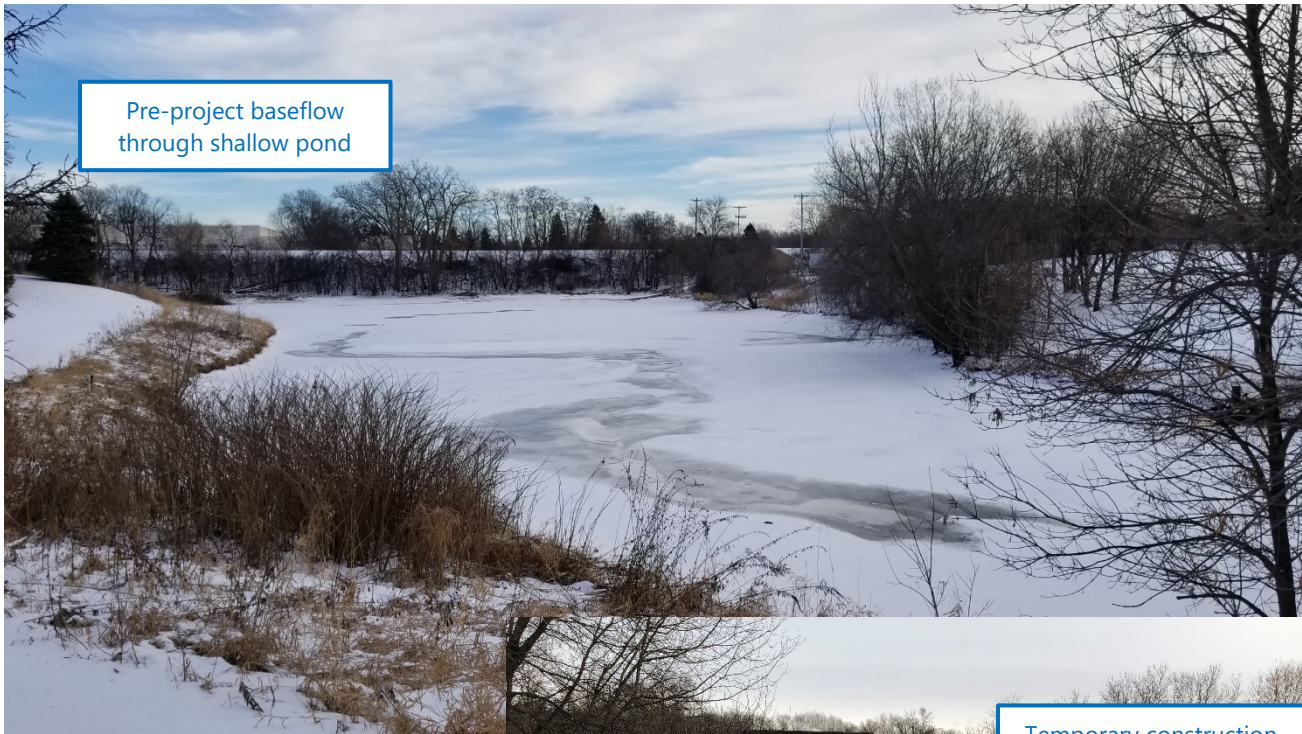
Pre-project baseflow through shallow pond

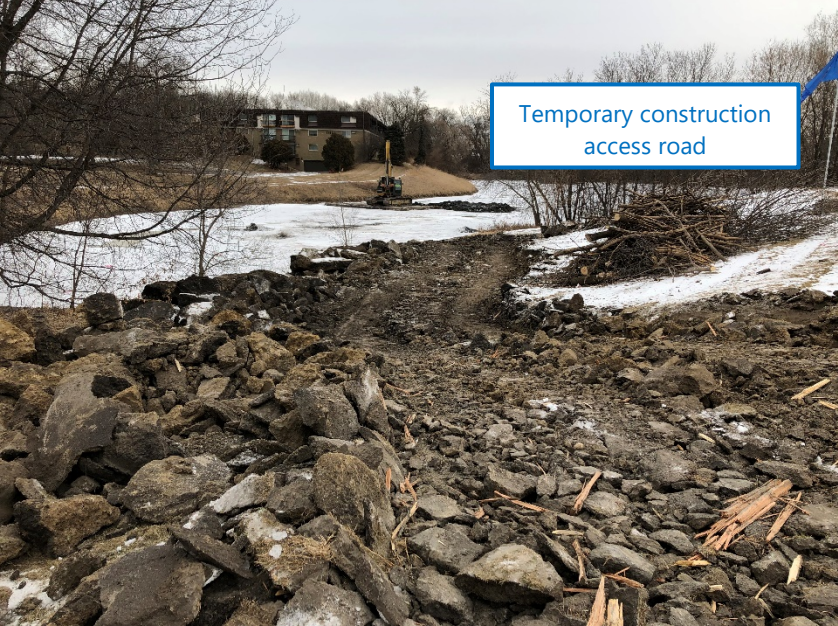
Temporary construction access road

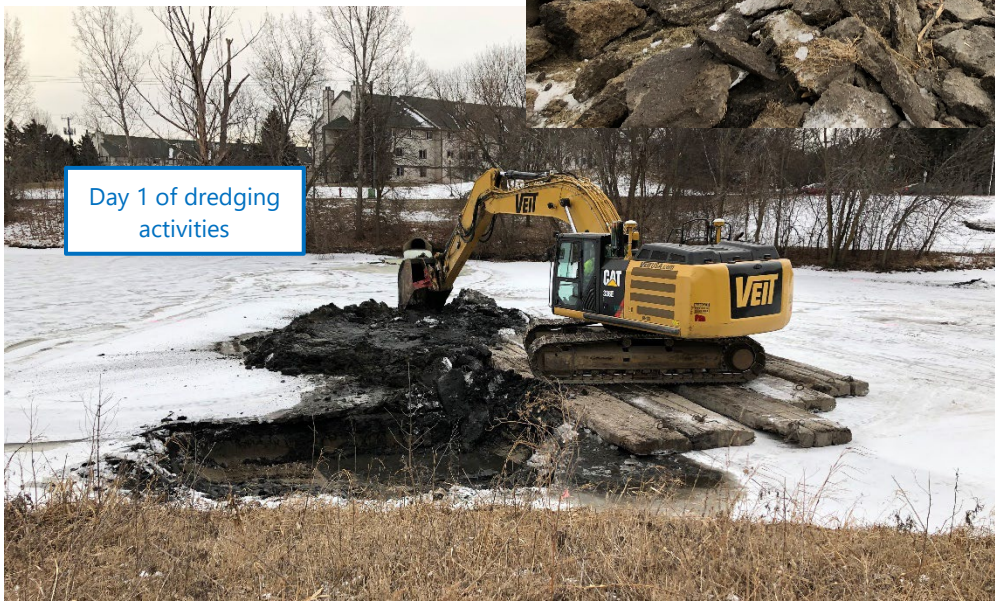
Day 1 of dredging activities

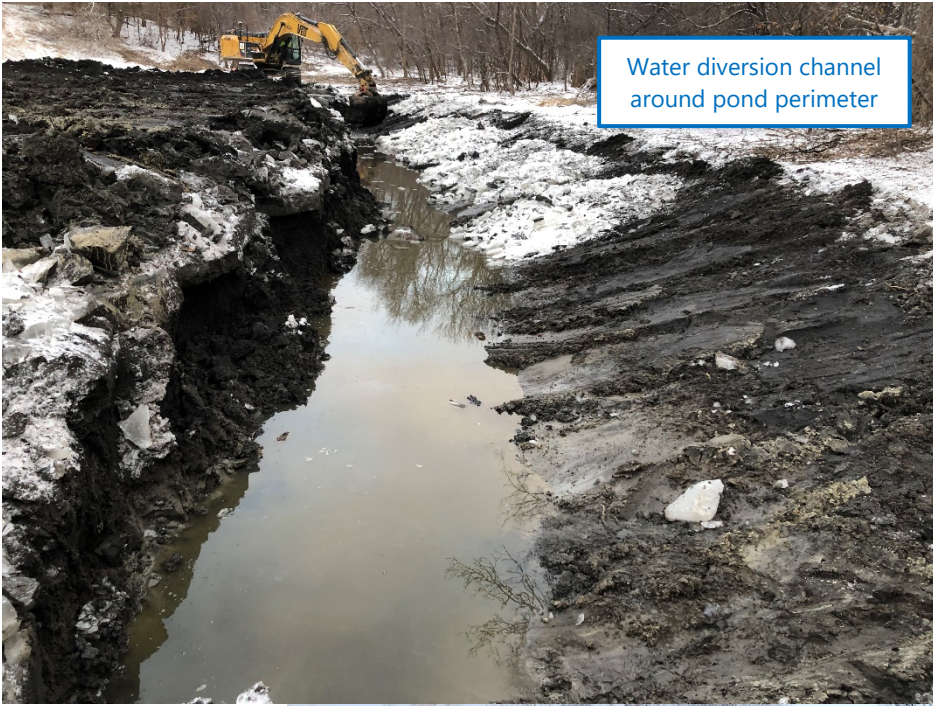
Water diversion channel around pond perimeter

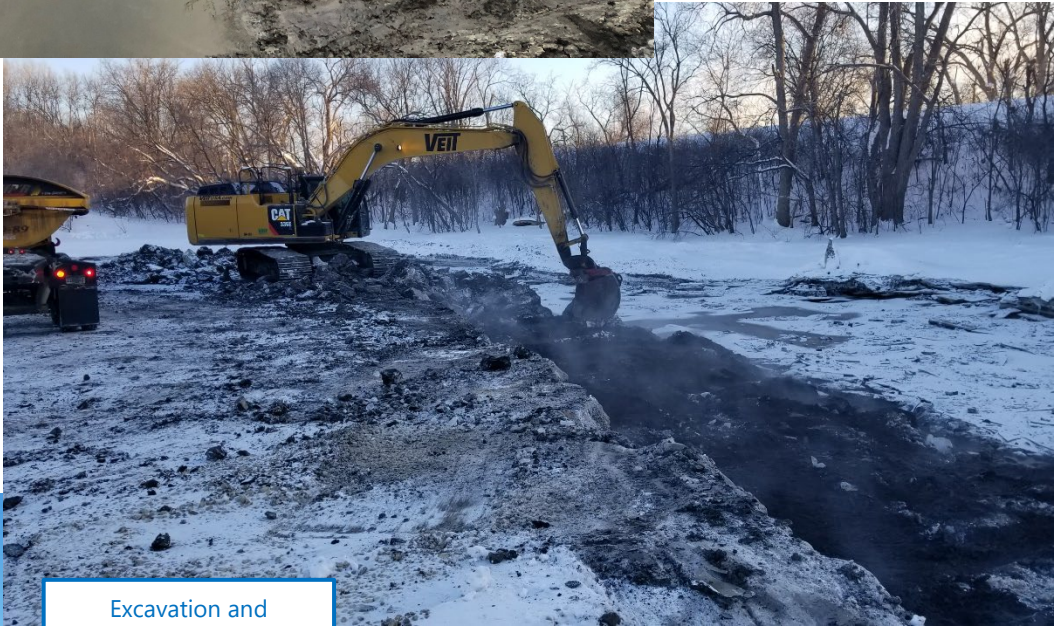
Excavation and removal of pond muck

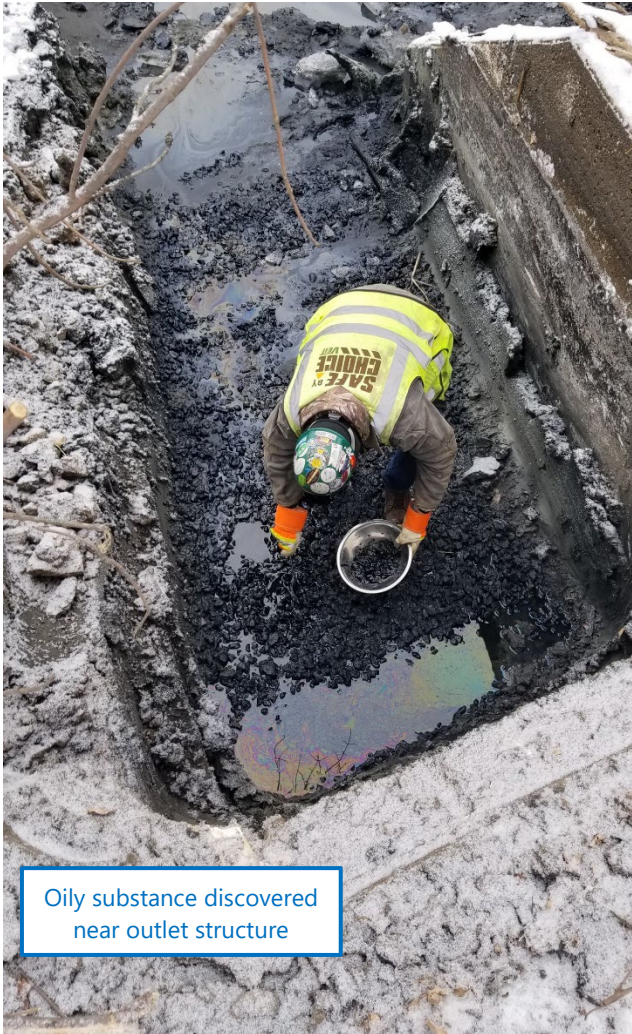
Oily substance discovered near outlet structure

The project removed approximately 14,600 CY of sediment and 5,500 CY of contaminated sediment from Winnetka Pond. The environmental investigations and sediment sampling during the feasibility study showed that the dredged material could be reused as unregulated fill. However, during construction contaminated sediment was discovered near the outlet structure. Further investigation resulted in changes to the construction plans that added \$65,000 in engineering fees, and \$370,000 in construction costs for disposal of the contaminated sediment in a landfill. Additionally, in order to sufficiently remove the contamination, the existing outlet structure that was intended to remain had to be demolished and replaced.

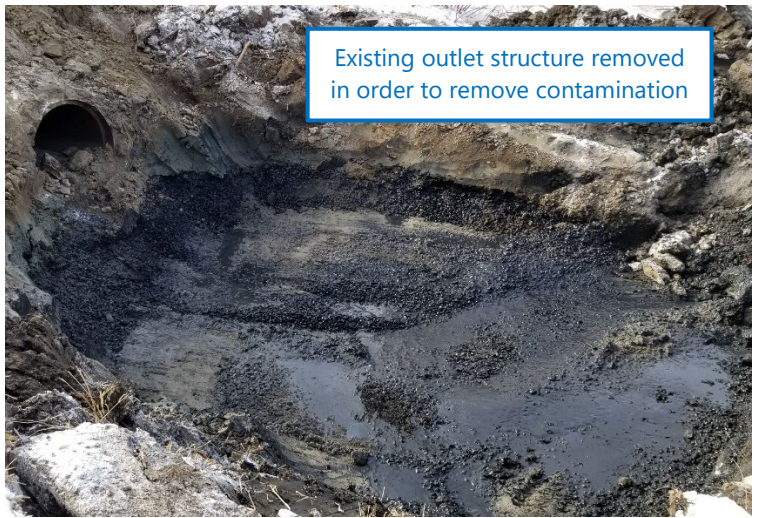
Existing outlet structure removed in order to remove contamination

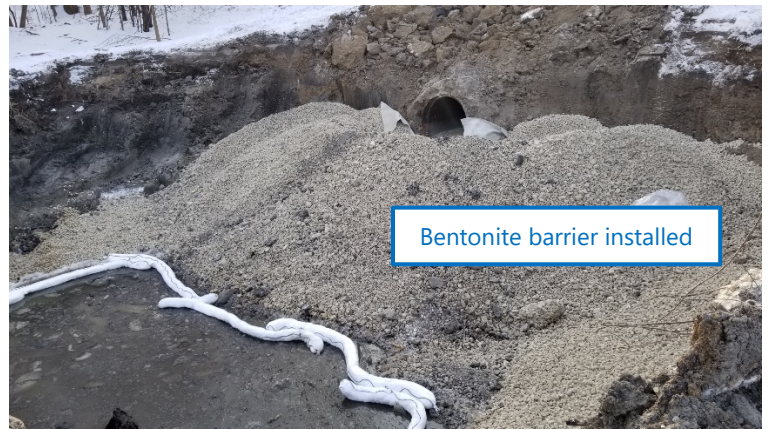
Bentonite barrier installed

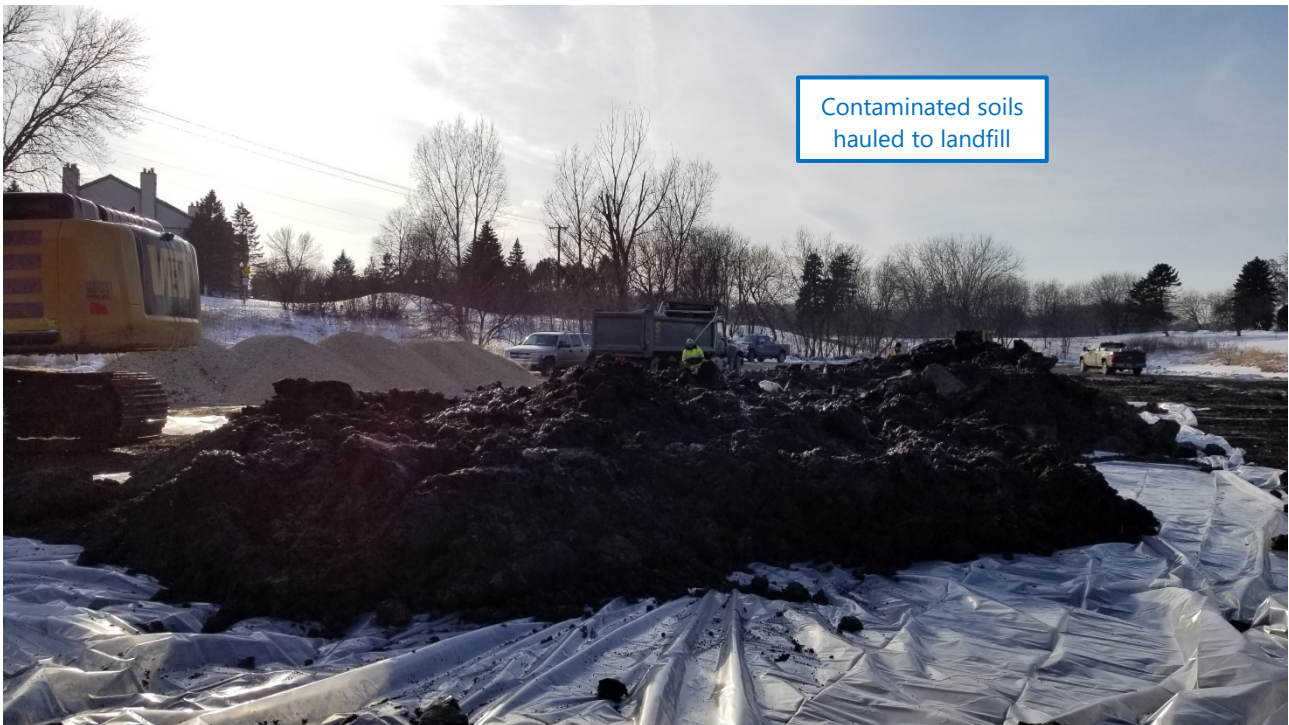
Contaminated soils hauled to landfill

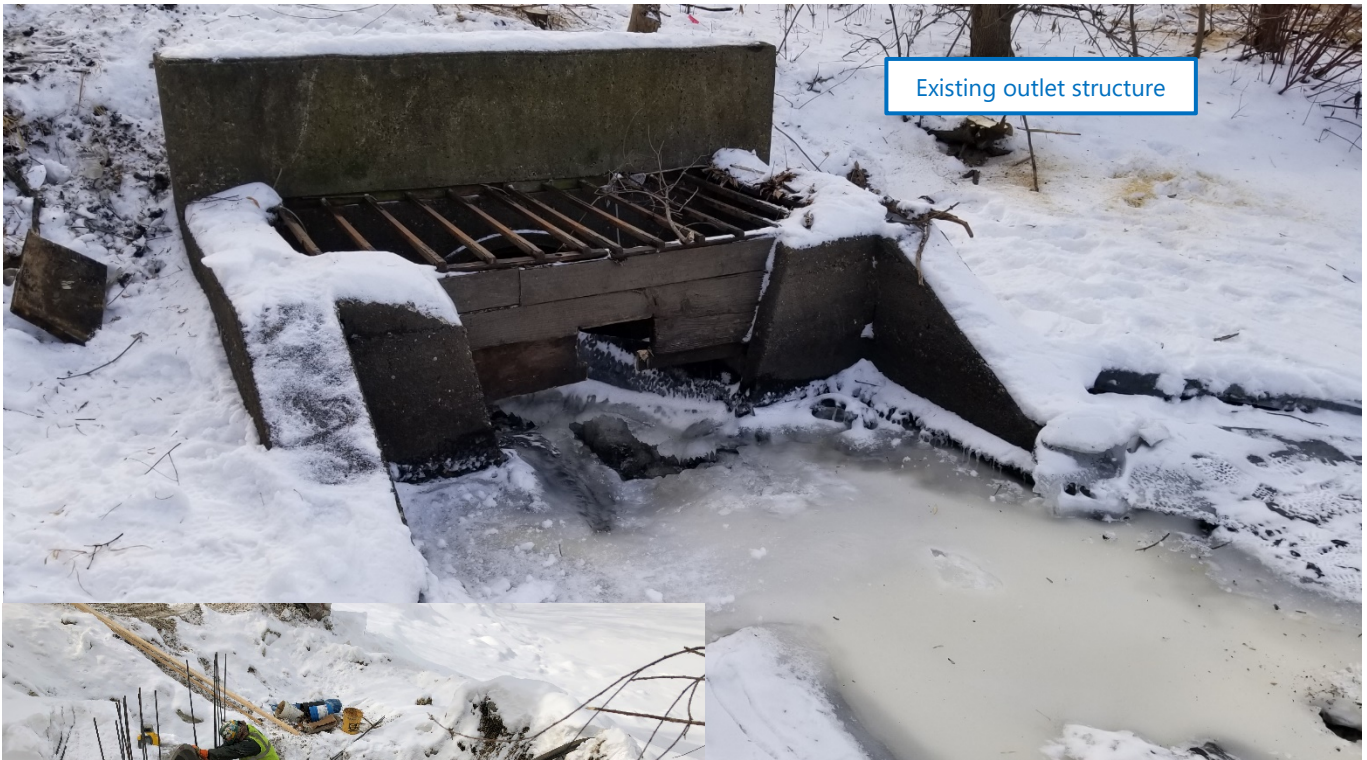
Existing outlet structure

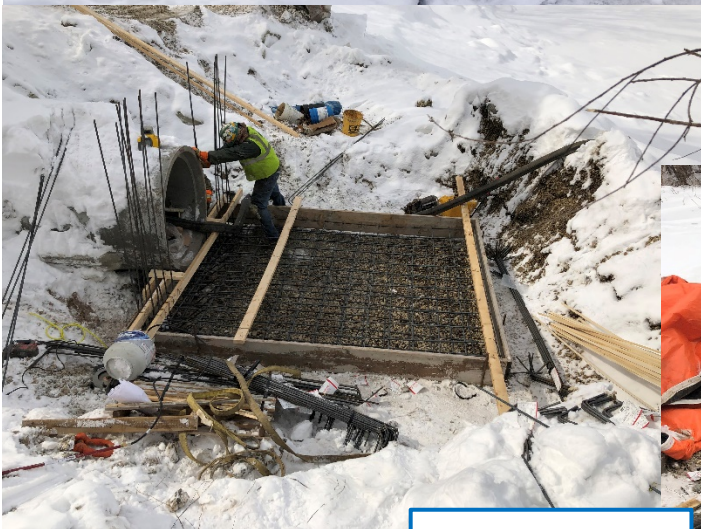
Forming and pouring new outlet structure

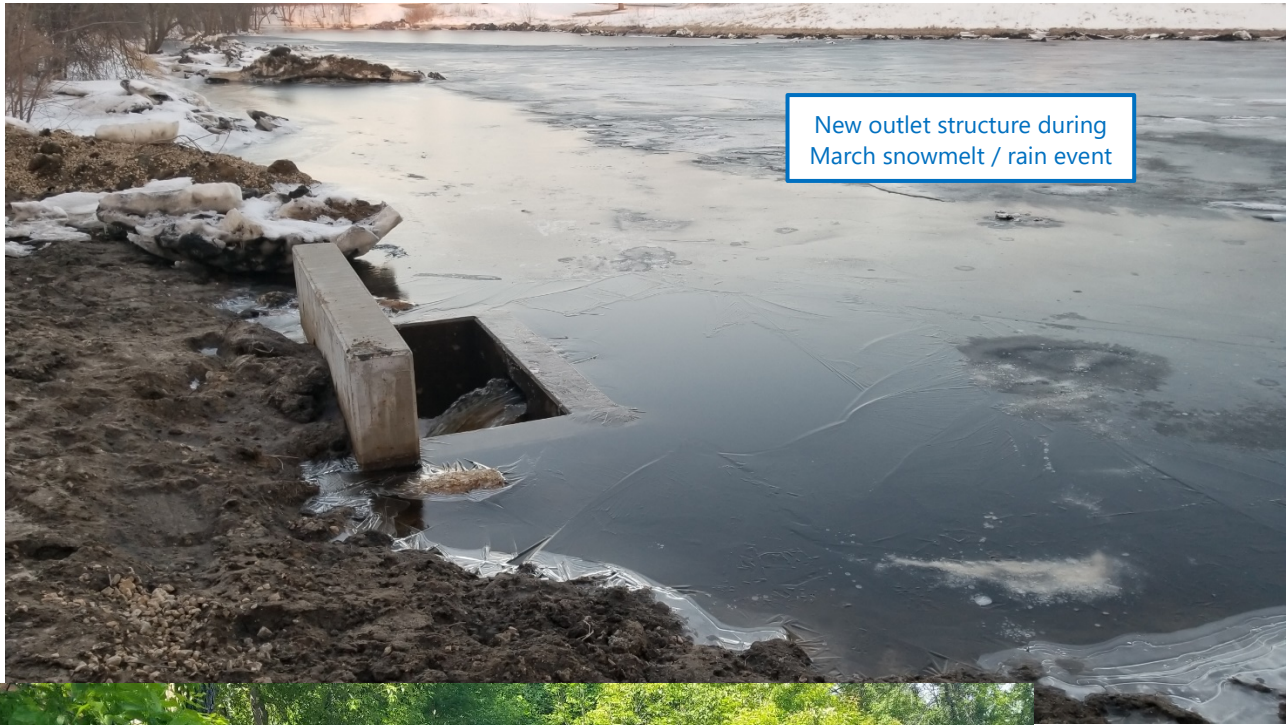
New outlet structure during March snowmelt / rain event

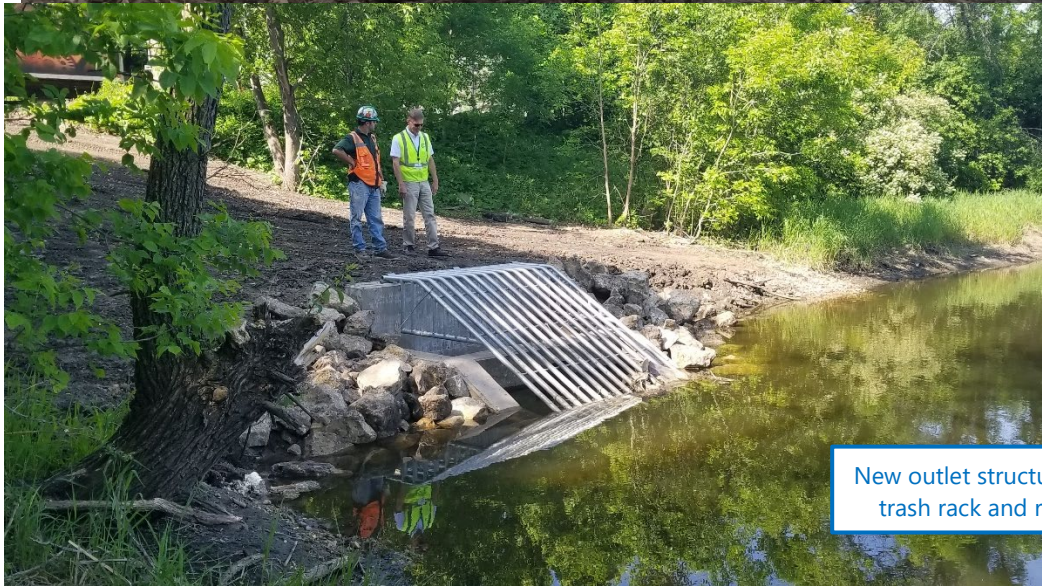
New outlet structure with trash rack and riprap

The City of Crystal will perform any required maintenance of the pond outlet structure including debris removal. The improved trash rack allows for easy cleaning as well as reduced risk of plugging of the outlet. Very little maintenance of the pond is anticipated for the foreseeable future.
