Stream Stabilization Plan

PLYMOUTH CREEK POTENTIAL STABILIZATION SITES
 Plymouth Creek Feasibility Study
 Bassett Creek Watershed Management Commission

Figure G-2
 PLYMOUTH CREEK REACH 1 ALTERNATIVES
 Plymouth Creek Feasibility Study
 Bassett Creek Watershed
 Management Commission

Figure G-3
 PLYMOUTH CREEK REACH 2 ALTERNATIVES
 Plymouth Creek Feasibility Study
 Bassett Creek Watershed Management Commission

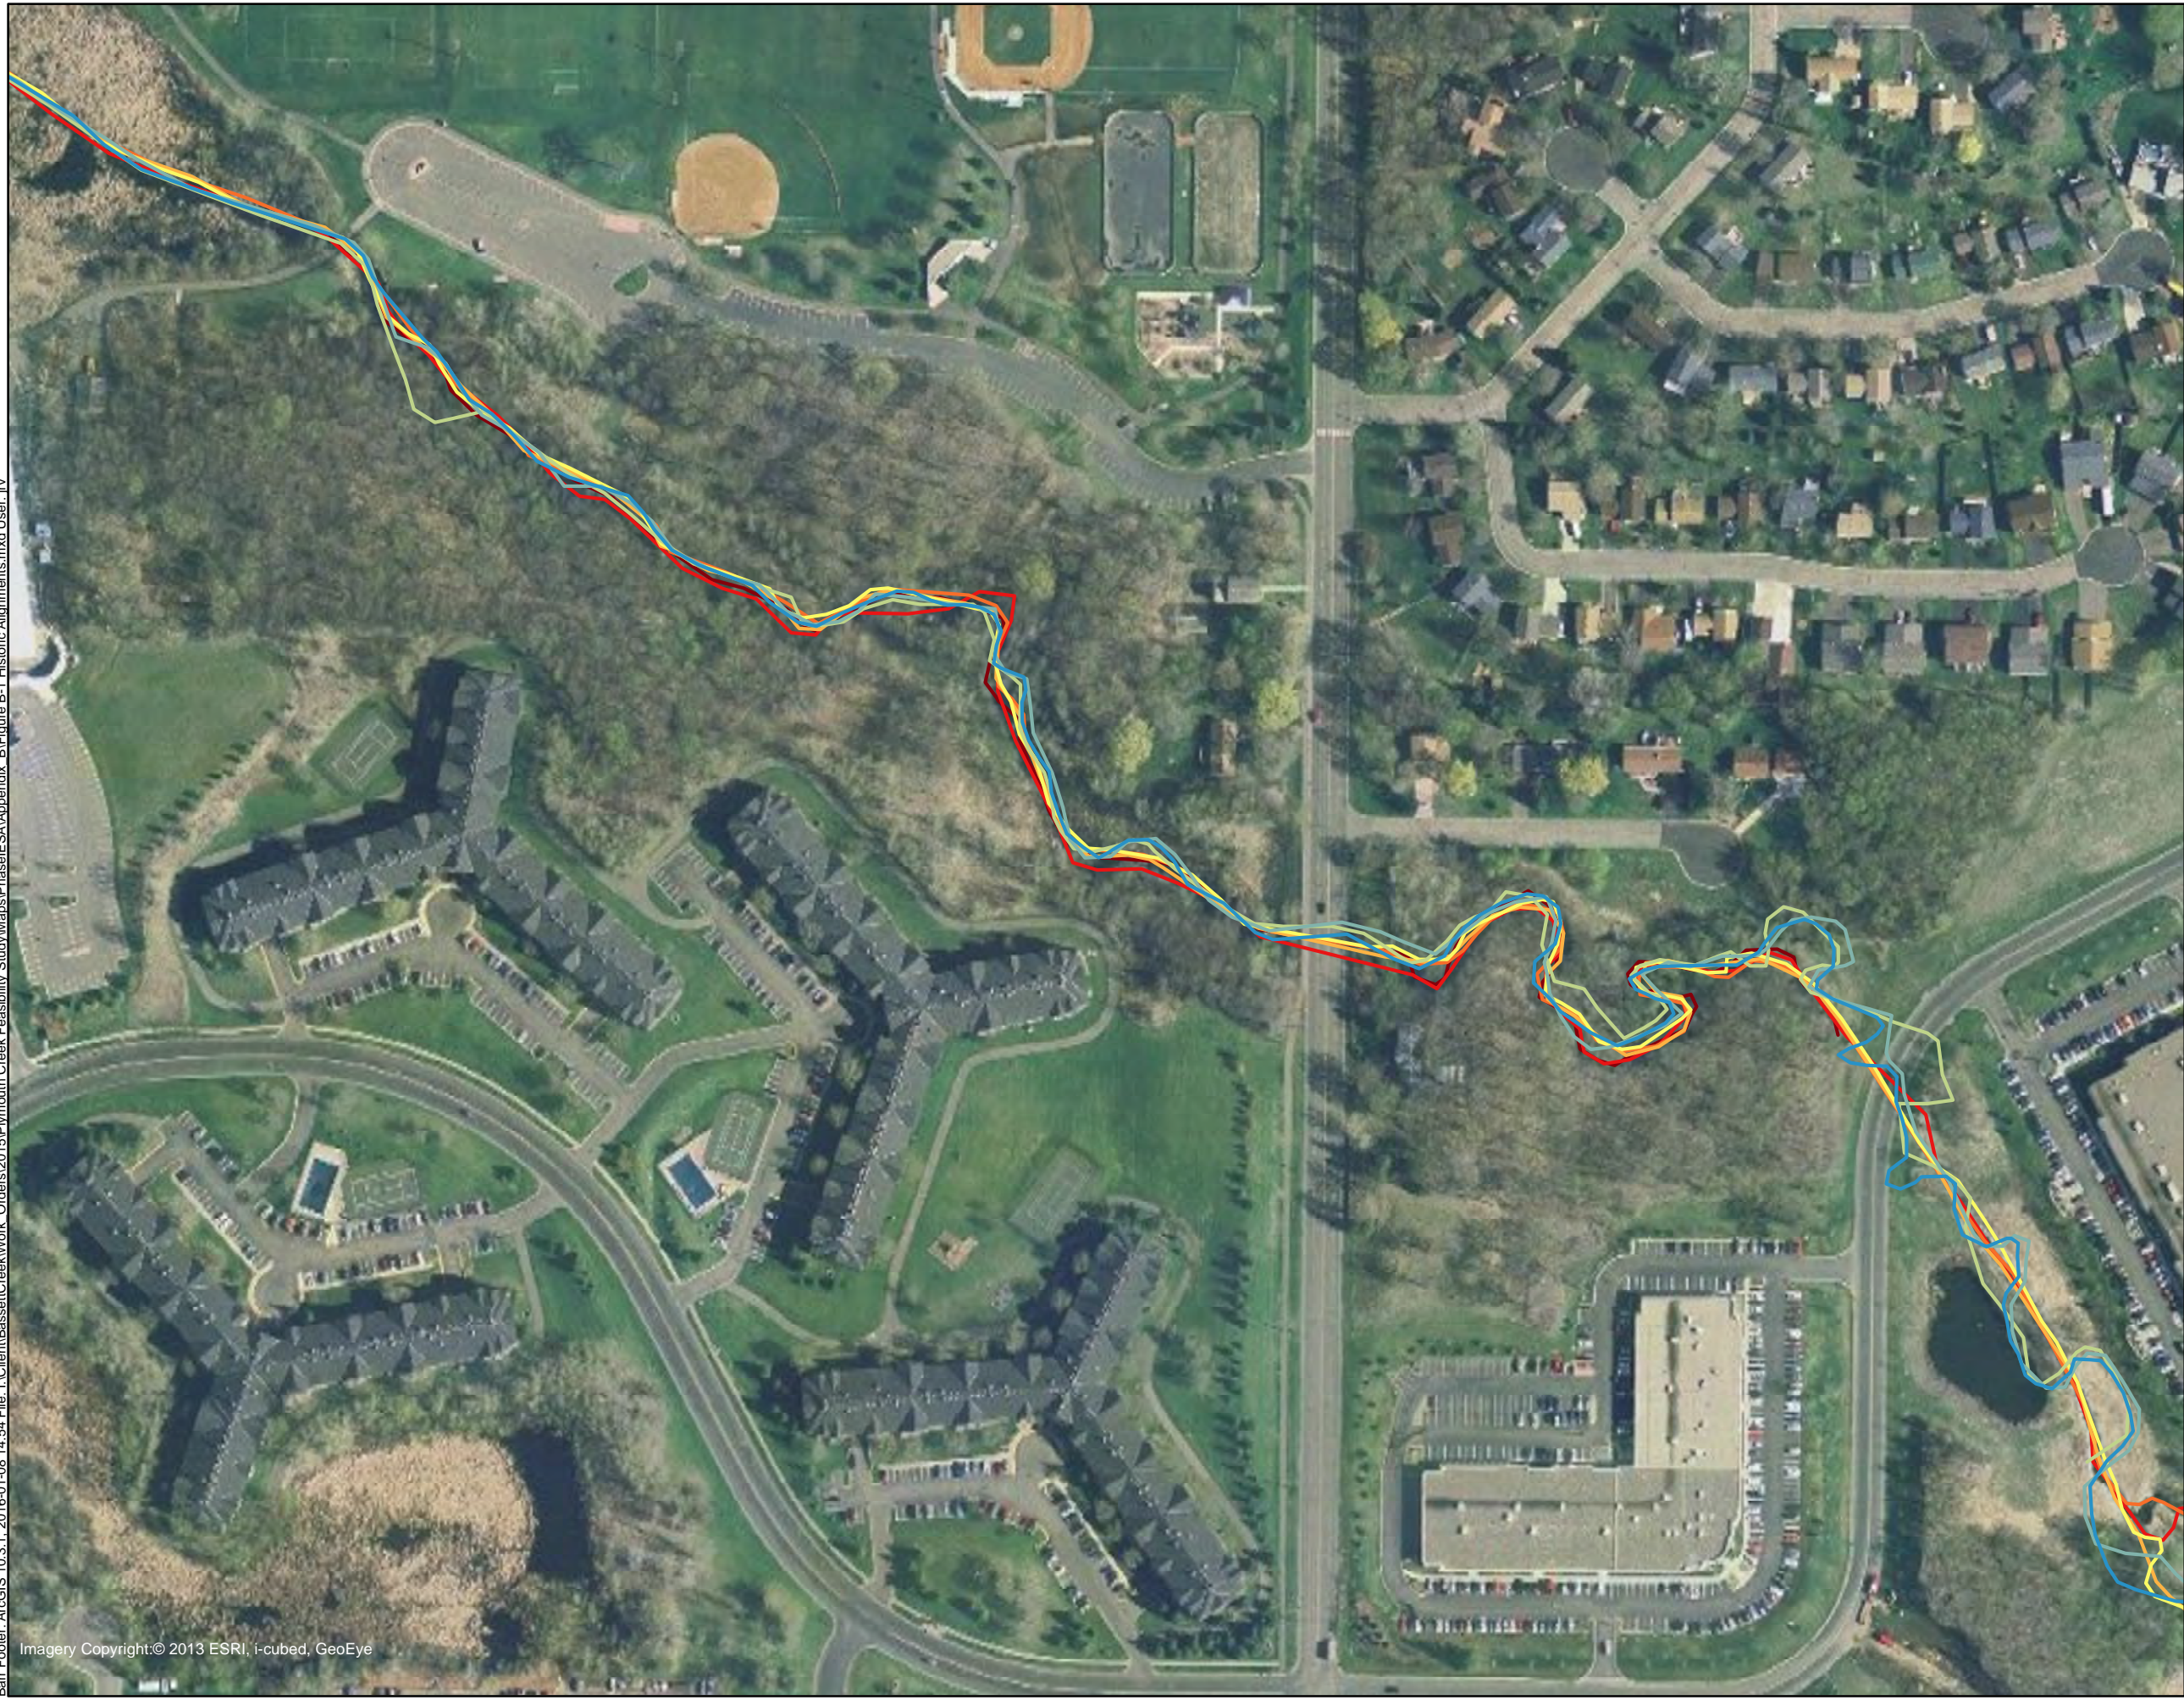
APPENDIX B
HISTORIC CHANNEL ALIGNMENTS
 Plymouth Creek
 Plymouth, MN

- Historical Channel Centerlines**
- 1947
 - 1953
 - 1957
 - 1984
 - 1991
 - 1997
 - 2002
 - 2015

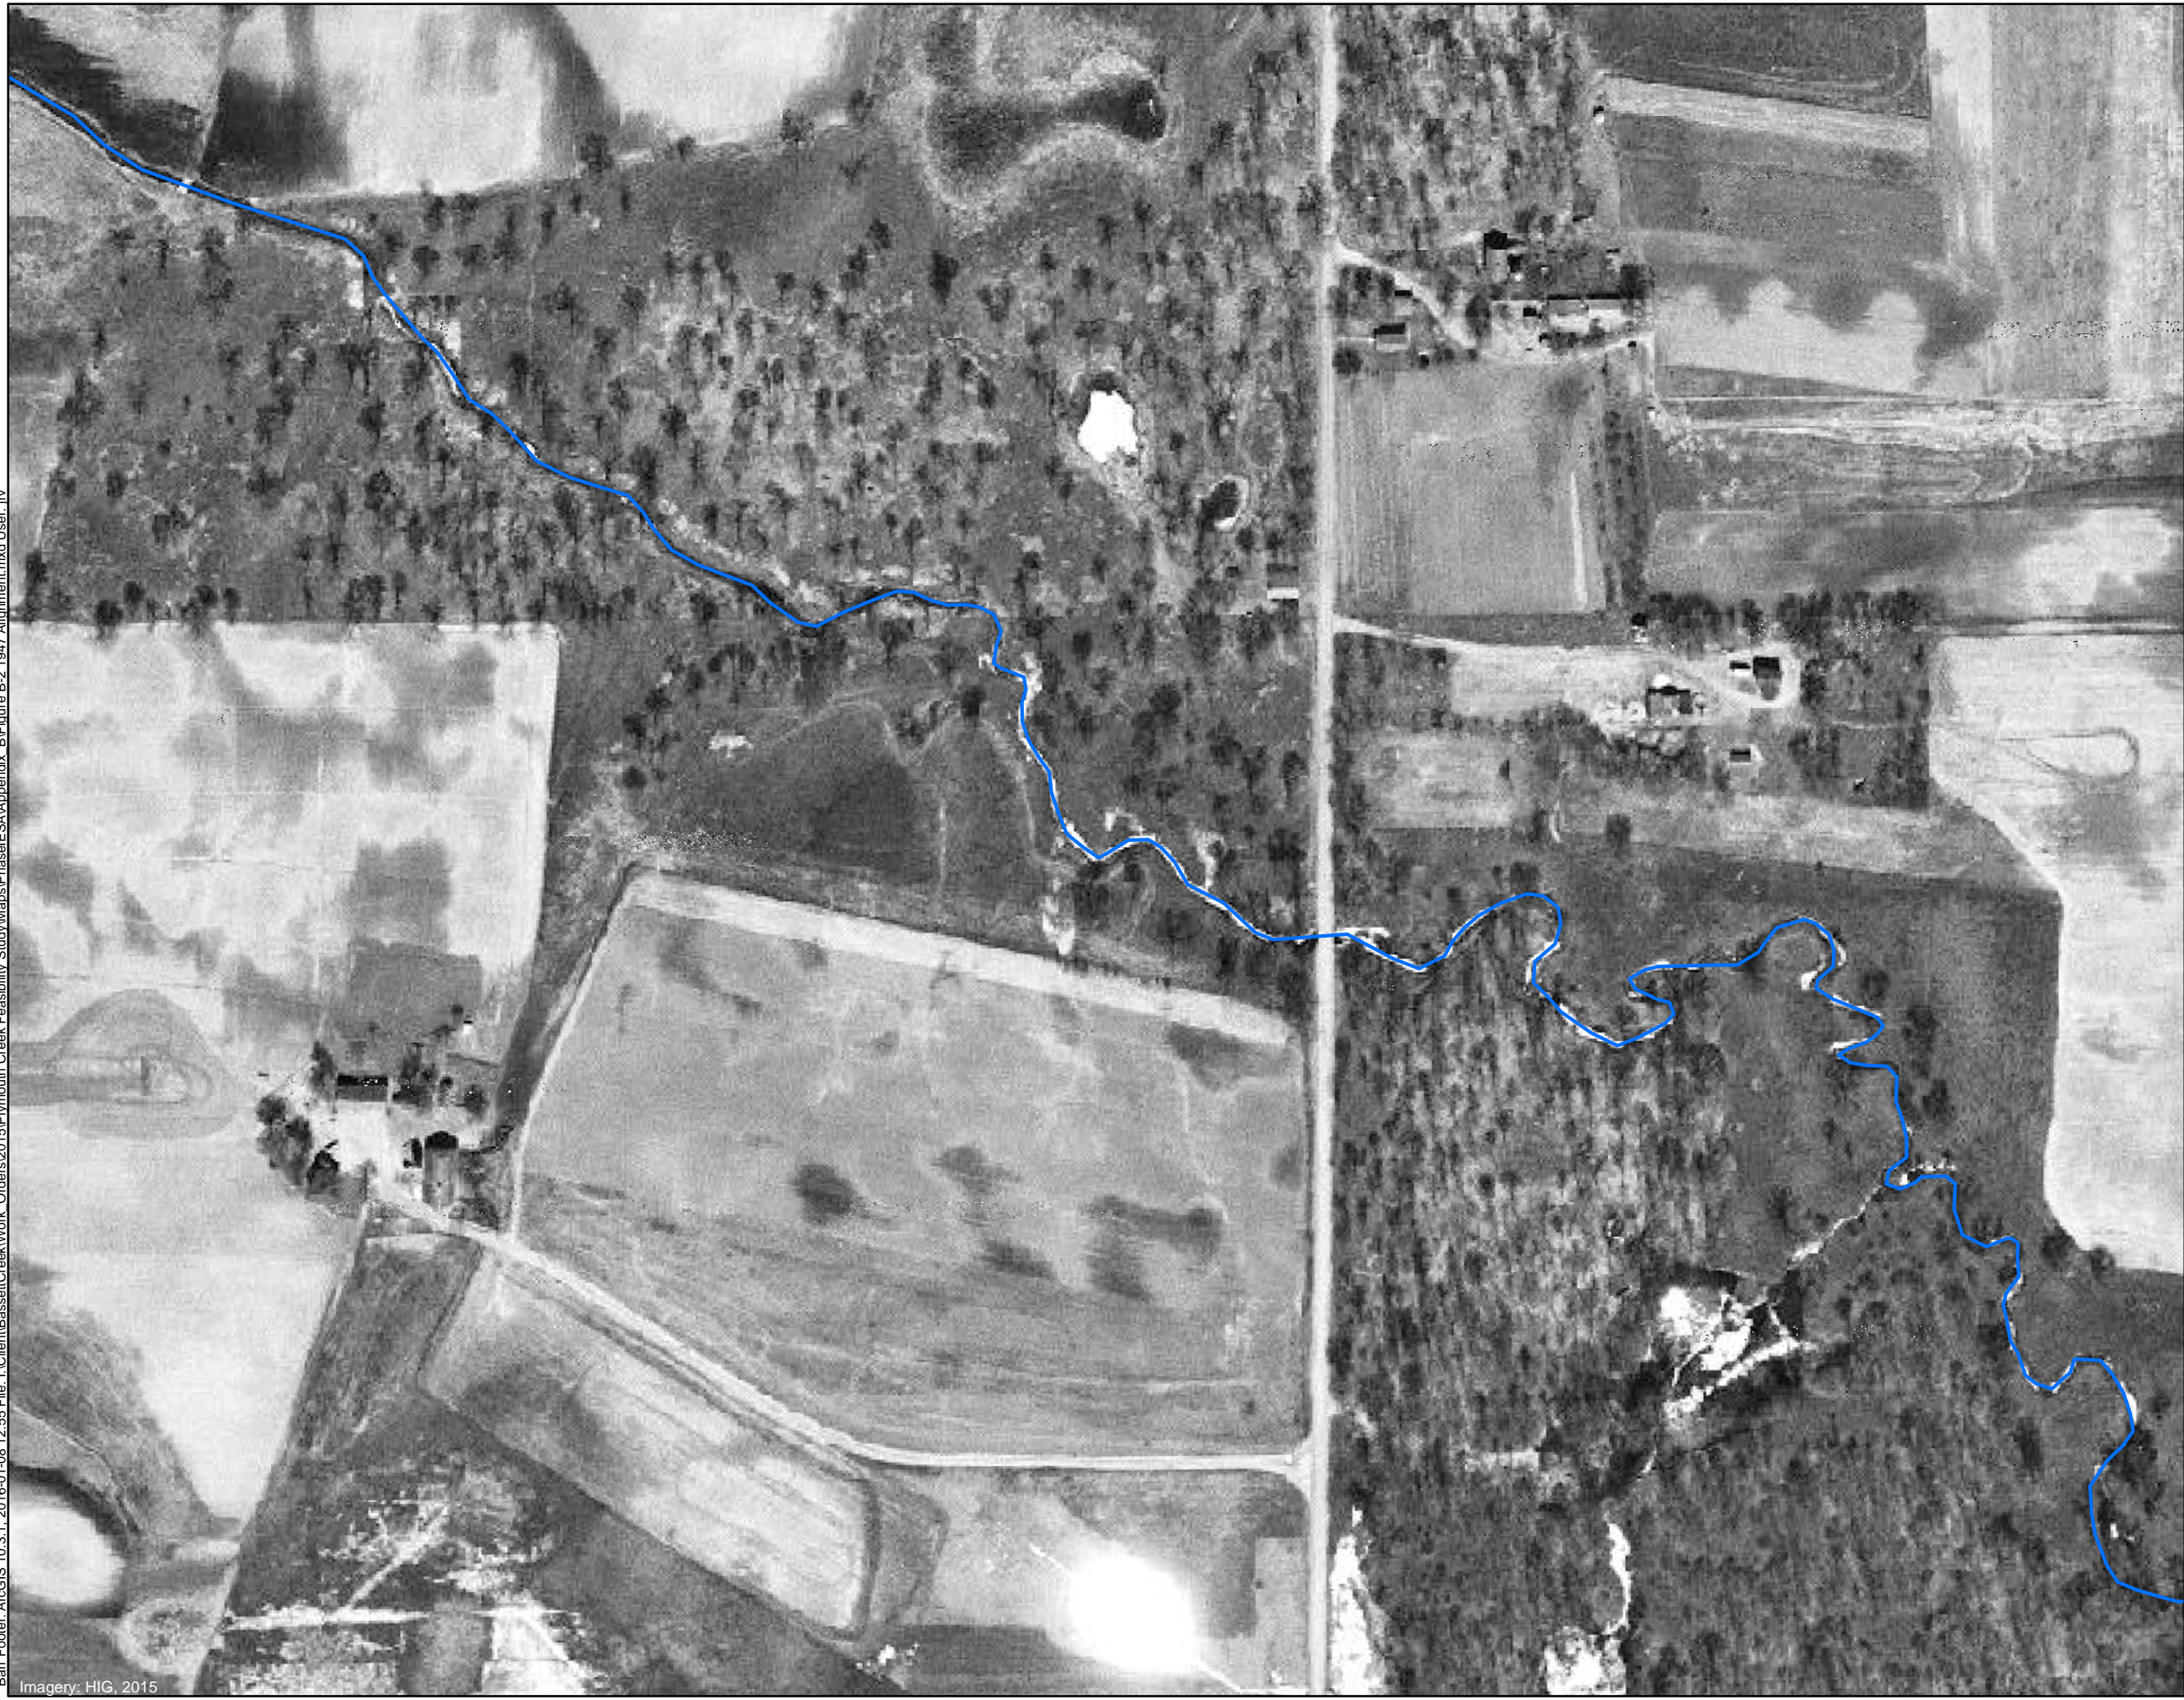
APPENDIX B
1947 CHANNEL ALIGNMENT
Plymouth Creek
Plymouth, MN

— 1947 Channel Alignment

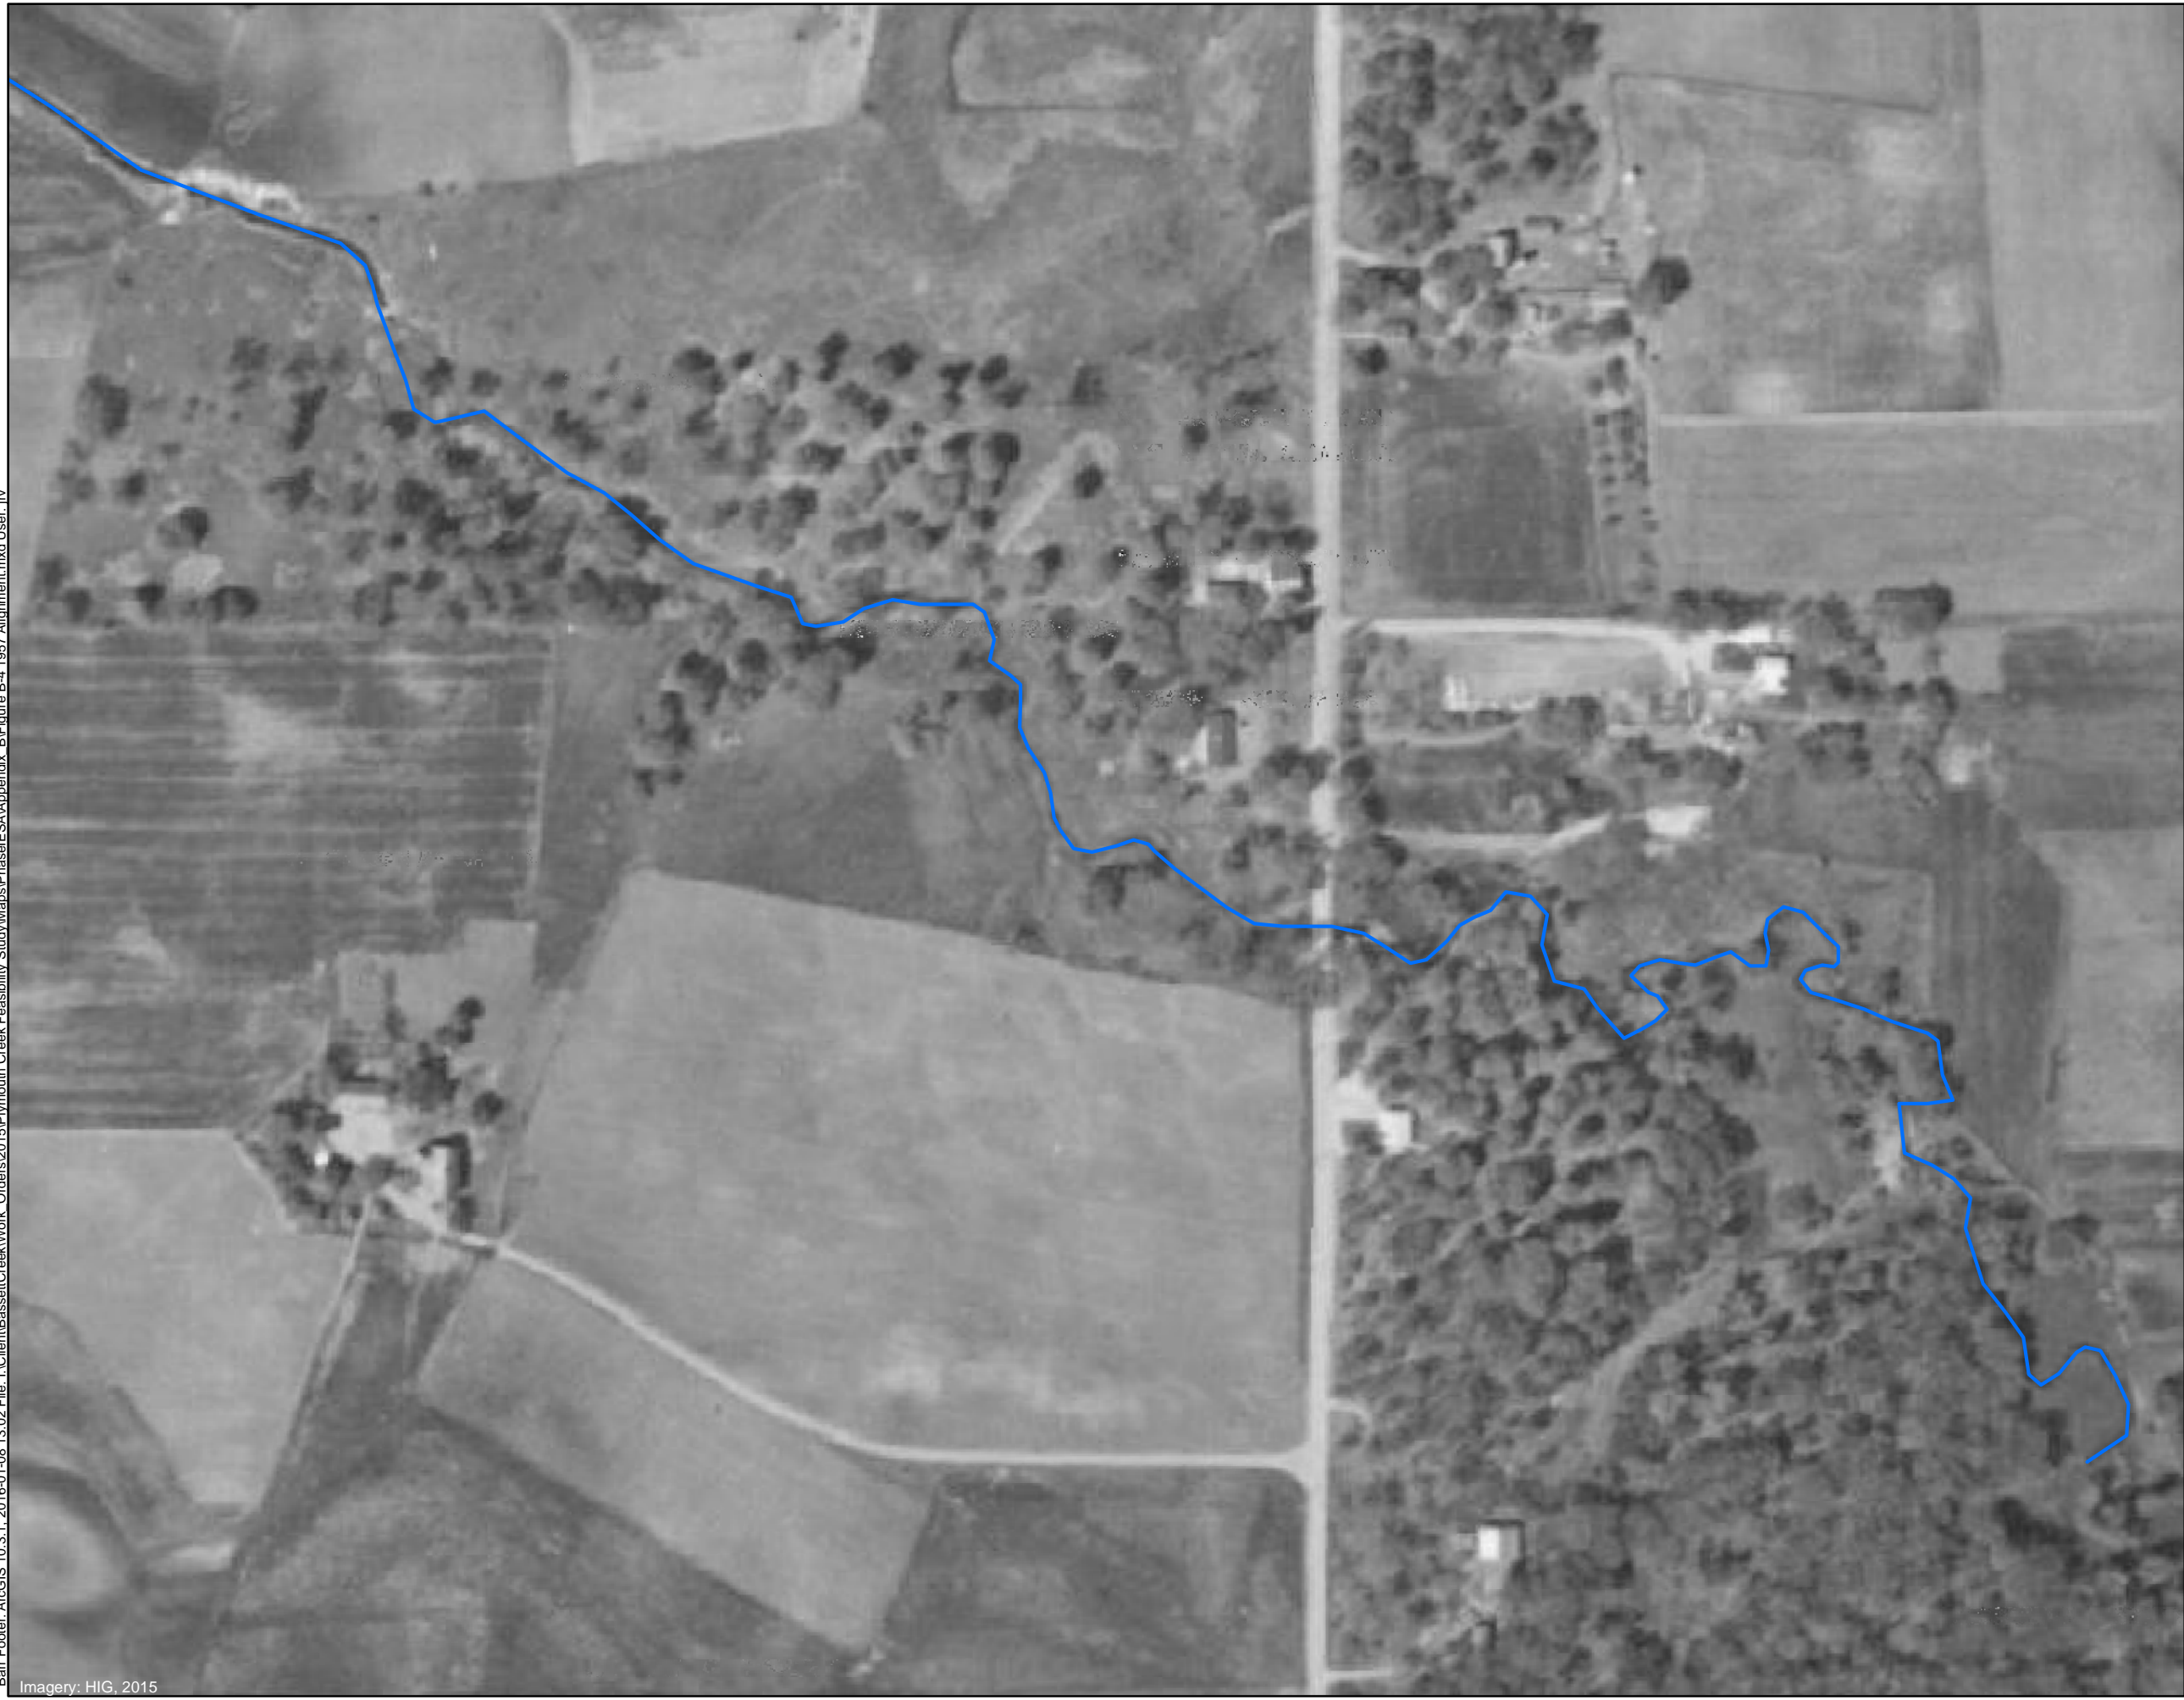
APPENDIX B
1957 CHANNEL ALIGNMENT
Plymouth Creek
Plymouth, MN

1957 Channel Alignment

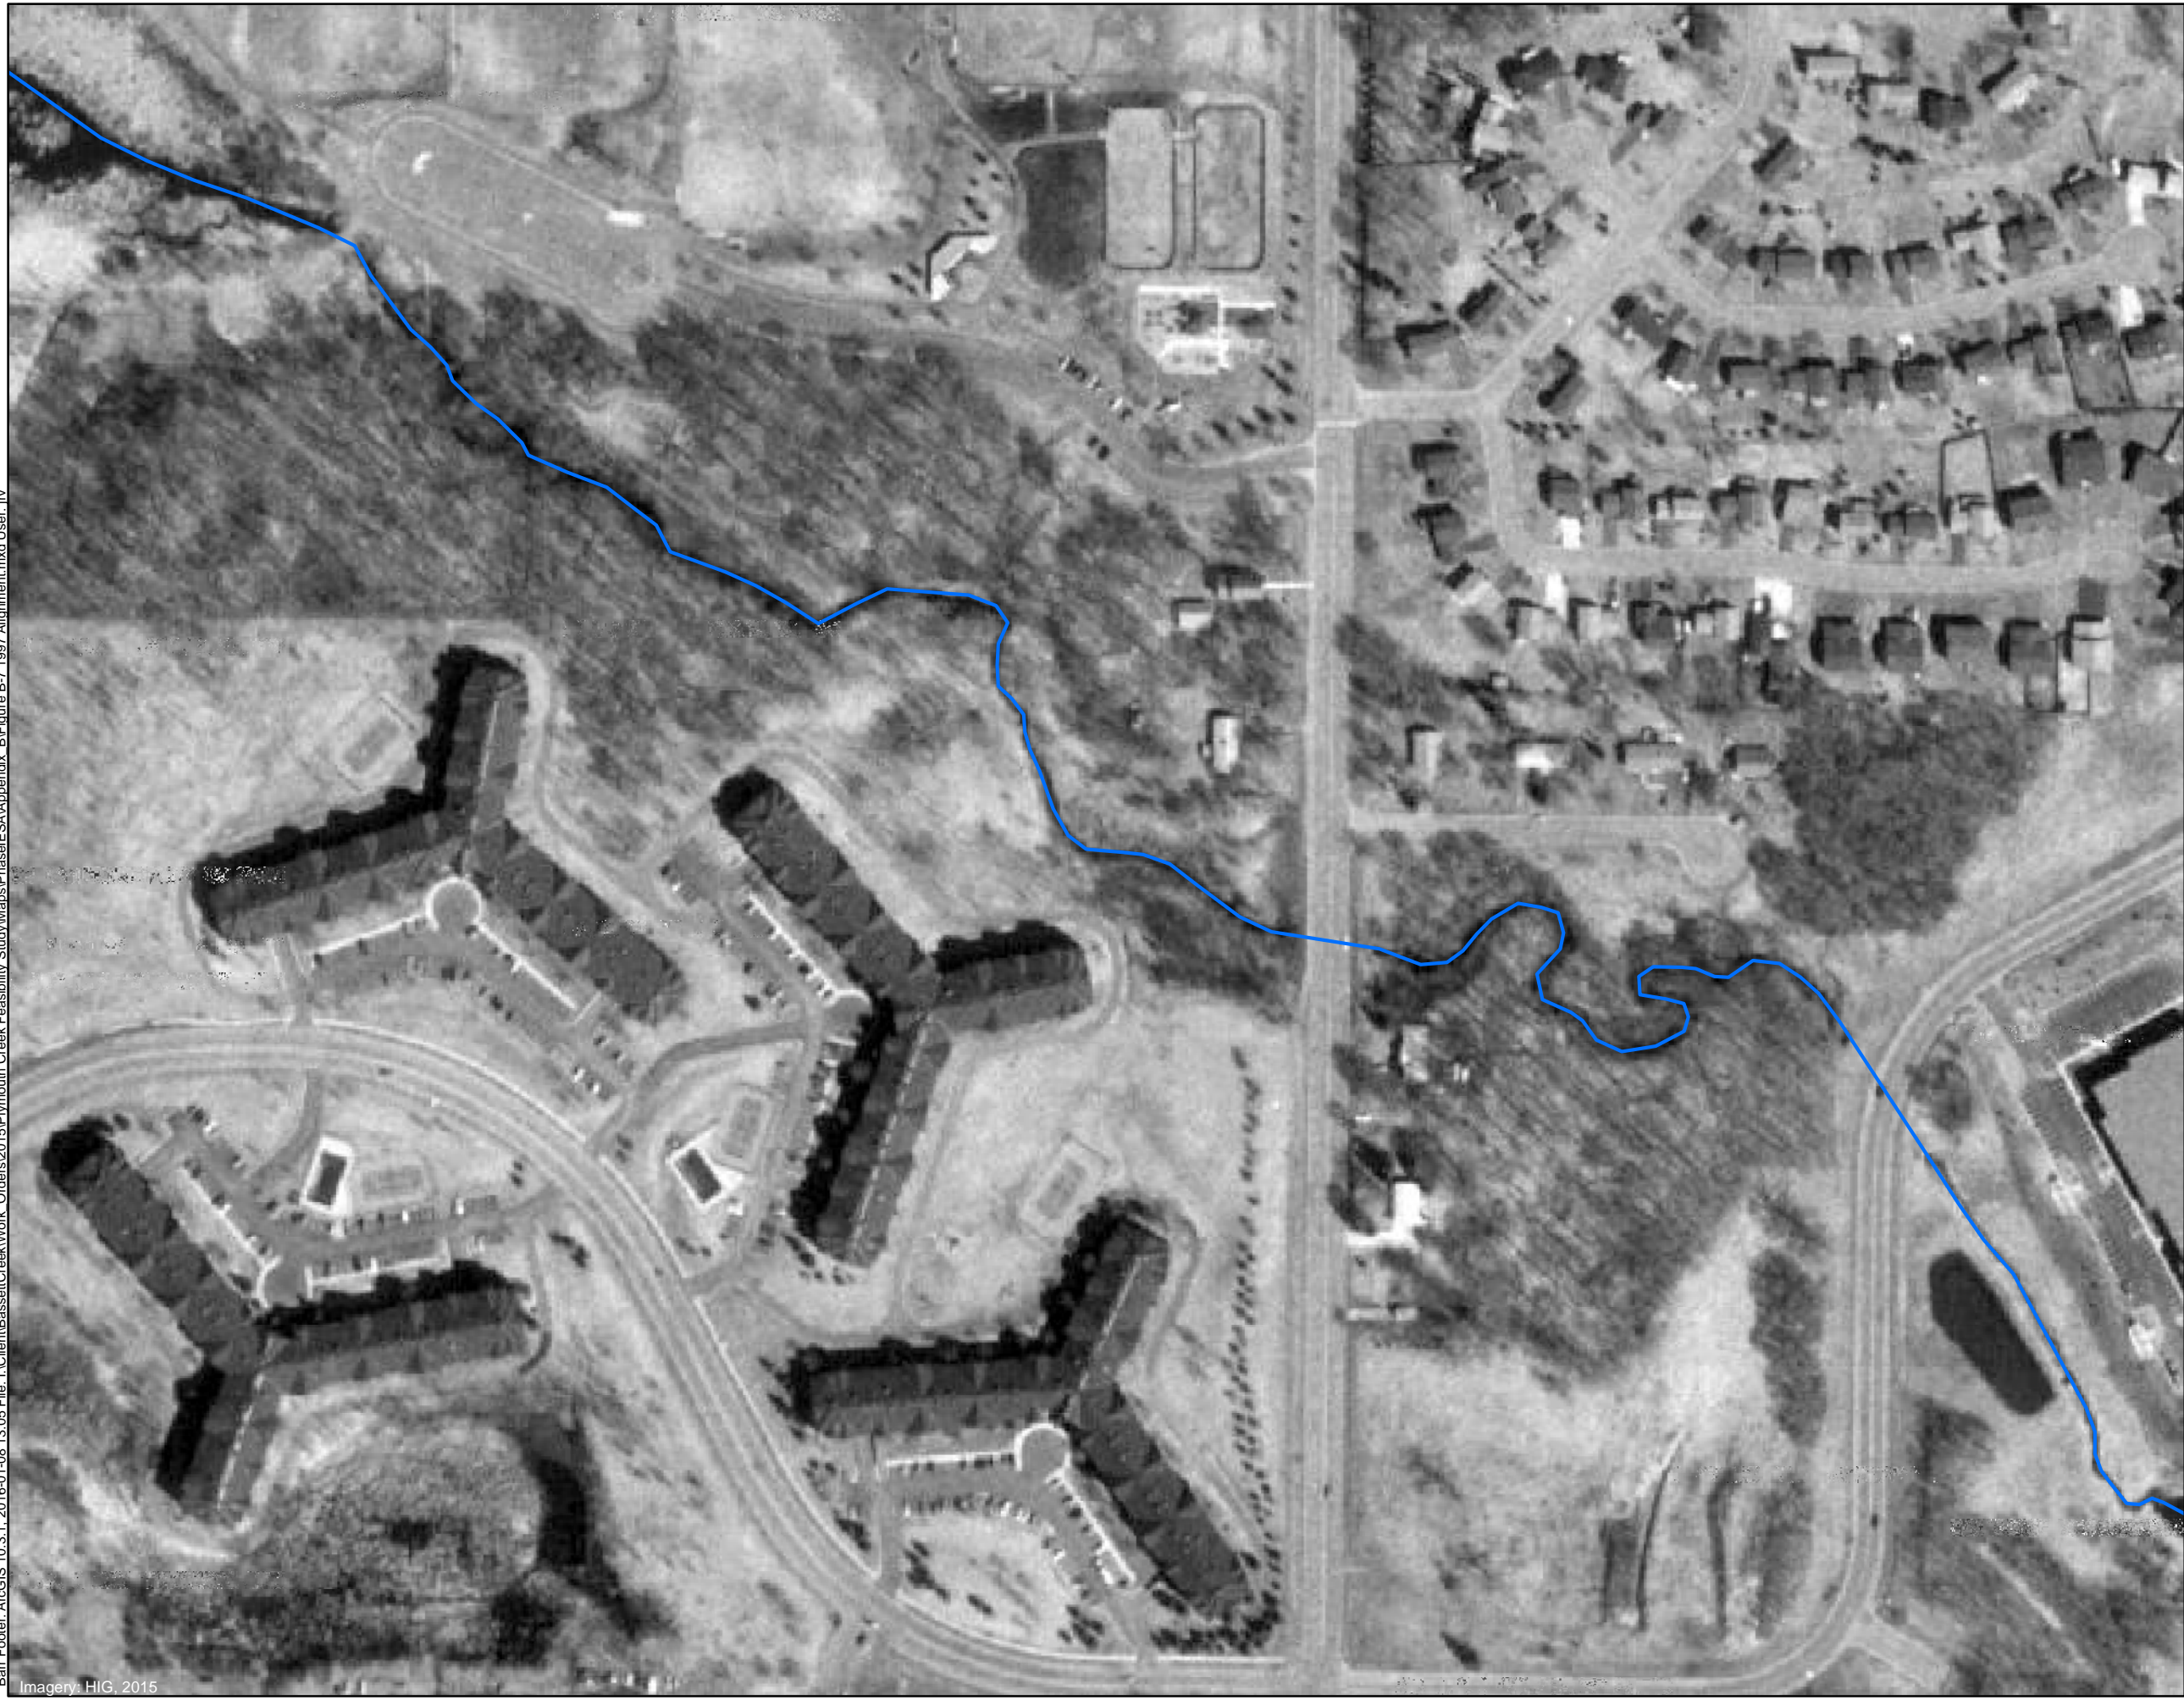
APPENDIX B
1997 CHANNEL ALIGNMENT
Plymouth Creek
Plymouth, MN

— 1997 Channel Alignment

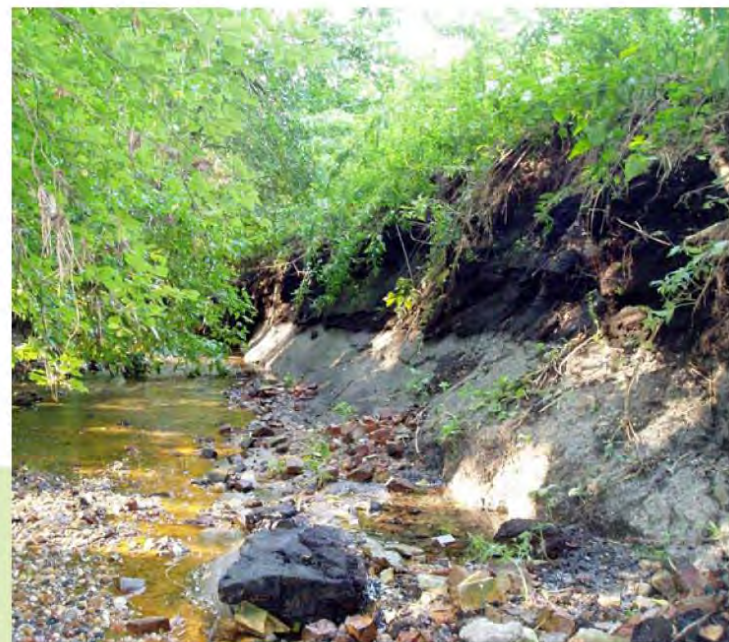
Fluvial bank erosion is caused by water in the stream moving past the streambanks. The shear stress caused by the flow entrains soil particles into the flow, causing the stream bank to erode away. This is the most common type of erosion that occurs in streams. Virtually all streams experience this type of erosion as their flow path evolves over time. However, the rate of fluvial bank erosion can increase when the stream is out of equilibrium with its watershed. Increased flow from a watershed will increase the rate of fluvial bank erosion. In many cases, it appears to be a part of the natural process of stream evolution. In places where the channel is confined by the valley walls, however, fluvial bank erosion can lead to failure of the high banks. It can also undermine storm sewer inlets.

Stone Toe Protection is constructed from cobble-sized rock on the creek edges. It extends to approximately the bankfull level, which will protect the channel banks for flow events that occur every 1 to 2 years or less. The material will extend into the ground to resist scour. Coarse gravel is used to separate the larger rock material from underlying soil. Stone toe protection is typically used in conjunction with revegetation of the upper banks.

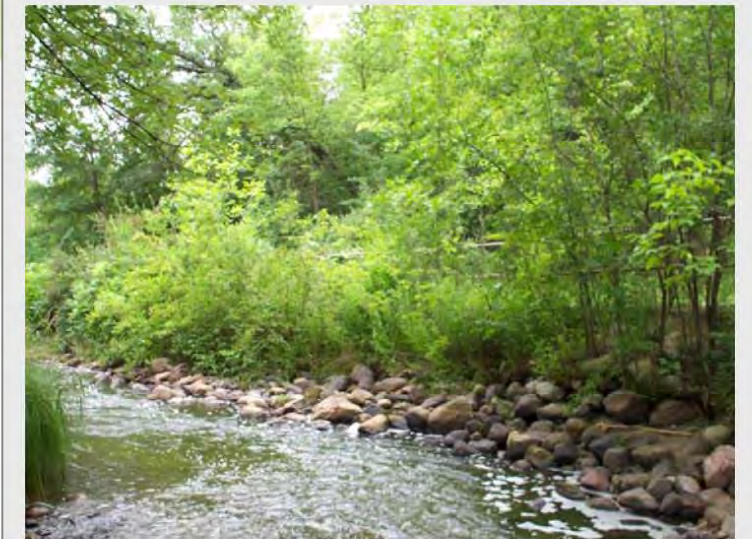
Stone toe protection has been used extensively in Nine Mile Creek's Lower Valley, in conjunction with deflector dikes, grade control measures and stabilization of large bank failures. Following the 1987 "super storm," the proposed design allowed the stream to continue its course while taking measures to protect areas where water flow was eroding valley walls. The resulting measures have stabilized the stream channel and valley walls while blending seamlessly with the natural environment.

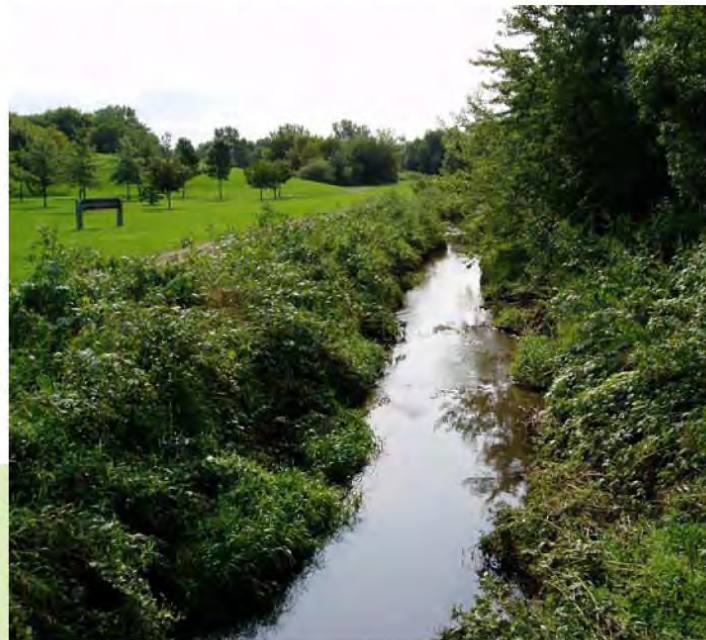
Channel incision occurs when there is an imbalance between the sediment supply and the sediment carrying capacity of the stream. Erosion will occur when the sediment carrying capacity of a stream exceeds the sediment supply. In streams with cohesive banks and steep channel slope, the erosion will first occur primarily on the channel bottom because that is where the erosive forces are the strongest. As the channel deepens, the stream will gradually become wider as the banks eventually fail. The stream will gradually return to equilibrium; however, the process can take many years and significant amounts of erosion will occur during the process.

Grade control measures are used where channel downcutting has occurred. Various types of weirs are commonly used to provide grade control on streams, particularly in steeper systems. Weirs can be constructed of sheetpile, concrete, or natural materials such as rock. In most cases, natural rock is used to emulate natural riffles. Large boulders would comprise the core of the structure, with smaller rock material placed on the upstream and downstream sides of the boulders to provide a gradual transition to the channel.

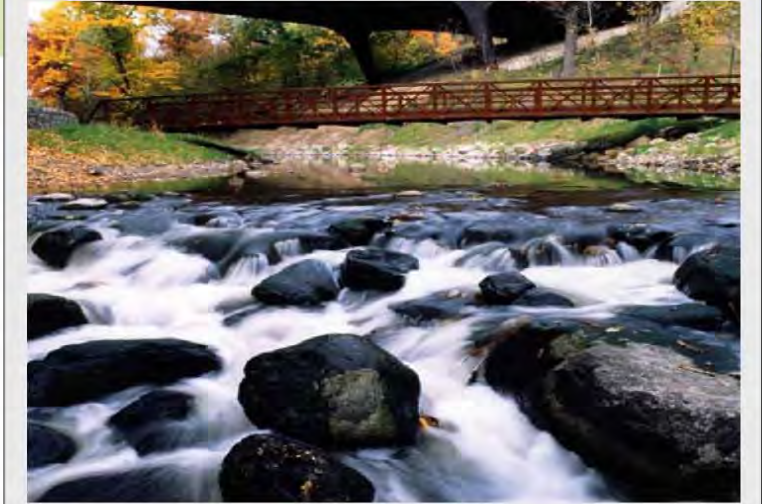
Following the 1987 "super storm," a rapids was constructed on Nine Mile Creek downstream of the 106th Street Bridge. The rapids was one of several grade-control structures that were installed on a three-mile stretch of creek in the lower valley. The proposal allowed the stream to continue its course while taking measures to protect areas where water flow was eroding valley walls. Protection measures included applying porous deflector dikes, burying sheetpile walls parallel to the creek to prevent undercutting of slopes, installing weirs (rock or capped sheetpile) to limit stream-bed degradation, and improving storm-sewer outlets.

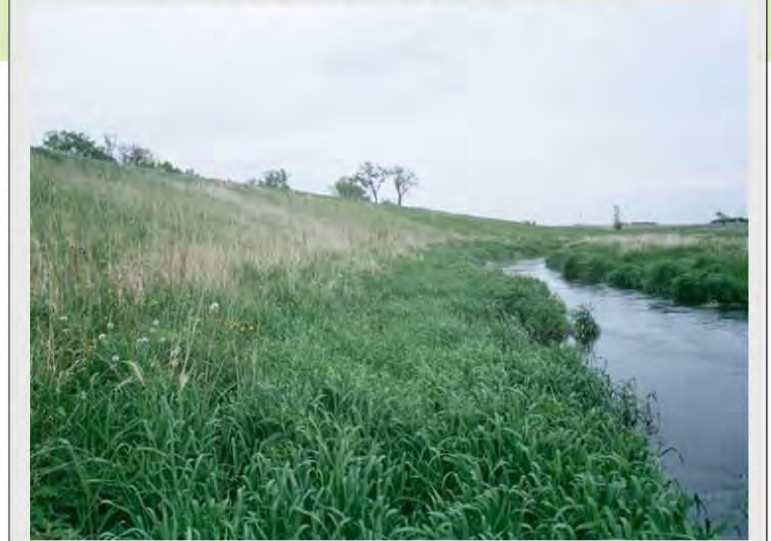
Here is an example of a stabilization project designed for a 1,000-foot long, 20-foot high streambank that was severely eroded. The channel was directed away from the bank toe by installing six rock vanes. The bank was planted with native vegetation and protected with erosion control blanket, while the terrace above the bank was graded to redirect surface runoff to a less vulnerable area. The restored streambank withstood significant flooding during 2001, and has become nicely vegetated (see picture above).

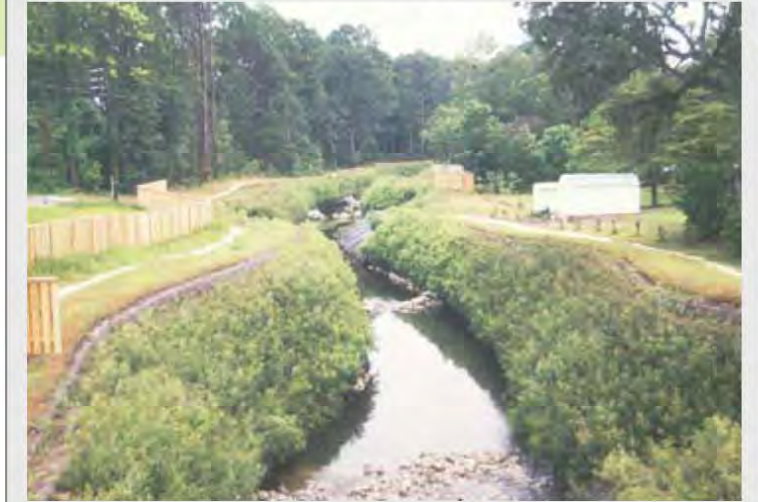
The Mill Creek Restoration Project utilized soil bioengineering design to stabilize 175 linear feet of severely eroding streambanks within the Caldwell Recreation Park in southeastern Ohio. The work included two 25-foot vegetated reinforced soil slope (VRSS) sections, two 50-foot fill bank sections protected with woven coir and direct woody plantings, and a 12.5-foot tie-in on the upstream and downstream end of streambank work area.

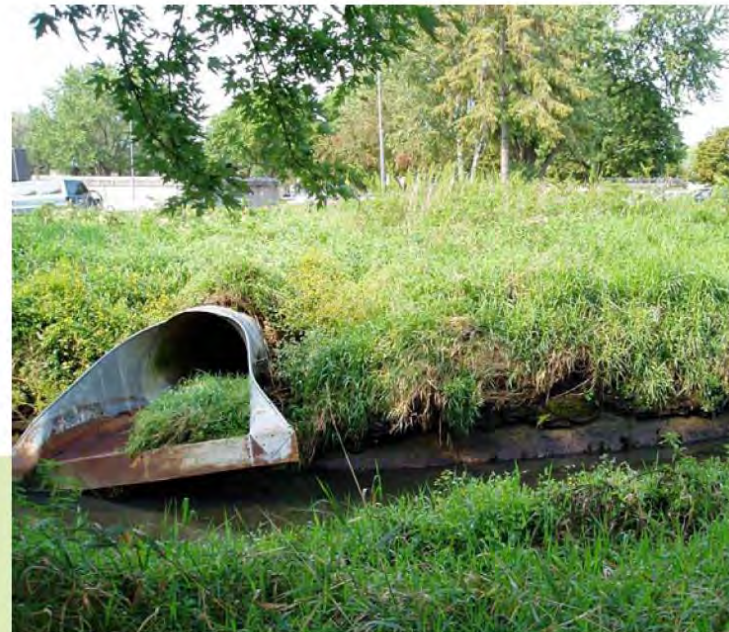
Erosion is frequently observed at culvert outlets for a variety of reasons, including insufficient erosion protection at the culvert outlet, streambank erosion, and channel downcutting, which leaves the culvert perched above the channel. Filter fabric is often used at culvert outlets to separate riprap protection from underlying soils, however the fabric provides a slippery surface for the riprap, which commonly slides into the channel.

Culvert Stabilization is somewhat unique to each situation, depending on the site circumstances. Most sites require additional rock placement with a granular filter layer (rather than filter fabric). Some cases may require re-alignment and/or lowering of the outlet to better align with the stream channel. Typically, outlets should be aligned in the downstream channel direction so that flow doesn't impinge on the opposite bank. It is usually desirable for the culvert to enter the stream at or just above the normal water level in order to minimize the potential for undercutting.
