Stream Stabilization Plan

PLYMOUTH CREEK POTENTIAL STABILIZATION SITES
 Plymouth Creek Feasibility Study
 Bassett Creek Watershed Management Commission

Figure G-2
 PLYMOUTH CREEK REACH 1 ALTERNATIVES
 Plymouth Creek Feasibility Study
 Bassett Creek Watershed
 Management Commission

Figure G-3
 PLYMOUTH CREEK REACH 2 ALTERNATIVES
 Plymouth Creek Feasibility Study
 Bassett Creek Watershed Management Commission

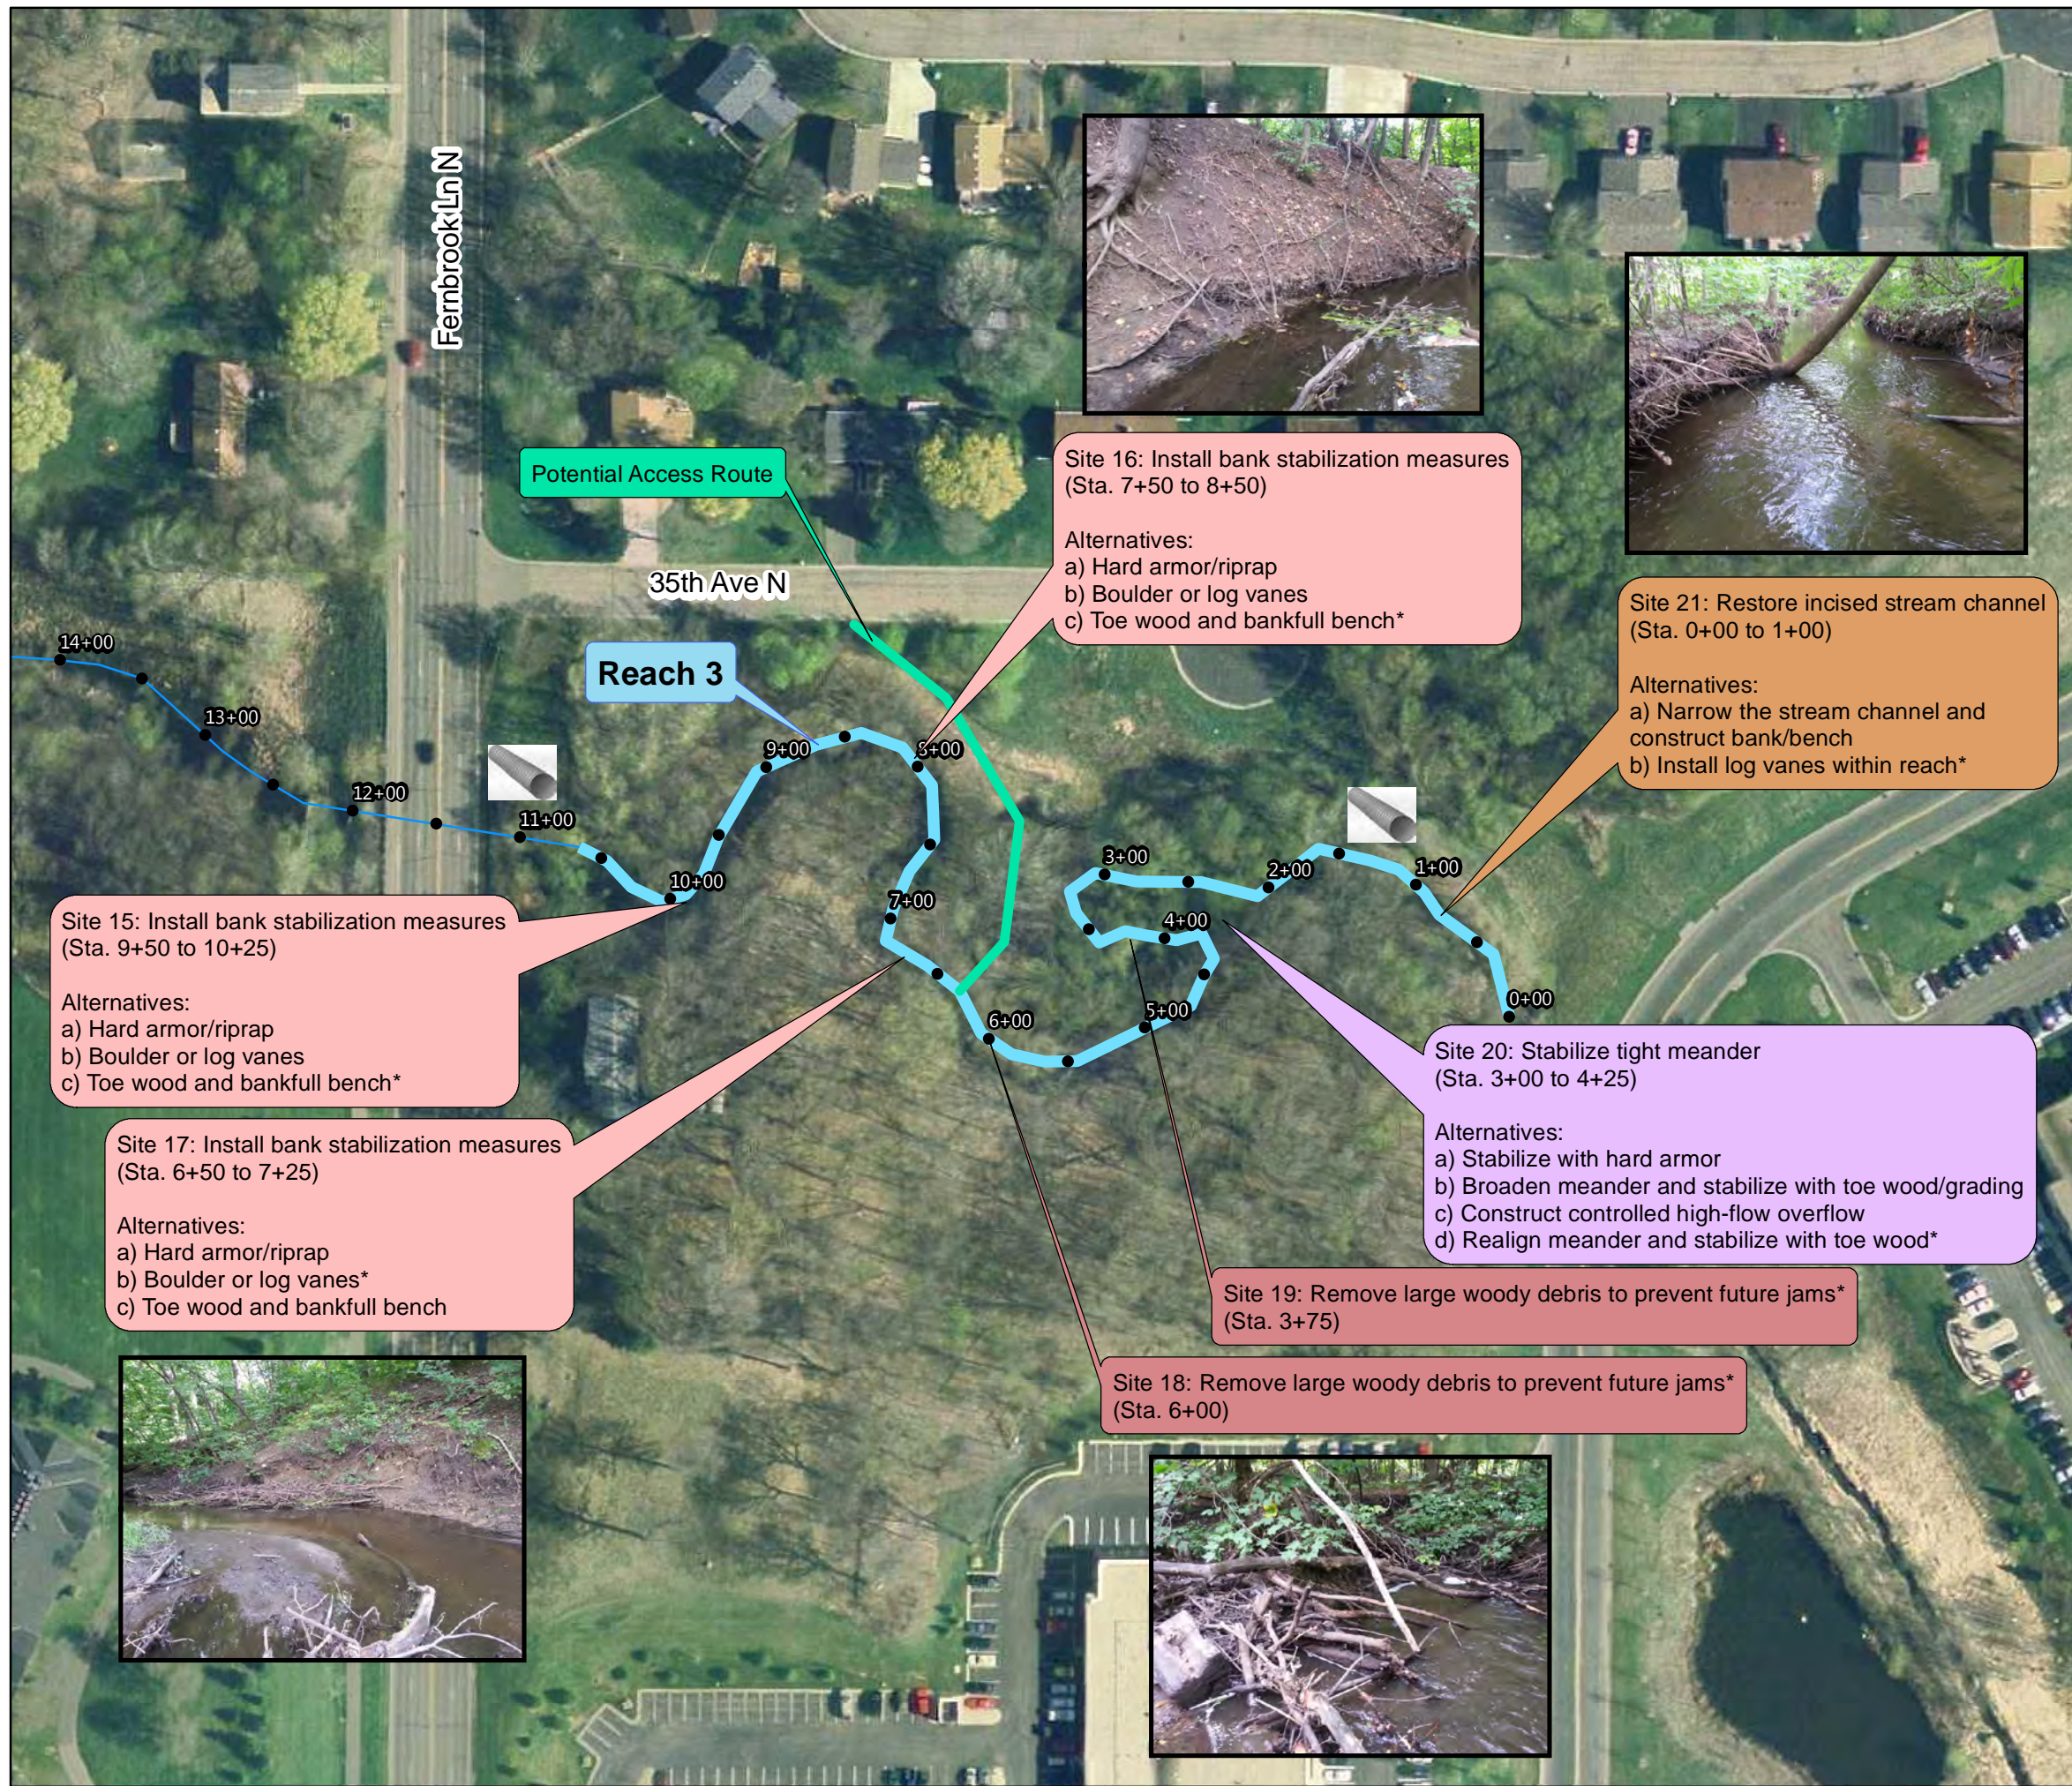
Reach 3

Issues: Several large eroding outer banks. Significant woody debris causing jams that redirect flow at banks. Unstable tight meander in downstream third in the process of being cut off.
