Phase II Investigation Work Plan

Bassett Creek Main Stem Erosion Repair Project

*Cedar Lake Road to Dupont Avenue N/2nd Avenue N, plus
Fruen Mill Site, Minneapolis, MN*

Bassett Creek Watershed Management Commission

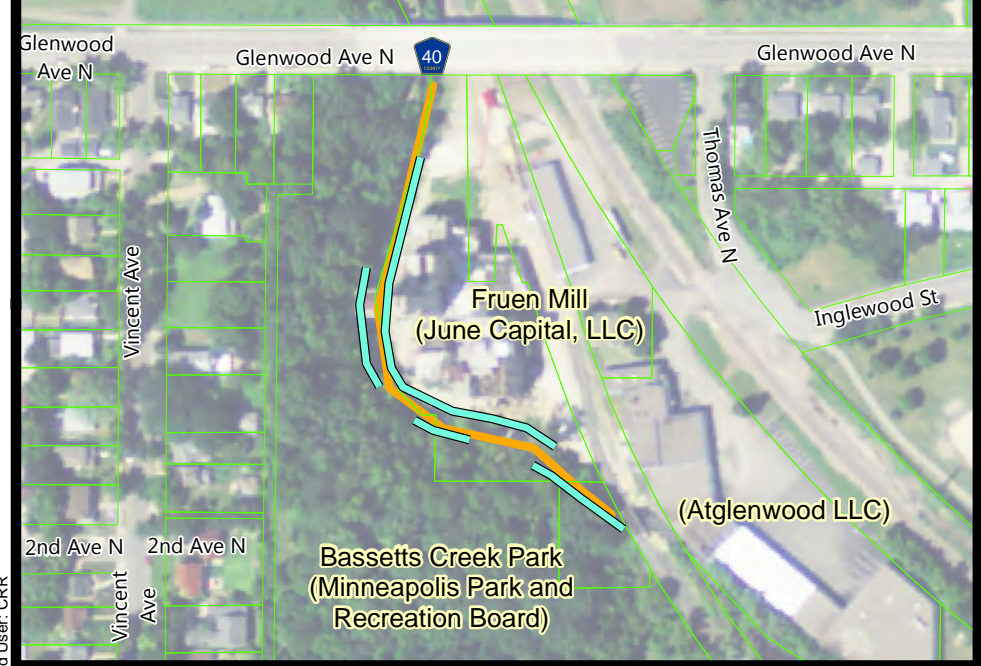
Figure 2
STUDY AREAS
Bassett Creek Main Stem Erosion Repair Project
Bassett Creek Watershed Management Commission
Minneapolis, Minnesota

- Cedar Lake Rd to Irving Ave (Reach 1)
- Irving Ave to Dupont/2nd Ave (Reach 2)
- Fruen Mill (Reach 3)
- Creek Bank Repair/Stabilization Target Areas
- Parcels

This Phase II Environmental Investigation Work Plan (Work Plan) has been prepared on behalf of the Bassett Creek Watershed Management Commission (BCWMC) for an investigation of potential environmental impacts in the soils along the proposed Bassett Creek Main Stem Erosion Repair Project. The investigation results will be incorporated into the Bassett Creek Main Stem Erosion Repair Project Feasibility Study report (Feasibility Study) that will evaluate erosion repair and creek bank stabilization options in preparation for construction planned for 2017. The Study Area is located west of Interstate I-94 and north of Interstate I-394 in Minneapolis, Minnesota, as shown on Figure 1. The project would address needed erosion repair and stabilization work along the Main Stem of Bassett Creek from Cedar Lake Road to Irving Avenue North (Reach 1), Irving Avenue North to the tunnel inlet plus the overflow section to Second Avenue North (Reach 2) and the reach adjacent to the Fruen Mill site (Reach 3), as shown on Figure 2.

It is anticipated that the investigation and creek stabilization/repair work will be completed within existing or planned easements held by the City of Minneapolis and BCWMC, or under access agreements to be established with some property owners. The project is not expected to result in ownership or land use changes in the project area. The work will involve several parcels owned by various entities (including the City of Minneapolis) as shown on Figure 2.

The objective of the proposed Phase II investigation is to further characterize the soils along Bassett Creek in the areas targeted for repair or stabilization to evaluate options for managing soils where planting, grading or excavation may be needed as part of the project. Based on the existing conditions of the creek banks, specific areas have been targeted for erosion repair and/or stabilization as shown on Figure 2.

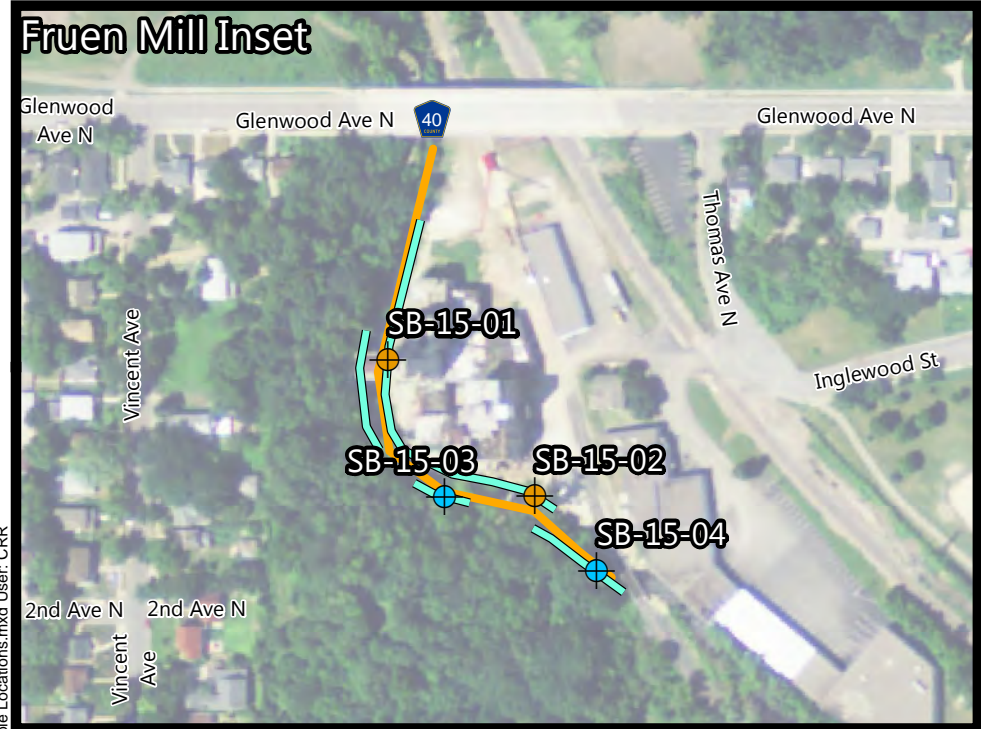
Figure 4
 PROPOSED SAMPLE LOCATION SUMMARY
 Bassett Creek Main Stem Erosion Repair Project
 Bassett Creek Watershed
 Management Commission
 Minneapolis, Minnesota

- Cedar Lake Rd to Irving Ave (Reach 1)
- Irving Ave to Dupont/2nd Ave (Reach 2)
- Fruen Mill (Reach 3)
- Creek Bank Repair/Stabilization Target Areas
- Proposed Geoprobe Sample Location
- Proposed Hand Auger Sample Location

Planned soil sampling locations are shown on Figures 4, 4a, 4b, and 4c. Due to the challenging access conditions in some areas, the investigation will involve a combination of hand auger, core drilling, and soil probing methods. It is anticipated that five shallow samples will be collected via hand augering, at approximately 1-2' below ground surface (bgs). Six soil samples are anticipated to be collected at depths up to 4' bgs using direct-push soil probing equipment. A utility locate will be performed prior to sampling and drilling.

Soil samples will be collected from the locations shown on Figures 4, 4a, 4b and 4c and analyzed for the parameters listed below. Soil sample depths will be based on the estimated depth of excavation required along each bank repair/stabilization area, as shown on Table 2.
