2015 Biotic Index Evaluation of Plymouth Creek and Bassett Creek

Prepared by
Bassett Creek Watershed Management Commission

April 2016

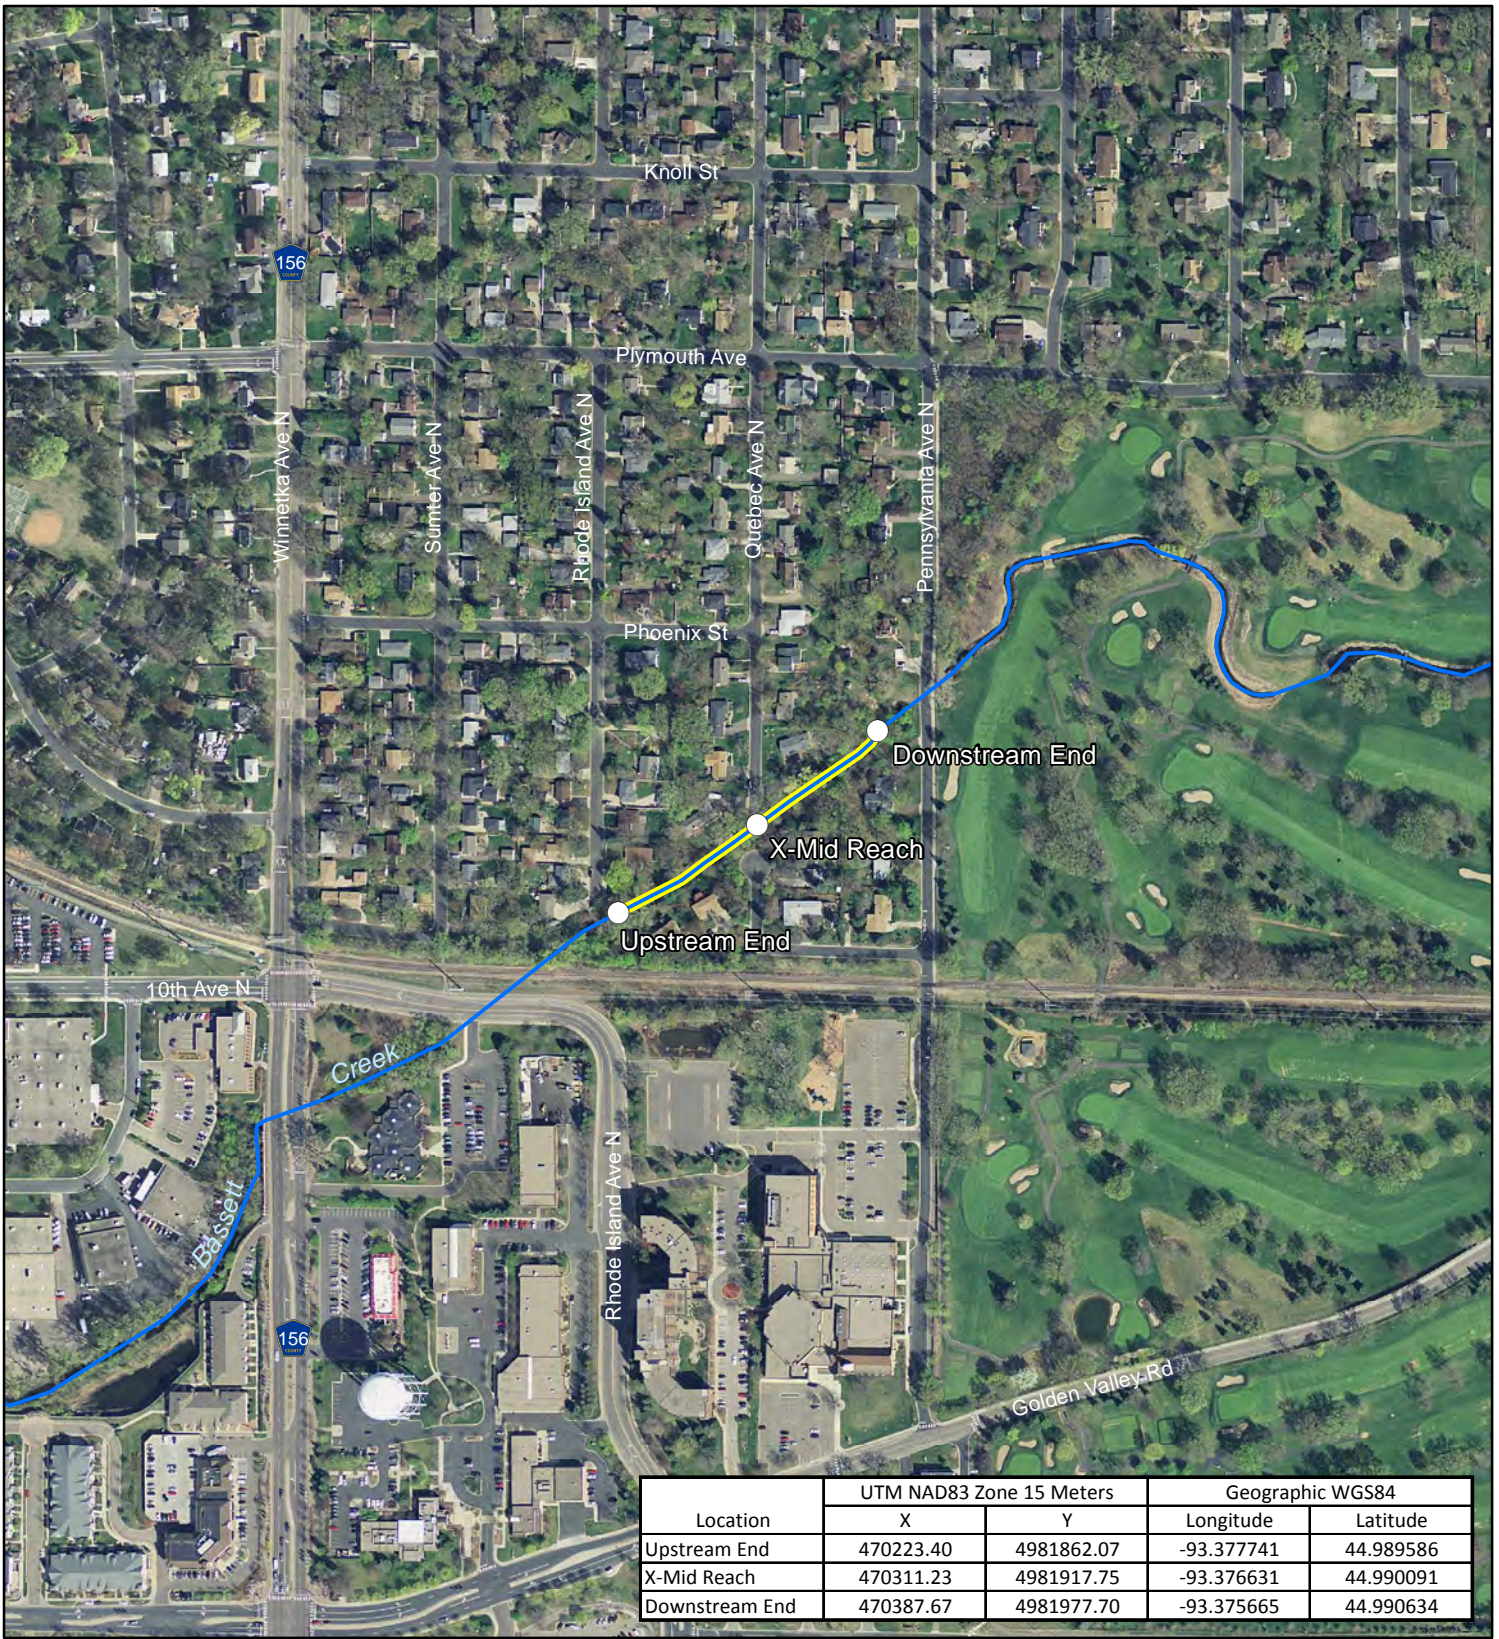
Figure 3-4

**NORTH BRANCH AT
34TH AVENUE SAMPLE
LOCATION**
(Water Quality, Habitat, and
Macroinvertebrates)
Hennepin County, Minnesota

Location	UTM NAD83 Zone 15 Meters		Geographic WGS84	
	X	Y	Longitude	Latitude
Upstream End	470223.40	4981862.07	-93.377741	44.989586
X-Mid Reach	470311.23	4981917.75	-93.376631	44.990091
Downstream End	470387.67	4981977.70	-93.375665	44.990634

Stream reaches for sampling were verified and/or finalized during a field reconnaissance in the spring and macroinvertebrate samples were collected in October. As required by MPCA methodology, each sample location was a minimum of 150 meters long; the exact length of each location was determined by multiplying the average stream width by 35. The lengths of the six sampling locations ranged from 150 to 211 meters (Figure 3-2, Figure 3-3, Figure 3-4, Figure 3-5, Figure 3-6 and Figure 3-7).

Habitat monitoring of each sample location was completed shortly after collection of macroinvertebrate samples. Sample locations are shown in Figures 3-1 to 3-7. Habitat within each station was quantified using a transect-point method (modified from Simonson, et al., 1994). Thirteen transects were established within the sampling reach of each station and four equally spaced sampling points plus the thalweg (deepest point in the transect) were established along each transect. Measurements or visual estimates were made to characterize key components of the physical habitat structure important in influencing stream ecology and the benthic macroinvertebrate community. Habitat parameters included:

Flow and water quality (temperature, dissolved oxygen, specific conductance, pH, and turbidity) were measured at each monitoring station (Figures 3-1 to 3-7) prior to collection of macroinvertebrate samples.

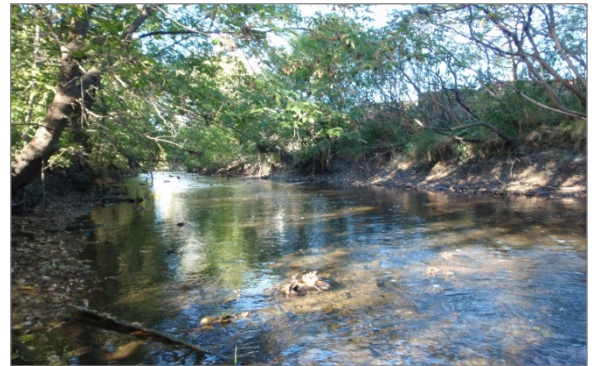
Bank erosion was prevalent in Bassett and Plymouth Creeks, including the Main Stem of Bassett Creek at Irving Avenue, pictured above, and the Main Stem of Bassett Creek at Rhode Island Avenue, pictured below.

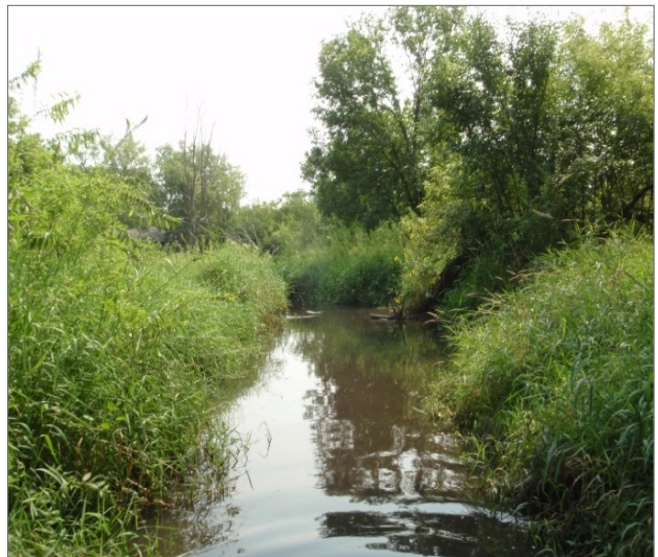
The Sweeney Lake Branch of Bassett Creek, pictured above, was the only location with overhanging vegetation. It provided valuable habitat for the macroinvertebrate community.

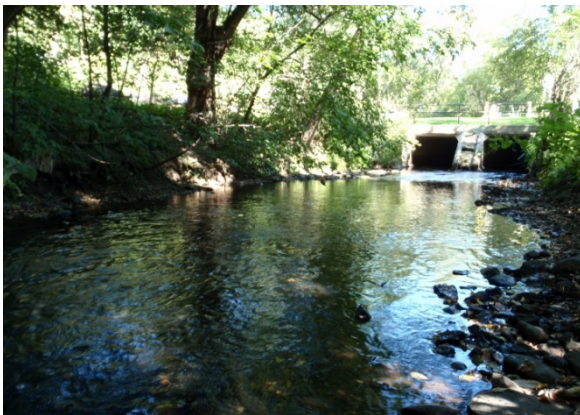
Main Stem of Bassett Creek at Rhode Island Avenue, pictured above, had very poor habitat for macroinvertebrates.

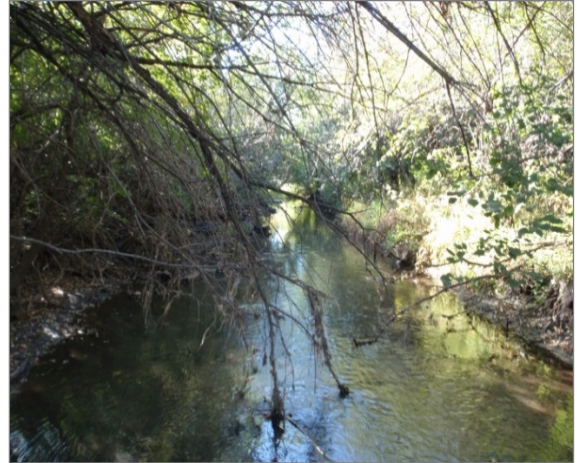
A significant increase in HBI over time was observed at the Sweeney Lake Branch of Bassett Creek, pictured above, indicating oxygen concentrations in the stream have declined over time.
