# **Wetland Delineation Report - DRAFT**

## ***Bassett Creek Restoration Project Feasibility Study***

Prepared for  
Bassett Creek Watershed Management Commission

March 2016

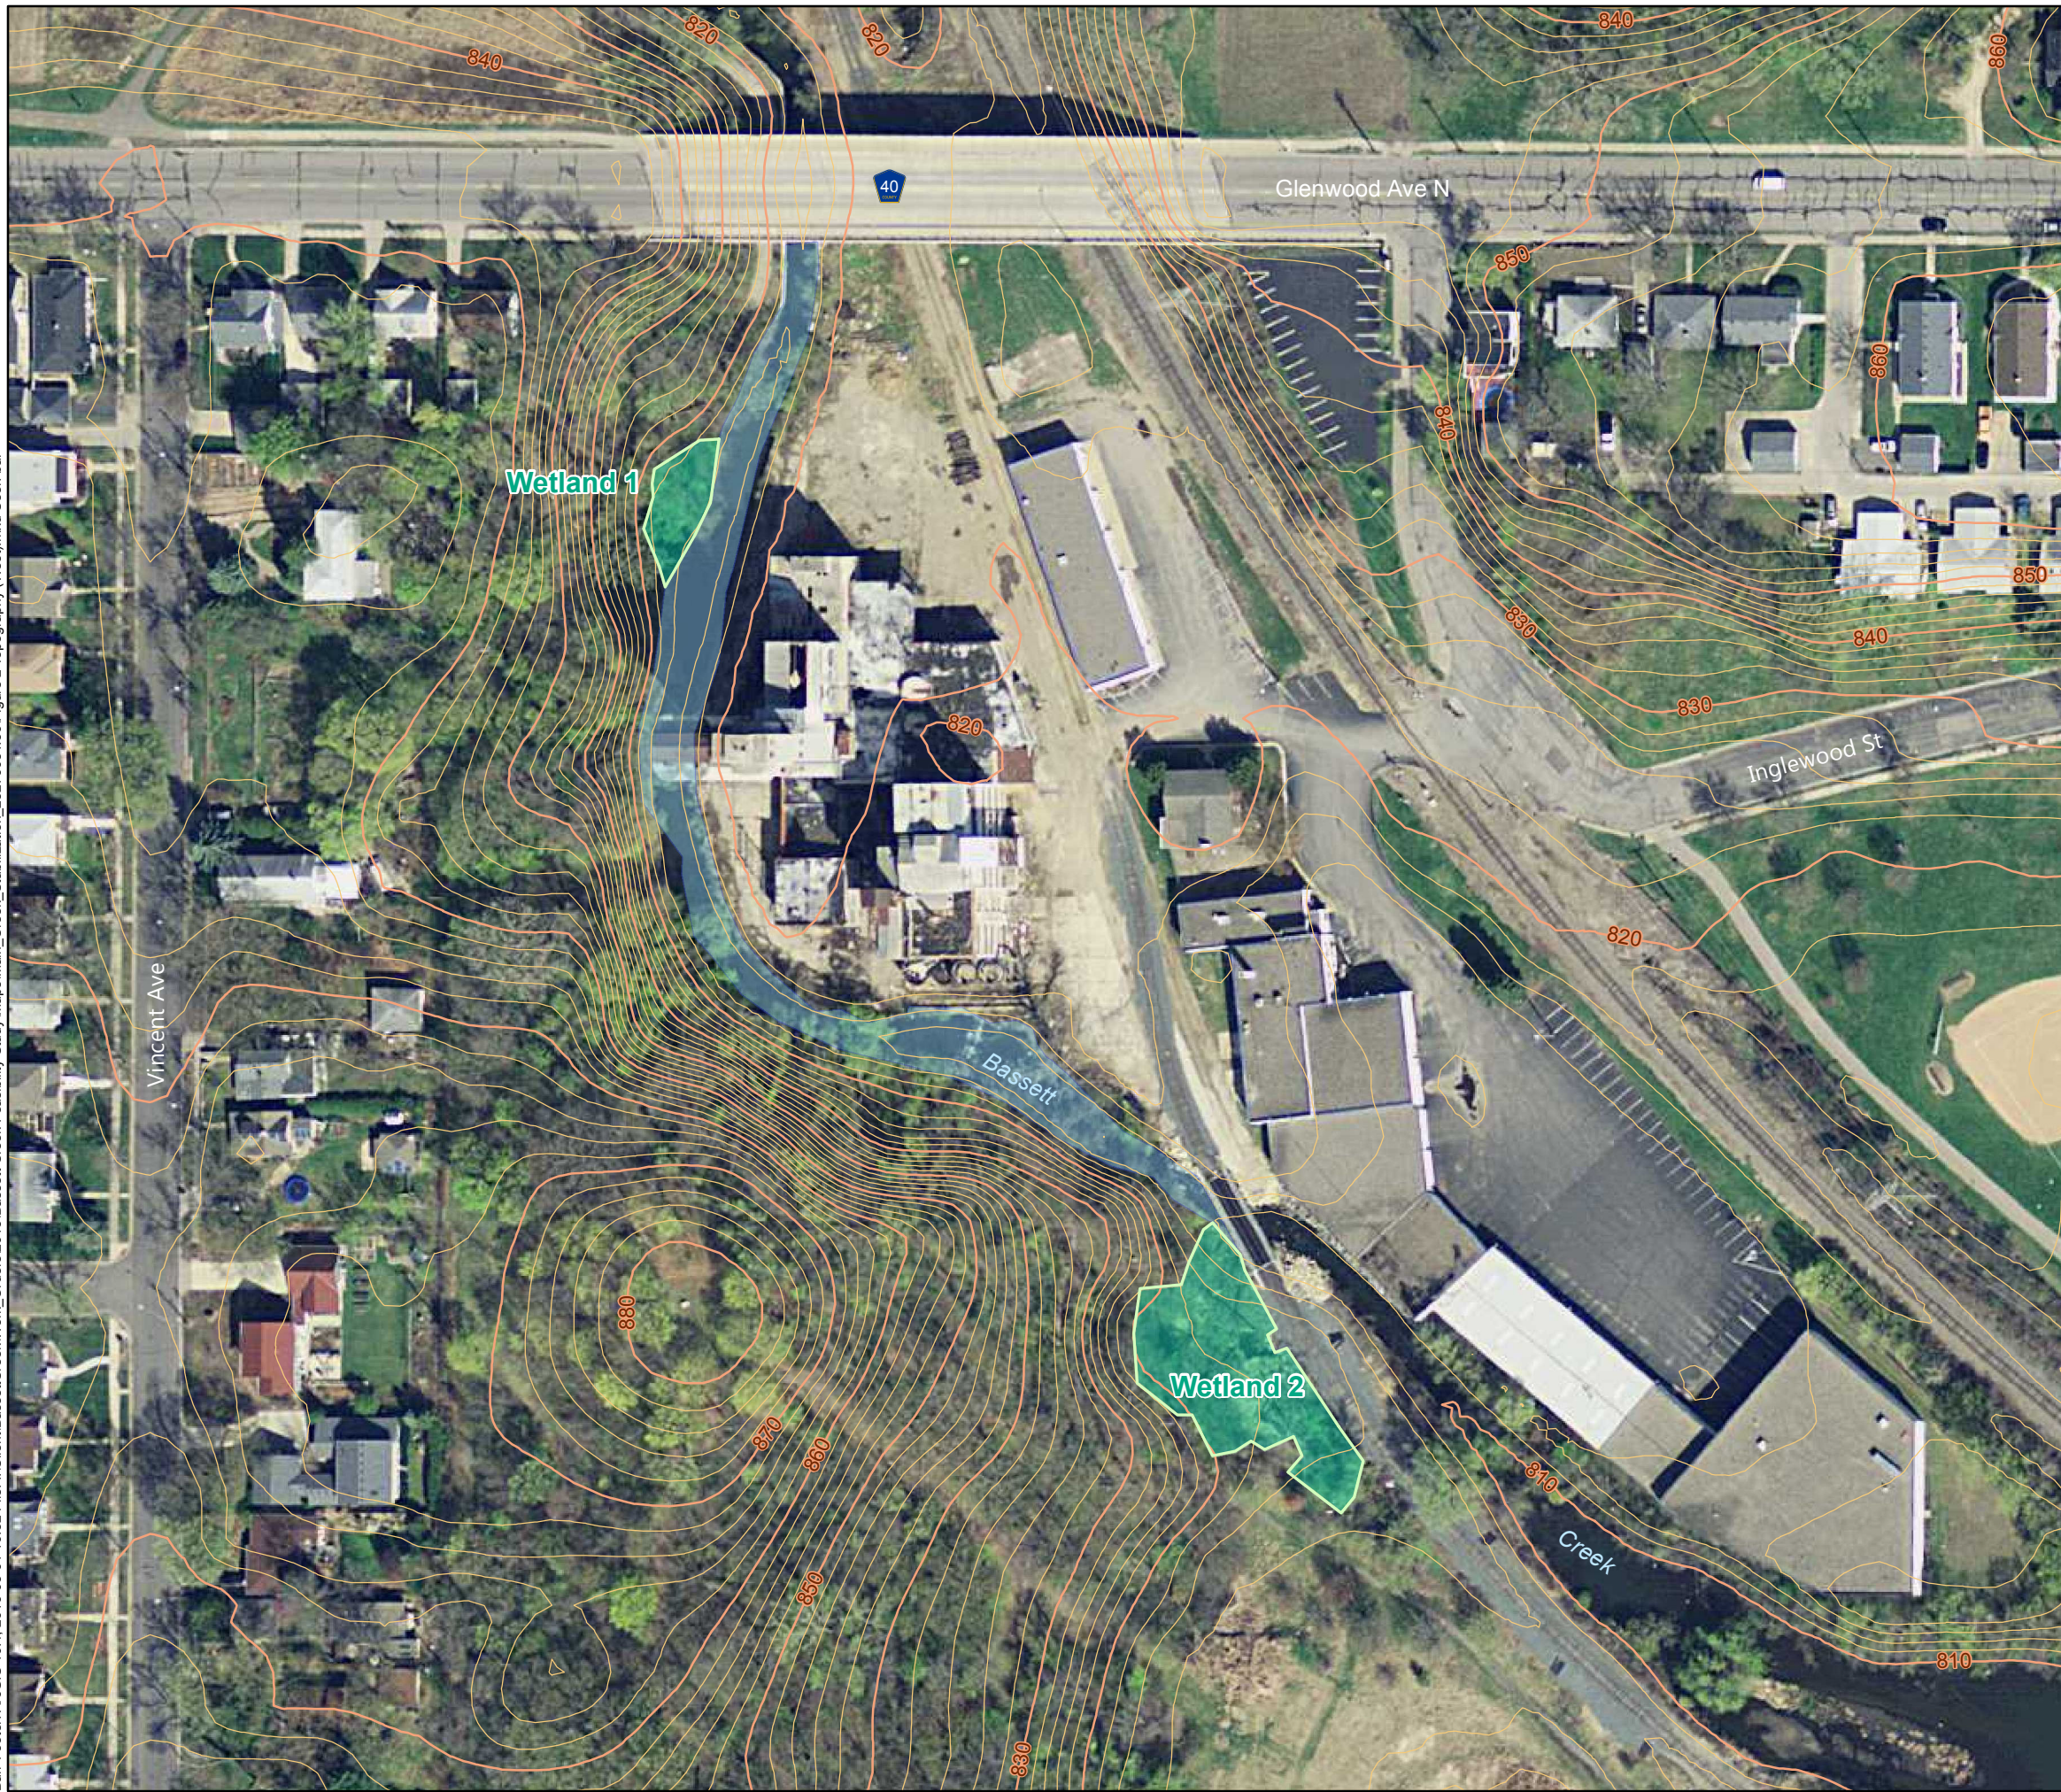
**FIGURE 2**  
**TOPOGRAPHY (WEST)**  
**Main Stem Stabilization-Delineation**  
**Bassett Creek Watershed**  
**Management Commission**

Most of the project area has steep and abrupt slopes leading into Bassett Creek. Adjacent areas to the creek and wetlands in the west section have abrupt to moderately undulating topography but flat topography on the Fruen Mill property (**Figure 2**). Adjacent areas in the east section of the project area have mostly flat topography due to the presence of parking areas, roads and industrial development closer to the creek (**Figure 3**).

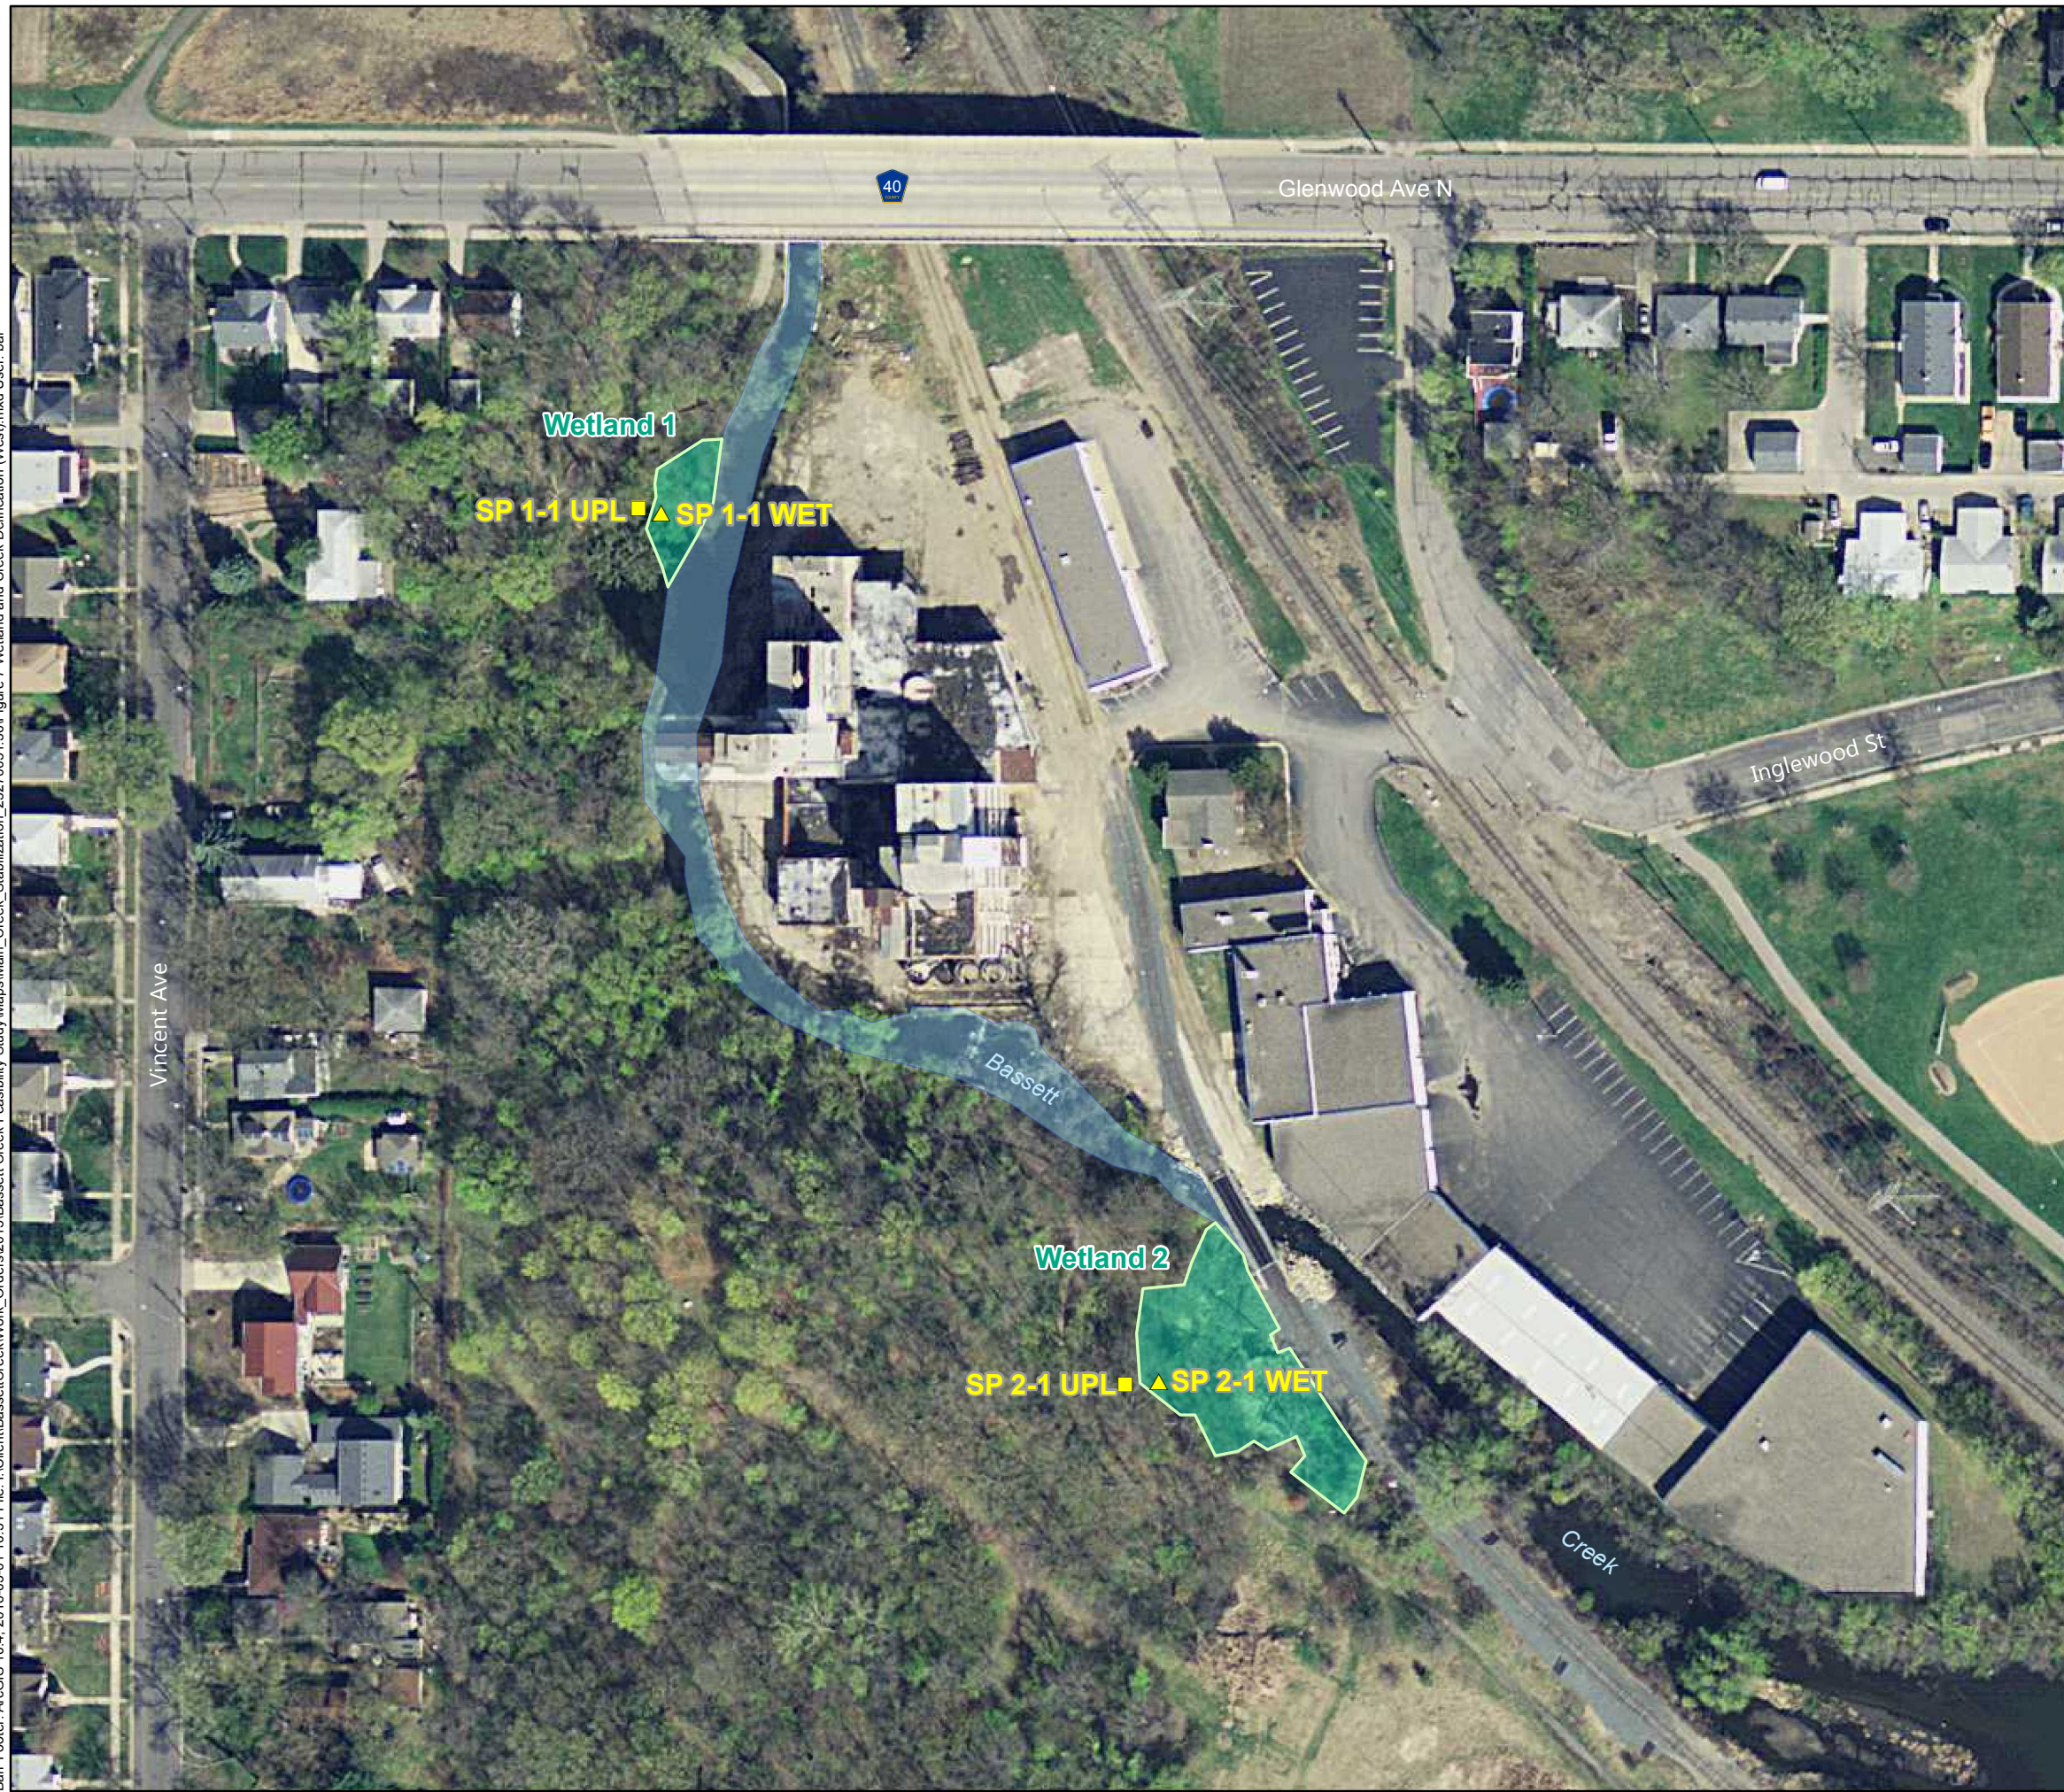
WETLAND AND CREEK  
DELINEATION (WEST)  
Main Stem Stabilization-Delineation  
Bassett Creek Watershed  
Management Commission

The delineated wetland boundaries, sample points and creek edges were surveyed using a Global Positioning System (GPS) with sub-meter accuracy (**Figures 7 and 8**).

Wetland 1 is a Type 1 (PEMA), seasonally flooded basin within floodplain located within the west section of the project area within Bassett Creek Park (**Figure 7**). The surrounding area has steep and abrupt slopes leading into Wetland 1 and into Bassett Creek at this location. The abandoned Fruen Mill site is located on the opposite side (east side) of Bassett Creek from Wetland 1 and has flat topography. Flood waters likely encroach Wetland 1 during the growing season which is keeping herbaceous vegetation from proliferating.

Wetland 2 is a Type 3/6 (PEM/SS1C), shallow marsh and shrub-carr wetland located in the west section of the project area approximately 500 feet downstream from Wetland 1 (**Figure 7**). Wetland 2 is a sloping wetland that appears to be fed by groundwater seepage coming from adjacent uplands. Several small channels extend through the wetland and connect to Bassett Creek.

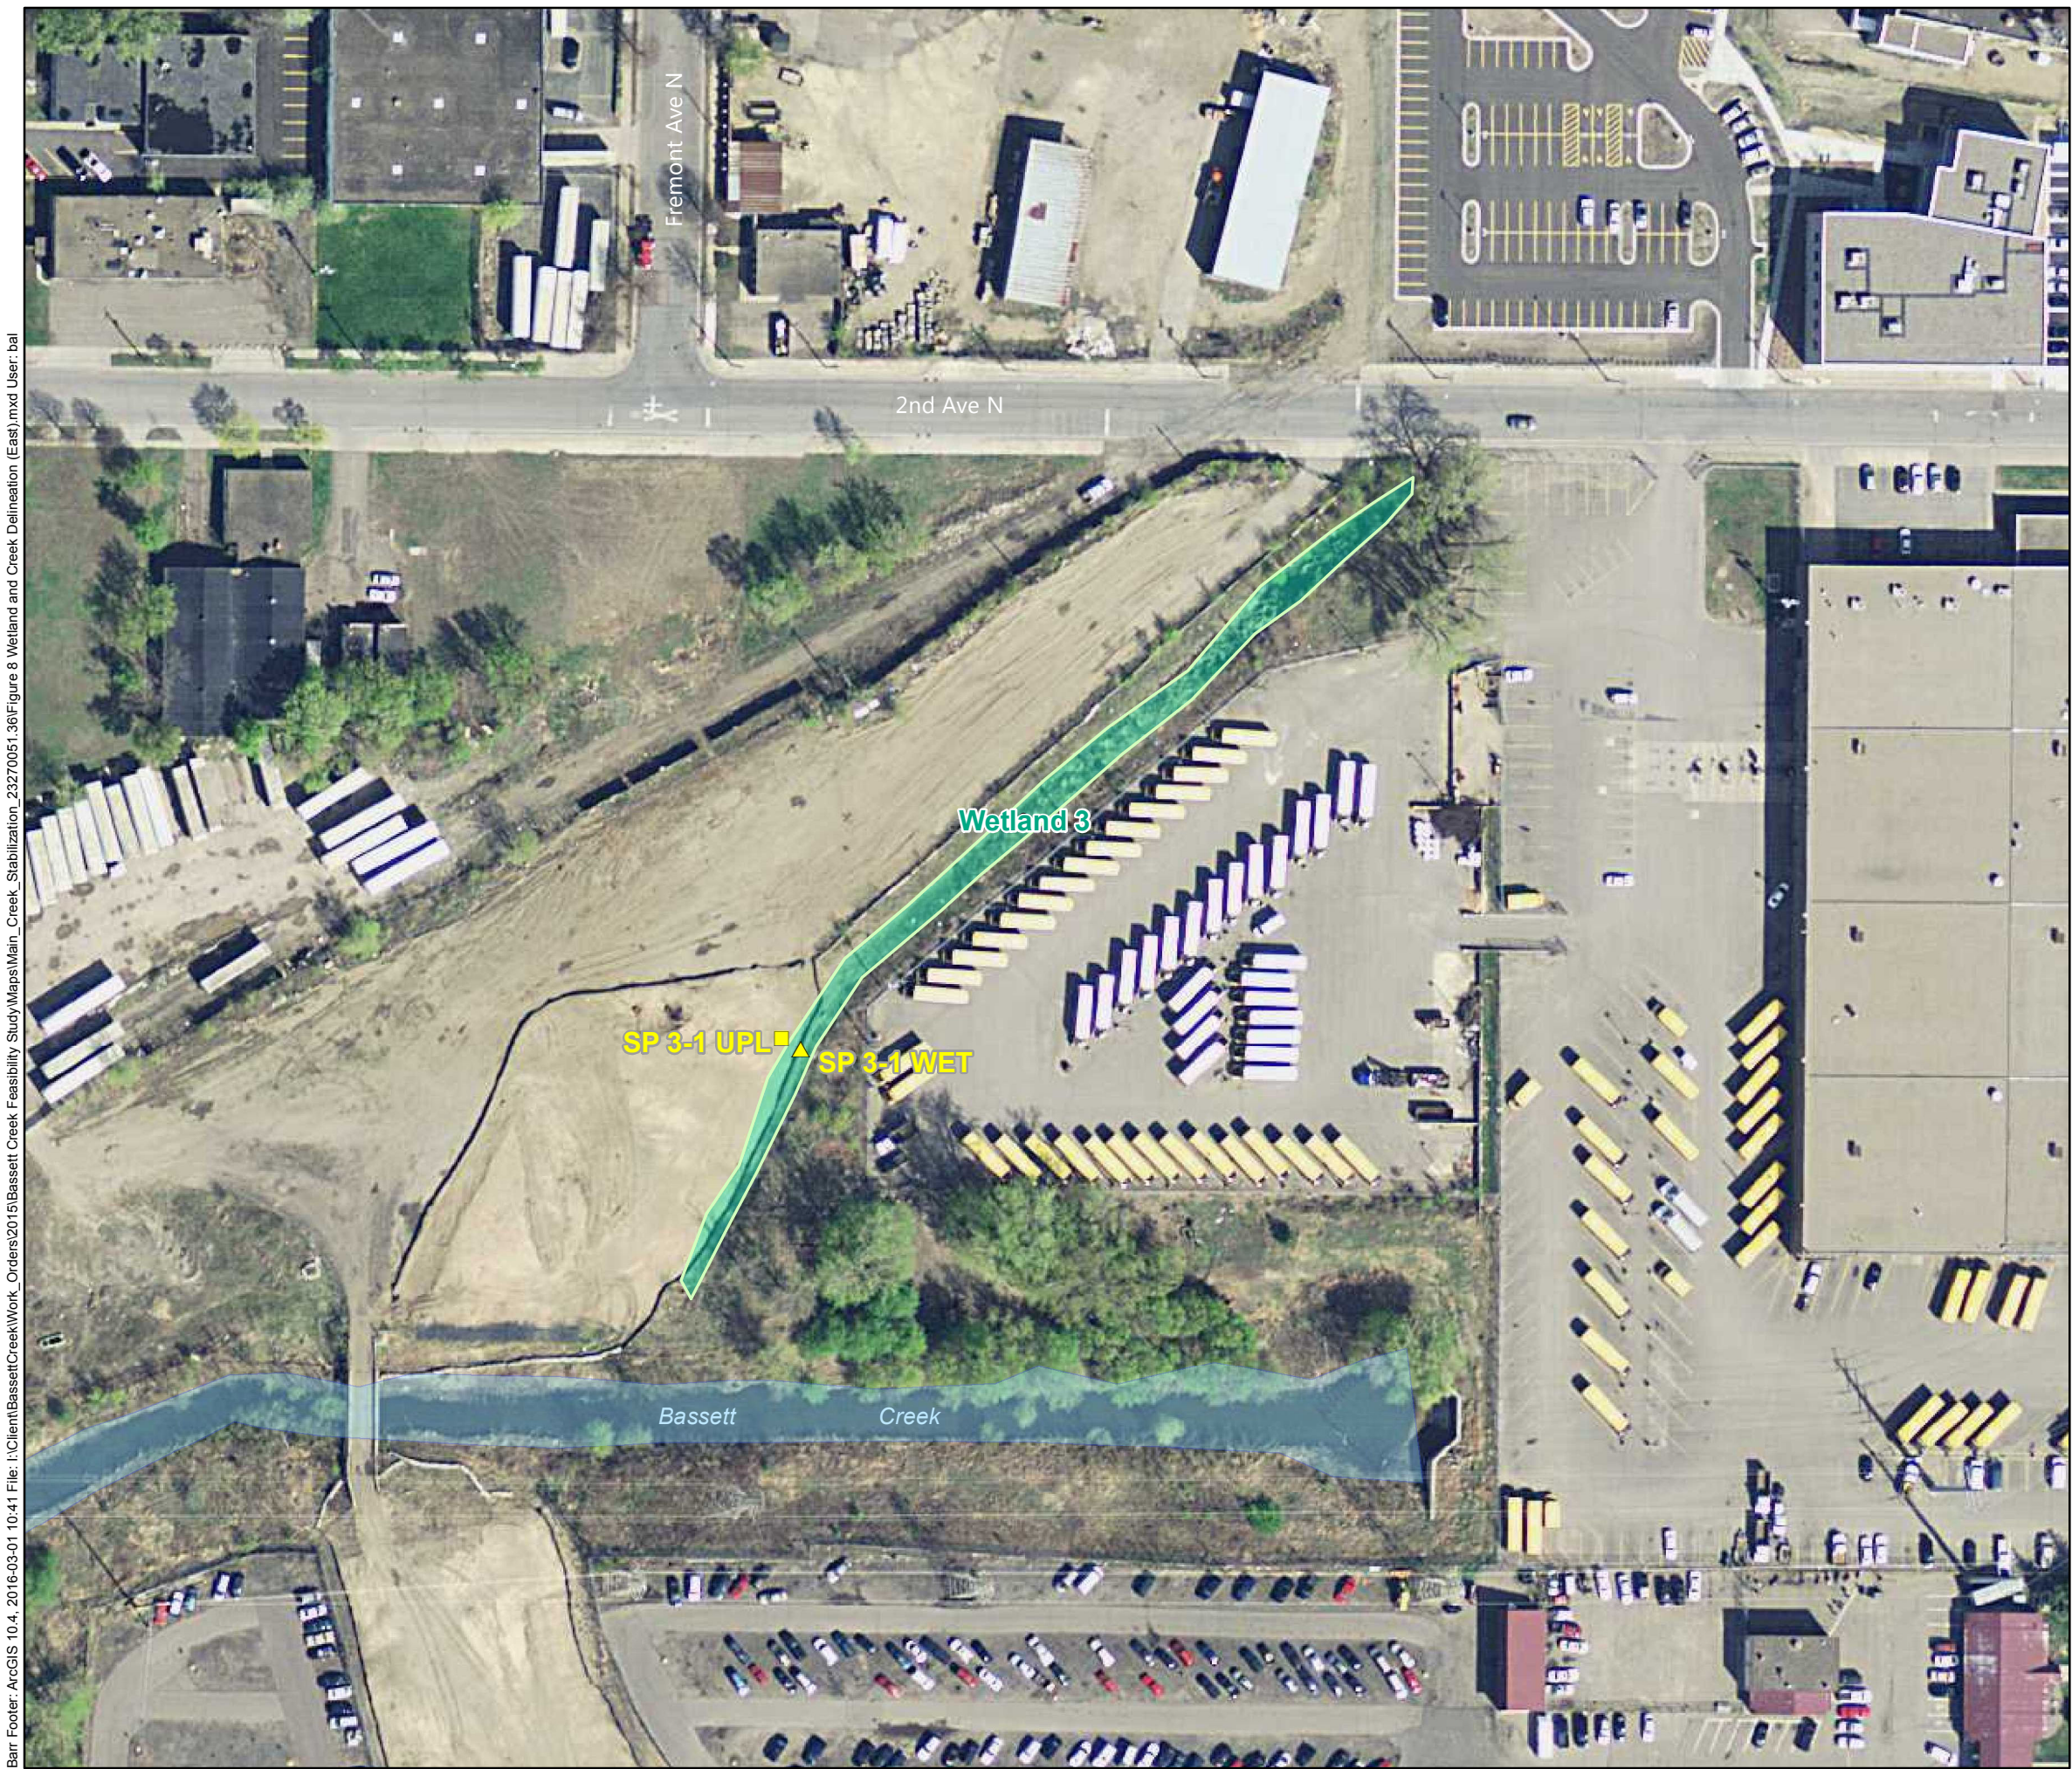
Wetland 3 is a Type 1/3 (PEMA/Fx), seasonally flooded basin and shallow marsh wetland located in the east section of the project area (**Figure 8**). Wetland 3 is an excavated linear wetland with a subsurface connection to Bassett Creek at its south end. Topography within Wetland 3 has a gradual descent from the south end to the north end where it then connects to the old Bassett Creek tunnel entrance at Second Avenue North and continues in a northerly direction underground.

Within the project area, the entire creek channel was delineated as a linear waterway and classified using the USFWS Cowardin System. The creek channel within the project area was classified as an R2UBG linear waterway (**Figures 7 and 8**), which concurs with the NWI designation.

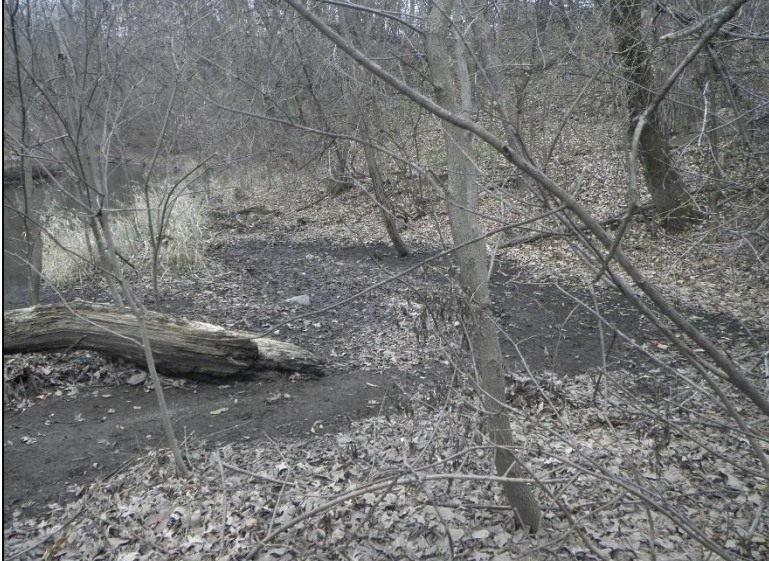
<p><b>Photo 1 – November 25, 2015</b></p> <p style="text-align: center;"><b>Wetland 1</b></p> <p>Wetland 1 is located on the west side of Basset Creek across from the abandoned Fruen Mill. It is seasonally flooded by Basset Creek during the growing season. Soils were saturated to the surface throughout most of the basin and it is sparsely vegetated. Upland side slopes leading into Wetland 1 are approximately 15 percent.</p>

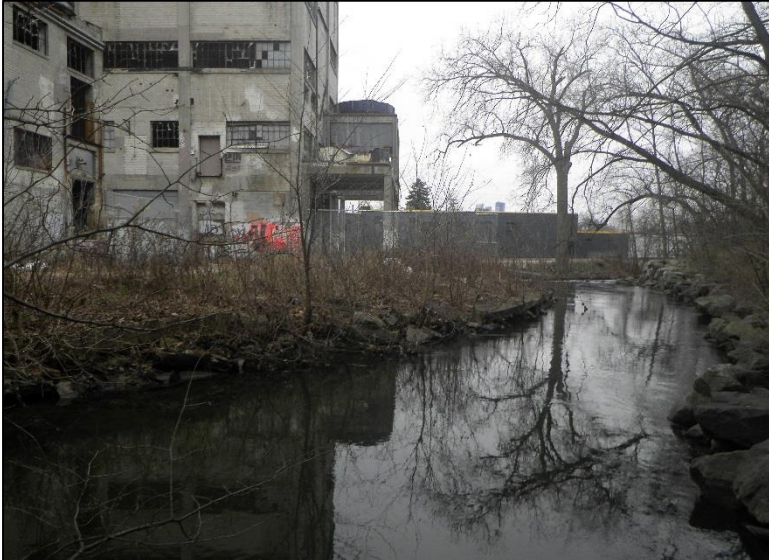
<p><b>Photo 2 – November 25, 2015</b></p> <p style="text-align: center;"><b>Basset Creek Study Reach</b></p> <p>Reach segment looking downstream between Wetlands 1 and 2. Fruen Mill is pictured on the east side of Basset Creek. Shoreline is mostly rip-rap, but some of the creek edges are concrete.</p>

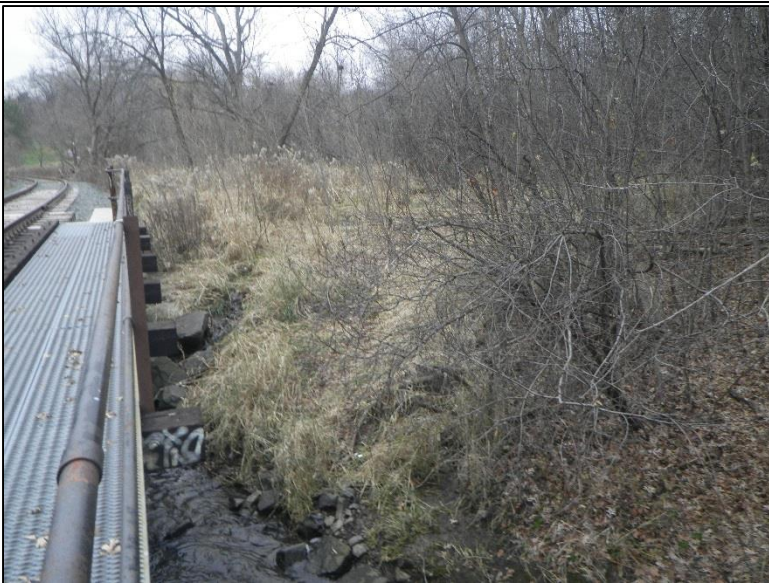
<p><b>Photo 3 – November 25, 2015</b></p> <p style="text-align: center;"><b>Wetland 2</b></p> <p>Wetland 2 is a seepage wetland. This photo shows where Wetland 2 connects with Basset Creek. Water drains from Wetland 2 into Basset Creek at this point.</p>

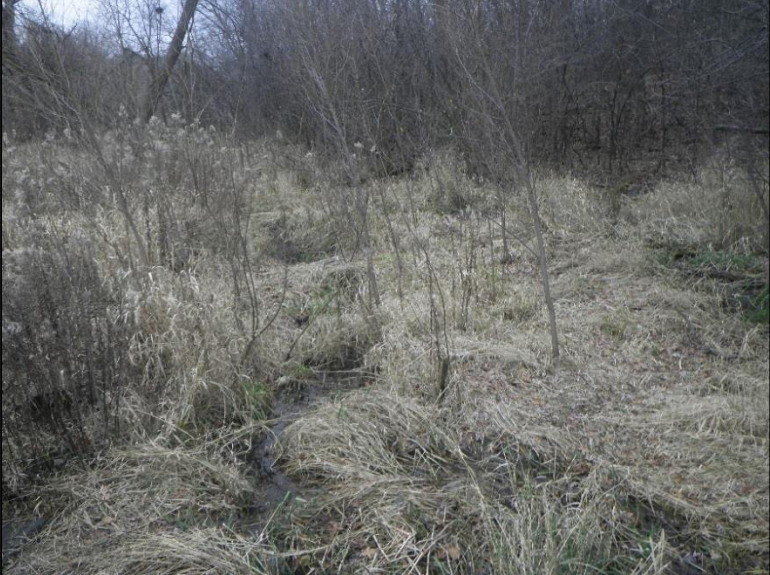
<p><b>Photo 4 – November 25, 2015</b></p> <p style="text-align: center;"><b>Wetland 2</b></p> <p>Facing southwest toward forested upland. Wetland 2 is much higher in elevation than Basset Creek but much lower in elevation than the adjacent uplands to the west. The small channel in this photo shows water draining from Wetland 2 into Basset Creek. Wetland 2 is dominated by reed canary grass and cattails but there are also shrubs and a few trees present. Bare saturated soil is present near the seepage area.</p>

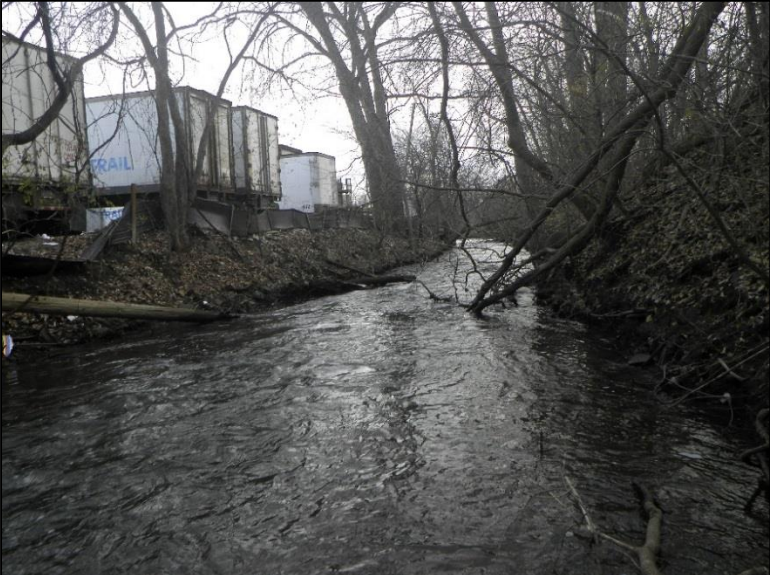
<p><b>Photo 5 – November 25, 2015</b></p> <p style="text-align: center;"><b>Basset Creek Study Reach</b></p> <p>Typical view of Basset Creek just east of Cedar Lake Road facing downstream to the east. Much of the creek edges are steep and undercut.</p>

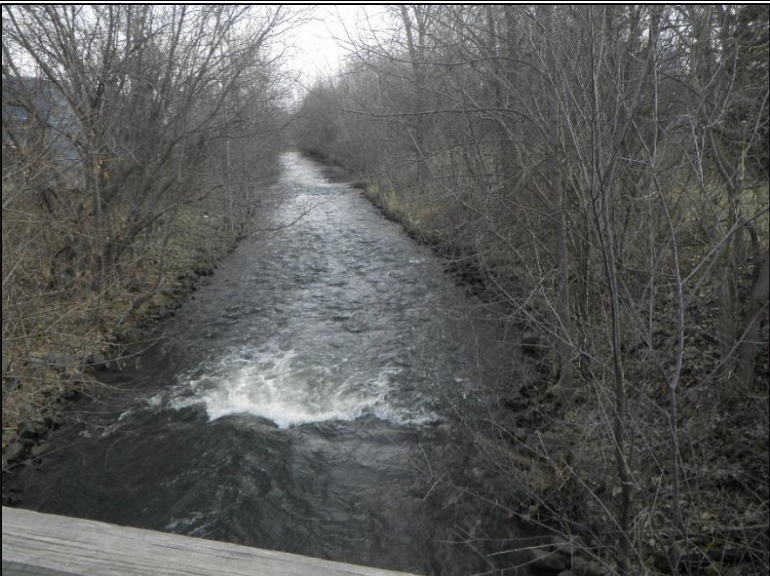
<p><b>Photo 6 – November 25, 2015</b></p> <p style="text-align: center;"><b>Basset Creek Study Reach</b></p> <p>Another view of Basset Creek facing east further downstream from Photo2.</p>

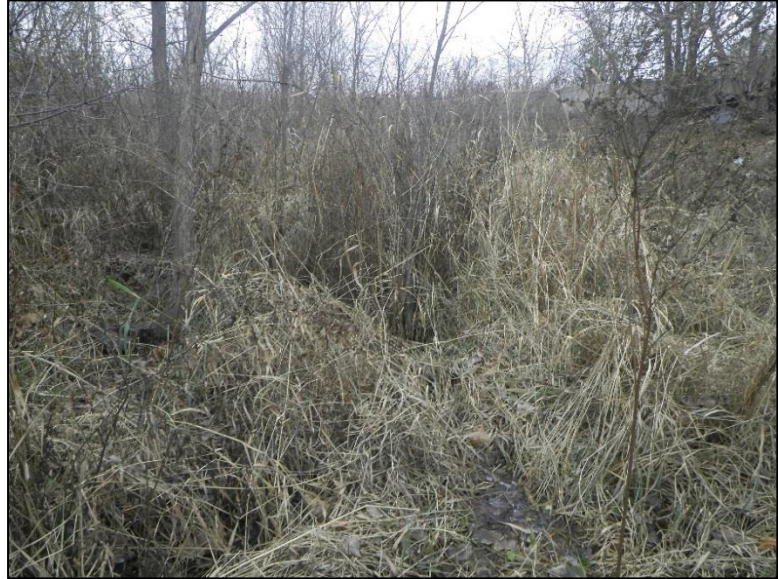
**Photo 7** – November 25, 2015

South portion of ditched Wetland 3. Soils are saturated within 12 inches of the soil surface in some areas. Dominant vegetation consists of reed canary grass, giant goldenrod and willow species.

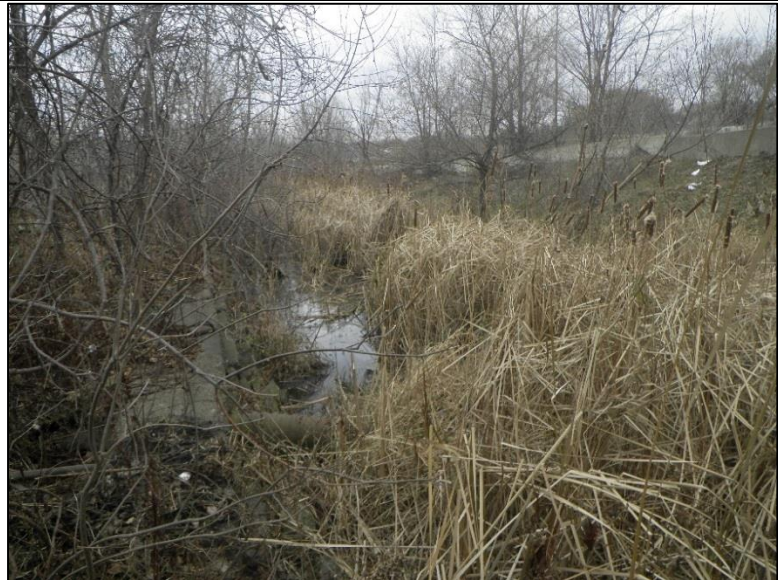
**Photo 8** – November 25, 2015

Central portion of ditched Wetland 3 has standing water up to 3 inches and is dominated by narrow-leaf cattail.

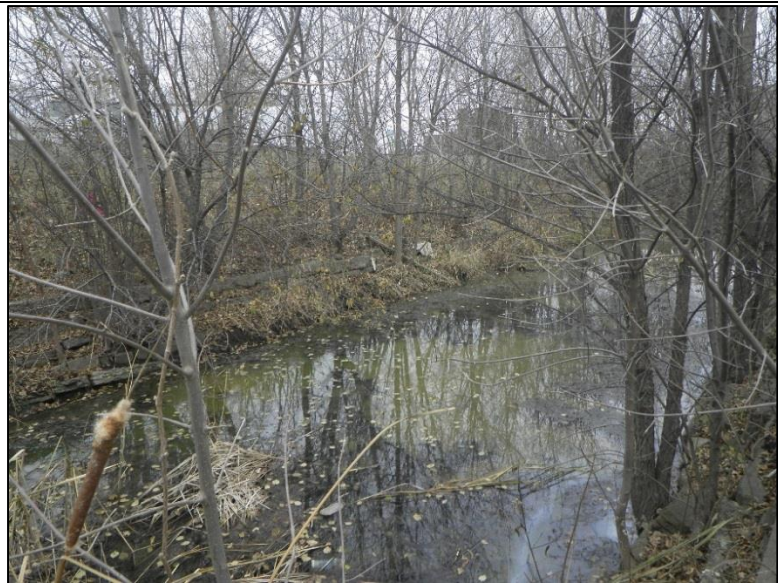
**Photo 9** – November 25, 2015

The northern portion of ditched Wetland 3 is inundated between 5 inches and 12 inches. Most of this area does not have emergent vegetation.
