Wetland Investigation Report

**1143 South Shore Drive
Medicine Lake, MN**

AE Comm. # 14322

May 4, 2016

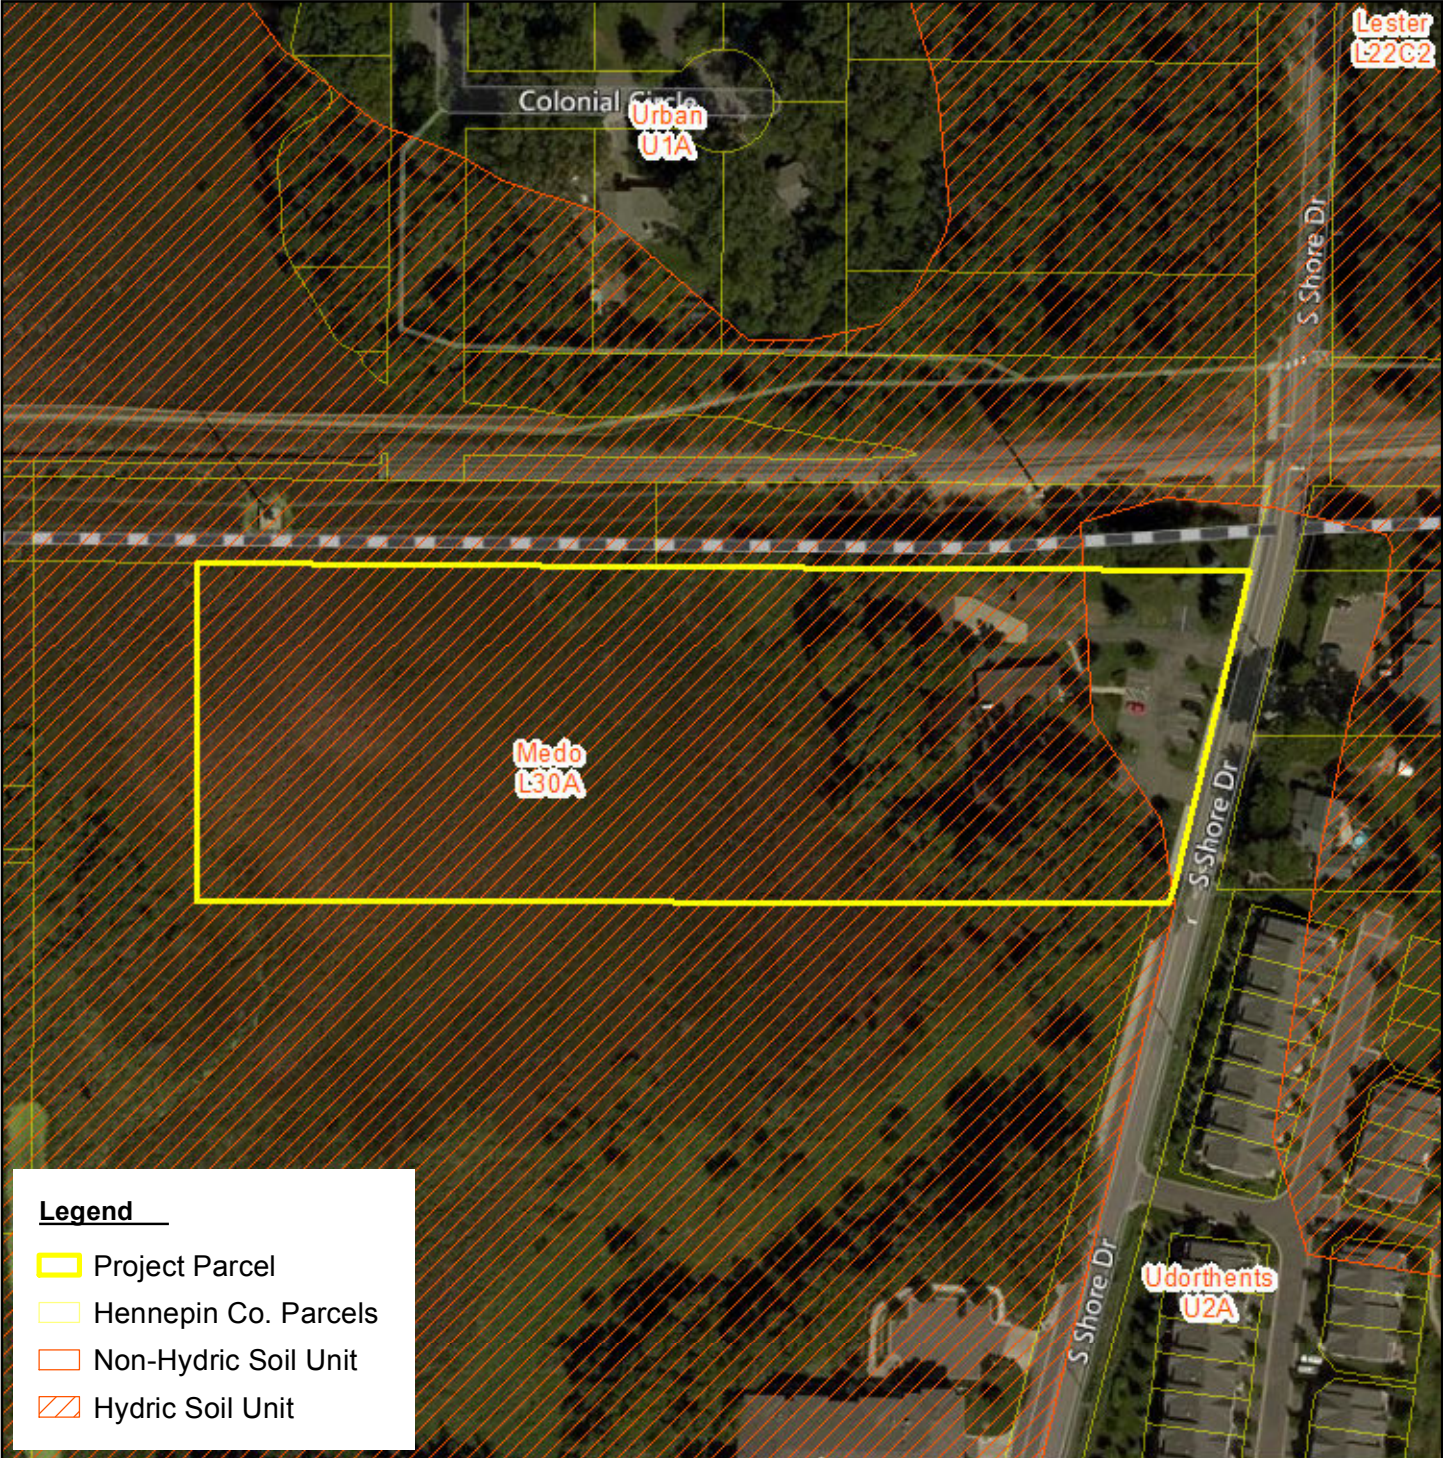
**SOILS - FIGURE 3
SKURAT PROPERTY**

The Soil Survey of Hennepin County, MN (*Appendix A. Figure 3*) one hydric soil series, Medo (L30A), within the project area.

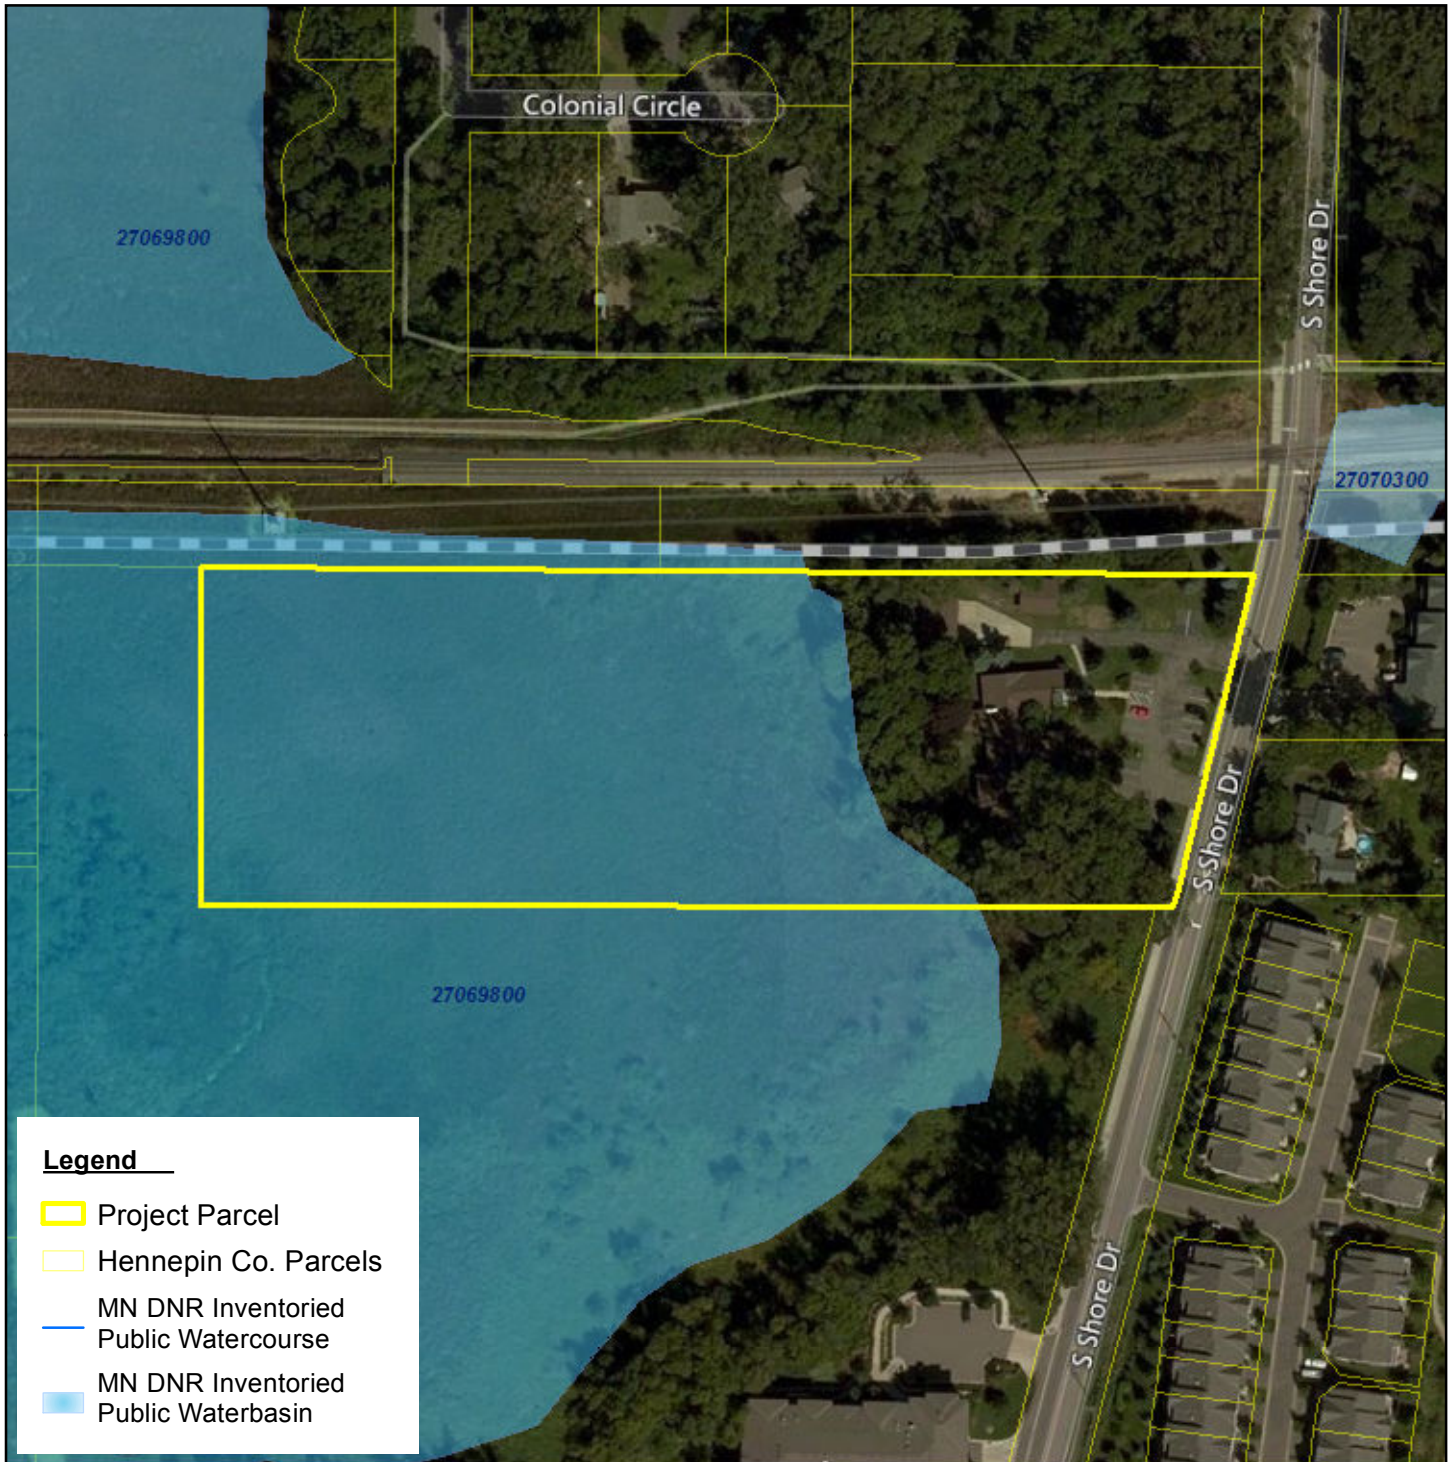
**PWI - FIGURE 4
SKURAT PROPERTY**

The MN DNR PWI for Hennepin County, MN (*Appendix A. Figure 4*) identifies one unnamed public water wetland (ID 27069800) within the project area.

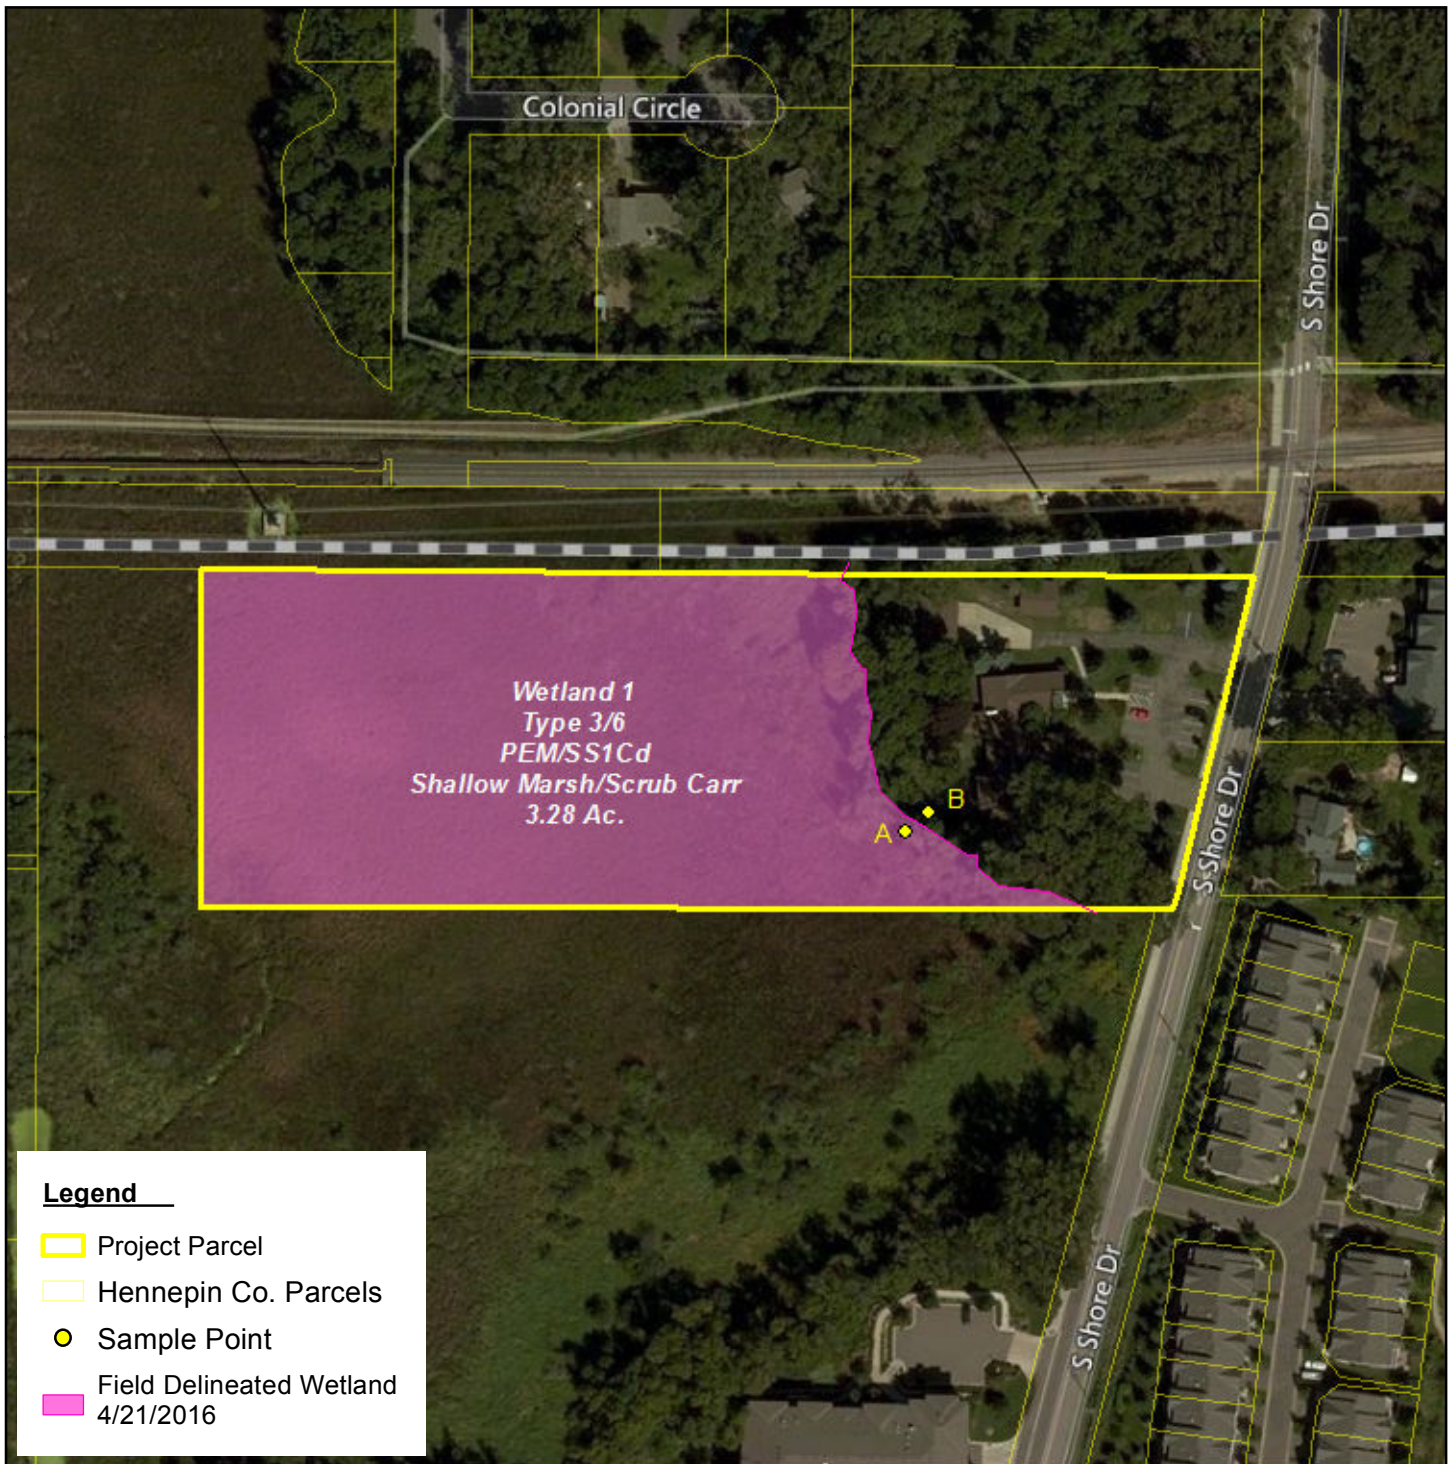
**DELINEATION - FIGURE 5
SKURAT PROPERTY**

A portion of one Type 3/6, PEM/SS1Cd, shallow marsh/scrub carr wetland was identified and delineated within the project area. The wetland extends off-site to the north, west, and south; the on-site portion is approximately 3.28 acres in size.

Wetland 1: Wetland 1 is a Type 3/6, PEM/SS1Cd, shallow marsh/scrub carr wetland. The wetland vegetation is dominated by narrow leaf cattail (*Typha angustifolia*), reed canary grass (*Phalaris arundinacea*), and common buckthorn (*Rhamnus cathartica*) shrubs. The underlying soils are mapped as Medo soils (L30A). The investigated soil profile met the hydrogen sulfide (A4) and depleted matrix (F3) hydric soil indicators. Hydrology indicators observed include a high water table at 8 inches (A2), saturation at 6 inches (A3), hydrogen sulfide odor at approximately 8 inches (C1), geomorphic position (D2), and the FAC-Neutral Test (D5). There are no constructed inlets or outlets on the property. The wetland appears to drain off-site to Medicine Lake.

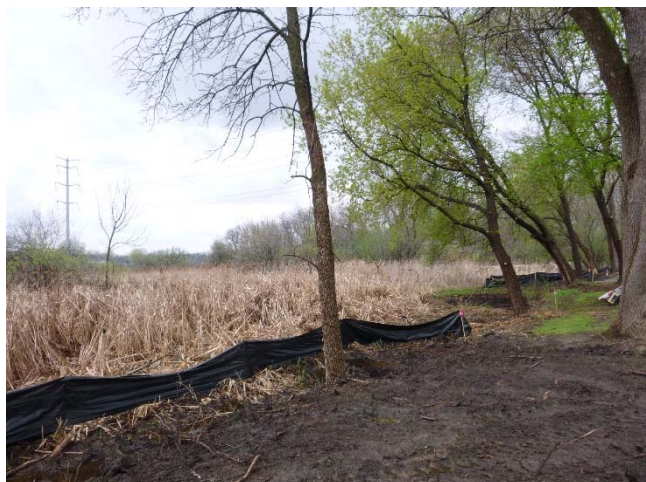
Wetland 1, Viewing Northwest

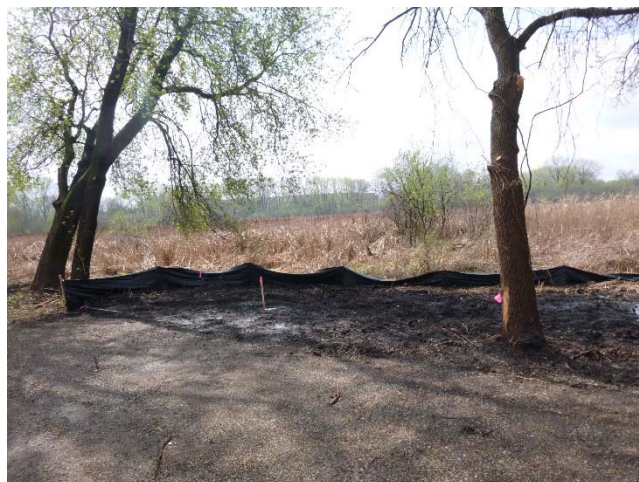
Wetland 1, Viewing Southwest

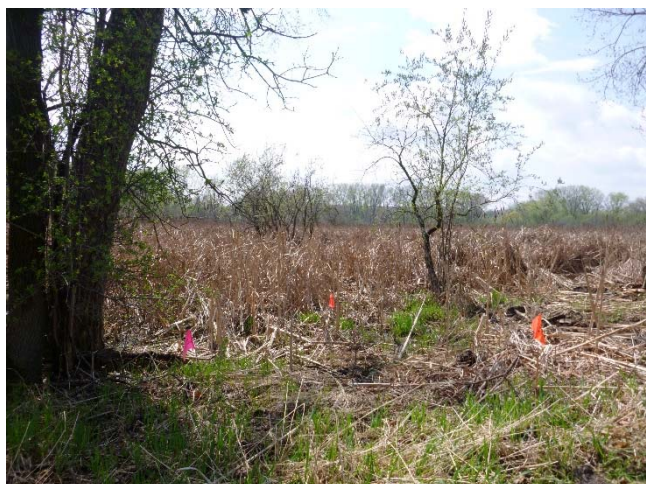
Based on the soil profile (starting at 15 inches), it appears that a portion of this property was likely filled prior to the construction of the existing building in 1962.

Hydrogen sulfide odor starting at approximately 8 inches.

Wetland 1, Sample Point A, Viewing Southwest

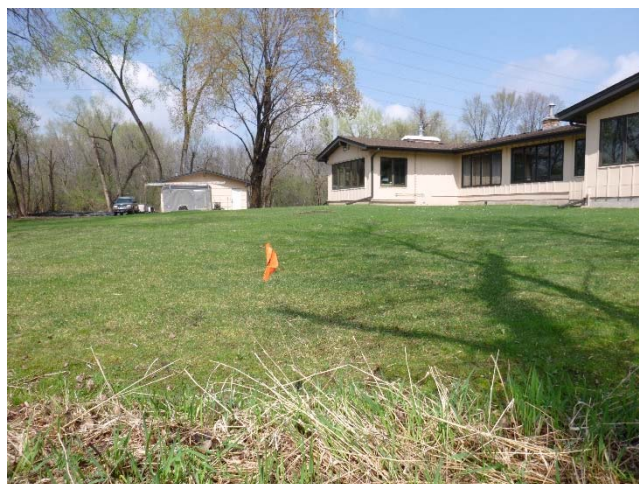
Hydrology criteria not met; area is not a wetland.

Wetland 1, Sample Point B, Viewing Northeast

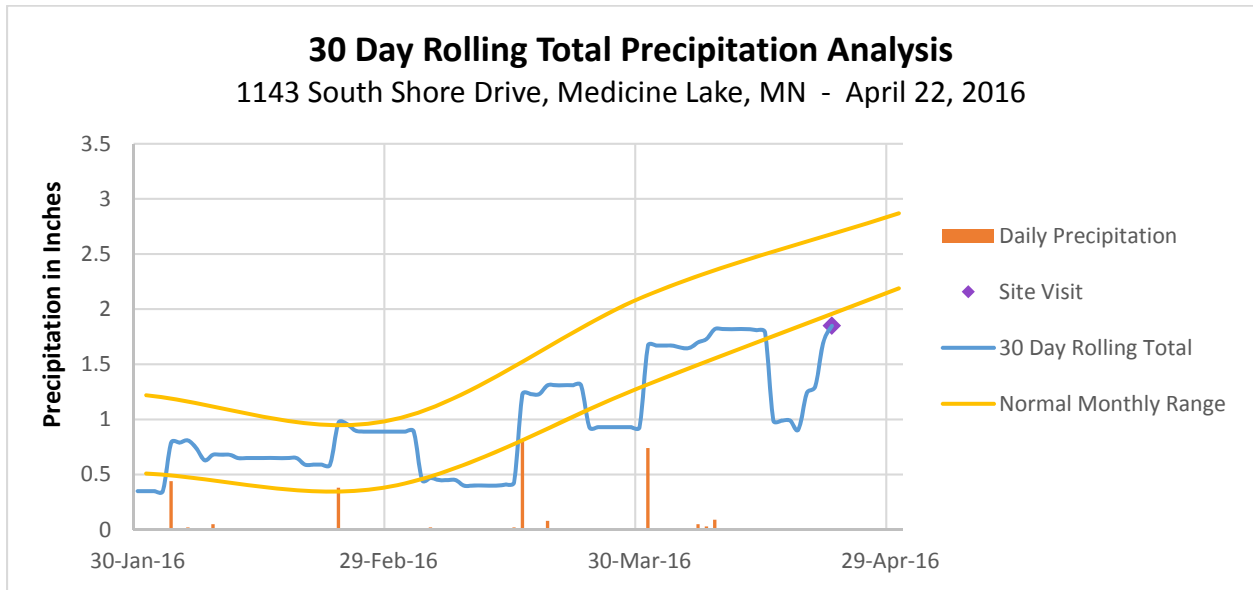
An analysis of the University of Minnesota Climatology Working Group's 30 day rolling precipitation data for the previous three months (*Appendix D*) indicate that precipitation totals for previous weeks were below the normal monthly range for this project area, but trending upward toward the normal range. Hydrologic conditions were suitable for completing an accurate wetland determination and boundary delineation.
