Sweeney Lake aeration study

This factsheet provides study results, as well as some background on lake systems.

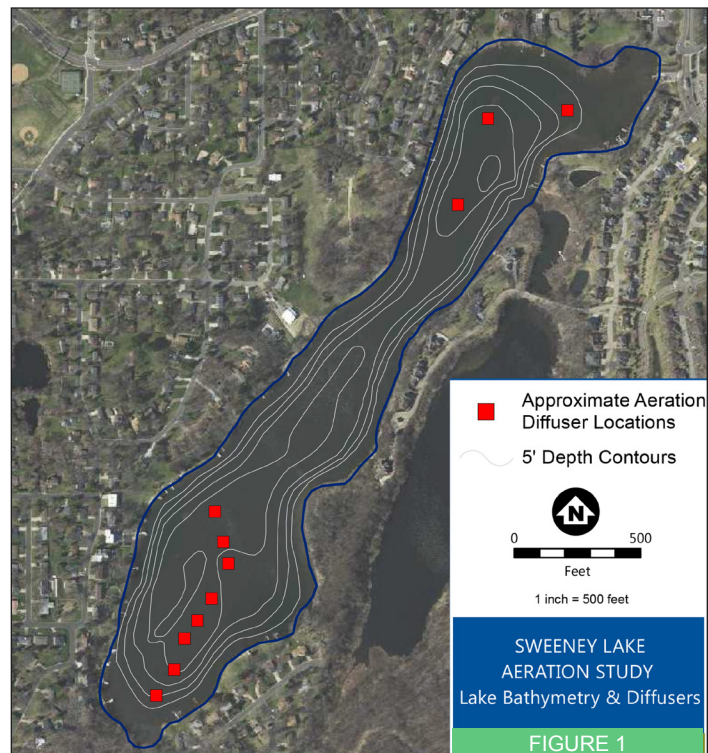
Sweeney Lake homeowners have long been concerned about the lake’s water quality. In fact, for the past 40 years they have operated an aeration system year-round to oxygenate the water—hoping to improve conditions for native fish and reduce the buildup of phosphorus, the nutrient that contributes to algae growth. The system consists of 11 diffusers and nine compressors (Figure 1 at right).

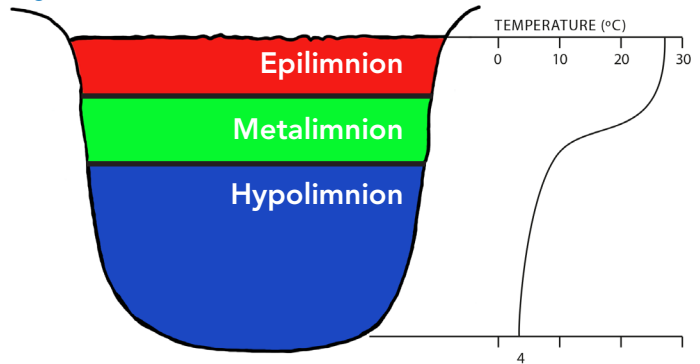
Figure 2 Thermal stratification

The aerators in Sweeney Lake disrupt the normal stratification of the lake. Figure 2 shows how Sweeney Lake would stratify during the summer without aeration; Figure 3 is a representation of the lake's aeration system. In this system a diffuser is placed on the bottom of the lake that circulates air from a compressor through the hypolimnion, up through the epilimnion layer, and back down. One effect of aeration is that it prevents lake stratification and stirs up the bottom layer, distributing phosphorus throughout the water column. This could be particularly problematic in Sweeney Lake where a significant portion of the lake's phosphorus is coming from internal sources, like sediments.

To understand the situation in Sweeney Lake, it's helpful to know a little about lake stratification. In lakes without aeration, stratification occurs each summer when lake water separates or stratifies into three distinct layers. Because of the temperature differences, the layers (described below) usually have stable boundaries and don't mix during the summer.

This layer contains dense, cooler, and relatively "quiet" water. The decomposition of plants and other organisms in this layer steals oxygen from the water, often leaving this layer anoxic (without oxygen). Anoxic conditions promote the release of phosphorus from bottom sediments.

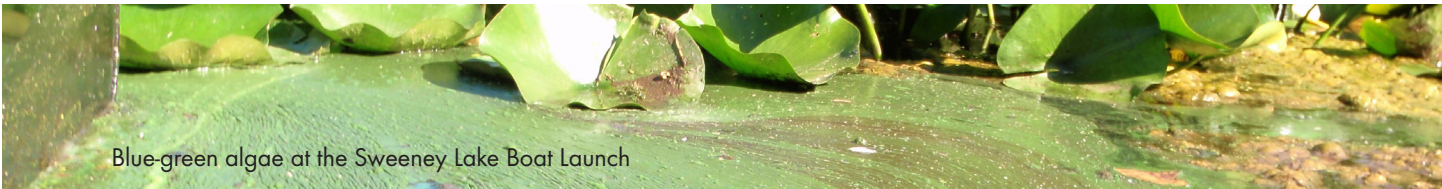
Blue-green algae at the Sweeney Lake Boat Launch

Water in this layer is warmer and has more oxygen and light. These characteristics promote algal growth and support zooplankton and fish. However, if nutrient levels become too high, algal blooms may occur (see photo at top of page 3).

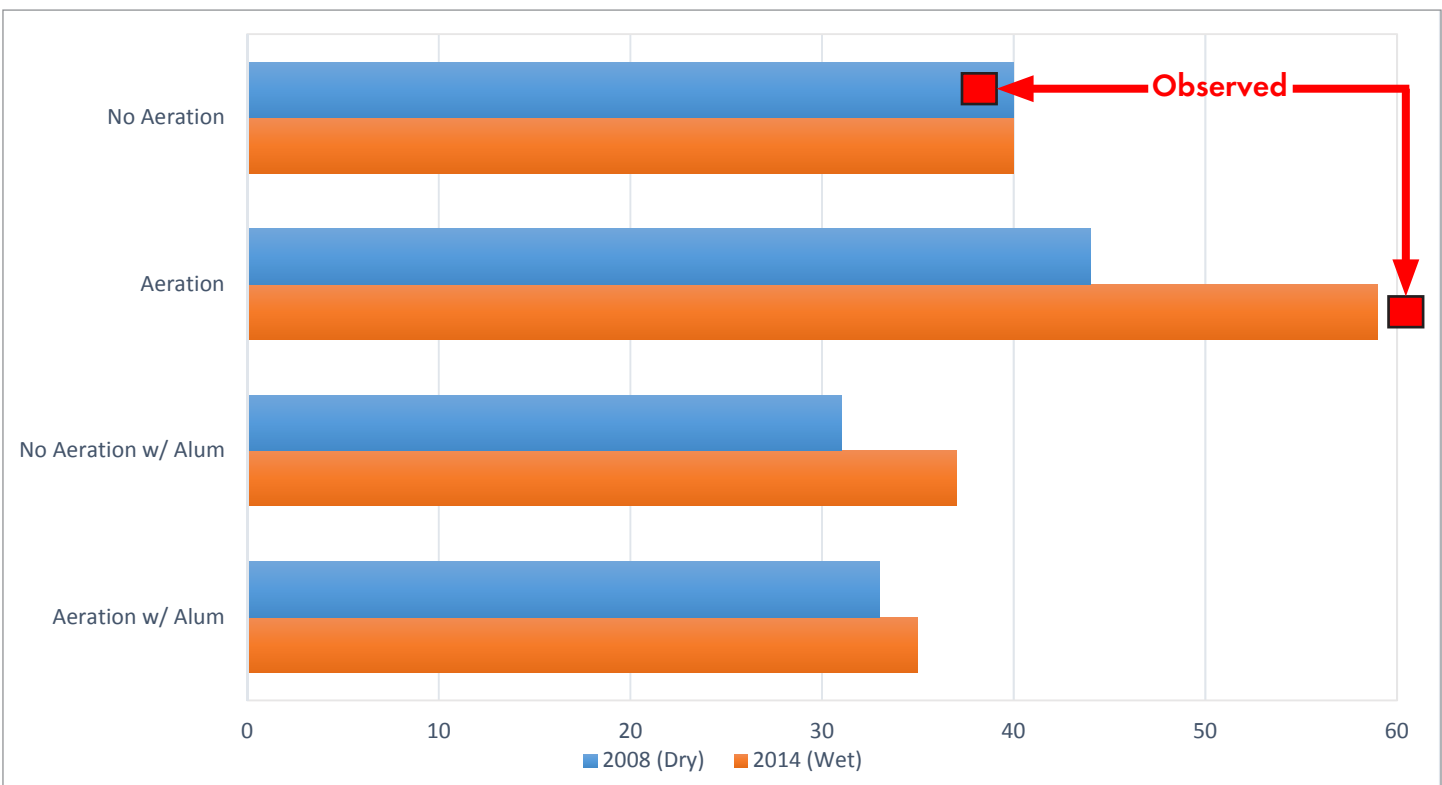
Figure 4 Predicted summer average total phosphorus concentration (µg/liter)

To answer the question of whether aeration is helping or hindering lake water quality (specifically, phosphorus levels), a three-dimensional lake-water-quality computer model was used to compare the individual effects of climate, aeration, and alum treatment (see page 4) on lake water quality. As seen in Figure 4, below, the combined approach of ceasing aeration and applying an alum treatment produces the best result in terms of limiting phosphorus.

- Modeling shows that whether the lake is aerated or not, phosphorus within the lake (internal loading) is the single largest source of phosphorus in the summer.
- Aeration exacerbates summer water quality problems in Sweeney Lake—surface water phosphorus concentrations were 10–30% higher with aeration.
- An alum treatment will greatly improve water quality and ensure that MPCA/BCWMC goals will be met for Sweeney Lake.
- Depending on sources of phosphorus coming from outside the lake and lake mixing, aeration after an alum treatment may not provide significant benefits.
