# Minnesota Wetland Conservation Act Notice of Decision

Applicant Name <b>Minneapolis Park Board</b>	Project Name <b>Wirth Cart improvements</b>	Date of Application <b>8/1/19</b>	Application Number <b>19-001</b>
<input checked="" type="checkbox"/> Attach site locator map.

# Wetland Delineation Report

## *Theodore Wirth Golf Course Improvements (Holes 15/16)*

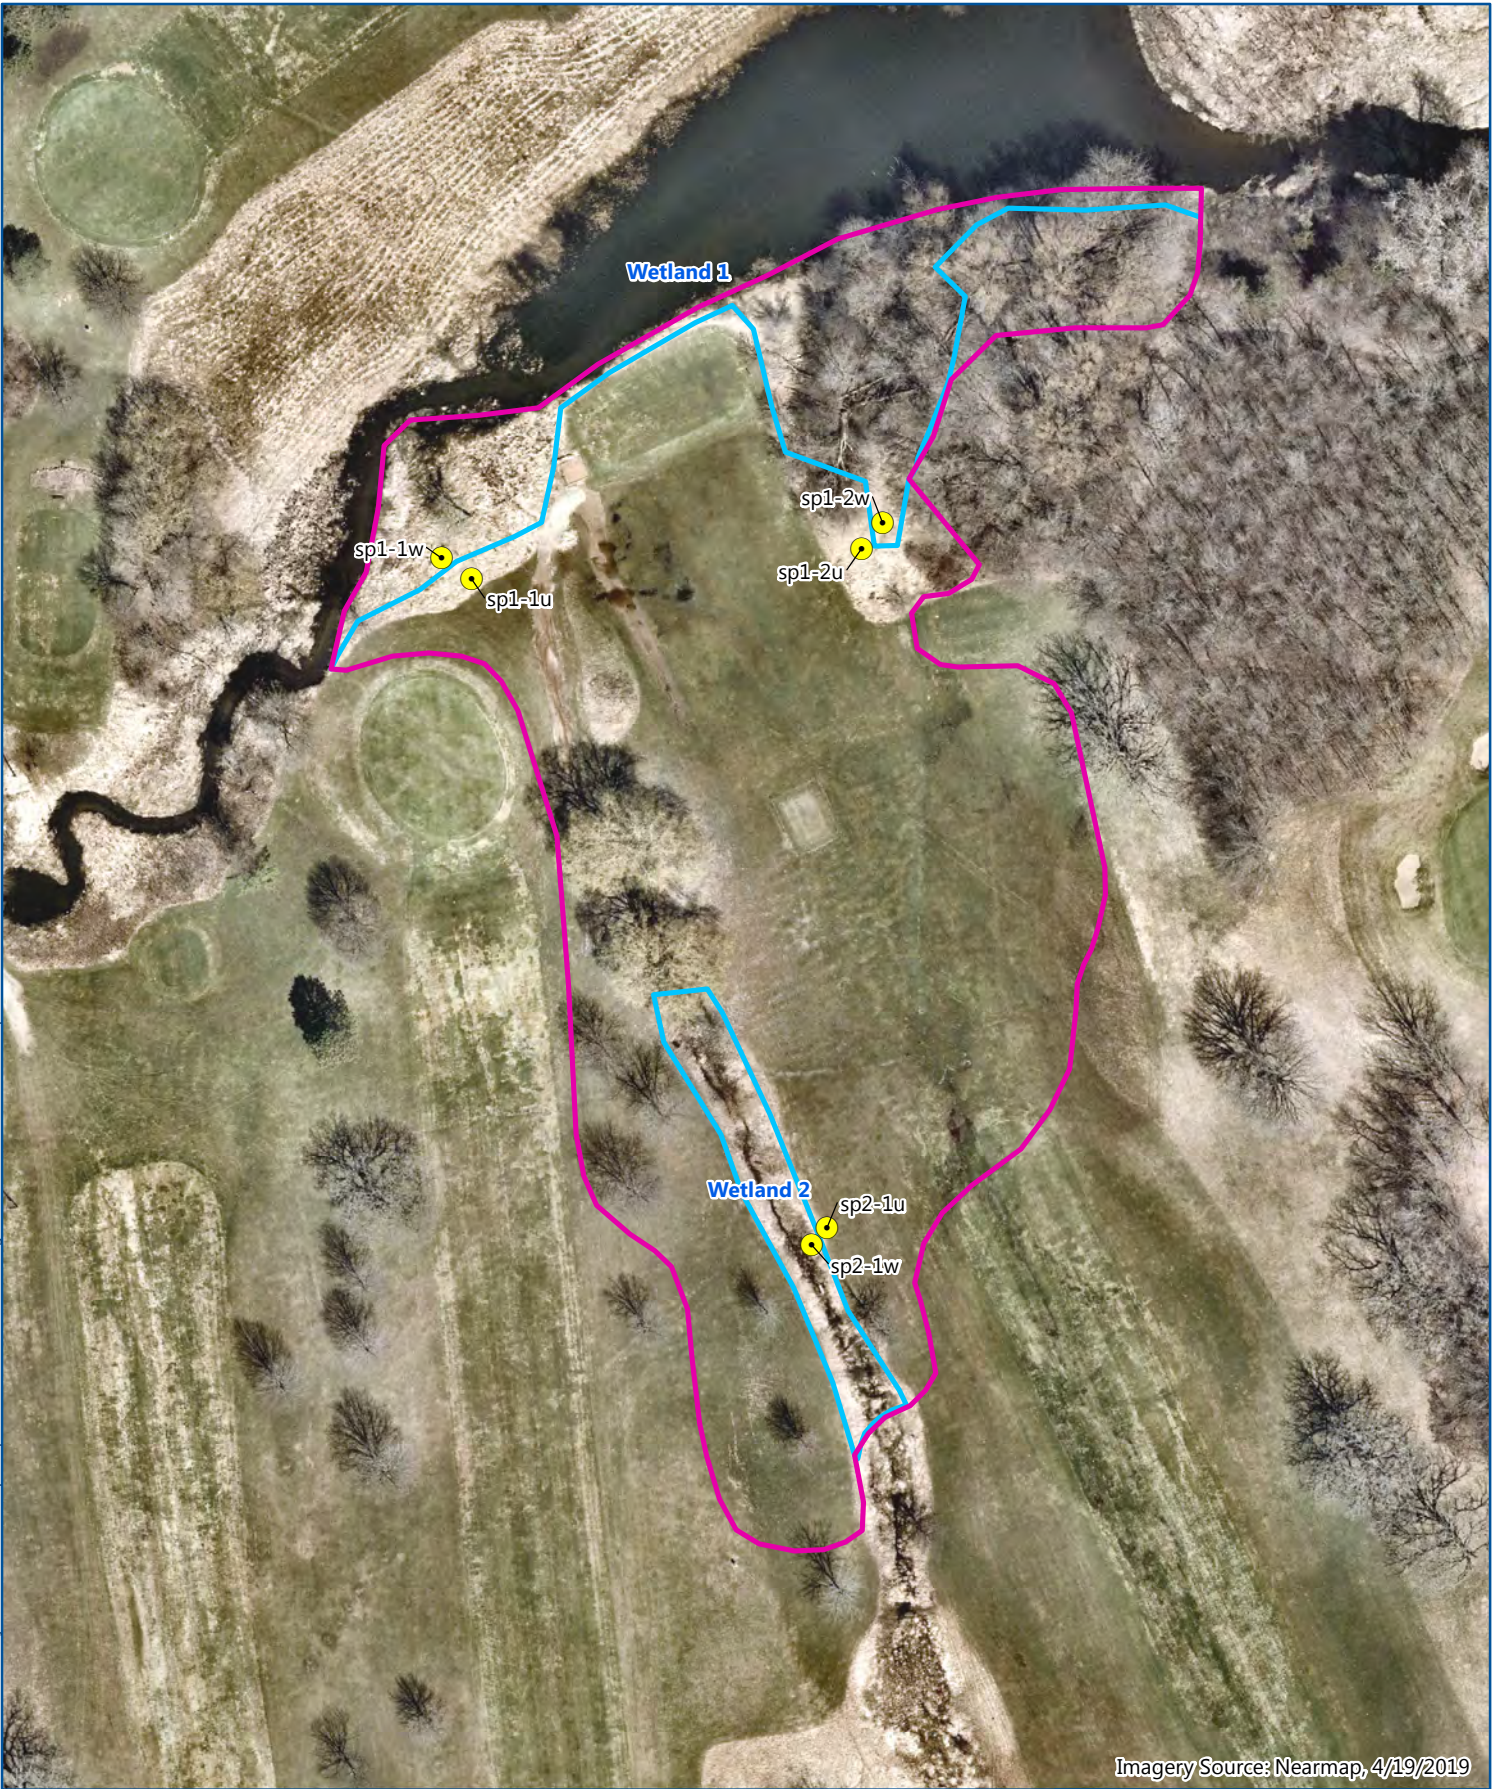
FIGURE 6

**WETLAND DELINEATION MAP**  
Theo Wirth Wetland Delineation  
Hole 15 & 16 Improvements  
Golden Valley, Minnesota

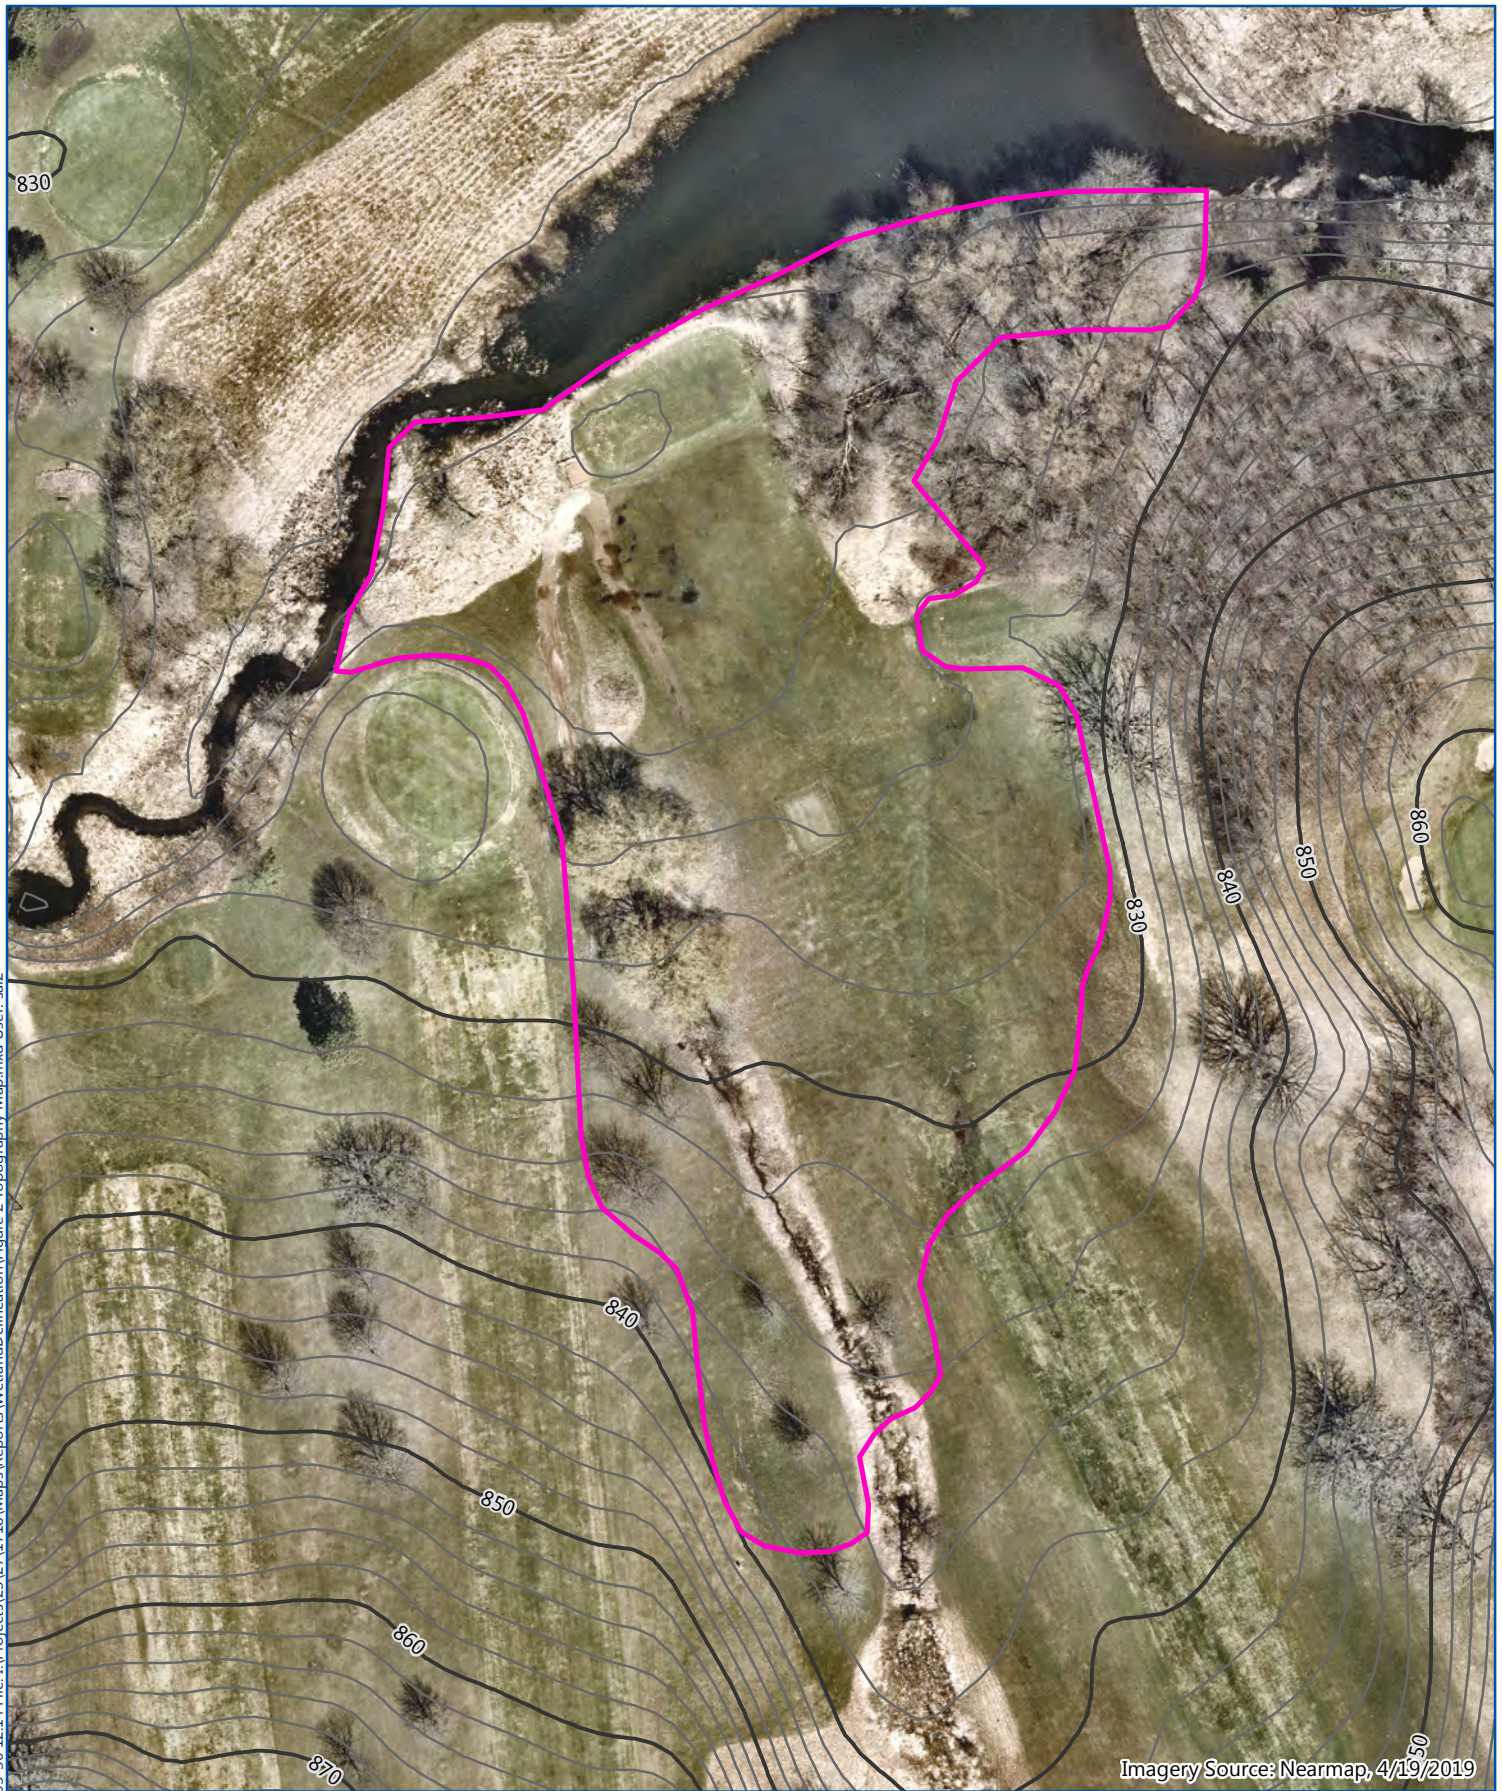
FIGURE 2

**TOPOGRAPHY MAP**  
Theo Wirth Wetland Delineation  
Hole 15 & 16 Improvements  
Golden Valley, Minnesota

The Project area has flat to moderately undulating topography and a more abrupt topographic break leading into Bassett Creek (**Figure 2**).

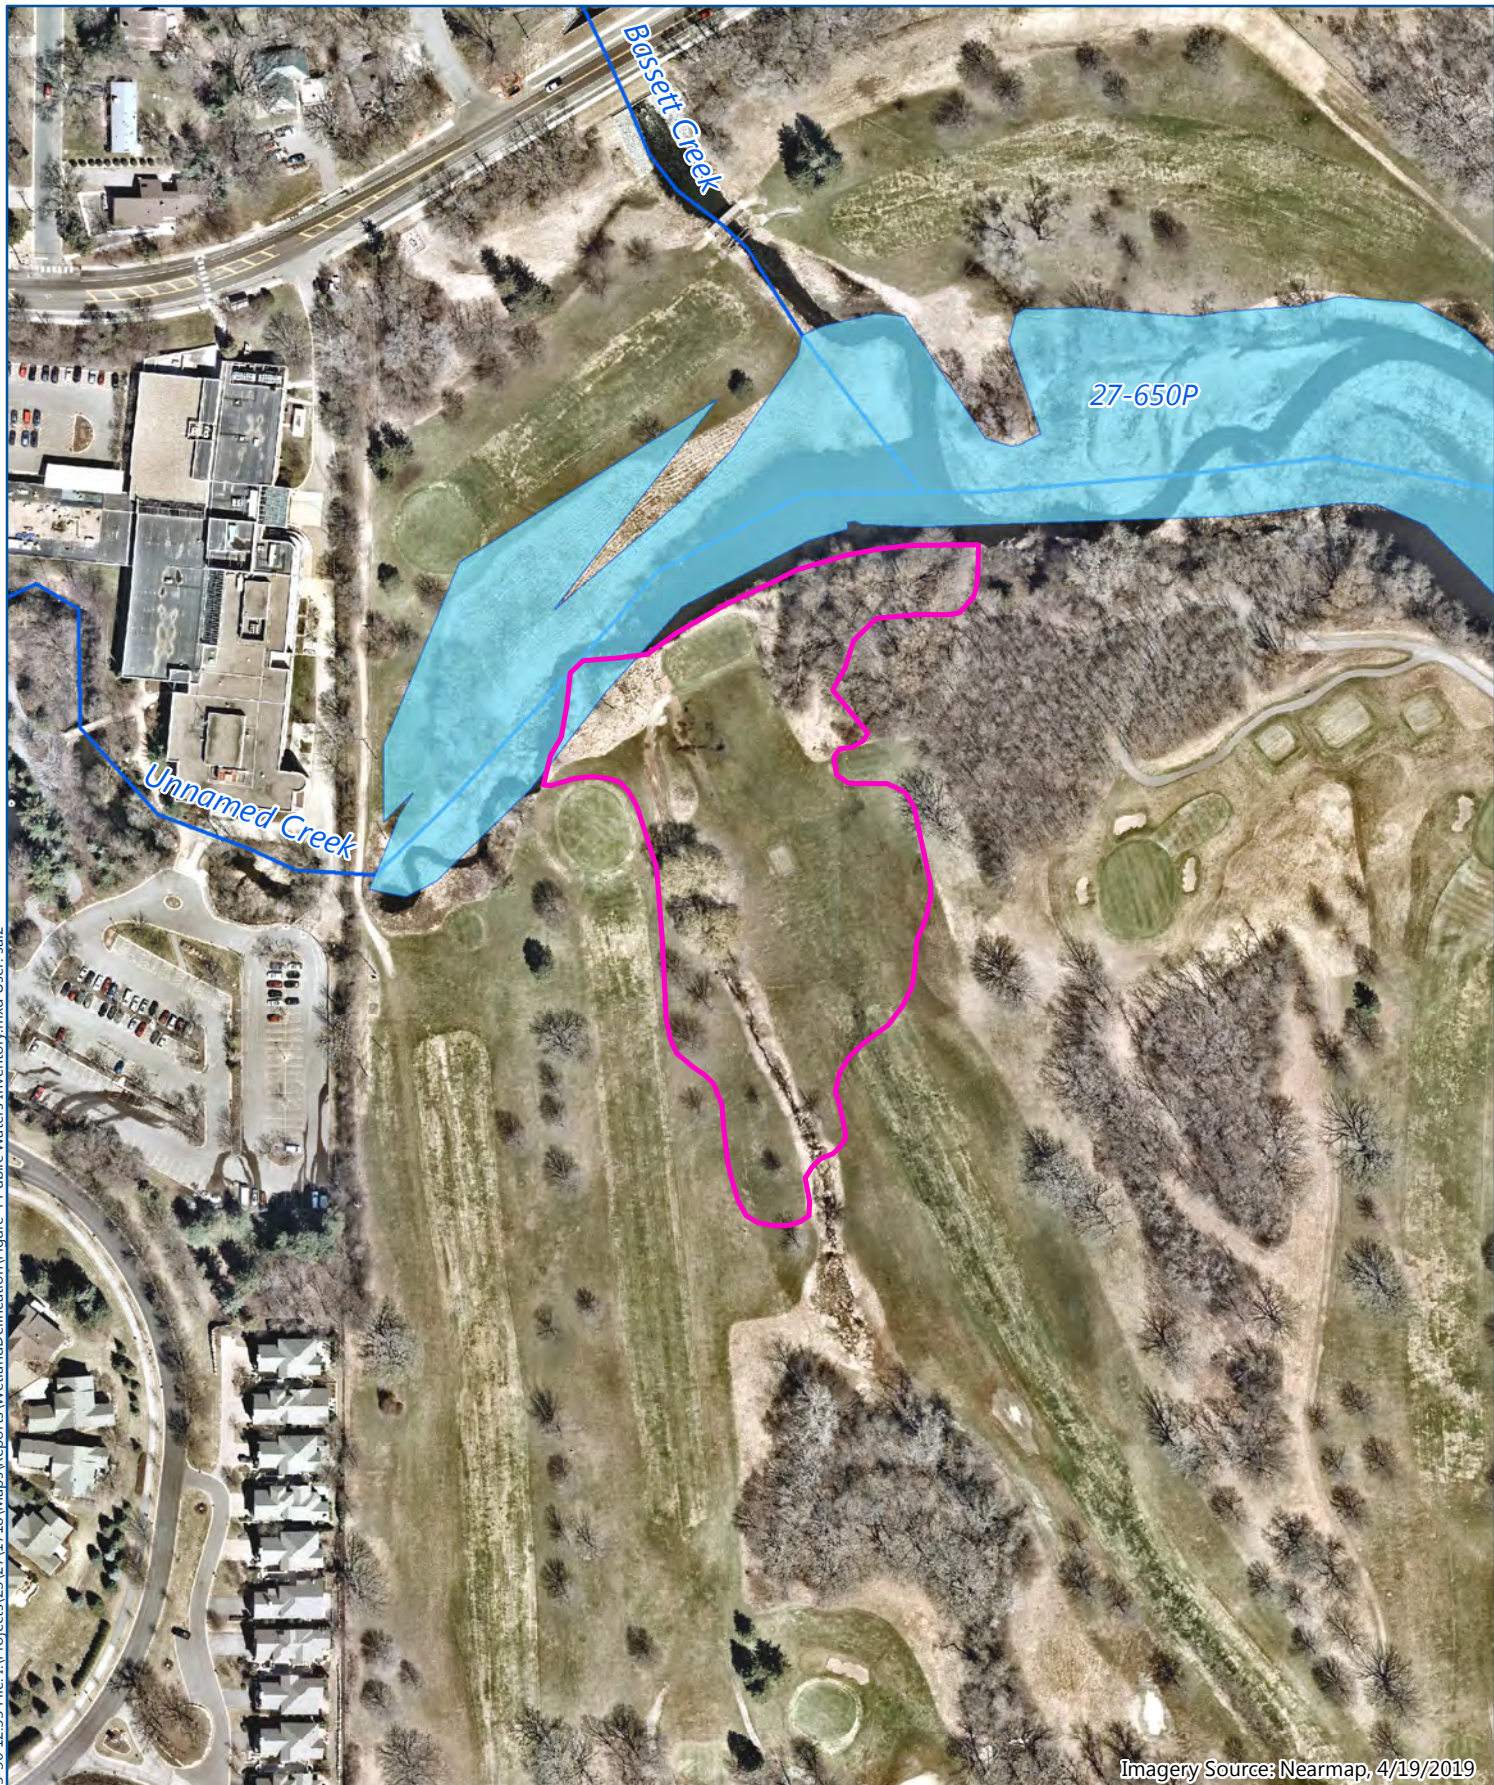
**FIGURE 4**

**PUBLIC WATERS INVENTORY**  
Theo Wirth Wetland Delineation  
Hole 15 & 16 Improvements  
Golden Valley, Minnesota

The Minnesota Department of Natural Resources (MnDNR) Public Waters Inventory (PWI) has identified Bassett Creek (27-650P) as a public watercourse; Bassett Creek is located at the northern edge of the wetland evaluation area (**Figure 4**). Bassett Creek is identified by the Minnesota Pollution Control Agency (MPCA) as an impaired water with aquatic life and aquatic recreation identified as the affected resources.

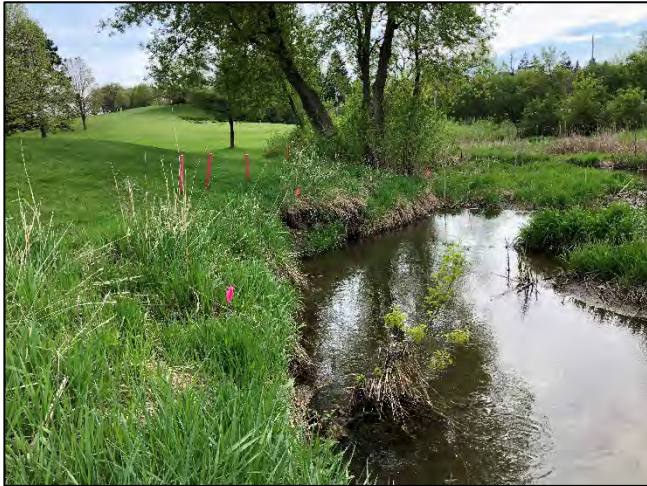
**Photo 1:** Bassett Creek facing west on the NW side of the grading limits. Fringe wet meadow community begins at this location.

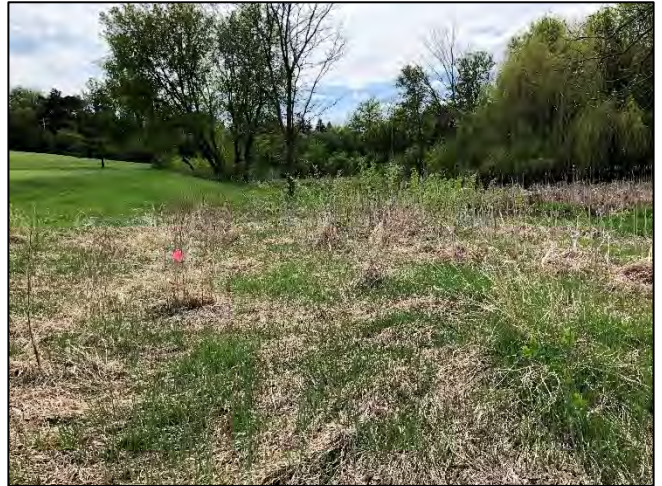
**Photo 2:** Wet meadow community within Wetland 1 located on the NW side of the grading limits. This photo is located near sample transect 1-1.

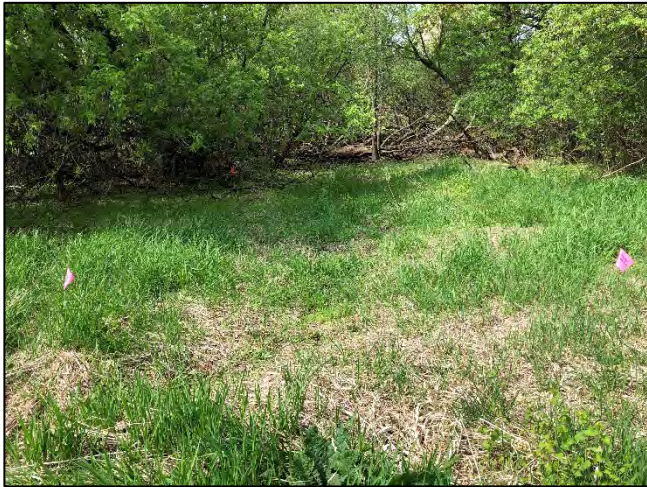
**Photo 3:** Wet meadow community within Wetland 1 located on the NE side of the grading limits. This photo is located near sample transect 1-2.

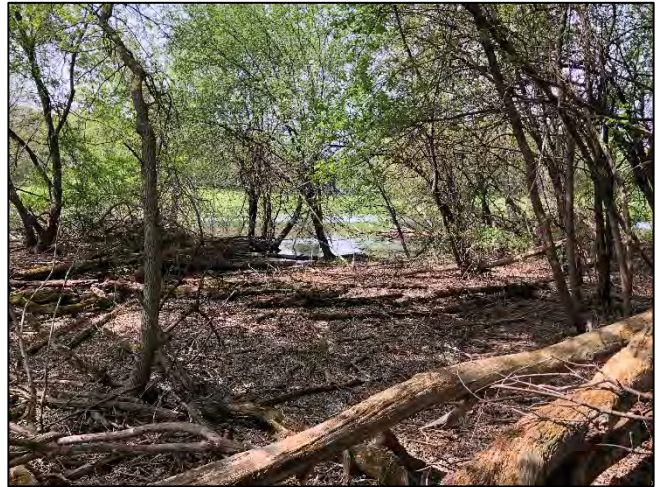
**Photo 4:** Floodplain forest community within Wetland 1 located on the NE side of the grading limits.

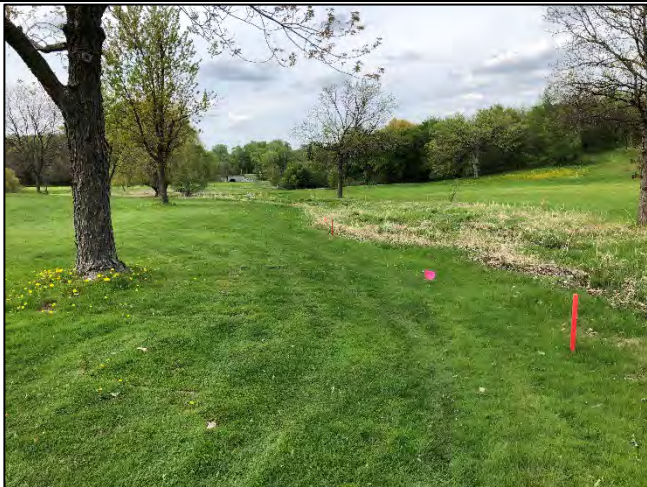
**Photo 5:** Wetland 2 is a swale that extends north toward Wetland 1 and Bassett Creek. Photo point is NE of Wetland 2 looking north.

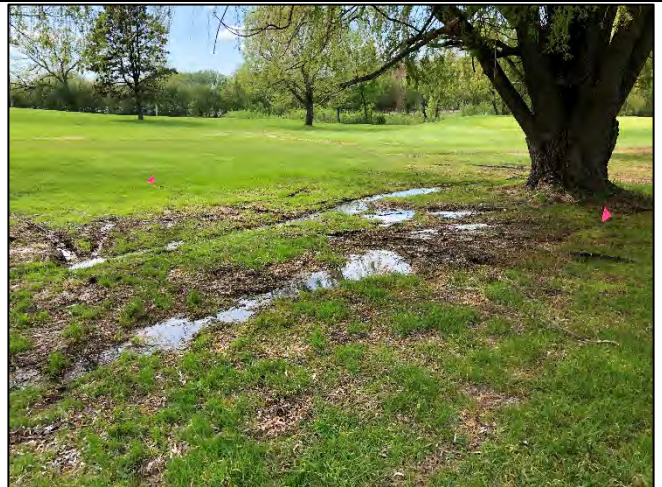
**Photo 6:** North end of Wetland 2 facing NW.
