# **Wetland Delineation Report**

## ***DeCola Ponds – SEA School/Wildwood Park Flood Storage Project***

Prepared for  
City of Golden Valley

October 2020

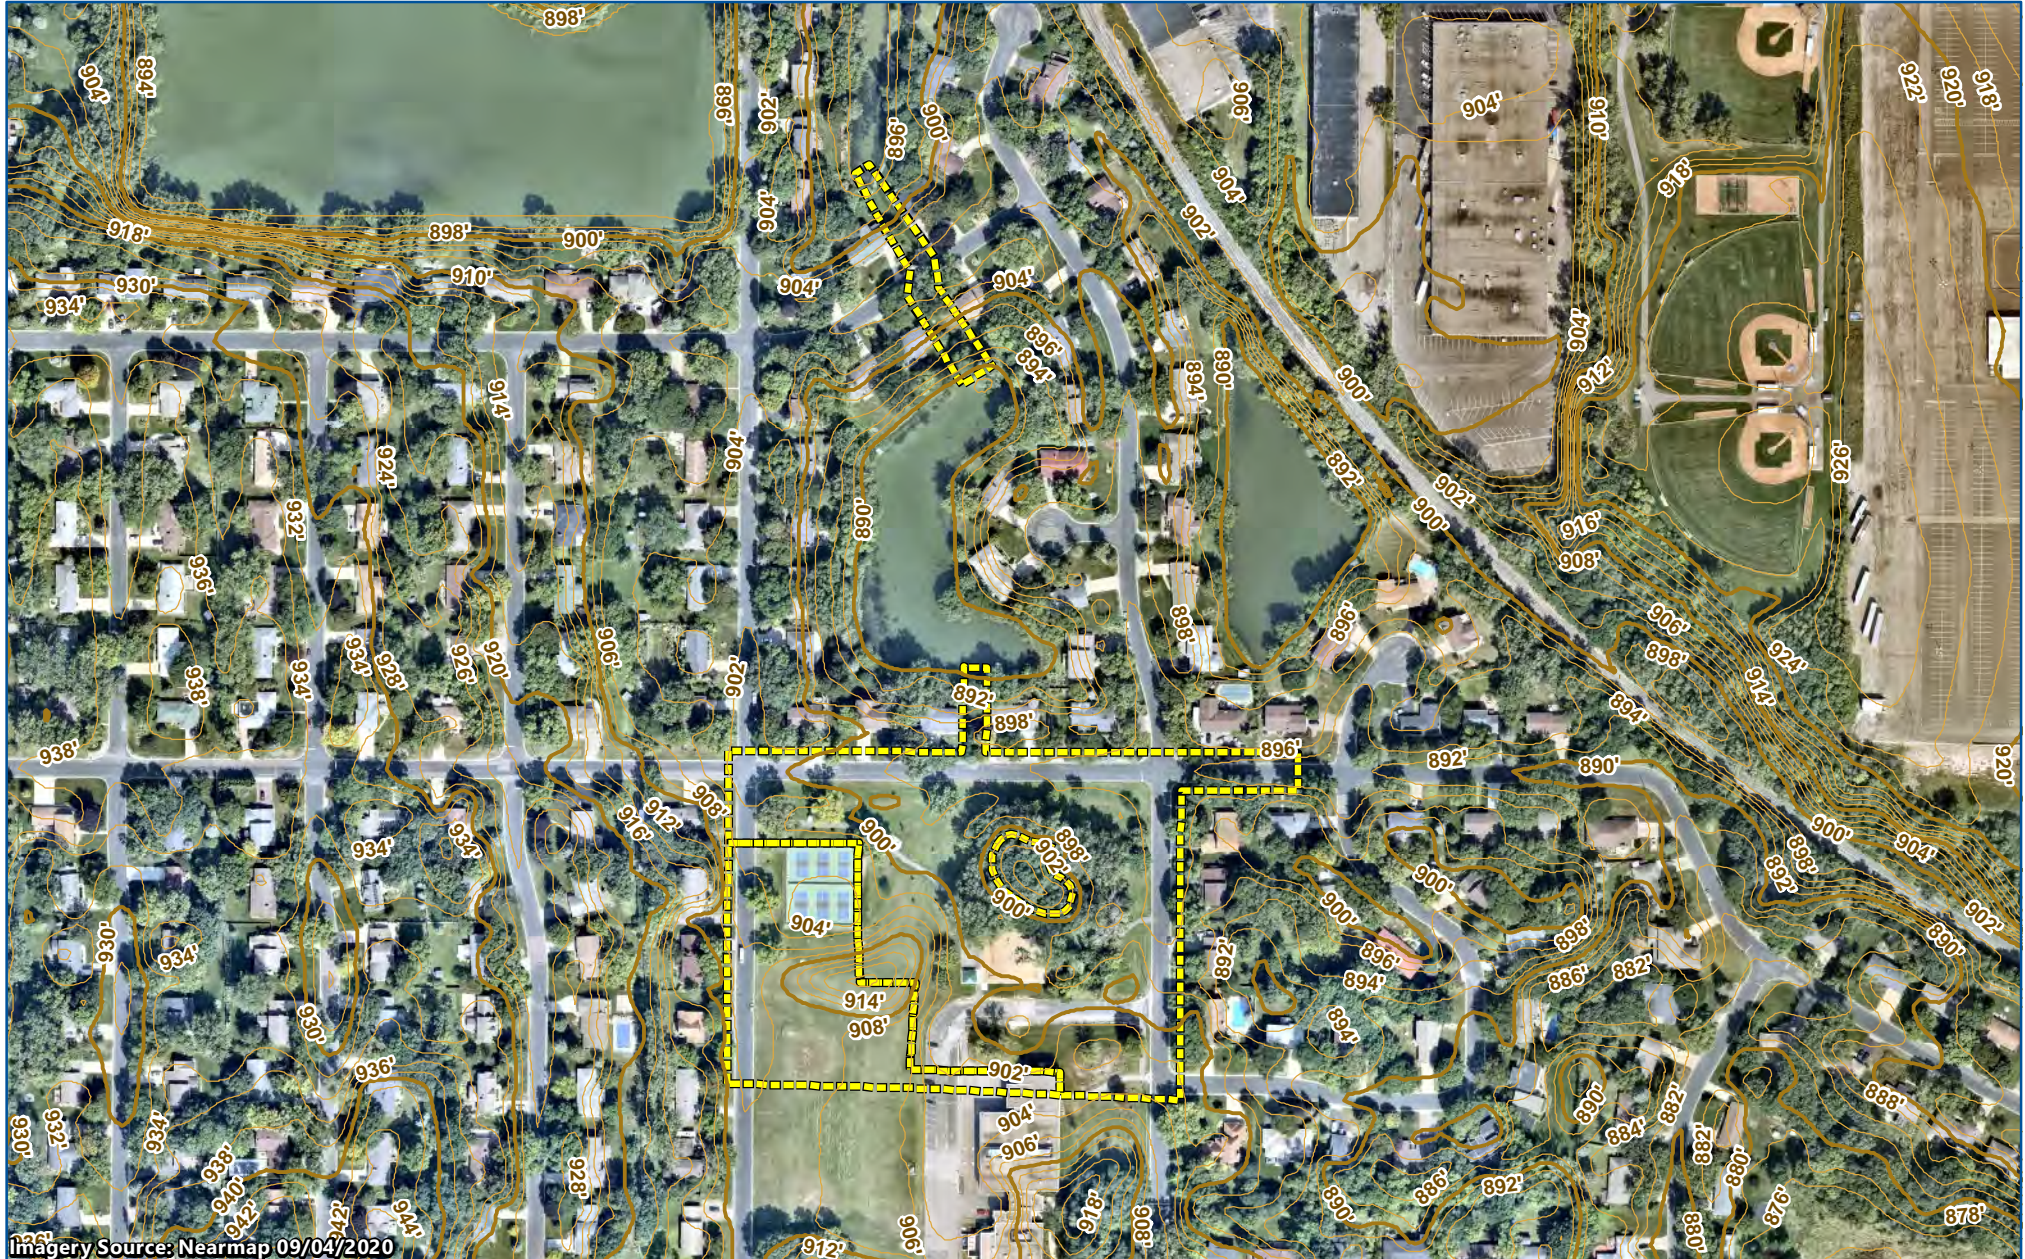
FIGURE 2

LIDAR MAP  
DeCola Ponds- SEA School-  
Wildwood Park Flood Storage  
Project

The project area is in an urban setting where the natural topography has been altered. Generally, The topography of the project area gentle slopes towards the DeCola Ponds. The highest elevation in the project area is 916 Feet MSL located in Wildwood Park just south of the pickleball court. The lowest elevation is 890 feet MSL along DeCola Pond E **(Figure 2)**. Developed areas surrounding the project area are relatively flat.

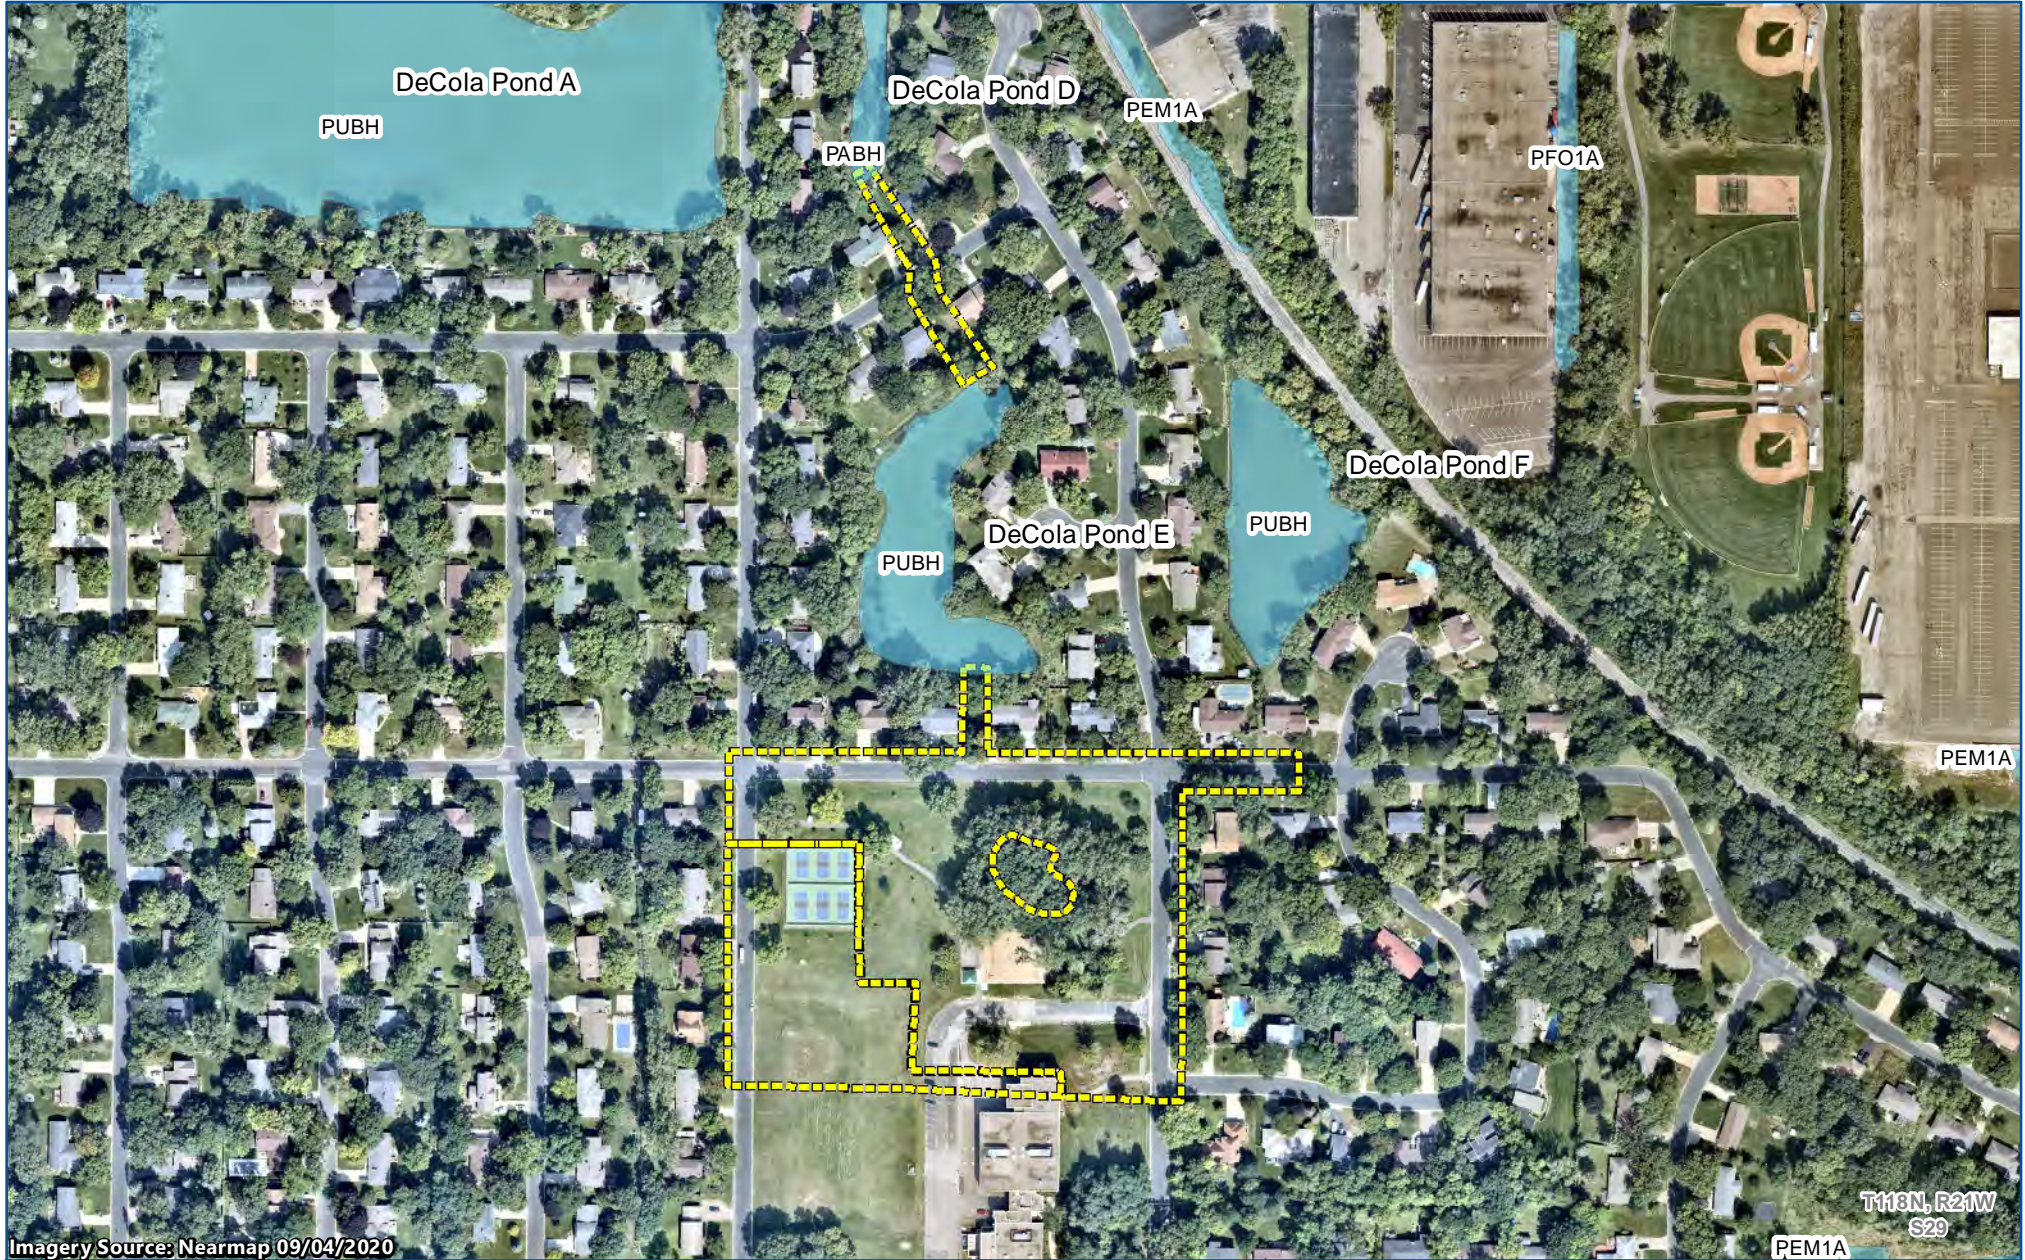
FIGURE 3

NWI MAP  
DeCola Ponds- SEA School-  
Wildwood Park Flood Storage  
Project

The National Wetland Inventory (NWI) data was reviewed for any wetlands located within or adjacent to the project area. Two NWI wetlands are mapped within the project area. The northern most NWI is classified as a freshwater pond with a shallow open water plant community (PABH; **Figure 3**). The southern most wetland is classified as a freshwater pond with a non-vegetated aquatic community (PUBH). No NWIs are located within Wildwood Park or the SEA School property.

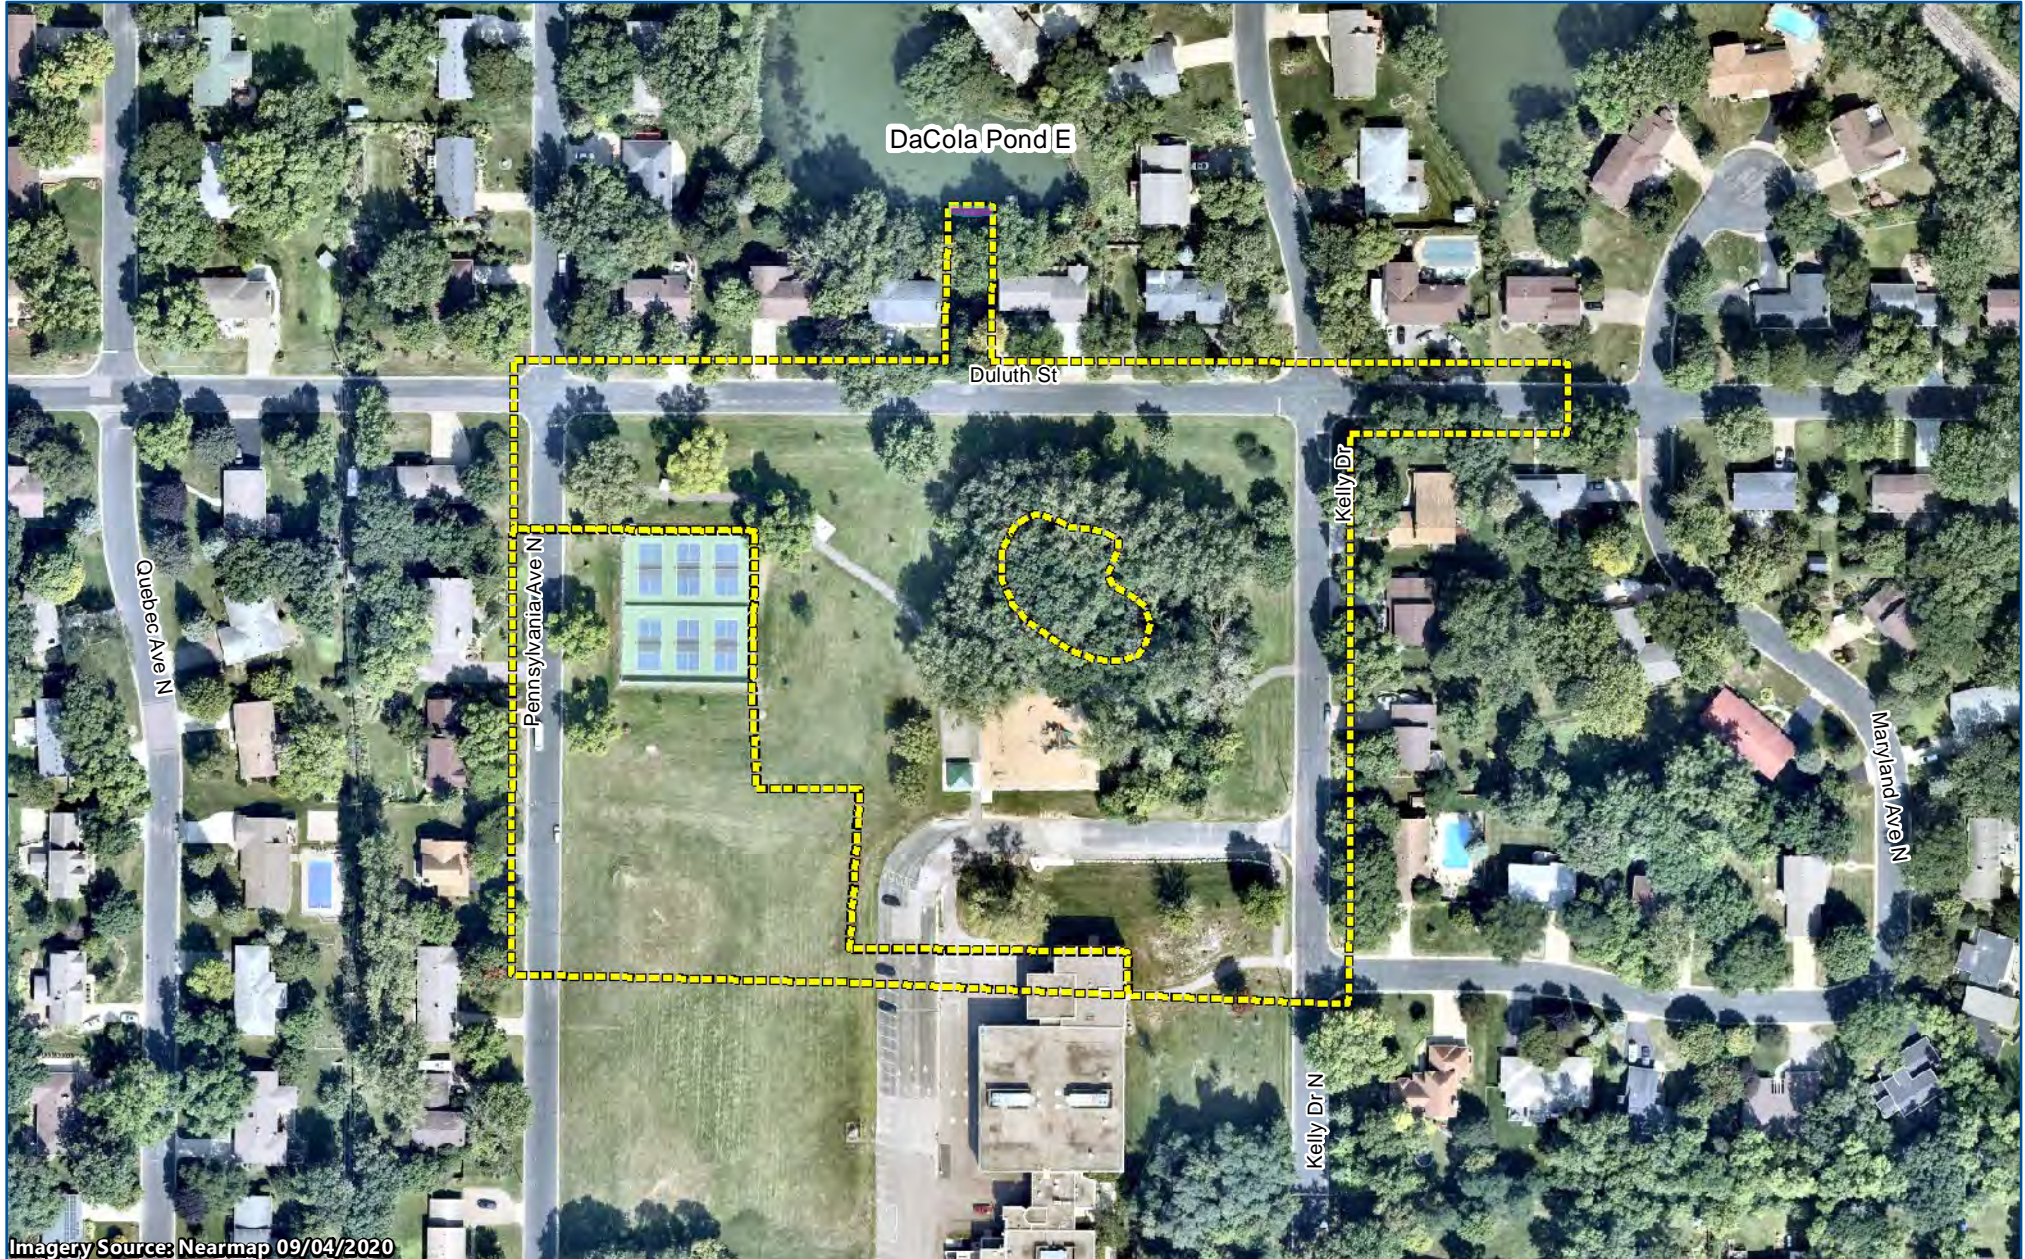
FIGURE 6

- Sample Point
- ▭ Project Boundary
- ▭ Delineated Wetlands (PUBH)
- Culverts

DELINEATED WETLANDS  
DeCola Ponds- SEA School-  
Wildwood Park Flood Storage  
Project

The project area is made up of two segments. **(Figure 1)**. The southern segment of the project area is located within the City of Golden Valley's Wildwood Park and the School of Engineering and Arts (SEA) School property. Wildwood Park offers recreational amenities such as pickleball courts, play structures, picnic shelter, general open space, and trails. This area also includes the area along the storm sewer discharge from Duluth Street to DeCola Pond E. The northern project area is located within a residential neighborhood and is crossed by Winnetka Heights Drive, following along the outlet pipe alignment from the south end of DeCola Pond D to the north end of DeCola Pond E (Figure 6).

During the wetland delineation, two wetlands totaling 0.03 acres were delineated within the project area (**Table 4**). The delineated wetlands included DeCola Pond D and E (**Figure 6**). Delineations were limited to the areas around the DeCola Pond D outlet pipe, the northern storm sewer discharge into DeCola Pond E, and the southern storm sewer discharge into DeCola Pond E, where potential modifications to storm sewer infrastructure might be made. Descriptions and assessments of the wetland areas are provided below, with representative photographs in **Appendix B**.

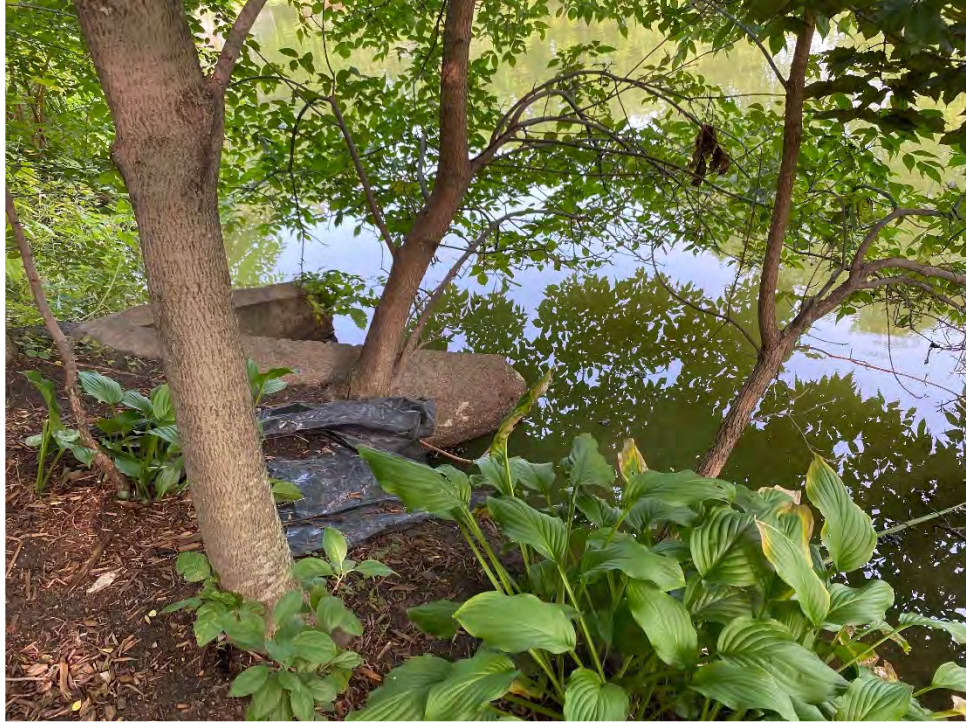
Photograph 7, Southern DaCola Pond E outlet.

DeCola Ponds D and E are connected hydrologically through a culvert located under Winnetka Heights Dr. Water flows from DeCola Pond D into Pond E and then flows outside of the project area into DeCola Pond F, ultimately draining to Bassett Creek. Since DeCola Ponds D and E are similar and, one upland/wetland transect was conducted to represent both of the delineated wetland areas for this project. At Sample Point 1, two primary hydrology indicators were observed, including saturation (A3), inundation visible on aerial imagery (B7). Both of the wetlands were classified as a Type 4/deep marsh due to the depth of the wetlands and lack of emergent vegetation (PUBH; **Figure 6**). The two ponds are hydrologically connected through a culvert under Winnetka Heights Drive, that drains Decola Pond D into Decola Pond E.
