Sediment Sampling and Bathymetric Supplementary Information (2020)

Technical Memorandum

To: Bassett Creek Watershed Management Commission
From: Kevin Menken & Katie Turpin-Nagel, Barr Engineering
Subject: Medley Pond Sediment Characterization
Date: January 26, 2021
Project: 23/27-0051.51

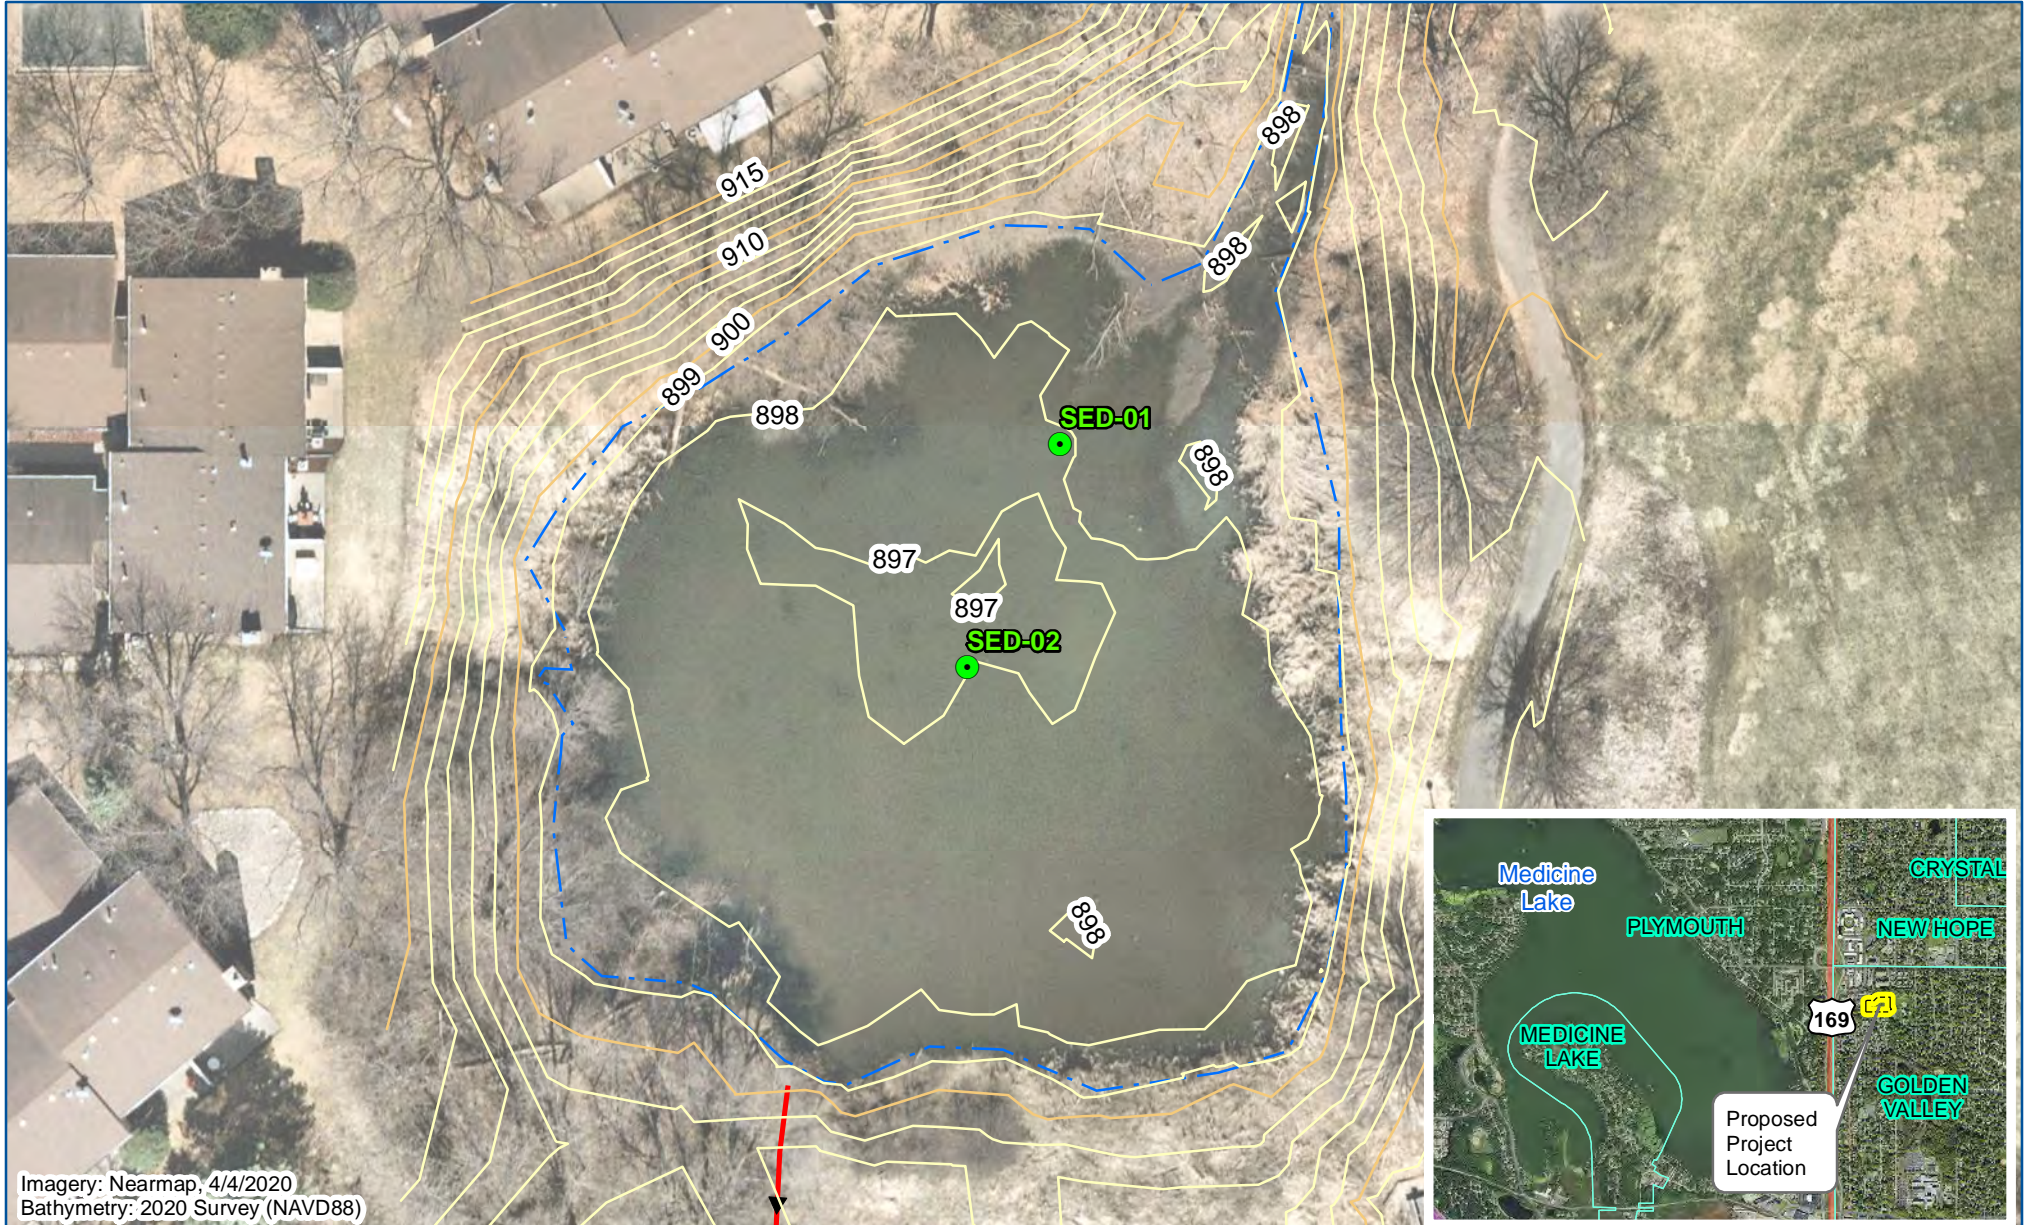
FIGURE 1

Imagery: Nearmap, 4/4/2020
Bathymetry: 2020 Survey (NAVD88)

- Sediment Sampling Location
- Major Contour 5ft
- Minor Contour 1ft
- Water Line (NWL = 898.6 ft)
- Storm Pipe

MEDLEY PARK
Bathymetric Survey &
Sediment Core Locations

Barr conducted a bathymetric survey of Medley Pond on September 16, 2020. Pond bottom elevations were collected using Real Time Kinematic (RTK) GPS and robotic total station survey equipment, with a horizontal accuracy of 0.03 feet and vertical accuracy of 0.1 feet. The current bathymetry of Medley Pond

is shown on Figure 1 attached to this memo. Current bottom elevations generally range from 897 feet (NAVD88) in the center of Medley Pond to 898 feet at the northeastern channel inlet.

Sediment cores were collected at two locations as shown on Figure 1. The sediment cores were visually logged in the field, and sediment core logs are included in Attachment A. At location SED-01, the water depth was 0.6 feet at the time of sampling and the approximate sediment elevation was 897.7 feet, NAVD88; the sediment coring tube was pushed 4.0 feet into sediment, and 2.7 feet of sediment was recovered. Core SED-01 consisted of soft organic silt with plant matter and sand lenses over interval 0-2.6 feet, and peat 2.6-2.7 feet. At location SED-02, the water depth was 1.0 foot at the time of sampling and the approximate sediment elevation was 897.3 feet, NAVD88; the sediment core tube was pushed 5.6 feet into sediment, and 4.0 feet of sediment was recovered. Core SED-02 consisted of soft organic silt with trace sand over interval 0-2.5 feet, and peat 2.5-4.0 feet. Based on sediment coring logs at the two locations, there is a transition from soft organic silt to peat at a depth of approximately 4.5-5.0 feet below the pond water surface (assuming that the difference between sediment core push length and recovered core length is due to displacement of soft sediment and not the displacement or loss of underlying peat). Thus, the soil transition elevation is approximately 893.5 feet, NAVD88.

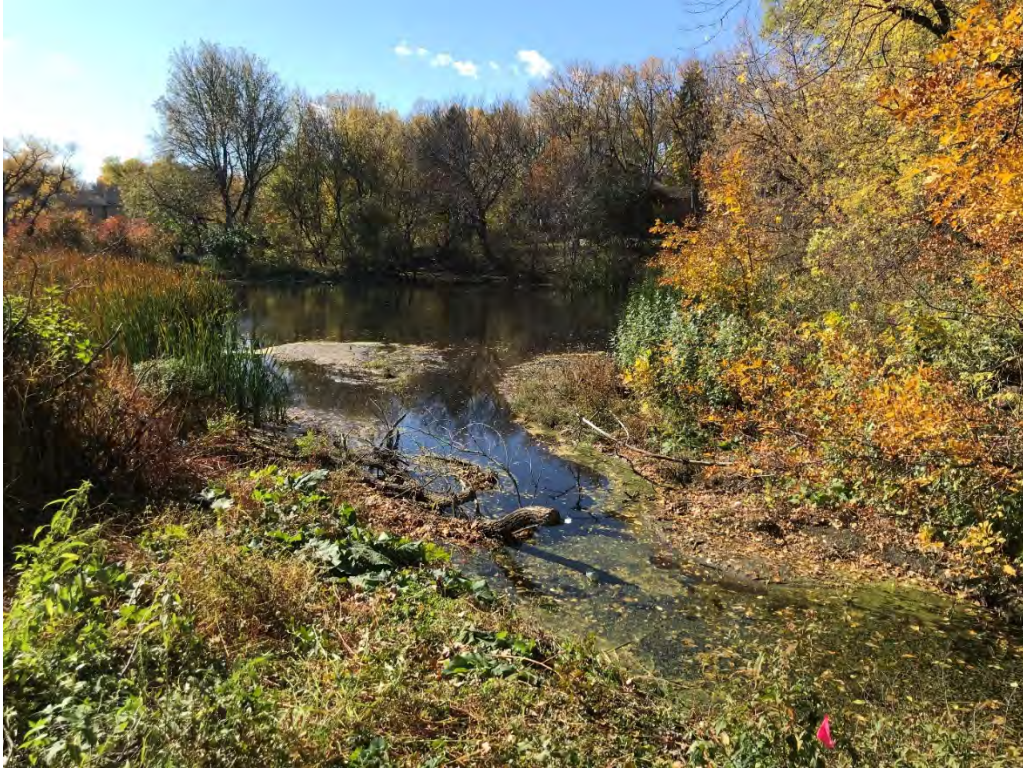
Photograph #1: Medley Pond, northeast shoreline facing southwest.

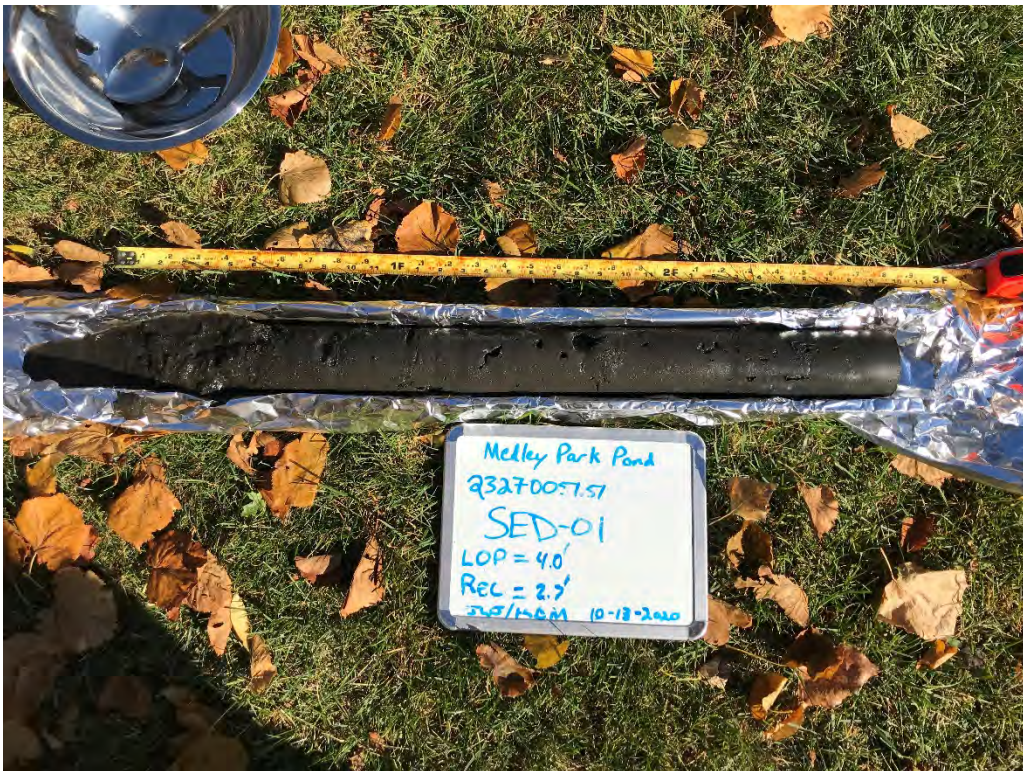
Photograph #2: Medley Pond, sediment core SED-01.

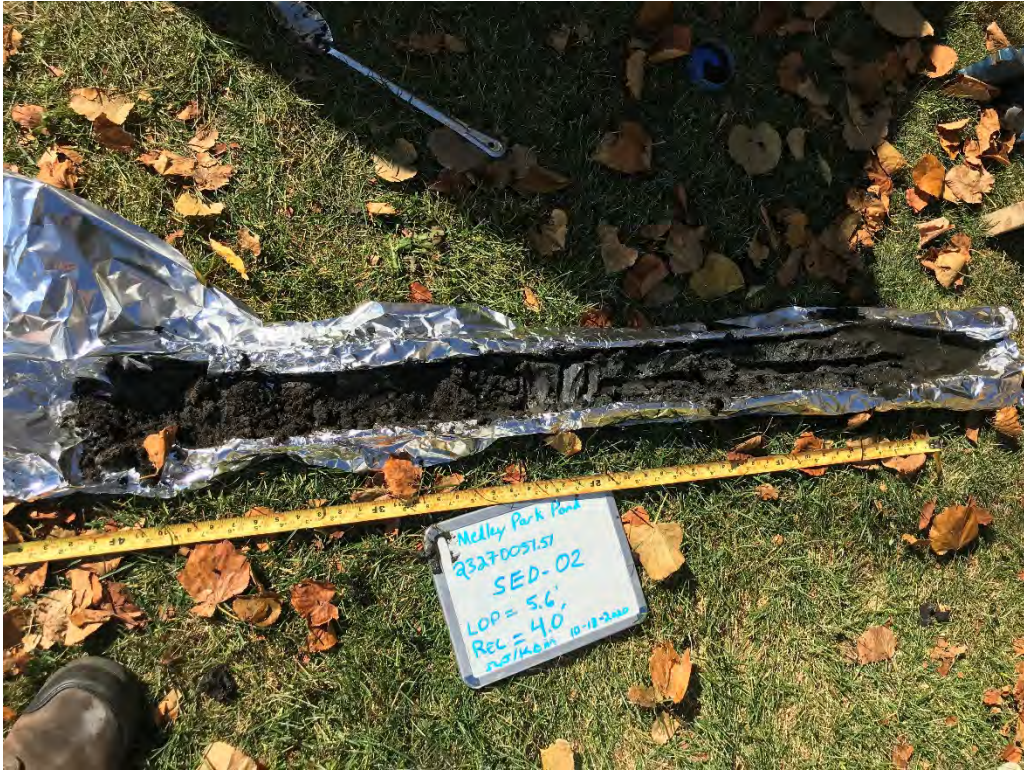
Photograph #3: Medley Pond, sediment core SED-02.

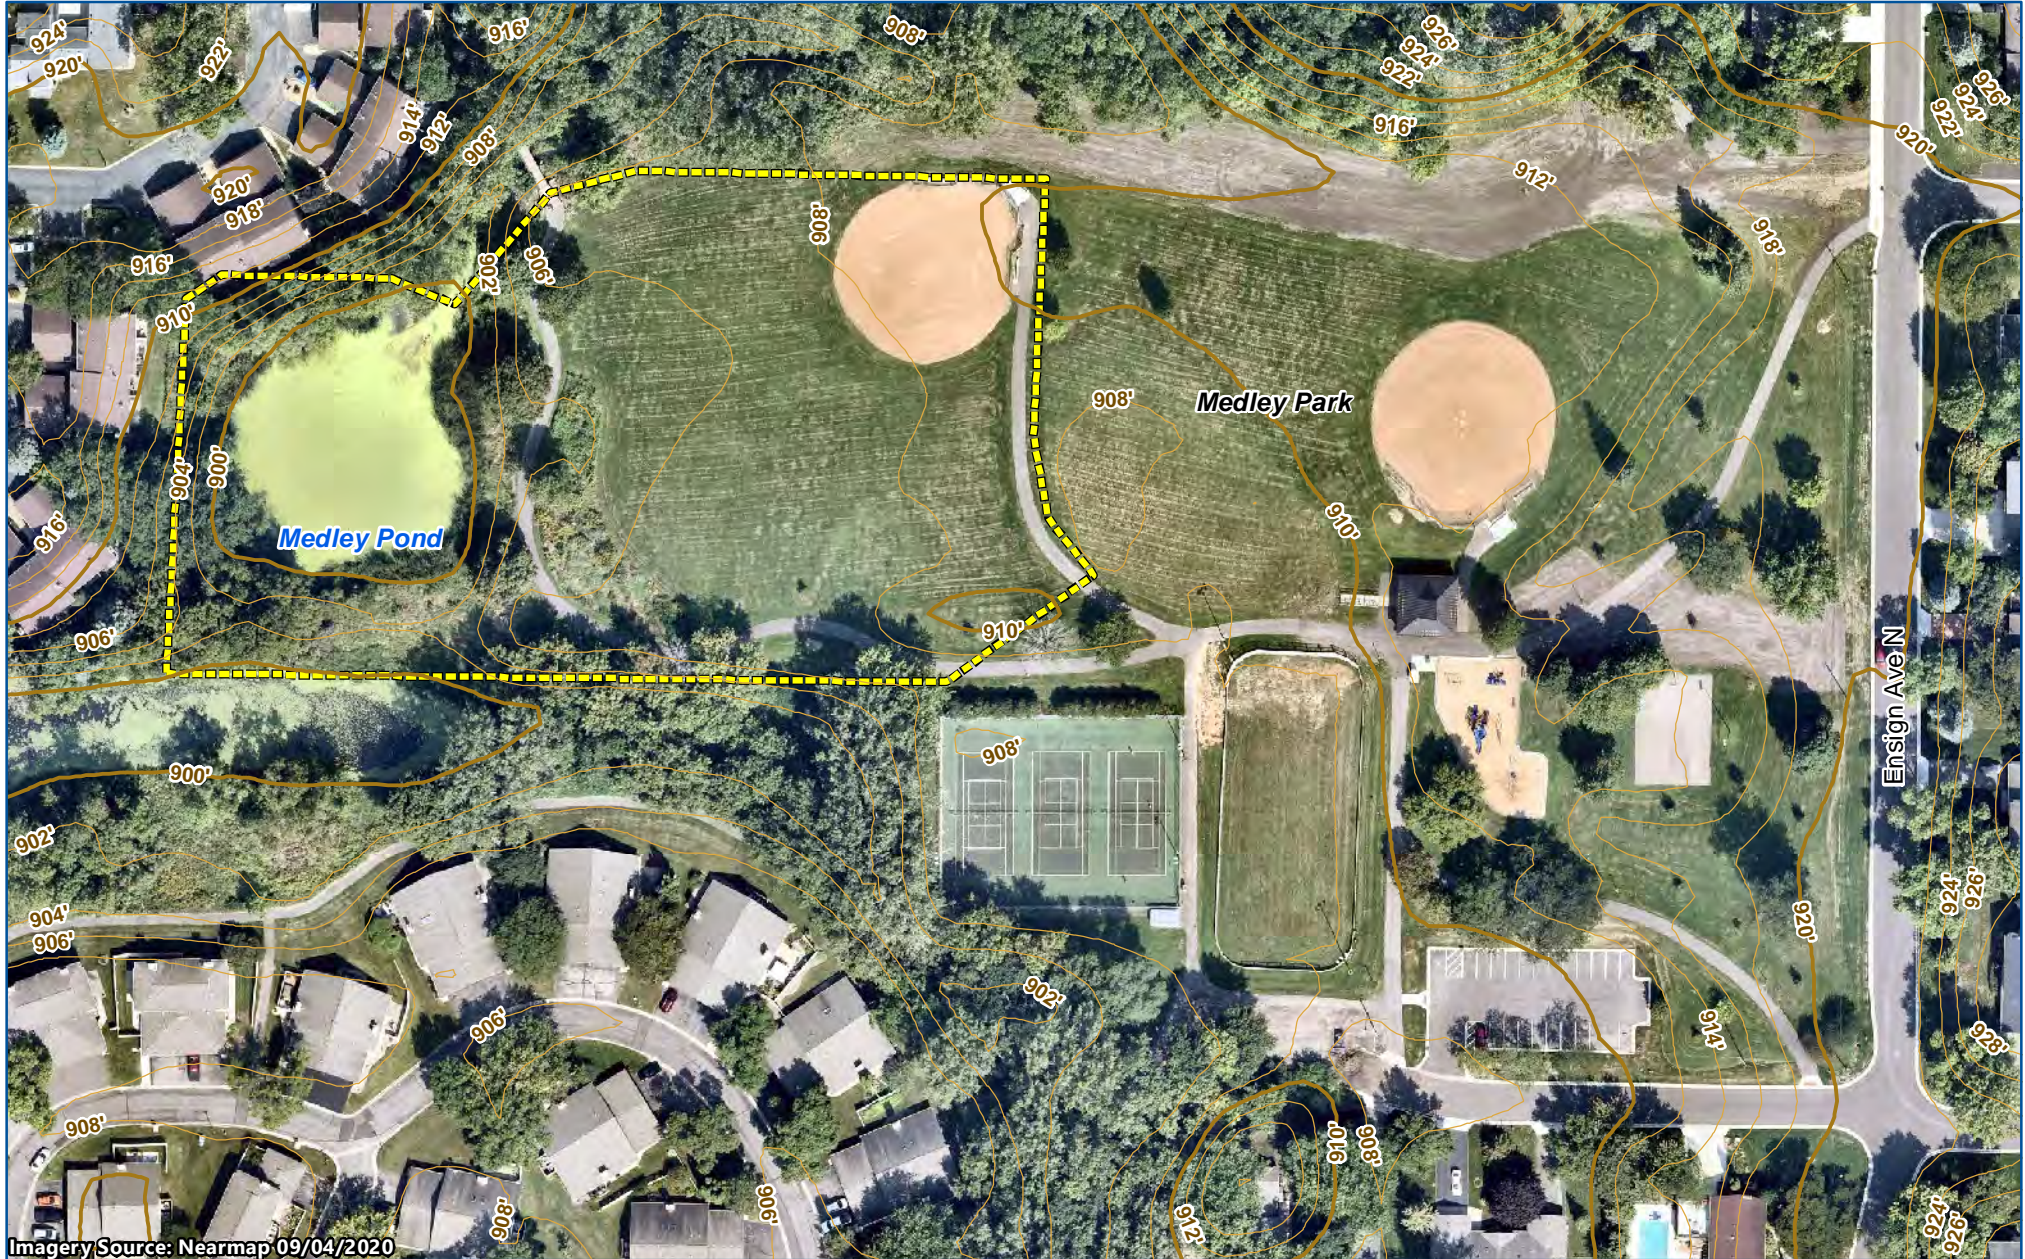
FIGURE 2

Elevation

LIDAR MAP
Medley Park Stormwater
Treatment Facility
Golden Valley, MN

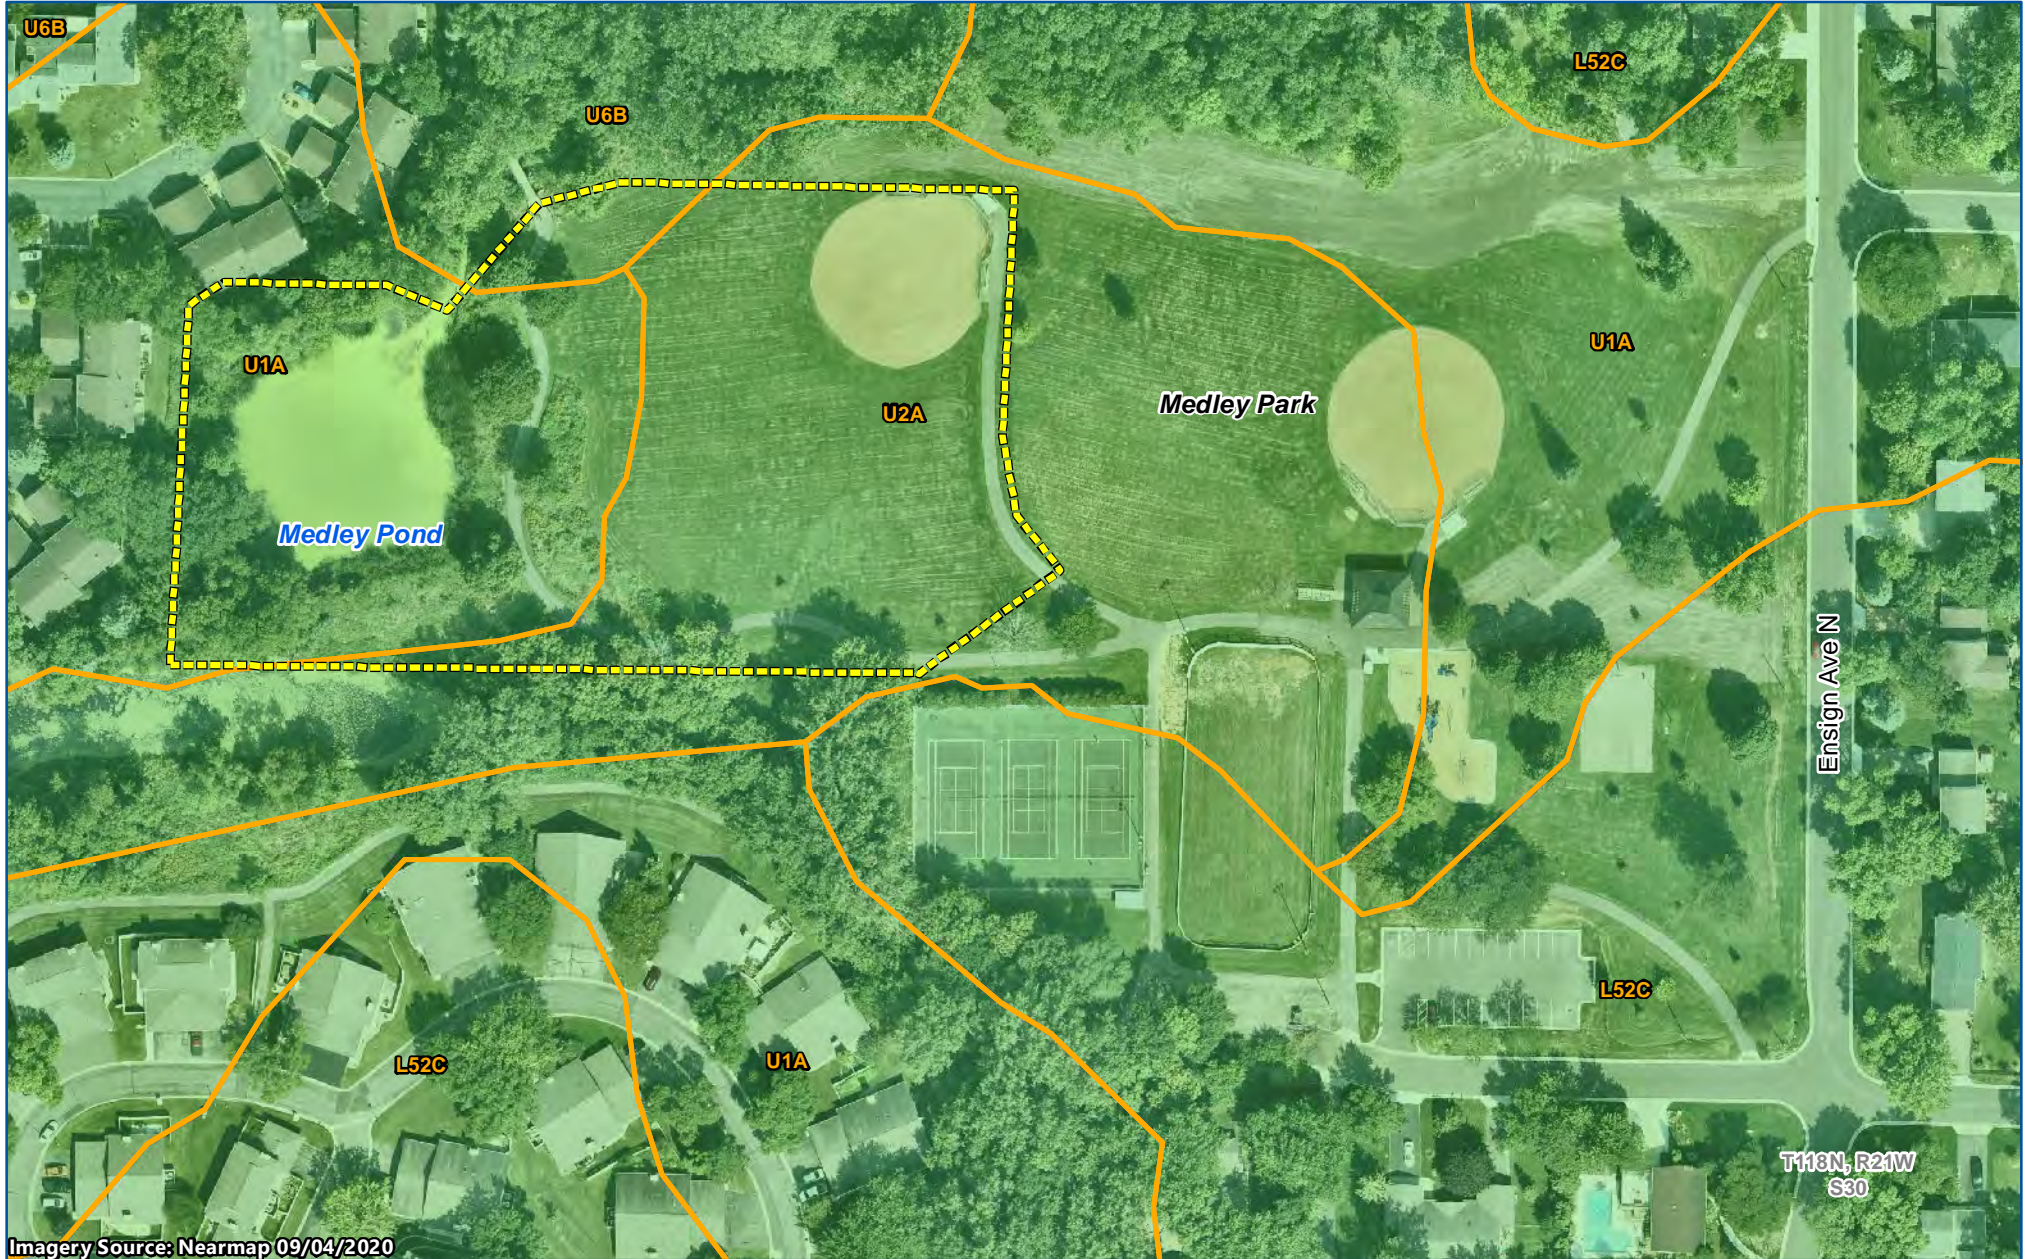
FIGURE 4

PWI MAP
Medley Park Stormwater
Treatment Facility
Golden Valley, MN

The Minnesota Department of Natural Resources (MnDNR) Public Water Inventory (PWI) was queried for any Public Waters located within or adjacent to the project area (**Figure 4**). No PWI watercourses or PWI basins are located within the project area. The nearest PWI basin is Medicine Lake located approximately 0.31 miles west of the project area.

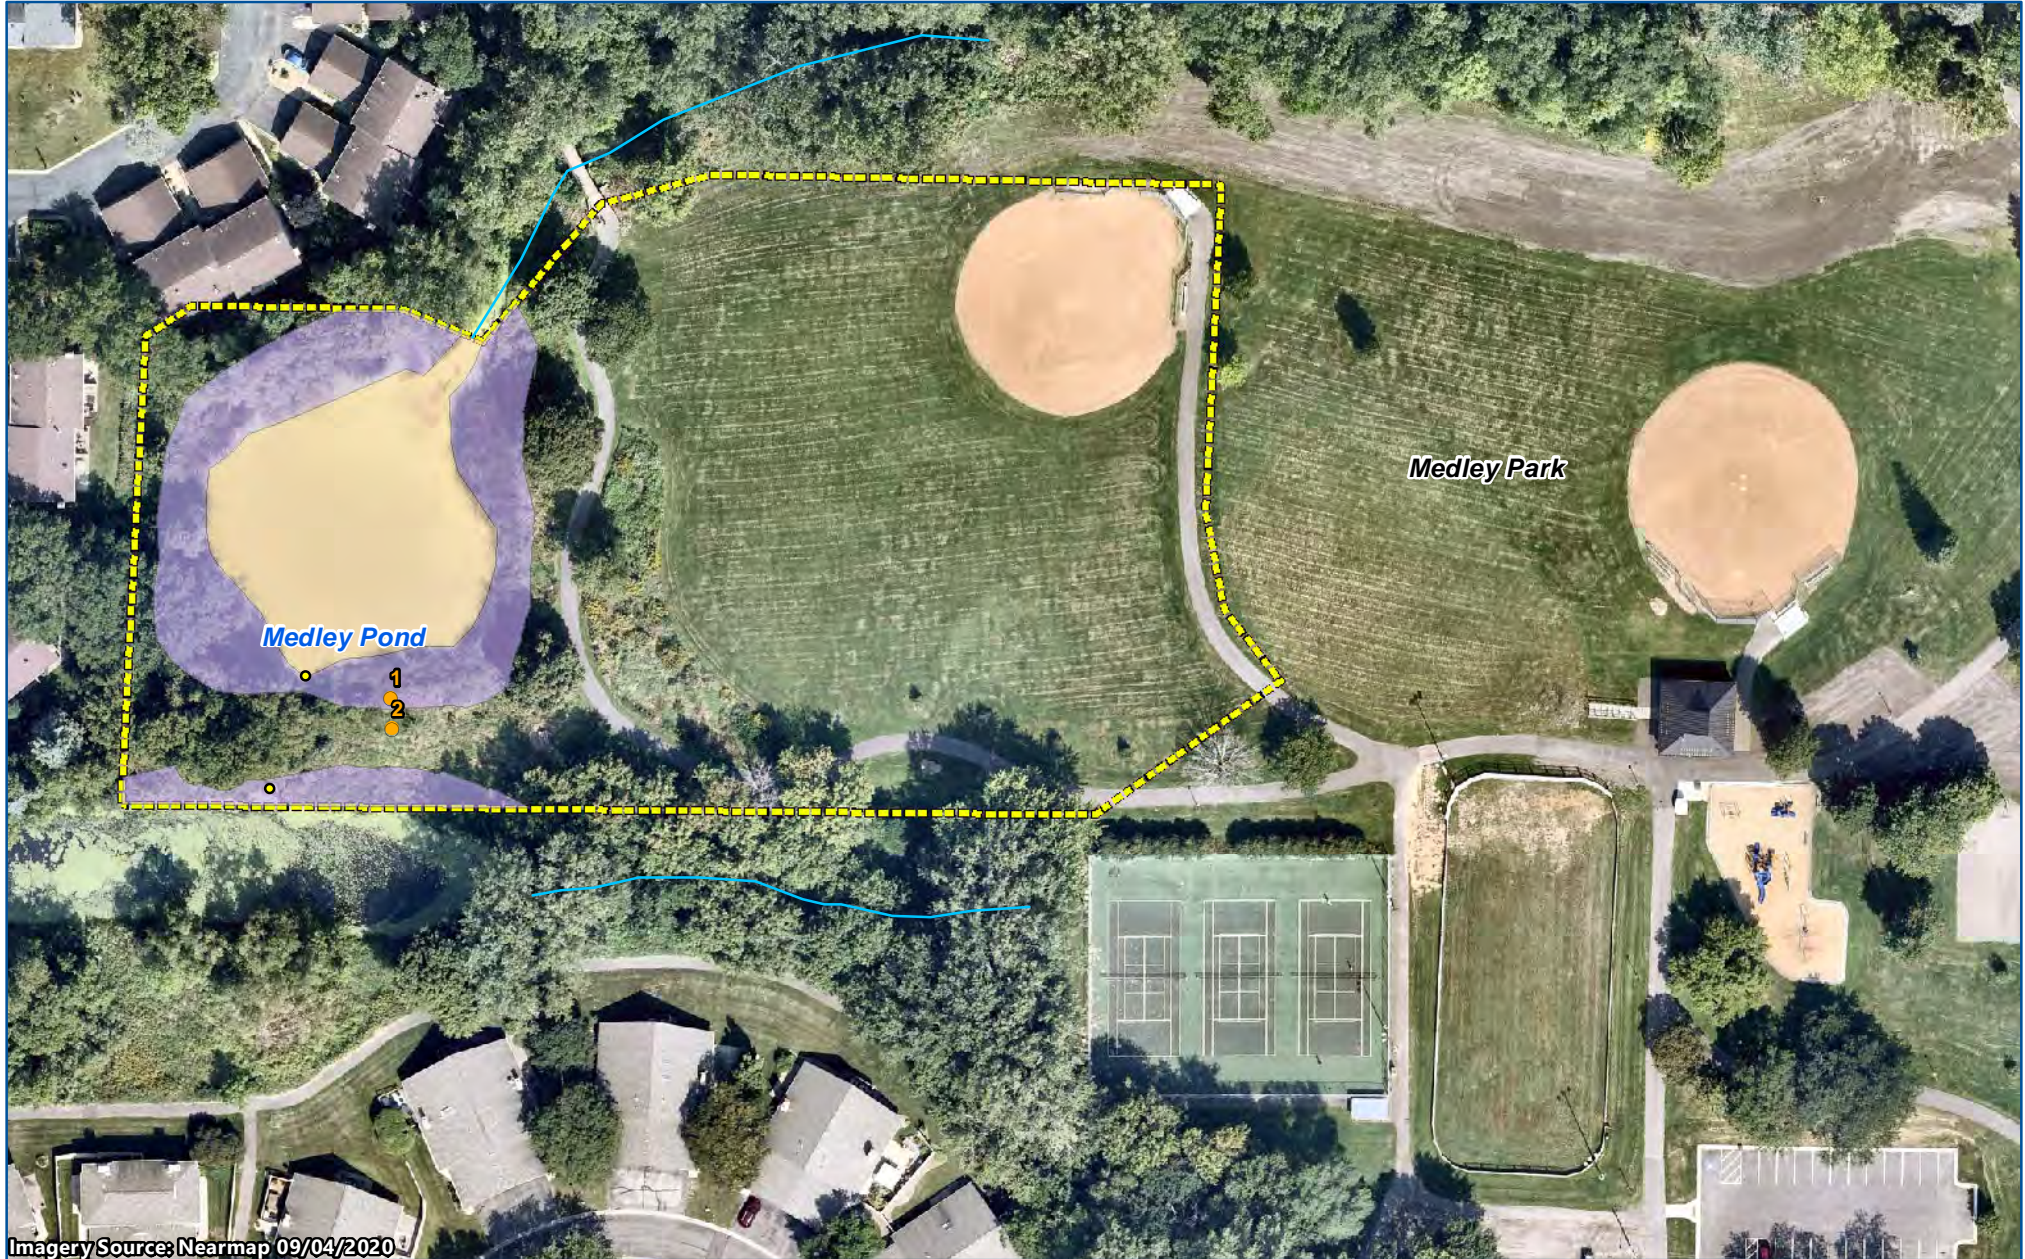
FIGURE 7

DELINEATED WETLANDS
Medley Park Stormwater
Treatment Facility
Golden Valley, MN

At the time of the field survey, much of the wetland area was inundated with approximately 4-6 feet of water. The area receives water from a drainage channel located on the northern end of the wetland boundary. Water flows from the northern wetland area into the wetland area to the south and outside of the project area. At sample point 1, two primary hydrology indicators were observed, including saturation (A3), inundation visible on aerial imagery (B7).

According to NRCS data, the soils mapped within the boundary of Wetland 1 are classified as Urban land-Udorthents, Wet Substratum Complex, a non-hydric soil. Sampled soils consisted of a very dark grayish brown (10YR 3/2) matrix color from the soil surface down to approximately 4 inches. A depleted grayish brown (2.5Y 5/2) matrix is present starting at 4 inches below ground surface with 10 percent distinct prominent redoximorphic features. A gleyed matrix with a dark greenish gray (10Y 4/1) color was found 8 inches below the soil surface. The soils at Sample Point 1 met the loamy gleyed matrix (F2) and redox dark surface (F6) hydric soil indicators.

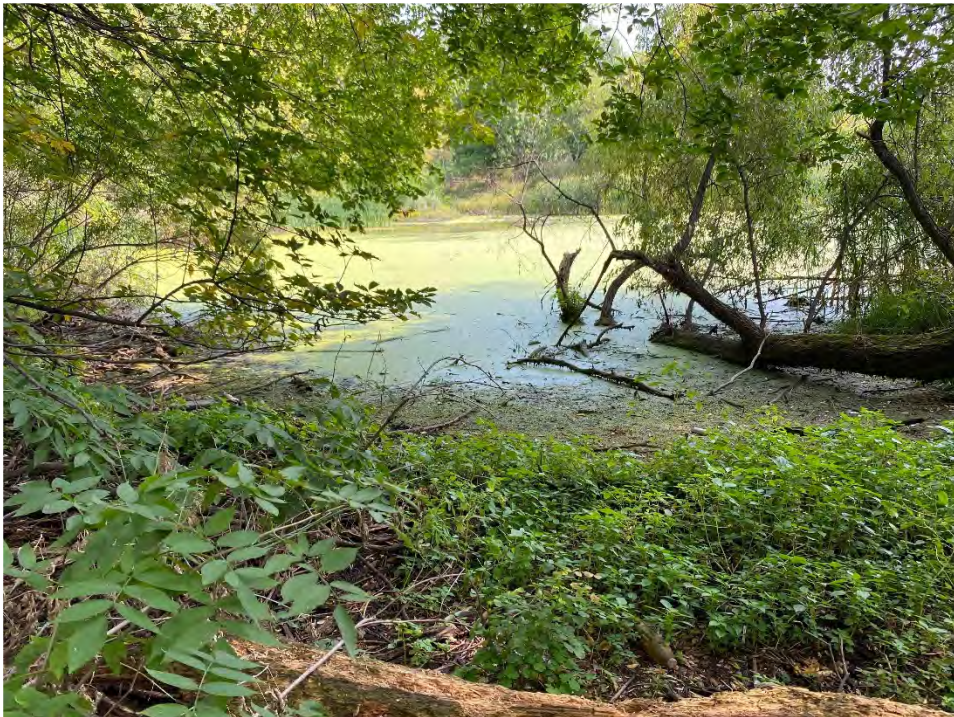
Photograph 6, wetland 1, view north

Wetland 1 is a storm water detention basin that is separated into two segments by an upland berm. The two wetland segments are connected through a culvert located underneath the berm. Both segments of the wetland were classified as a deep marsh boarded with a seasonally flooded basin (PUBGx/PEMC; **Figure 7**). Vegetation along the wetland boundary was dominated by cattails (*typha spp.*; OBL), boarded by reed canarygrass (*Phalaris arundinacea*; FACW), jewel weed (*Impatiens capensis*; FACU), water smartweed (*Persicaria amphibia*; OBL), in addition to woody vegetation such as boxelder (*Acer negundo*; FAC) and common buckthorn (*Rhamnus cathartica*; FAC). floating vegetation like duck weed (observed within the deep marsh portion of the wetland).

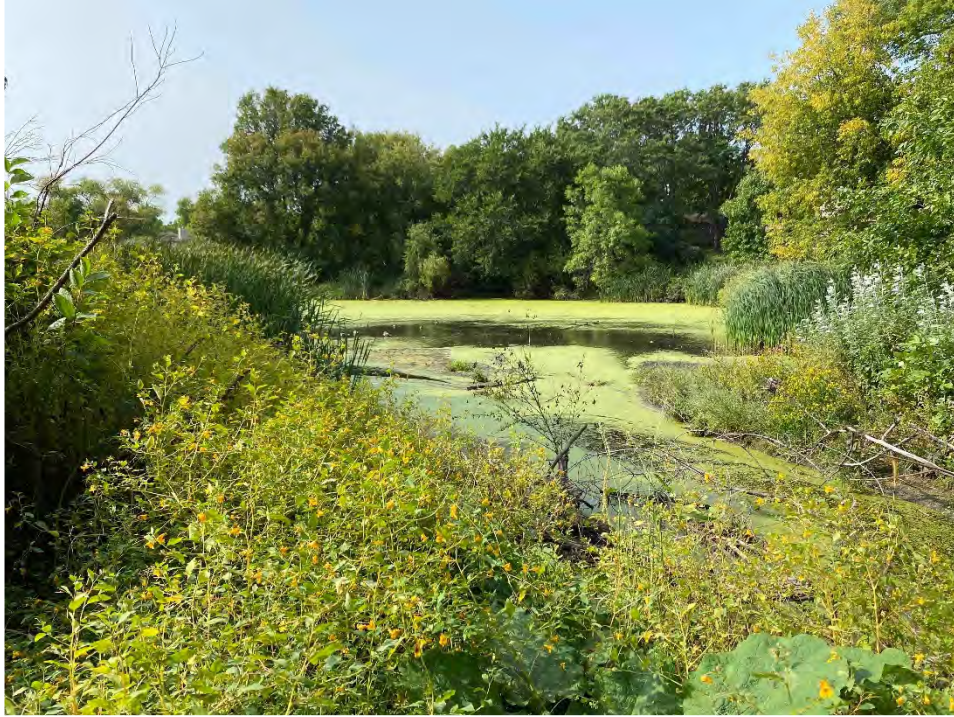
Photograph 7, northern end of wetland 1, view south

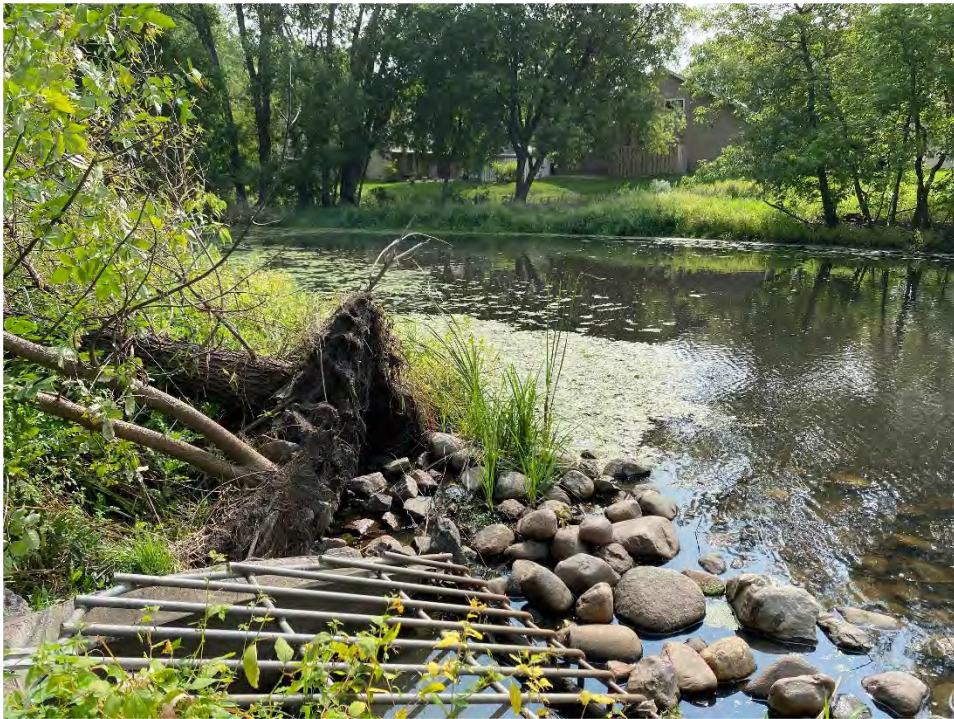
Photograph 8, Southern segment of wetland 1, view southeast
