Westwood Lake Improvement Project WST-2

FINAL REPORT
June 1, 2021

I. Project Overview

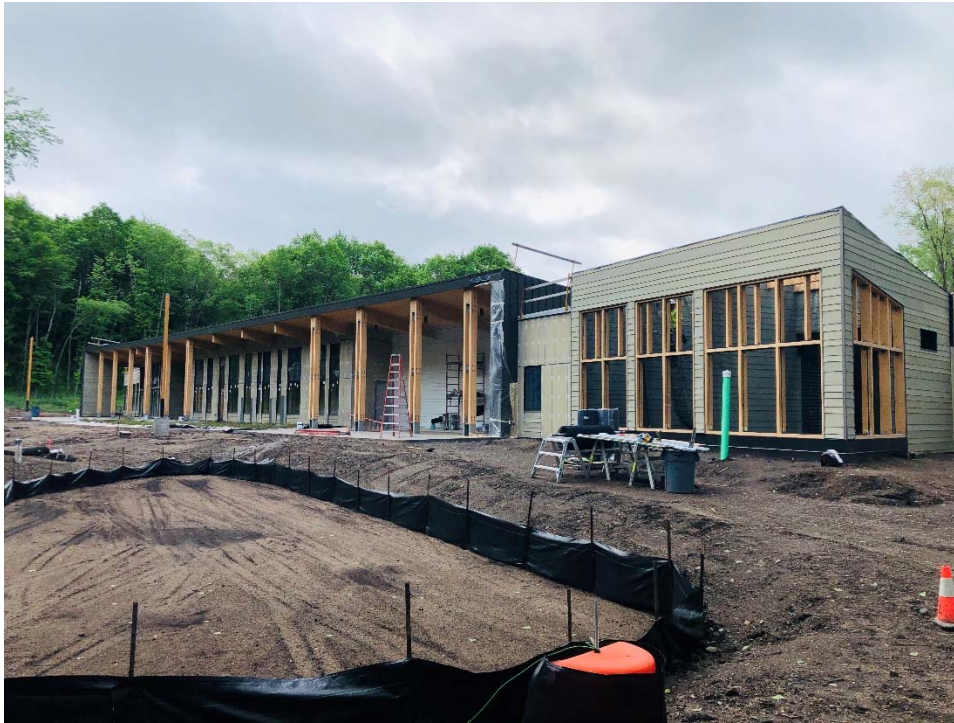
North water feature under construction

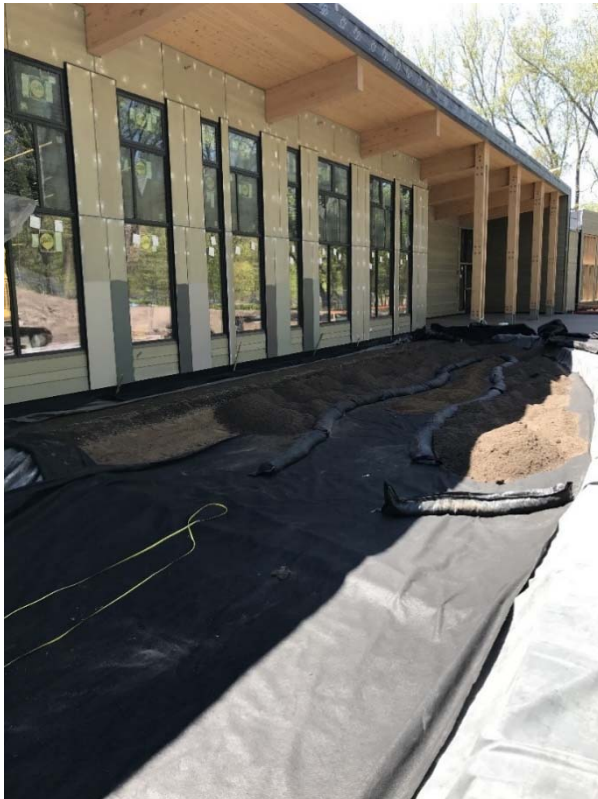
Bog liner and maintenance channel installation

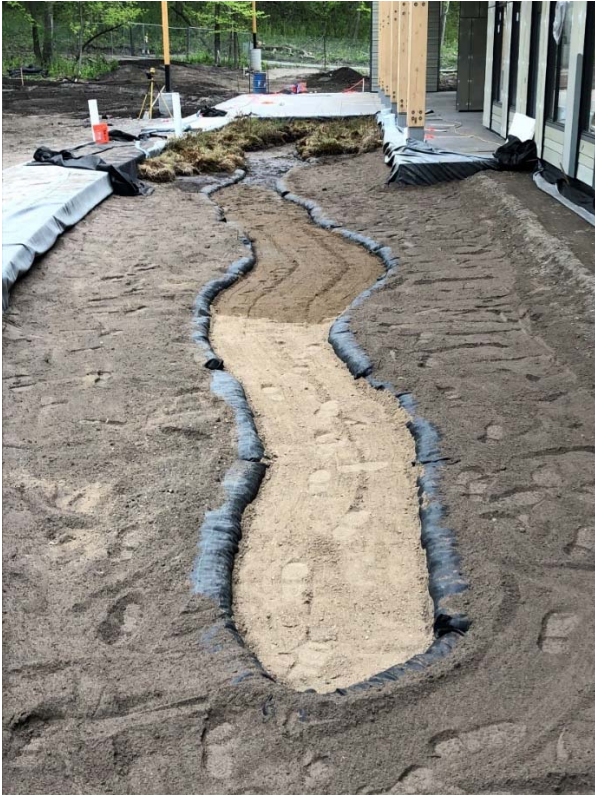
Tamarack bog at the start of planting

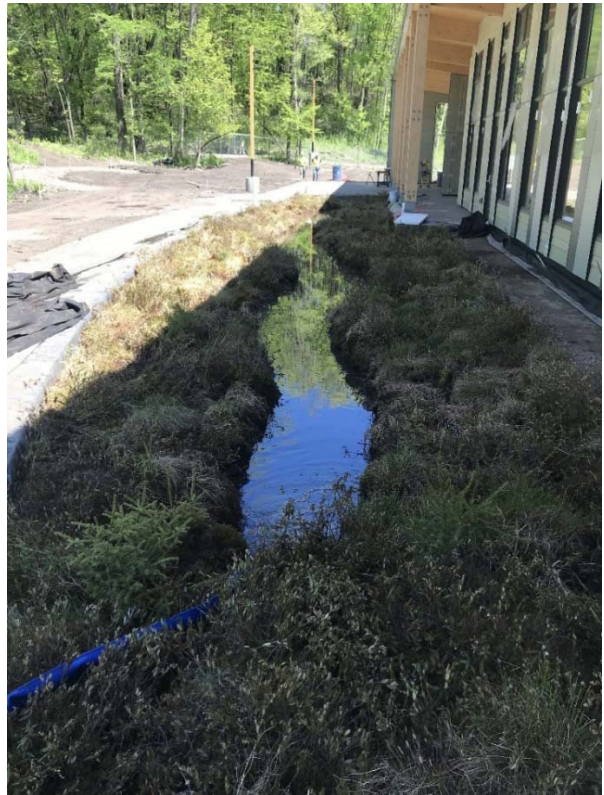
Transplanted bog fully planted
