# Bassett Creek Main Stem Stabilization Project

## Minneapolis, Minnesota

FINAL REPORT  
February 2022

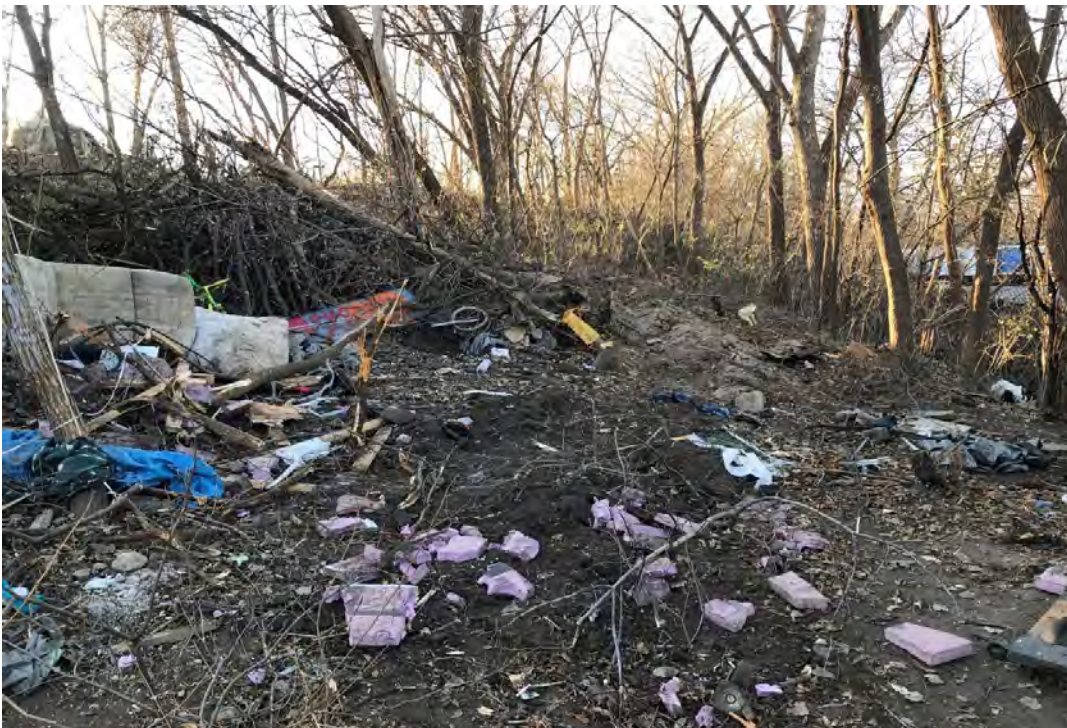
**Reach 1: Debris and trash along the southern bank (12/1/2020)**

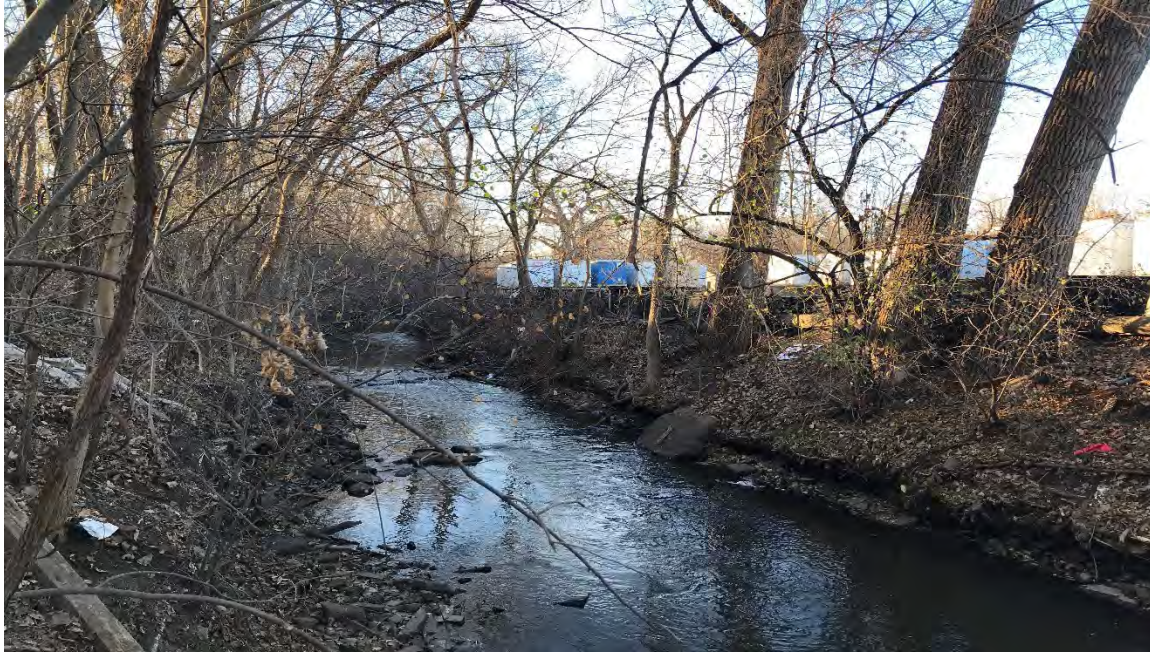
**Reach 1: Upstream portion of the reach prior to construction activities (12/1/2020)**

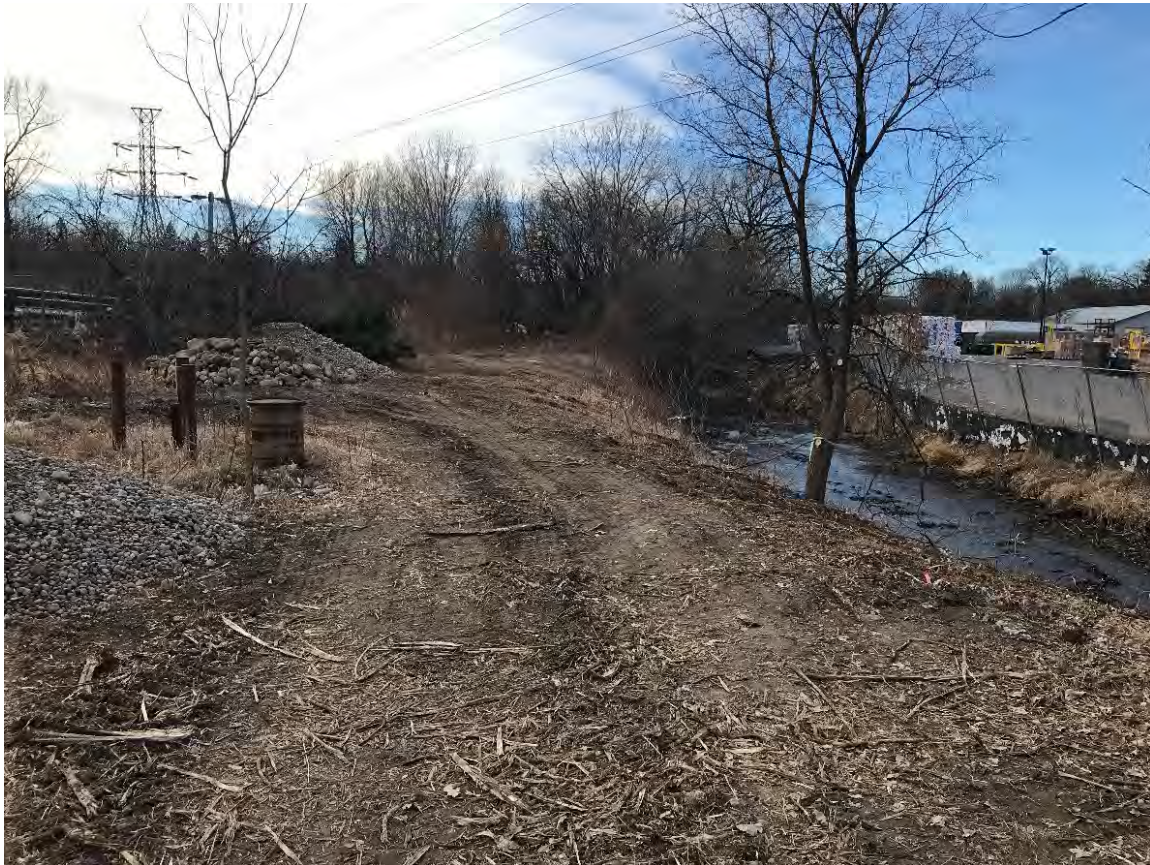
**Reach 1: Southern bank following tree and shrub clearing. Drum disposed of at landfill (12/3/2020)**

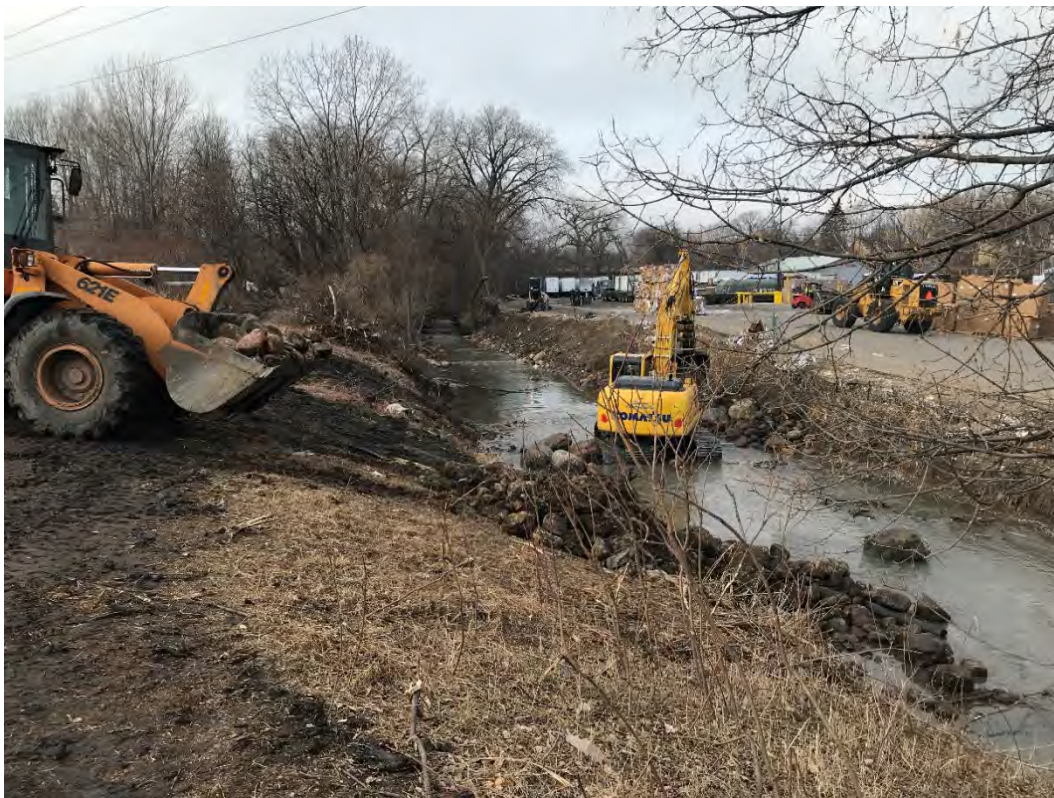
**Reach 1: Installation of downstream boulder vanes (12/8/2020)**

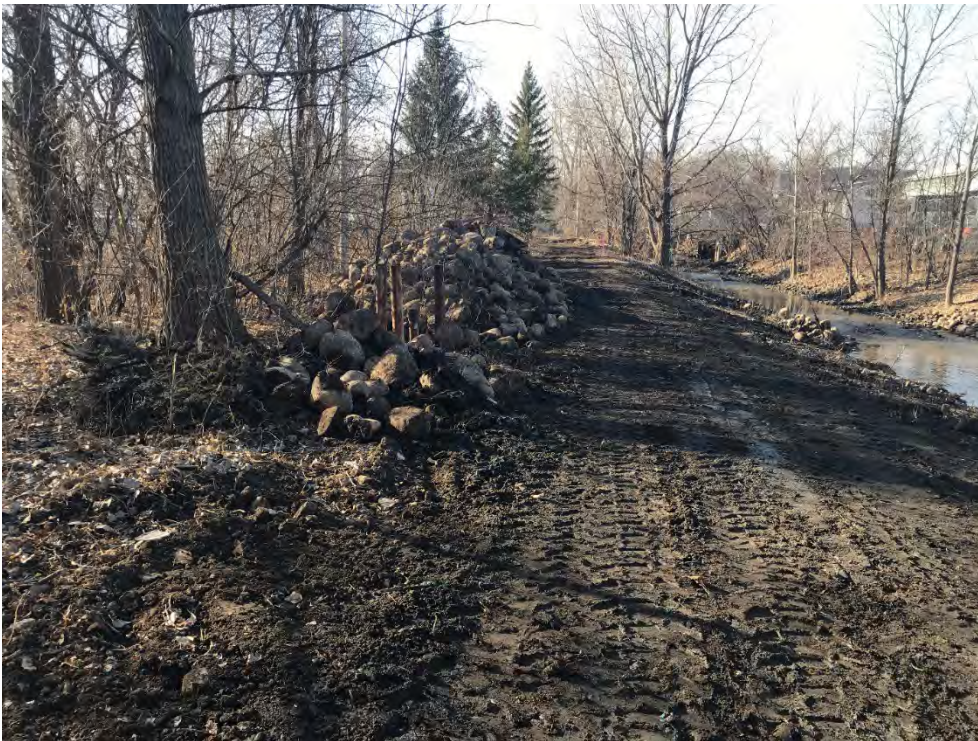
**Reach 1: Cleared southern bank downstream of Irving Ave. footbridge (12/10/2020)**

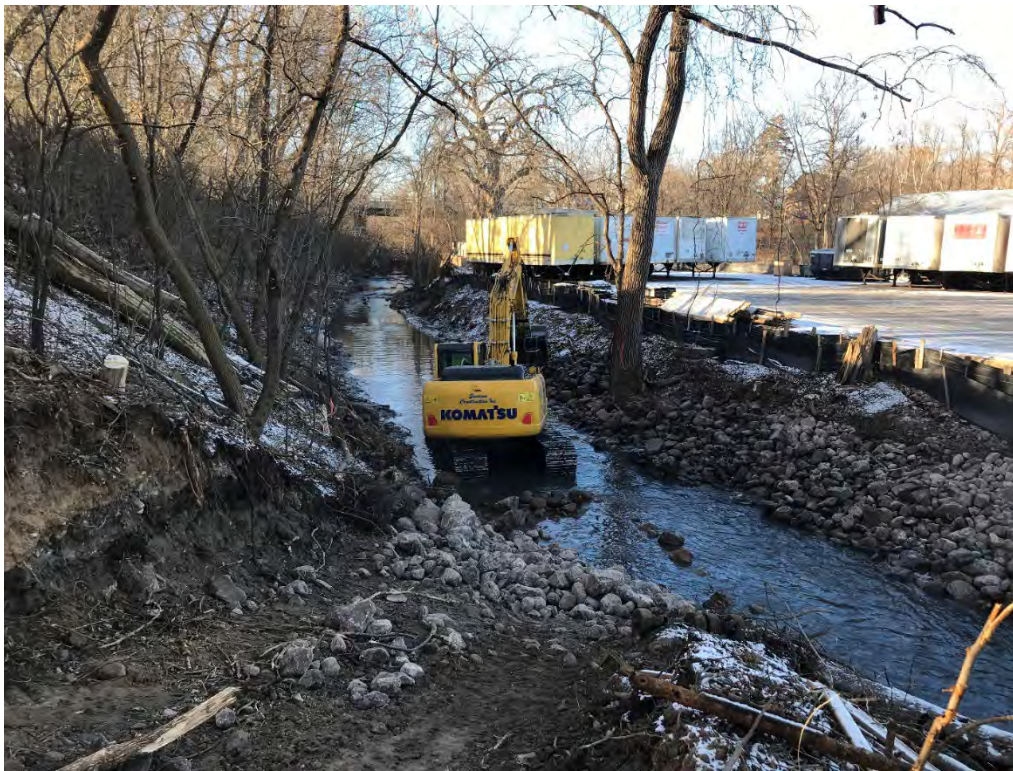
**Reach 1: Installation of upstream riprap and boulder vanes (12/14/2020)**

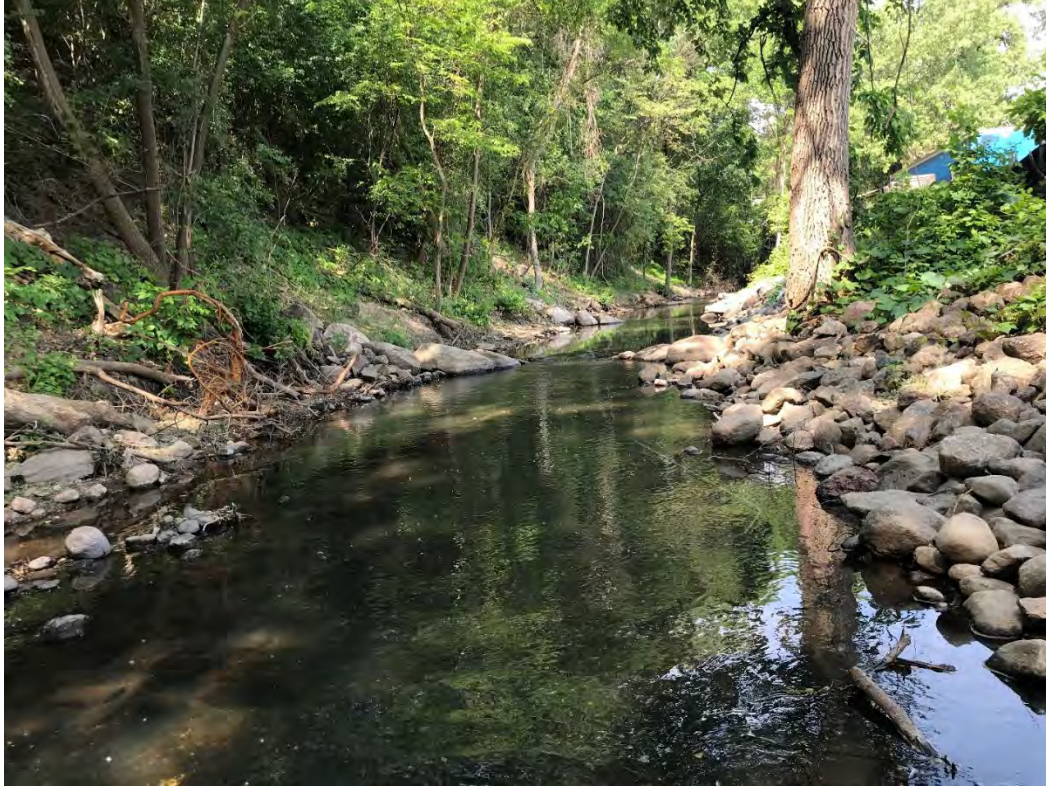
**Reach 1: Upstream boulder vanes and riprap (6/17/2021)**

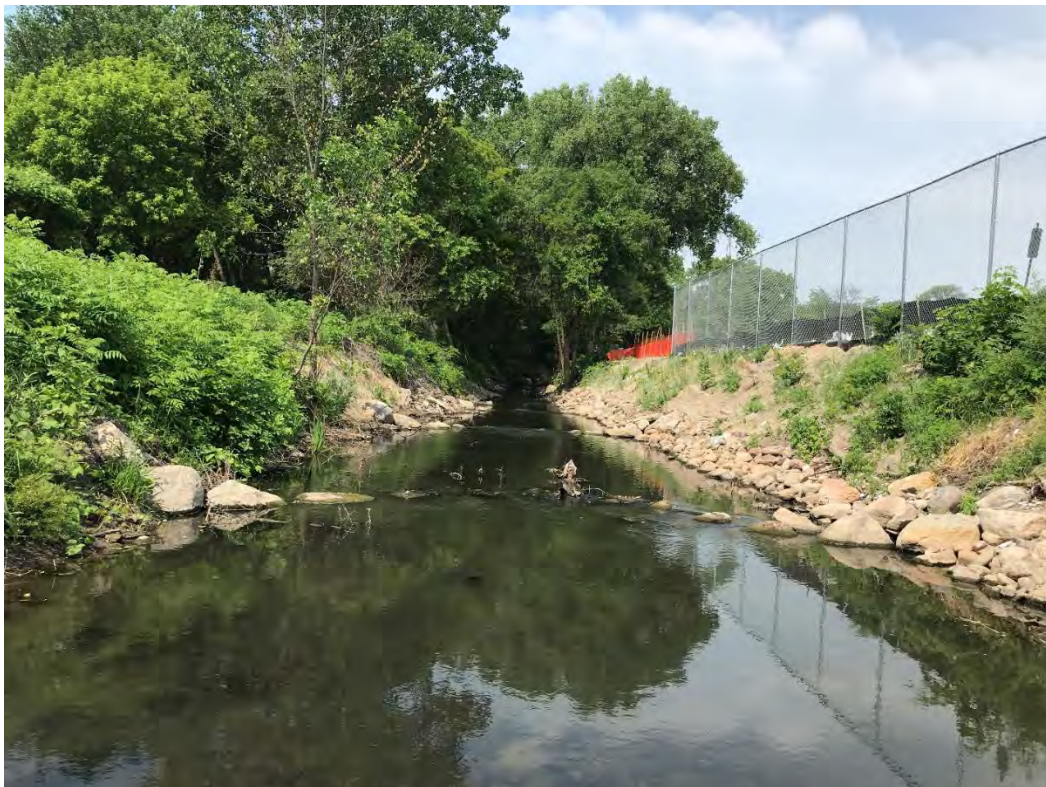
**Reach 1: View of boulder vanes, riprap, and vegetation reestablishment in upstream portion of reach  
(6/17/2021)**

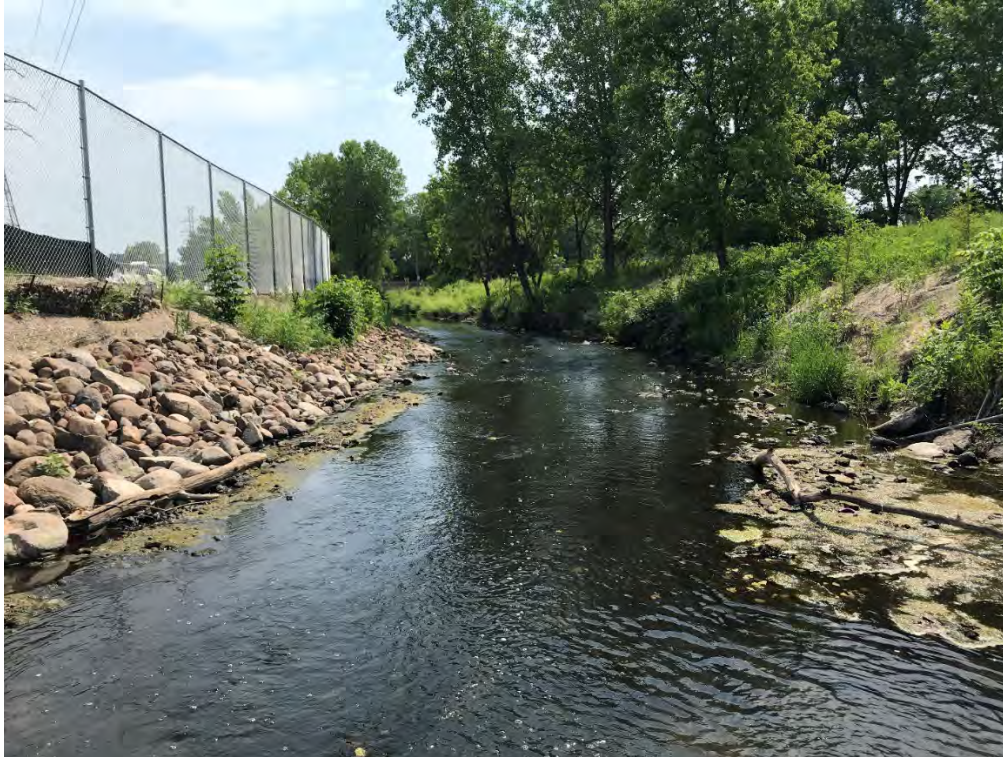
**Reach 1: Riprap and native vegetation reestablishment upstream of Irving Ave. footbridge  
(6/17/2021)**

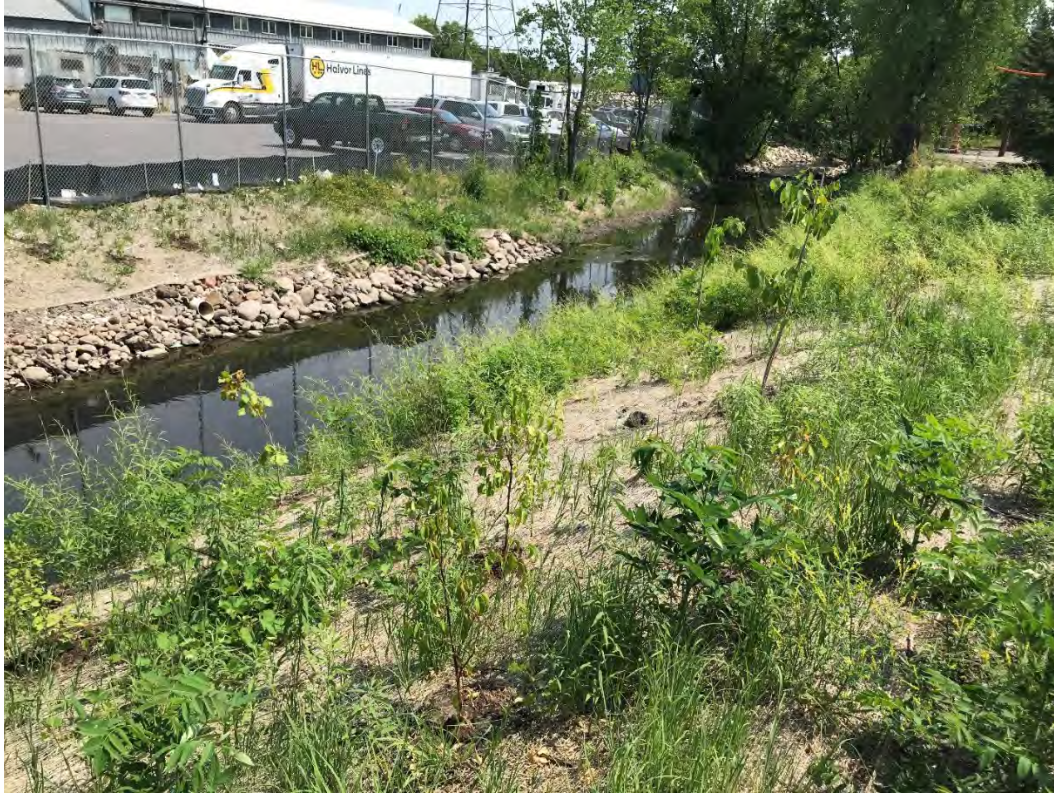
**Reach 1: Native vegetation reestablishment along southern bank (6/17/2021)**

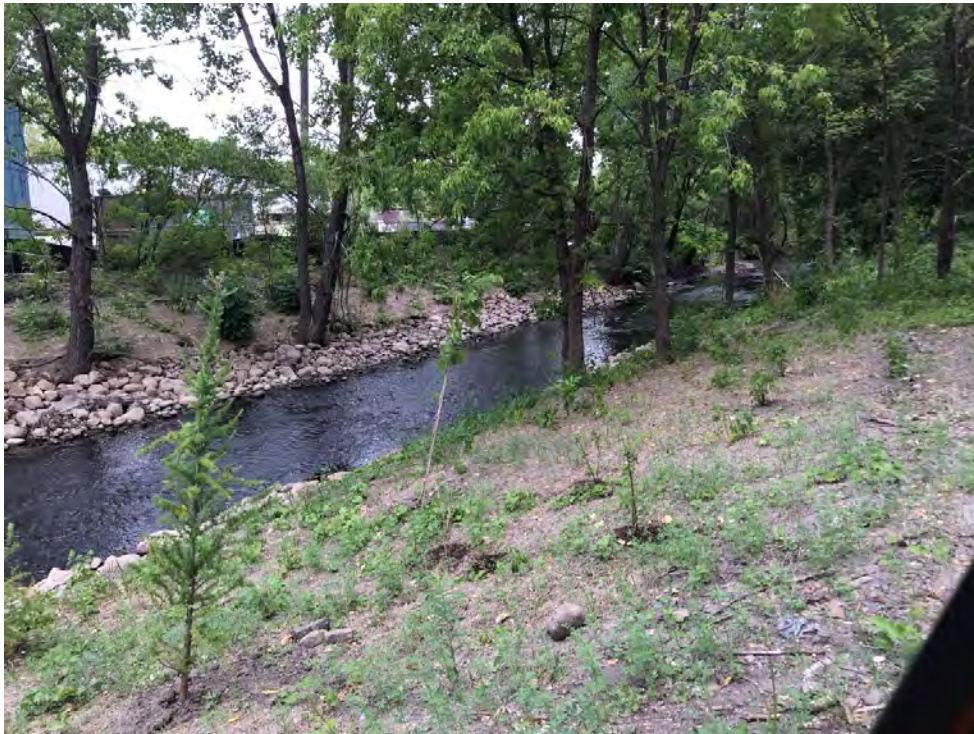
**Reach 1: Riprap and native vegetation reestablishment along southern bank downstream of Irving Ave. footbridge (6/17/2021)**

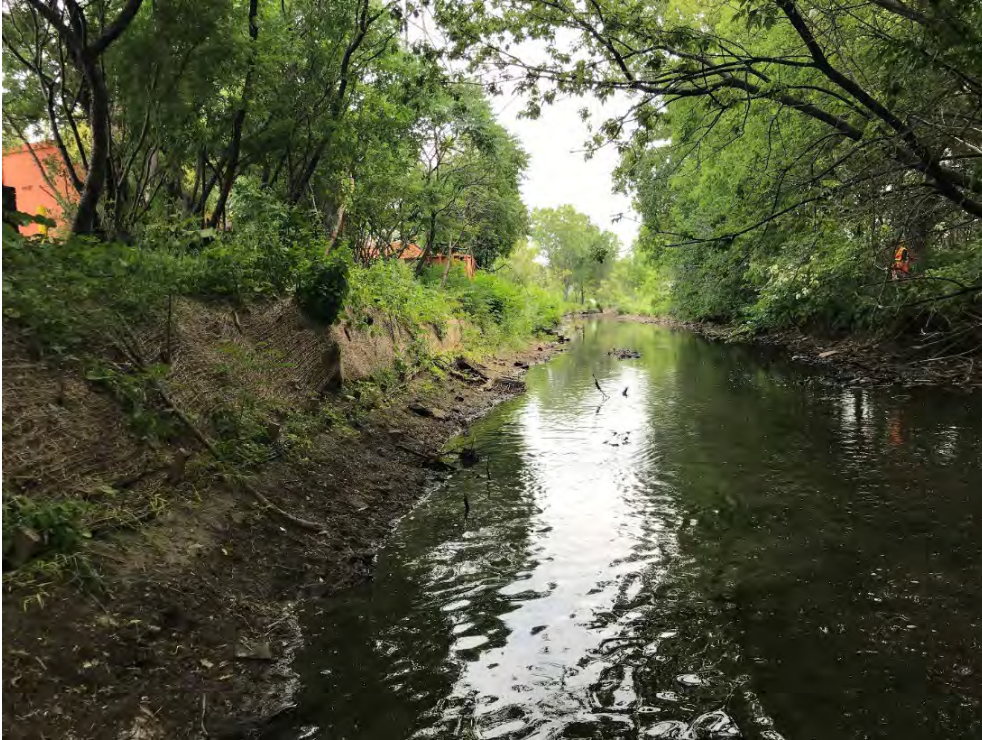
**Reach 1: Native vegetation reestablishment and fascines upstream of Van White Memorial Blvd. (6/17/2021)**

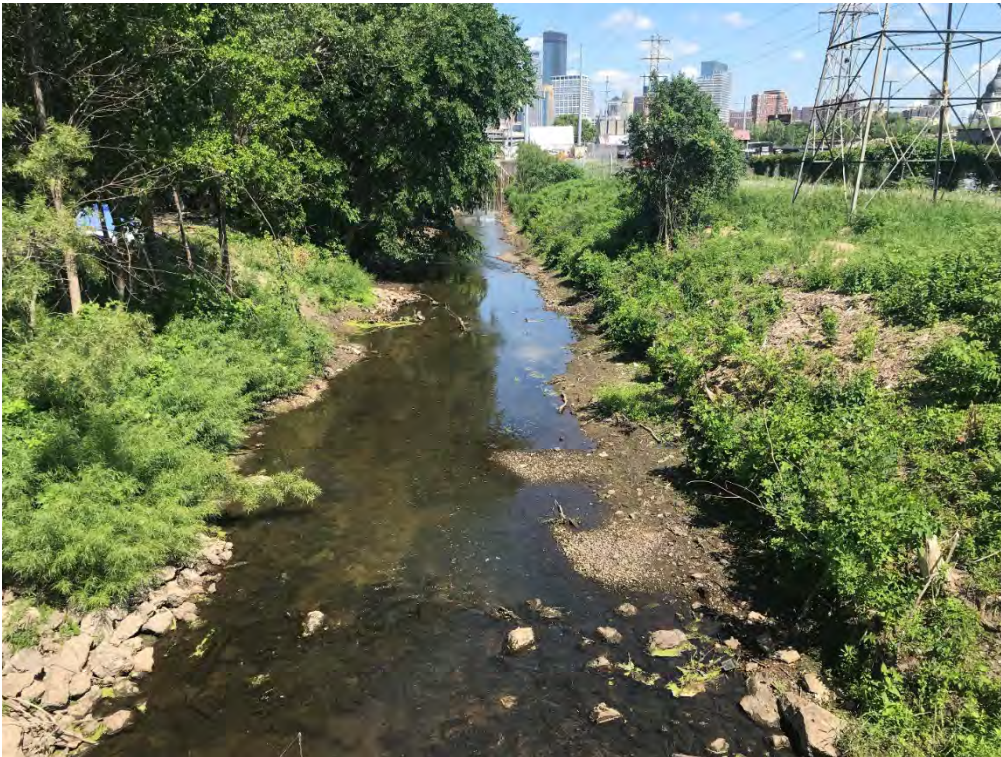
**Reach 1: Section downstream of Van White Memorial Blvd. to Bassett Creek tunnel (6/23/2021)**

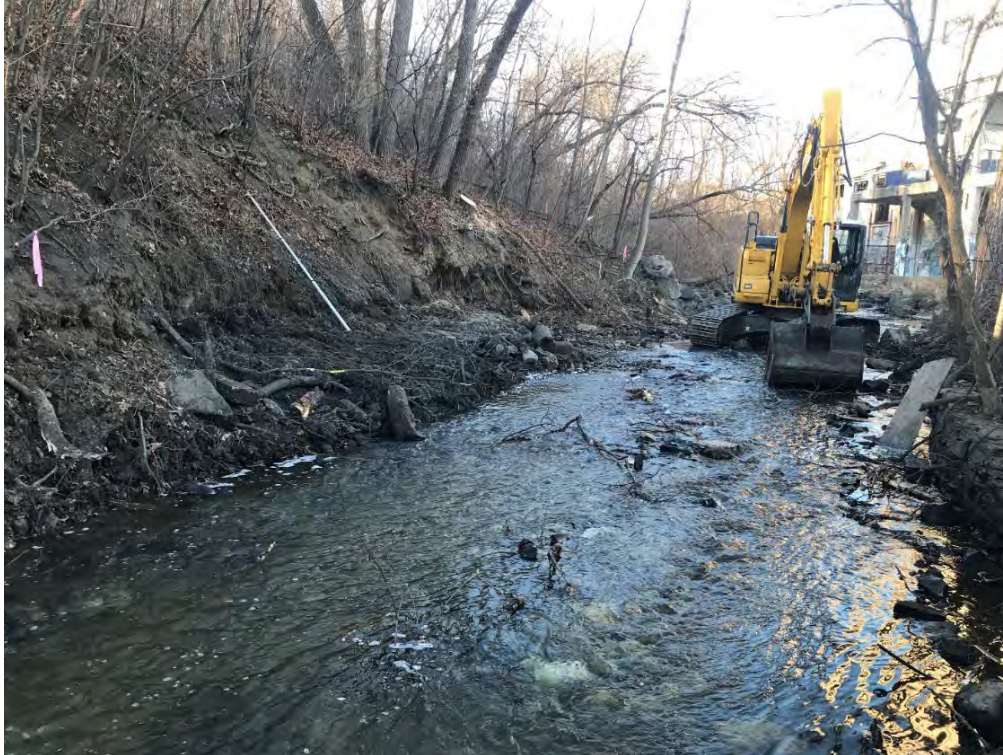
**Reach 2: Clearing for riprap and VRSS (12/1/2020)**

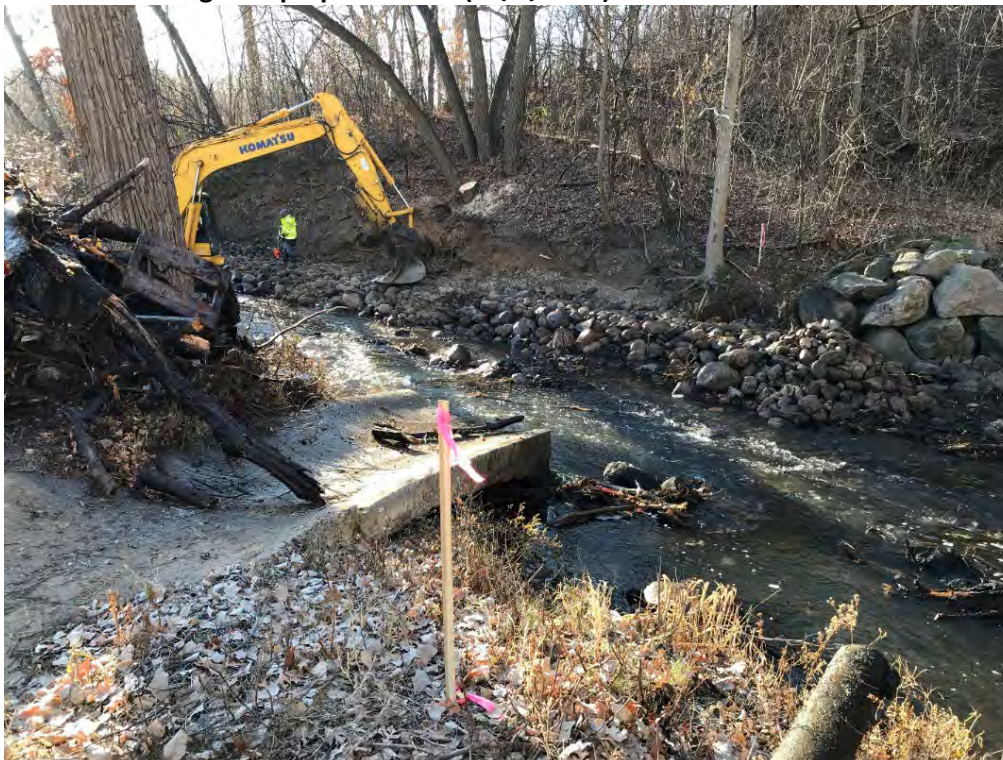
**Reach 2: Installation of riprap for VRSS and bank stabilization (12/1/2020)**

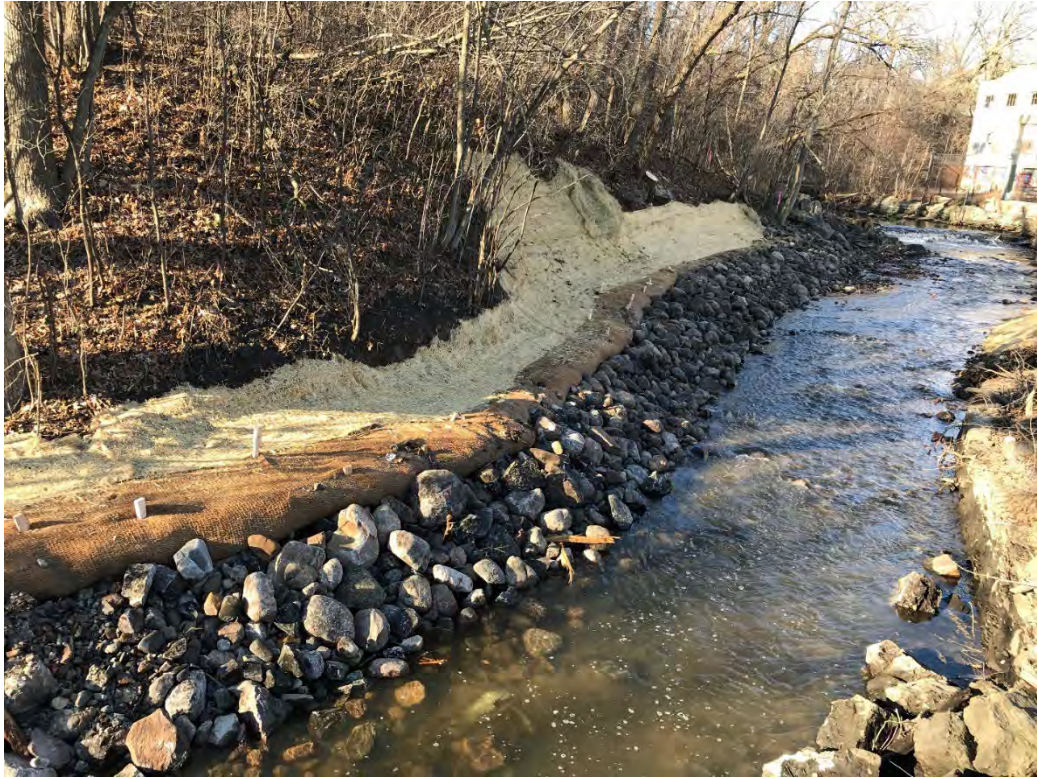
**Reach 2: Installed riprap, erosion control blanket, and VRSS (12/4/2020)**

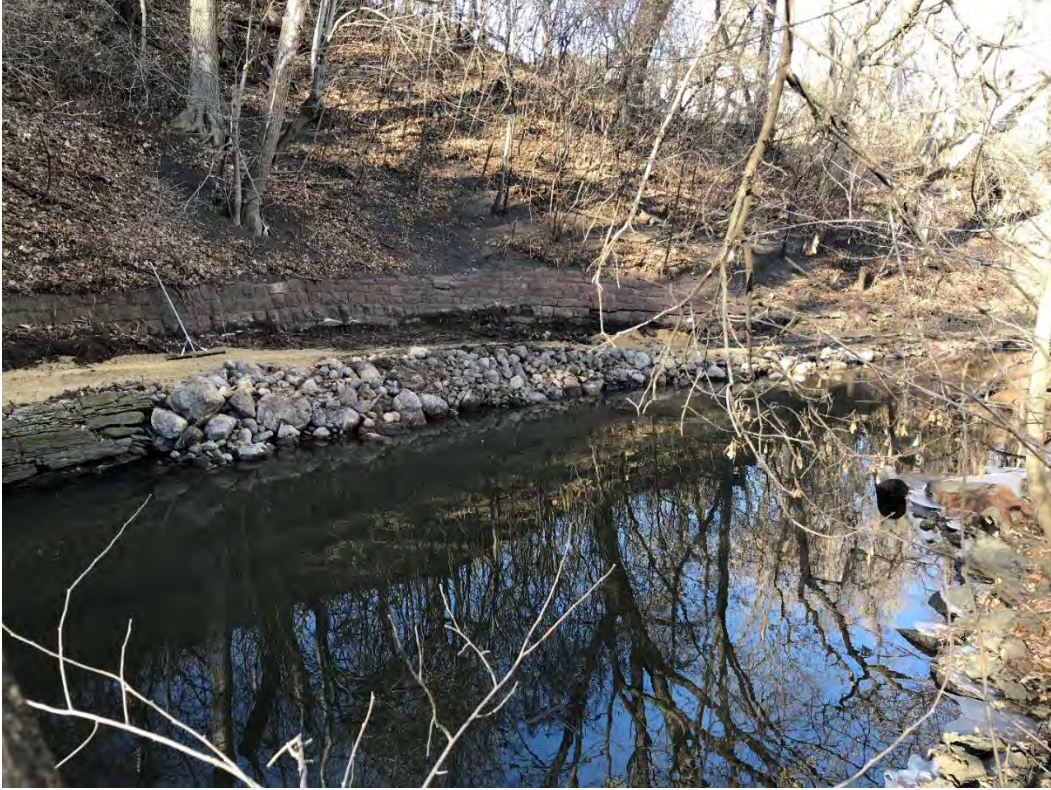
**Reach 2: Installed riprap and trail improvement (12/4/2020)**

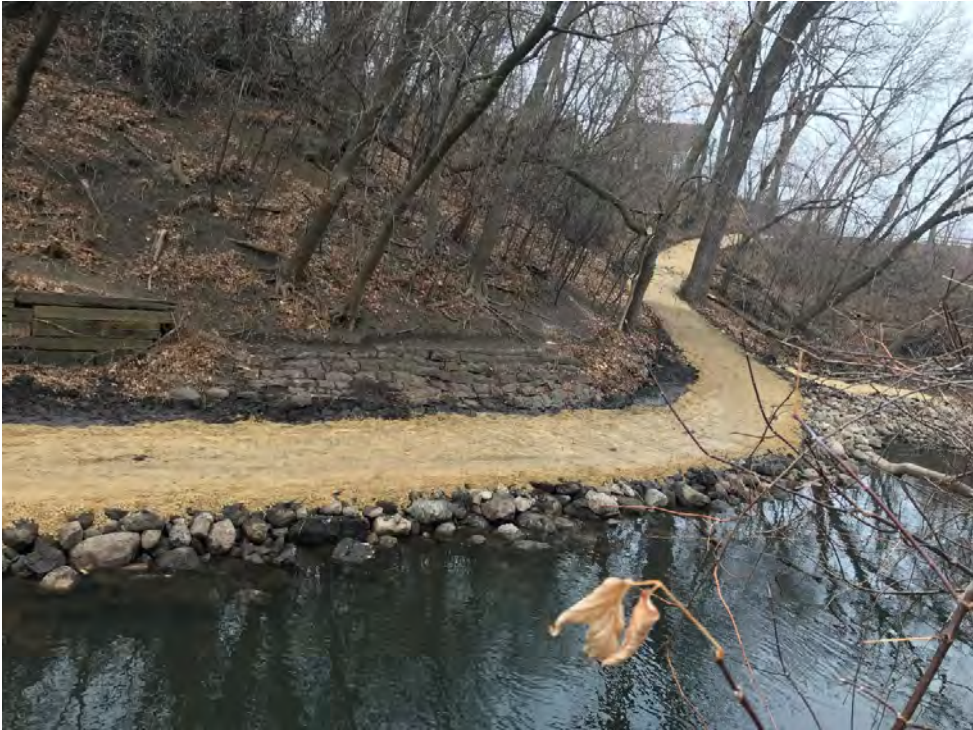
**Reach 2: Installed riprap and trail improvement (12/8/2020)**

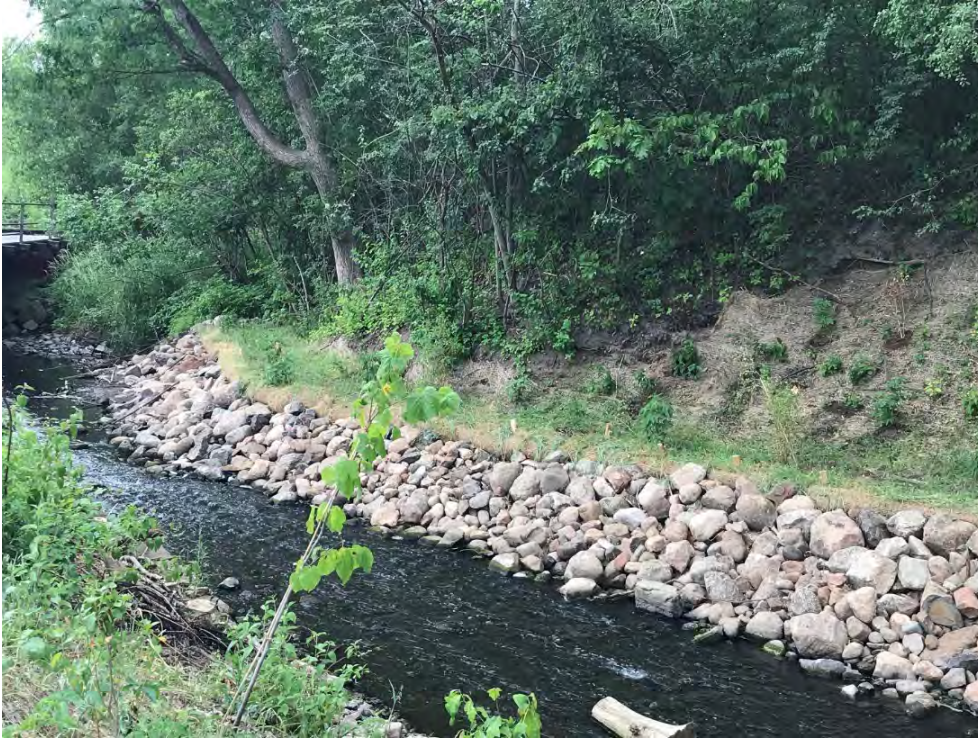
**Reach 2: Native vegetation reestablishment in VRSS (6/17/2021)**

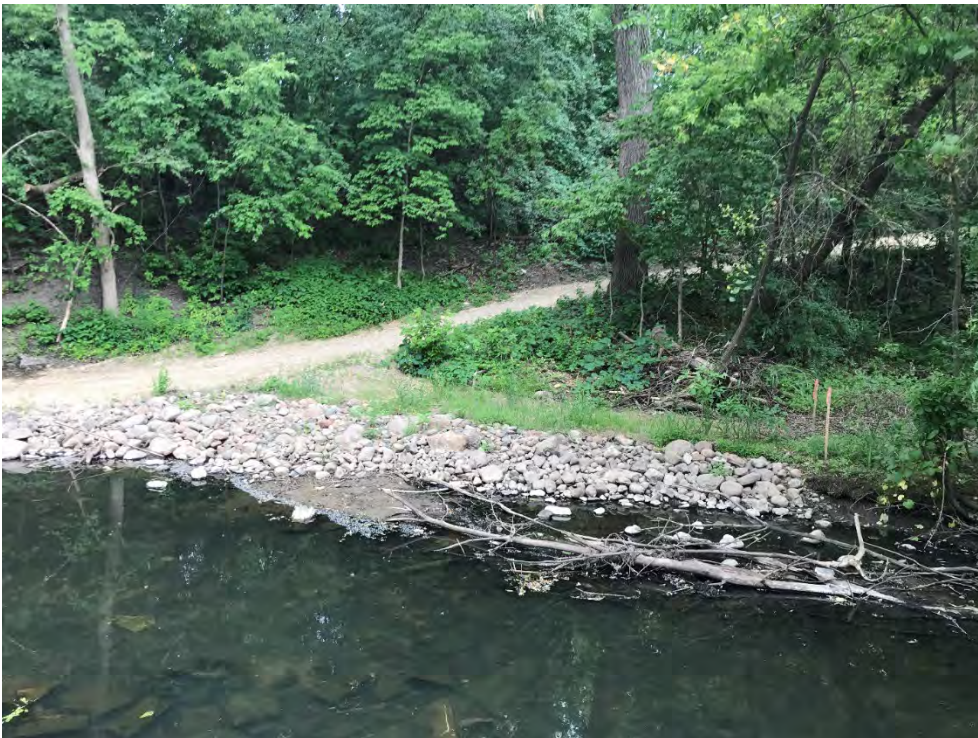
**Reach 2: Riprap and native vegetation reestablishment at trailhead from Glenwood Ave. to site (6/17/2021)**

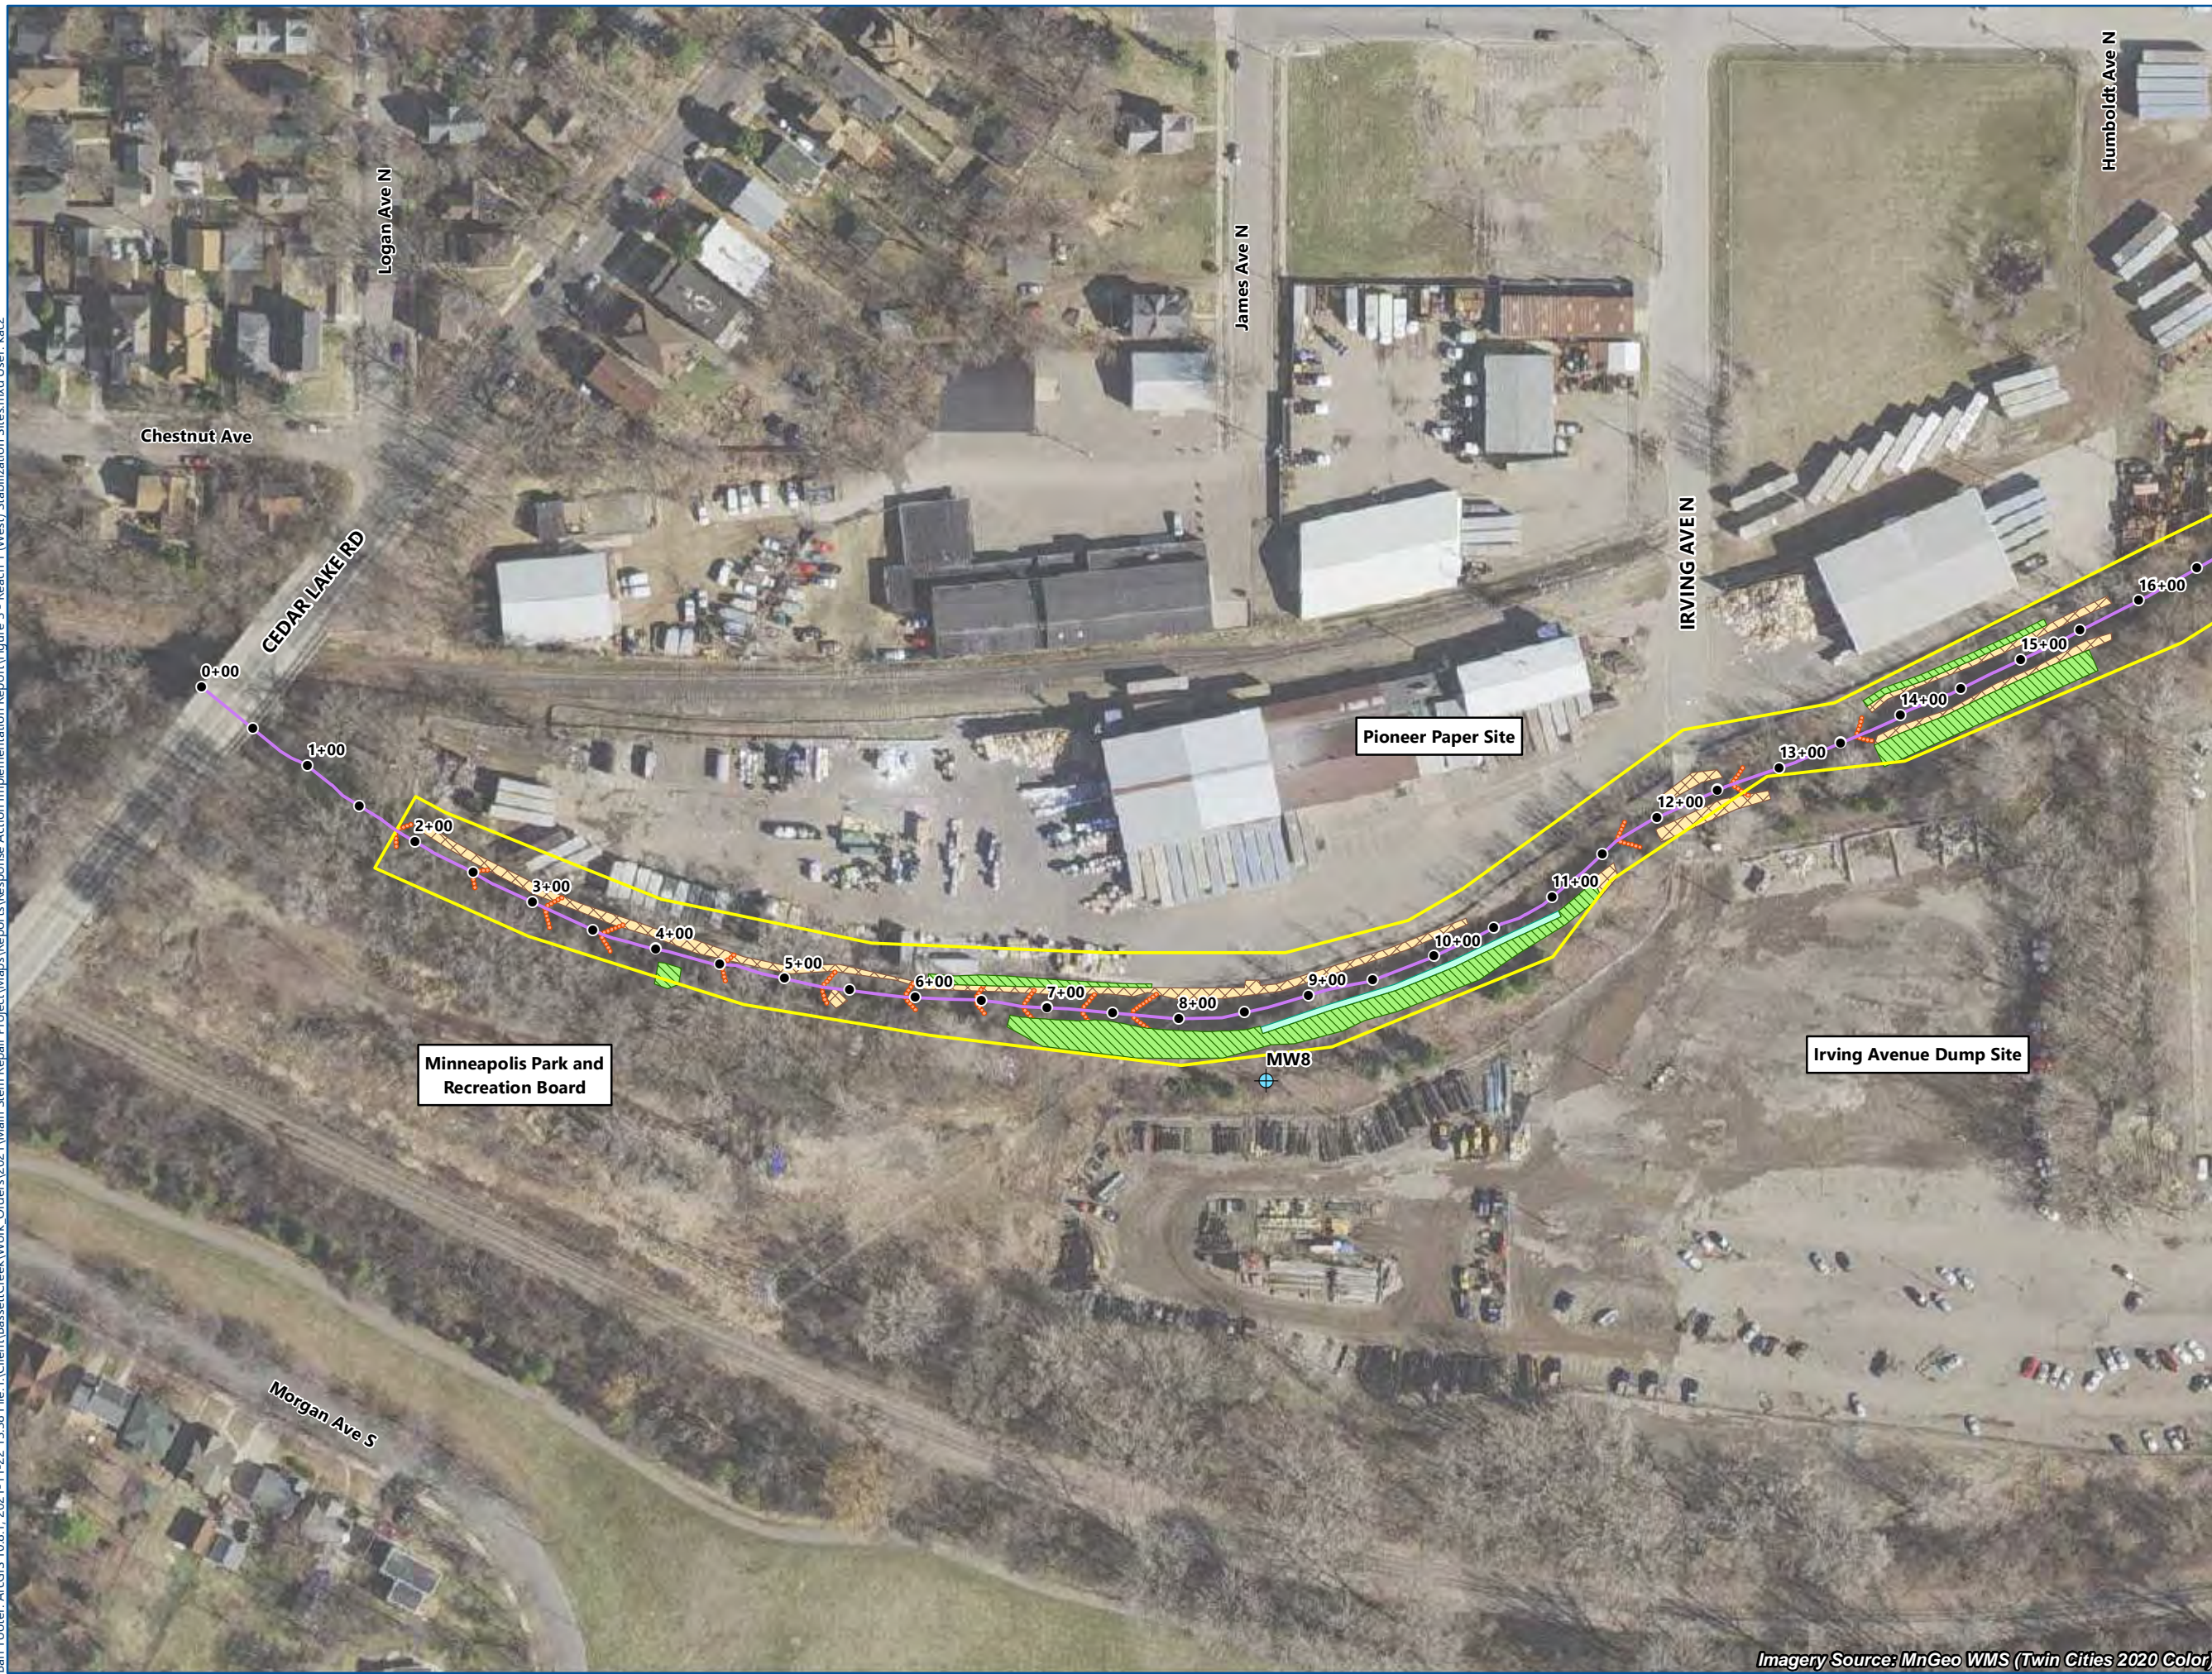
FIGURE 2

REACH 1 (WEST) STABILIZATION SITES  
 Bassett Creek Main Stem Erosion Repair Project  
 Minneapolis, Minnesota

north side of the creek in Reach 1 (Figure 2). The access allowed by the property owner was not sufficient for the installation of the proposed vegetated reinforced soil slope (VRSS); the modified design included debris removal and installation of riprap toe protection on the lower portions of the slope only (accessed via the creek channel), as well as bank grading, vegetation establishment, and installation of boulder vanes in the creek channel. In addition, the bid alternates designed for the east bank of the creek in Reach 2 on the Fruen Mill properties (Figure 4) were not constructed due to the pending redevelopment and restoration of larger areas on those properties that would need to coordinate with any work along the creek banks.

In Reach 1, Sunram installed a total of 1,220 feet of riprap (Figure 2 and Figure 3). Original plans called for 910 feet, but additional riprap was added beyond what was planned to further protect the bank and existing sewer outlets and to tie into the bank in a better position. Approximately 710 feet of fascines were installed by Landbridge along the edges of the banks in the center and downstream portions of the reach. Landbridge also installed approximately 1,380 feet of live stakes in the downstream portion of the reach. In spring 2022, Landbridge is expected to install additional rows of live stakes east of Van White Memorial Boulevard. Sunram installed 12 boulder vanes: 11 vanes in the upstream portion of Reach 1 and one vane further downstream. The original plan called for 10 vanes in the upstream portion of the reach; an additional vane was added to provide adequate spacing between vanes. Additional riprap and boulder vanes were also installed as part of the City's Irving Avenue Sanitary Sewer near the former Irving Avenue bridge as part of the sewer project site restoration, in coordination with this project. Those quantities are not reflected in this report.
